Sidewalk And Intersection Snow Clearing Standards In Brampton

Quality of winter maintenance with regard to active transportation.

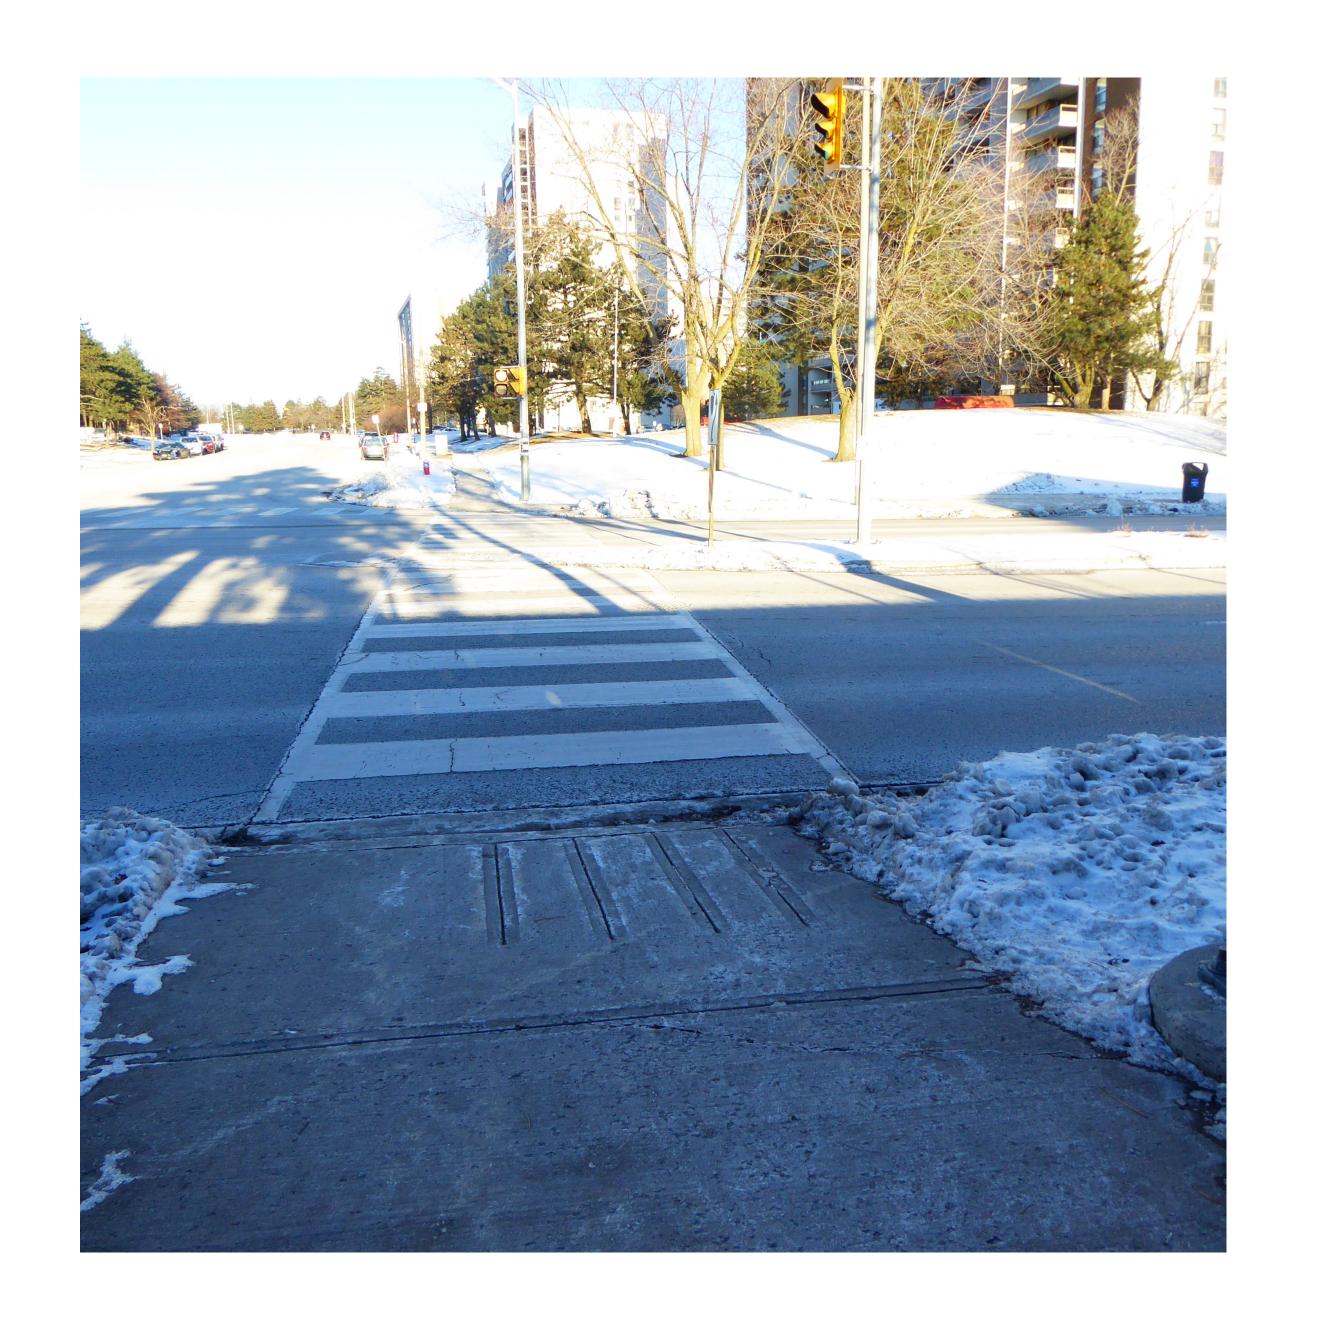
Clark Blvd. And King's Cross

- East side of King's cross intersection.
- January 21, 2024.
- 9 days after a 4/5 cm snowfall.

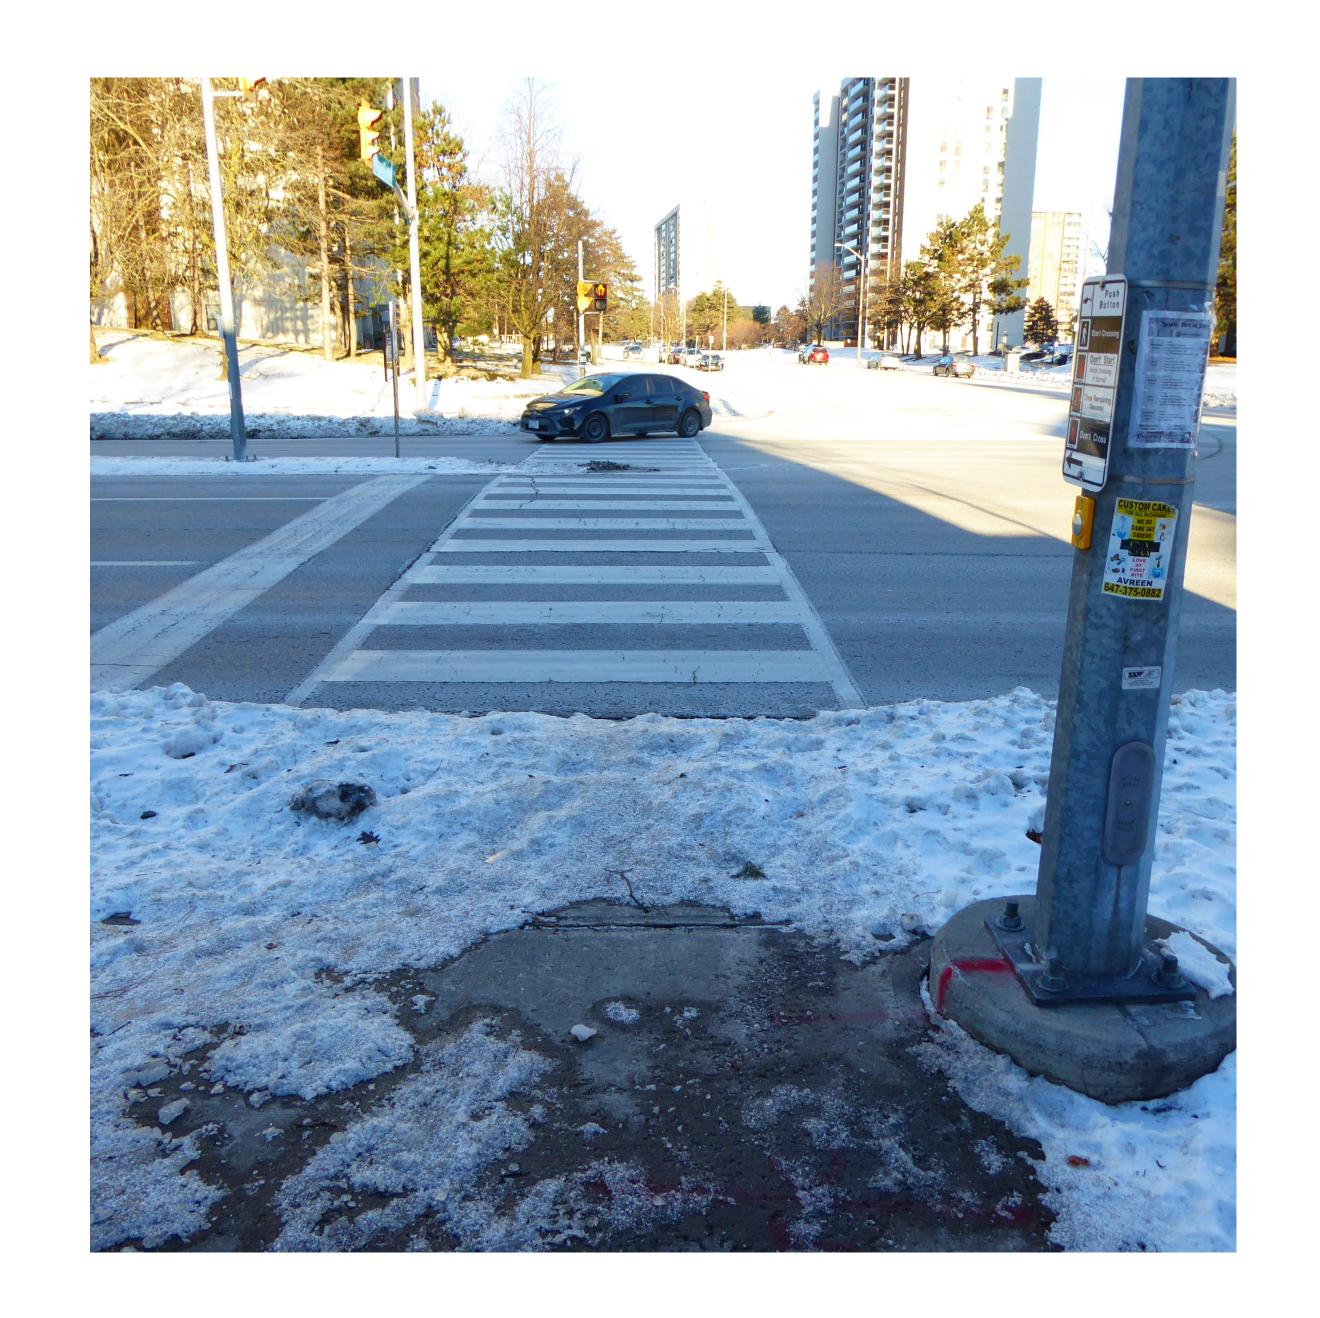
Clark Blvd. And King's Cross

- January 21, 2024
- West side of King's Cross.
- Snow mounded at street curbing.
- Pedestrian signal button accessible.

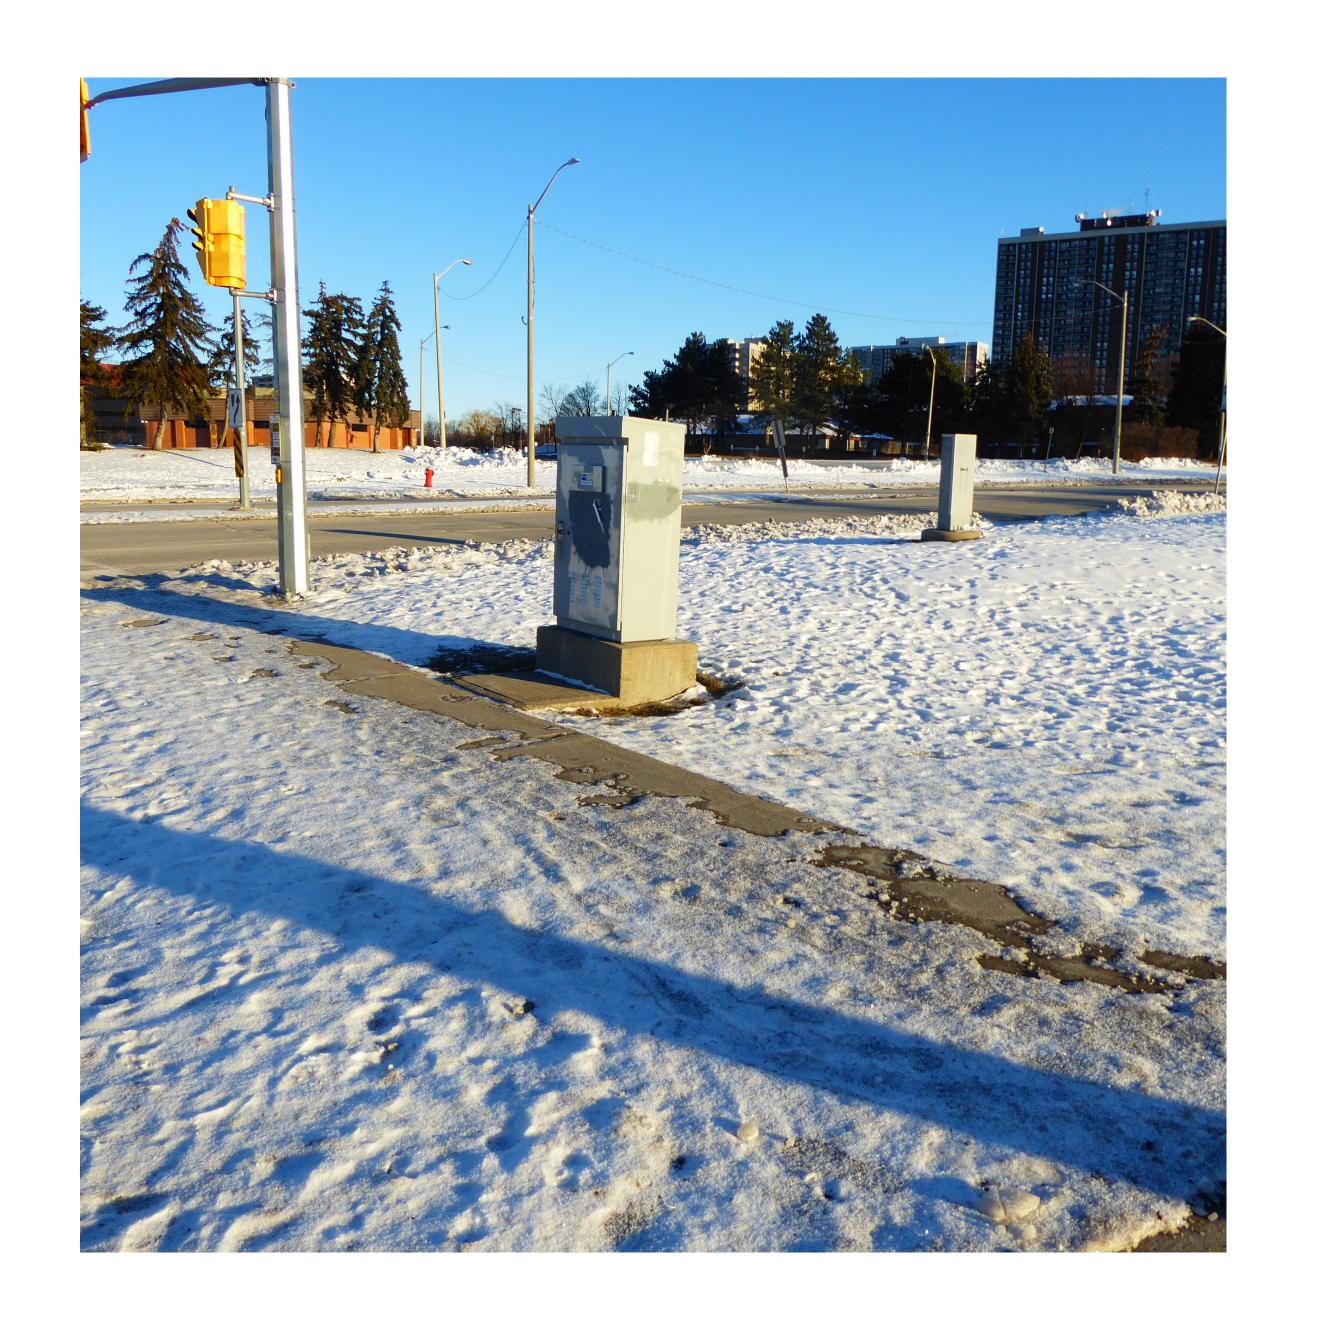
Clark Blvd Public School

- January 21, 2024
- East side of intersection, in front of school.
- Rough ice consistency.

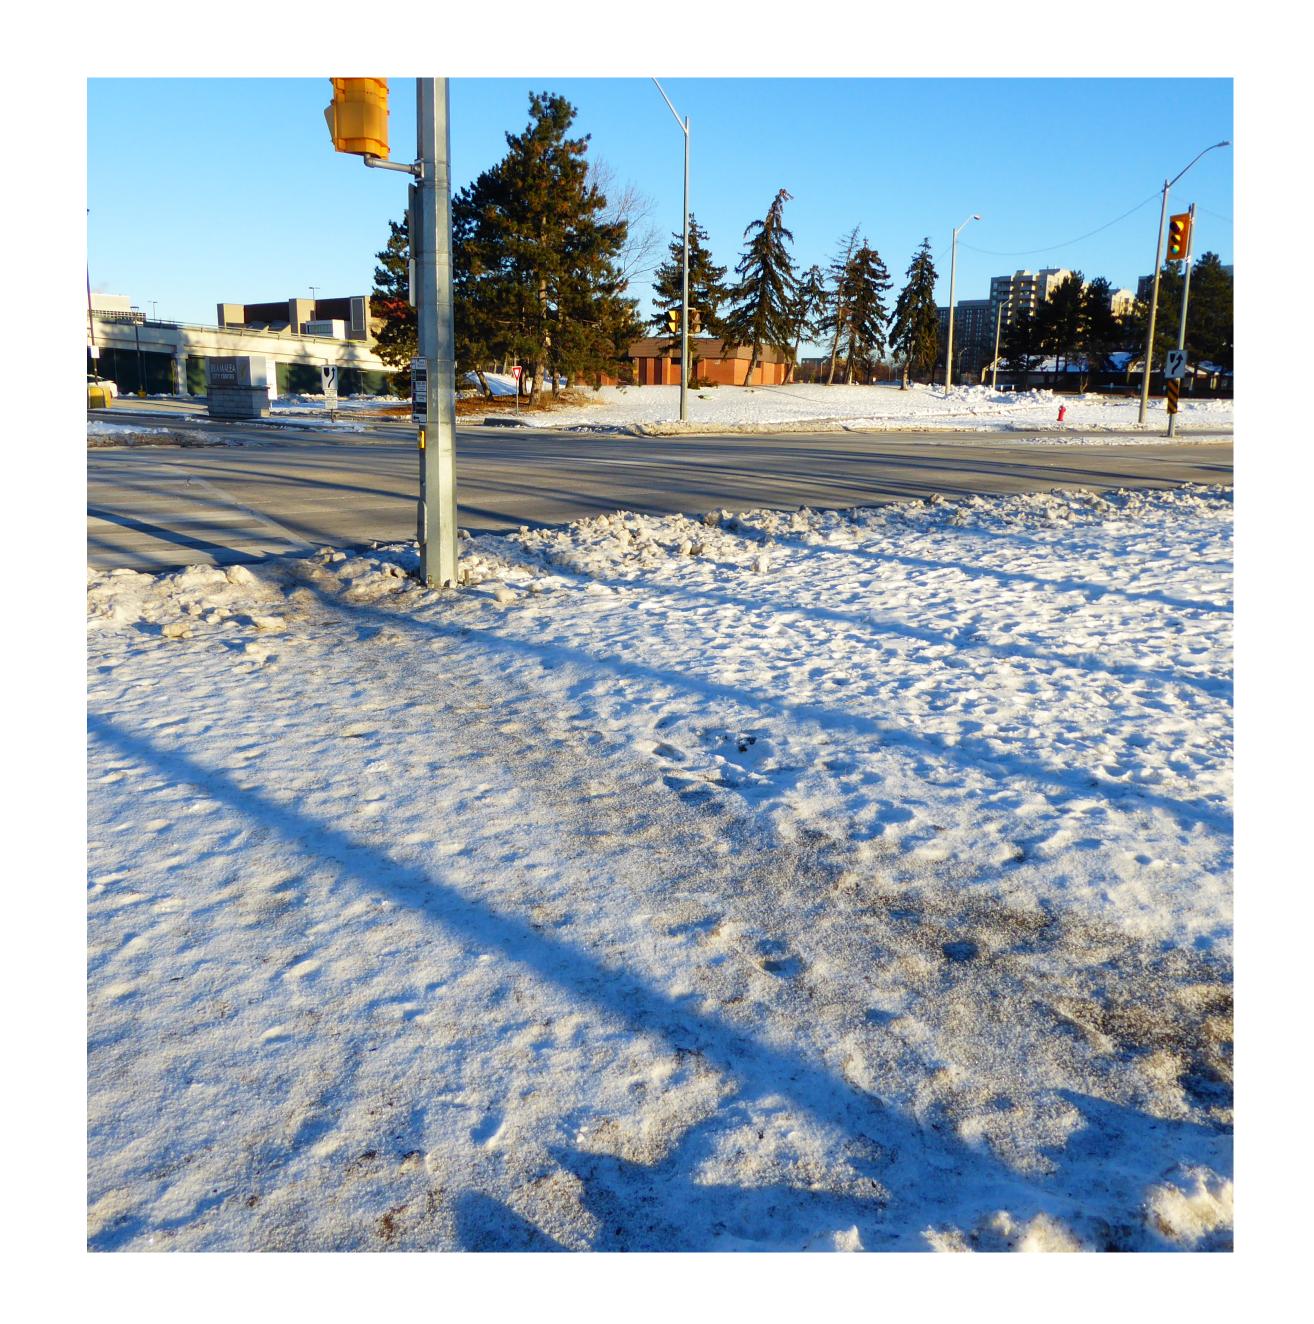
Clark Blvd Public School

West Side of Intersection.

- January, 21, 2024.
- No attempt at snow/ice clearance to street.
- Snow mounded at street curb.
- Hazardous access to pedestrian signal button.

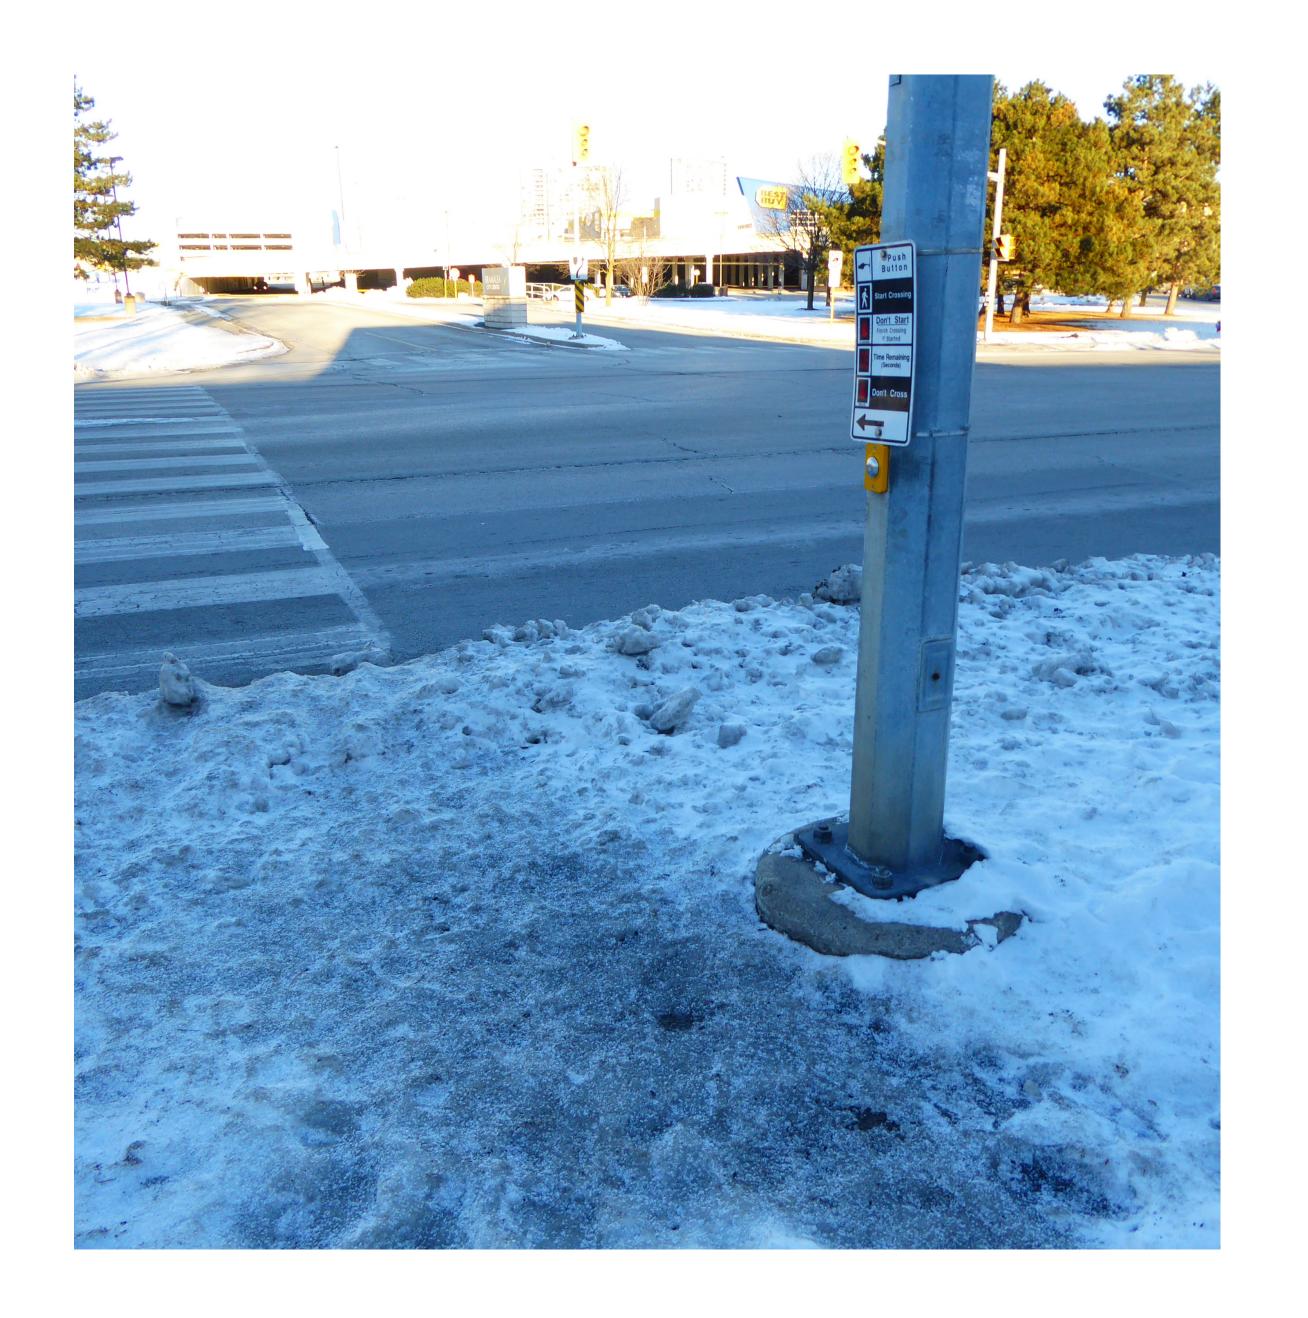
Clark Blvd. And Briar Path

West side of Intersection

- January 21, 2024.
- No attempt at clearance.

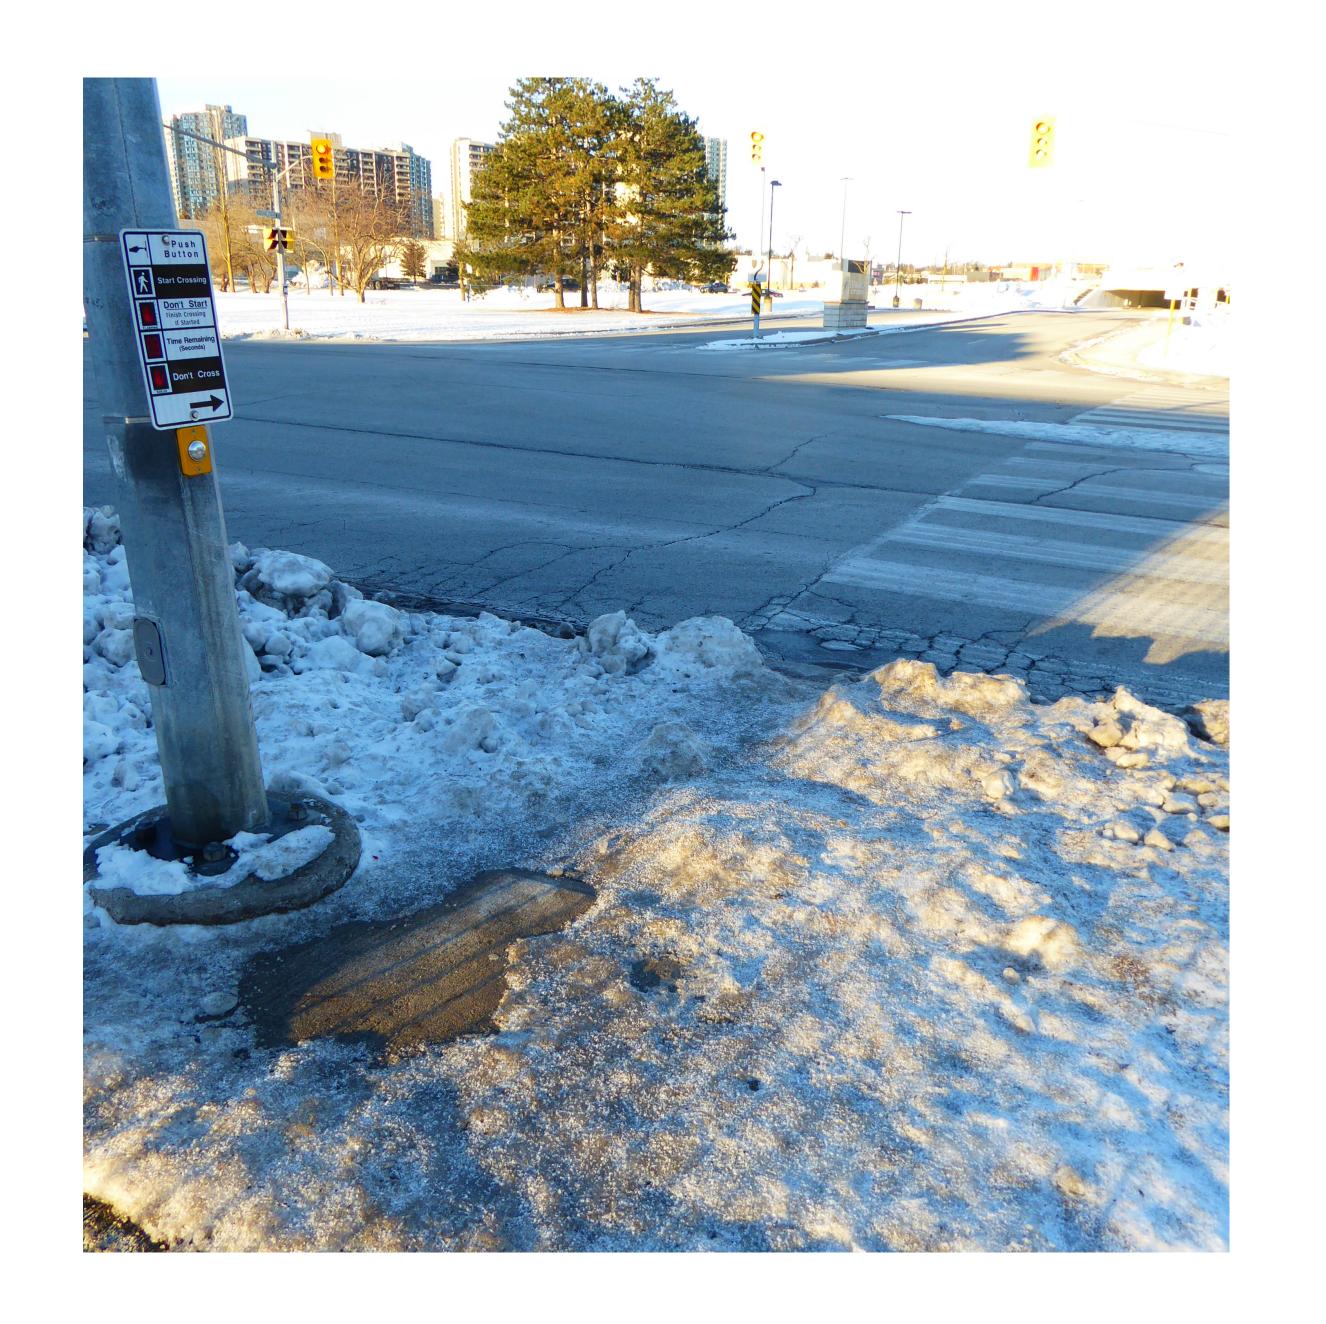
Clark Blvd. And Briar Path.

East Side of Intersection.

- January 21, 2024.
- No clearance attempt.
- Ice worn through by pedestrians accessing signal button.

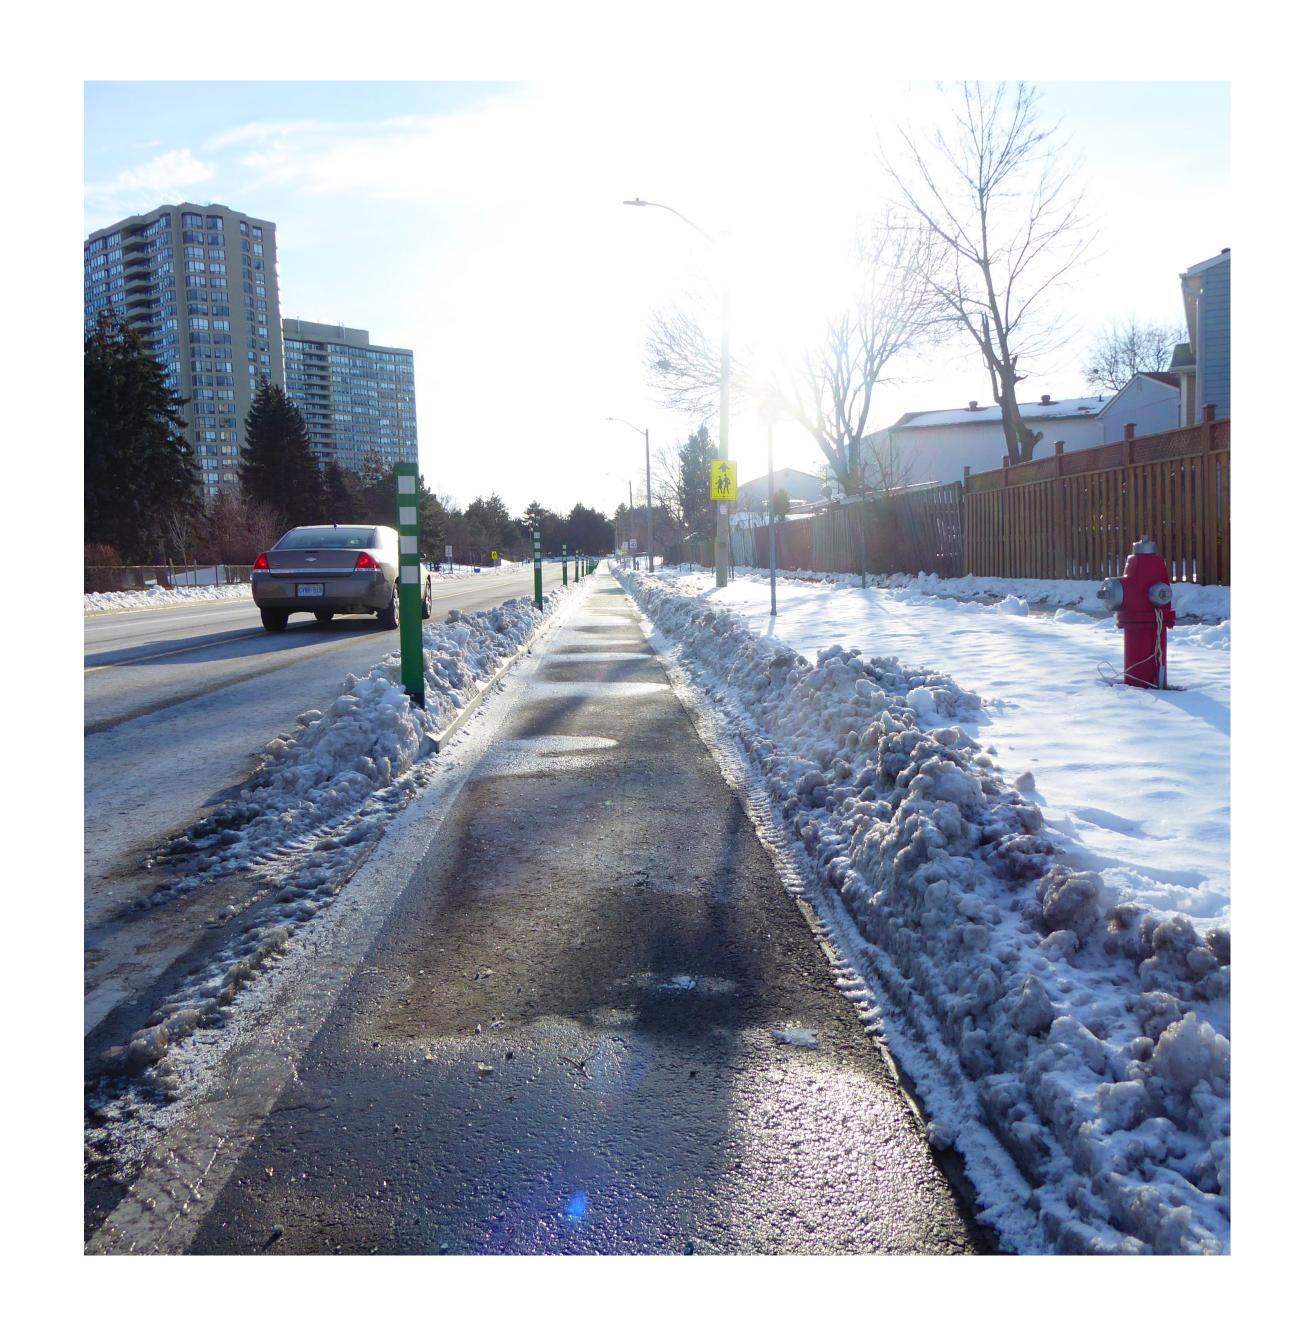
Hanover Road

Separated Bicycle Lane

- Snow clearing, as it appeared one day after January 13th snowfall. (4/5 cm)
- An example of the utility of high quality winter maintenance as it relates to usability for active transportation.

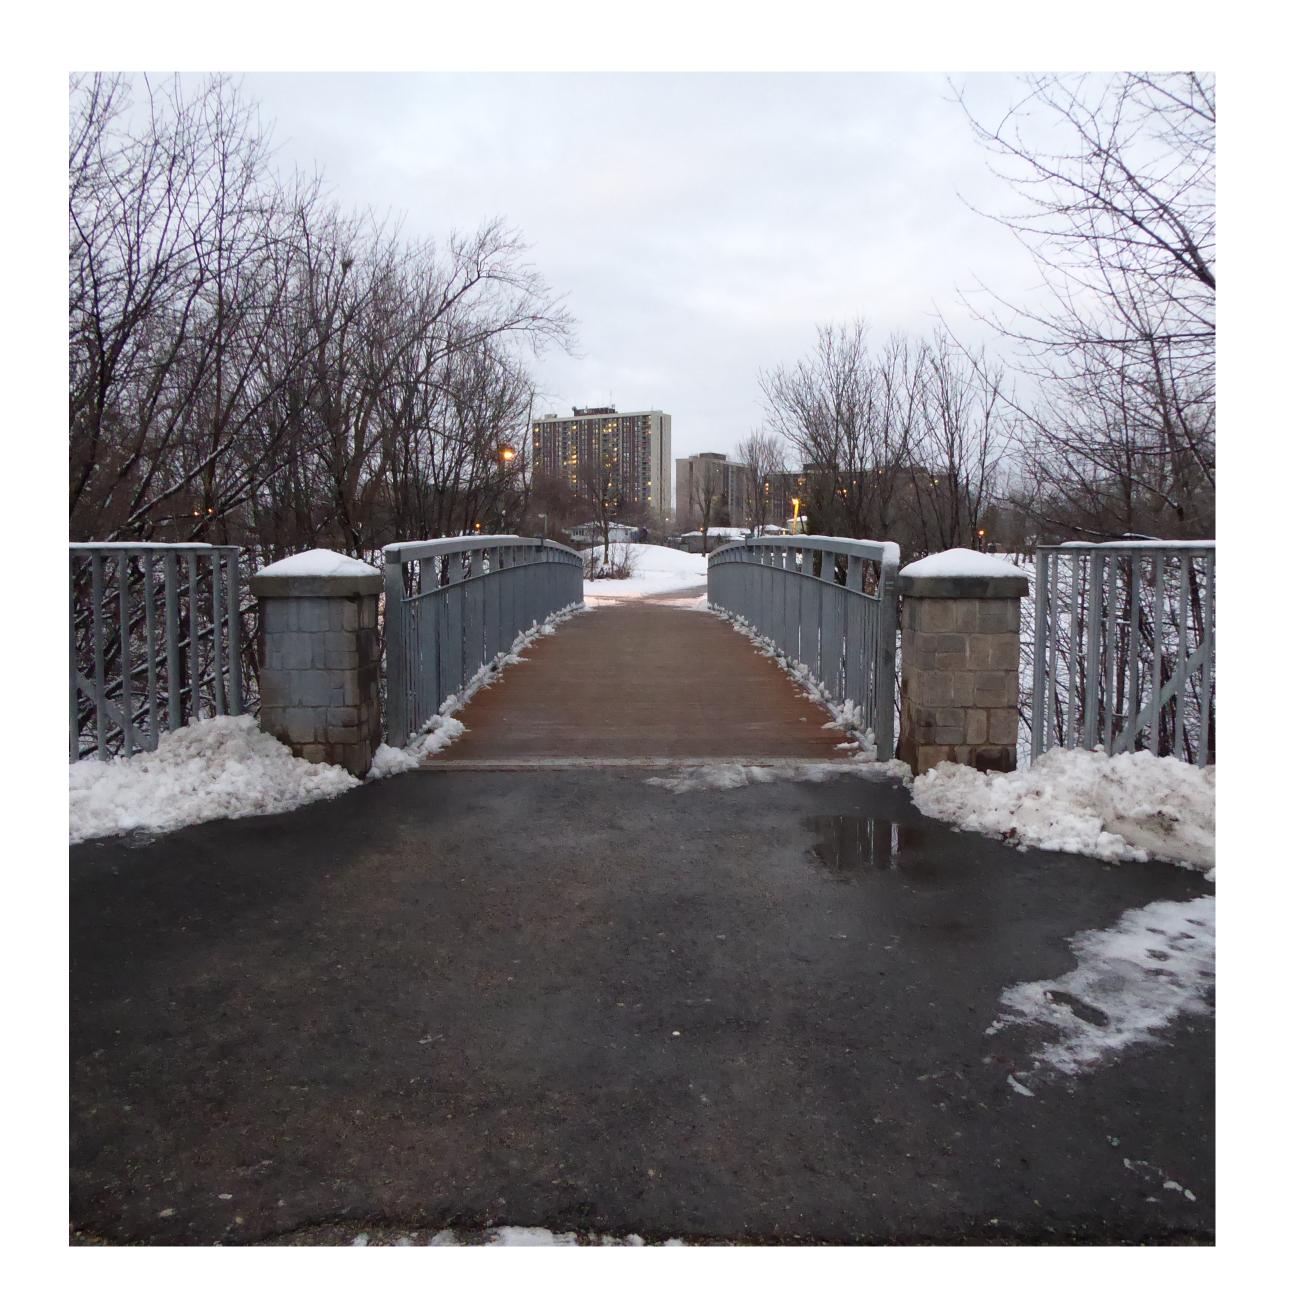
Clark Park

• Winter 2022. An example of full bridge clearance, done by a concerned citizen.

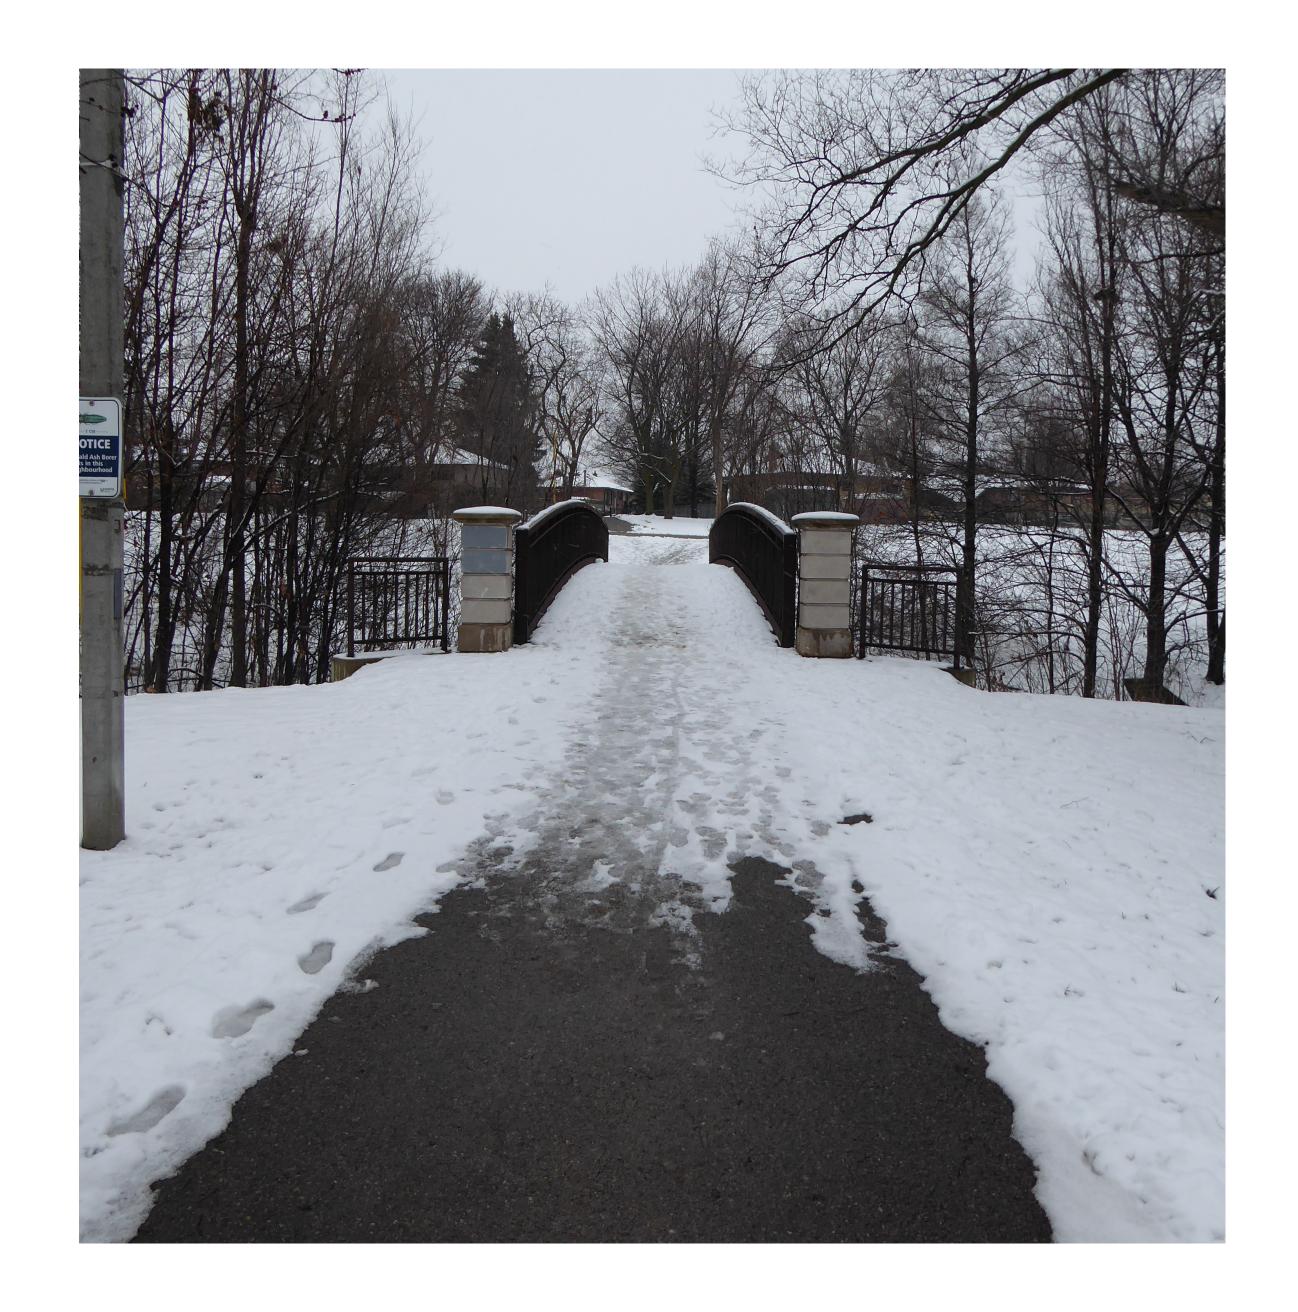
Aloma Park by Aloma School

2022 snow fall.

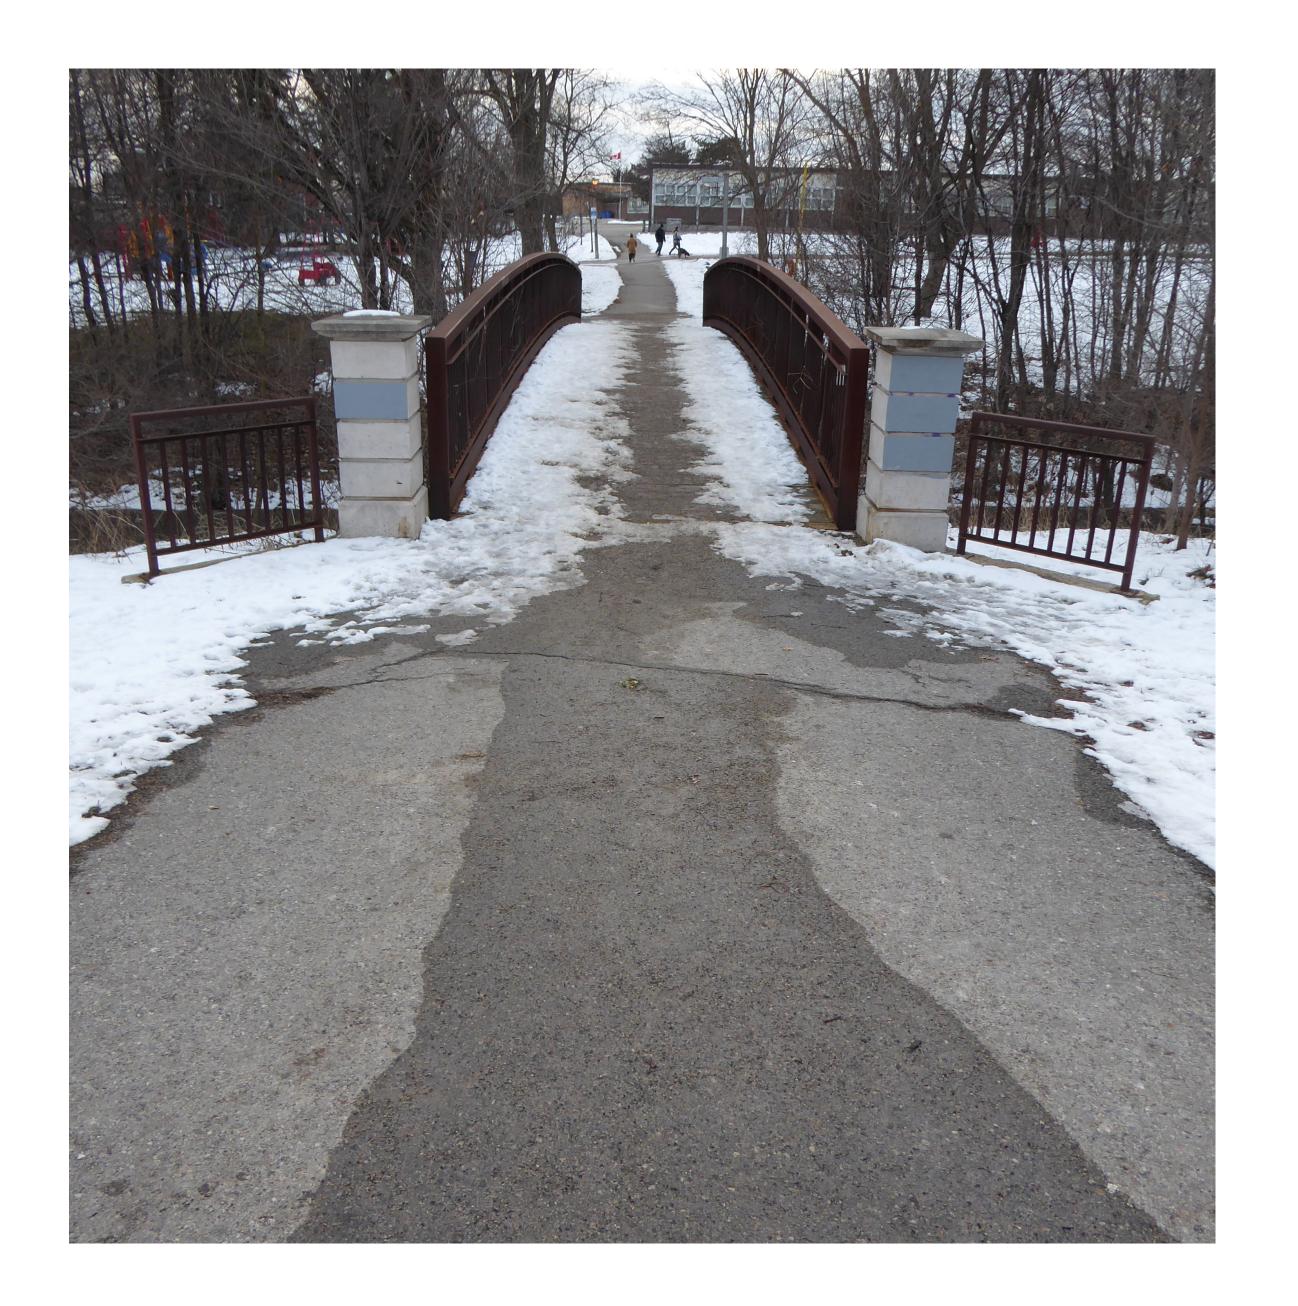
Aloma Park by Aloma School

• Snow fall 2022, a number of days later.

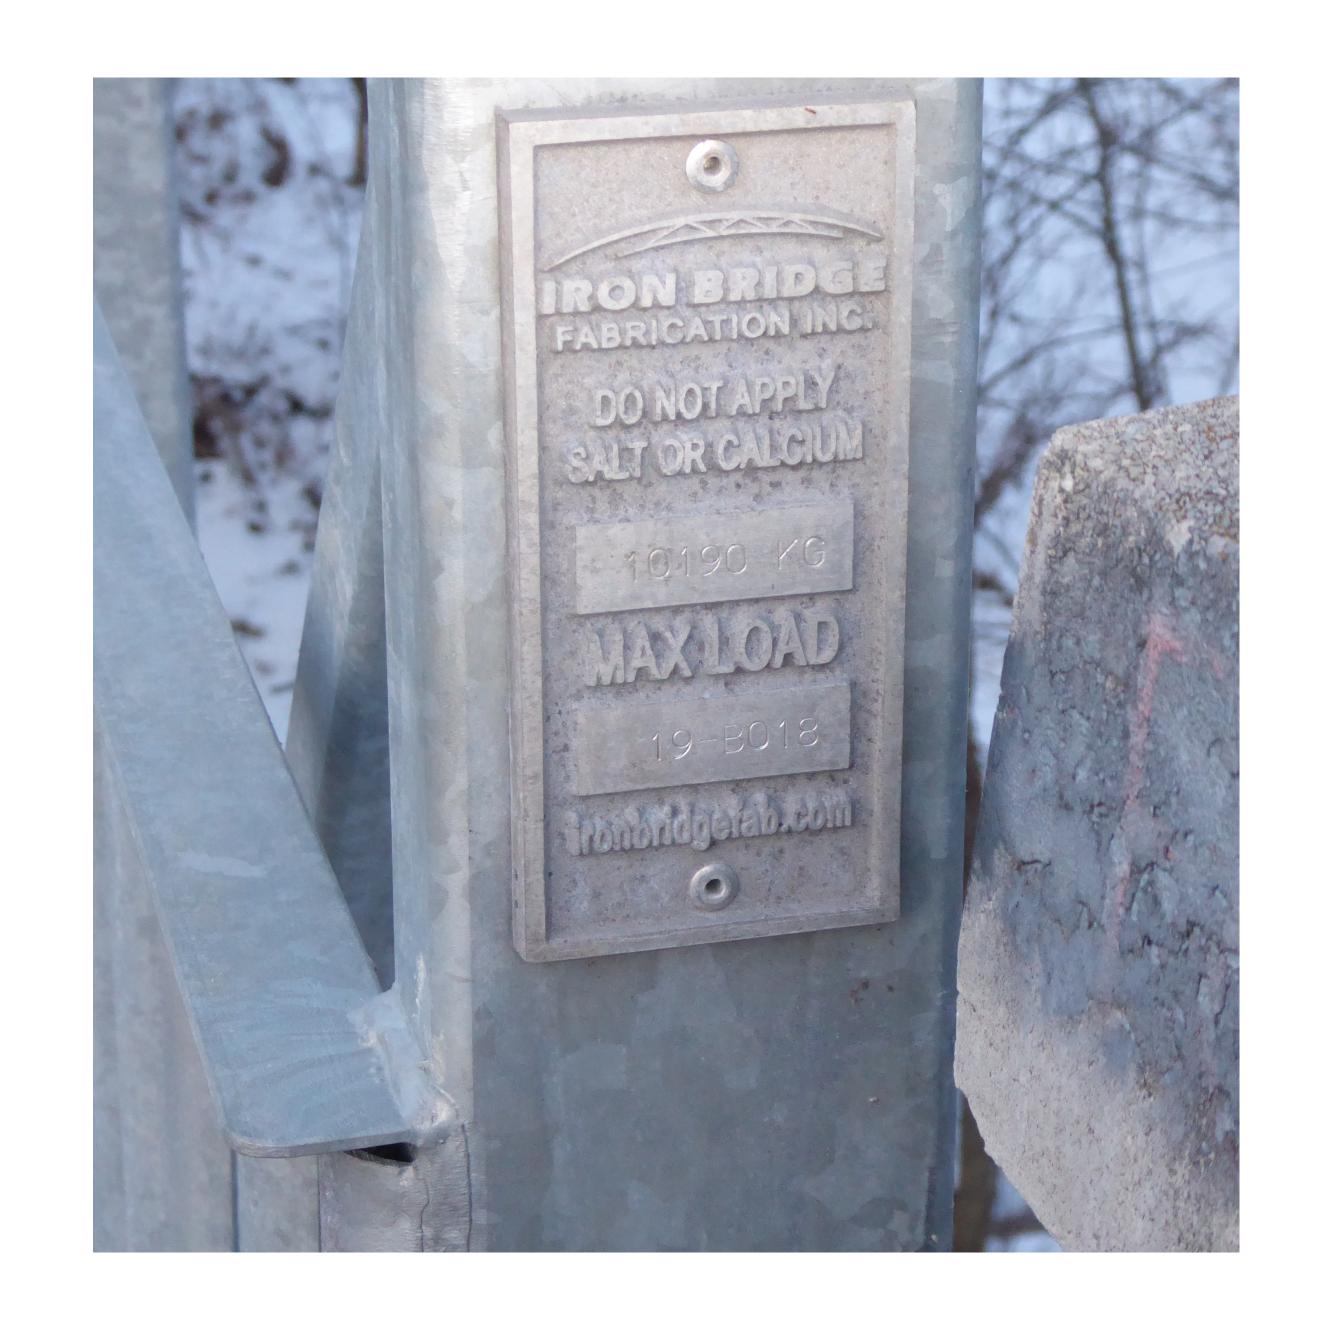
Park Bridge Construction

- One of the factors that effects winter maintenance is the manufacturers specifications, which discourage the use of salt or calcium on the bridge.
- The other aspect is a combination of arch structure and wood decking, which discourage the use of plows.
- This leaves sand as the only treatment option.
