TO: Opal Valley Developments, c/o Tony Priori
FROM: Chelsey Collins (Tyers), Cultural Heritage Specialist, WSP Canada Inc.
Heidy Schopf, Cultural Heritage Lead, WSP Canada Inc.
SUBJECT: 11185 Airport Road Heritage Impact Assessment Addendum
DATE: August 8, 2024

11185 Airport Road Structural Condition Assessment

11185 Airport Road
Brampton Ontario

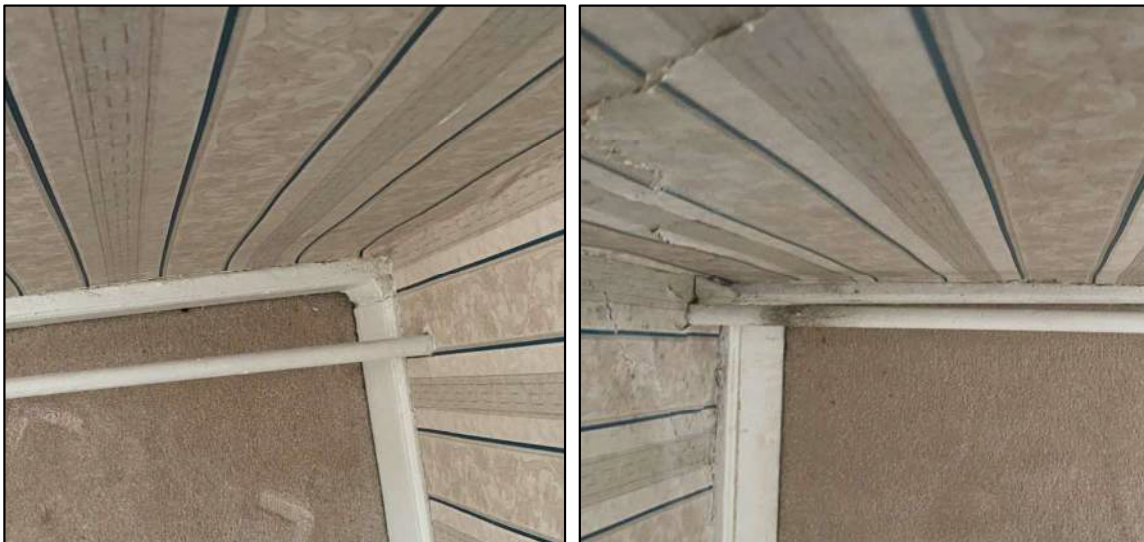
The exception was a significant horizontal (out of plane) deflection in the south wall, both along the height and length of the wall. A deflection of approximately 2-3" was measured at mid-length of the wall near the finished floor elevation. Refer to Photograph 1a and 1b for the relative deflection based on the offset of the wall to the tension rod.

Photograph 1a & b: Relative deflection of wall based on offset from tension rod

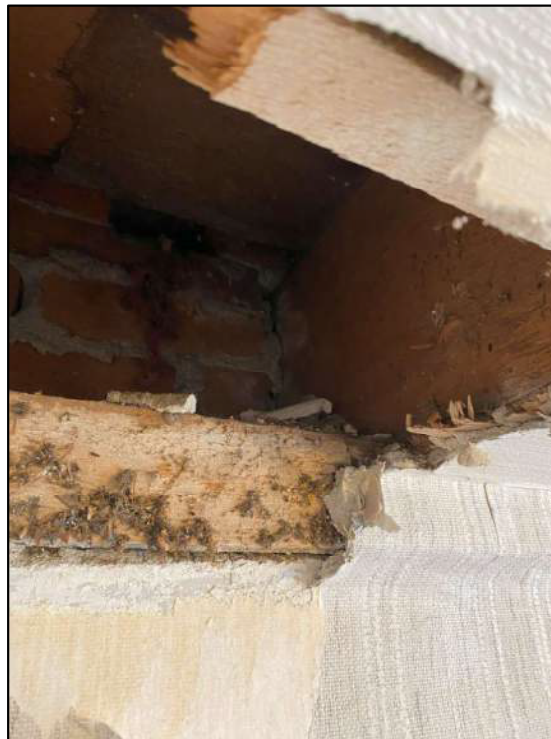
A section of ceiling finishes was removed at the southwest corner of the building and approximately at the middle of the south wall (refer to Photograph 2). Due to the absence of damage or evidence of movement, it is unlikely that the deflection on the second floor was caused by an outward movement of the wall after construction. It is assumed that the wall was built out of plumb. Refer to Section 5.5 Exterior for further discussion on the condition of the south wall.

Photograph 2: Section of removed ceiling finishes at the middle of the south wall

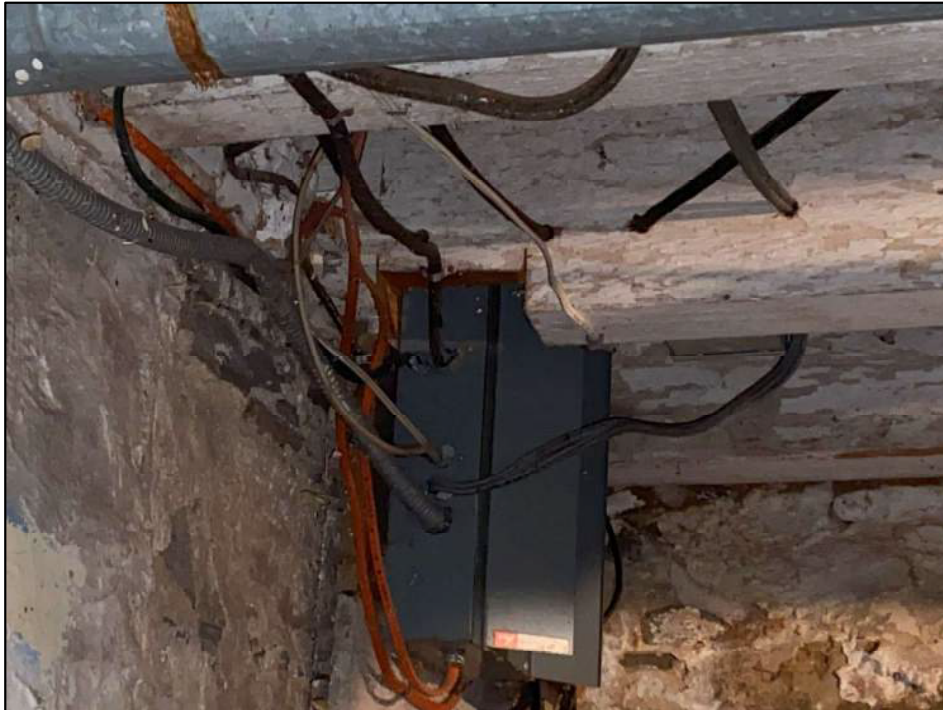
The basement was generally in fair condition. A notched joist was noted behind the furnace (Photograph 3), and the foundation wall was undermined in a localized area where a water supply pipe enters the building on the west wall (Photograph 4). The foundation walls also exhibit signs of deterioration due to moisture.

Photograph 3: Notched joist behind furnace

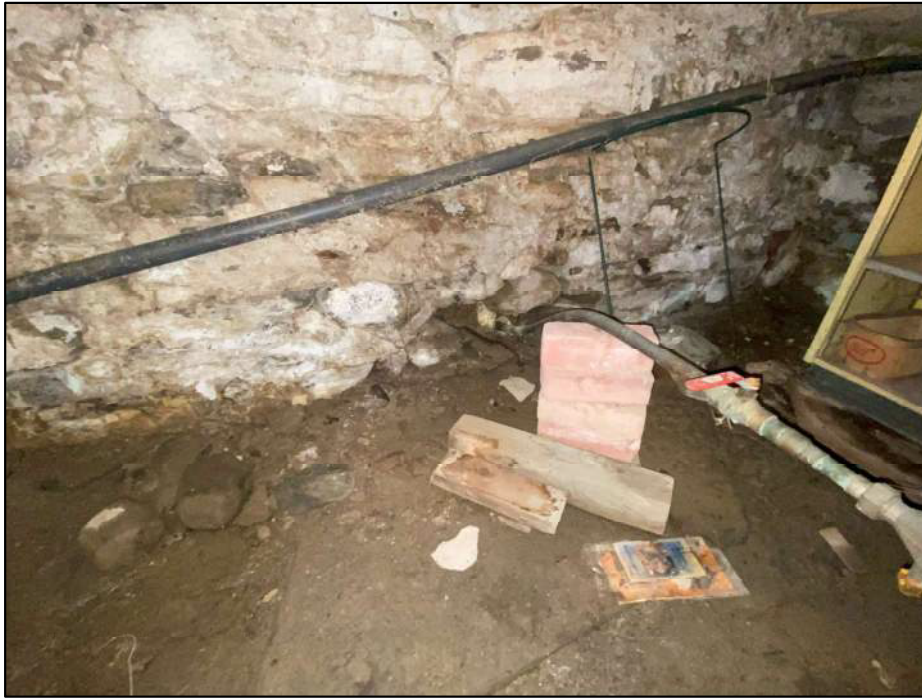
Photograph 4: Undermined section of foundation wall

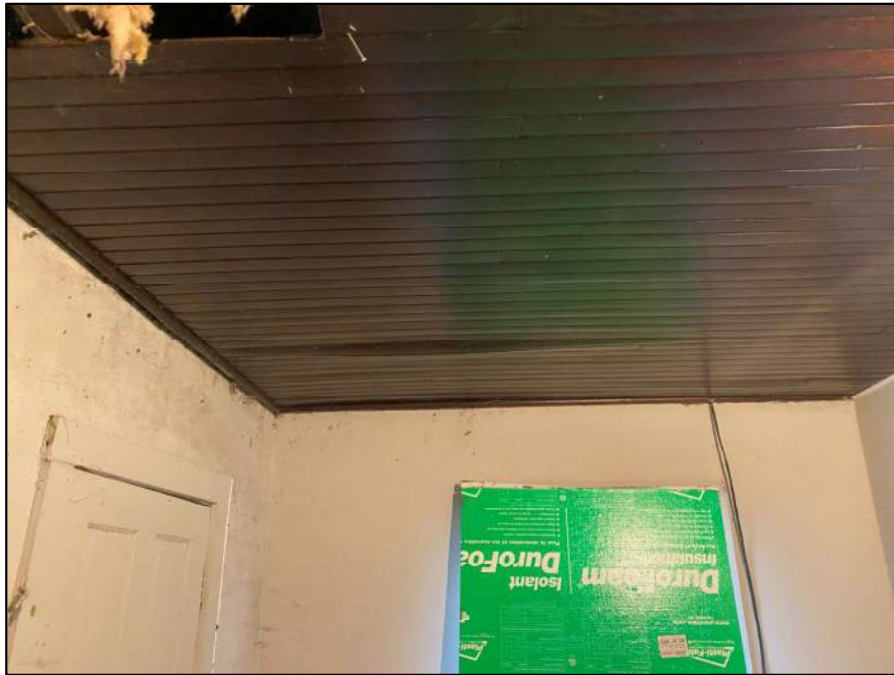
The finishes in the summer kitchen were generally of poor quality and/or in poor condition. Water damage was noted to the ceiling and floor finishes, as seen in Photograph 5 and 6, which could pose a larger concern to the underlying structure.

Photograph 5: Water damage to ceiling finishes

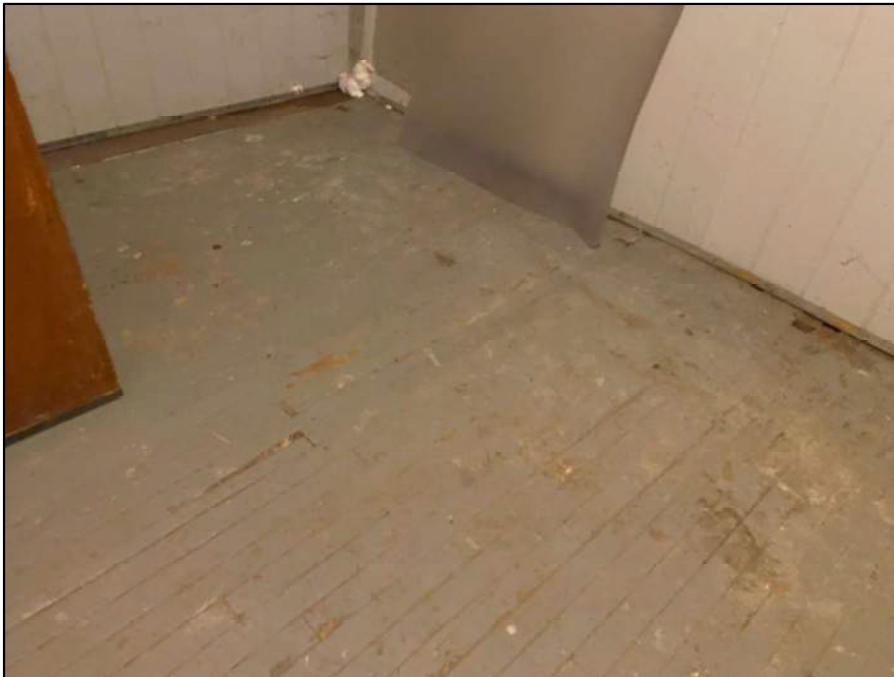
Photograph 6: Water damage to floor finishes

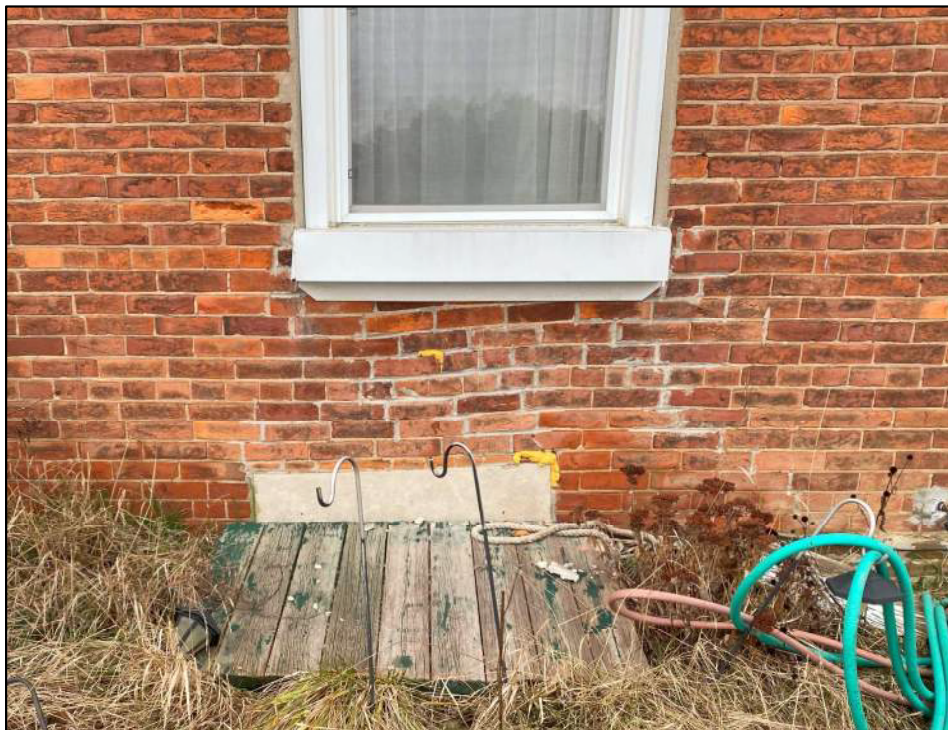
Deterioration was noted on each elevation below windows, consistent with damage from water ingress. Diagonal cracks were also noted extending upward from the top corners of windows. Loose or damaged bricks were present in the jack arches above windows at several locations. Several failed repairs were evident, many with non-compatible materials. The typical condition of the walls can be seen in Photograph 8. Inconsistent coursing was also noted on the south elevation, as seen in Photograph 9, which does not appear to be due to movement, rather it appears to have been constructed this way.

Photograph 9: Inconsistent coursing
