**TO:** Opal Valley Developments, c/o Tony Priori  
**FROM:** Chelsey Collins (Tyers), Cultural Heritage Specialist, WSP Canada Inc.  
Heidy Schopf, Cultural Heritage Lead, WSP Canada Inc.  
**SUBJECT:** 11185 Airport Road Heritage Impact Assessment Addendum  
**DATE:** August 8, 2024

# 11185 Airport Road Structural Condition Assessment

11185 Airport Road  
Brampton Ontario

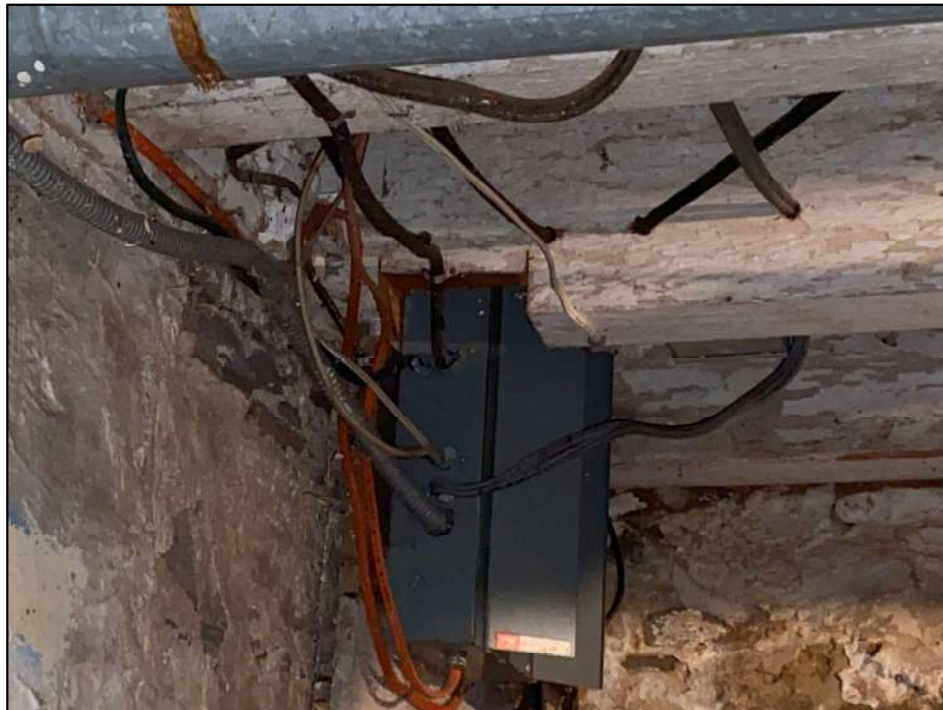
**Photograph 3: Notched joist behind furnace**

The basement was generally in fair condition. A notched joist was noted behind the furnace (Photograph 3), and the foundation wall was undermined in a localized area where a water supply pipe enters the building on the west wall (Photograph 4). The foundation walls also exhibit signs of deterioration due to moisture.

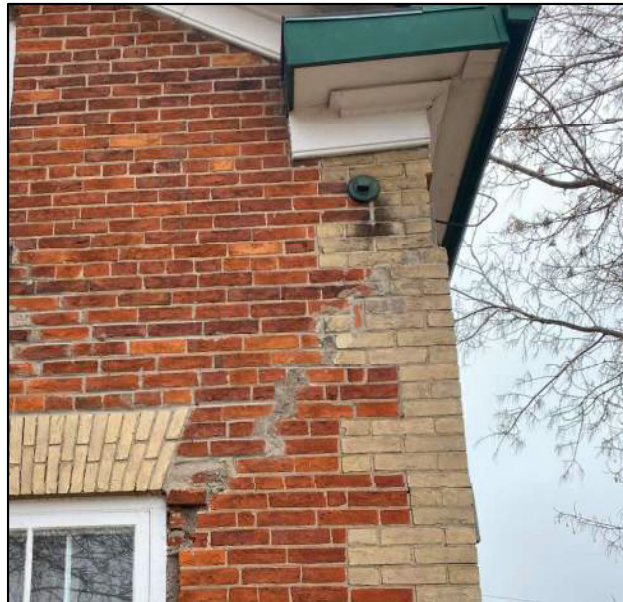
**Photograph 7: Cracks and displacement at accent masonry**

The deflection noted on the interior of the south wall was also apparent from the exterior, along with deflections to the west and north elevations. Cracks and displacement of bricks were also visible at the corners of each wall where the accent masonry had pulled away from the surrounding masonry, as seen in Photograph 7. Some cracks extended well into the surrounding masonry. The tension rods appeared to be installed to restrain this outward movement; however, their effectiveness is unclear.

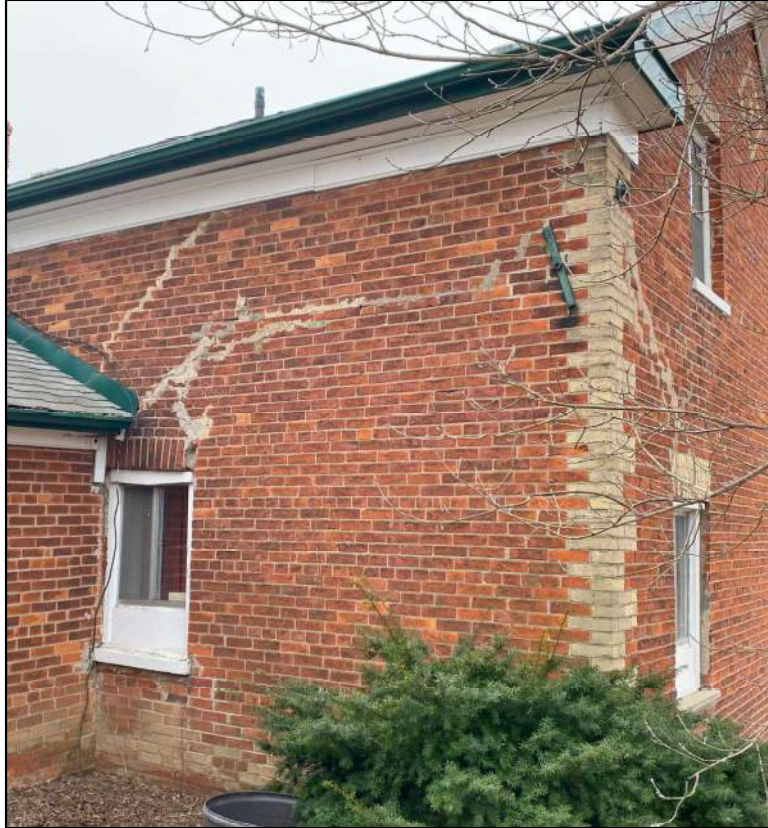
**Photograph 8: Typical condition of exterior walls**

Deterioration was noted on each elevation below windows, consistent with damage from water ingress. Diagonal cracks were also noted extending upward from the top corners of windows. Loose or damaged bricks were present in the jack arches above windows at several locations. Several failed repairs were evident, many with non-compatible materials. The typical condition of the walls can be seen in Photograph 8. Inconsistent coursing was also noted on the south elevation, as seen in Photograph 9, which does not appear to be due to movement, rather it appears to have been constructed this way.

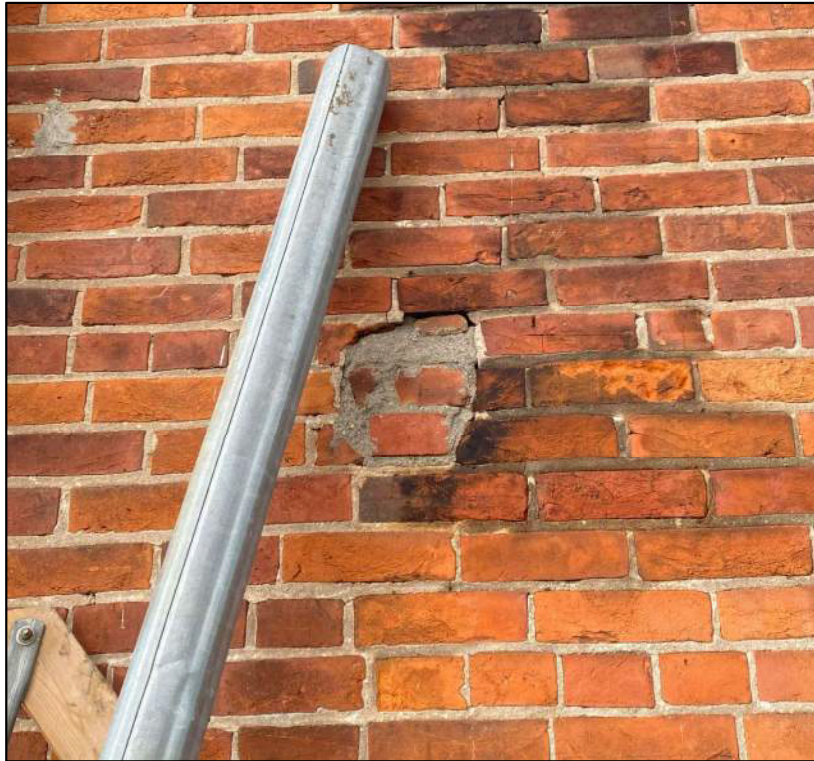
**Photograph 10: Repair of past holes**

Areas were noted throughout the walls where past repairs had been made to larger openings by filling the holes with large amounts of mortar and cutoffs from brick (Photograph 10).

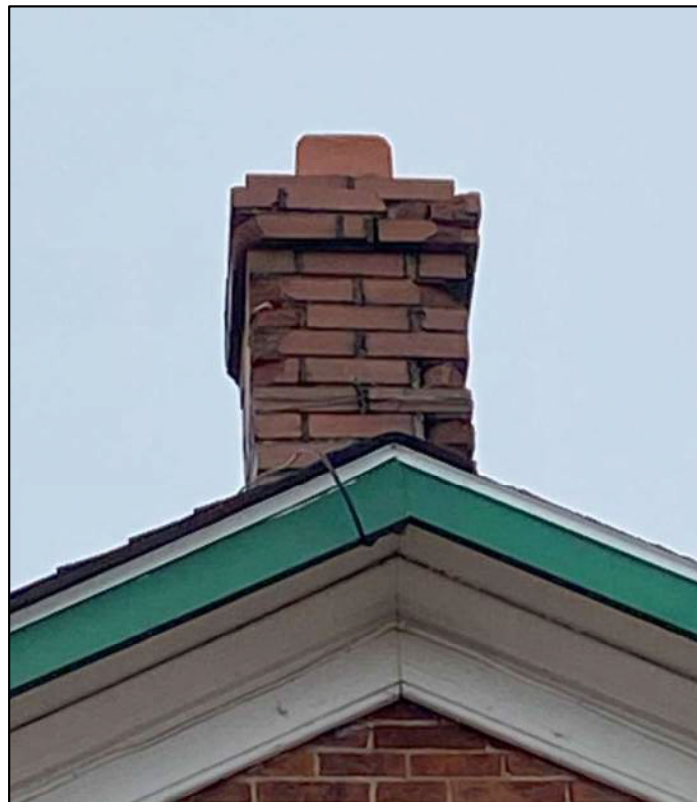
**Photograph 11: Condition of chimney**

The roof rafters had notable deflections, and the chimney above the roof line had several loose and spalled bricks, as visible in Photograph 11. The loose bricks at the chimney and jack arches pose a safety concern from falling material.
