PEEL MUSEUM AND ARCHIVES - OLD JAIL WALL HERITAGE MASONRY CONSERVATION SCOPE

9 WELLINGTON STREET EAST, BRAMPTON, ON
HERITAGE CONSULTANT: +VG ARCHITECTS

22298
HERITAGE REPAIRS & JAIL WINDOW REPLACEMENT
PAMA - PEEL MUSEUM AND ARCHIVES
7 & 9 WELLINGTON ST E
BRAMPTON, ON - L6W 1Y1

**PEEL ART GALLERY MUSEUM AND ARCHIVES
OLD JAIL WALL MASONRY CONSERVATION**

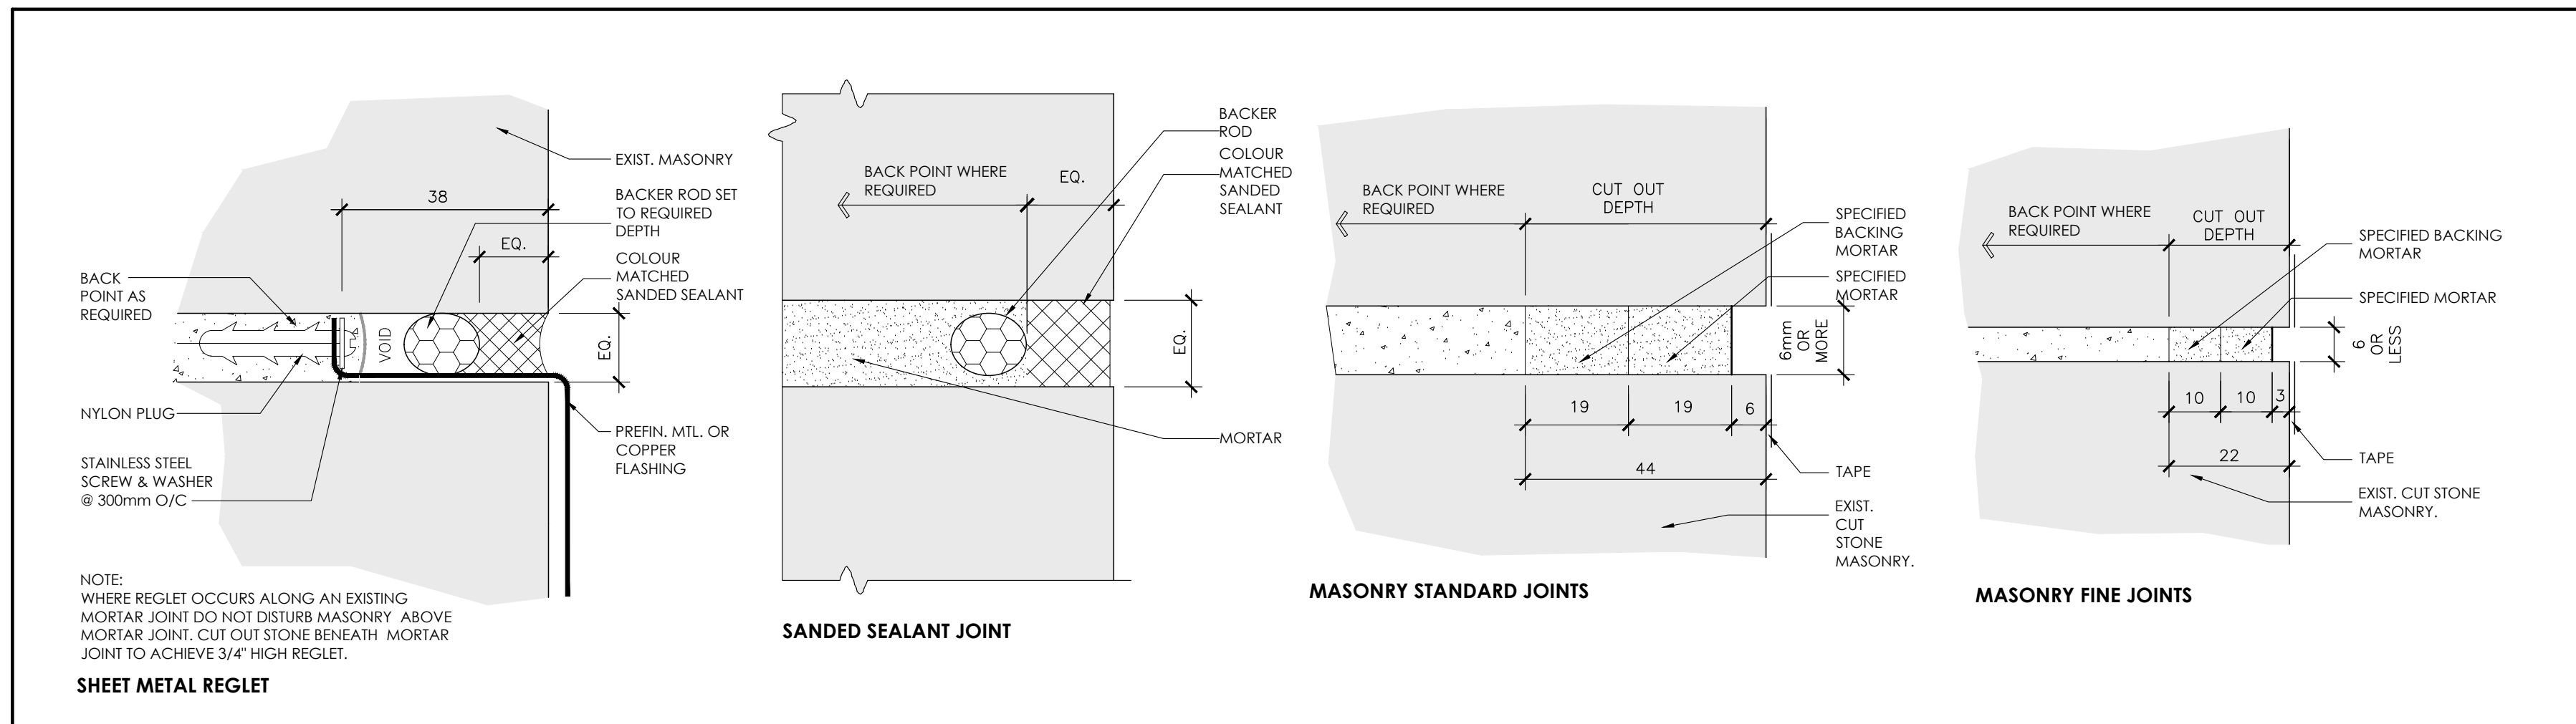
01 TYPICAL MASONRY REPAIR DETAILS
HC-03 1:100

CRACKING MASONRY WALL - REBUILD WALL USING EXISTING STONE UNITS, NEW BEDDING AND REPOINTING MORTAR, UTILIZING EMBEDDED HELICAL TIE ANCHORS AND/OR THREADED ROD REPAIR SEE DETAIL 01/ HC-03

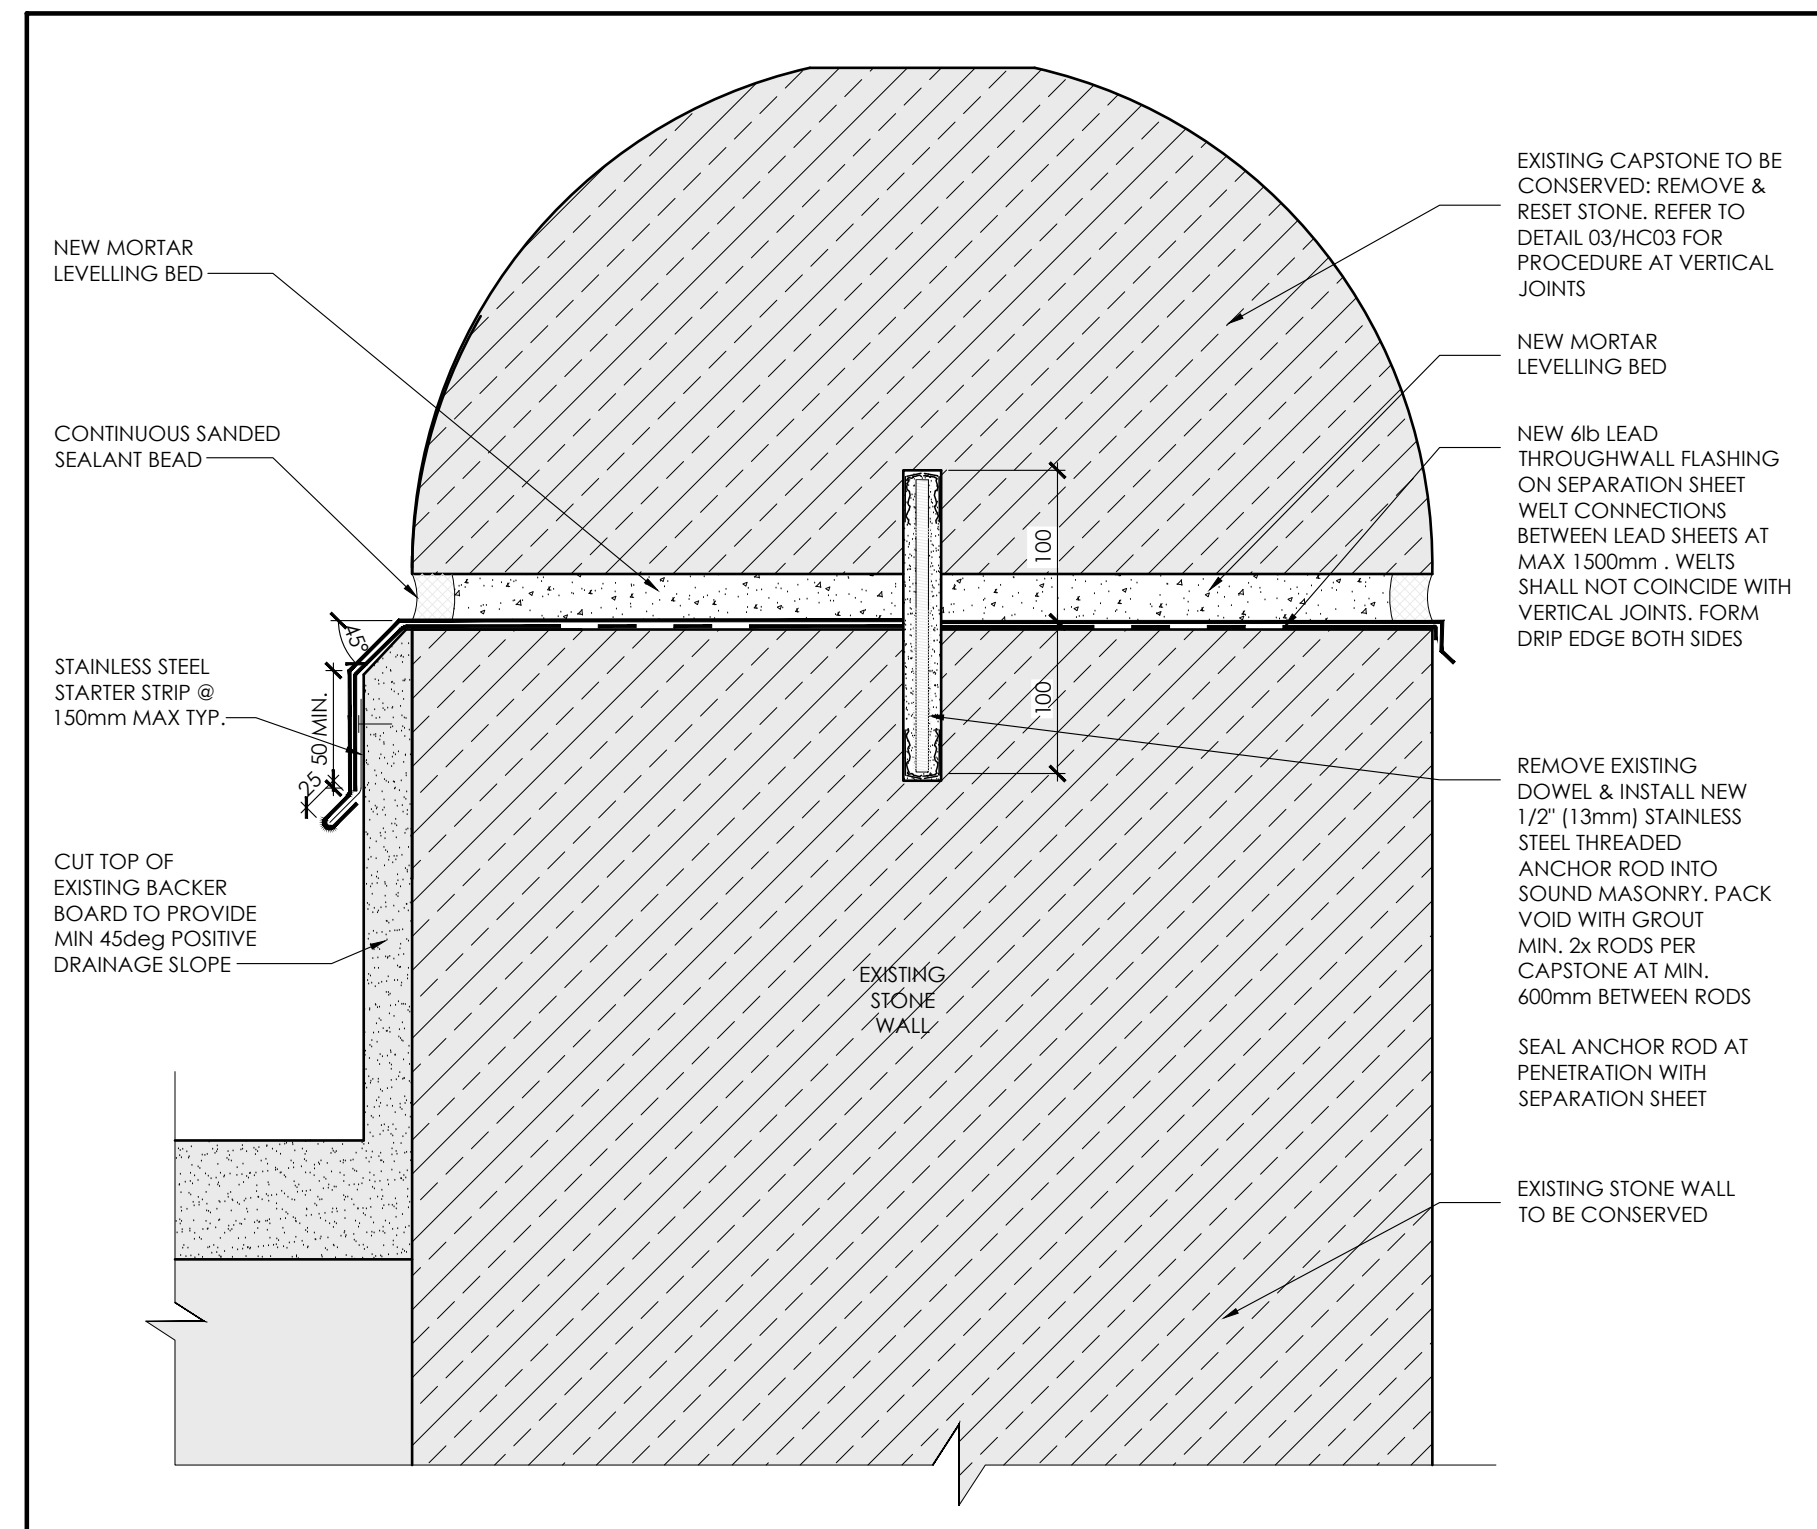
03 CAPSTONE REPAIR DETAILS
HC-03 1:10

EXISTING COPING STONES TO BE REMOVED AND RE-SET WITH NEW EMBEDDED S/S DOWELS AND NEW LEAD FLASHING WITH DRIP EDGE. REFER TO DETAIL 03/ HC-03

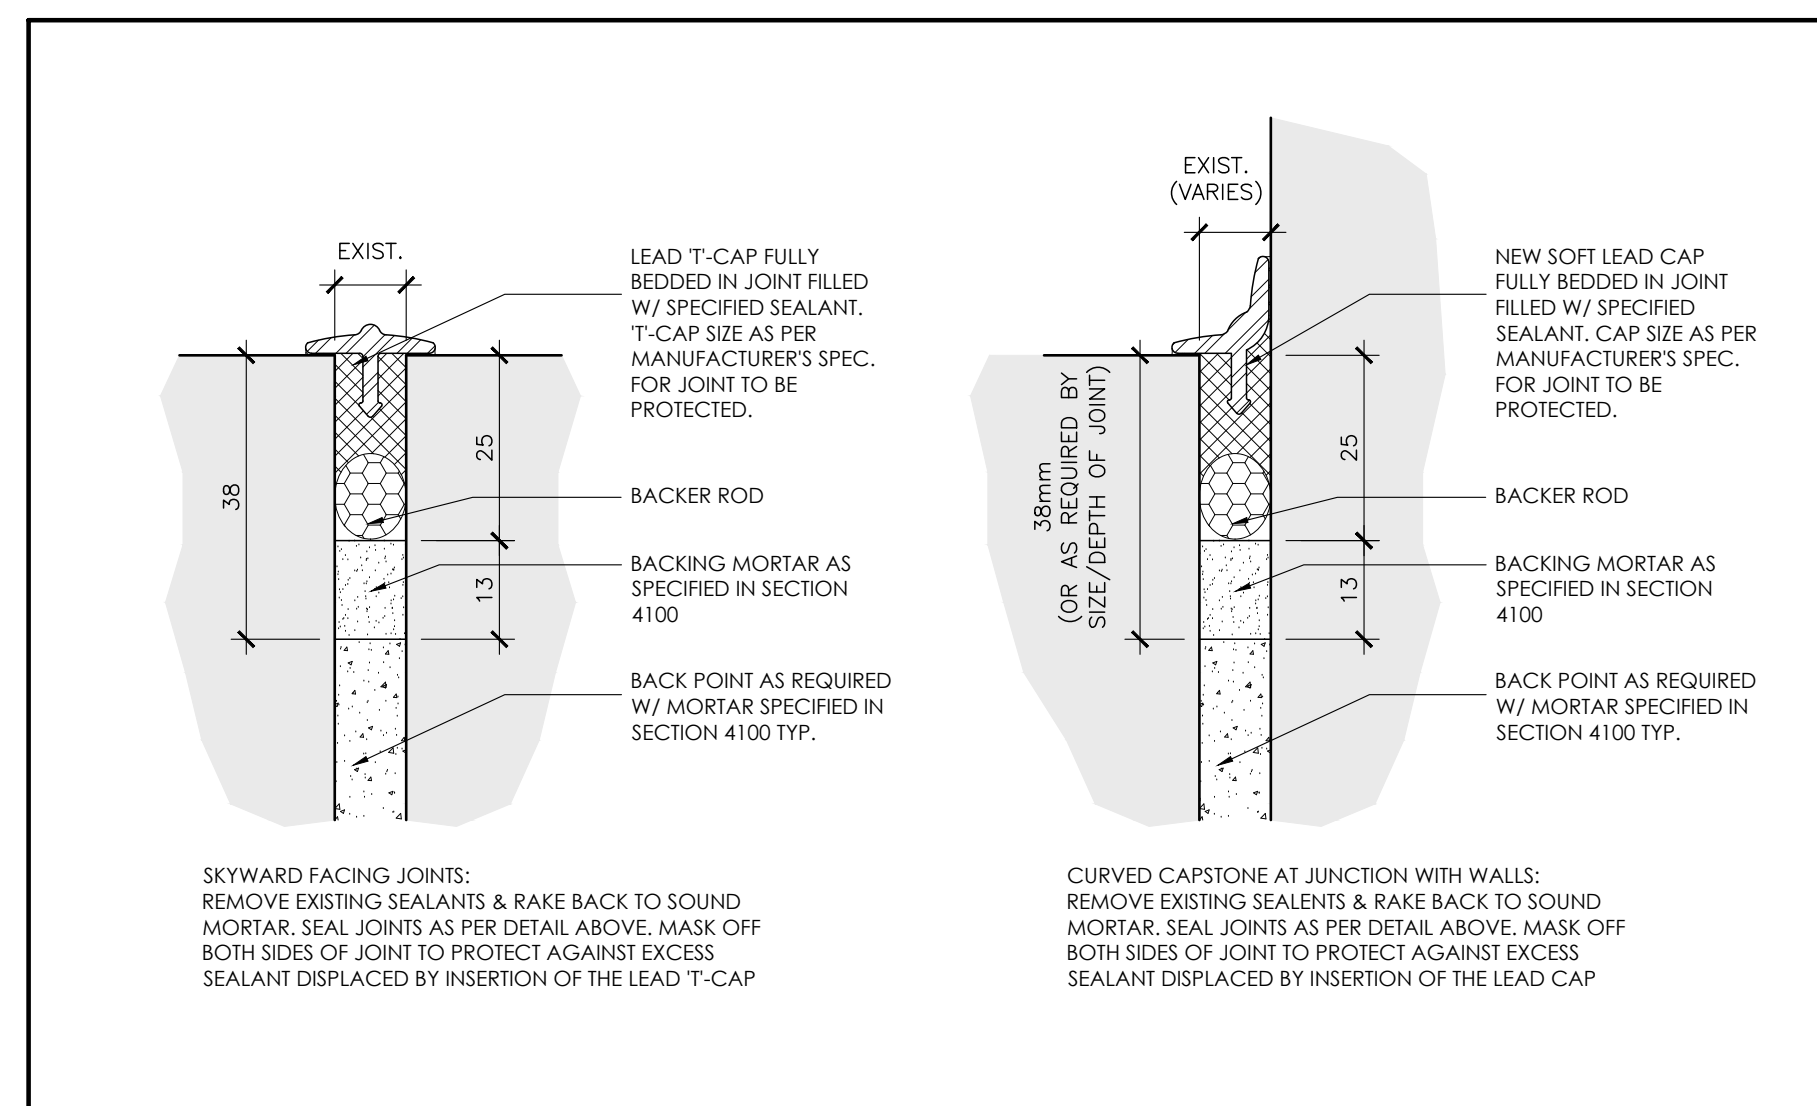
04 VERTICAL MASONRY JOINTS DETAILS
HC-03 1:1

CAPSTONES GENERALLY: REMOVE EXISTING STONES AND EXISTING FLASHING BELOW. INSTALL NEW LEAD THROUGHWALL FLASHING, REINSTATE AND SECURE NEW STONE IN PLACE USING STAINLESS STEEL DOWELS. REFER TO DETAIL 04/HC-03
