HERITAGE BUILDING PROTECTION PLAN

7 Church Street East
City of Brampton, ON

FINAL REPORT

Project #: LHC0487

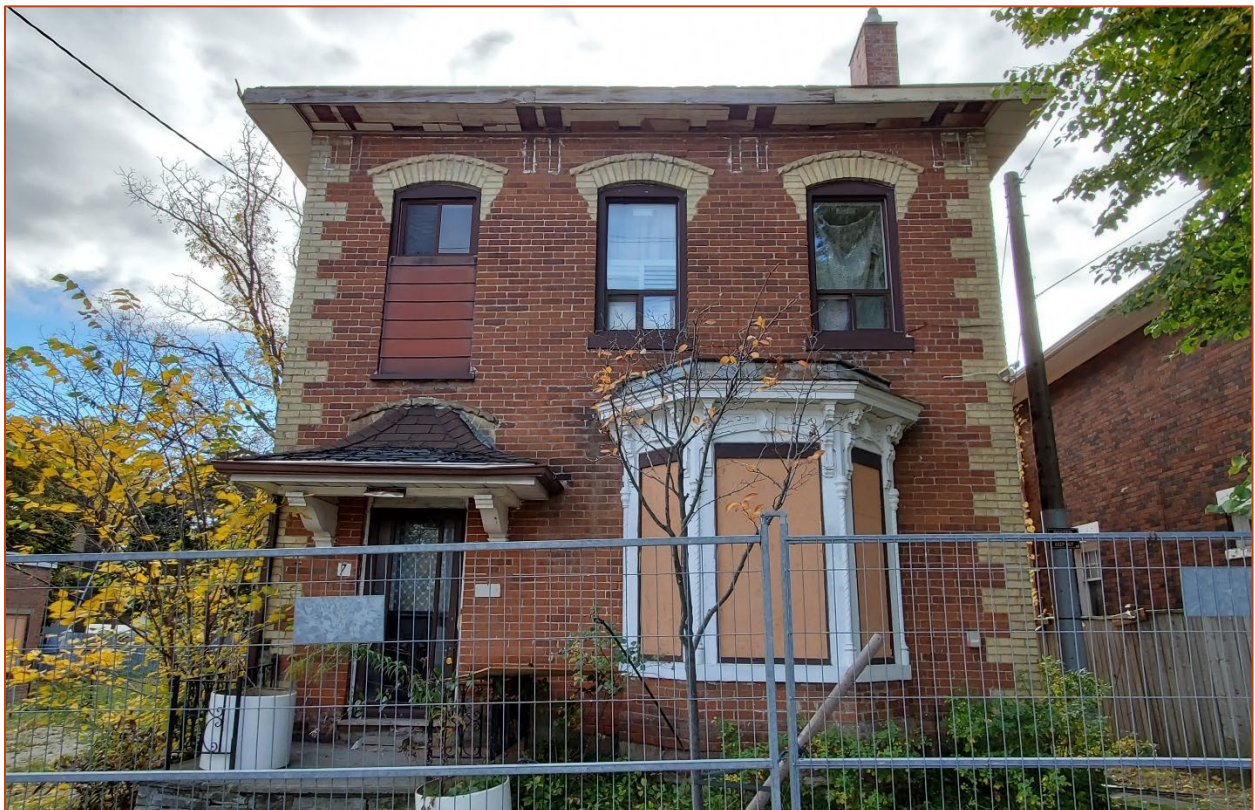
Image 1. This photo looks southeast and shows the primary, northwest elevation of the house on the Property

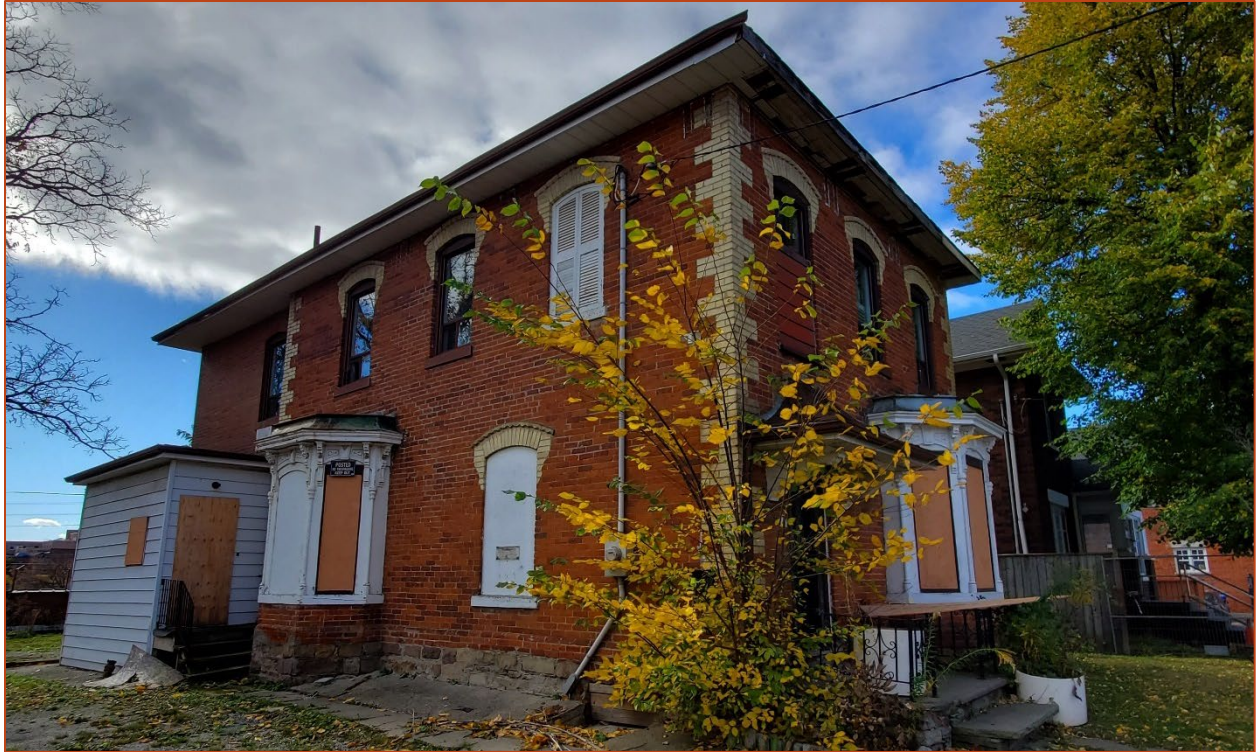
Image 2. This photo looks south and shows the northwest and northeast elevations of the house on the property

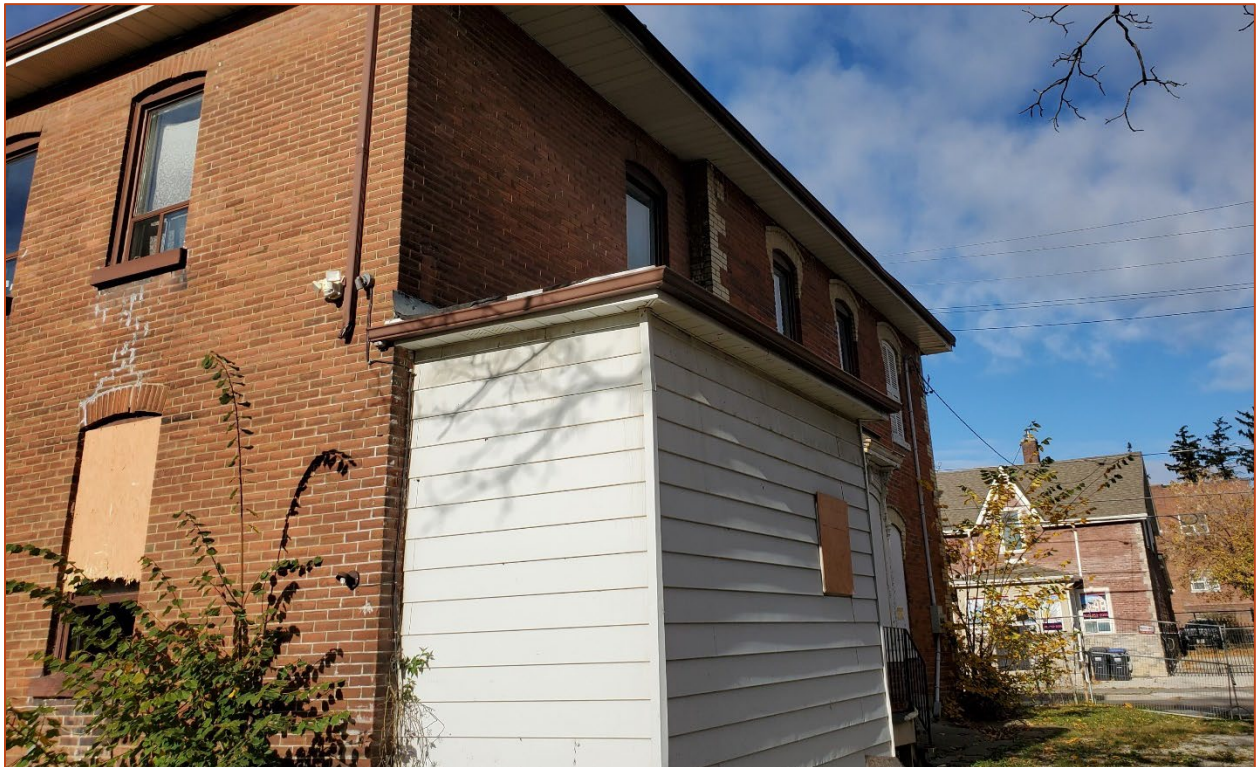
Image 3. View northwest showing the northeast and southeast elevations of the house on the Property

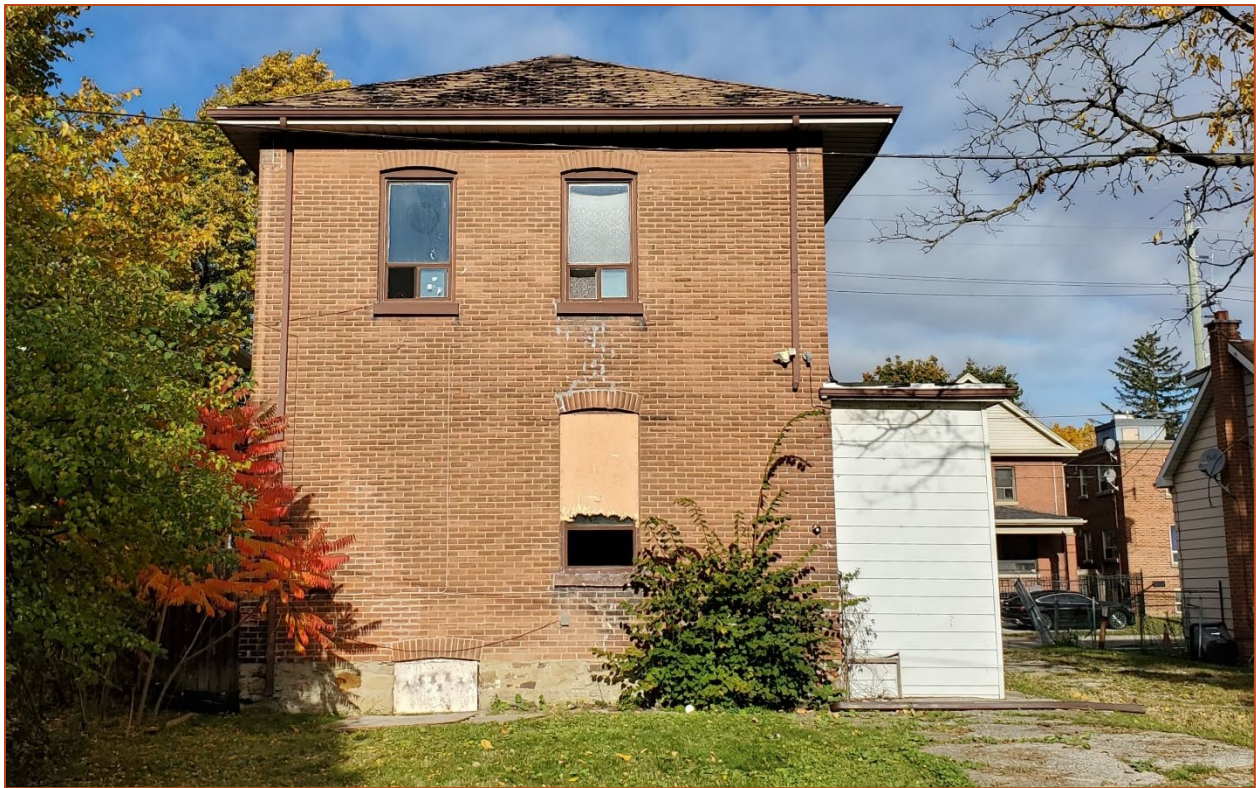
Image 4. View northwest showing the southeast elevation of the house on the Property

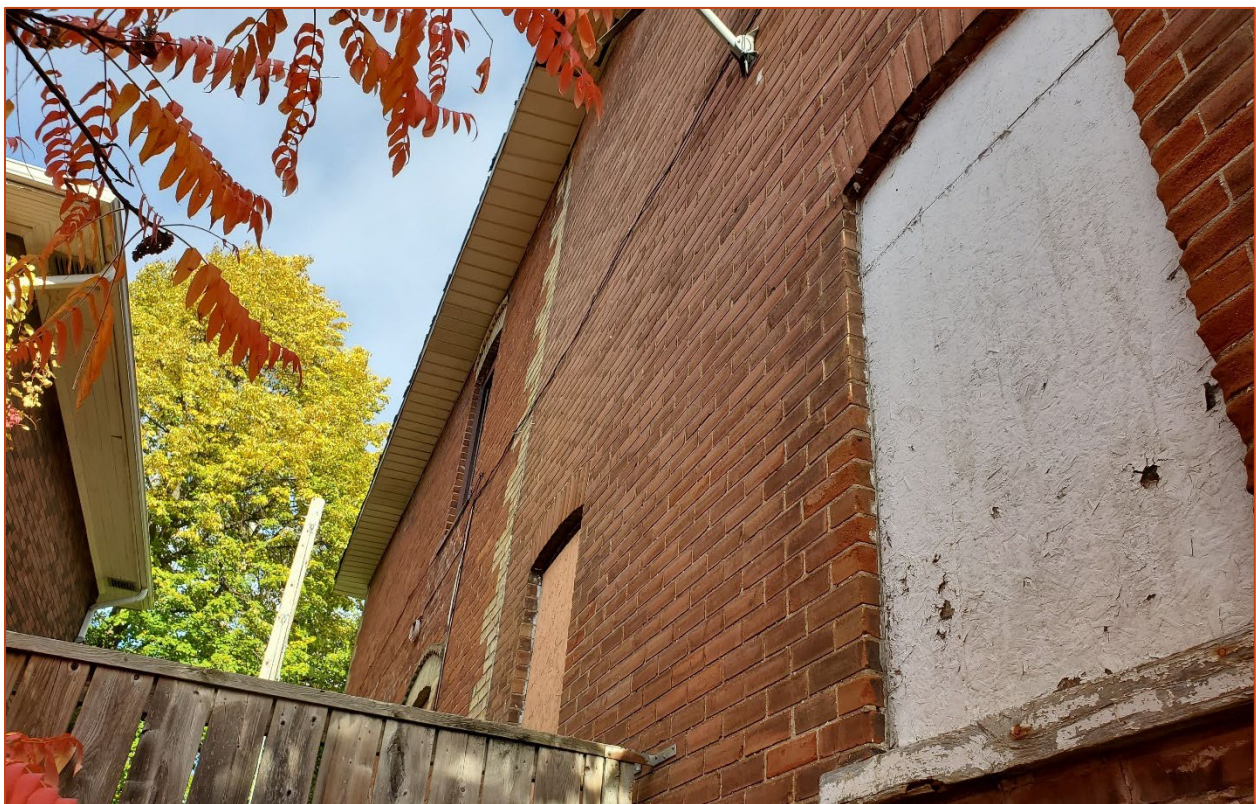
Image 5. View north showing the southwest elevation of the house on the Property

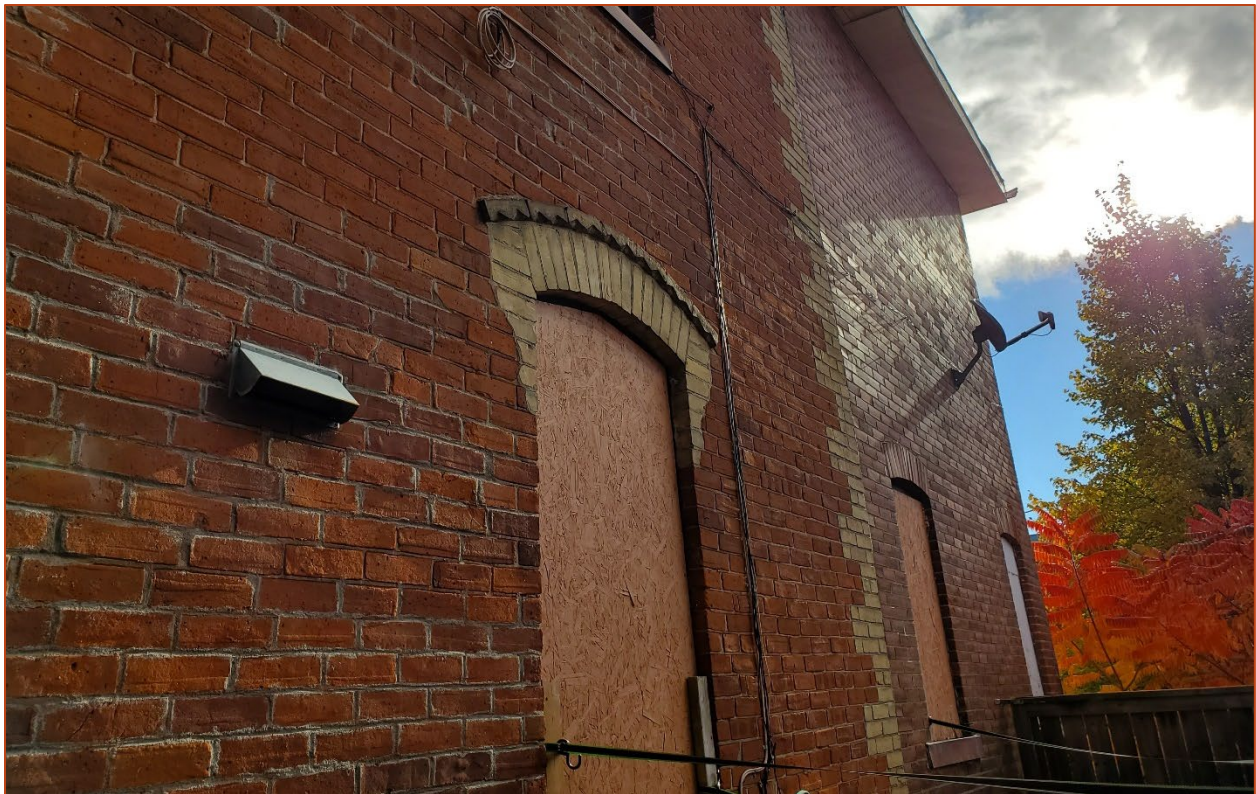
Image 6. View southeast showing the southwest elevation of the house on the Property

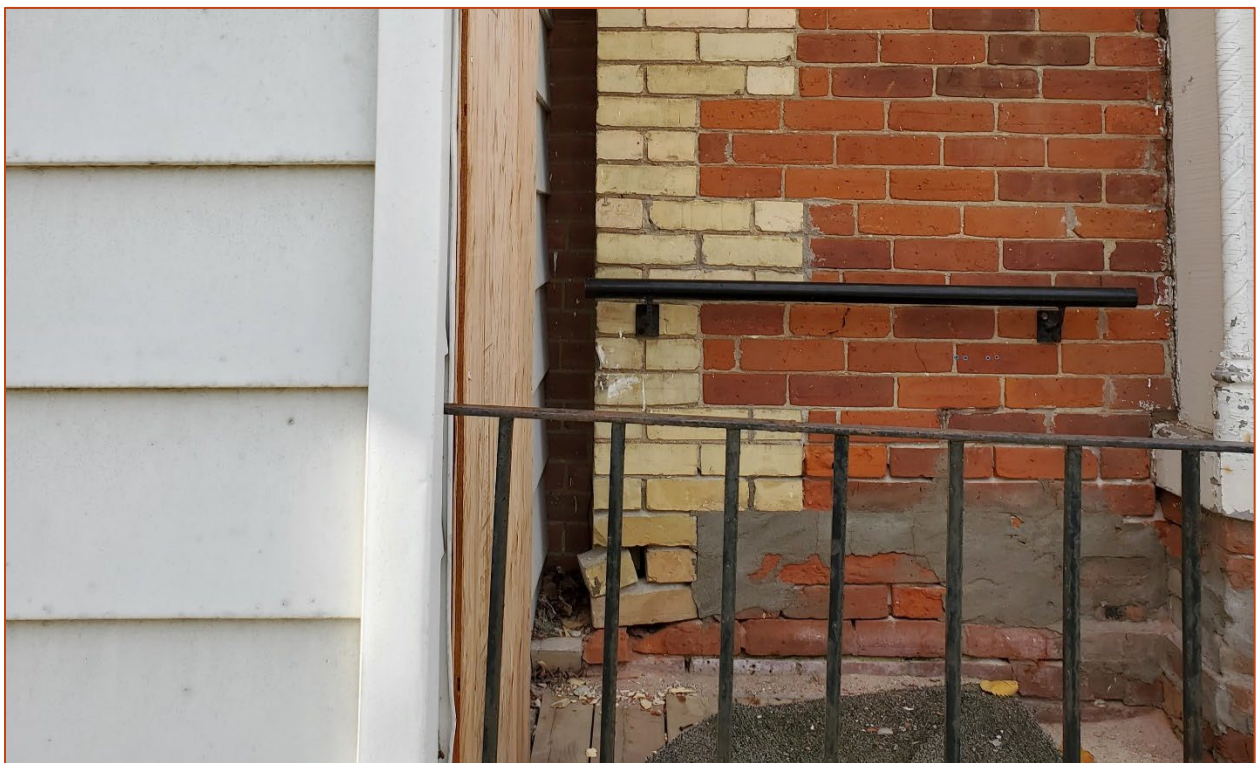
Image 7. View southwest showing the connection between the main house and its additions on its northeast elevation

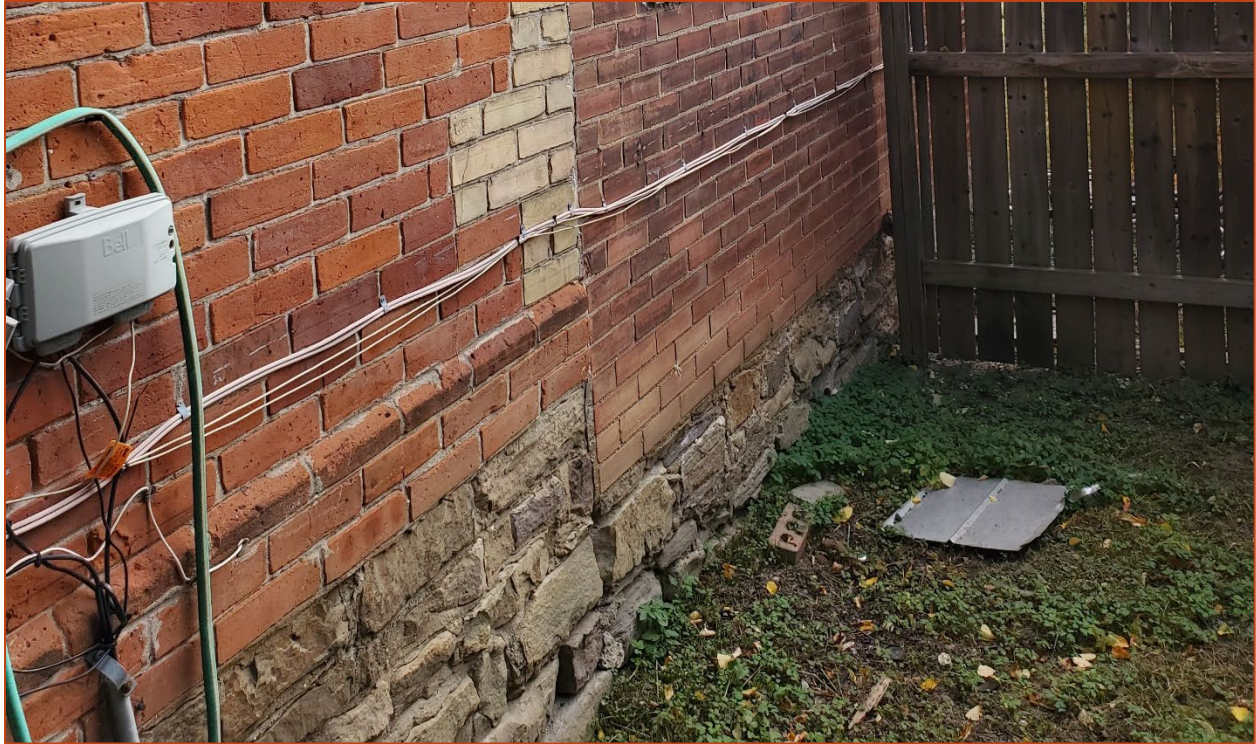
Image 8. View southeast showing the connection between the main house and its addition on its southwest elevation

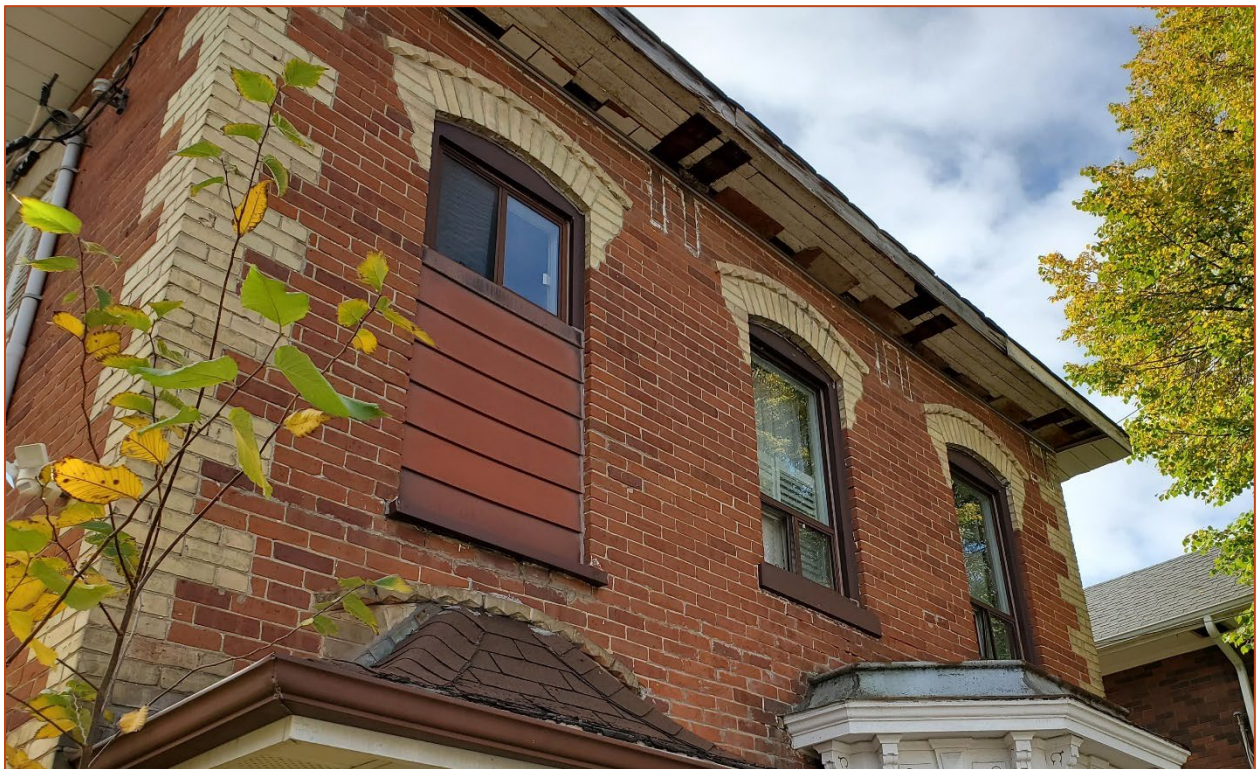
Image 9. View south showing the brick on the second storey of the northwest elevation of the house on the Property

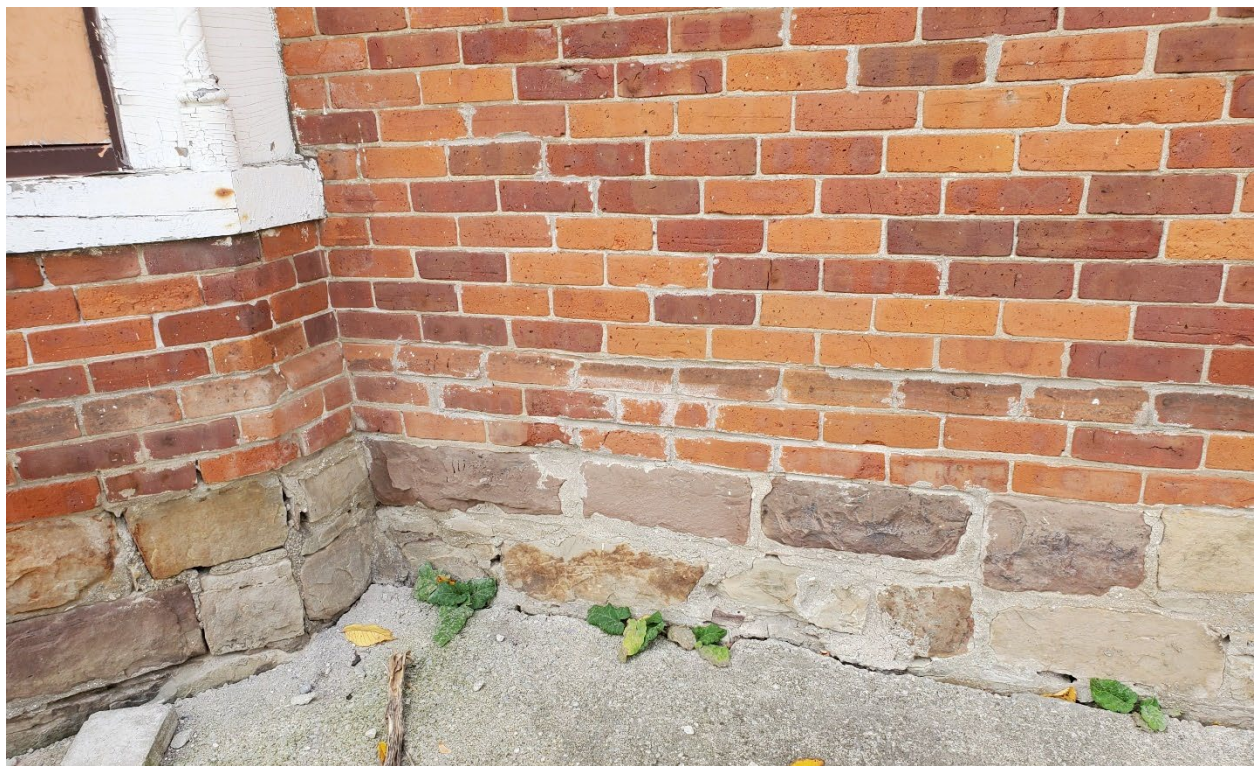
Image 10. View southwest showing the stone foundation and brick on the first storey of the northeast elevation of the house on the Property

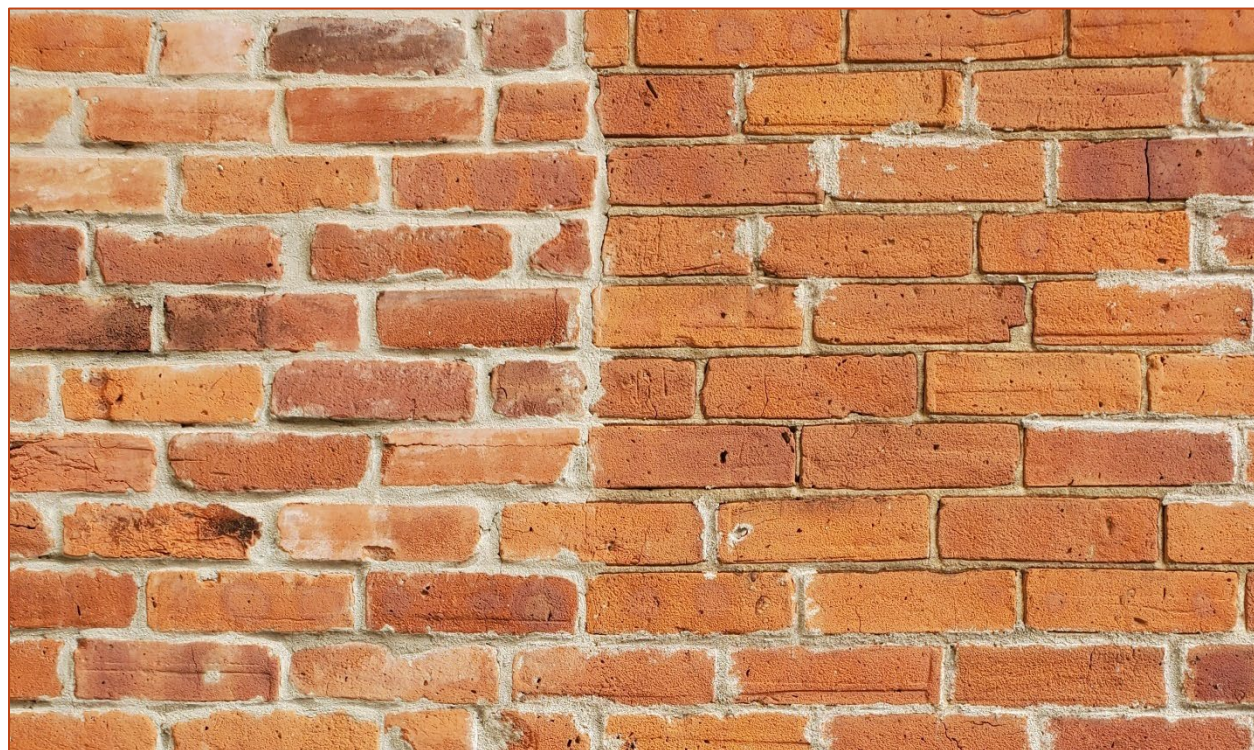
Image 11. View northeast showing the brick on the first storey of the southwest elevation of the house on the Property

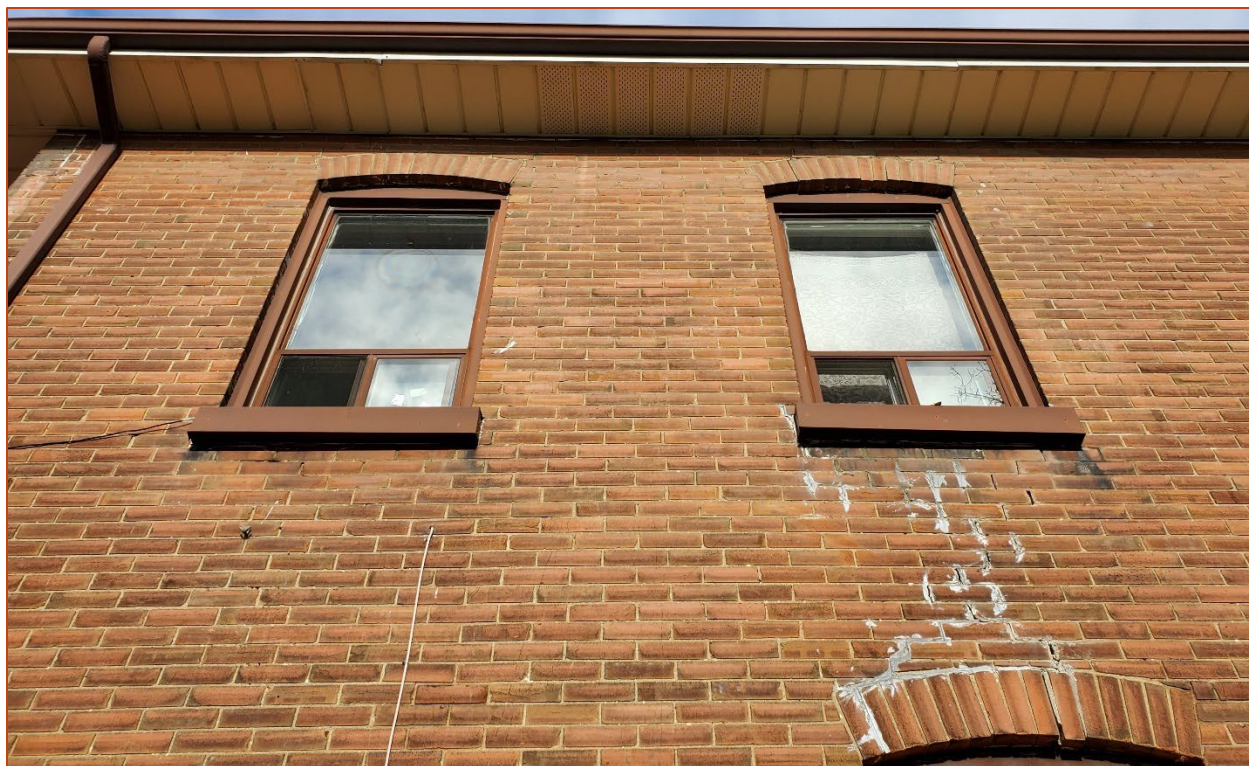
Image 12. View northwest showing the brick on the second storey of the southeast elevation of the house on the Property

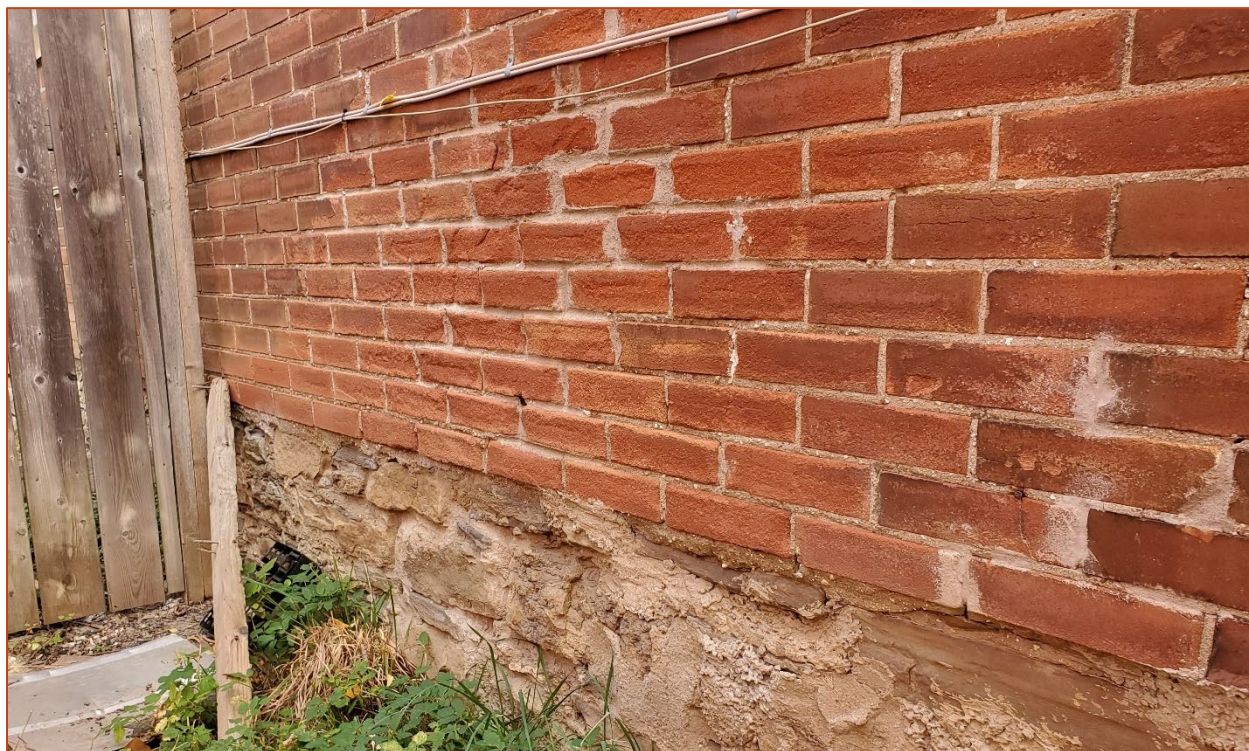
Image 13. View north showing the stone foundation and brick on the first storey of the southwest elevation of the house on the Property

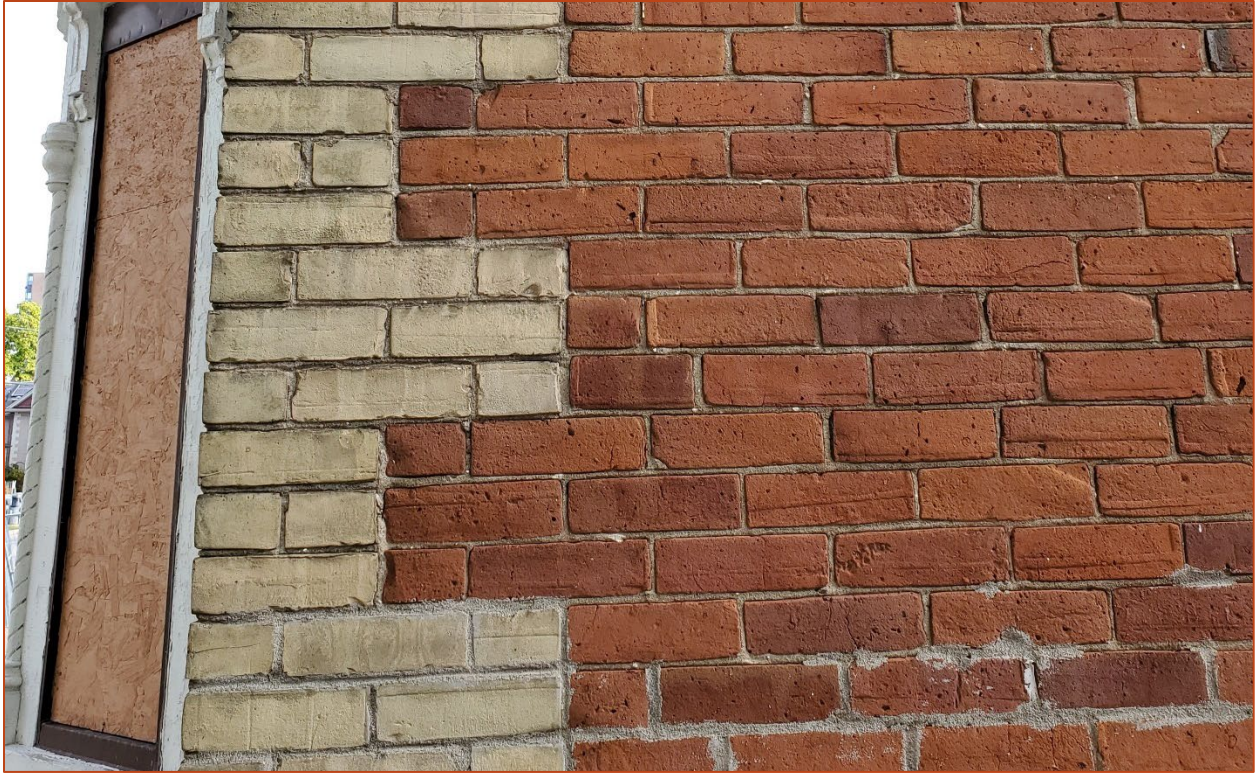
Image 14. View northeast showing the buff brick quoin on the house on the northwest corner of the house on the Property

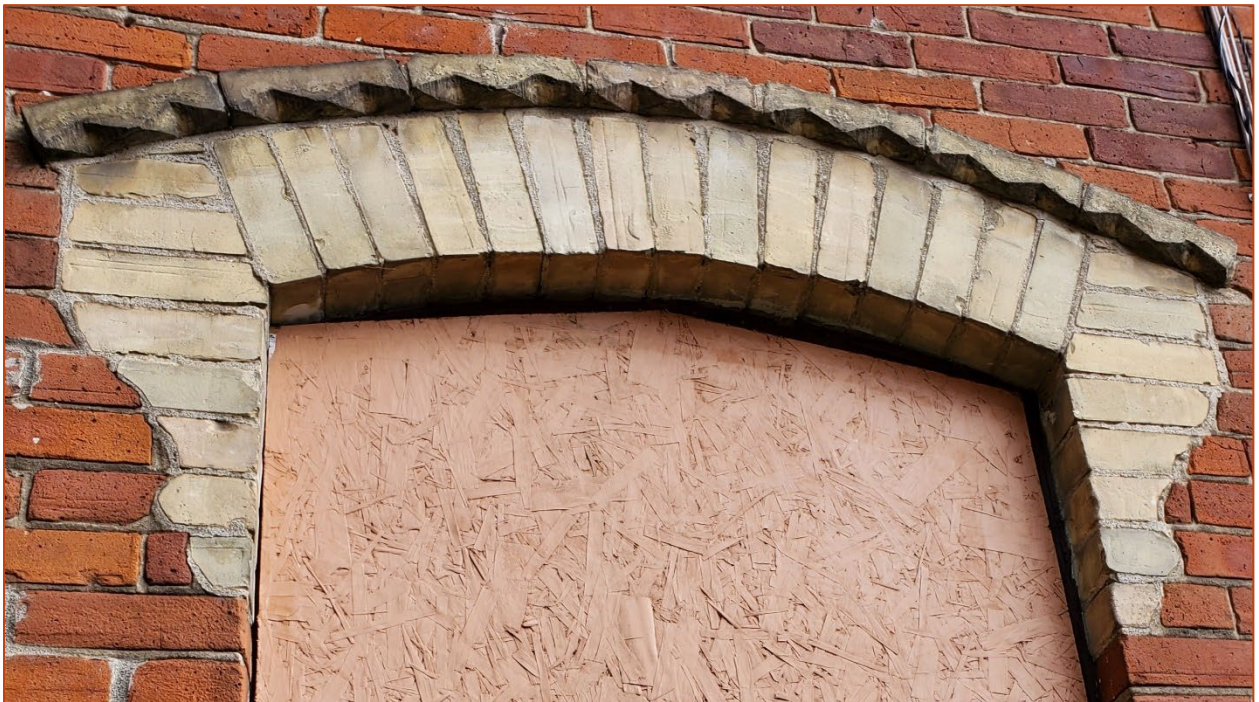
Image 15. View northeast showing a typical buff brick voussoir on a window on the first storey of the southwest elevation of the house on the Property

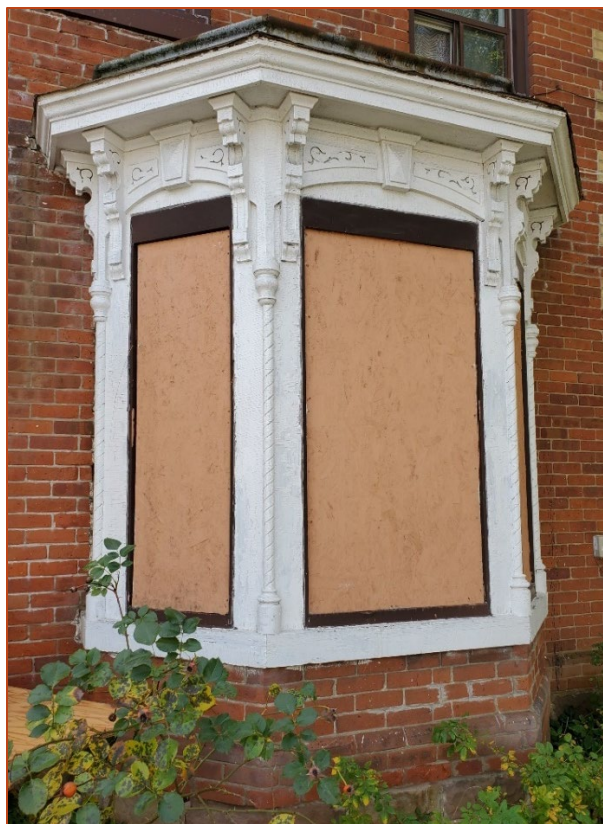
Image 16. View south showing the bay window on the northwest elevation of the house on the Property

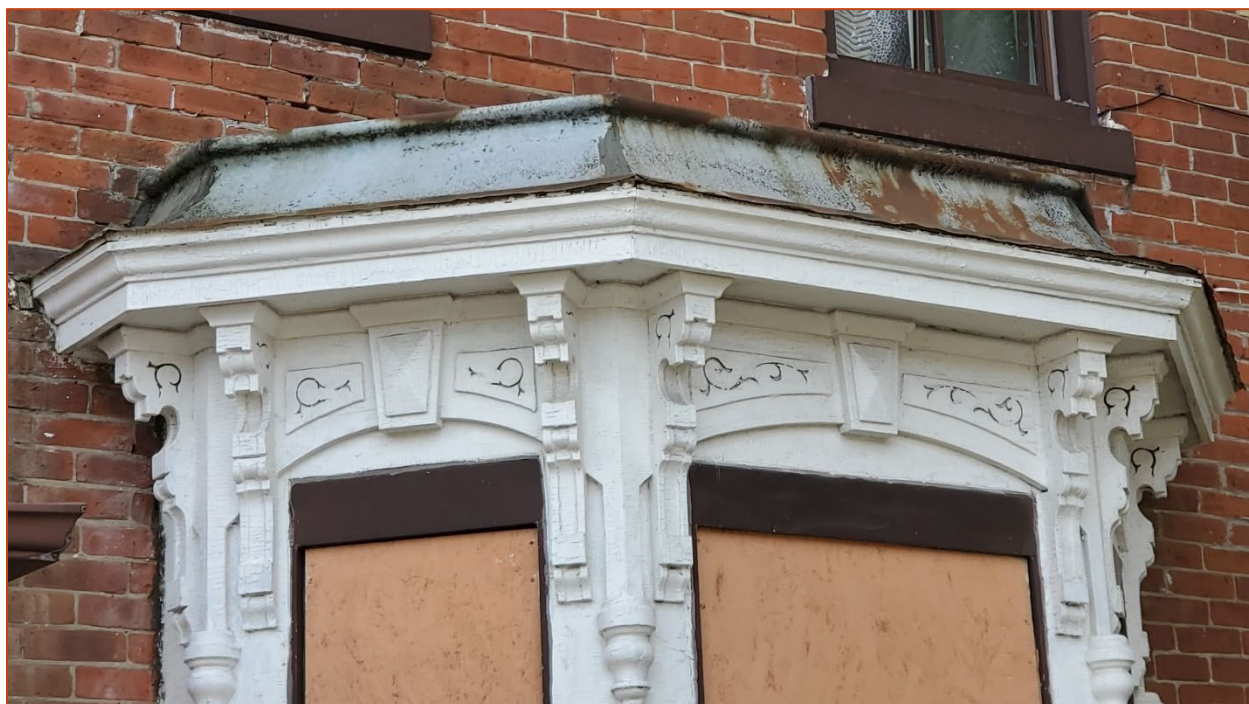
Image 17. View south showing the roof structure and wooden frame of the bay window on the northwest elevation of the house on the Property

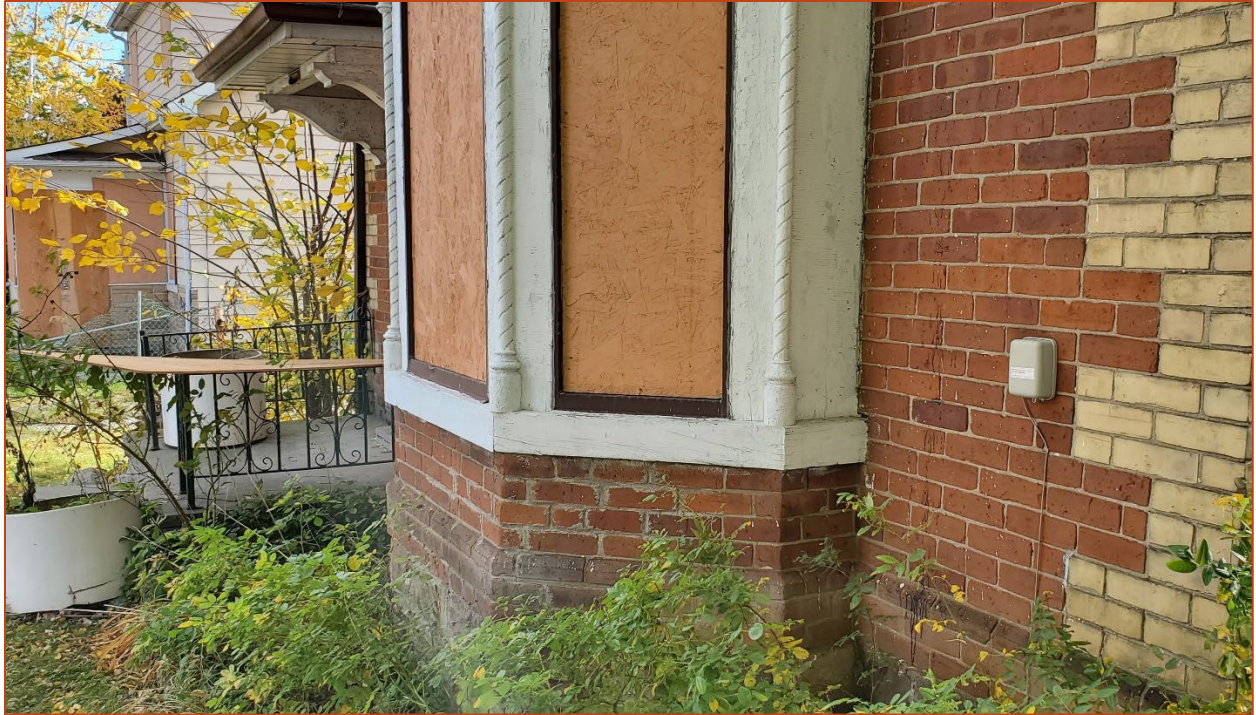
Image 18. View east showing the wooden frame and base of the bay window on the northwest elevation of the house on the Property

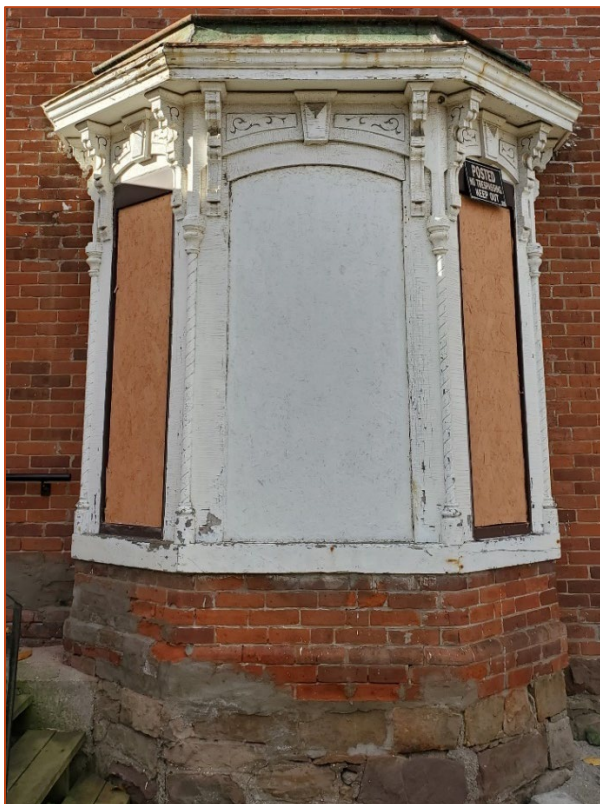
Image 19. View southwest showing the bay window on the northeast elevation of the house on the Property

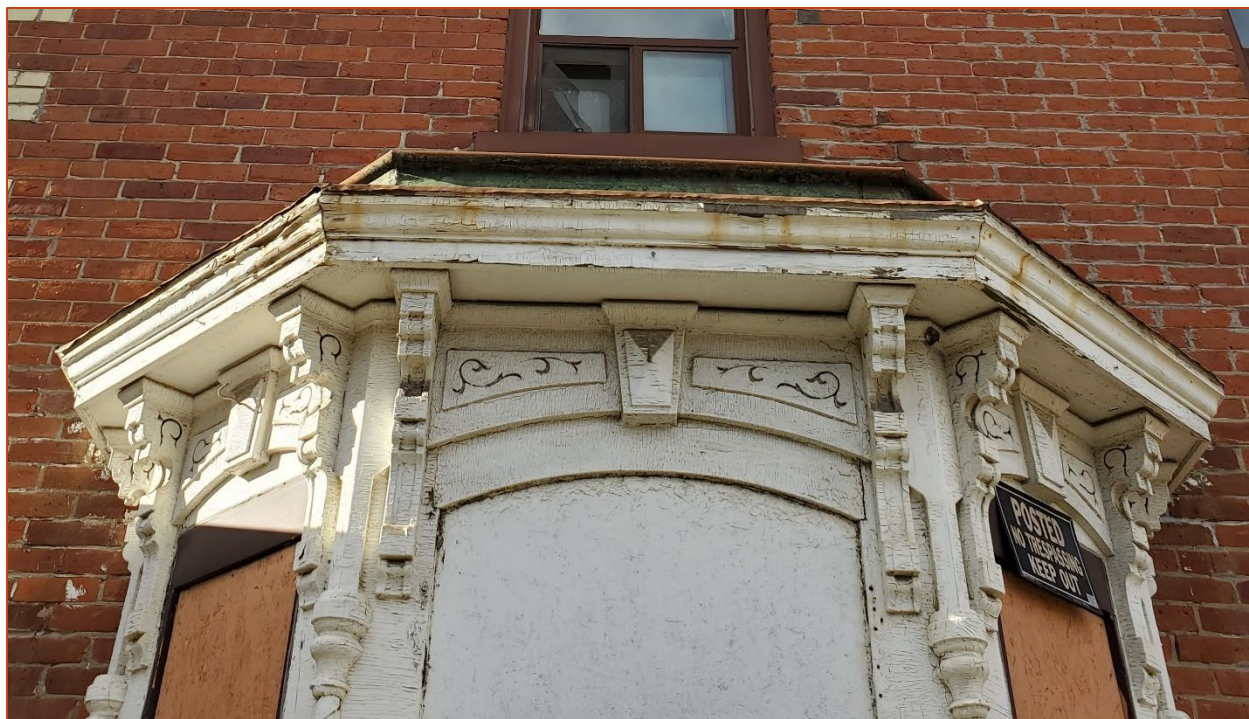
Image 20. View southwest showing the roof structure and wooden frame of the bay window on the northeast elevation of the house on the Property

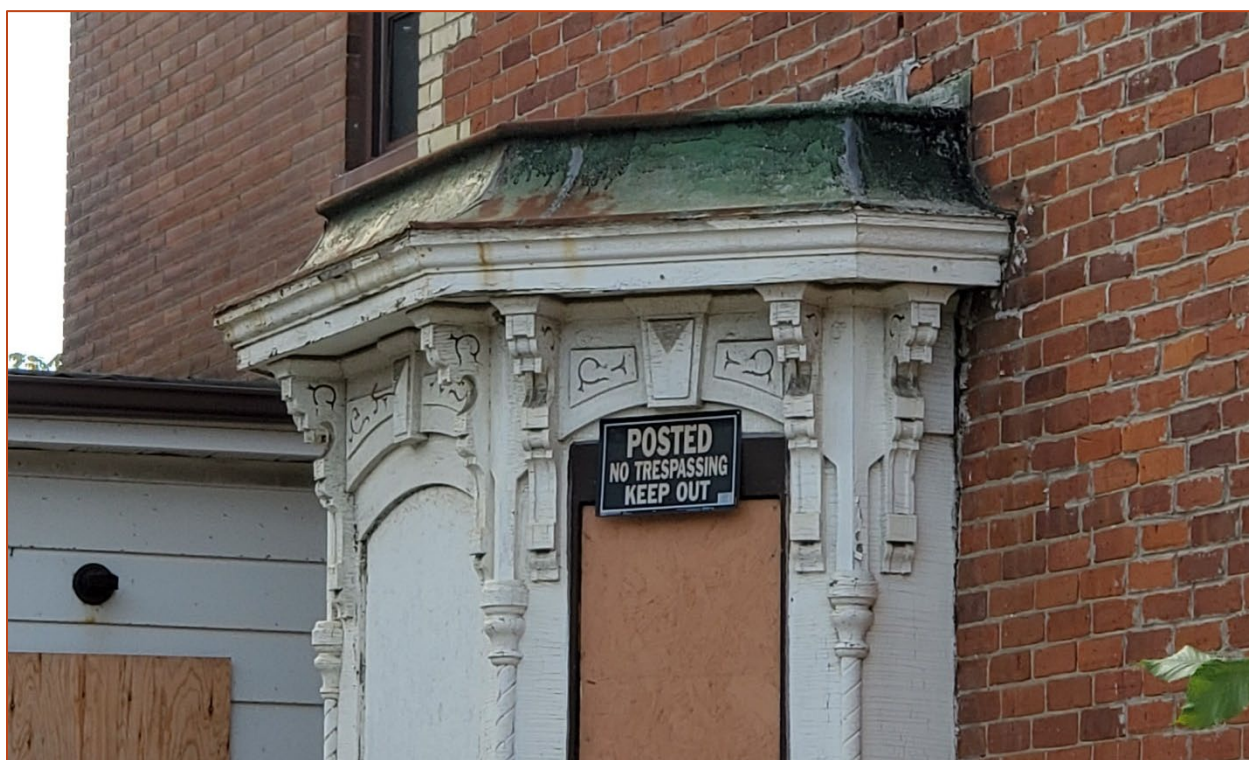
Image 21. View south showing the roof structure and wooden frame of the bay window on the northeast elevation of the house on the Property

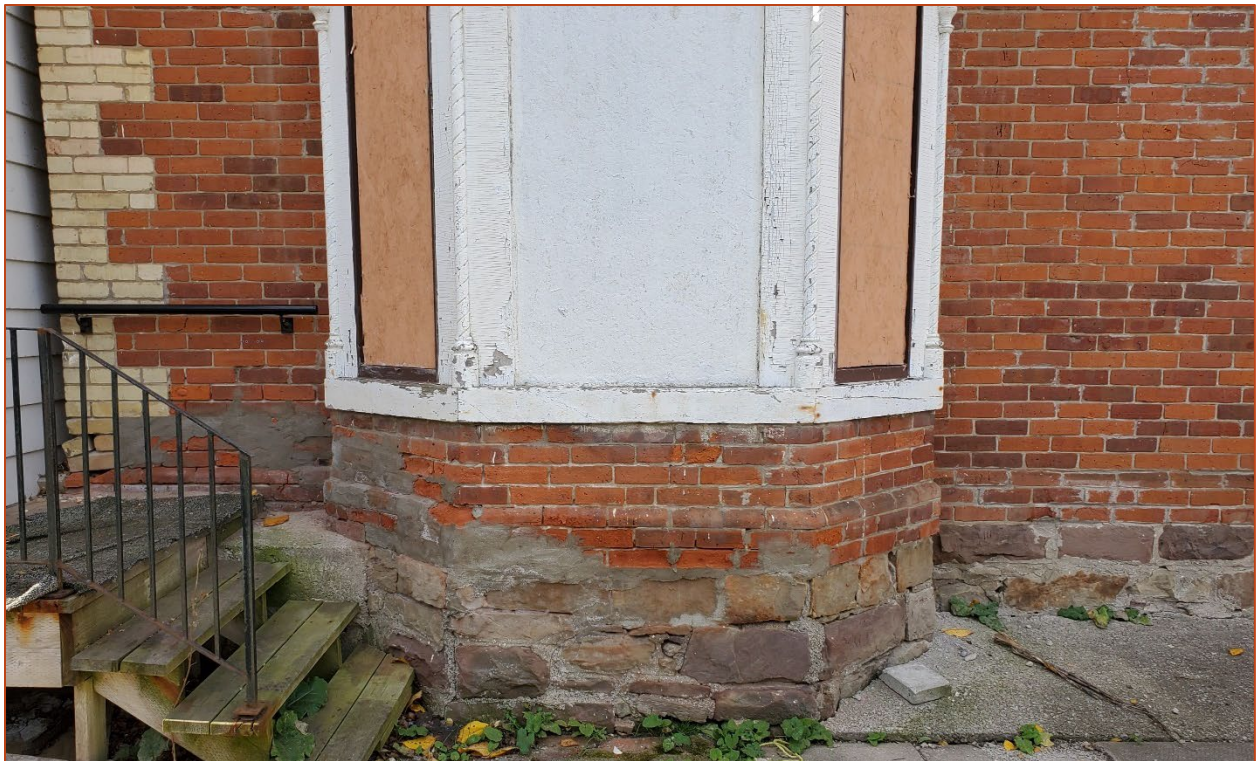
Image 22. View southwest showing the wooden frame and base of the bay window on the northeast elevation of the house on the Property

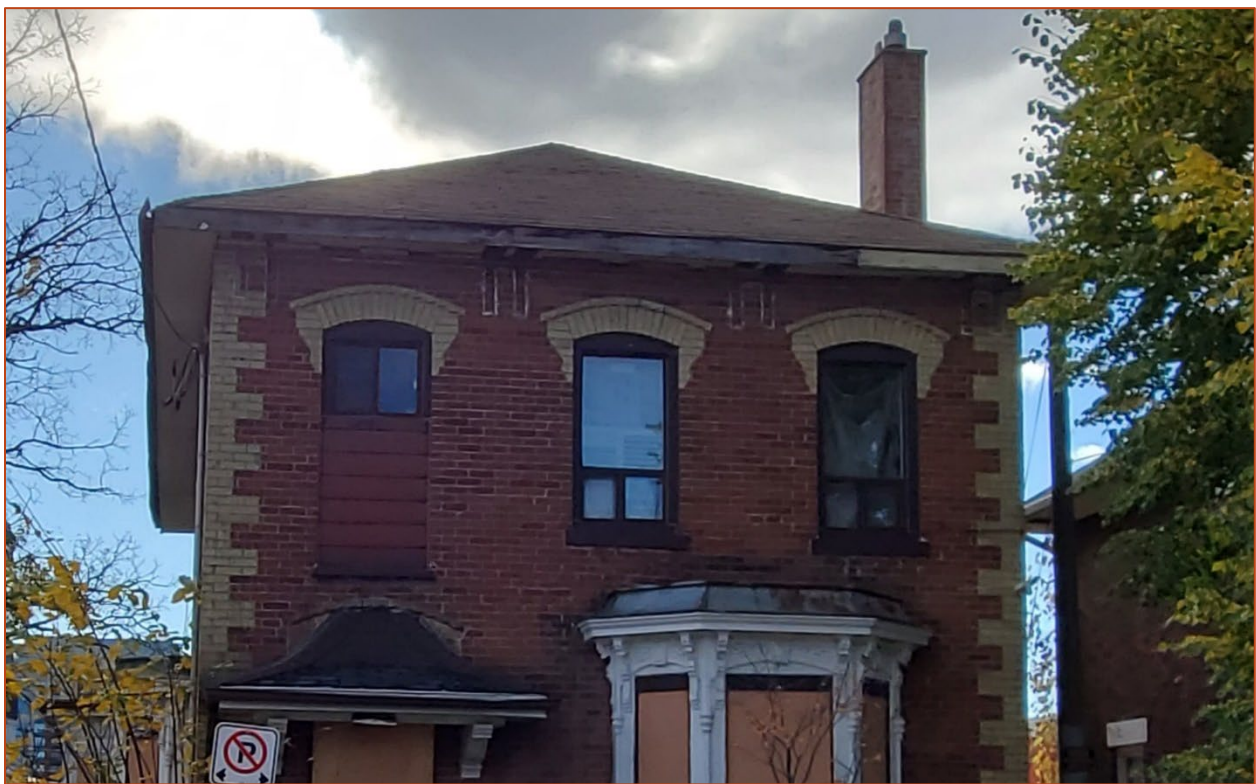
Image 23. View southeast showing the hipped roof of the house on the Property

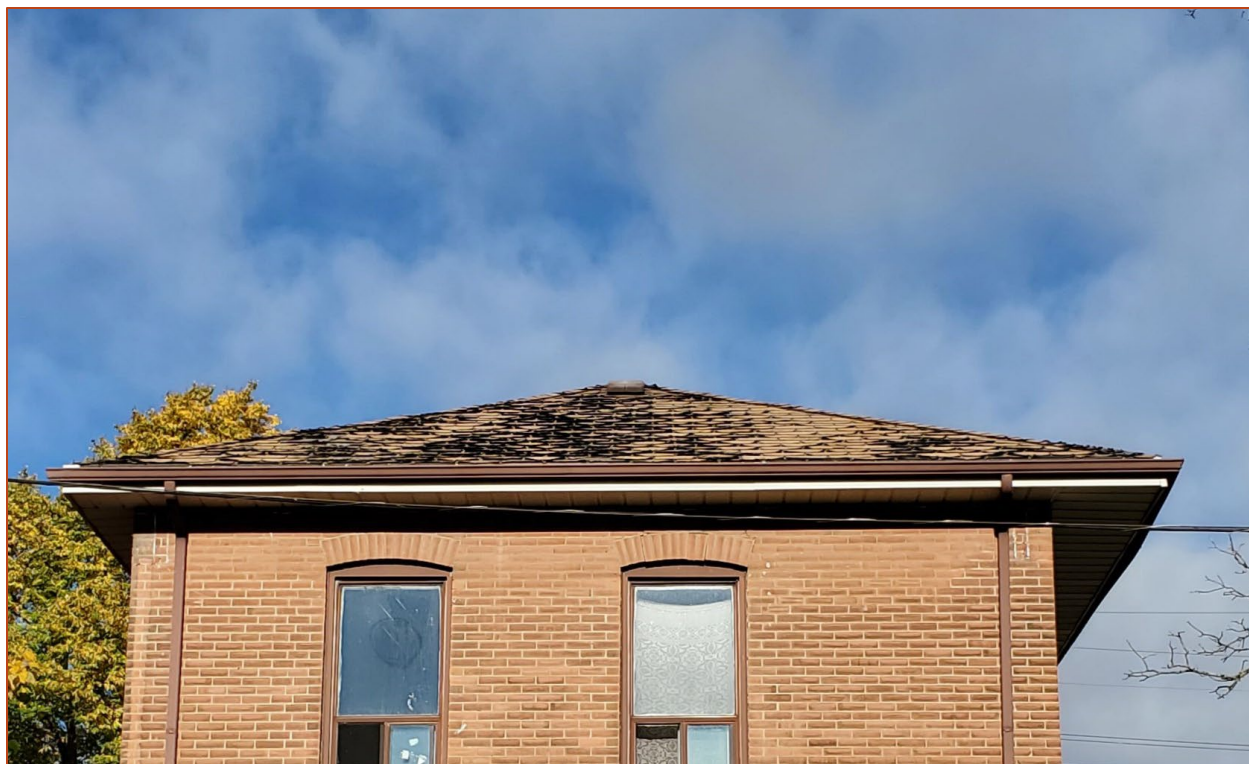
Image 24. View northwest showing the hipped roof of the house on the Property
