HERITAGE BUILDING PROTECTION PLAN

7 Church Street East
City of Brampton, ON

FINAL REPORT

Project #: LHC0487

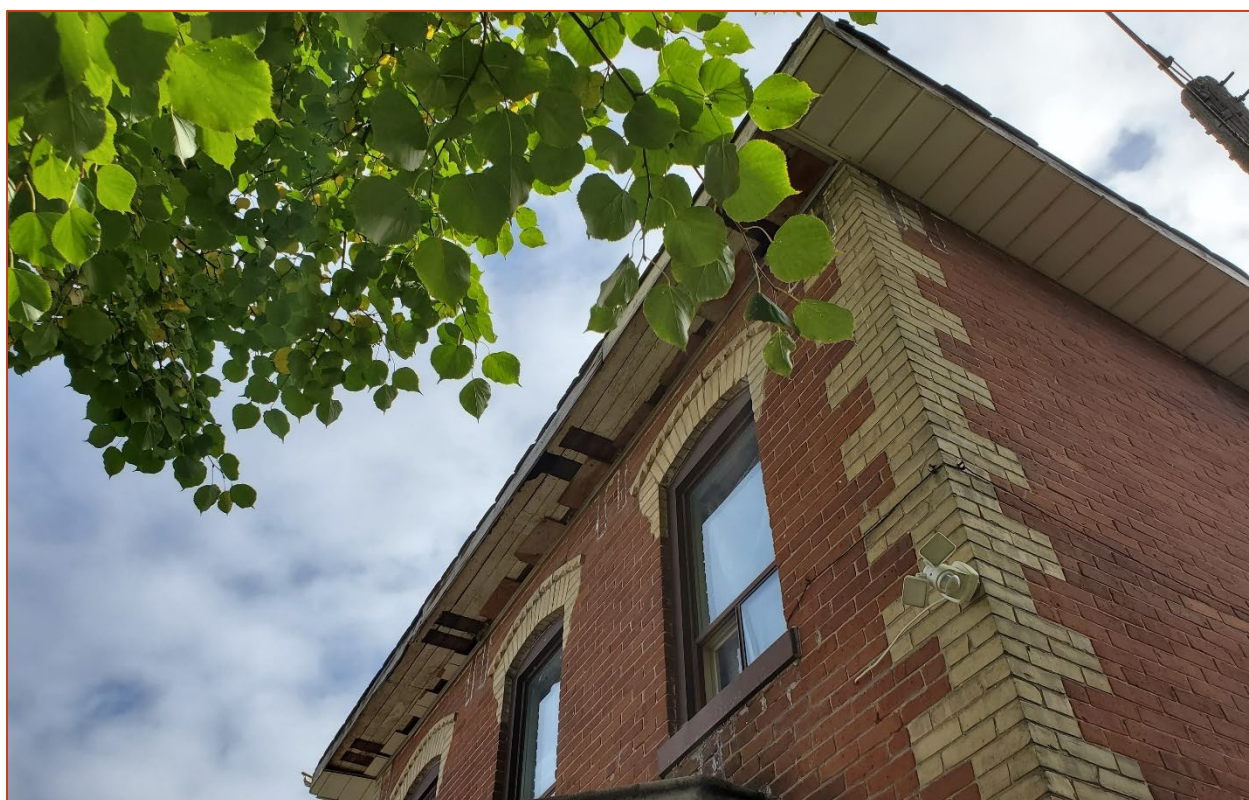
Image 25. View east showing the projecting eave and soffit of the roof on the northwest and southwest elevations of the house on the Property

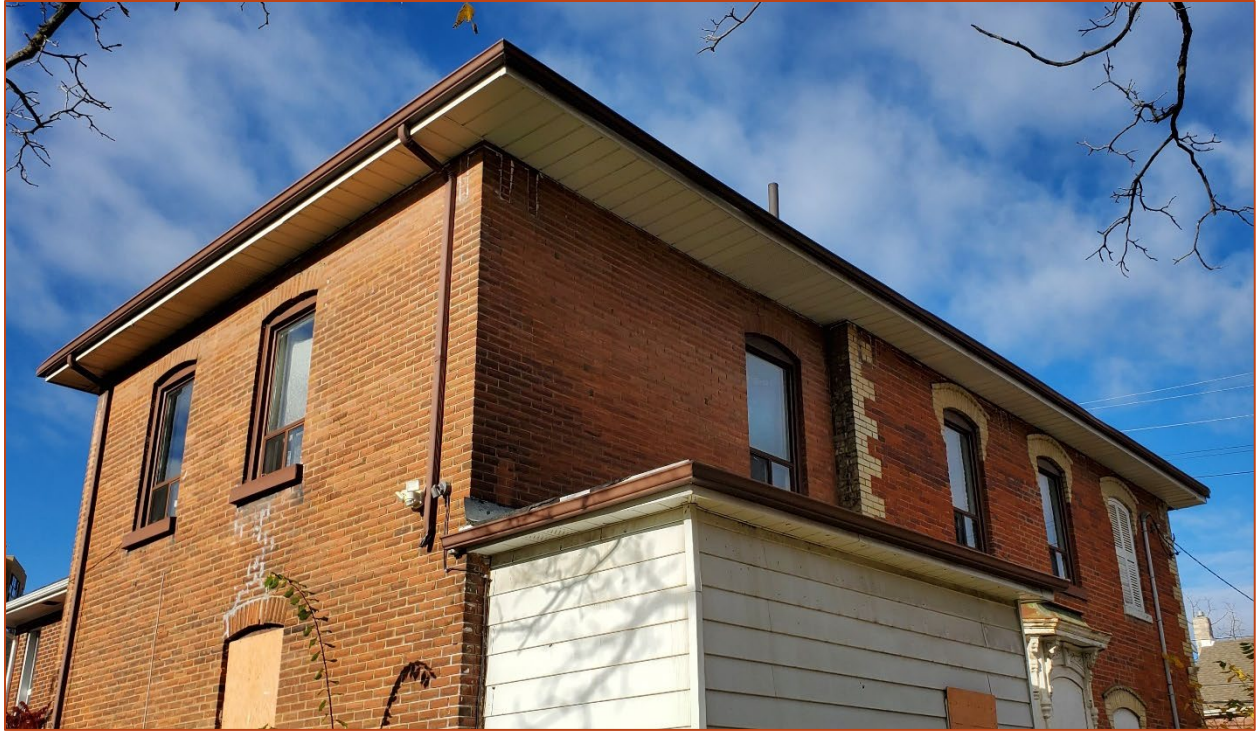
Image 26. View west showing the projecting eave and soffit of the roof on the northeast and southeast elevations of the house on the Property

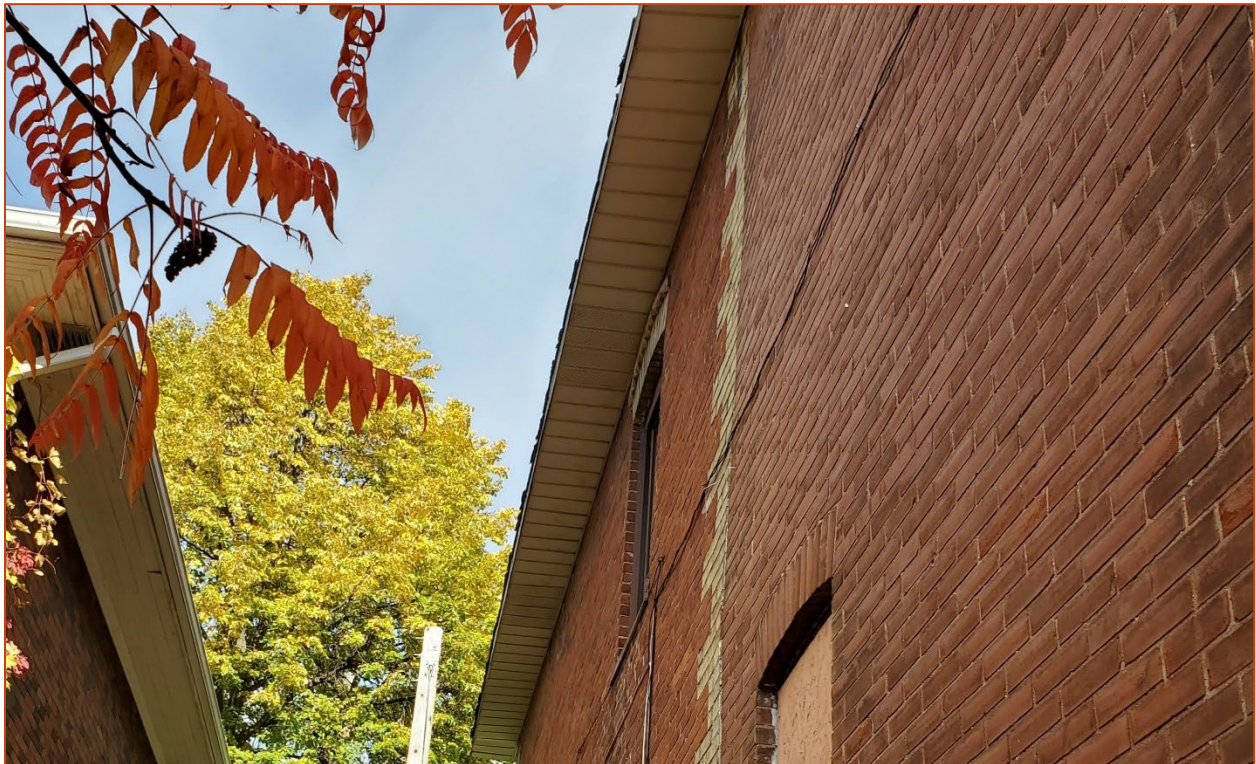
Image 27. View north showing the projecting eave and soffit of the roof on the southwest elevation of the house on the Property

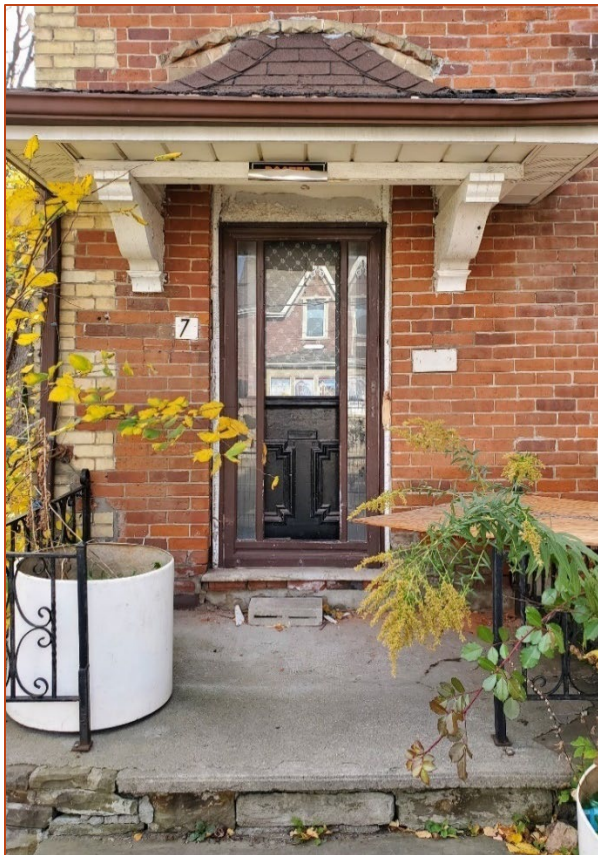
Image 28. View southeast showing the main entrance of the house on the Property

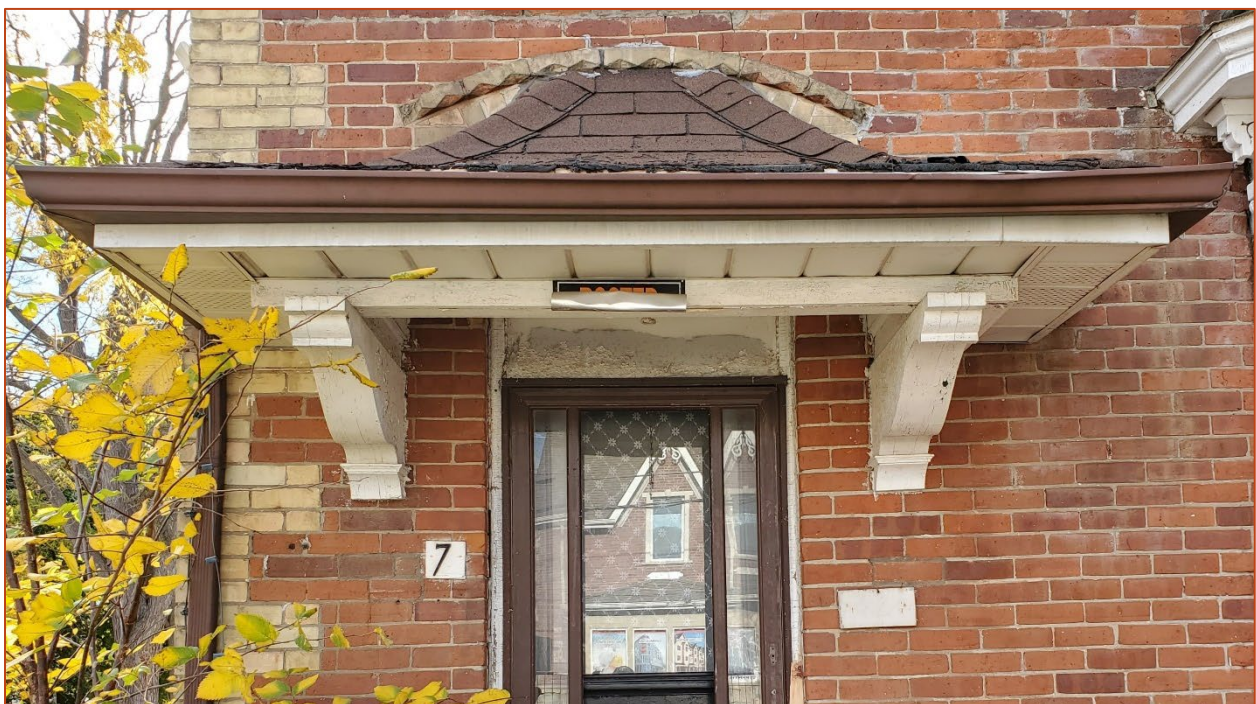
Image 29. View southeast showing the canopy over the main entrance of the house on the Property

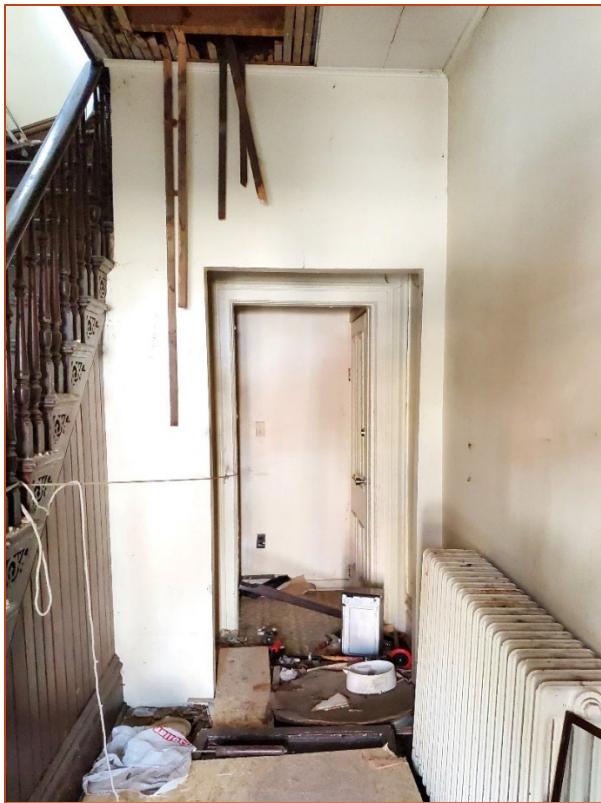
Image 30. View southeast showing the main hallway in the house on the Property

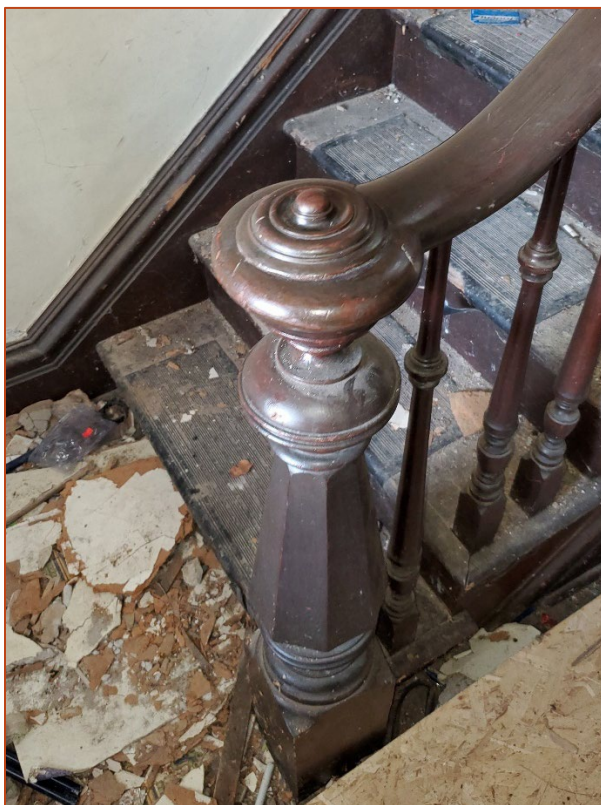
Image 31. View east showing the newel post at the base of the staircase

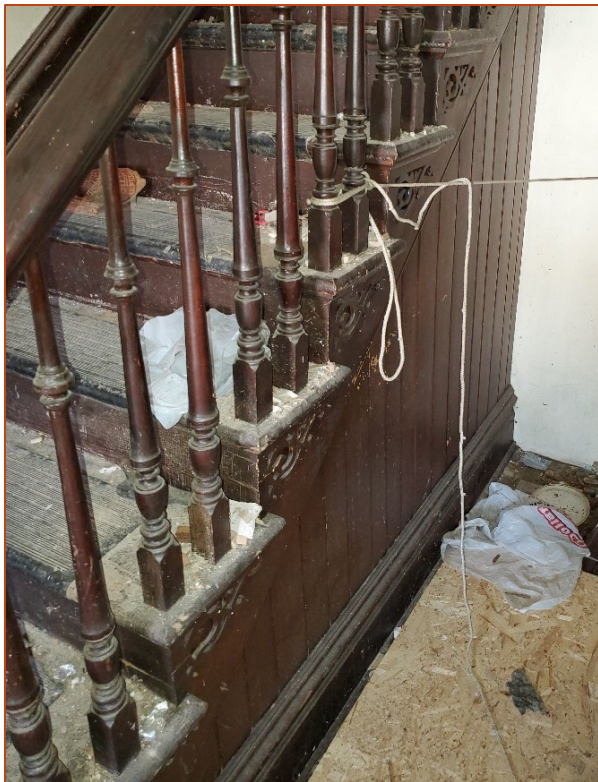
Image 32. View east showing the base of the staircase in the house on the Property

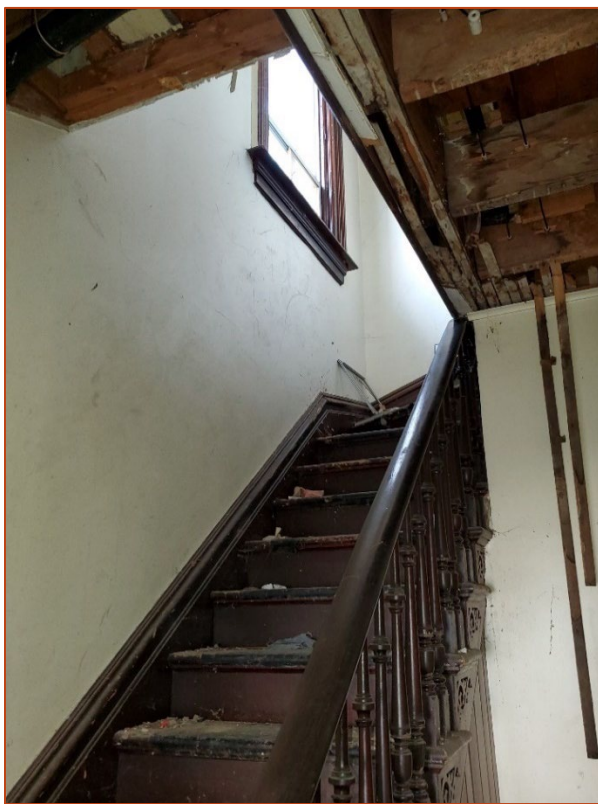
Image 33. View east showing the top of the staircase in the house on the Property

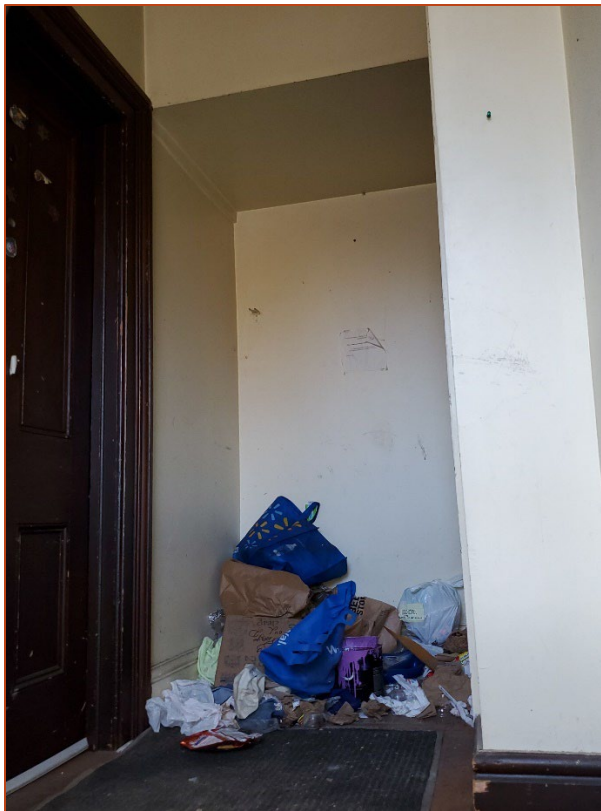
Image 34. View southwest showing the landing at the top of the stairs

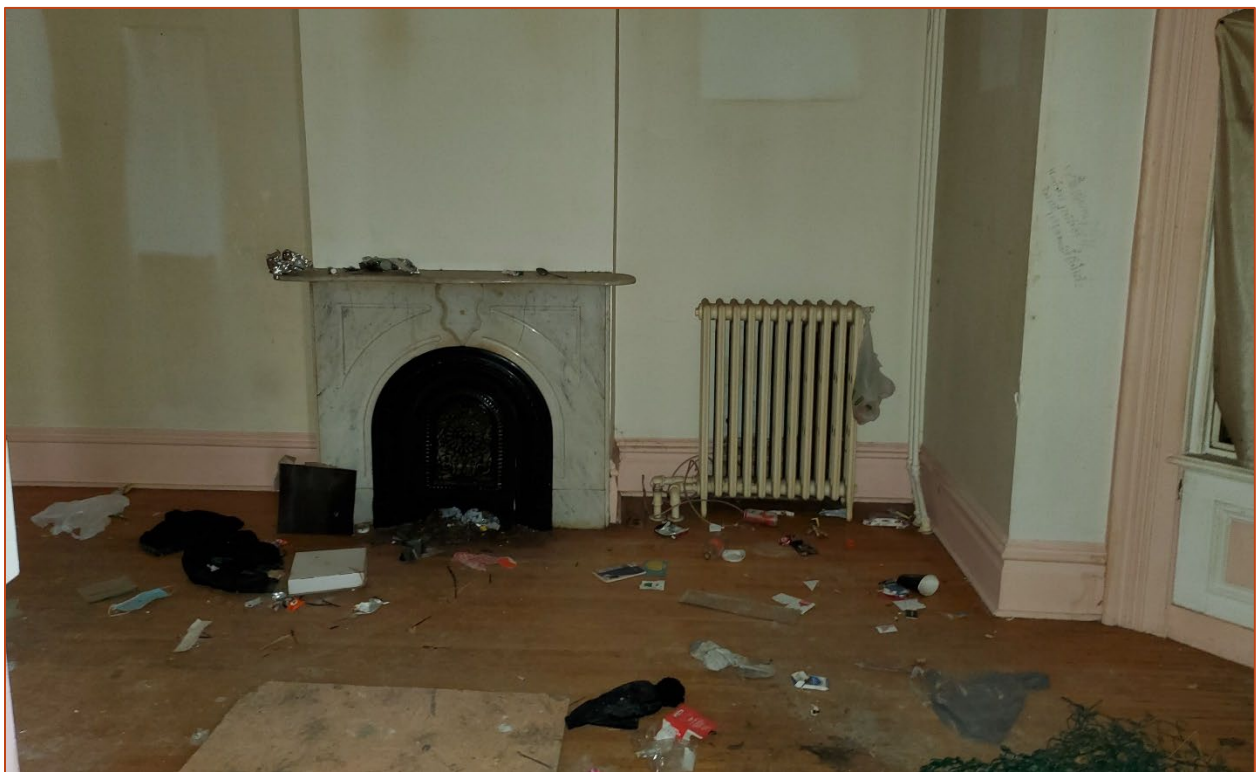
Image 35. View southwest showing the living room in the house on the Property

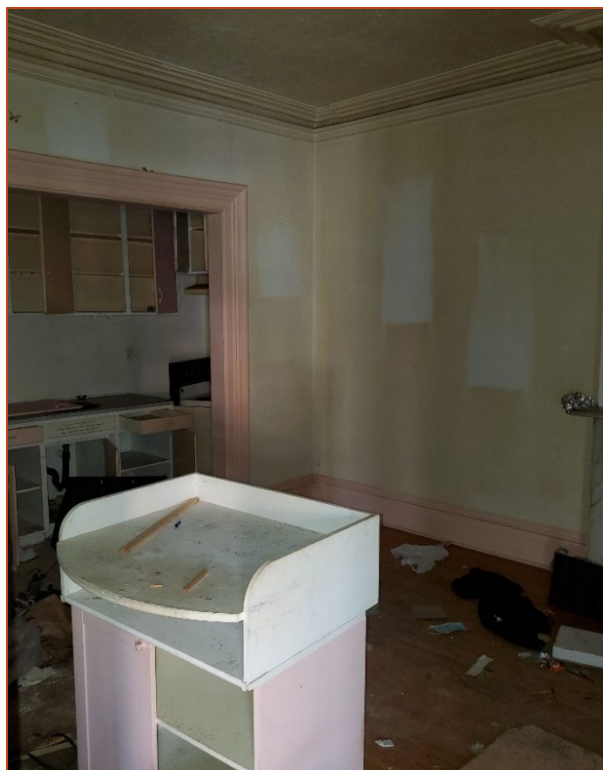
Image 36. View south showing the living room and kitchen in the house on the Property

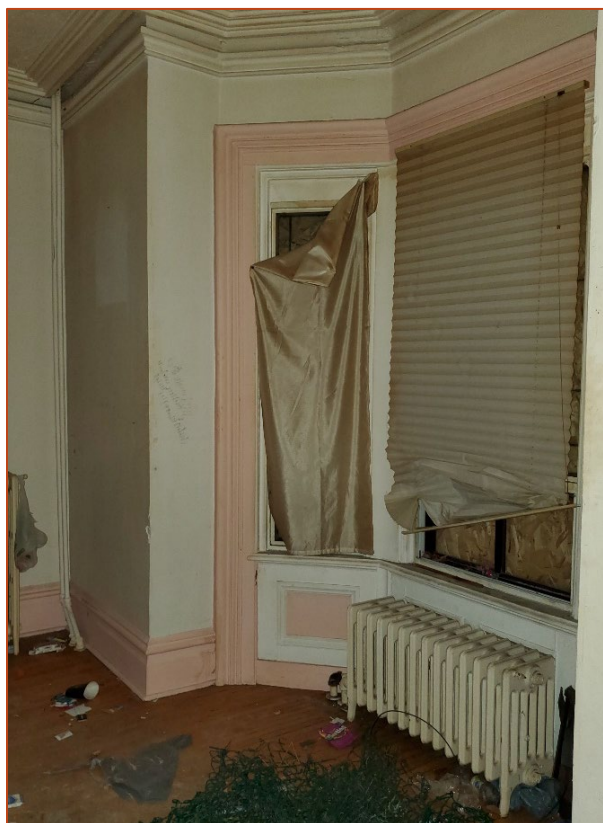
Image 37. View west showing the living room in the house on the Property
