12061 Hurontario St., Snelgrove Baptist Church Heritage Permit Application Recommendation Report

Building Condition Assessment

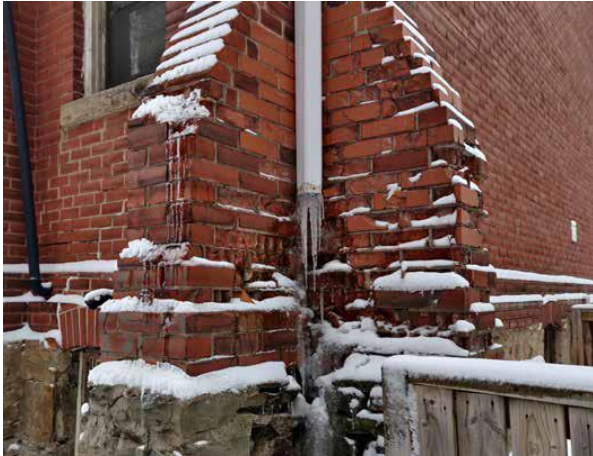
Significant deterioration at buttresses due to water ingress

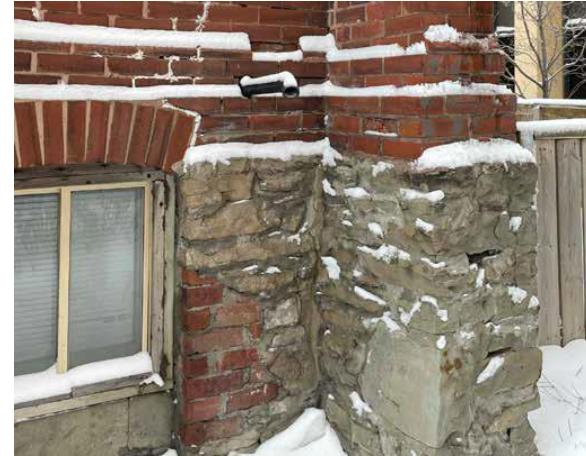
General condition of foundation wall around basement windows : open joints and incompatible repairs

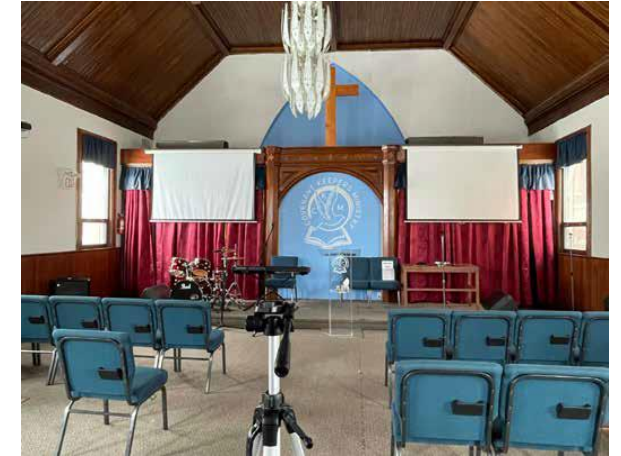
All mechanical and electrical services on the interior to be disconnected, general condition of interior is fair
