**Documentation and Salvage Report –
59 Elizabeth Street North and
Railroad Street Cultural Heritage
Landscape**

Final Report

April 23, 2025

Project Number:
160941102

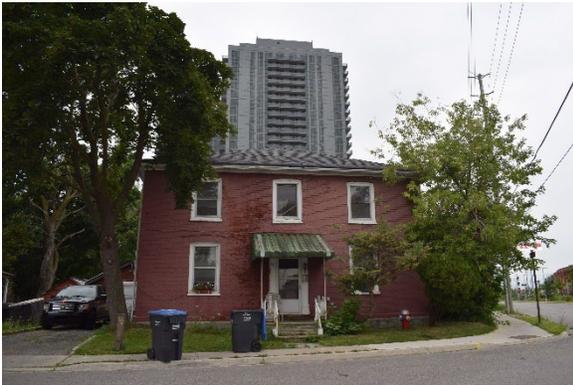
The east façade faces the intersection of Railroad Street and Elizabeth Street North. It has three metal sash windows with wood frames and sills on the second storey (Plate 1). It has a central front entrance with a metal awning, and a stone entrance porch. There is a replacement door situated in a wood frame, with wood surrounds and painted plywood covering the transom. A buzzer system is located to the side of the door (Plate 2). Two sash windows flank the entrance at either side, both metal in wood frames with wood sills. The two first storey windows have brick hood moulds. The bricks on the exterior façade are painted with localized areas of peeling.

Plate 1 East façade of 59 Elizabeth Street North

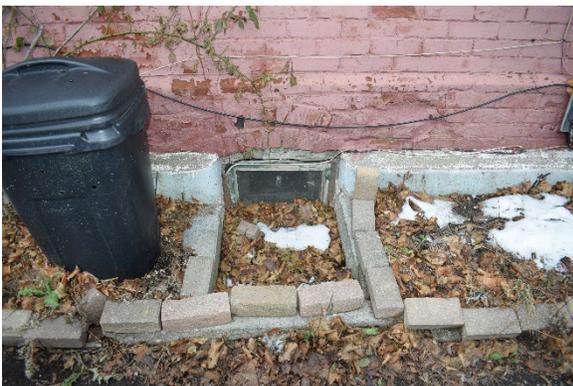
Plate 5 Coal shoot with plexiglass cover

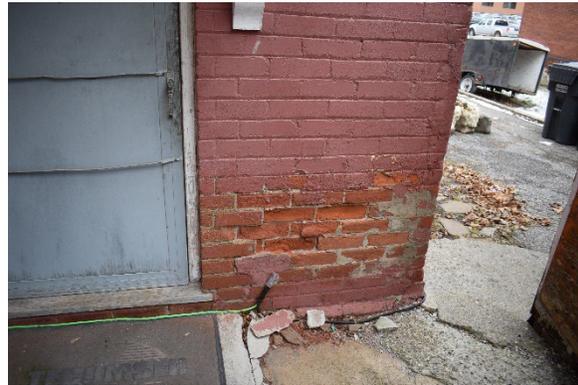
The west façade is the rear of the structure. On the first storey are two doorways, both with small wooden entrance porches (Plate 6). The doors are replacements. There is a small window beside the north entrance, with a metal window in a wood frame. There are two metal sash windows on the second storey, to the north side of the façade, both in wood frames with wood sills. The brick chimney runs from the ground to above the roofline on the north side of the façade (Plate 7). The brickwork in the south corner of the façade is spalling (Plate 8).

Plate 8 Spalling brickwork on south-west corner of building
