REPORT

11185 Airport Road, City of Brampton, Municipality of Peel, Ontario

Documentation and Salvage Plan Report

April 11, 2025

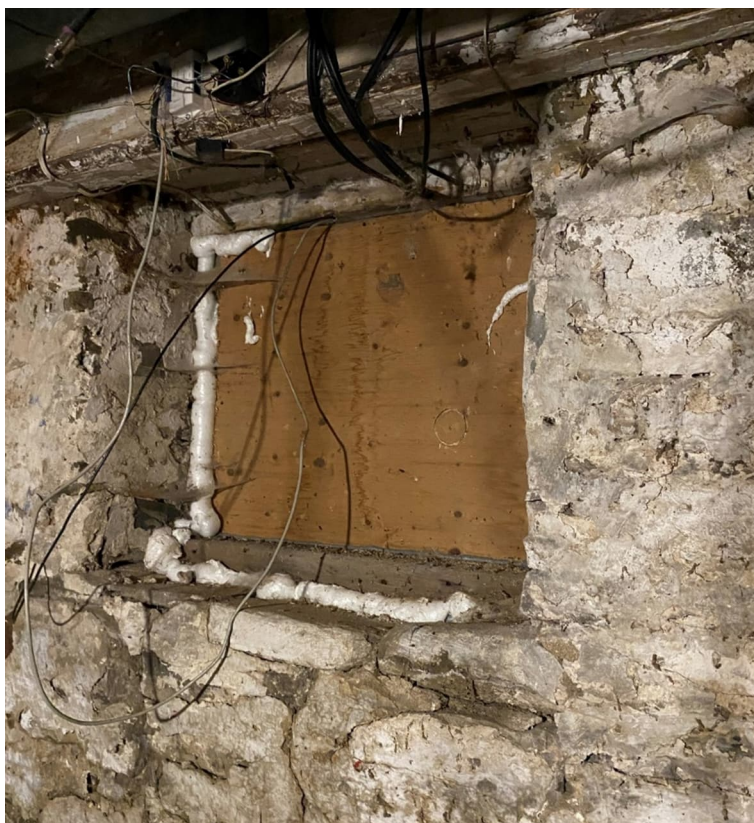
Entrance to the basement beneath the south half of the main block is a single flight of wood straight stairs from a doorway in the kitchen (Plate 38). The basement is unfinished with exposed floor joists and poured concrete floor, which is broken in several areas (Plate 39 to Plate 41). Coursed fieldstone foundation is visible in the interior of the basement with signs of deterioration due to water damage (Plate 42)

Plate 42: Coursed fieldstone foundation, facing west (View Y in Figure 10)

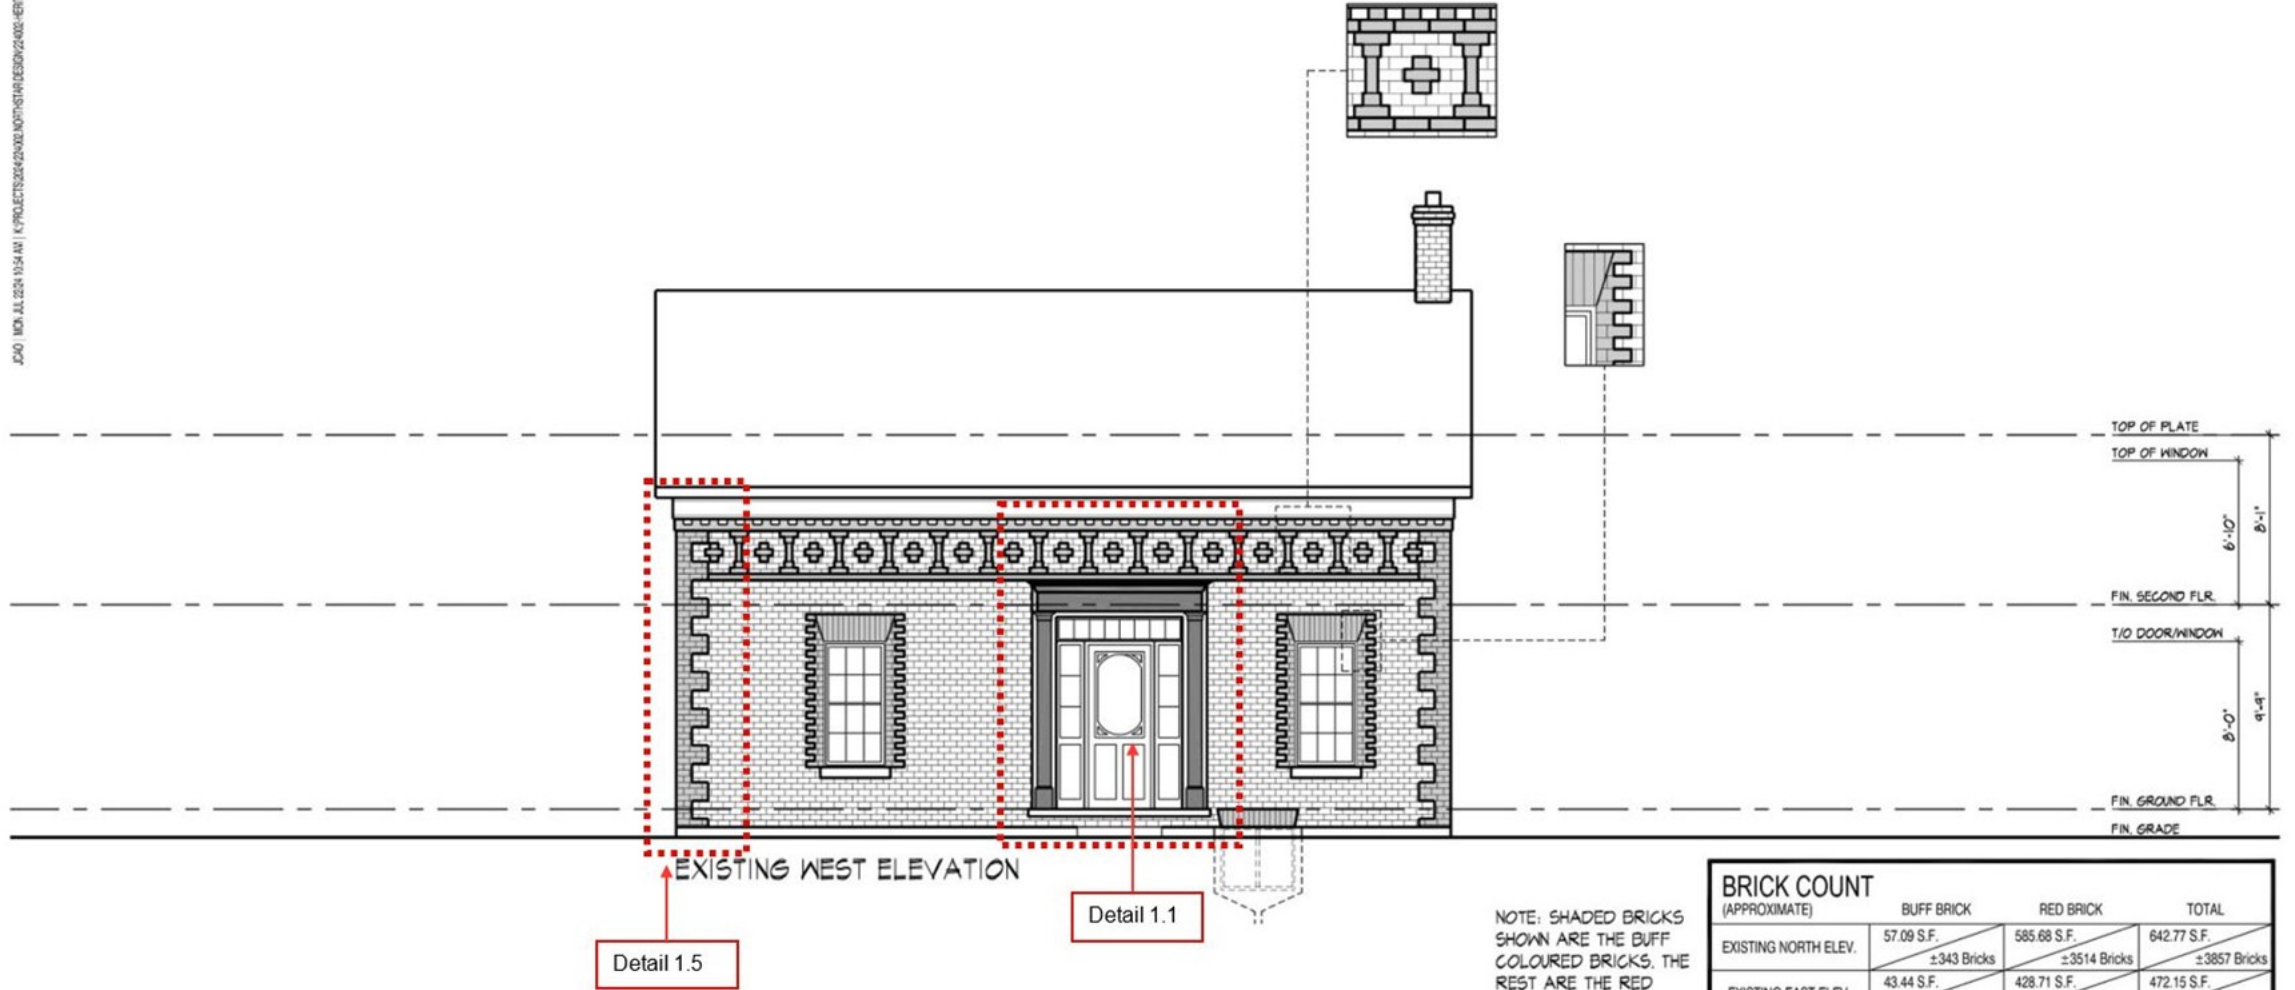
FIGURE 4

BRICK COUNT (APPROXIMATE)	BUFF BRICK	RED BRICK	TOTAL
EXISTING NORTH ELEV.	57.09 S.F. ±343 Bricks	585.68 S.F. ±3514 Bricks	642.77 S.F. ±3857 Bricks
EXISTING EAST ELEV.	43.44 S.F. ±261 Bricks	428.71 S.F. ±2572 Bricks	472.15 S.F. ±2833 Bricks
EXISTING WEST ELEV.	108.21 S.F. ±649 Bricks	343.56 S.F. ±2061 Bricks	451.77 S.F. ±2711 Bricks
EXISTING SOUTH ELEV.	40.65 S.F. ±244 Bricks	584.14 S.F. ±3505 Bricks	624.79 S.F. ±3749 Bricks
TOTAL	249.39 S.F. ±1497 Bricks	1942.09 S.F. ±11652 Bricks	2191.48 S.F. ±13149 Bricks

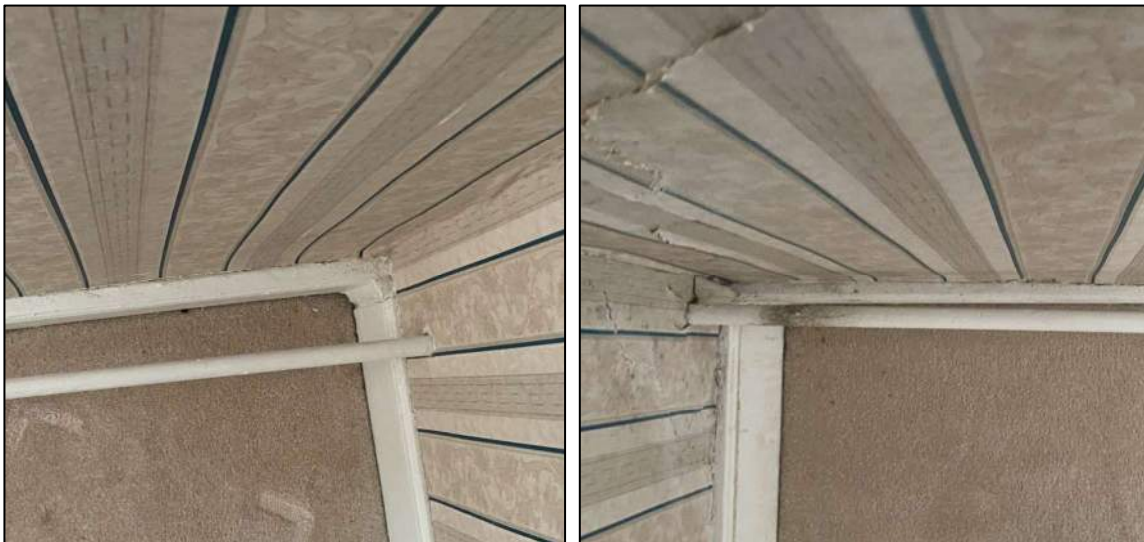
The exception was a significant horizontal (out of plane) deflection in the south wall, both along the height and length of the wall. A deflection of approximately 2-3" was measured at mid-length of the wall near the finished floor elevation. Refer to Photograph 1a and 1b for the relative deflection based on the offset of the wall to the tension rod.

Photograph 1a & b: Relative deflection of wall based on offset from tension rod

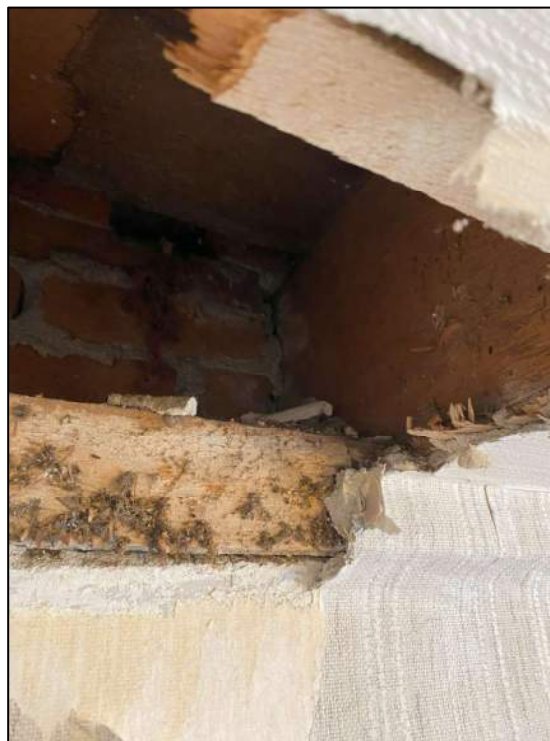
A section of ceiling finishes was removed at the southwest corner of the building and approximately at the middle of the south wall (refer to Photograph 2). Due to the absence of damage or evidence of movement, it is unlikely that the deflection on the second floor was caused by an outward movement of the wall after construction. It is assumed that the wall was built out of plumb. Refer to Section 5.5 Exterior for further discussion on the condition of the south wall.

Photograph 2: Section of removed ceiling finishes at the middle of the south wall

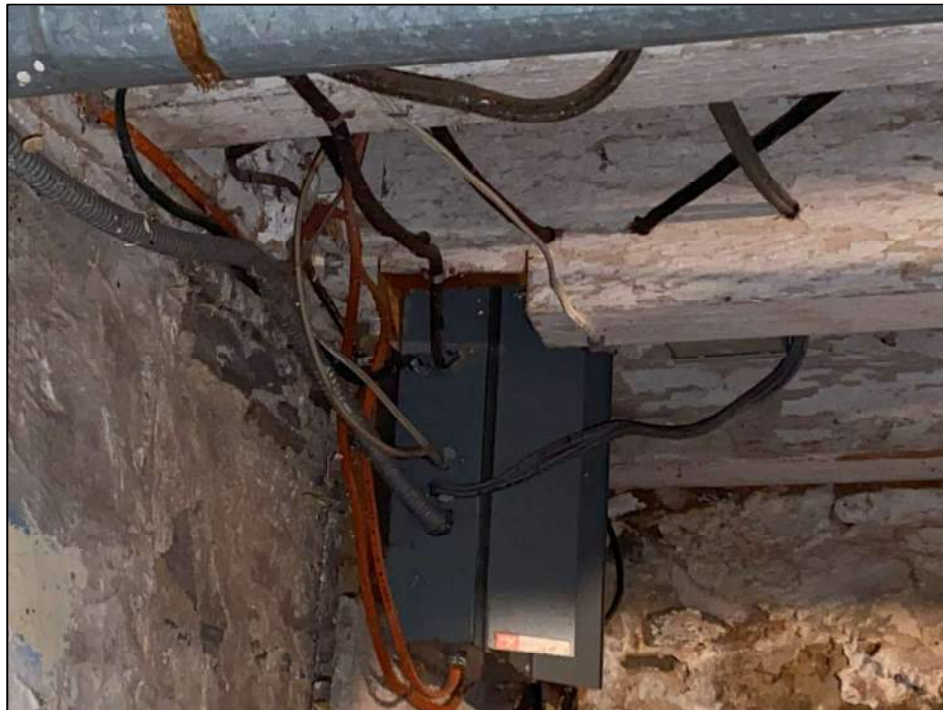
The basement was generally in fair condition. A notched joist was noted behind the furnace (Photograph 3), and the foundation wall was undermined in a localized area where a water supply pipe enters the building on the west wall (Photograph 4). The foundation walls also exhibit signs of deterioration due to moisture.

Photograph 3: Notched joist behind furnace

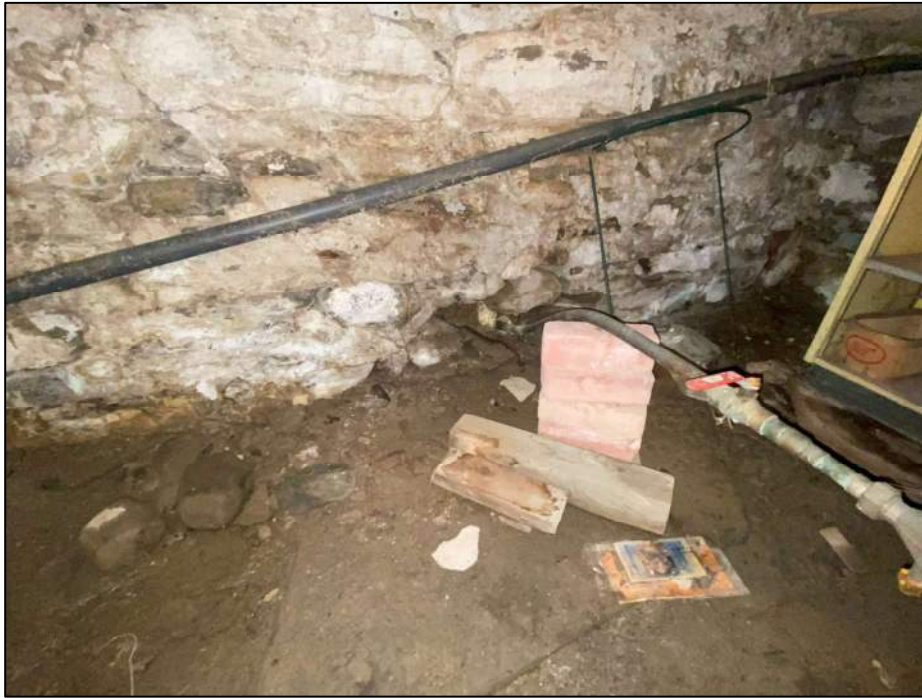
Photograph 4: Undermined section of foundation wall

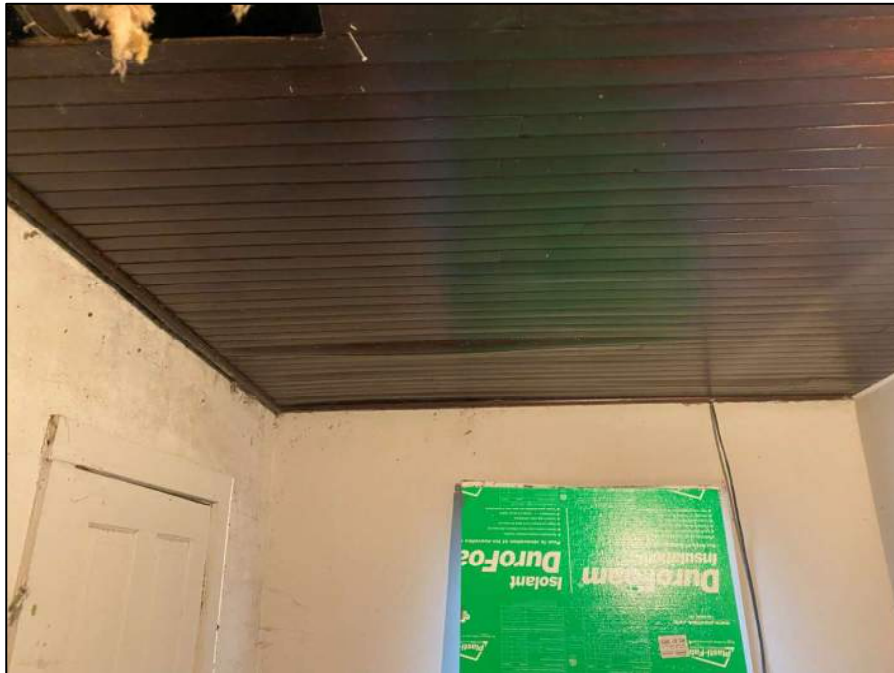
The finishes in the summer kitchen were generally of poor quality and/or in poor condition. Water damage was noted to the ceiling and floor finishes, as seen in Photograph 5 and 6, which could pose a larger concern to the underlying structure.

Photograph 5: Water damage to ceiling finishes

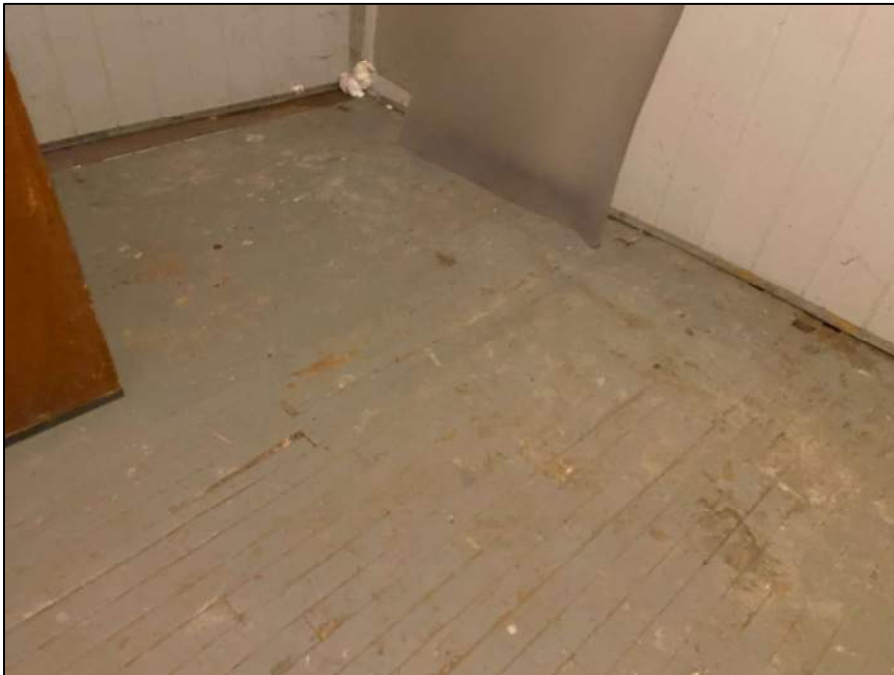
Photograph 6: Water damage to floor finishes

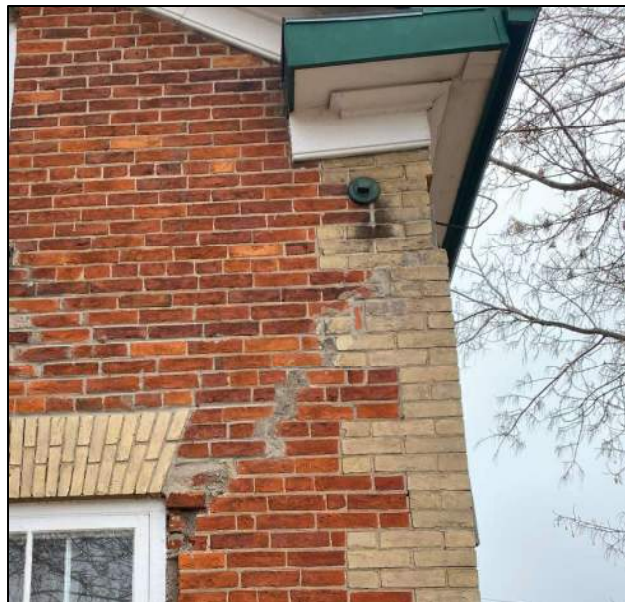
Photograph 7: Cracks and displacement at accent masonry

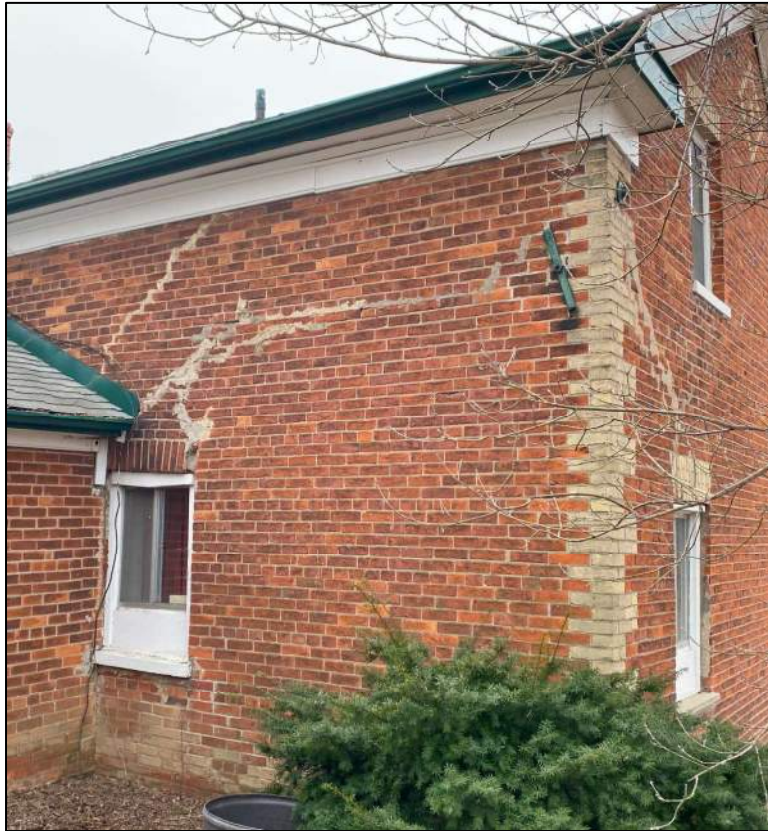
Photograph 8: Typical condition of exterior walls

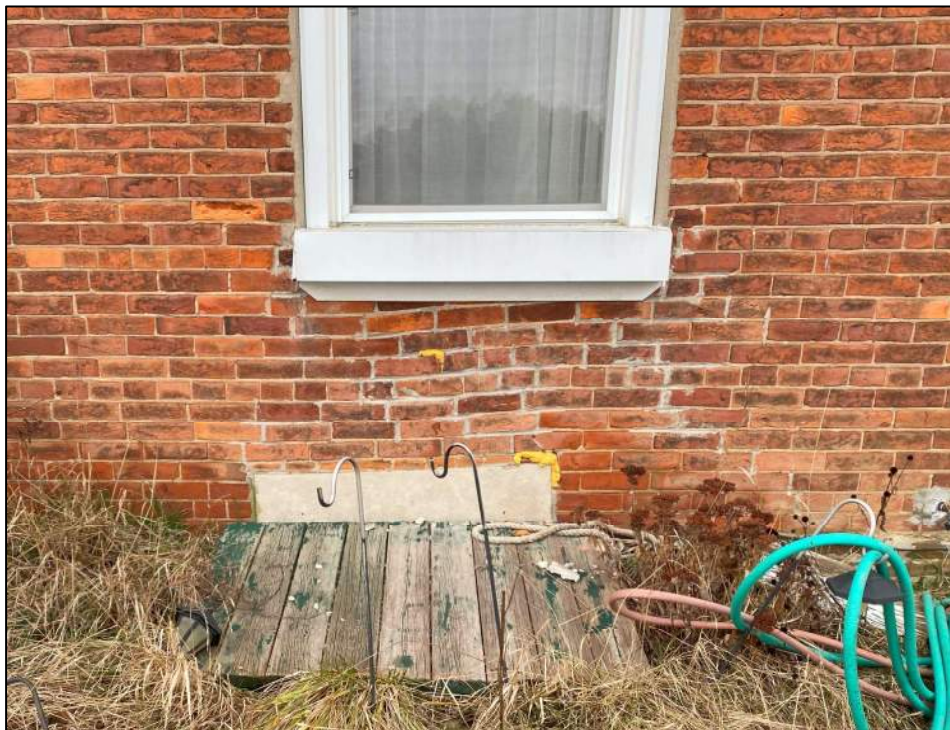
Photograph 9: Inconsistent coursing

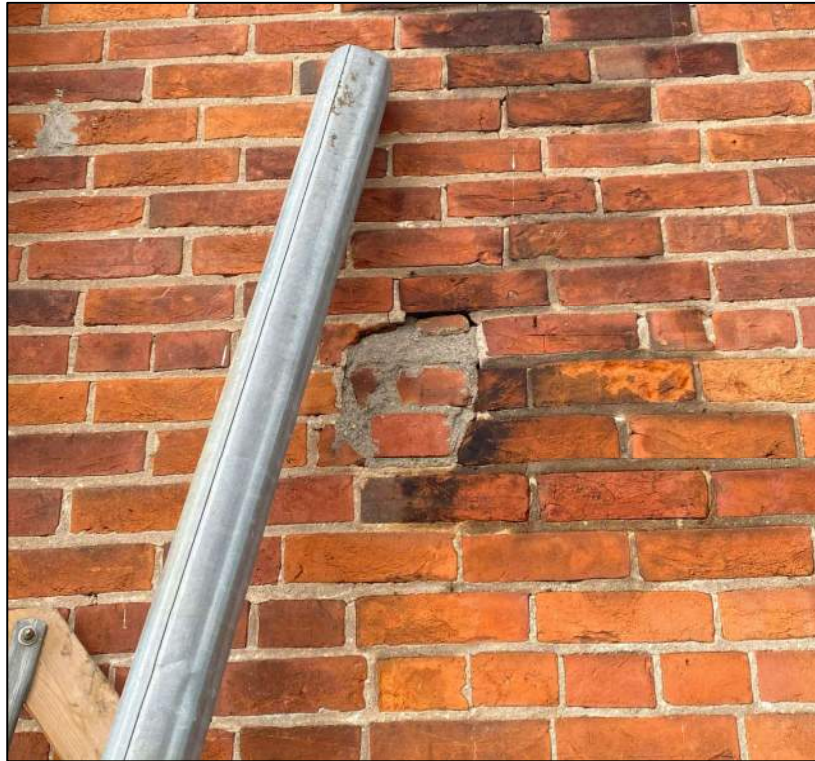
Areas were noted throughout the walls where past repairs had been made to larger openings by filling the holes with large amounts of mortar and cutoffs from brick (Photograph 10).

Photograph 10: Repair of past holes

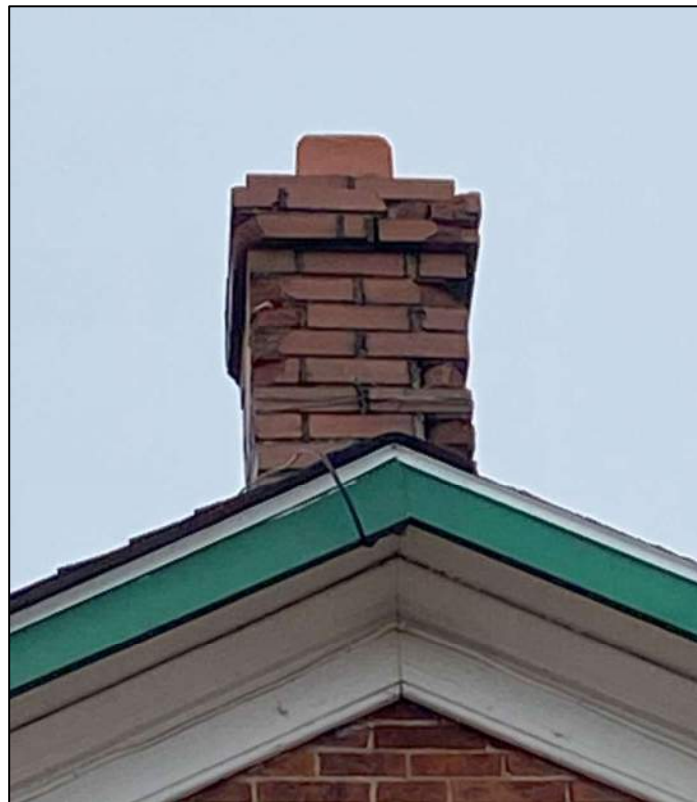
The roof rafters had notable deflections, and the chimney above the roof line had several loose and spalled bricks, as visible in Photograph 11. The loose bricks at the chimney and jack arches pose a safety concern from falling material.

Photograph 11: Condition of chimney
