Scoped Heritage Impact Assessment

*10980 Hwy 50
Brampton ON*

File no. 2558A

May 2025 (revised)

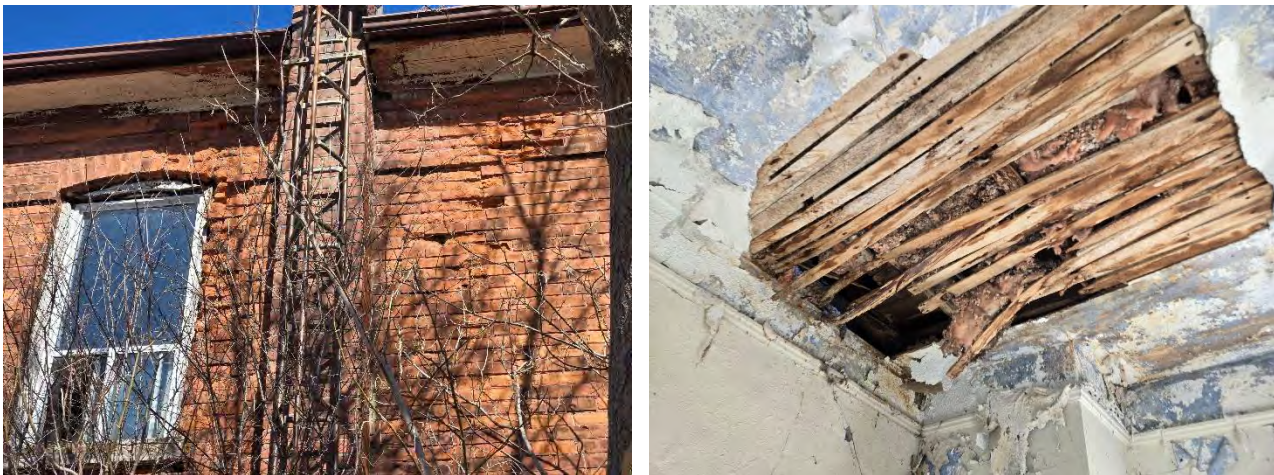
- The barn and all existing wood framed outbuildings are in very poor condition, most are in a state of partial collapse;
- The dwelling was assessed in terms of structural stability, framing, masonry, roofs systems, and foundation:
- The features of the dwelling vary in their state of deterioration, from poor to very poor;
- Bricks are in poor to very poor conditions, and other portions require removal including existing chimneys;
- Given exposure to water and environmental conditions, the roof is in poor condition and rafters are no longer structurally sound;
- The basement has flooded and rubble stone foundations are in poor condition given water penetration;
- The extent of damage requires repairs and/or replacements to the extent that a small amount of authentic building materials would remain;
- Given the existing condition, the building is not able to be repaired.

Photos 17-18- (above, left) View of south elevation noting condition of brick, (below, right) View of interior framing (second storey) noting condition of wood as a result of water egress (MHBC, 2025).

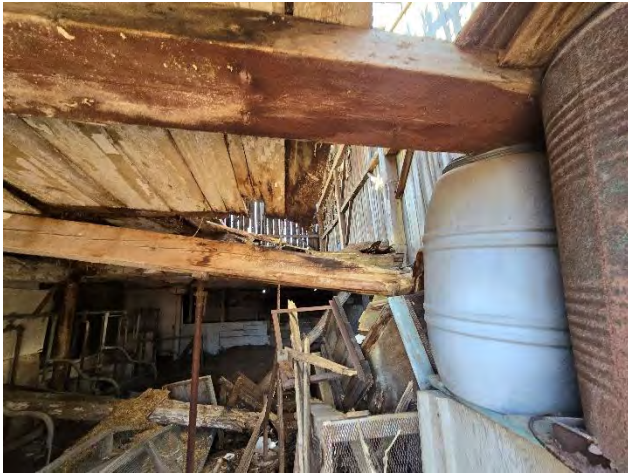
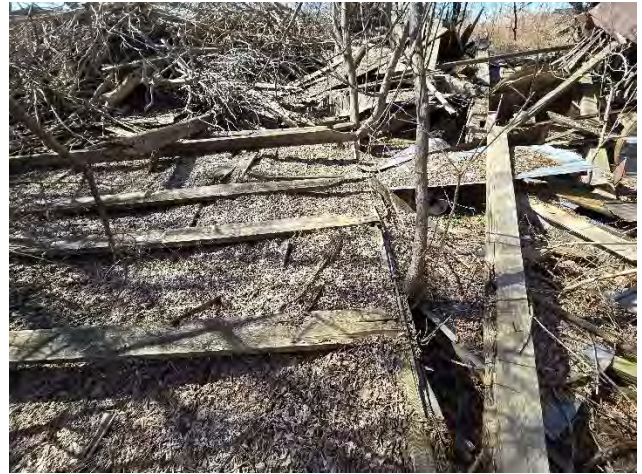
Photos 19-20- (above, left) View of collapse of interior structural beams of the barn, (below, right) View of collapsed barn framing materials, (MHBC, 2025).

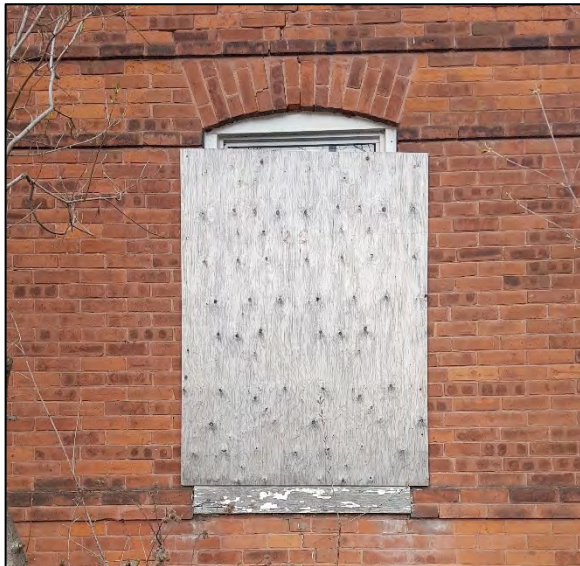
Figure 23: First storey window covered in plywood (ASI 2020)

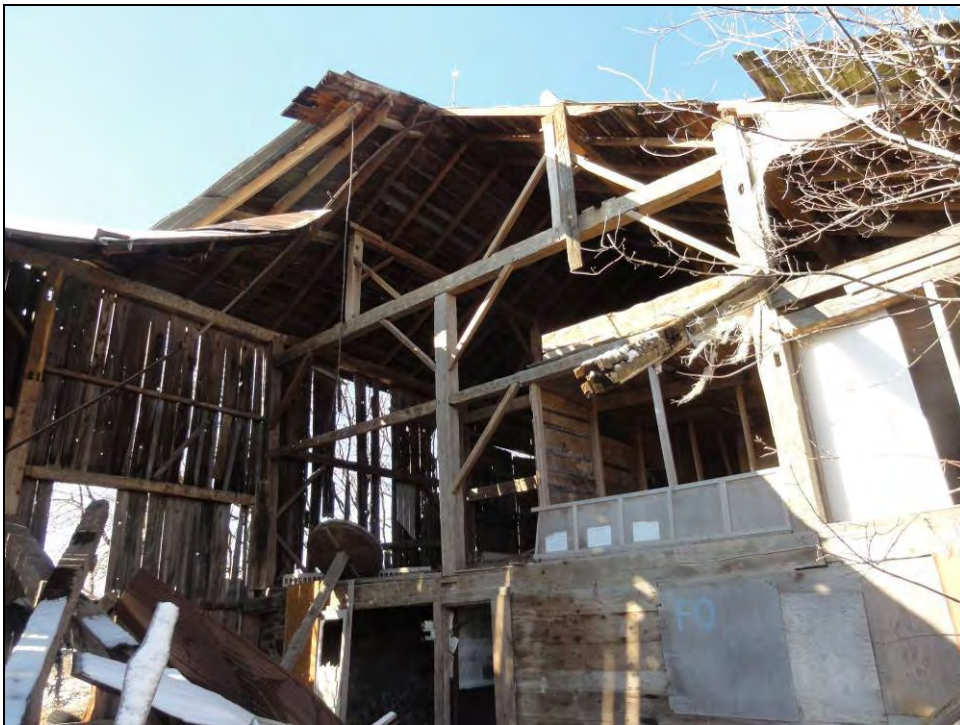
Plate 59: View of south elevation of Section 2 of barn, and collapsed section of barn.
