Pichler Engineering Limited
150 North Shore Road, Grafton, ON K0K 2G0 905 269-7364

April 9, 2021

*Rosedale Village – Sound Barrier Fence Review (SBFR)
Brampton, Ontario*

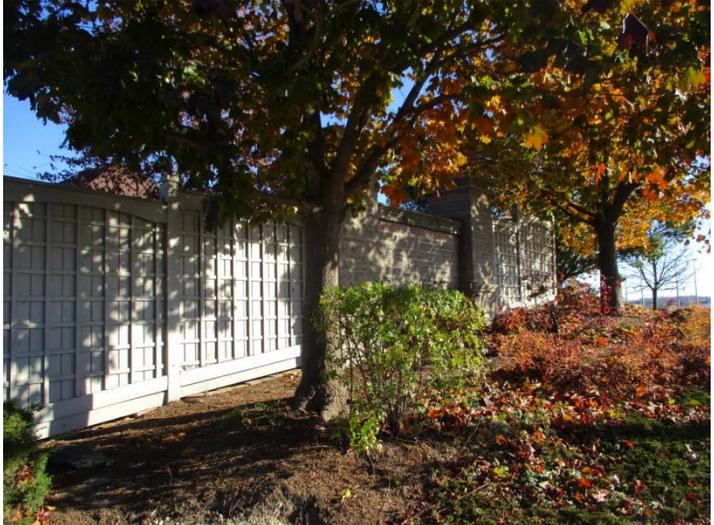
Ref. No.	Observation and Comment	Photo
1	General overview of the sound barrier fence east of the entrance to Rosedale Village. Referred to as "Entrance A" in the City of Brampton report (Appendix A - Rosedale Village Noise Walls).

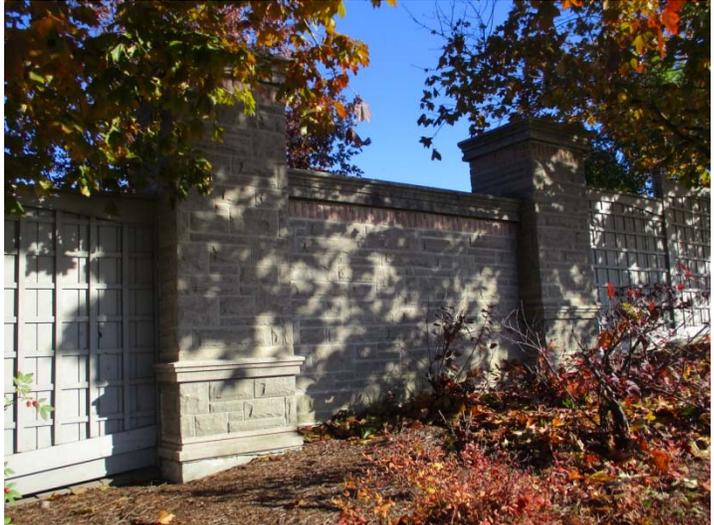
2	Masonry portion of sound barrier fence; located east of the south entrance to Rosedale Village.

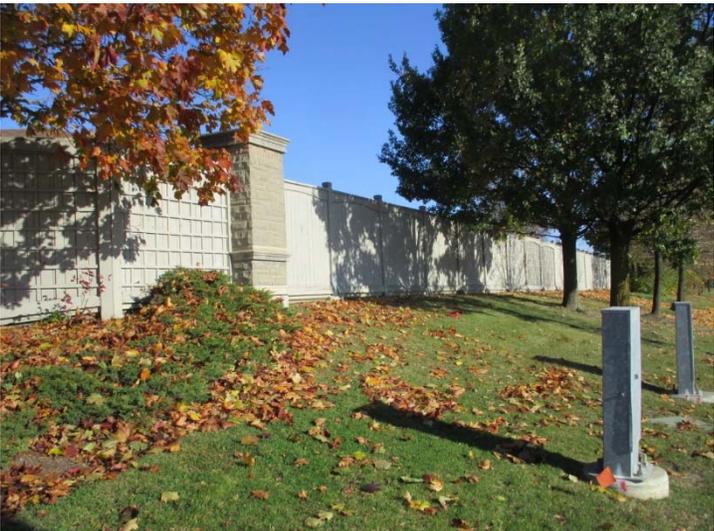
3	General overview of west end of sound barrier fence along Sandalwood Parkway.

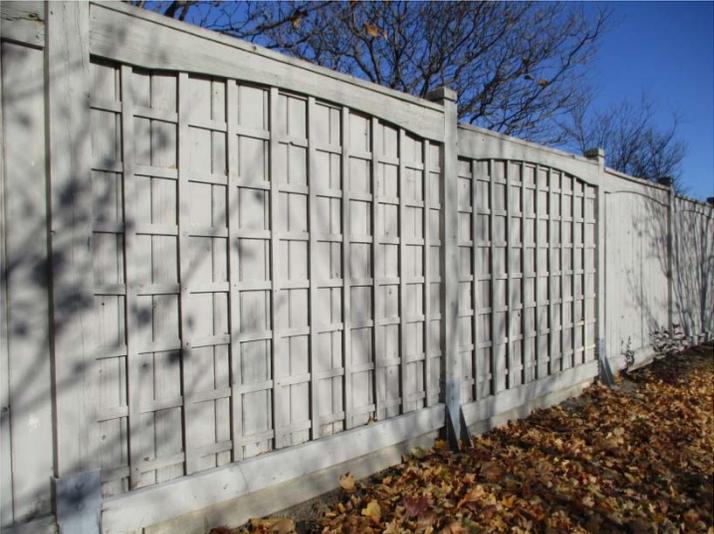
Ref. No.	Observation and Comment	Photo
4	Typical view of wood sound barrier fence along Sandalwood Parkway, west end.

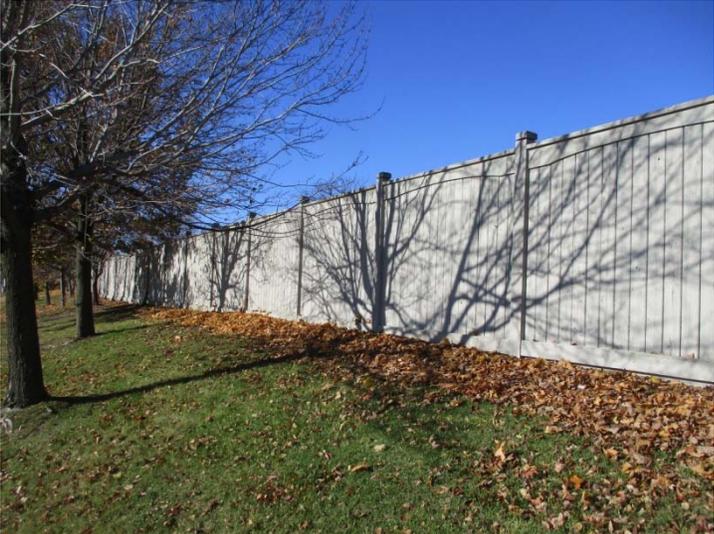
5	Typical view of wood sound barrier fence along Sandalwood Parkway, west-central end.

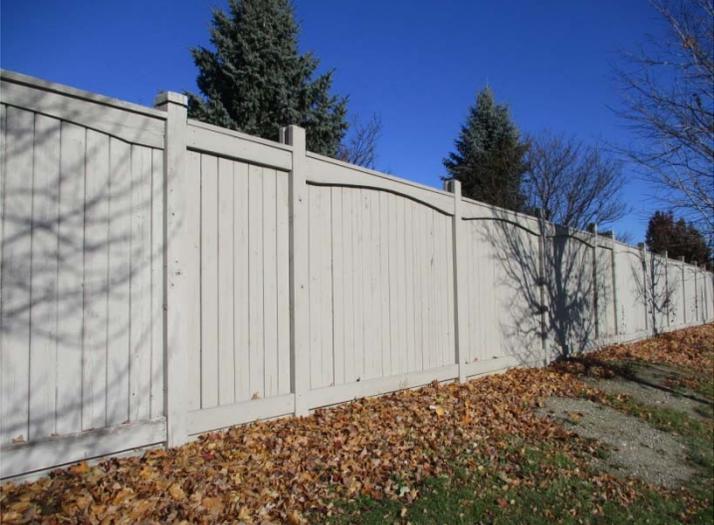
6	Typical view of wood sound barrier fence along Sandalwood Parkway, central area.

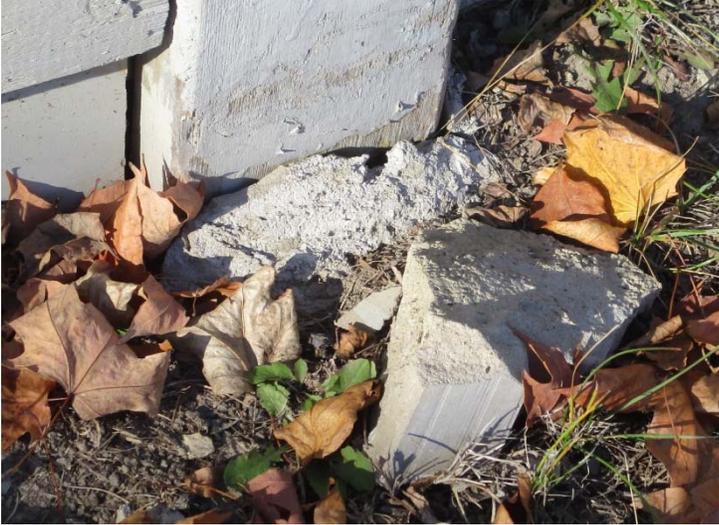
Ref. No.	Observation and Comment	Photo
13	<p>Although not common, several of the concrete foundation pours were deteriorated. Likely cause poor concrete and/or stresses induced from the "swelling" of the wood post in the concrete.</p>

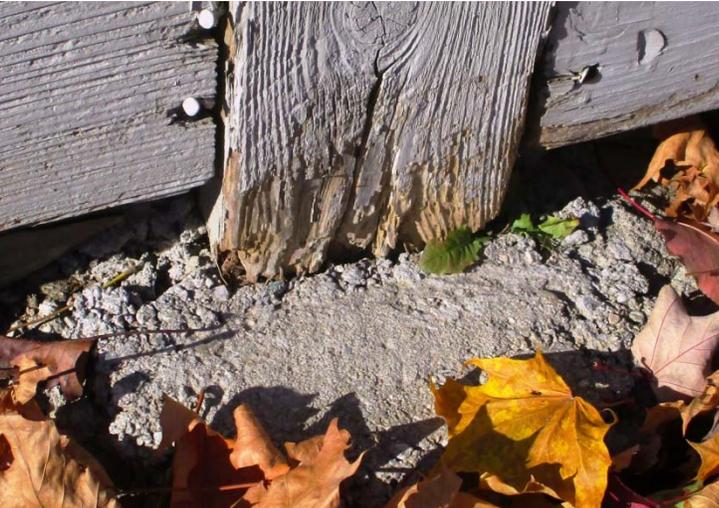
14	<p>Example of typical wood rot at the base of the fence post where it enters the poured concrete foundation. The depth of rot at this location was tested at all accessible fence posts using the screwdriver, starting at Reference Number 17.</p>

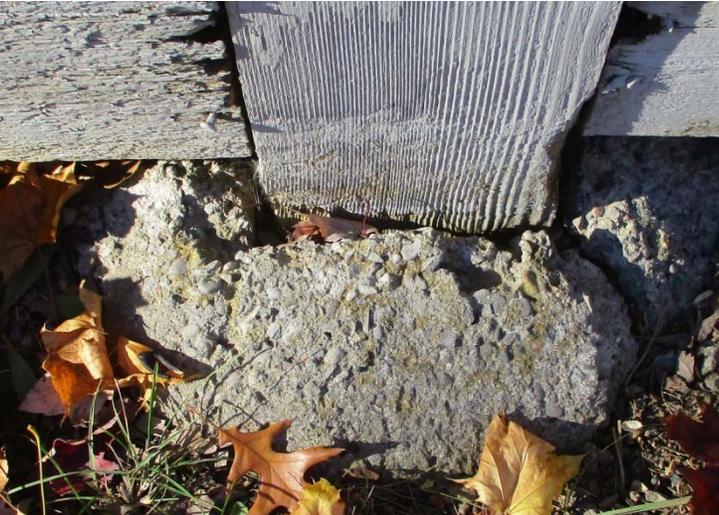
15	<p>Another example of concrete foundation failure where the post was inserted into the concrete.</p>

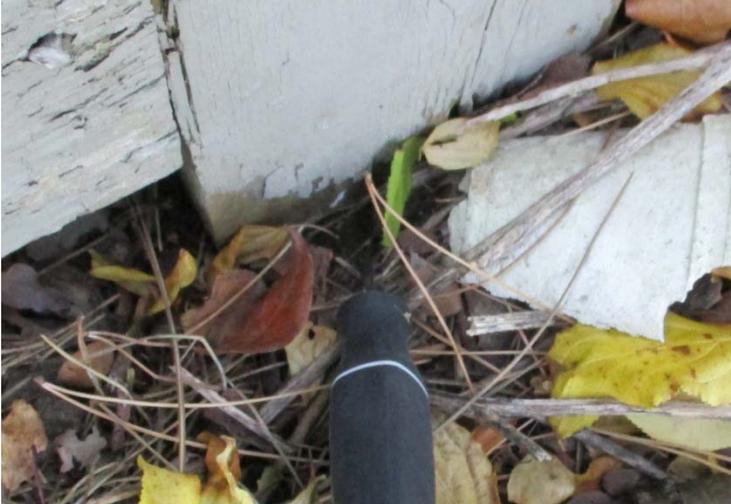
Ref. No.	Observation and Comment	Photo
19	Example of another fence post where rot extends 7 centimeters into the post.

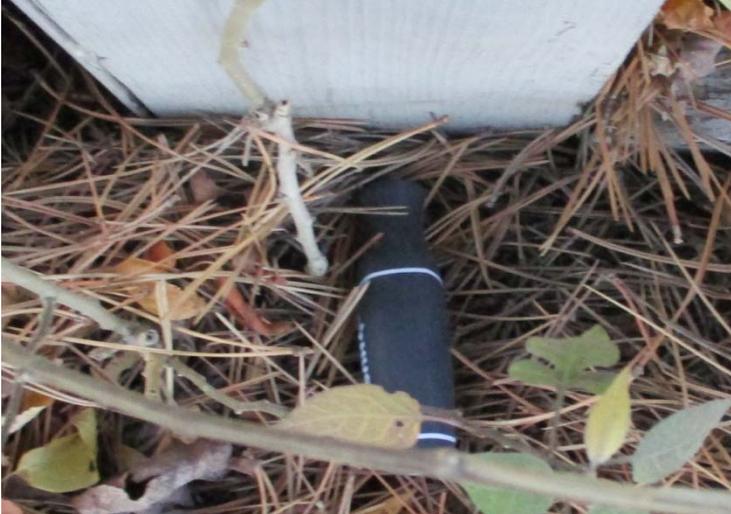
A close-up photograph of a white-painted wooden fence post. A black-handled screwdriver is inserted into the ground at the base of the post. The tip of the screwdriver is positioned against the wood, and a small section of the wood is being probed. The surrounding area is covered with dry leaves and pine needles.
20	Example of another fence post where rot extends 12 centimeters into the post.

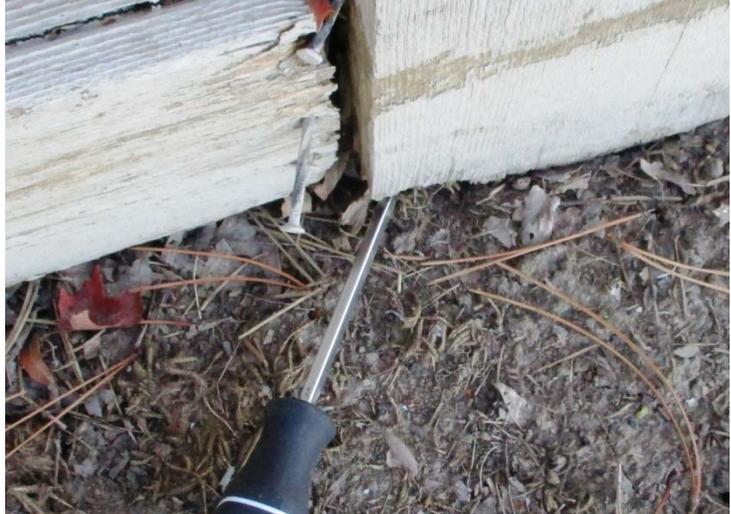
A close-up photograph of a white-painted wooden fence post. A black-handled screwdriver is inserted into the ground at the base of the post. The tip of the screwdriver is positioned against the wood, and a small section of the wood is being probed. The surrounding area is covered with dry leaves and pine needles.
21	Example of another fence post where rot extends 3 centimeters into the post.

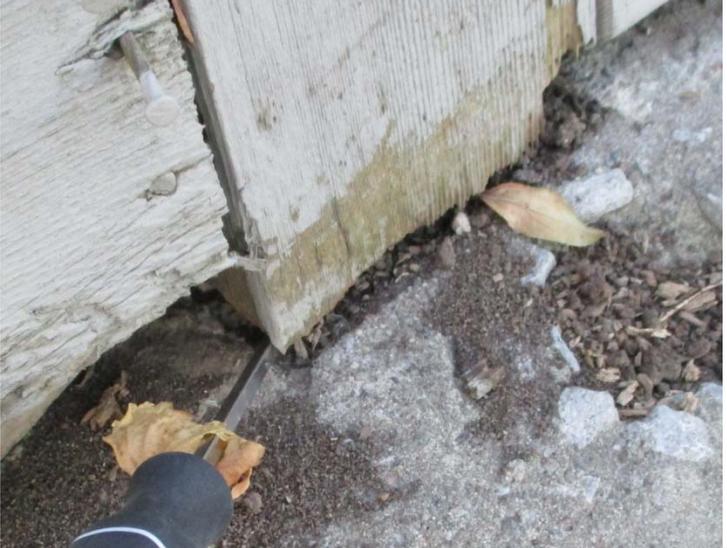
Ref. No.	Observation and Comment	Photo
25	Example of another fence post where rot extends 9 centimeters into the post.

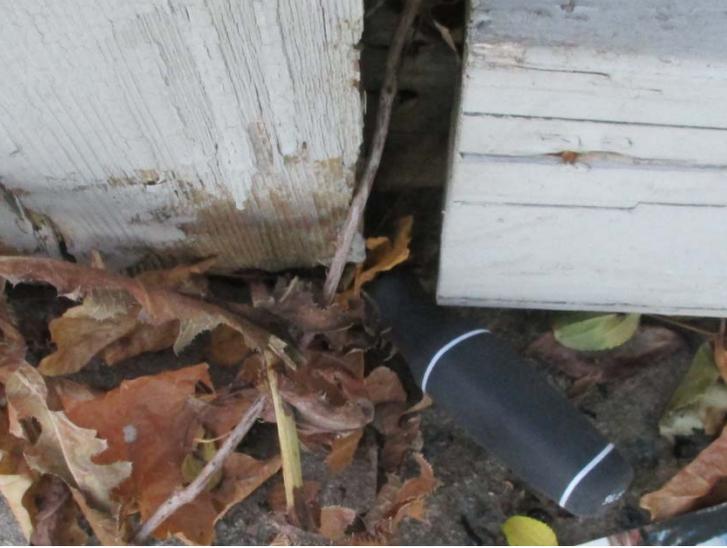
26	Example of another fence post where rot extends 14 centimeters into the post.

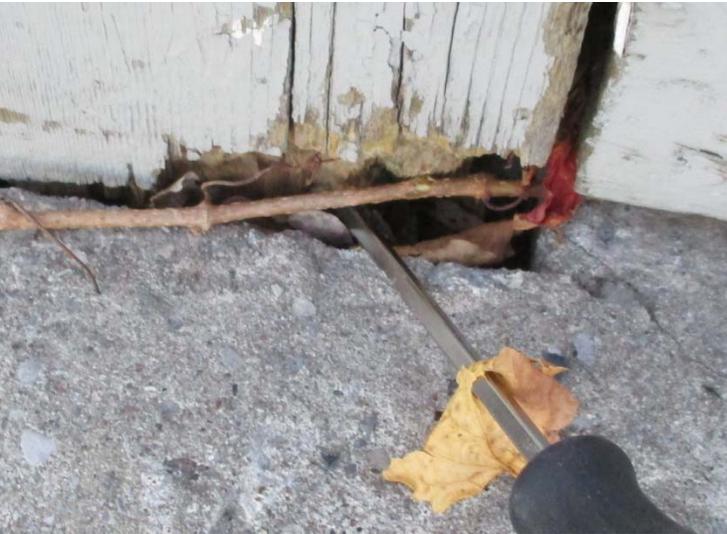
27	Example of another fence post where rot extends 4 centimeters into the post.

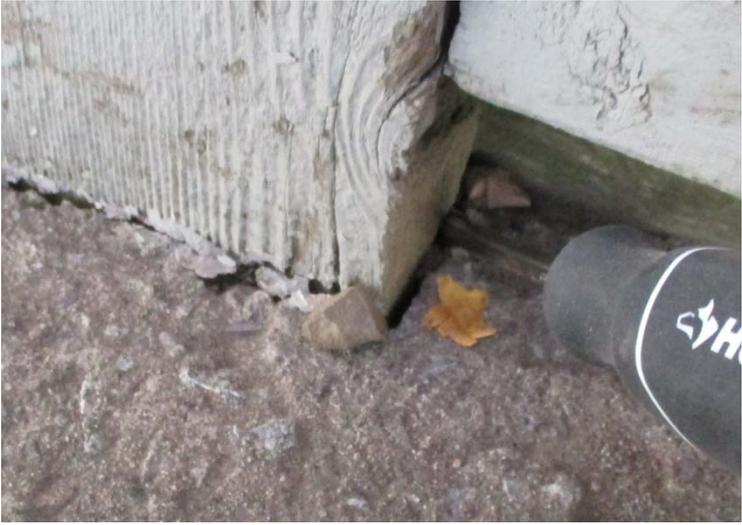
Ref. No.	Observation and Comment	Photo
28	Example of another fence post where rot extends 9 centimeters into the post.

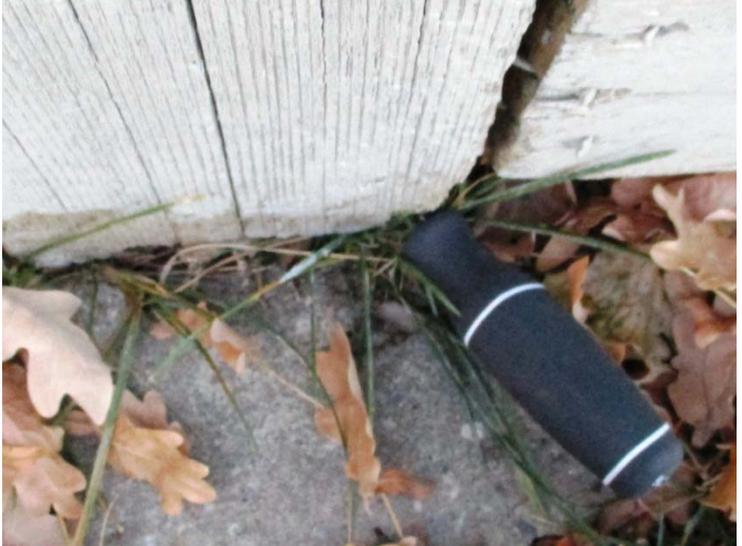
29	Example of another fence post where rot extends 14 centimeters into the post.

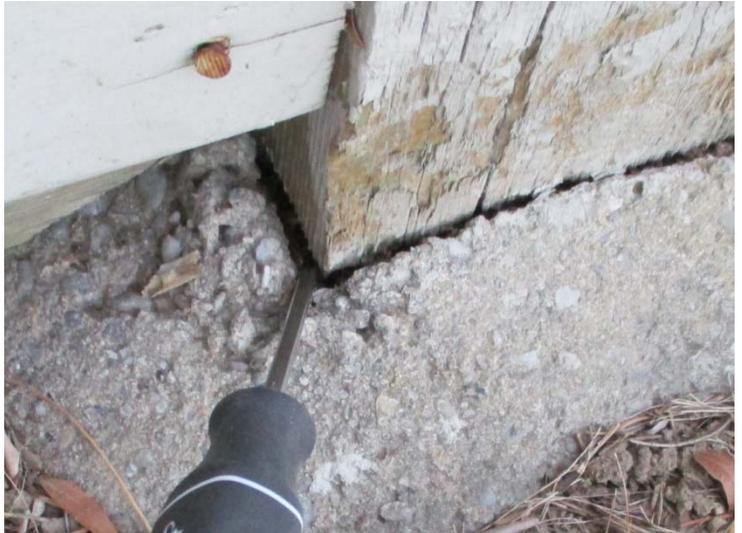
30	Example of another fence post where rot extends 9 centimeters into the post.

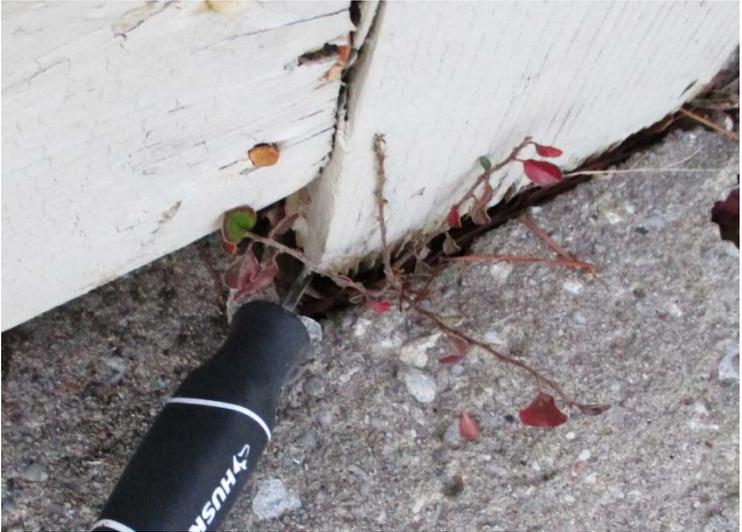
Ref. No.	Observation and Comment	Photo
31	Example of another fence post where rot extends 12 centimeters into the post.

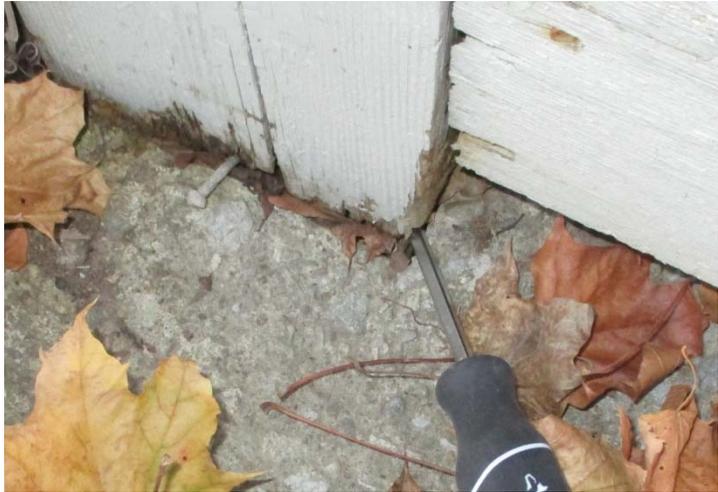
32	Example of another fence post where rot extends 7 centimeters into the post.

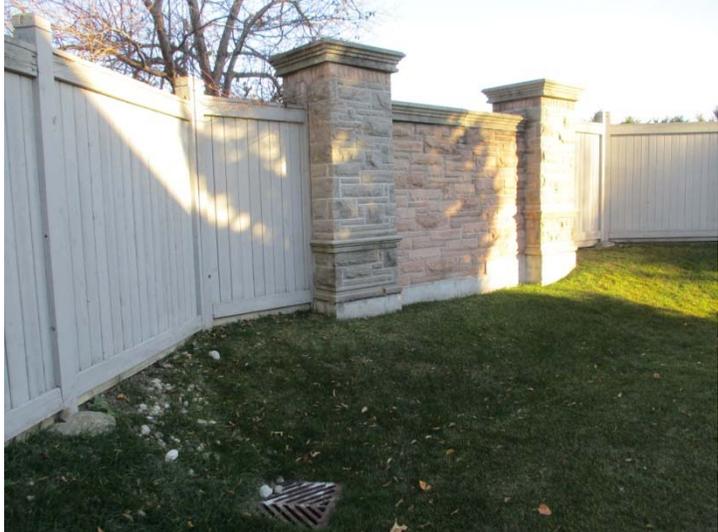
33	Inside view of the sound barrier fence at the east end of Sandalwood Parkway; the diagonal section of the fence is the transition point for the sound barrier fence that runs northward along Dixie Road.

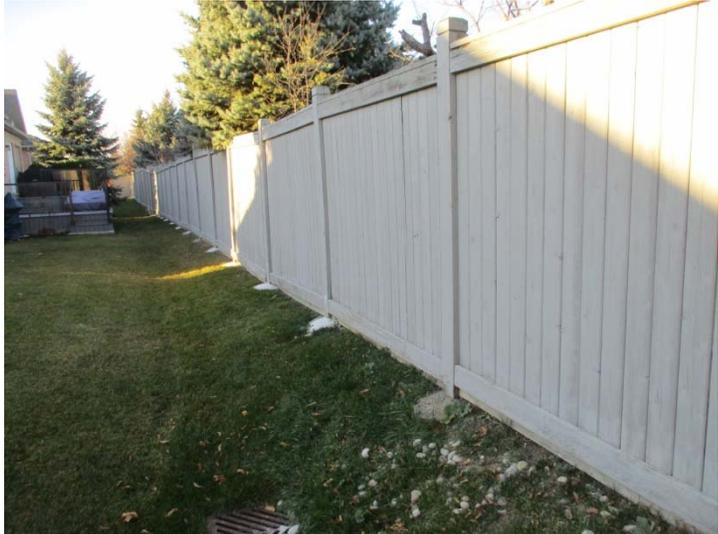
Ref. No.	Observation and Comment	Photo
34	General overview of the south end of the sound barrier wood fence running northwards parallel to Dixie Road.

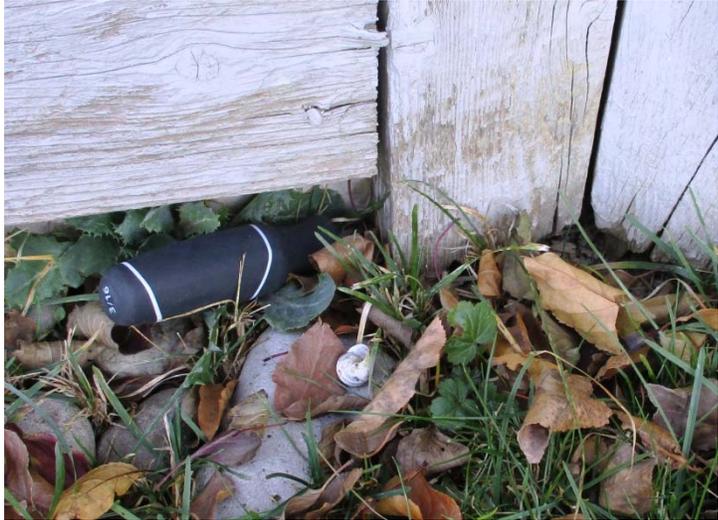
35	Example of another fence post where rot extends 12 centimeters into the post.

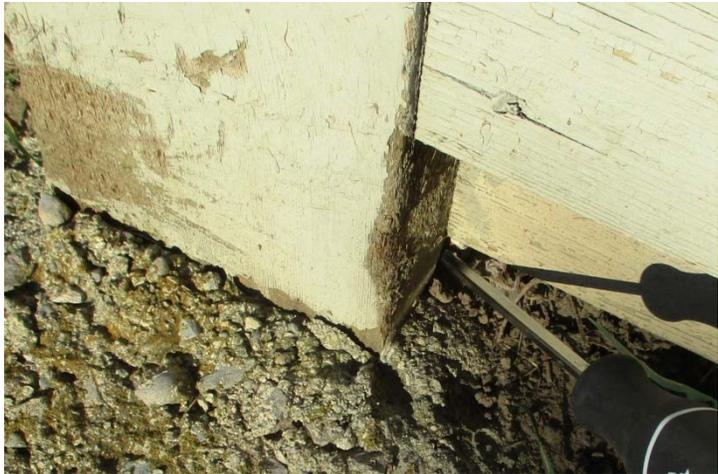
36	Example of another fence post where rot extends 3 centimeters into the post.

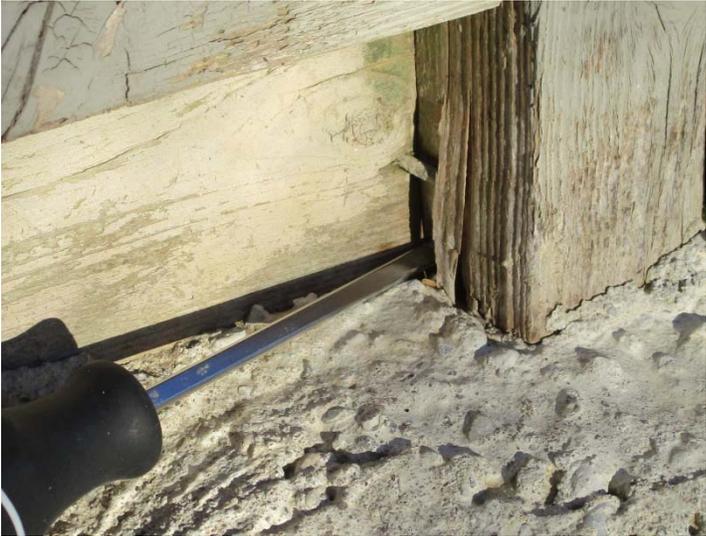
Ref. No.	Observation and Comment	Photo
37	Example of another fence post where rot extends 2 centimeters into the post.

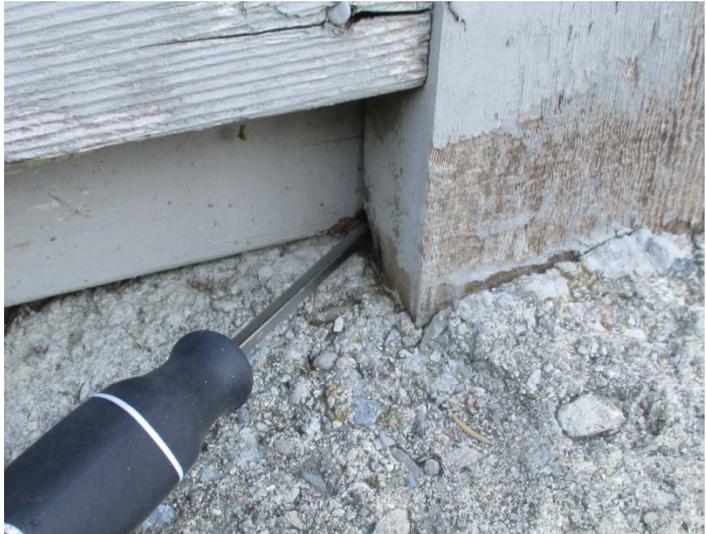
38	Example of another fence post where rot extends 3 centimeters into the post.

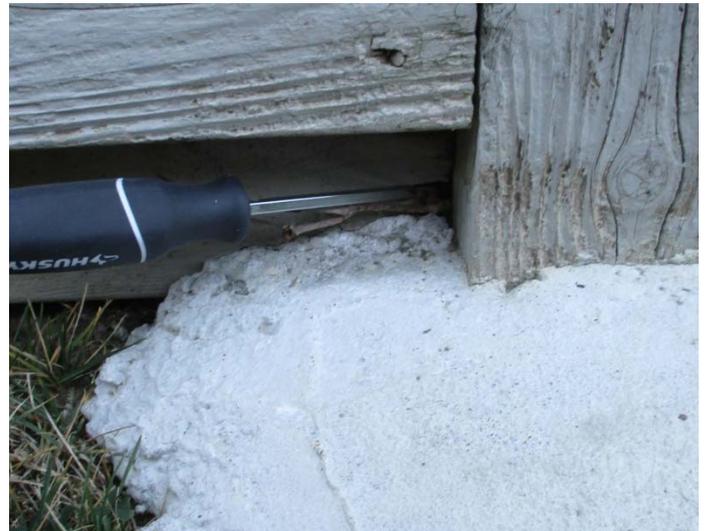
39	Example of another fence post where rot extends 6 centimeters into the post.

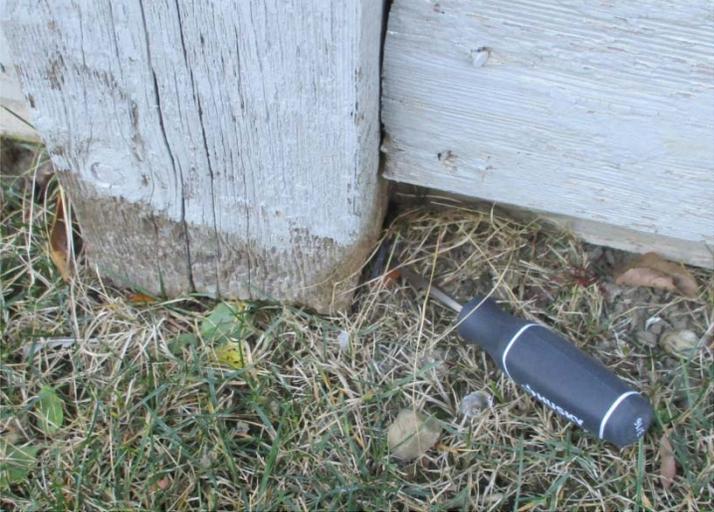
Ref. No.	Observation and Comment	Photo
43	Example of another fence post where rot extends 9 centimeters into the post.

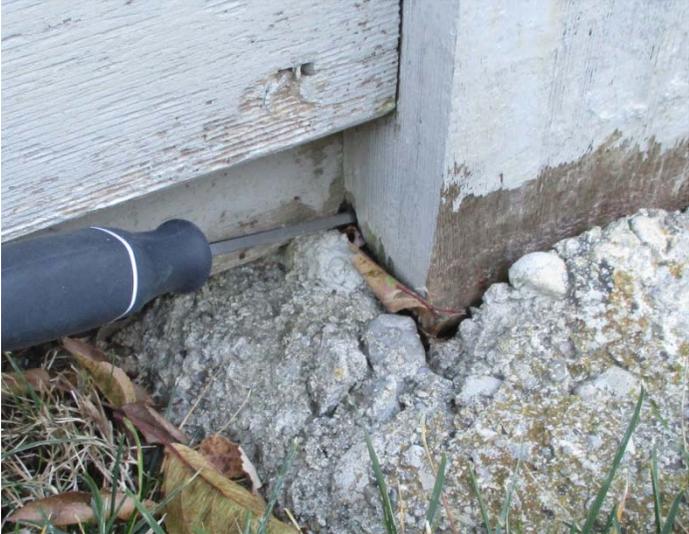
44	Example of another fence post where rot extends 6 centimeters into the post.

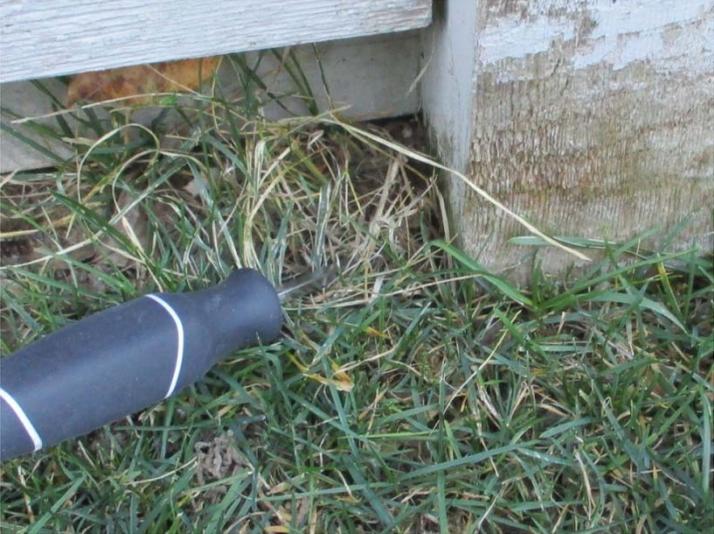
45	Example of another fence post where rot extends 5 centimeters into the post.
