# ROBERT HALL HOUSE

11687 CHINGUACOUSY ROAD, BRAMPTON, ONTARIO

HERITAGE CONSERVATION PLAN (HCP)  
HERITAGE BUILDING PROTECTION PLAN (HBPP)

COVER PAGE

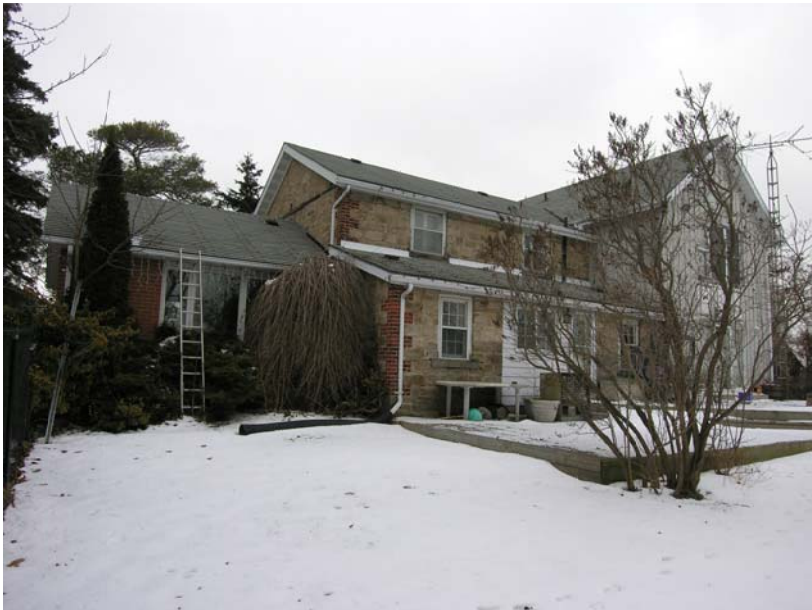
Figure 8: Demolished east and west additions

a. Demolition, Partial Salvage & Relocation <ul style="list-style-type: none"><li>i. Retain the Original Building,</li><li>ii. Demolish Non-original West and East Additions</li><li>iii. Remove and Replace Entrance Wood Porch and Wood steps on North,</li><li>iv. Remove Stone Foundations,</li><li>v. Relocate the Original Building,</li><li>vi. Demolish Non-Original Materials &amp; Components.</li></ul>

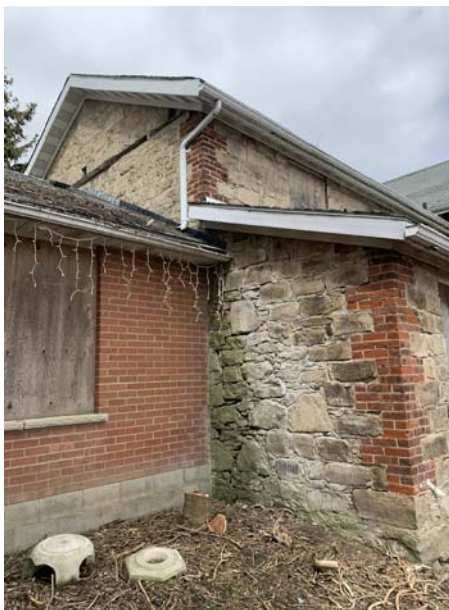
Some deterioration is observed at the exterior stone facade and needs to be repaired. All existing stone surfaces are required cleaning prior to additional masonry restoration work to eliminate efflorescence & to remove dirt & detritus for further inspection of any loosened stone units & cracked mortar joints.

Figure 9: Stone restoration

c. Stone Repointing & Tuckpointing: Repoint open & cracked stone and joints, as applicable. Repoint specific areas, shown light toned, but other areas will be identified on site to make up the 30% of each of the wall areas. Allow for 25% of total repointing areas for deep void repointing. Cut out & tuck point using lime mortar mix to match width, profile & colour of existing joints.

Clean exterior stone cladding (see Item 1a) and inspect for any deterioration or damage. Repair masonry surfaces (stone) for 30% of each of the wall areas where damage or deterioration is visible (i.e., significant cracks, holes, etc.). Replace masonry units (stone) where severely damage, altered or significant masonry features are missing. The areas will be identified on-site to make up 30% of each of the wall areas. Use salvaged stone retained on-site or new matching stone from specialized suppliers dealing with historic masonry. Replacement portion to be inserted with dutchman repair technique using in-kind material (like for like). The repair piece should be natural stone, chosen to match the hue and texture of the existing masonry.

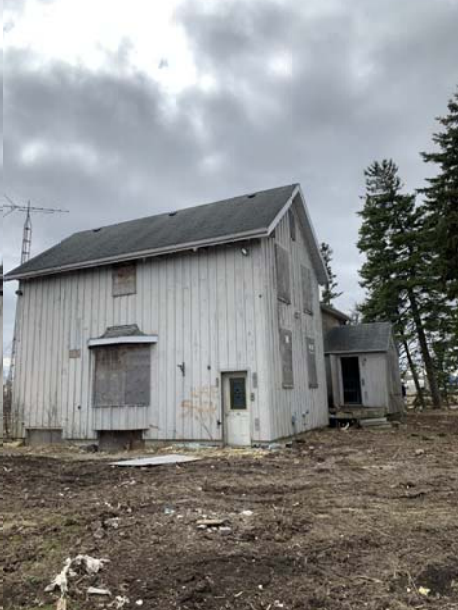
Figure 10: Wood-clad west non-original addition

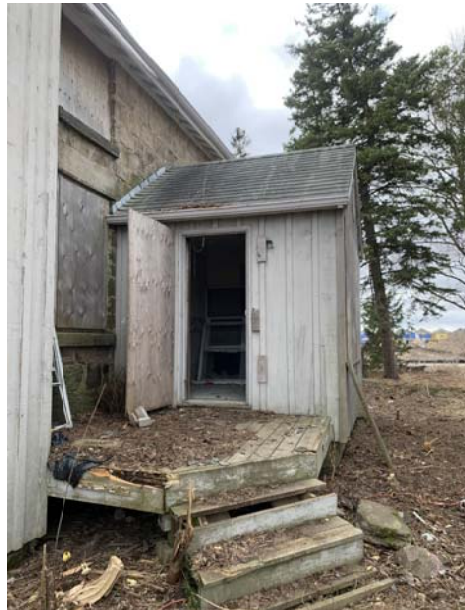
Wood porch served as an access point since 1969, and as the main entrance since 1979. With its material and architectural form, the wood porch differentiates itself from the rest of the masonry structure. Therefore, Northern wood porch could be replaced with in-kind wood materials as part of house re-use.

Figure 11: North wood porch to be removed & reconstructed

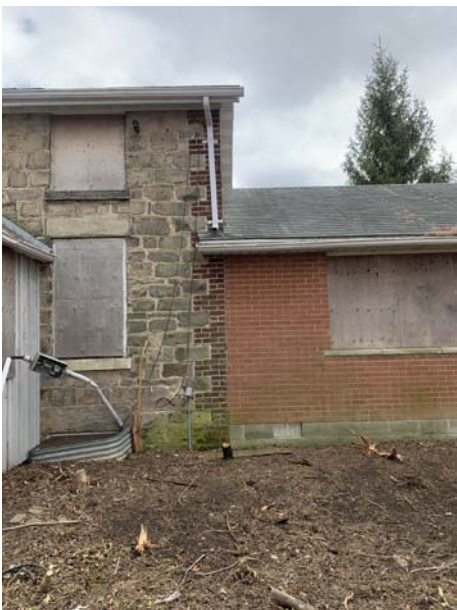
Formal decorated brick quoins on the South-west corner (missing from the east facade). Some deterioration is observed and need to be repairs.

Figure 12: Brick quoins to be restored

Remove paint from redbrick quoins on the south-west corner. Inspect for any deterioration or damage. Repair and repoint open & cracked existing bricks and joints for 40% of the area, as applicable. Cut out & tuckpoint using lime mortar mix to match the width, profile & colour of existing joint .

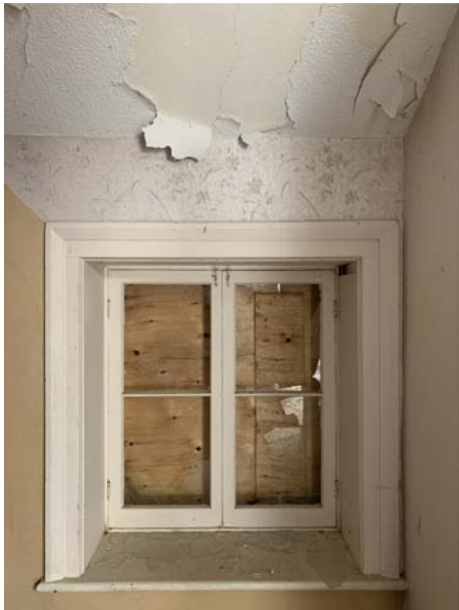
Severe deterioration is observed at window and door, and need to be replaced by contemporary units.

Figure 13: Non-original windows to be replaced

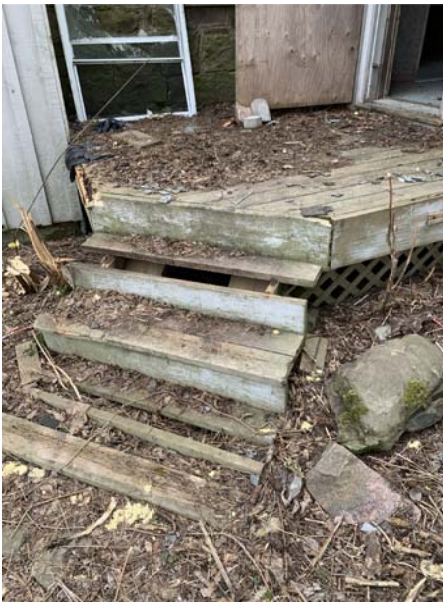
Severe deterioration is observed at the wood entry steps and need to be replaced.

Figure 14: North porch entry steps to be removed & replaced

Remove and replace entry steps with historically compatible entrance steps.

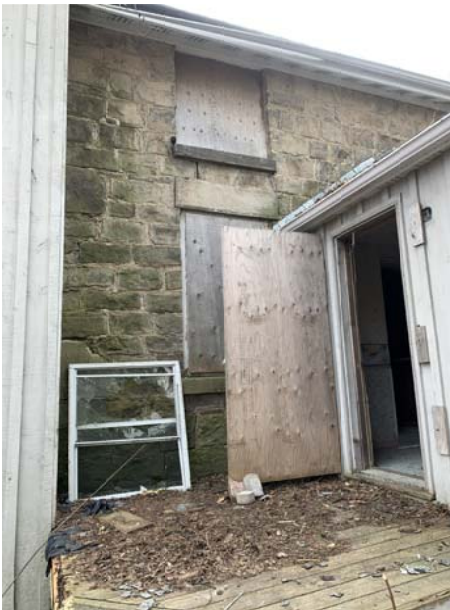
Two bays of windows on the north and south facades are supported on stone sill. Some of the windows are crowned with large, fully dressed stone lintels. Some cracks and chipped edges are observed at the stone window lintels and sills. All existing stone window lintels and sills require cleaning prior to additional masonry restoration work to remove dirt & detritus for further inspection.

Figure 14: Stone sill and lintel to be restored

Clean all stone sills & lintels (see M1, item a) and inspect for any deterioration or damage. Replace the missing portion of a chipped or broken stone unit with in-kind materials. Areas will be identified on-site to make up 15% of each. Use salvage stones retained on-site ore replace them with in-kind material using the dutchman method; The repair piece should be natural stone, chosen to match the hue and texture of the existing masonry. Provide reinforcement at the openings as required.

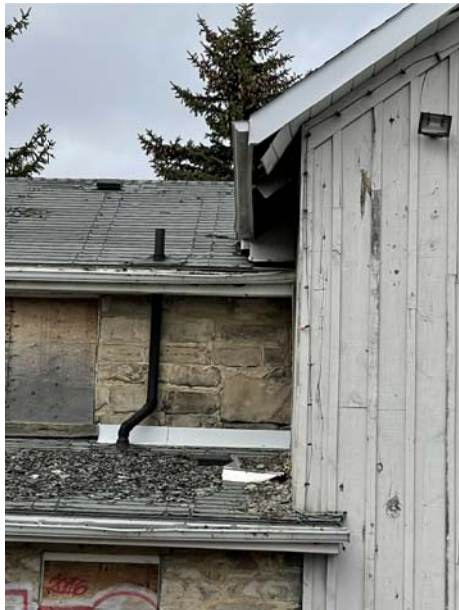
Some deterioration is observed at roof cladding on original historic structure. Gutters and flashings are all contemporary refinish metal.

Figure 16: Roof accessories to be replaced

Replace roofing accessories (Gutter, downspouts, flashing, eavestroughs, etc.) with galvanized steel materials. Provide original size, exact profile to consultant approval.
