23 Centre St. S, Brampton, Ontario

Kilpatrick-Young House

Issued: August 2019

HERITAGE IMPACT ASSESSMENT

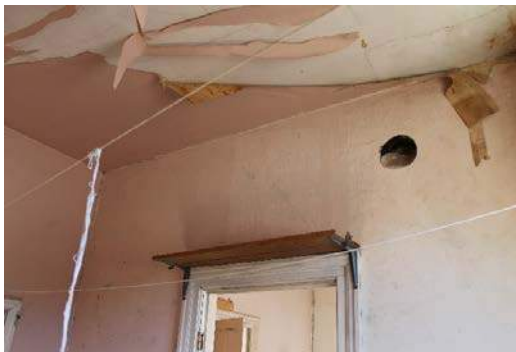
- peeling paint (Figure 17);
- holes in the wall assemblies related to plumbing or heating systems (Figures 18 & 19);
- cracks in plaster throughout (Figure 19);
- discolored floor finishes (Figure 21);
- marks and cracks on hardwood and tiles (Figures 19, 20, 22);
- cracked and deteriorated window frames and window sills (Figure 23);
- cracks on wood doors and frames (Figures 24 & 25).

Figure 17 - Peeling Paint Finishes on Ceiling

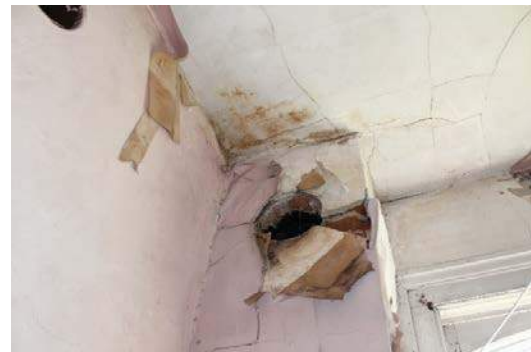
Figure 18 - Visible Hole in Wall Assembly from former (stove) pipe

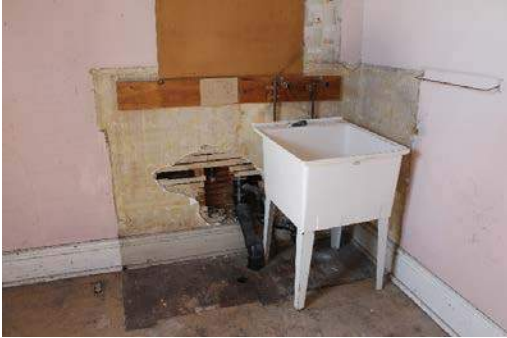
Figure 19 - Exposed Wood Framing & Deteriorated Wall Finishes

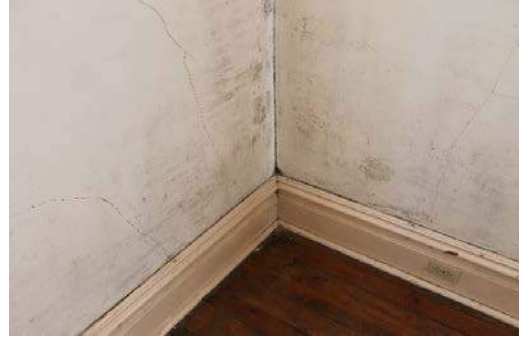
Figure 20 - Hairline Cracks on Interior Walls

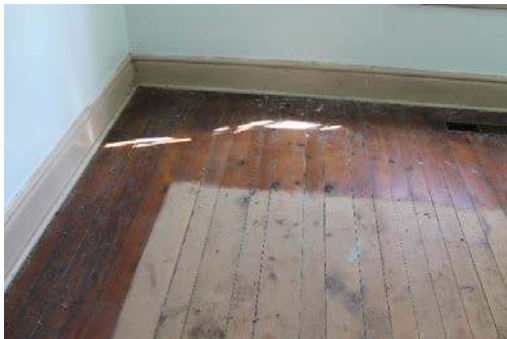
Figure 21 - Discoloration on Hardwood Flooring

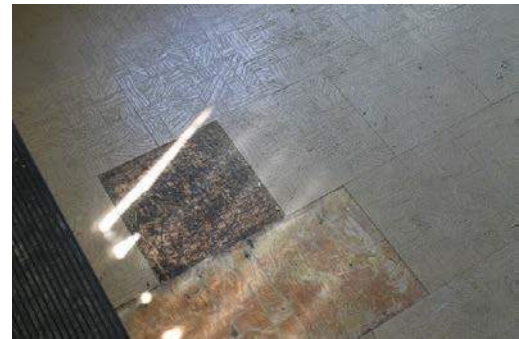
Figure 22 - Deteriorated Floor Tiles

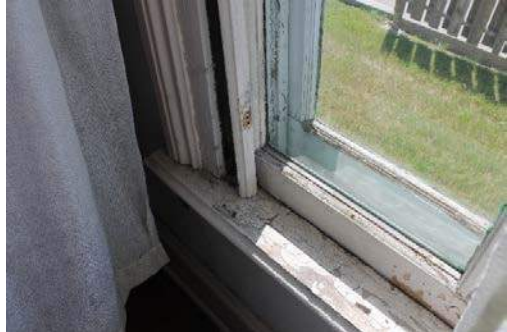
Figure 23 - Chipped & Decayed Window Sills & Frames

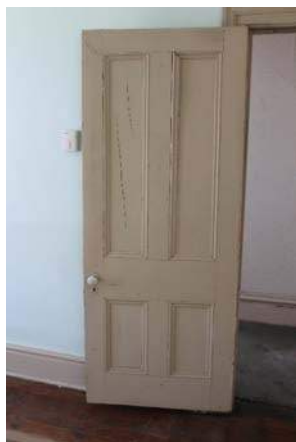
Figure 25 -Cracks in Interior Door

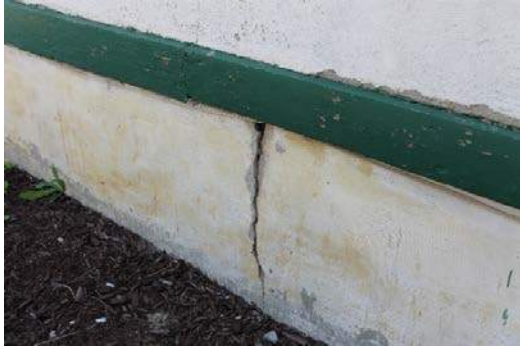
As can be seen at several locations (Figures 26, 27, 30 & 31) there are numerous visible cracks within the exterior stucco cladding and/or the substrate of the house. The cracks may, in some cases, entail damage in the substrate of wood framing or masonry and reflect structural issues such as differential settlement. The wood framing can be and will need to be rectified and reinforced as part of the rehabilitation work to be outlined in the subsequent HCP drawings.

No matter the cause, the cracks can become a pathway for water and moisture to seep into the wall assembly. When water penetrates behind the stucco, it causes the stucco to soften and break off, which is seen in several locations (Figures 26 & 29). It can be seen in these images that part of the substructure is exposed due to cracked or missing stucco cladding. If water or moisture is trapped within the walls it can manifest into issues such as mould, wood decay, masonry movement, or plaster bulge.

Patrick Young suggested that the damage to the exterior walls could have resulted from heavy pounding that occurred in 1986-87 during the grade separation that came with the construction of the railway underpass. Other reasons could include shrinkage caused by freeze-thaw cycles, or water seepage due to stucco being a porous material.

Figure 26 - Cracks in Exterior Wall

The existing stucco is not original as will be explained below. Remediating this issue can be done through patch repair which includes widening the crack, applying compatible caulking, and then allowing it to cure for at least 24 hours. However, if there are numerous damage locations, patches may generate further cracking at their edges in the future. It would be more prudent to re-stucco the entire exterior in order to have a homogeneous finish.

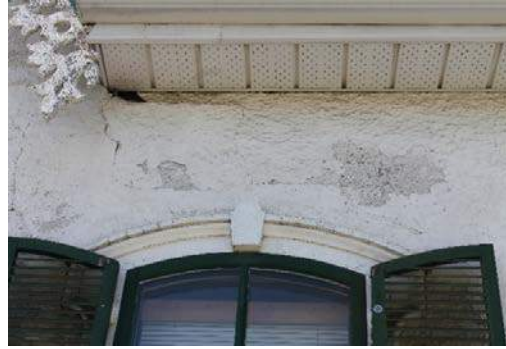
Figure 27- Hairline Cracks & Chipped Paint on Exterior Wall

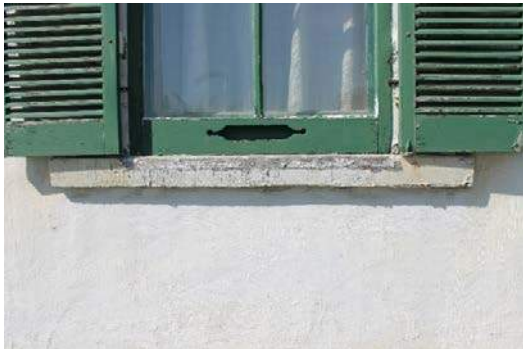
This type of deterioration could be the result of incompatible surfaces, condensation, water infiltration, deferred maintenance and age. When moisture penetrates through the paint coating the layers separate and detach from the walls surface. Water penetration can result from roof, flashing or gutter leakage and causes bulging, cracking, and ultimately peeling between the paint coating and the surface. Water infiltration into the surface causes the paint and stucco to bubble, flake and peel.

Figure 28 - Peeling Paint on Window Sill & Exterior Shutters

To remediate this deterioration all loose paint must be scraped off and the surface must be smoothed and cleaned to adequately prepare it for repainting. It is also proposed that the windows and doors of the house be replaced with reproductions since many are not original (see

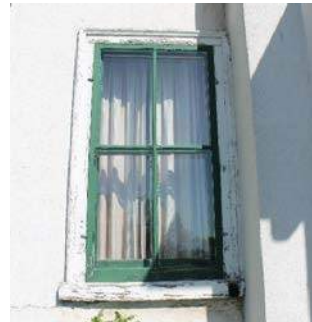
Figure 29 - Peeling Paint on Window Frame

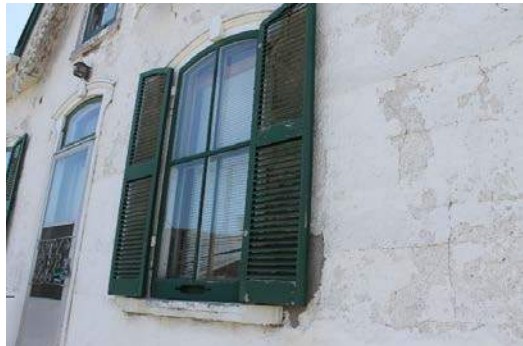
Figure 30 - Deterioration on Exterior Wall & Arched Windows with Cracks

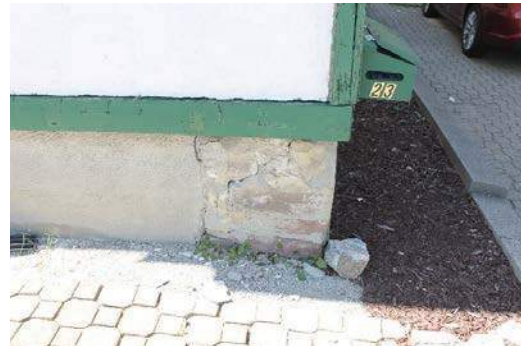
Figure 31 - Exposed Foundation Wall

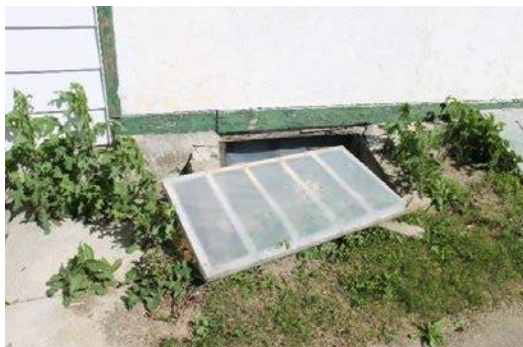
Figure 32 - Detached Window Cover for Basement Window

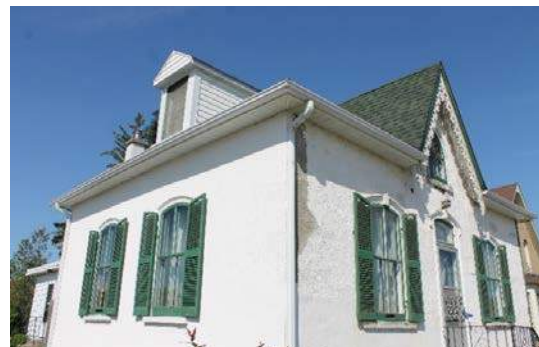
Figure 33 - Paint peeled of Pebble-Stucco Wall

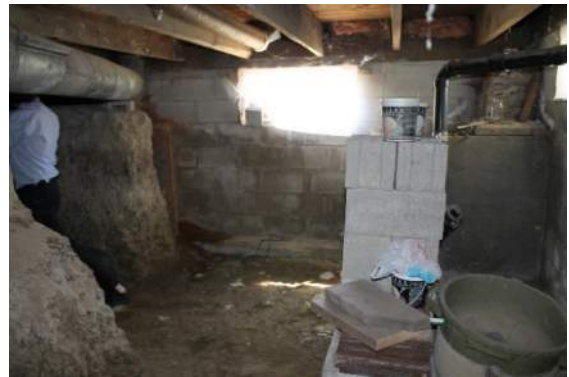
Figure 43 - Partially Excavated Foundation facing north

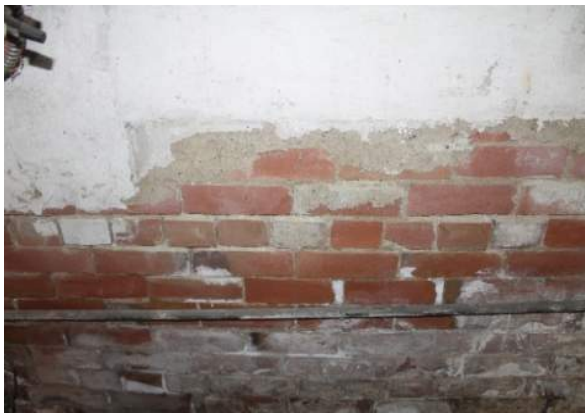
Figure 44 - Partially Painted Brick Foundation Wall facing west

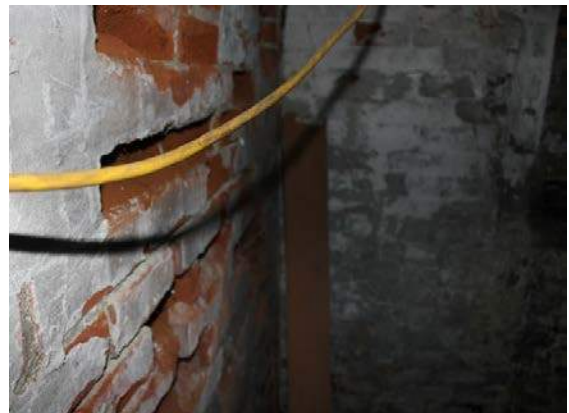
Figure 45 - Missing Brick Features in Foundation Wall facing north
