Heritage Impact Assessment, 8940 Creditview Road, Part of Lot 5, Concession 4 West of Center Road, Chinguacousy Township, Now City of Brampton, Regional Municipality of Peel

Project number: PHC-2021-027

Report Type: Revised

Report Date: 2 November 2021

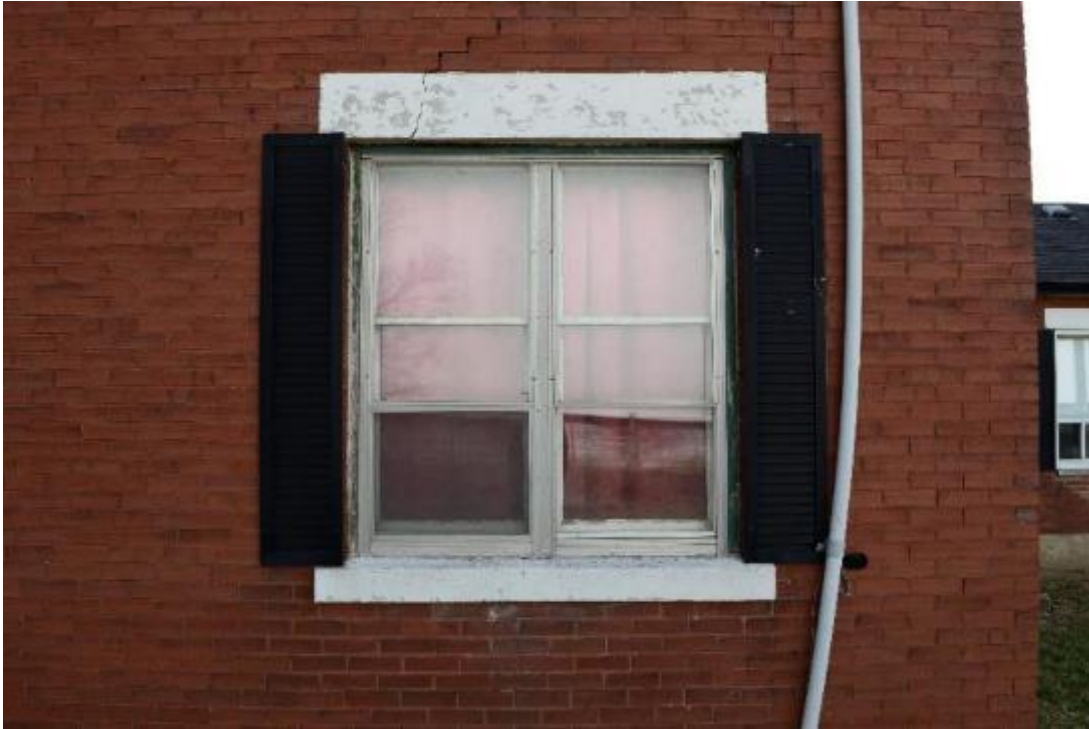
Image 18: Typical original window with later external aluminum storm. Note crack in brick and cement lintel. Southwest corner.

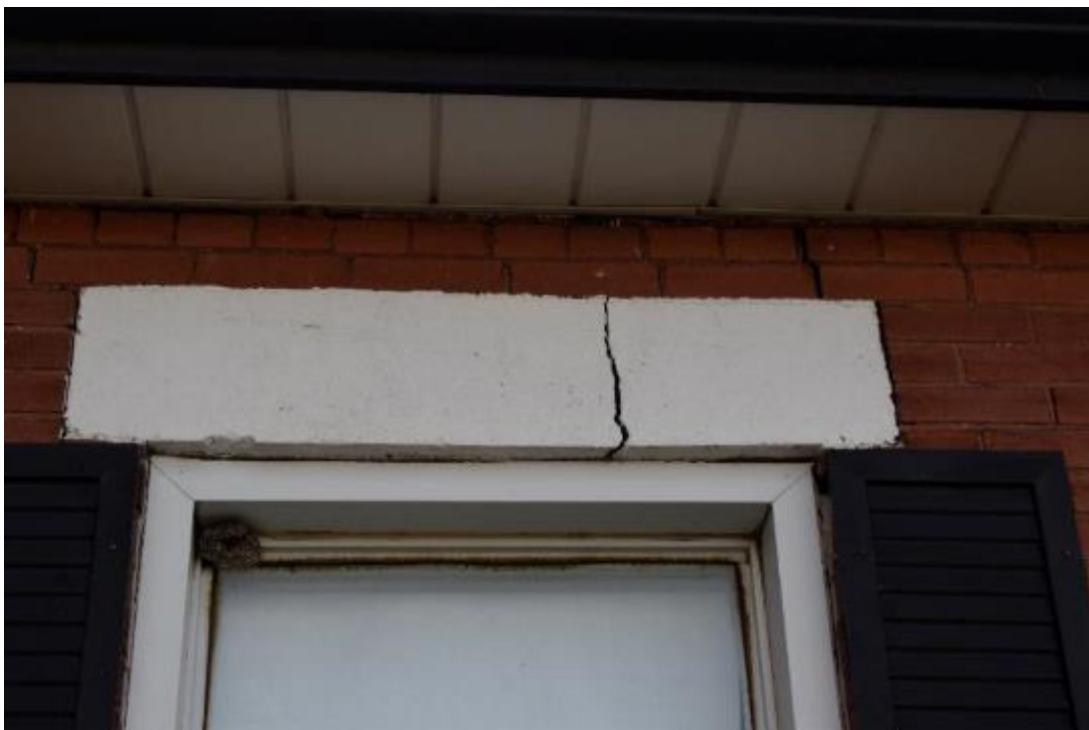
Image 19: Structural damage to second storey cast concrete lintel. This damage is typical of structural openings.

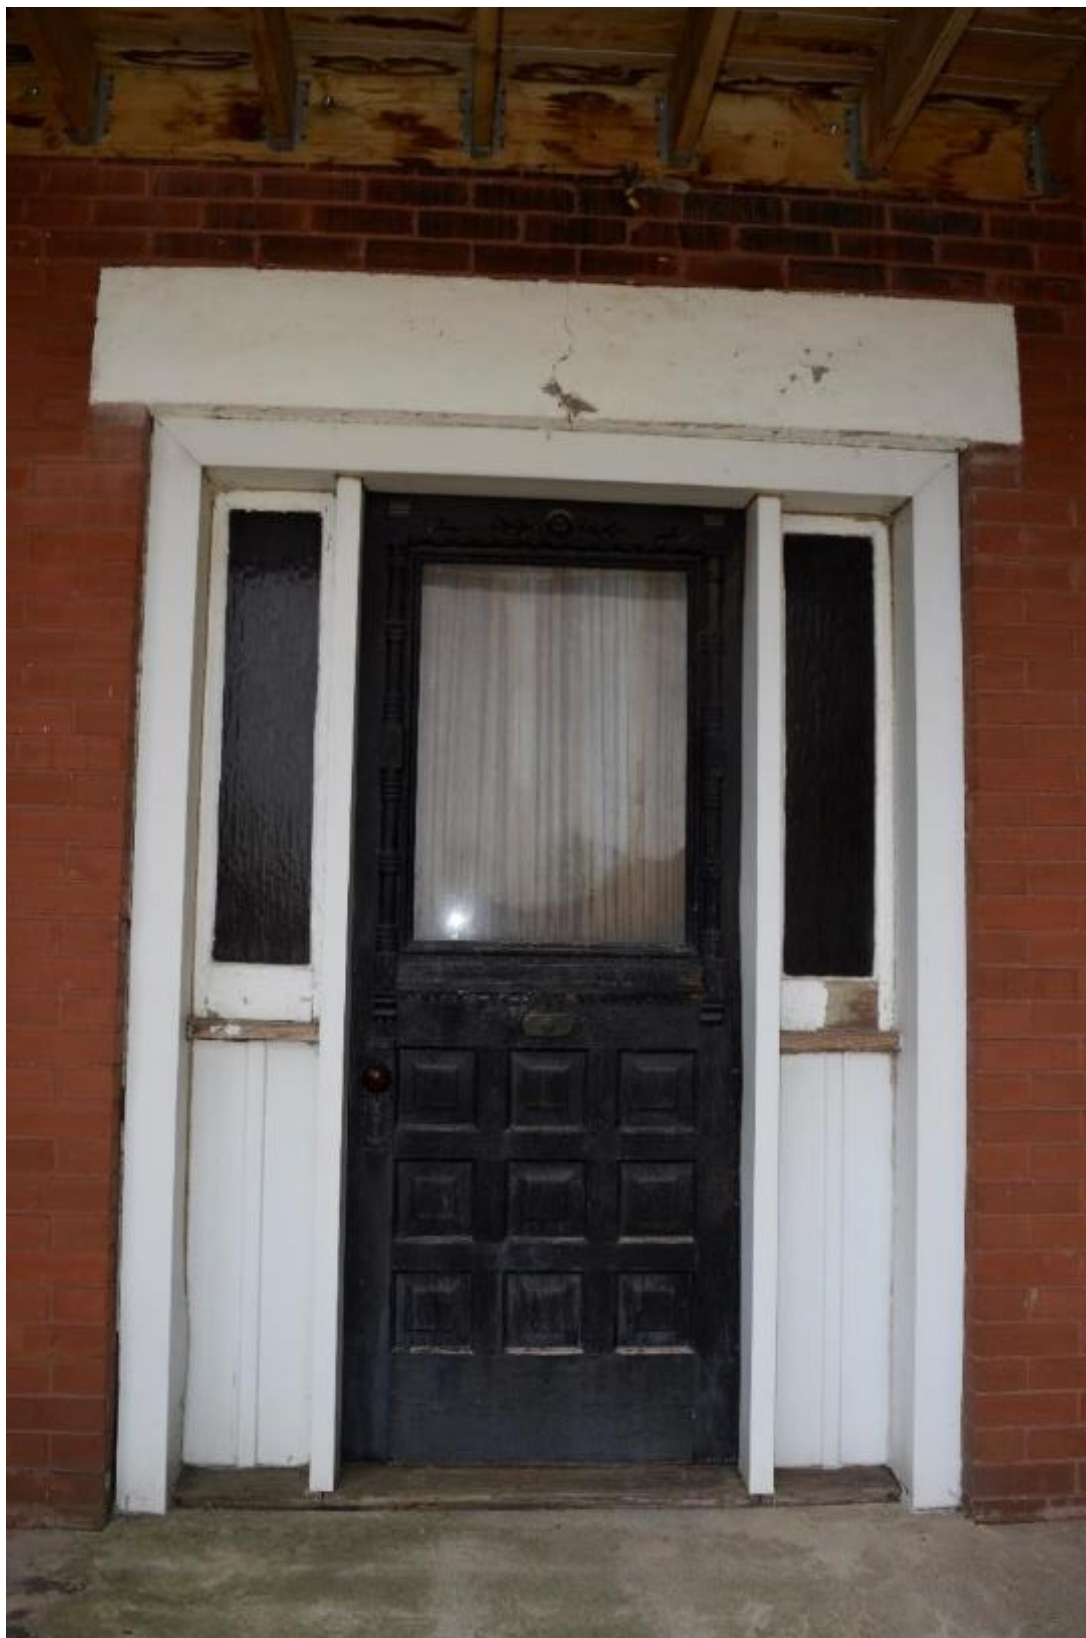
Image 21: Front door and sidelights. Note split in concrete lintel.

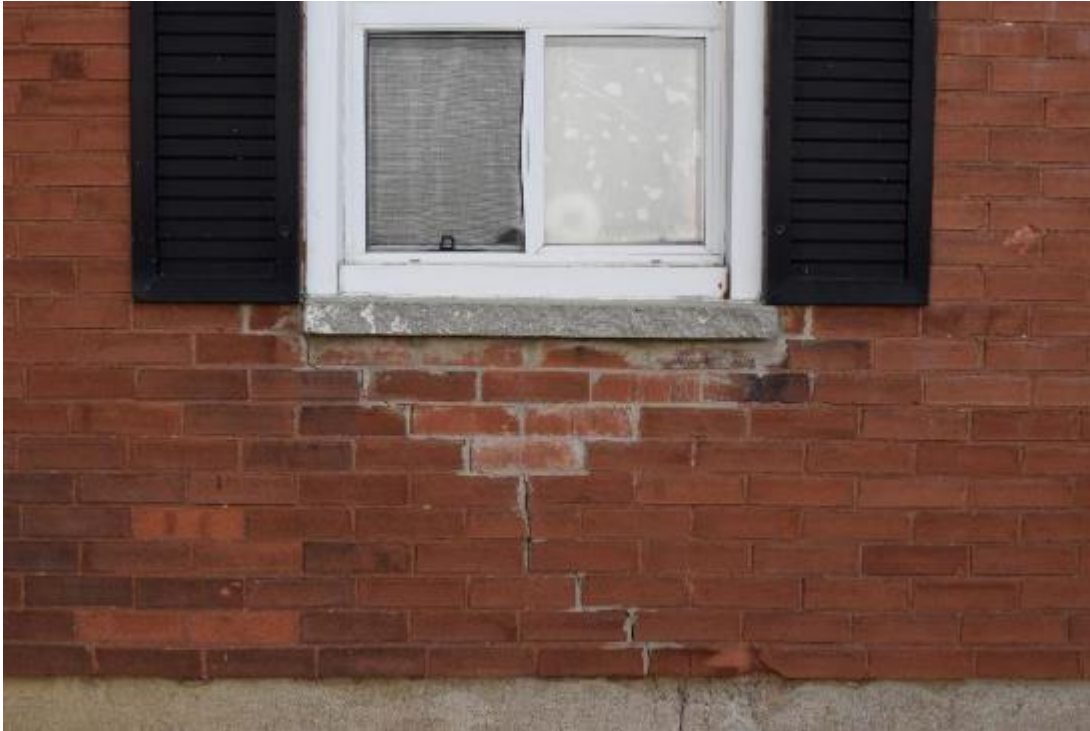
Image 22: Typical repair of damage to structural openings, Note use of new sill material and crack continuing into foundation.

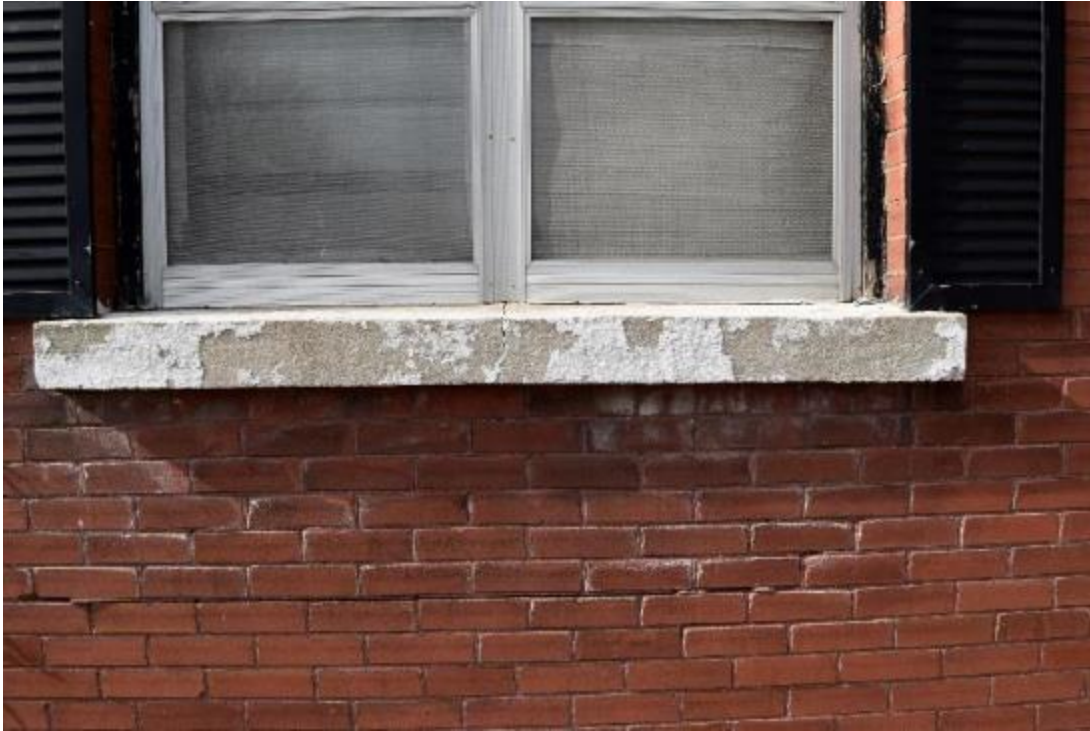
Image 24: Water damage and settlement associated with windows on front façade. Note crack in sill and staining indicative of water damage on brick under sill.

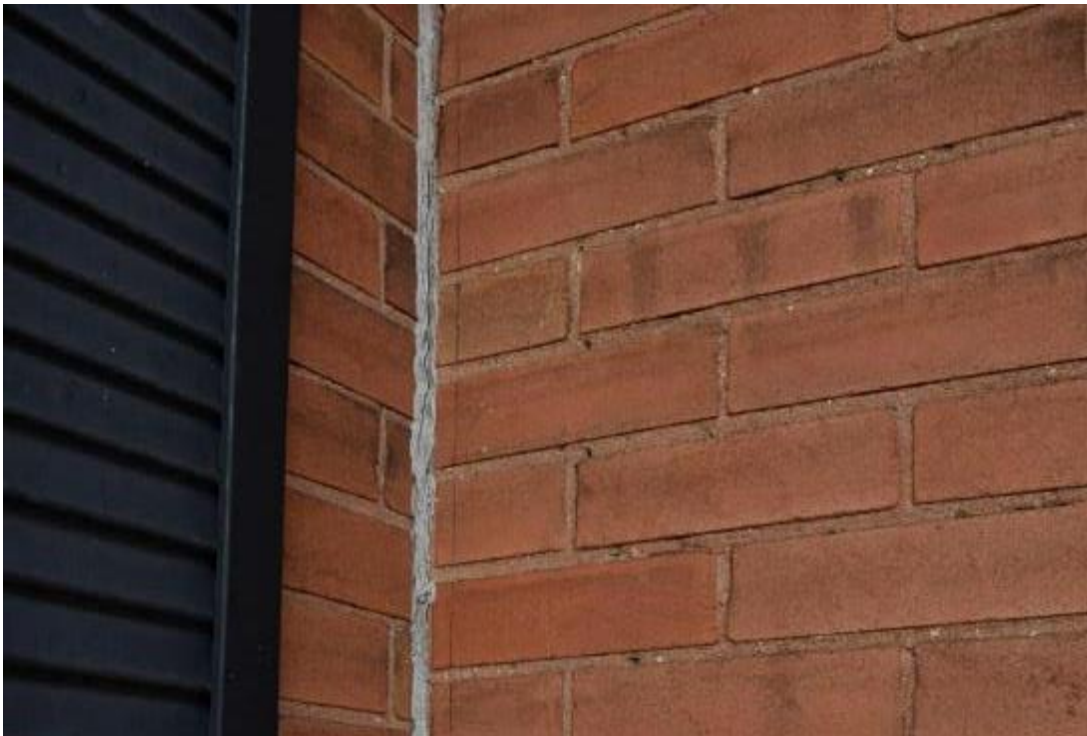
Image 25: Seam between main house and rear addition, brick courses do not align.

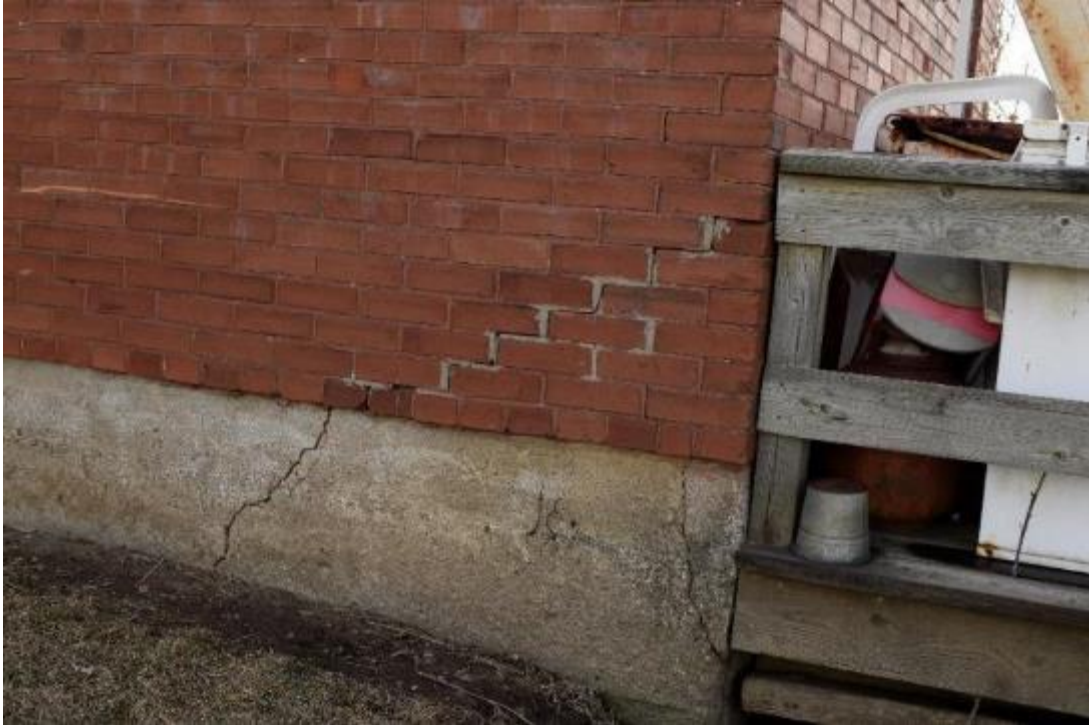
Image 26: Cracks in cement foundation continuing into brick veneer of rear addition.

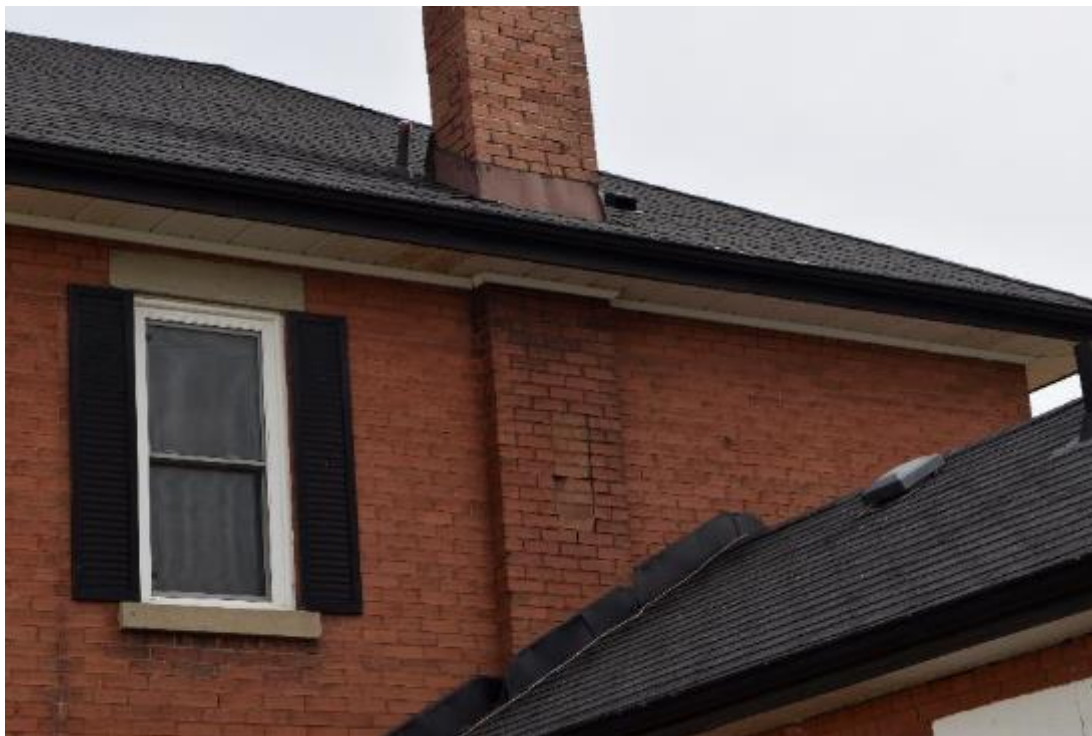
Image 28: Damage to and repair of extant chimney. Note rust streaks on soffit indicating underlying water damage.

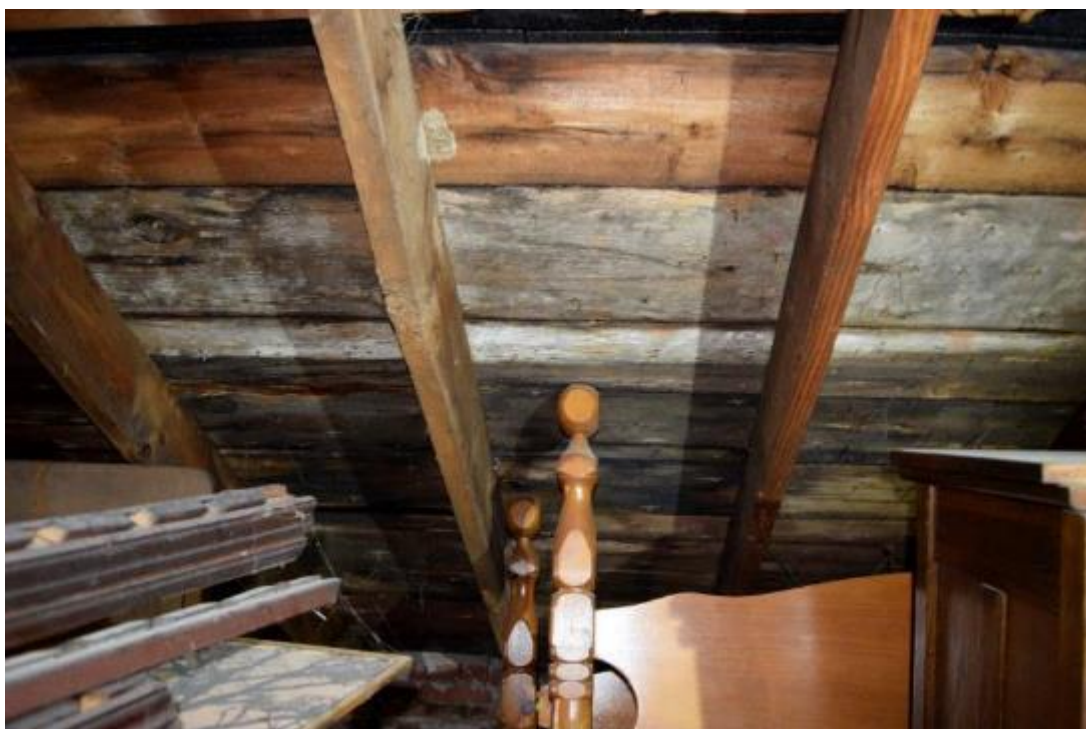
Image 62: Example of discolouration of roof decking indicative of water infiltration.

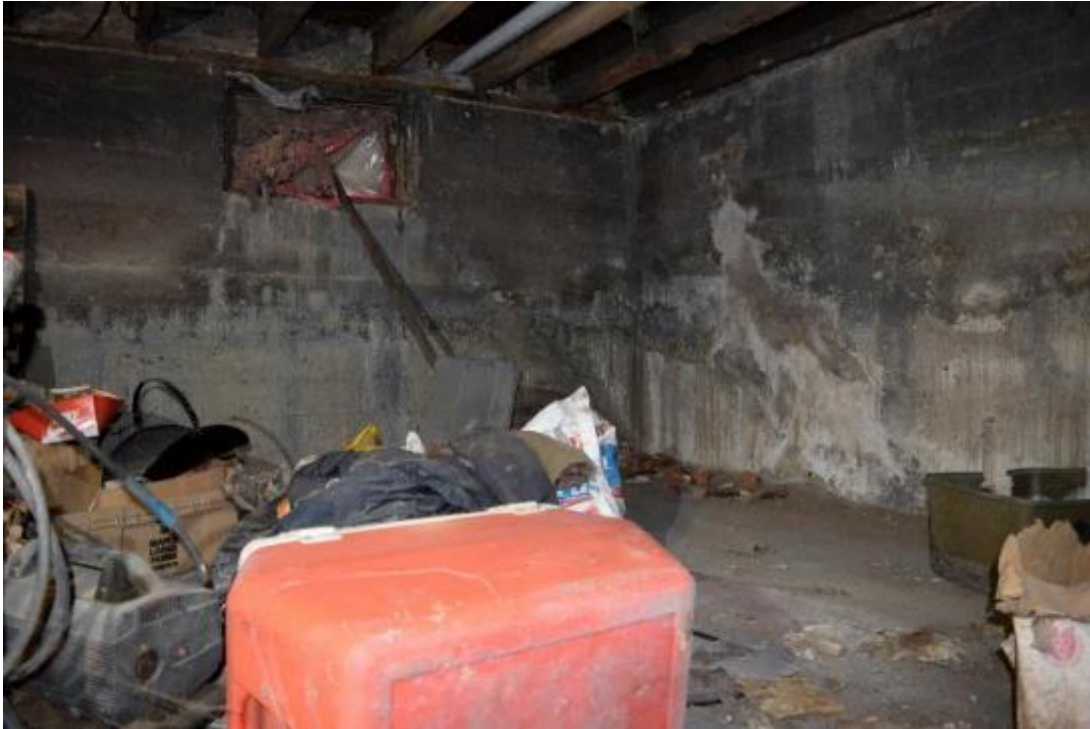
Image 69: Poured concrete foundation in northwest corner of home, note extent of water staining indicating seasonal flooding of basement. Light colour represents high water mark.

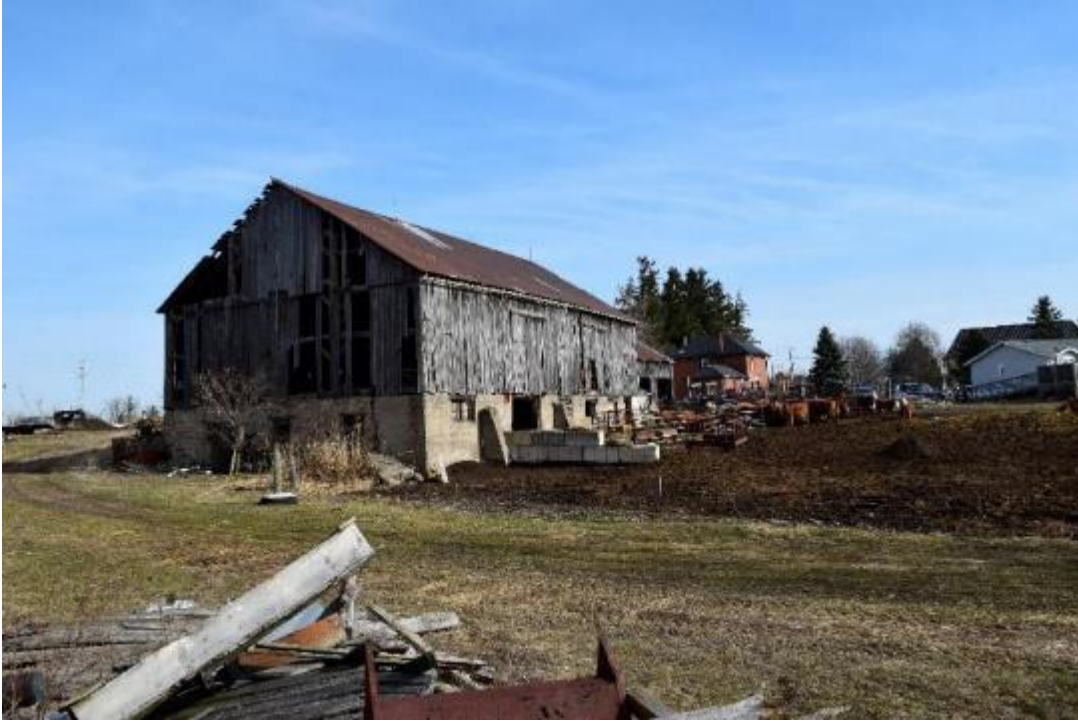
Image 87: Timber frame barn with field stone foundation and later concrete repair and buttress, facing north.

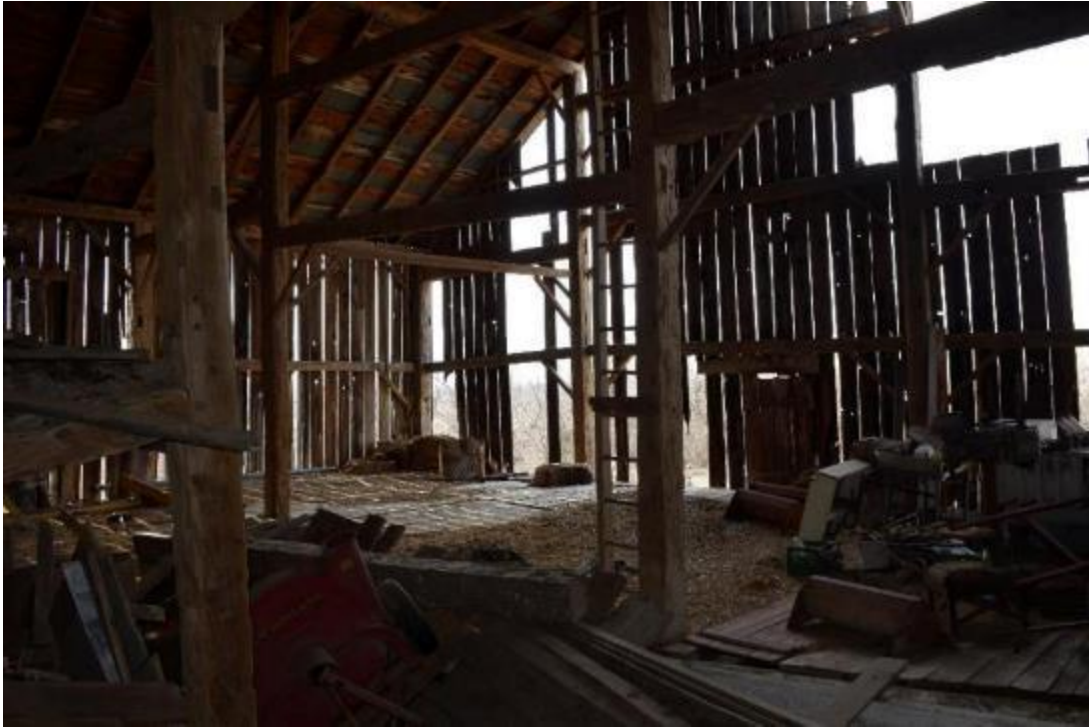
Image 91: Typical condition of timber frame barn, facing south.
