HERITAGE IMPACT ASSESSMENT

Snelgrove Baptist Church

12061 Hurontario St.
Brampton, ON L6Z 4P8

Reissue Date: 16 March 2022

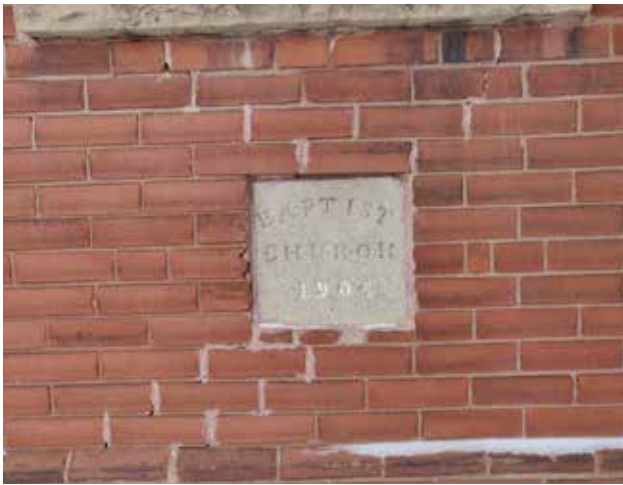
Fig. 5.1. Cornerstone in fair condition with minor chipping around the edges.

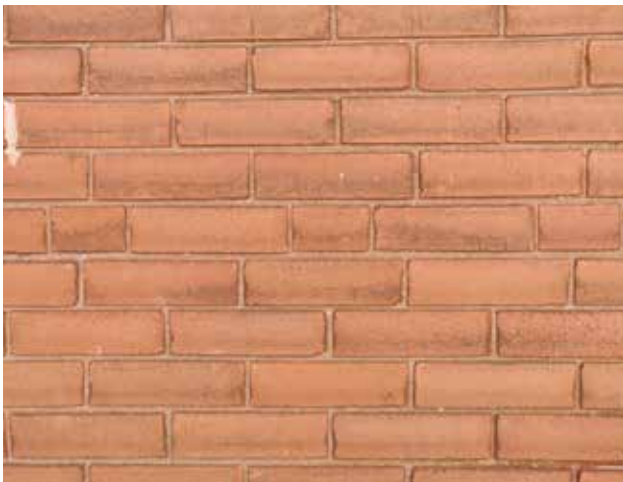
Fig. 5.2. Sample of brick in good condition in areas with less exposure to the elements. (mainly back facade)

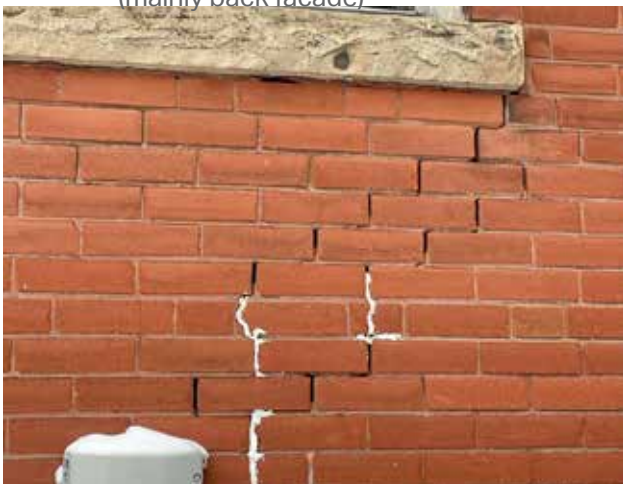
At the time of the review, the exterior masonry appeared to be generally in fair condition, with localized areas of significant deterioration. Mortar joints are generally deteriorated, open or repaired with incompatible mortar.

Fig. 5.3. General condition of brick throughout, displaying signs of deterioration, structural cracks, open joints and incompatible repairs.

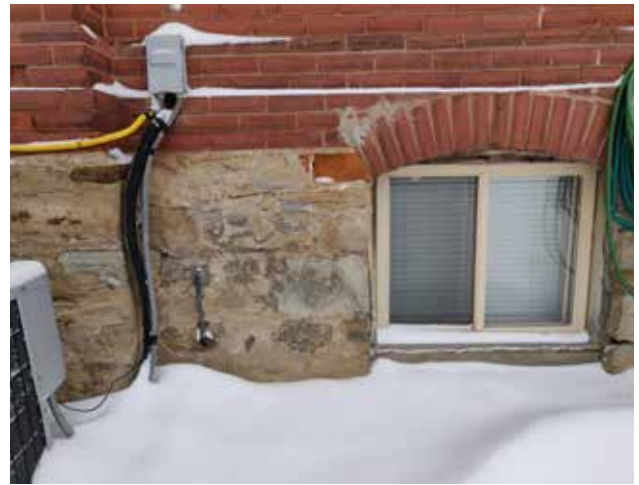
Foundation walls are generally in fair condition, with localized areas in poor condition, there are visible openings in localized areas that are likely allowing water ingress and contributing to the ongoing deterioration of the masonry in these areas. Previous incompatible repairs are visible throughout the foundation walls.

Fig. 5.4. Foundation walls at basement window: incompatible repairs and spalling.

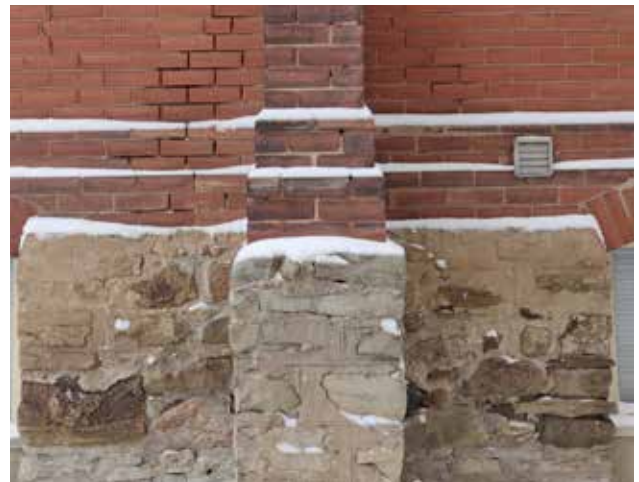
Fig. 5.5. General condition of foundation walls: open joints and incompatible repairs.

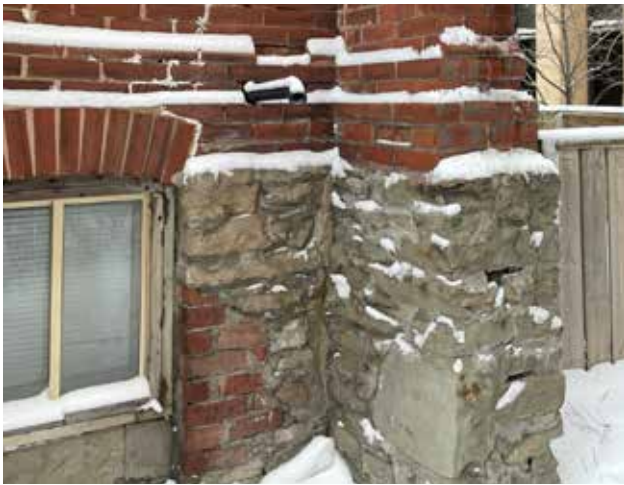
Fig. 5.7. Incompatible repairs of foundation walls and open joints.

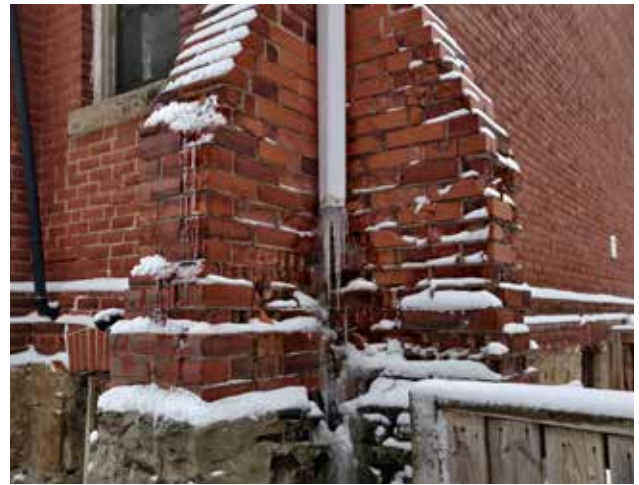
Fig. 5.10. Significant deterioration at buttresses due to water ingress.

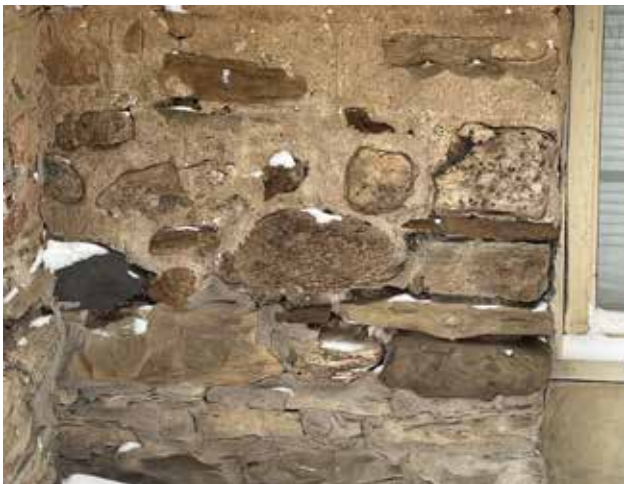
Fig. 5.8. General condition of foundation walls around basement windows.

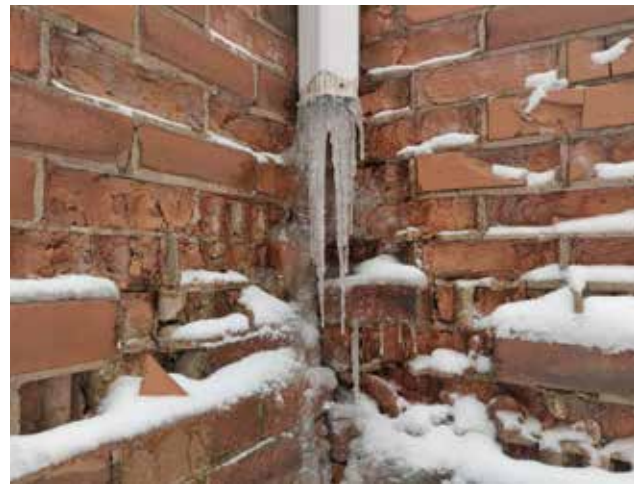
drainage systems, localized areas at the inside corners between the buttresses and the main walls are significantly deteriorated.

Fig. 5.11. Close-up of inside corner at buttresses: damaged masonry due to water ingress.

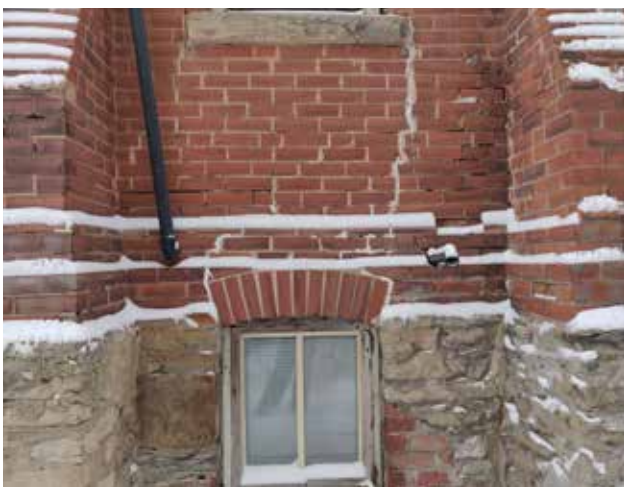
Fig. 5.9. General condition of masonry condition at inside corners. Deteriorated mortar, structural cracks, and incompatible repairs.

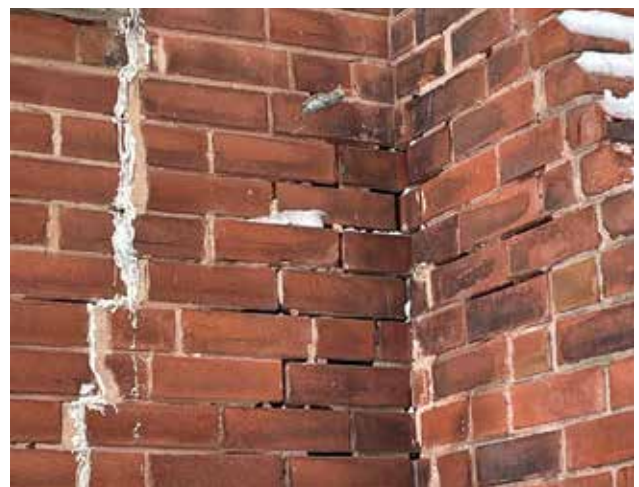
Fig. 5.12. General condition at inside corners: open joints, deteriorated mortar, incompatible repairs.

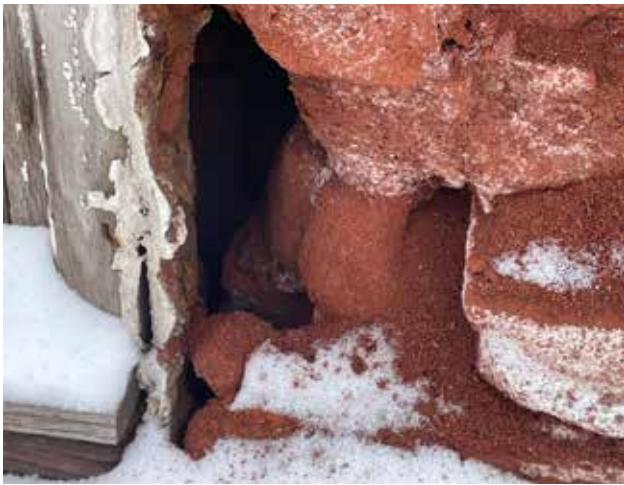
The brick is generally in fair condition, with localized areas in poor condition. Areas around the front entrance of the building and the front buttresses are significantly deteriorated. The lower portion of the front façade is in poor condition, majority of the brick is damaged, loose, and heavily spalled. The front buttresses are partially collapsed. It is assumed that the proximity to Hurontario street, a five-lane high traffic road, is contributing to the deterioration of these areas. It also appears that due to failed

Fig. 5.13. Severe deterioration of masonry at lower portion of front entrance wall.

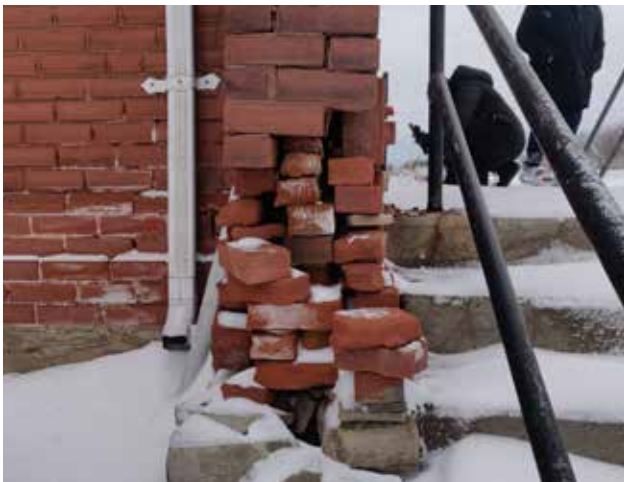
Fig. 5.14. Front buttress partially collapsed.

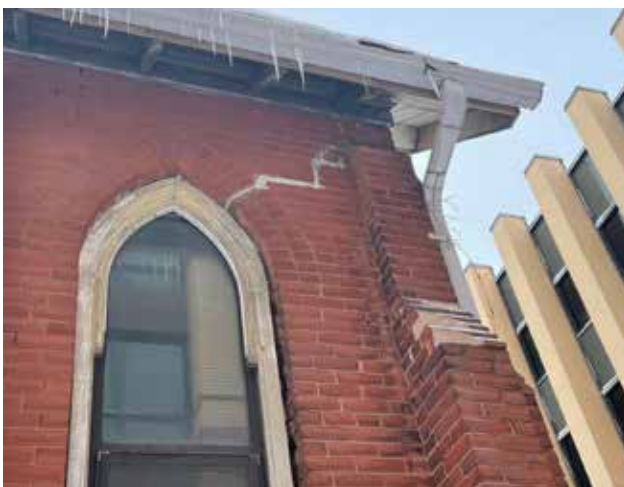
Fig. 5.15. Typical condition at window openings: structural cracks and incompatible repairs.

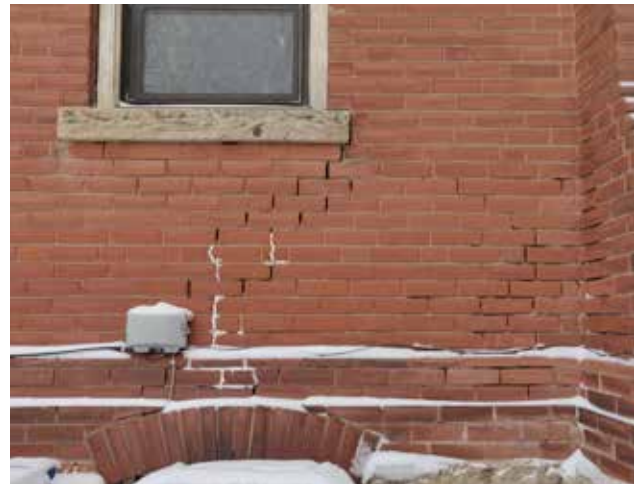
Fig. 5.16. Typical condition at window openings: structural cracks and incompatible repairs.

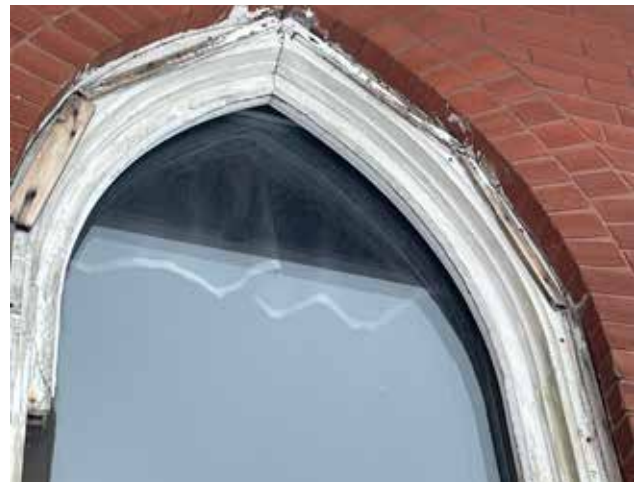
The original wood window frames are in fair condition, the windows have been replaced with incompatible aluminum or vinyl windows. The main entrance door appears to be original and in good condition. The side entrance door has been replaced and in fair condition.

Fig. 5.17. Original wood window frames in fair to poor condition. Windows have been replaced.

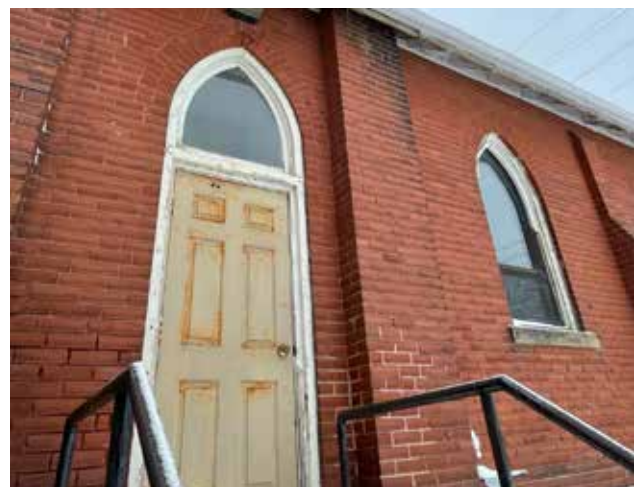
Fig. 5.18. Side entrance door appears to be replaced and in fair condition.

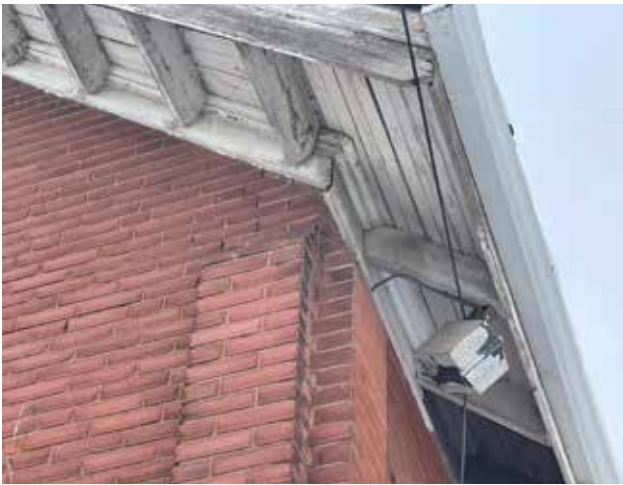
Fig. 5.19. Wood soffits and roof brackets in fair to poor condition.

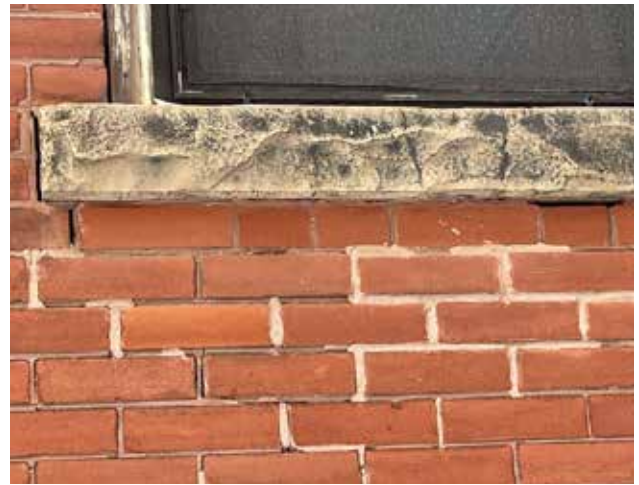
Fig. 5.22. Stone sills are generally in fair condition.

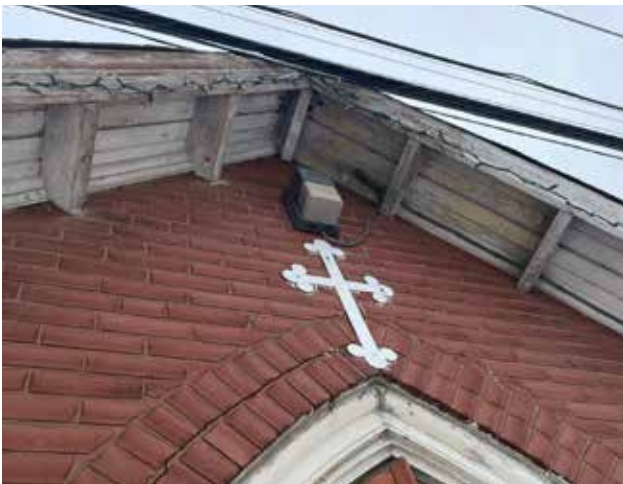
Fig. 5.20. Wood soffits and roof brackets in fair to poor condition.

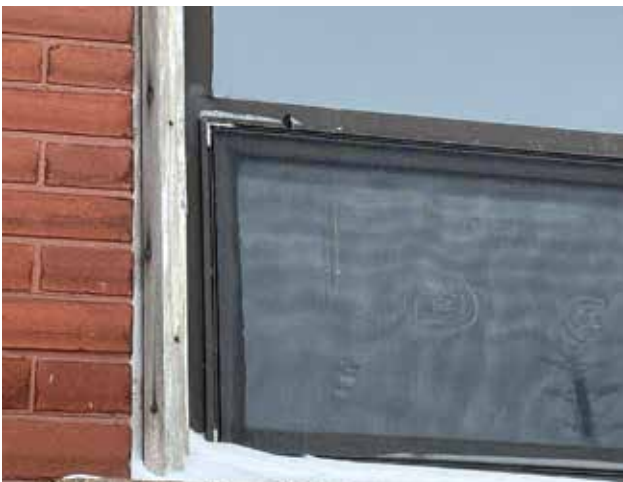
Fig. 5.21. Windows have been replaced throughout.

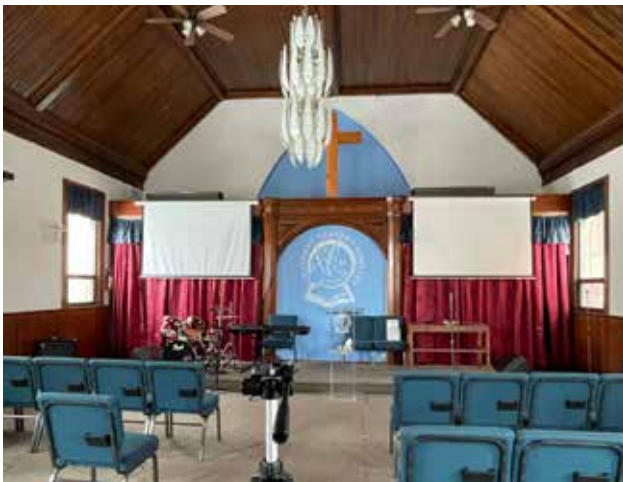
Fig. 5.23. Main floor interior, wood paneling and ceiling are in good condition. Floors are covered in carpet.

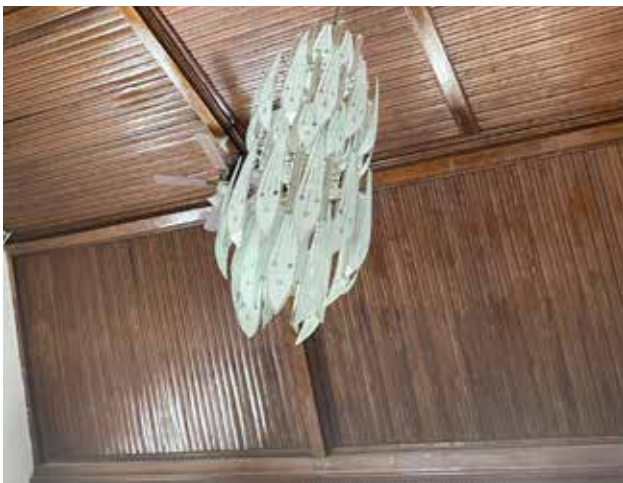
Fig. 5.24. Wood ceiling appears to be in good condition.

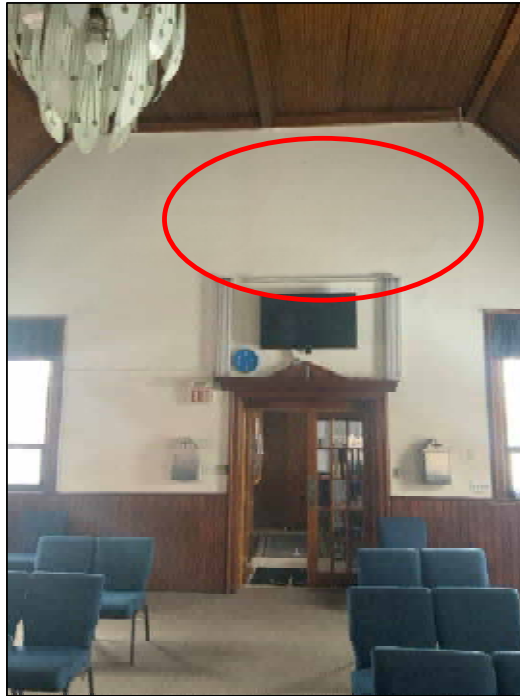
Limited deterioration of the plaster finishes was noted, particularly at the rear and front endwalls of the assembly space.

Photograph 2: South endwall; minor plaster deformation

Finishes were found to be in generally fair condition, with limited distortion of plaster and localized staining.

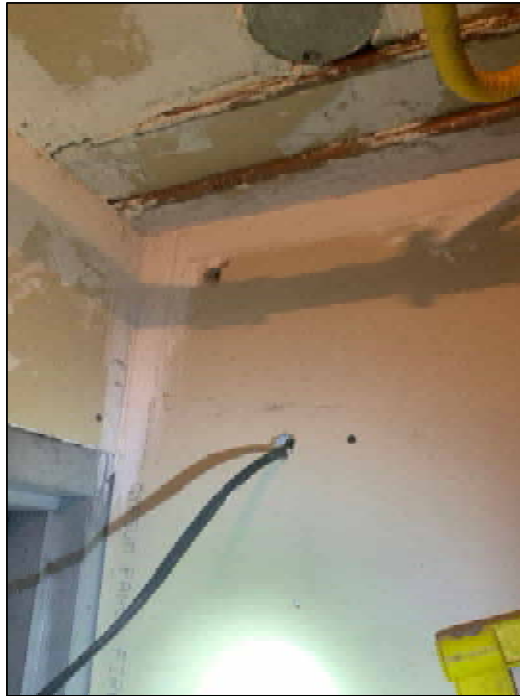
Finishes are in poor condition in the basement, with multiple holes in the dropped ceiling panels, ceiling drywall, and fire rated wall assemblies separating the mechanical room from the remainder of the basement.

Photograph 5: Penetrations through fire rated wall assemblies

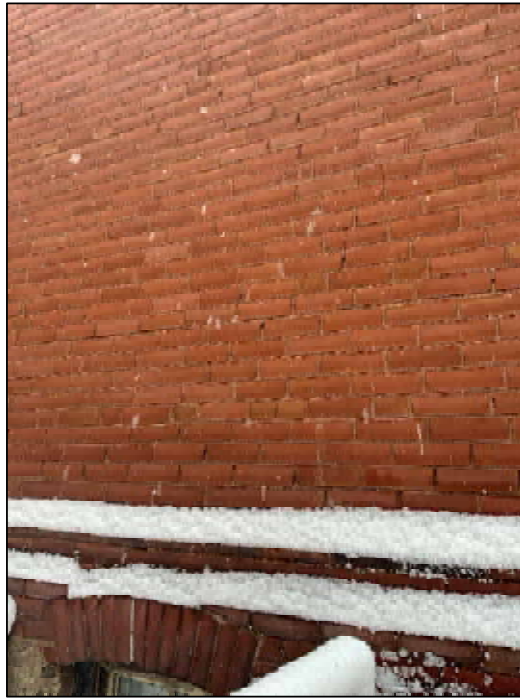
The exterior masonry is in fair condition throughout the building, with localized areas in poor condition. Larger sections of wall, specifically the rear wall and sidewall sections to each side of the existing window openings, are in good condition with limited open head joints and localized bed joint deterioration.

Photograph 8: Open head joints on rear wall

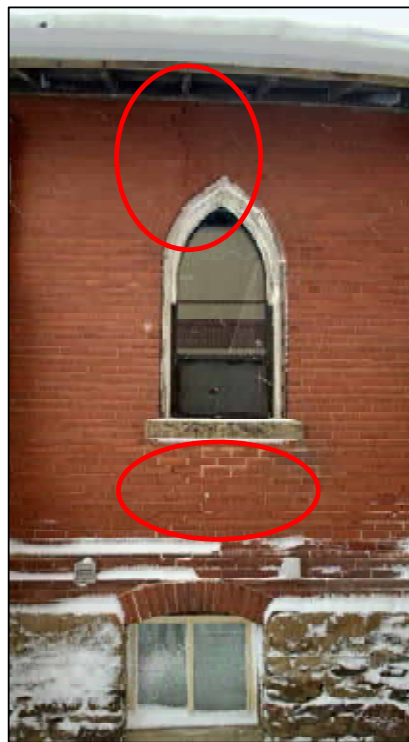
Structurally significant cracking was noted above and below many of the side window and door openings.

Photograph 9: Cracking above and below sidewall window opening (typical)

Most of the general deterioration of the masonry is concentrated above and below door and window openings, on all elevations, as illustrated in photographs 9 and 10. Eroded masonry joints were also found to be concentrated at the inside corner between the buttresses and the main walls.

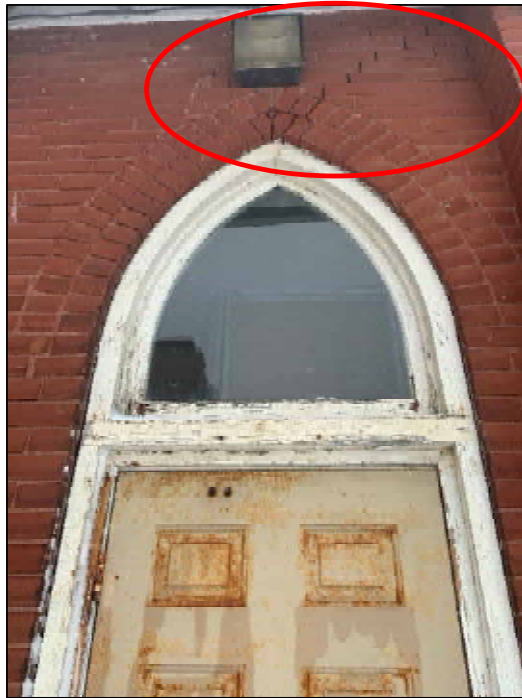
Photograph 10: Open masonry joints above peaked arch (typical)

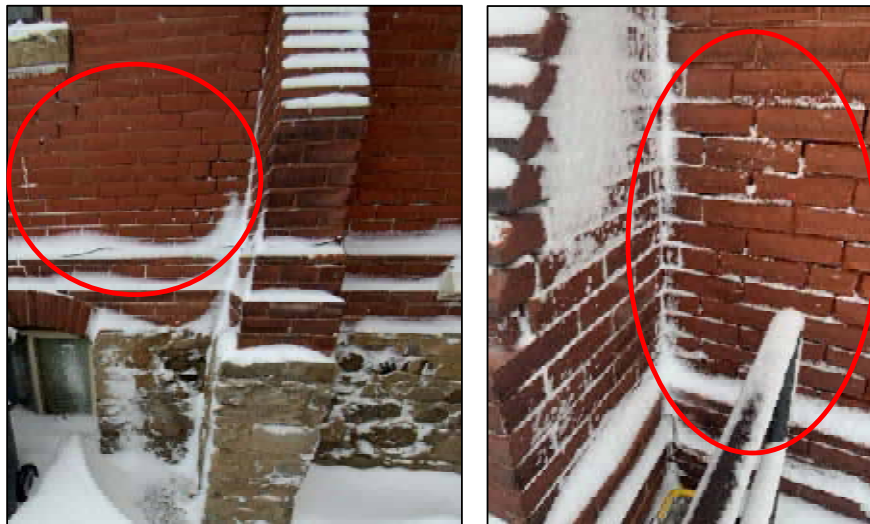
Photograph 11a, 11b: Eroded masonry joints at inside corner of buttress (north and south)

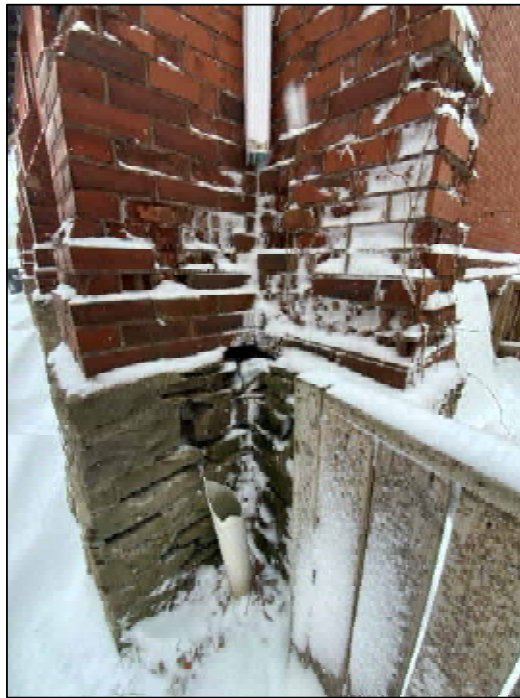
Foundation walls were found to be in fair condition throughout, with localized areas in very poor condition. Much of the advanced deterioration was found adjacent to failed rainwater leaders.

Photograph 12: Open foundation wall at south corner

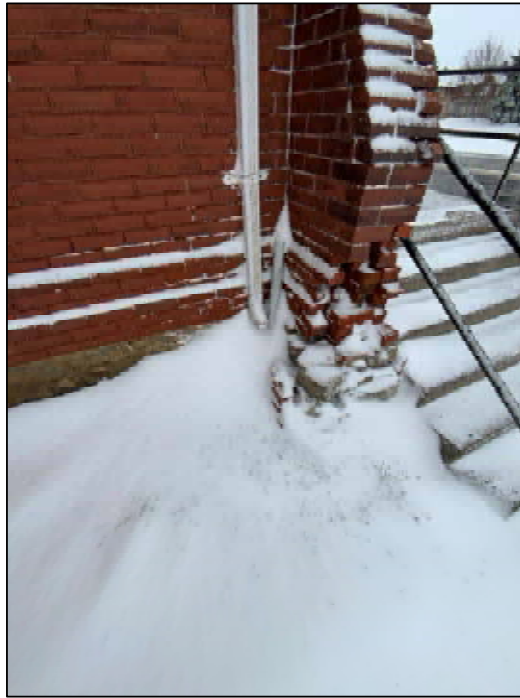
All the brick buttresses have sustained some level of deterioration, ranging from damaged mortar joints to partial collapse.

Photograph 13: Partially collapsed brick buttress at front entry
