Cultural Heritage Impact Assessment Report *Revised*

8265 Churchville Road,
Brampton, Ontario

Date:
August 2022

Prepared by:
**MacNaughton Hermesen Britton
Clarkson Planning Limited (MHBC)**

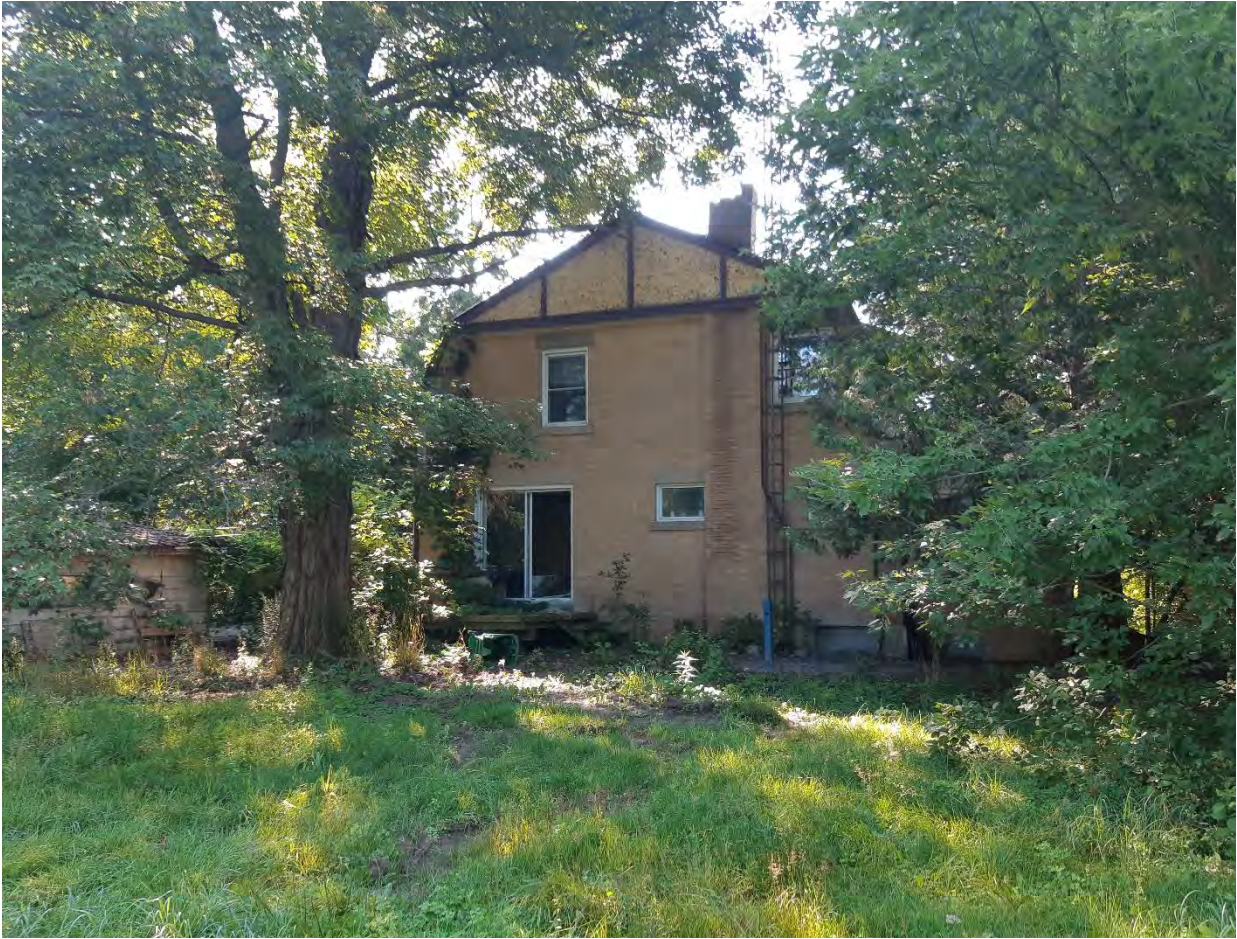
elevation extends above the roofline and is damaged. The side gable of the gambrel roof includes half-timbers and cobblestones.

Figure 25: View of north elevation looking south (Source: MHBC, 2021)

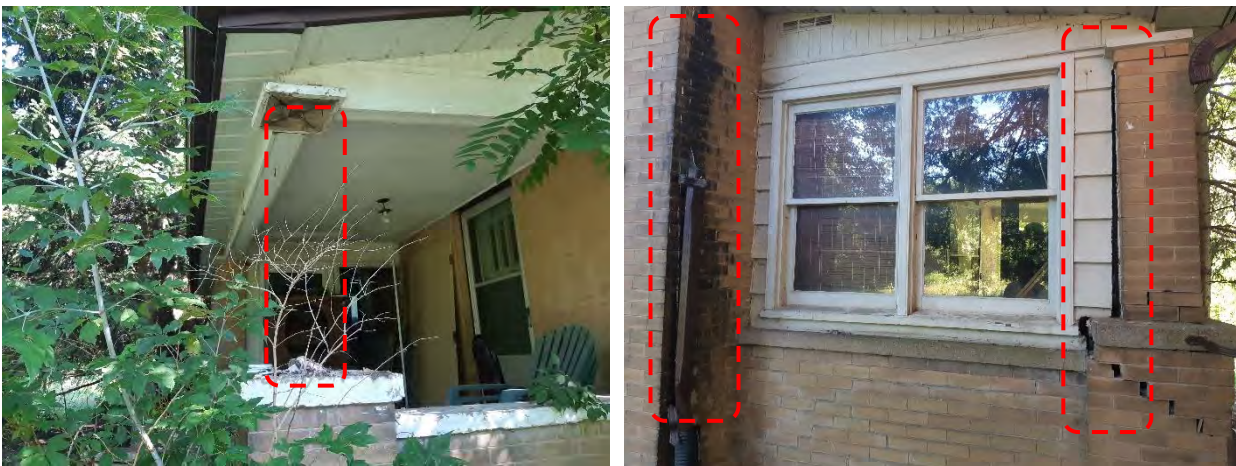
Condition issues related to masonry and water damage are readily identifiable at the exterior of the dwelling. This includes structural and masonry issues with the front verandah, stairs, and sun room. The north elevation of the sun room shows evidence of structural detachment where the porch has pulled away from a brick pillar (**Figure 40**). At the west (front) elevation, brick pillars have decayed and fallen on the ground. The chimney at the north elevation is damaged above the roofline.

Figures 40 & 41: (left) Detail view of west elevation missing brick pillar (outlined in red), (right) Detail view of north elevation noting water damage as well as detachment between the sun room and brick pillars (Source: MHBC, 2021)

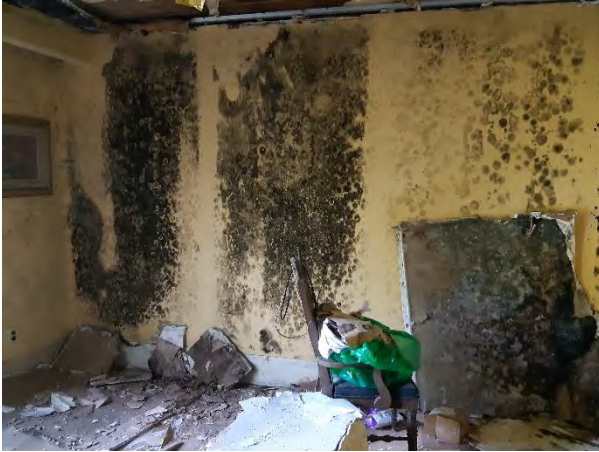
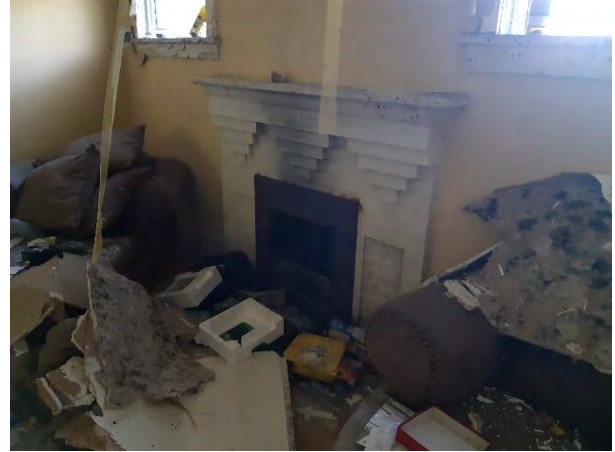
The interior of the dwelling had extensive black mould across the interior finishes. The majority of the interior of the building was not assessed due to the extent of mould and concerns related to health and safety.

Figures 42 & 43: (left) View of interior black mould in living room, (right) View of black mould on interior finishes and water damage. (Source: MHBC, 2021).

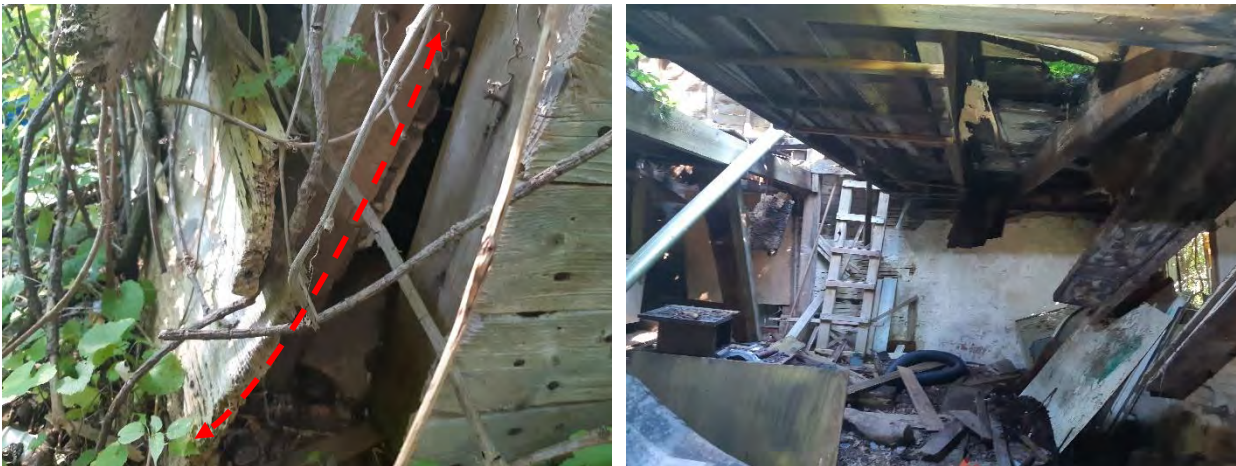
Figures 48 & 49: (left) Detail view of framing at the base of the south-east corner of the building where the framing has become detached from the building (noted in red), (right) View of collapsed portions of the outbuilding and exposed roof (Source: MHBC, 2021)

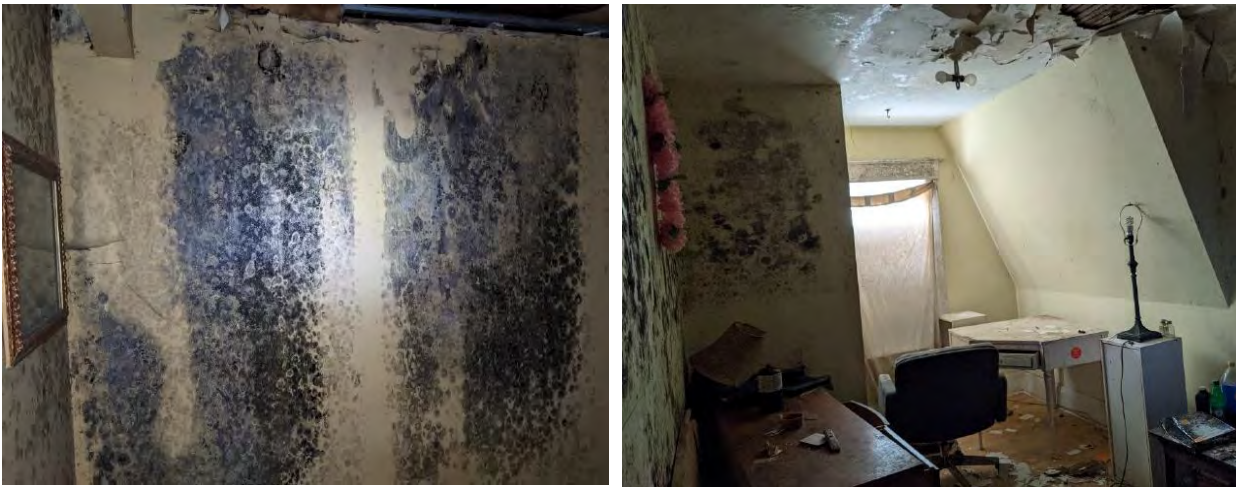
The dwelling's interior finishes are covered in mould, the flooring is buckled in most places, and floor joists are significantly rotted. Significant water damage is present in the basement in addition

Figures 50 & 51: (left) Detail view of black mold on interior finishes of the dwelling (first storey), (right) View of black mold on interior finishes of the dwelling (second storey) (Source: Renoasis, 2021)

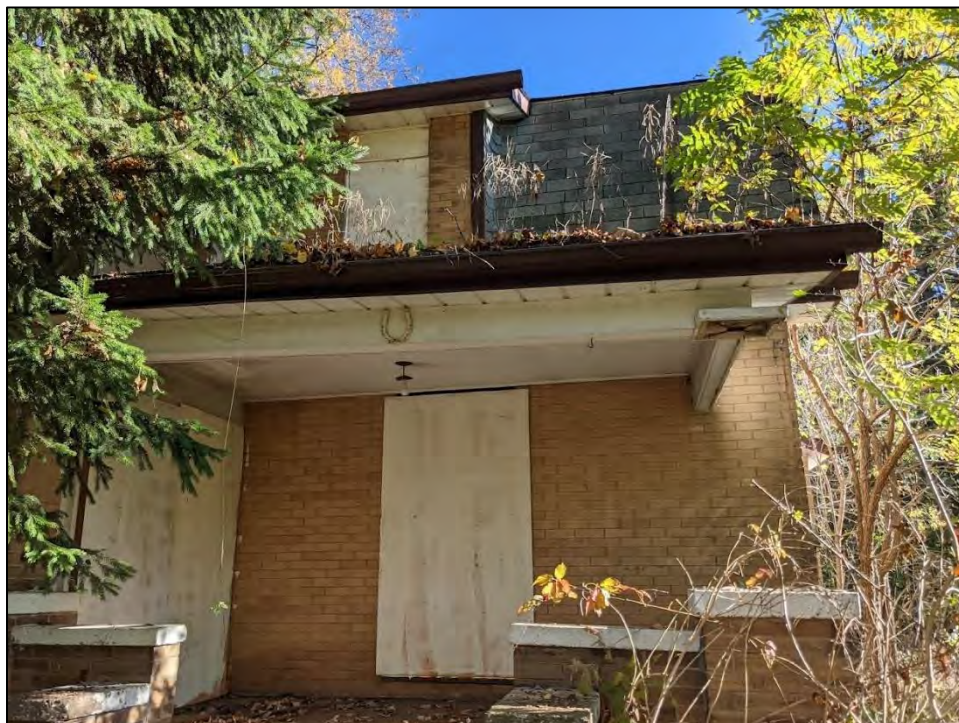
Photo 2 – Missing post at porch

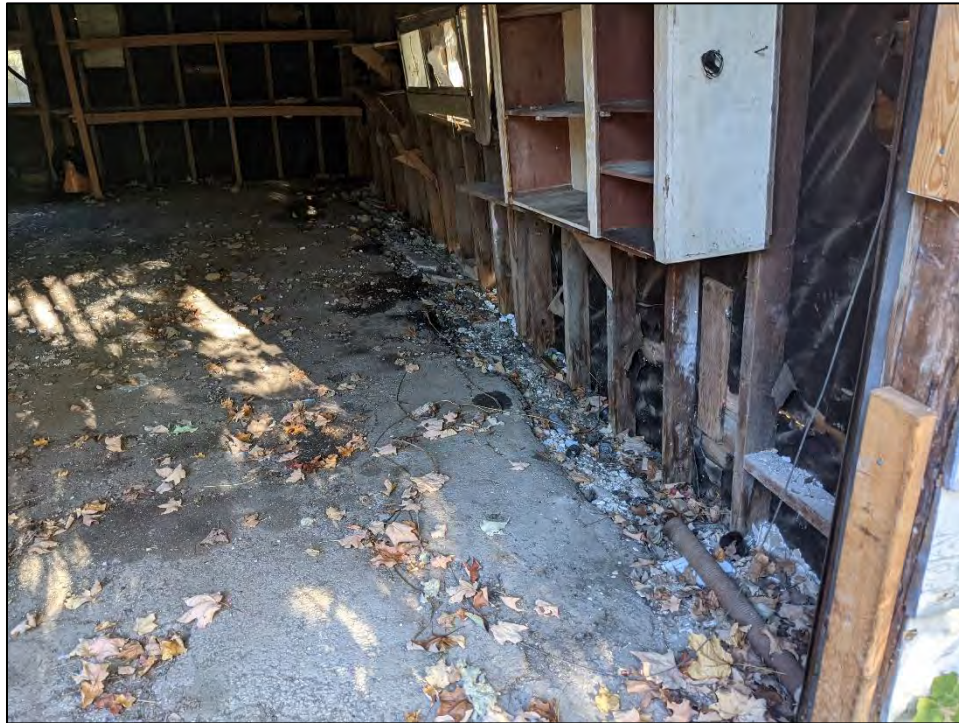
Photo 5 – Interior of drive-shed (foundation supporting exterior wall significantly damaged)

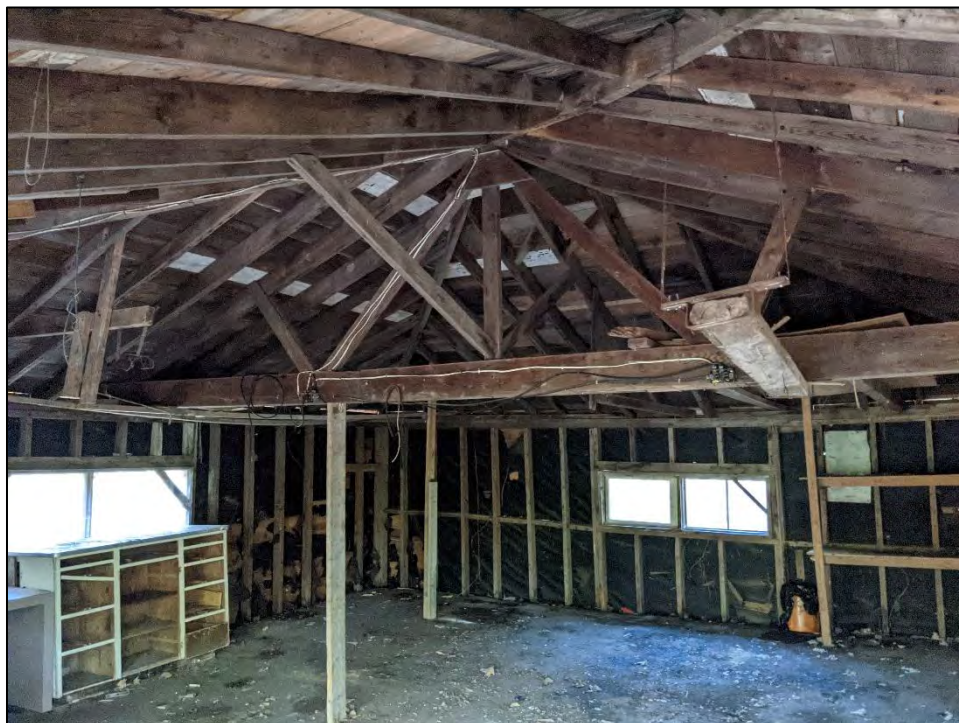
Photo 6 – Interior view of drive-shed roof framing and prop supports

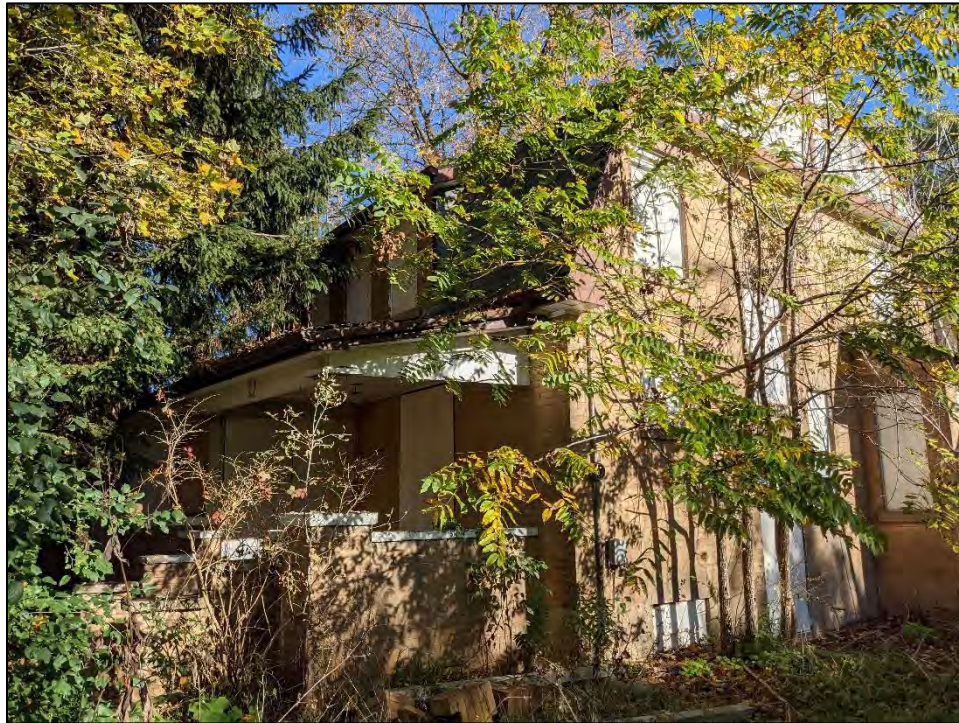
Photo 7 – Damage to exterior porch on side of house

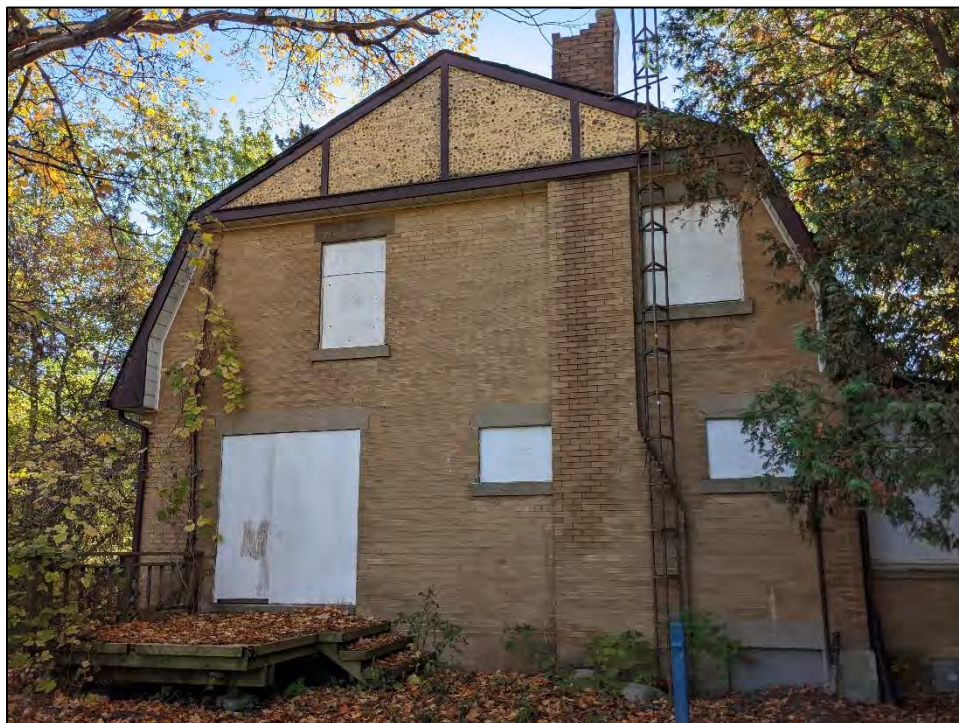
Photo 8 – Exterior view of house, with damaged chimney noted

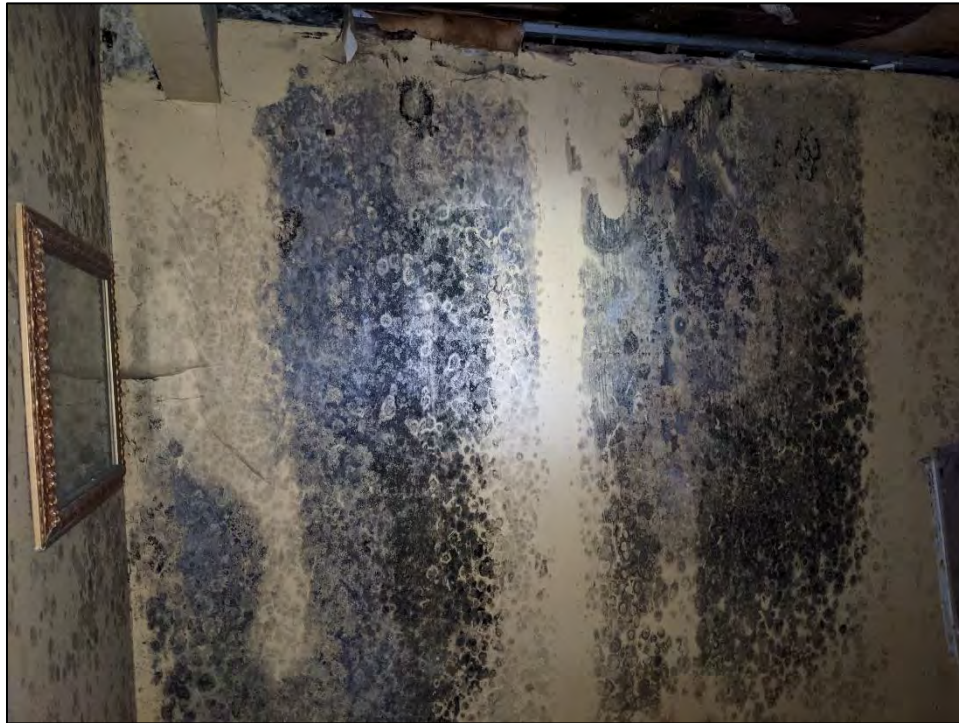
Photo 9 – Black mold on interior finishes (lower level)

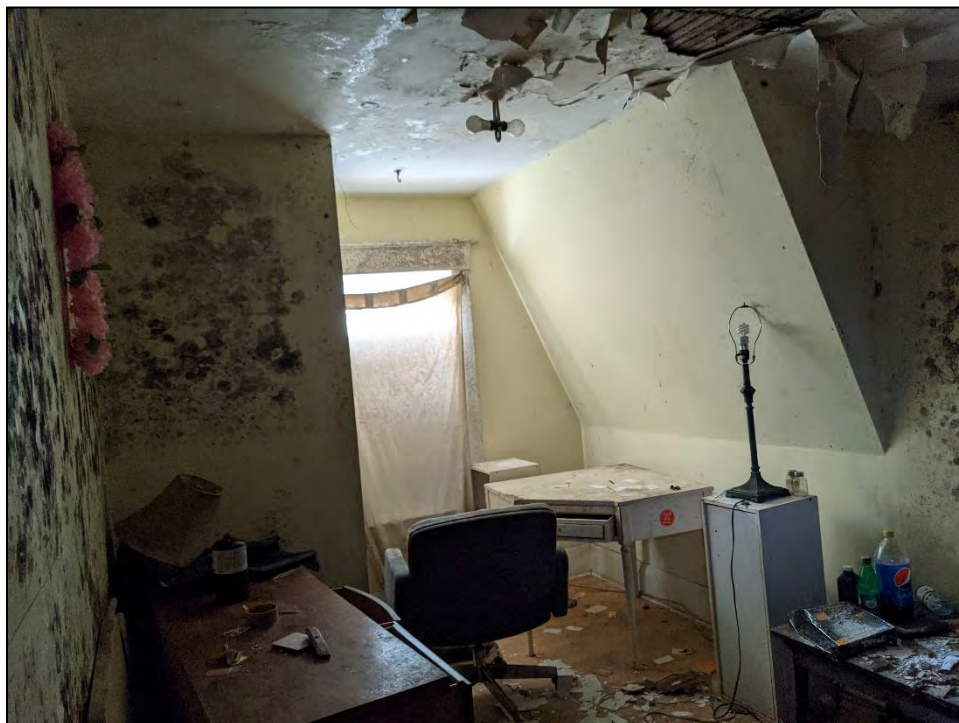
Photo 10 – Significant water damage to interior finishes on upper level

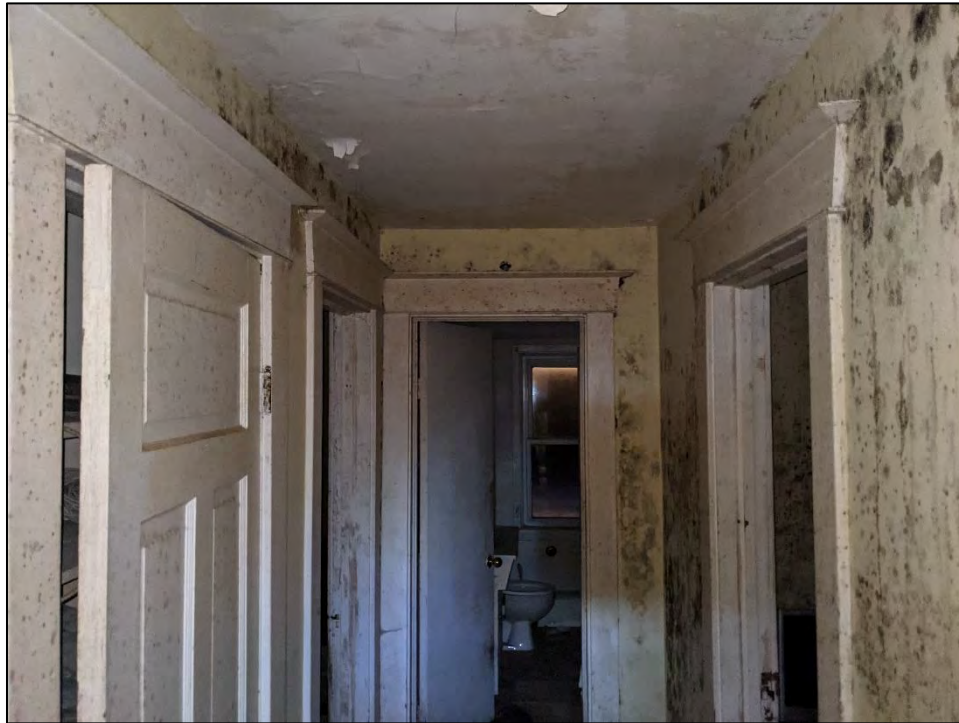
Photo 11 – Water damage and black mold throughout the upper level of the house

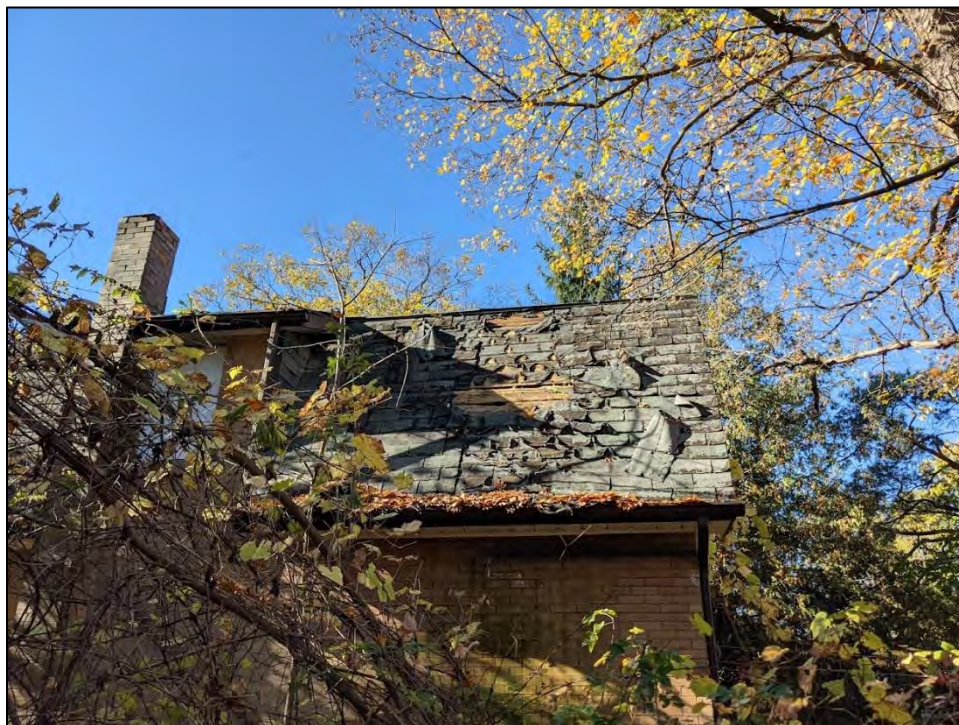
Photo 12 – Active water infiltration observed in several locations on the upper level

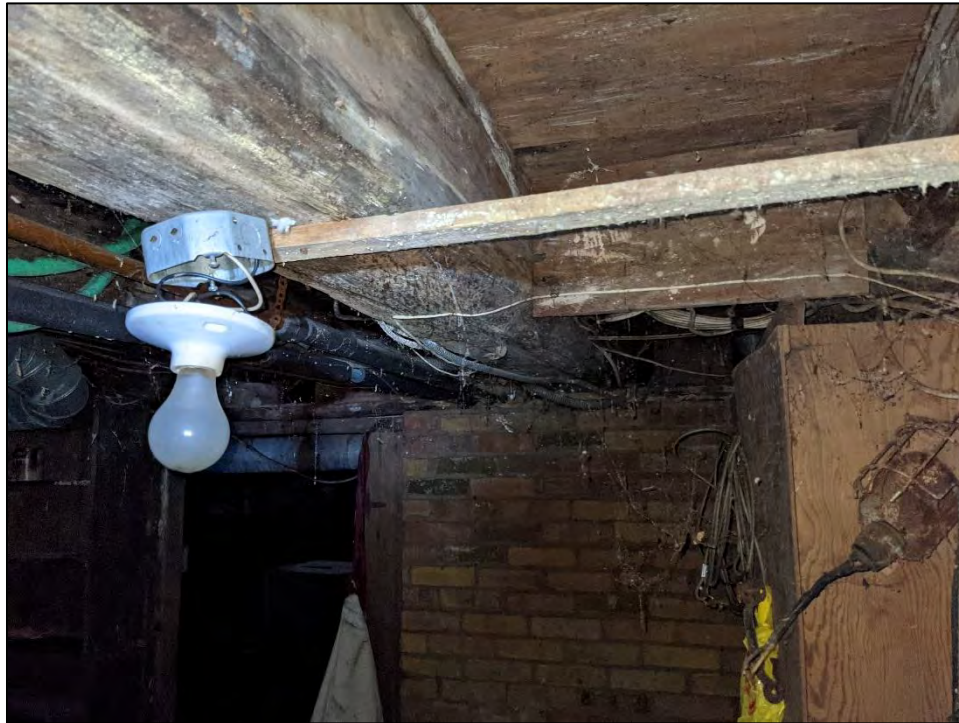
Photo 13 – Water damage and staining on timber floor beams in basement

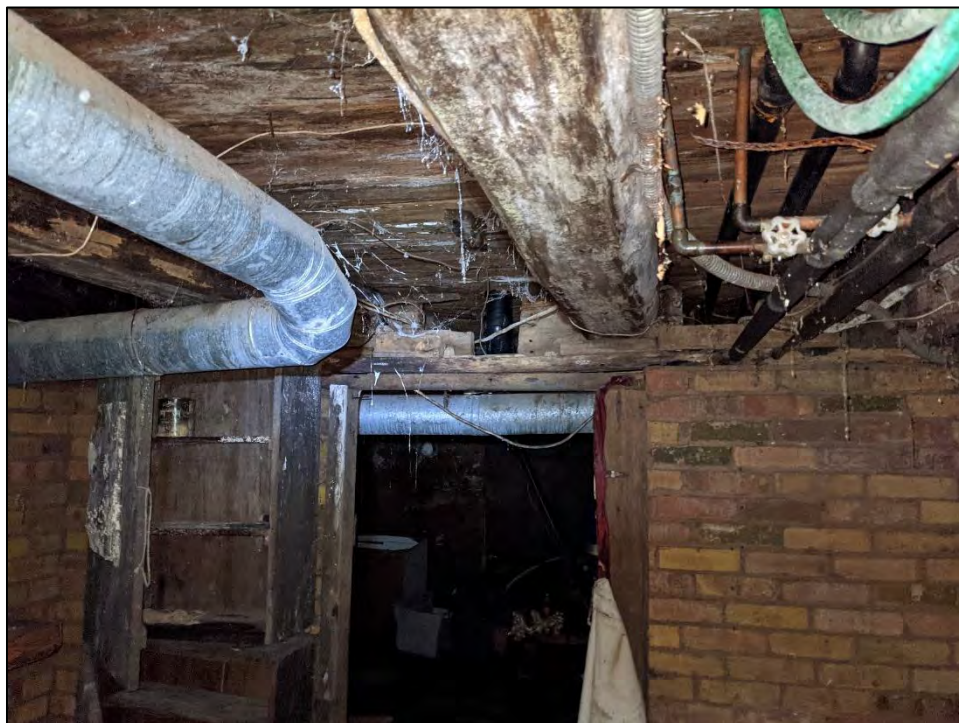
Photo 14 – Deterioration to floor beams and lintel in basement

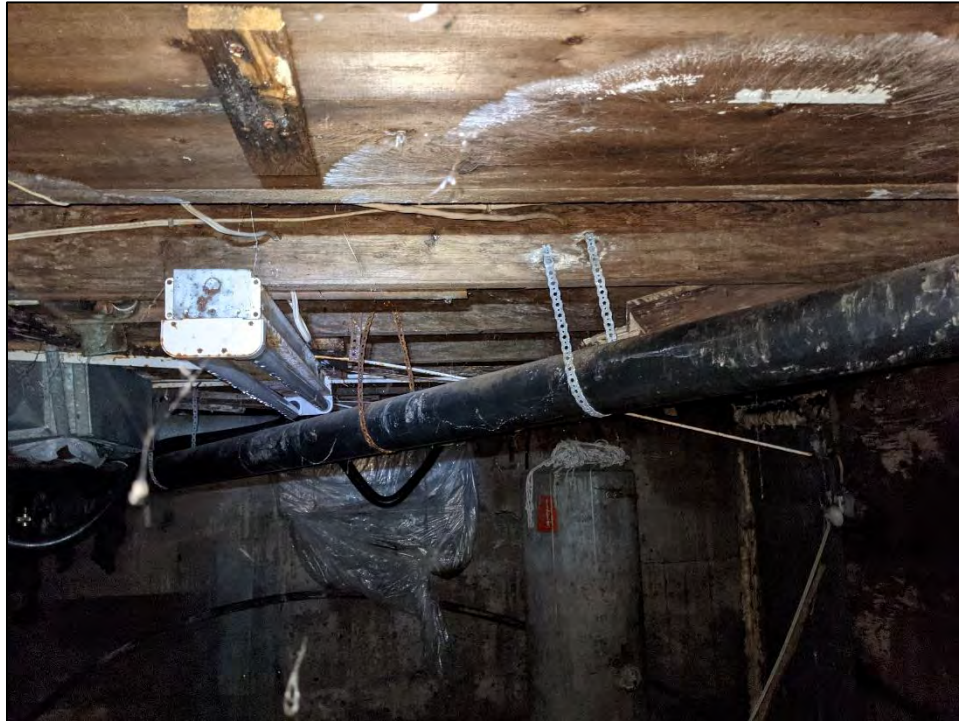
Photo 15 – Water staining, active water infiltration and deterioration of wood framing in basement
