# Building Pathology Critical Report

**One Isabella St,**  
Brampton, Ontario

EZDimensions  
Erin Zagar  
Building Pathologist, Architectural  
Technologist, House BCIN

Issued: July 15, 2022

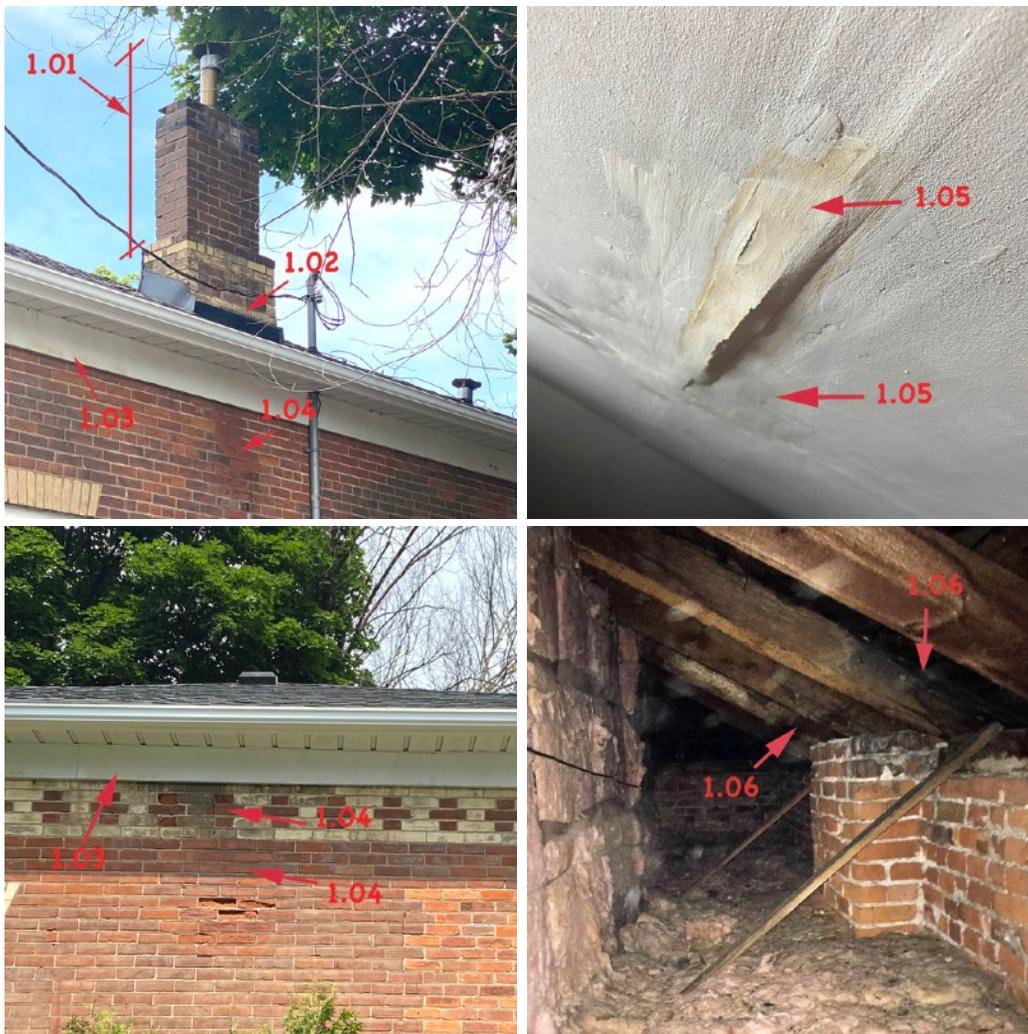
The existing north side chimney is no longer in use. At some point, an extension was added with modern bricks to the original chimney base (1.01). This portion should be removed as it is in bad repair and unnecessary. The chimney could be built up to its original height using *historic bricks* to match for decorative effect or remain at its present height. Either way, it must be capped with a stone chimney cap to prevent pests and water infiltration. Improperly installed *flashing* at the roof line (1.02) evident by staining on the exterior *frieze* (1.03) and brick erosion (1.04) below and stained and failing drywall on the interior (1.05). From the ground it could not be verified if the chimney has a suitable *cricket* to divert water from behind the chimney to the side *flashing*.

Evidence of similar conditions can be found on the south wall where only a small portion of the chimney is evident within the attic space of the house (likely originally serving a stove) similar *frieze* water stains (1.03), brick deterioration (1.04) and water stains on the roof *rafters* (1.06) is evident. It is recommended in both cases the original brick be cleaned, the remaining chimney properly *flushed* and the wood *roof rafters* below be inspected to ensure they have not been structurally compromised, although the roof looks to be sound and in good condition. (See 3.0)

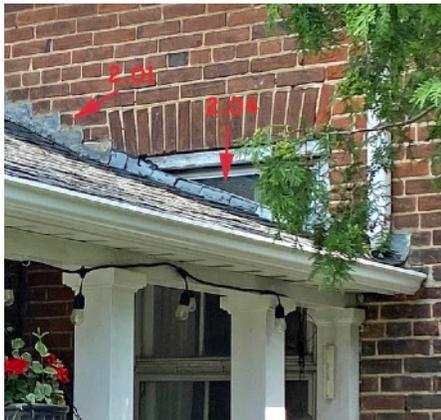
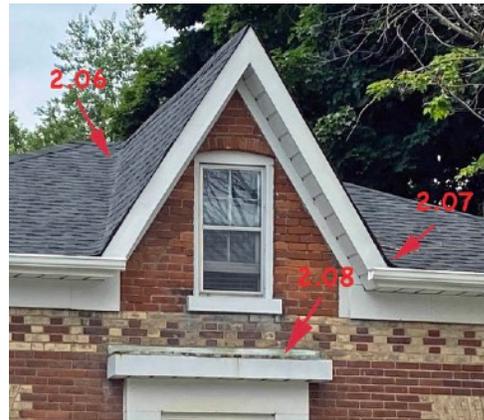
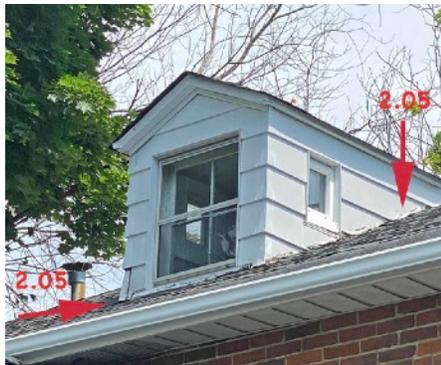
The *flashing* where the rear addition and porch meet the main brick wall has been installed correctly with lead *step flashing let-in* to the brick and extending under the shingles. (2.01) This *flashing* should be checked for deteriorating metal and replaced where necessary. The *flashing* on the *canopy* at the rear west wall, (2.02) the north chimney (1.02) and capped rear chimney are not adequately installed. All flashing must be stepped and let-in to the brick (see illustration), and extend under the shingles except at the lowest slope should be allowed to drain over the shingles.

Moreover, the *flashing* ‘ledge’ (2.04) in front of the rear southwest window does not satisfactorily prevent water from finding its way to the wood window frame and porch below. It is critical that water be directed away from the edge to protect it from the ingress of water. Some signs of water damage is beginning to appear on the underside wood ceiling of the porch.

The second floor rear *dormer* does not appear to have *flashing* (2.05) as the wall seam at the roof is *caulked* and it appears to be failing. Proper *flashing* is needed when the roof is next replaced in the meantime regular inspection of the *caulking* and maintenance is required.

The *flashing* provided at the roof *valleys* at the front *dormer* are done incorrectly. There should be an open application valley flashing (see illustration below) where the *dormer* roof and main roof intersect. Overlapping shingles will not provide adequate protection. (2.06) The *flashing* should be installed in an open installation and a *splash guard* (2.07) installed at the *gutter* end to keep the water from overshooting the gutter to the stoop below. The metal *flashing* cap over the front door *architrave* (upper door trim) *flashing* is showing signs of rust and should be replaced. (2.08)

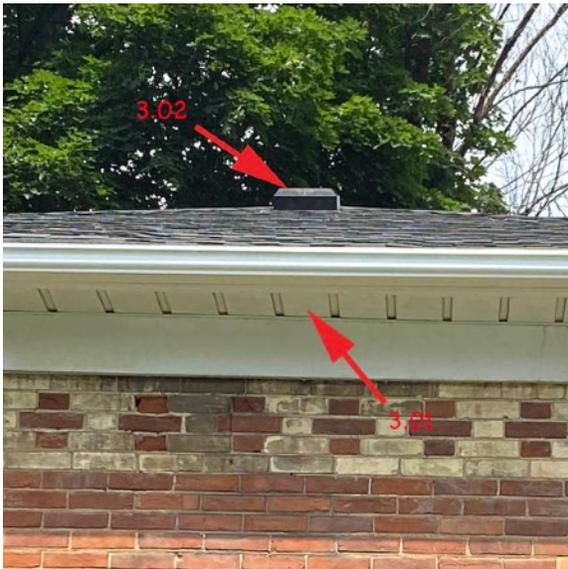
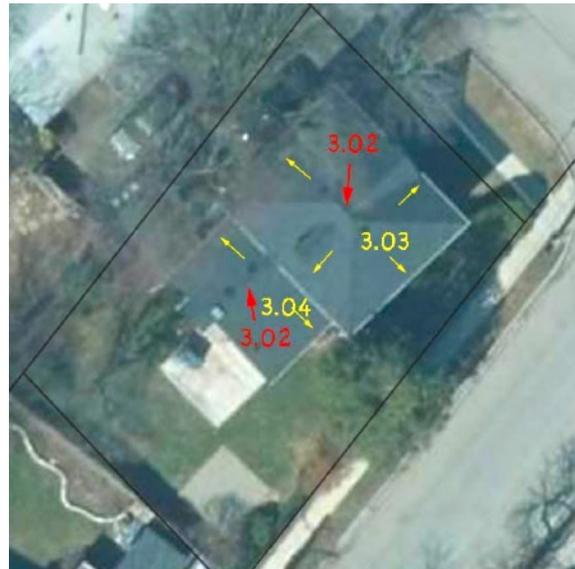
The average life expectancy of an asphalt roof is approximately 15 to 30 years depending on type (basic vs. architectural). The roofing material appears to be in good condition. Some minor curling and asphalt debris was noticed. The *soffits* are lacking *soffit vents* (3.01) and minimal upper *roof vents* (2 per roof) can be observed on the main house and addition (3.02).

The main structure of the second floor has a cottage or *hip roof* (3.03) (4 sloped sides) with a *vaulted ceiling* making it more imperative for proper venting and *insulation*. To promote the longevity of the roofing materials and framing, and to help keep the 2nd floor more comfortable, *remediation* of this issue should be considered.

The rear addition has a *gabled roof* (3.04) (2 slopes) with a flat ceiling. This presents ample opportunity for adding more *insulation* in the ceiling area, adding *soffit vents* (3.01) and upper *roof vents* (3.02) is recommended for the planned renovations.

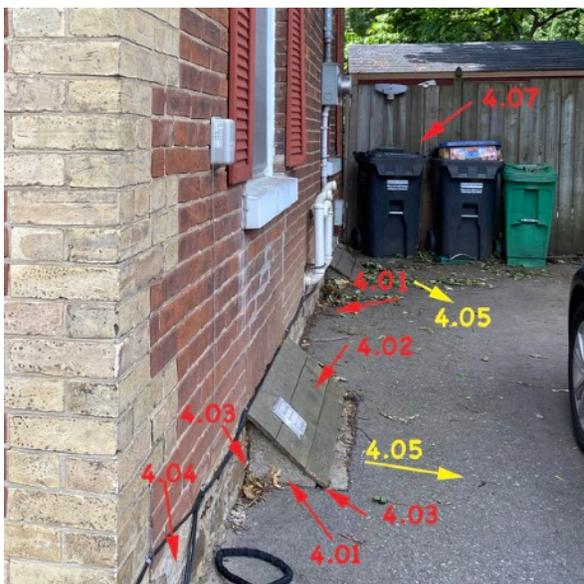
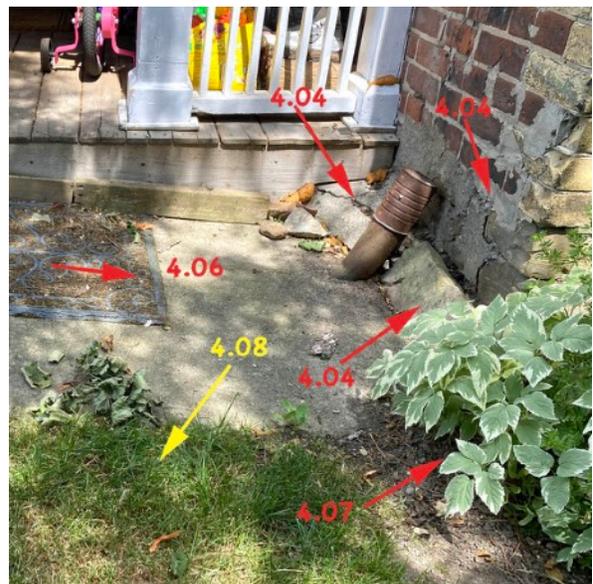
The most effective way to avoid water issues is to divert it away from the building. This prevents water from penetrating and eroding the heritage materials and leaking into the home. Several water management issues have been noted in this inspection that urgently need addressing to prevent decline of the building structure. The replacement of the *gutters and downspouts* has included *leaders* to divert the water but should terminate on a stone or solid splash pad to divert water flow further away from the house.

The North side of the building contains the driveway and 3 concrete *window wells* (4.01) with wood covers (4.02). There is significant deterioration of the *window well* where cavities allow water to leak between and into the well and *foundation*. (4.03) The paving surface is slightly sloped however there is evidence of water splash back and drainage of water to the *foundation*. Attempts have been made to *repoint* the brick *mortar*; unfortunately with *portland cement* (5.0) Redirecting the slope of the driveway away and to the street (4.05) or creating a *berm* at the edge of the building directing the water to drainage material that will allow the water to drain further away from the building is preferred.

The *concrete* walk at the South West corner where the main house meets the covered porch is in a critical state as the grade drains directly to the *foundation*. Evidence of damage to the *foundation* is observed including the bricks above (6.0) and should be rectified immediately to prevent further harm. Aside from the obvious slope of the *concrete* pad, (4.06) several attempts to block the water has been attempted (4.04), unfortunately, using *portland cement* (5.0) thus complicating the problem.

All storage, large shrubs and plantings should be kept away from the *foundation* (4.07) wall in order to monitor ground erosion at the *foundation*. A 10' perimeter is preferred or at a minimum provide a *berm* or sufficient slope away and drainage material to allow the water to drain to the ground cover and monitor annually and maintain the slope (4.08).

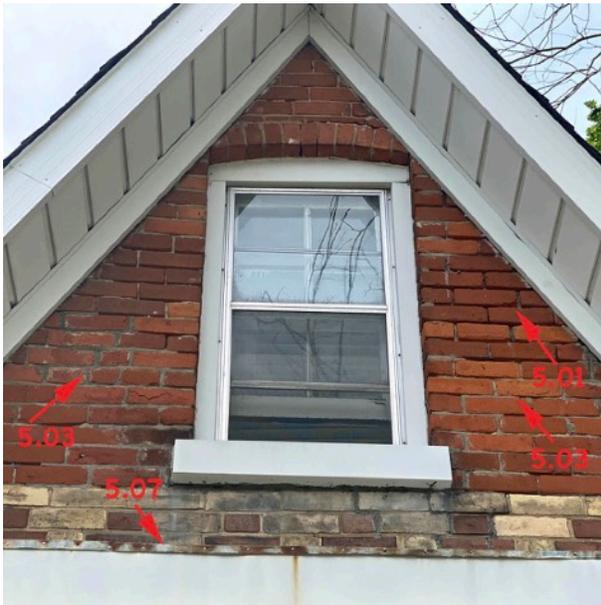
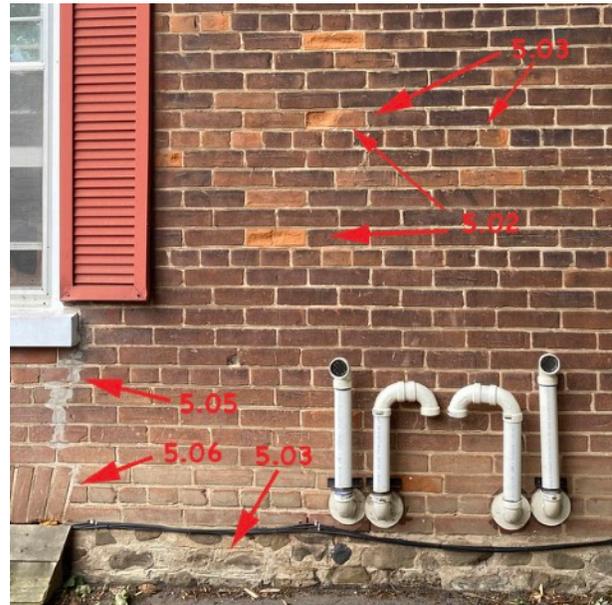
The triple and double brick exterior walls built with *historic brick*, appear to be sound except at some corners, spot repairs will be necessary to the brick and *mortar* in areas on all walls to protect the overall structure of the house. Erosion of the brick face and *mortar* (5.01) has occurred from failed water protection, this exposes the softer *historic brick* centre and ultimately the interior of the wall. *Spalling* and cracks have occurred (5.02) where *repointing* and repairs were attempted using *portland cement* (5.03) which is incompatible with *historic brick* and stone materials. The *cement* locks in and holds moisture in the brick or stone and spaces between. This prevents it from draining, consequently, the freeze-thaw cycles of our climate cause the brick to crack and break.

*Pyramidal cracks* (5.05) above the windows indicate the slippage of the *spring brick* (5.06) and should be stabilized when the brick repairs are performed by a professional brick mason with heritage experience. Where the brick has become dirty or mouldy (5.07) a gentle cleaning can be done with a *non-ionic solution*.

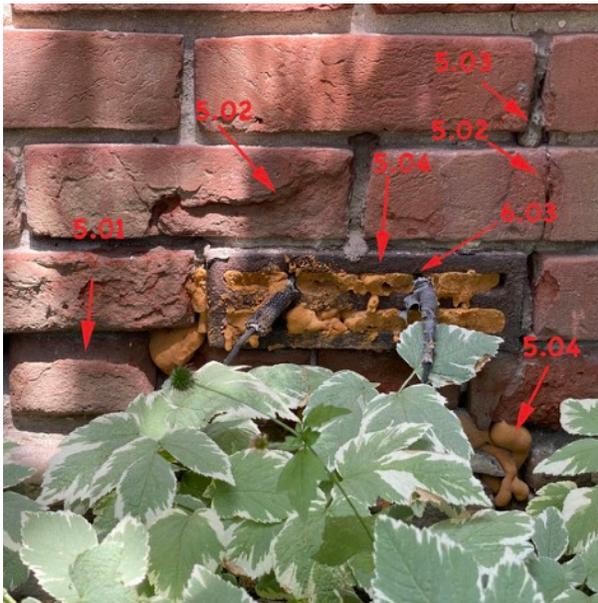
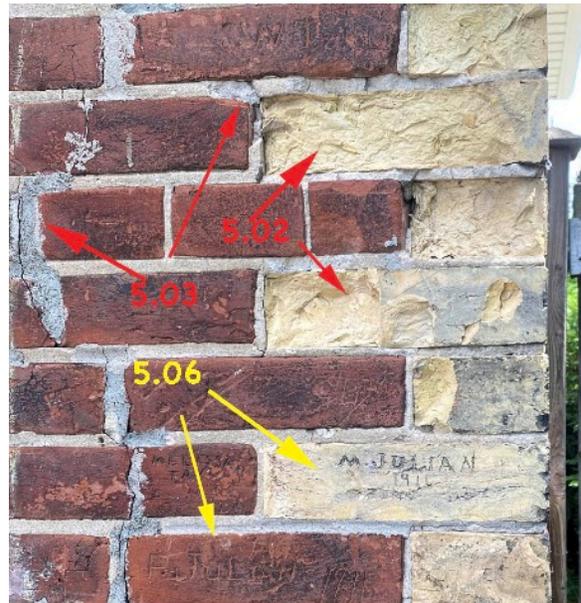
In addition to the issues noted, *basement vents* installed to vent the basement space have been clogged with *sprayfoam* or *mortar*. (5.04) (See 6.0) Any *spray foam* and *portland cement* within a heritage fabric wall will cause problems.

A professional brick and stone mason experienced with heritage masonry should be contracted to remove the *cement* and *sprayfoam* remnants, replace or repair the brick and repoint using *lime mortar only*. Some bricks have been carved with the names of past family members residing in the house. These bricks should be cleaned and saved where possible as a nod to the past. 5.08

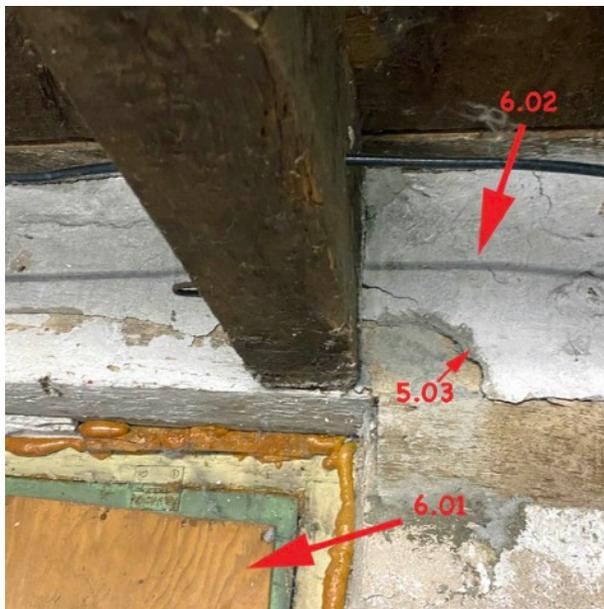
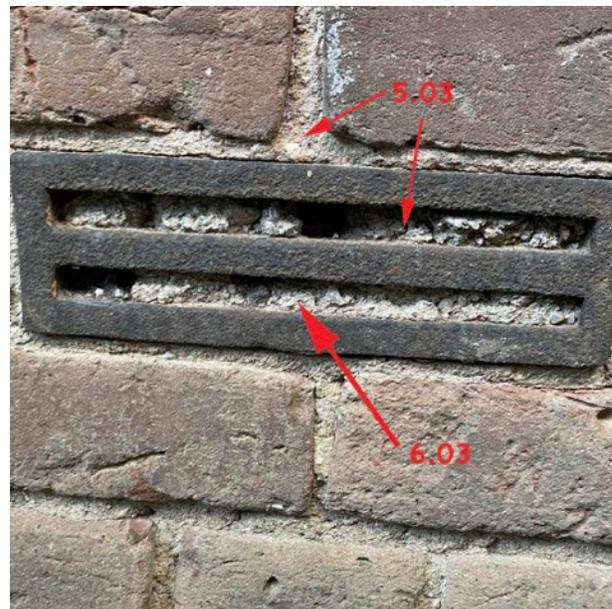
Water is the primary issue causing *foundation* failure. Basements originally were utilitarian at best, equipment only came later. With good water management and regular maintenance water can be diverted or managed away from the basement. However, any moisture in the air or absorbed in the wood materials is intended to vent through the windows (originally above grade), *nogging*, *foundation mortar* and *vents* placed on opposite sides of the building; all of which are integral to the health of the basement.

Mistakably some assume the vents are the cause of water and air leaks and block the air flow entirely. The basement should be left to exhaust the moisture naturally and *insulation* should be added to the basement ceiling under the main floor to keep the humidity or colder temperatures in the basement space separate. Sealing up windows, (6.01), parging the *nogging* (6.02) with *cement* or *sprayfoam* (5.03) and blocking vents (6.03) stunts the basements ability to vent and exchange the air trapping moist air in the basement will lead to *rising damp* conditions affecting any wood and the air quality.

The brickwork should be done by a qualified mason only, the concrete or foam should be removed and restored with lime mortar only as needed. Any *sprayfoam* should be removed from the windows, especially at grade level and ensure the window is secure and in good working condition. The *basement vents* should be cleaned out of any material and can be backed with screening to prevent rodents from entering the basement space.

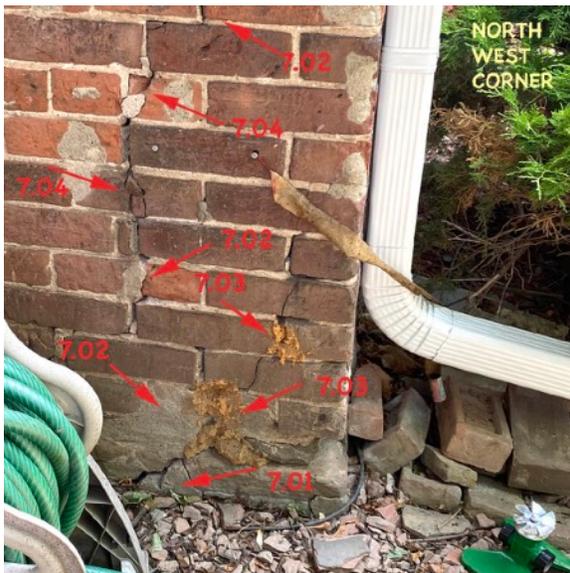
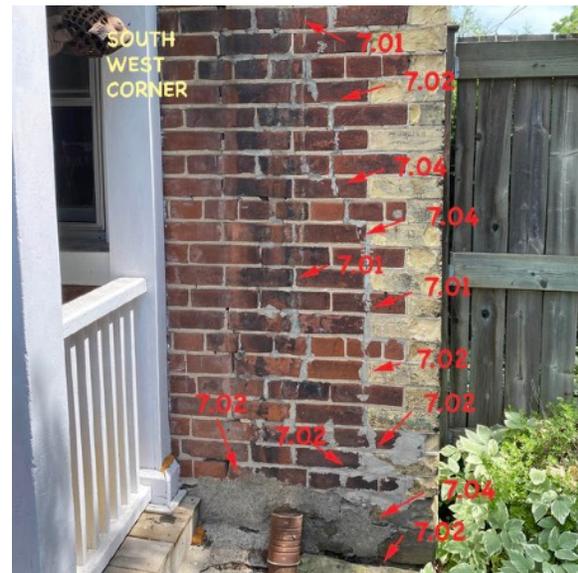
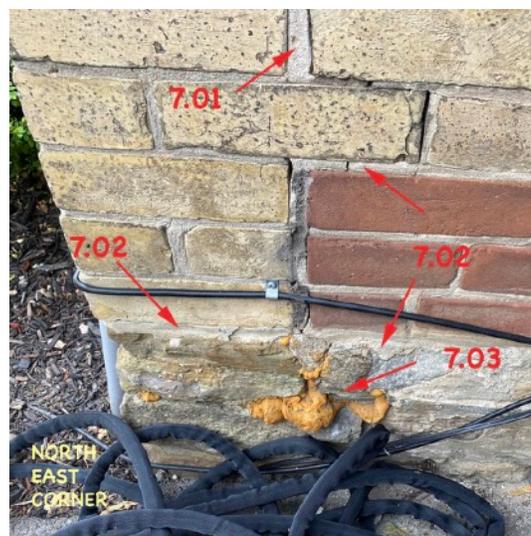
The south half of the basement contains a *crawl space* only accessible from a small opening in the centre wall. It is my belief the southern *crawl space* was the original *foundation* of an earlier building. The northern half was added or dug out and rebuilt to full depth (6'+/-) when the brick structure above was built. The rear ‘assumed summer kitchen’ was added, originally with a *crawl space* below; then the walls were *underpinned* and brought to full depth.

Structural instability is evident by exterior cracks (7.01) at the southwest corner of the existing main house at the *crawl space* and can't be inspected thoroughly below. The northwest corner of the rear addition which is in the part that has been *underpinned* with *concrete*, and several repairs to fill the cracks and missing *mortar* has been attempted with *portland cement* (7.02) and in places *spray foam* (7.03). The underlying *foundation* issues have remained and destabilized the wall, extending the settling cracks down into the *foundation* and up the structural brick walls, thus causing some bricks to crack and break. (7.04)

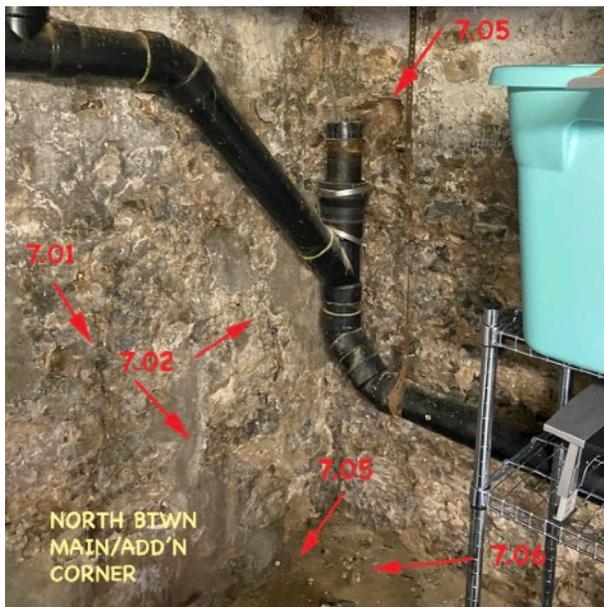
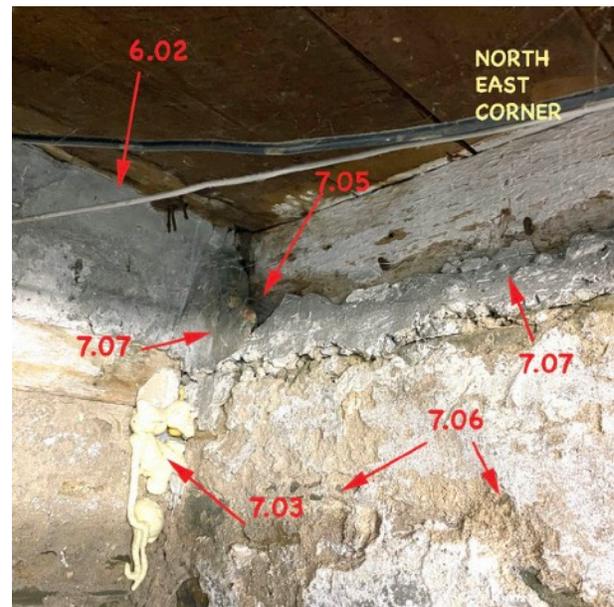
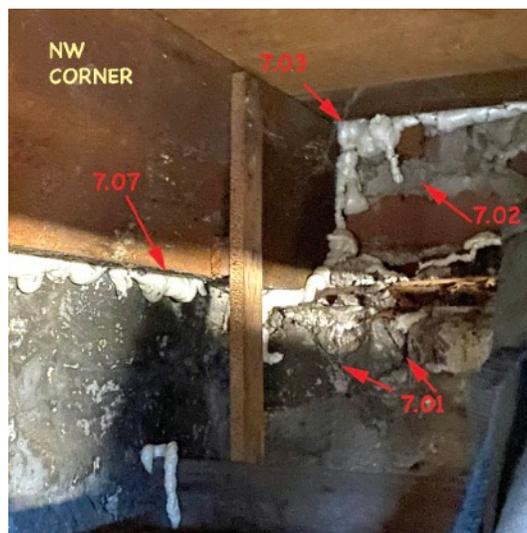
The southern *crawl space* could not be inspected however, most of the full-height basement walls demonstrate water retention in the *foundation* (7.05) This has caused the *mortar* to erode on the interior, evident by debris on the floor (7.06). In the case where *portland cement* or *sprayfoam* was used against the wooden *sill plate* or *joists* (7.07) this holds water on the wood and in time undermines the structure of the wood structural member.

A Professional structural engineer is needed and a qualified brick and stone mason familiar with heritage buildings and historic brick should be hired to review the issues and make plans for structural stabilization and prevention of further deterioration.

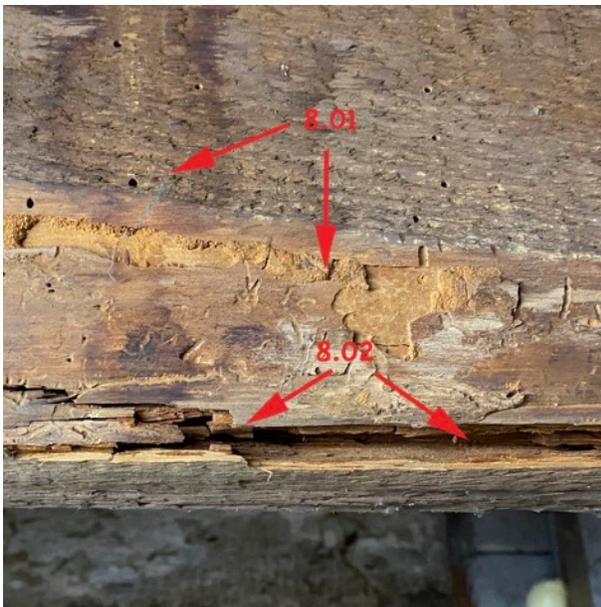
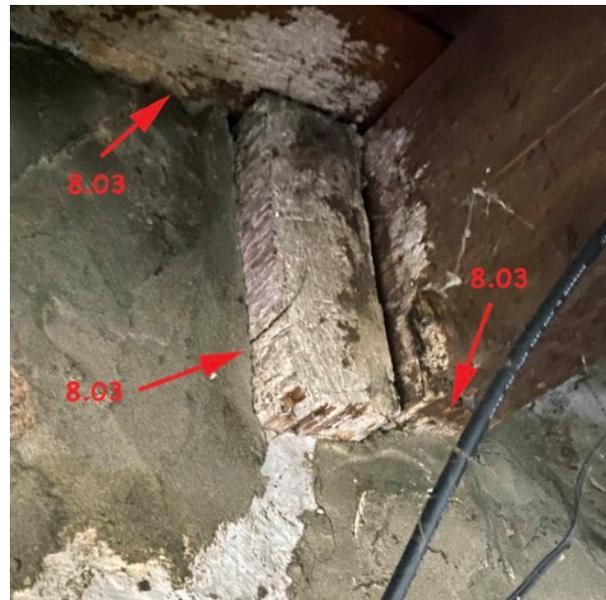
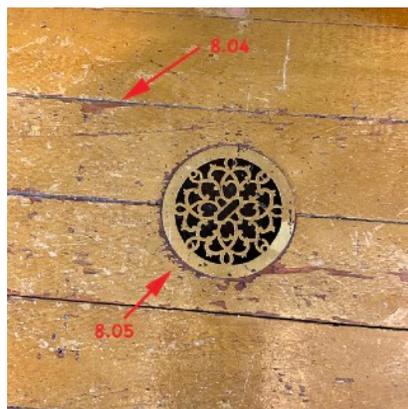
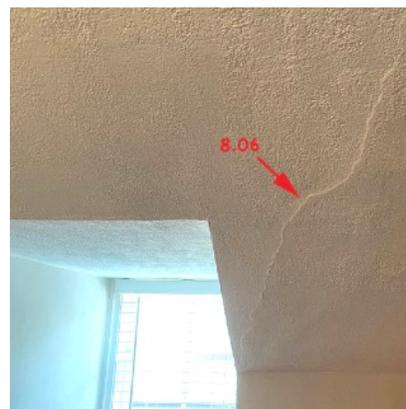
Only the main floor *joists* could be viewed at the time of the inspection. Most floor members appear to be sound with some signs of past issue with *powder post beetles* (8.01) which has caused cracking and weakening of a few joists (8.02). The wood joist ends resting at the mid-wall between the southern *crawl space* and furnace space, and are in direct contact with *concrete* (8.03) which holds potential for decay and rot. A structural engineer should review the soundness of all joists to ensure they are structurally sound. All wood *floorboards* appear to be original, and are integral to the building structure, they are sound but worn (8.04). Without sanding the floors should be refinished or painted as they originally would have been. All *floor vents* should be secured to avoid tripping hazards. 8.05

The *roof rafters* or second floor *joists* could not be viewed as they are covered with a stucco finish ceiling. Cracking was evident in areas (8.06) where water issues are likely due to a lack of proper *flashing* on the roof. If the stucco finish was to be removed it would present an opportunity to verify the integrity of the framing, ensure air space for proper *roof venting* and *insulation* and improve the interior finish.

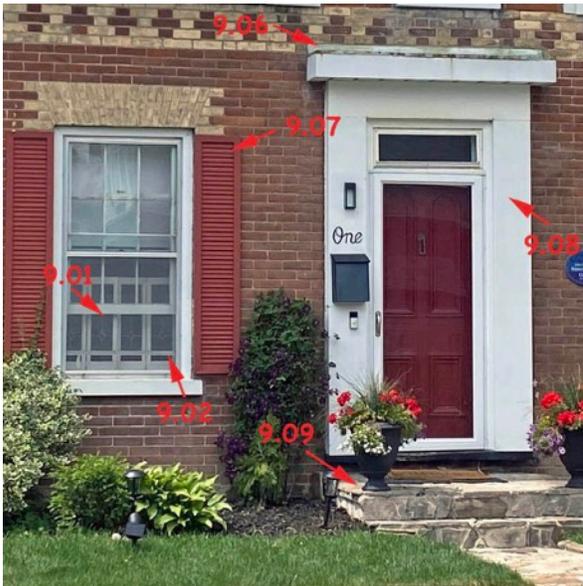
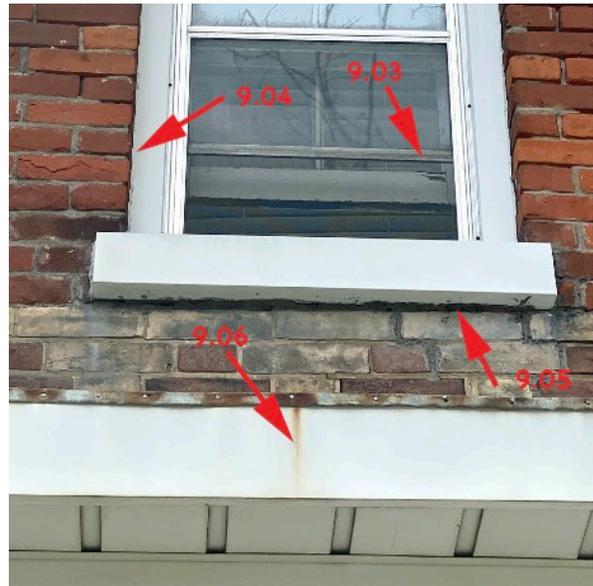
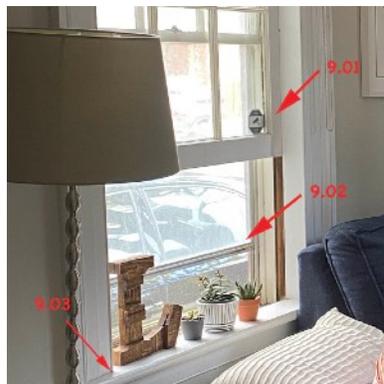
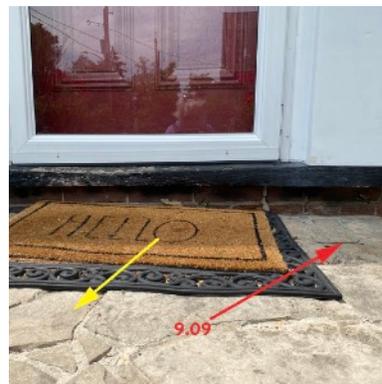
All but two windows (in the rear addition bathroom and kitchen) are original (9.01). I'm told the 6 over 6 windows work well and all the hardware systems are in place. The wood window interior frame and *sills* are in good shape requiring some maintenance and fresh paint (9.03). The exterior of the windows trim and sill is flashed with aluminum therefore it is not possible to view the exterior conditions. Aluminum *storms* and screens have been added (9.02) however, they do not open more than 6-8". If the exterior aluminum is to remain the *caulking* at the brick around the sides and top should be attended to (9.04). Do not caulk or seal under a window sill, this will trap moisture surrounding the window or door frame from evaporating or draining. The exterior *sill* for the *dormer* window above the front door has been sealed with *concrete* under the *sill* (9.05). Any material should be removed from under the *sill* when the other proposed brickwork is done. The metal *flashing* above the small awning over the door is contributing to brick decline with rain splashing on the wall above and the metal is failing, presenting rust stains (9.06).

The *shutters*, (9.07) aluminum *storms*, screens and aluminum *architrave* around the front door (9.08) are inconsistent with the style of the home and should be retrofitted with appropriate materials and properly sized (example 3 Isabella). The front stoop at the entry is sloped towards the house and should drain away. (9.09).

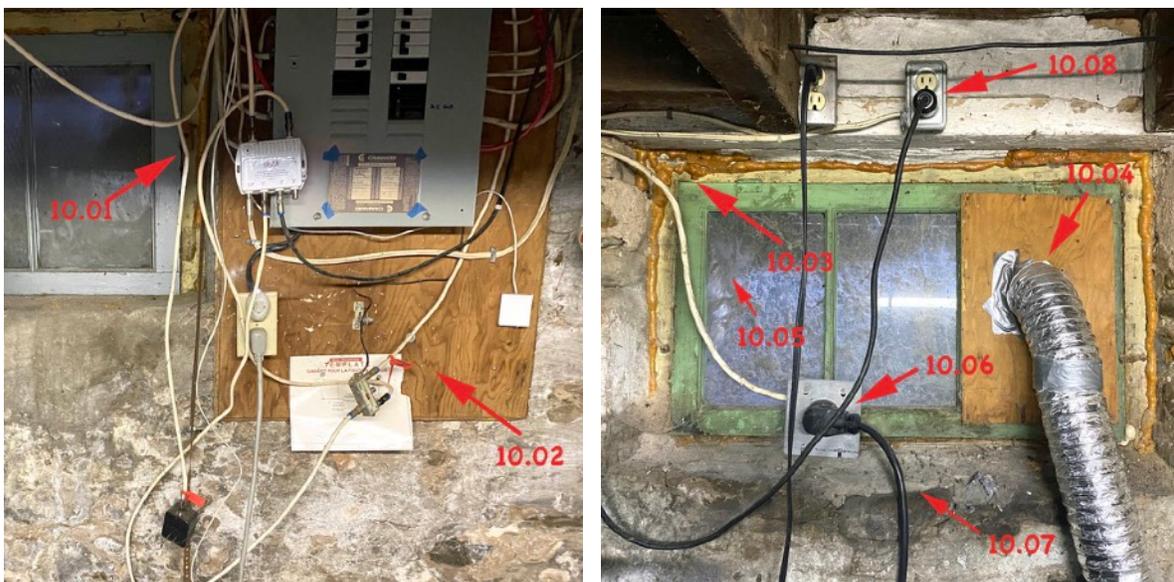
There is evidence of *knob & tube wiring* which appears to be out of service, this should be verified. This is a fire hazard and insurance companies may not adequately cover a fire associated with a *knob and tube* system! Many systems which appear to have been replaced may not be. Ceiling lighting is regularly disregarded (due in part to access) in a rewire and should be inspected to see if it has been executed properly.

There are also numerous loose and hanging wires within the basement and surrounding the electric panel (10.01) and basement ceiling. The plywood backing behind the panel is slightly damp to touch (10.02). All windows have been sealed (10.03) and the *window wells* are covered on the exterior. (4.02) Over the current laundry area, the northeast the dryer vent exhaust, (10.04) accumulated lint, debris (10.05) and snow or water within the *window wells* will affect the *foundation* and brick within these spaces. As mentioned in item (6.0) regarding 'basement health' this constricts the ventilation as designed and will need regular maintenance to be kept clean and dry.

A 220V dryer plug (10.06) is secured to the lower window frame where obvious signs of mould indicating that water has been present. (10.07) The two 120V outlets above are secured to the *nogging* (10.08) where moisture in the brick can collect. These situations pose real hazards and should be investigated and addressed by a licensed professional Electrician as soon as possible.

A thorough inspection of all outlets and wiring on the exterior or near any plumbing fixtures must be provided with a *ground-fault circuit interrupter* (GFCI) circuit breaker shut off.

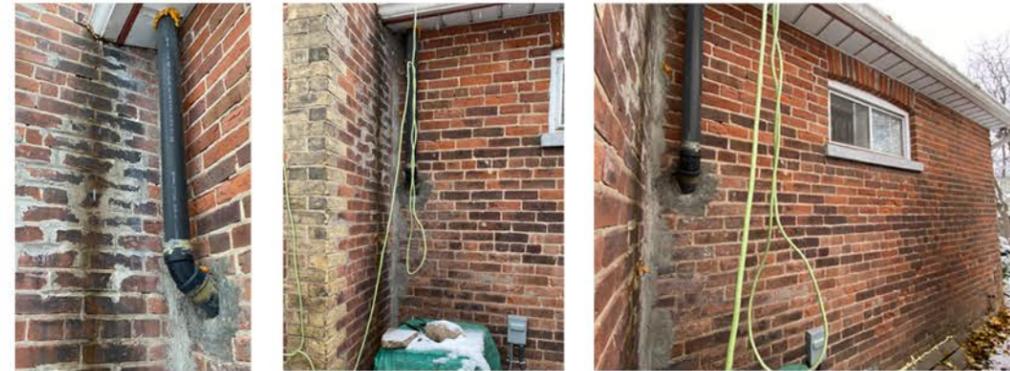
← EXTENSIVE BRICK DAMAGE  
POOR BRICK REPOINTING  
NORTH EXPOSURE  
SHADDED & WET
