CACHET DEVELOPMENTS (EMERALD CASTLE) INC.

# HERITAGE CONSERVATION PLAN FOR 10431 THE GORE ROAD

LOT 13, CONCESSION 10 NERN DIV,  
FORMER TOWNSHIP OF TORONTO GORE,  
PEEL COUNTY NOW CITY OF BRAMPTON,  
REGIONAL MUNICIPALITY OF PEEL,  
ONTARIO

PROJECT NO.: OCUL2205  
DATE: NOVEMBER 10, 2022

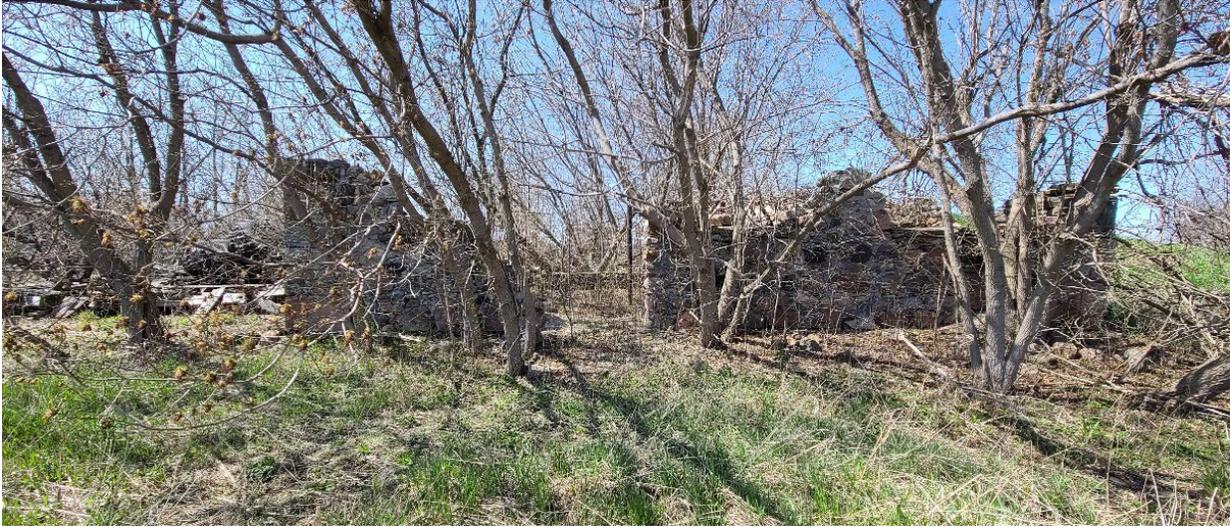
**Plate 5: Southeast view of the remnant west elevation of the barn complex (located at the end of the circulation path)**

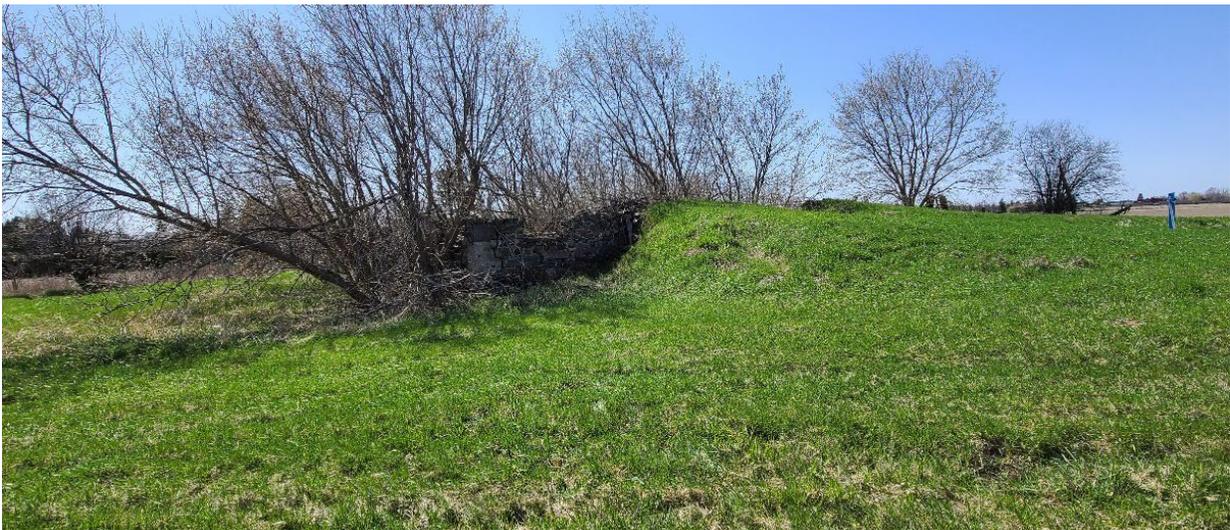
**Plate 6: West view of the remnant north elevation of the barn complex showing a grassed gangway**

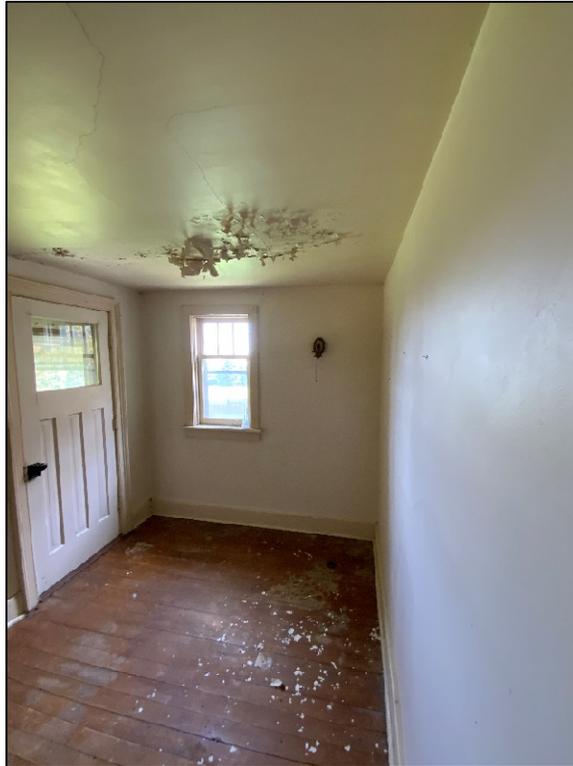
The asphalt shingles are at or near the end of their service life. Several shingle tabs were missing at the time of the review and limited evidence of water ingress was noted on the second floor ceiling.

**Photograph 1: Minor ceiling damage**

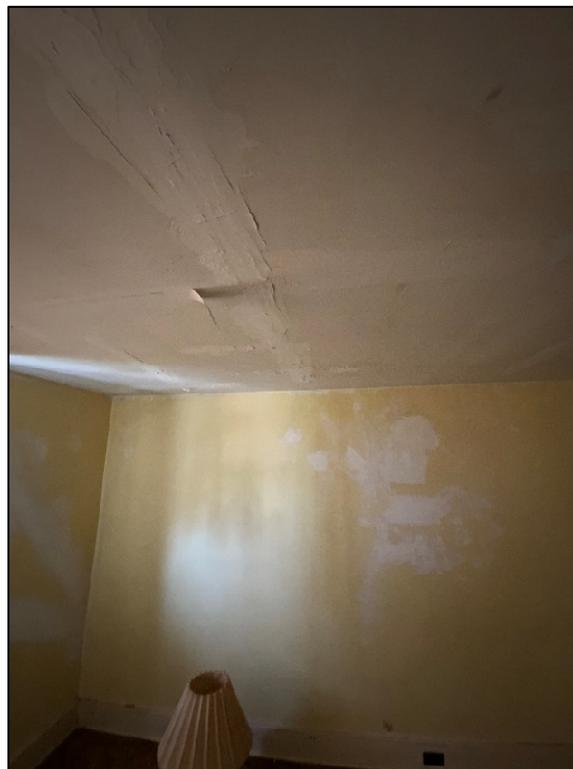
Floor finishes, where present, are in poor condition. Cracking is visible in several locations including walls and ceilings.

**Photograph 2: Previously repaired ceiling damage**

There is no cracking visible on the second floor that suggests there is structurally significant deterioration or damage.

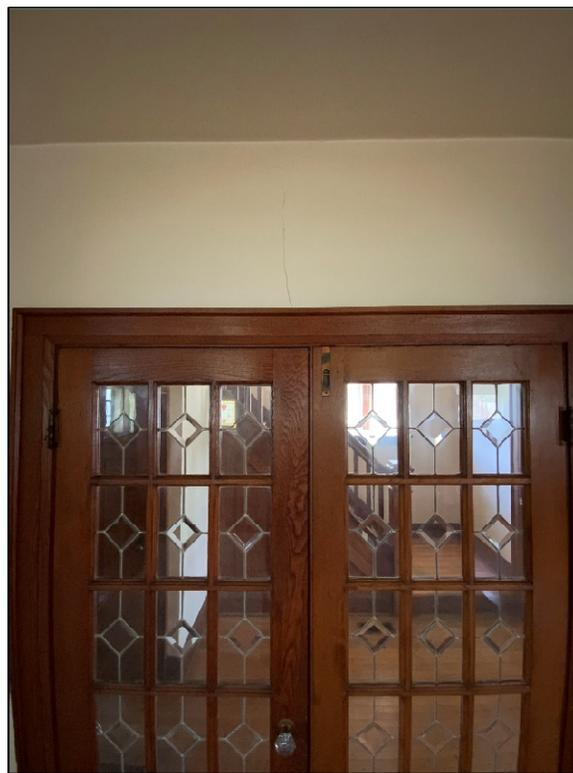
A vertical crack was noted above the door from the front hall into the living room, and the door was found to be rubbing against the floor below.

**Photograph 3: Minor settlement at door opening**

This settlement is likely a result of the combination of offset loadbearing elements between the second floor and ground floor framing and the lintel above the double swing door opening.

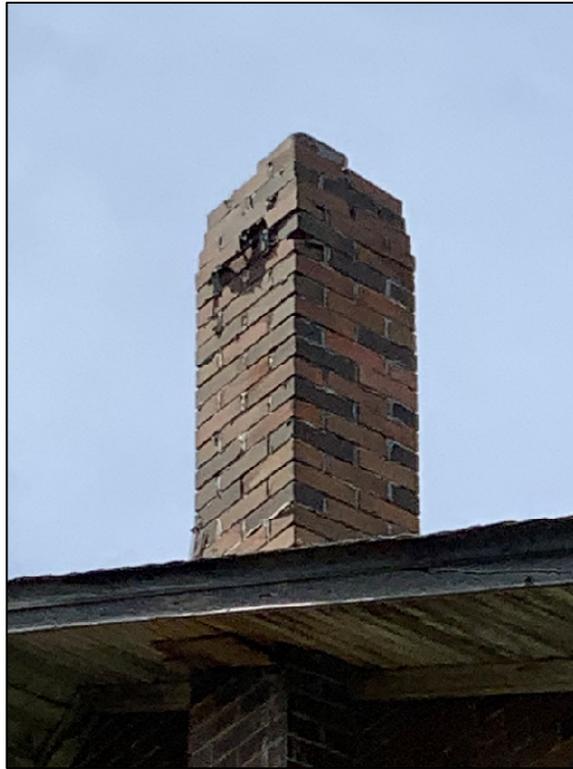
The chimneys are in fair condition for the majority of the height, with some open mortar joints; however, the upper 5-6 courses of each chimney appear to have sustained some damage and several bricks appear to be loose.

**Photograph 4: Damaged masonry at southeast chimney (typical to both chimneys)**

This could be the result of freeze-thaw damage due to the increased exposure of these elements. In cases where the chimneys are no longer required to vent mechanical equipment, the reduction in secondary heat can lead to accelerated deterioration.
