Date: 2023-04-29

Subject: Churchville Ice Jam and Flood Risk Management

Report Number: Planning, Bld & Growth Mgt-2023-403

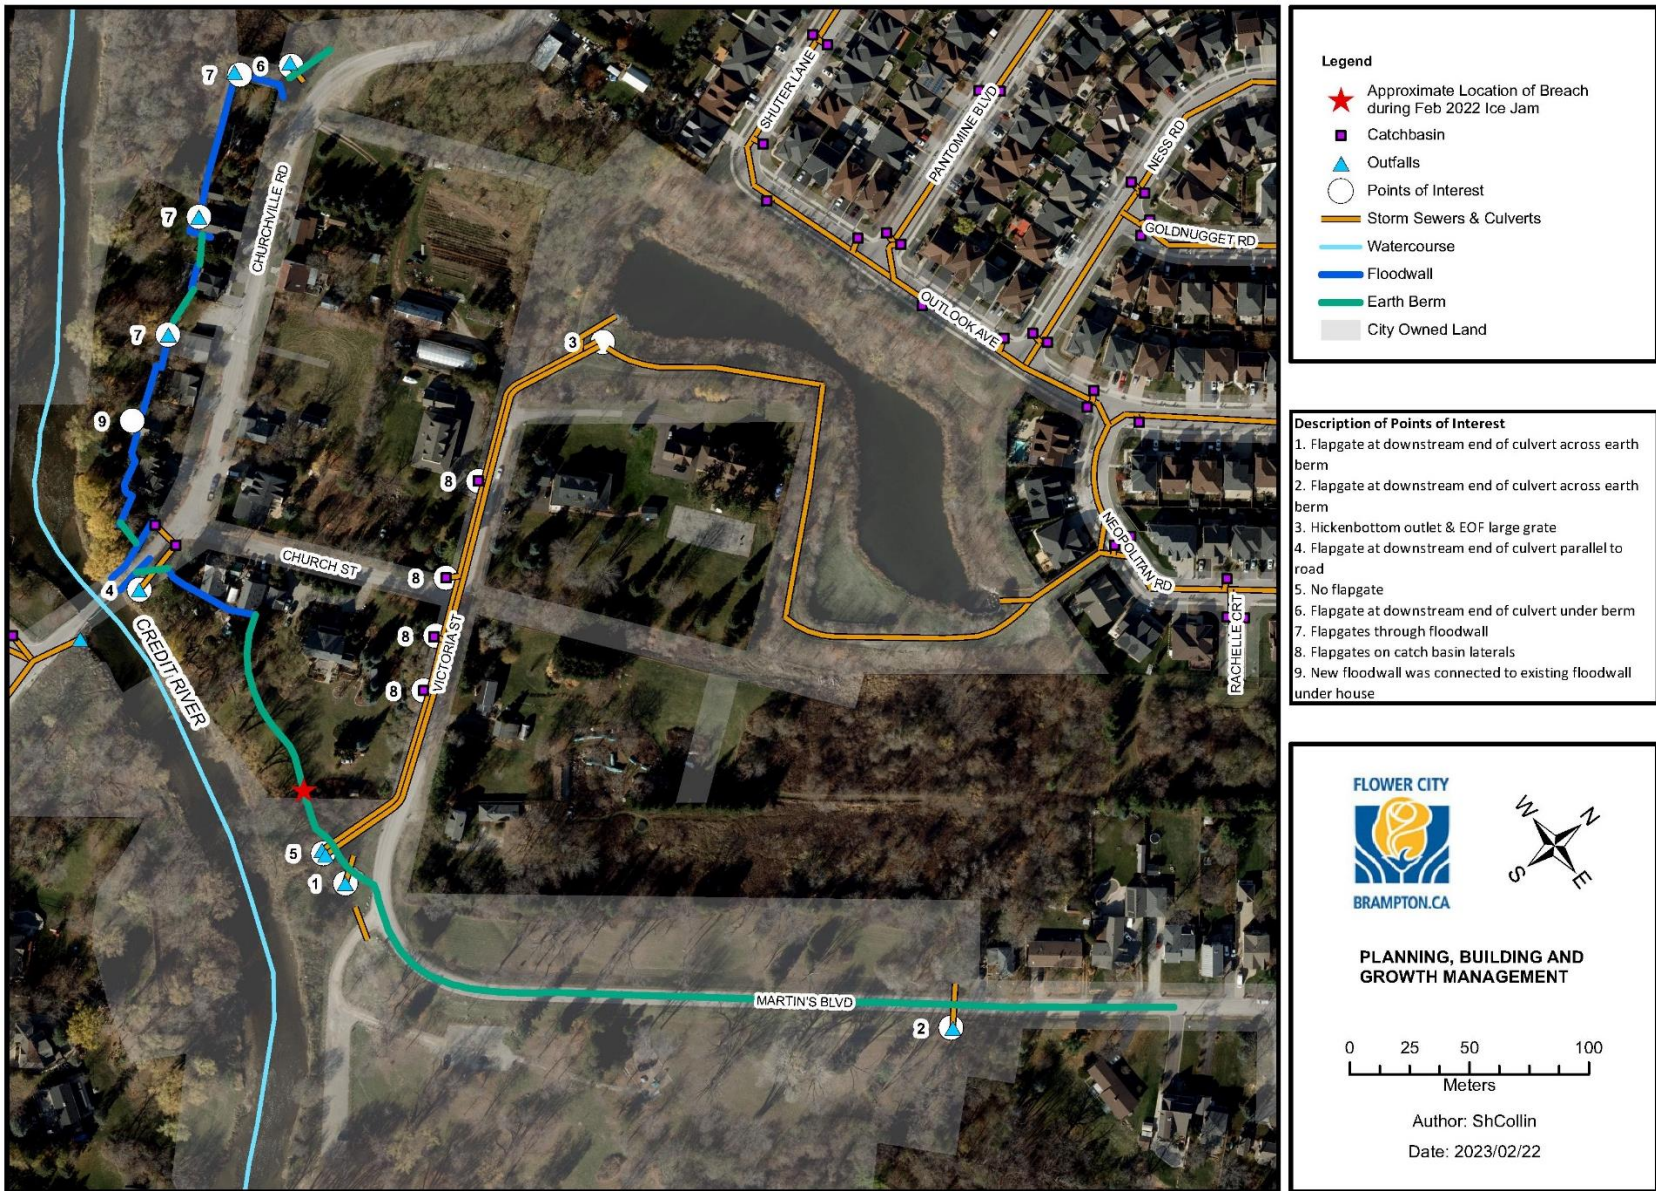
Figure 1. Churchville Flood Control Project Infrastructure

Outfall failures at locations 4 and 5 (Figure 1) allowed flooding in the Credit River to back up into the roads and properties behind the berms and floodwalls.

A small part of the flood protection berm was overtopped at the location shown in Figure 1 but this was a minimal contribution to flooding compared to the sewer backup and surcharging.

City staff and contractors inspected the storm sewers, culverts, flap gates, and ditches after the ice jam to identify maintenance needs. The failures at locations 4 and 5 in Figure 1 appear to have occurred due to jammed flap gates and bolts securing manhole lids being sheared off. City staff have replaced the flap gates with new backflow prevention valves that are less prone to clogging or jamming. In addition, the manhole lids have been replaced and bolted. Storm sewers and culverts have also been flushed which will help reduce the risk of clogging the valves. City staff have repaired the culvert at location 2 in Figure 1.

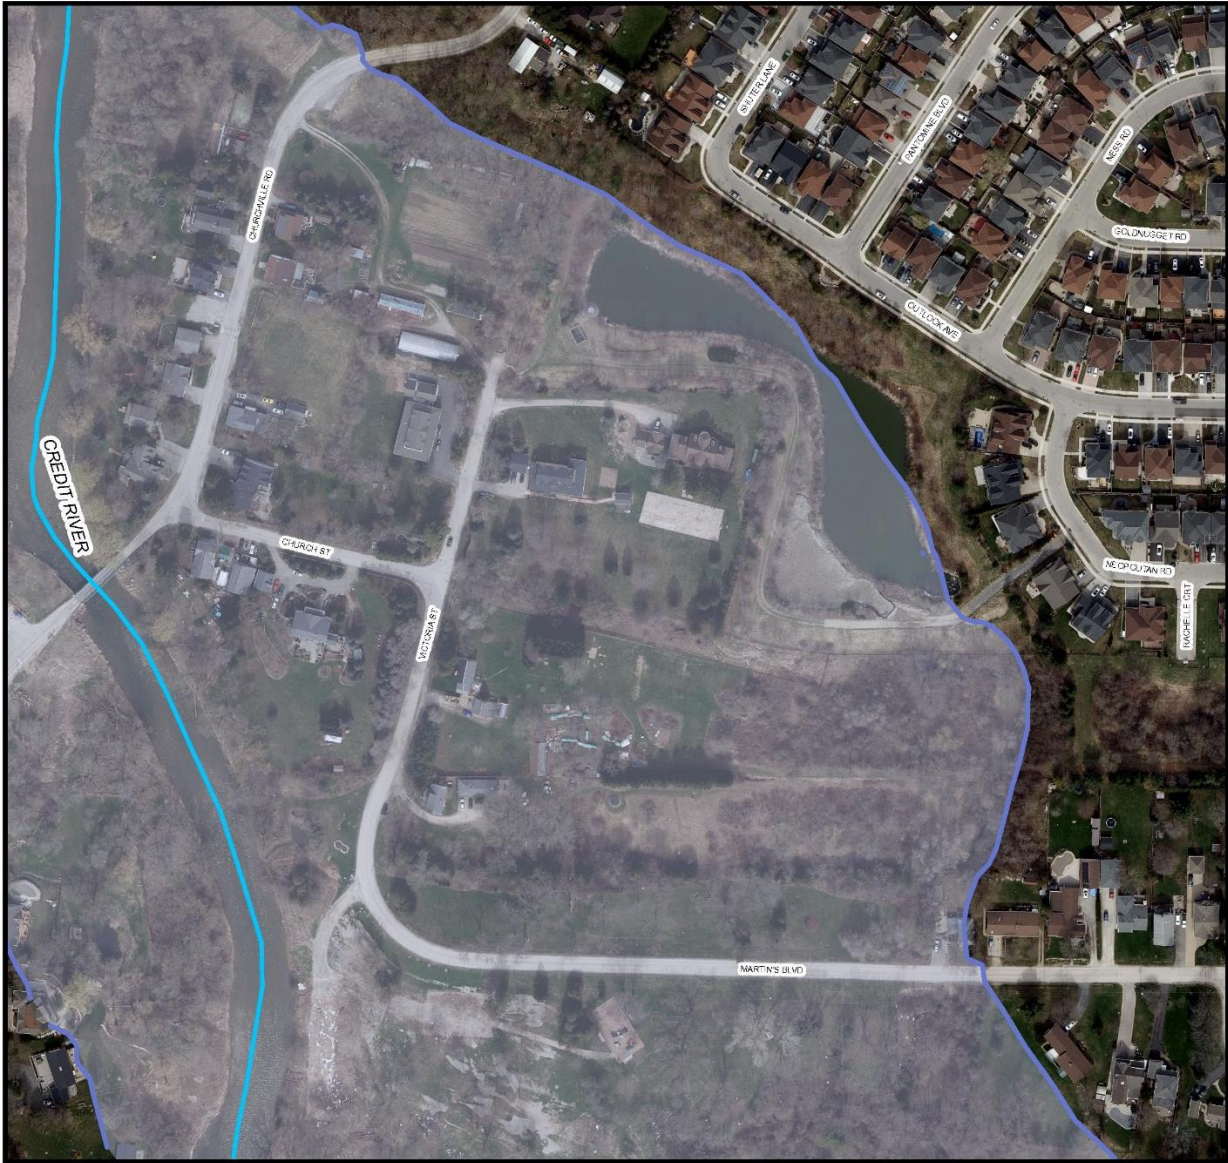
Figure 2. Credit River Floodplain in Churchville Neighbourhood

The 15 to 20 flooded homes in the Churchville neighbourhood are located within the floodplain of the Credit River as shown in Figure 2. There are 550 properties in Brampton that are wholly or partially located within the floodplain of the Credit River and its tributaries.

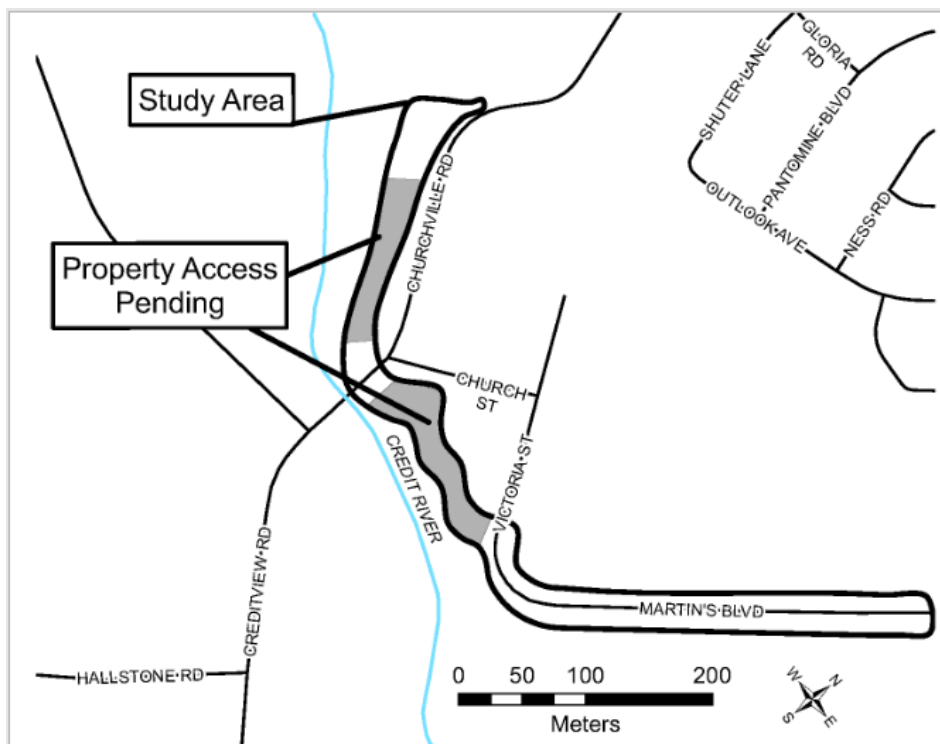
Figure 3. Property Access Needed for Private Berm and Floodwall Condition Assessment

The City has retained a qualified consultant to inspect the existing floodwalls and berms, assess their structural condition, and identify any improvements needed to restore full functionality and integrity. Inspections are expected to be completed by Q3 2023. Approximately 40% of the berms and floodwalls are across private property, as shown in Figure 3. Given the absence of any easements to allow the City to enter onto private property to access these segments of the berms and floodwalls, City staff have contacted these property owners requesting permission to access their property.
