St Andrews Presbyterian Church, 44 Church St E, Brampton  
Heritage Grant Application  
Front steps restoration.

Item 7 – Historic Photos related to the project

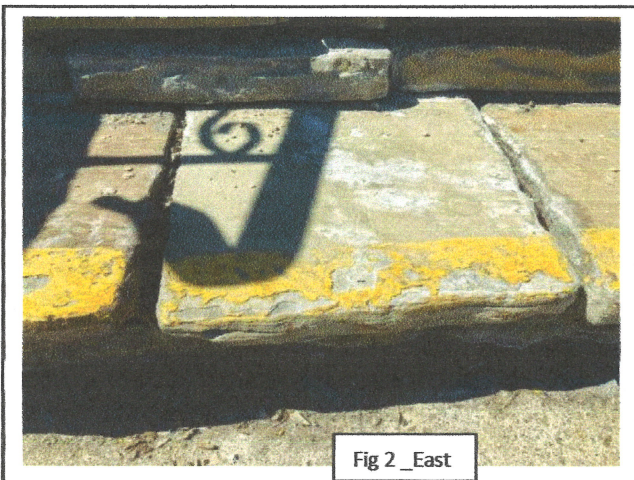
Fig 2\_East

Note the missing mortar in both of these photos. The slab on the left is no level because the vertical support has sank once mortar was eroded. The vertical support on the right is not mortared into place at all and is not attached to either slab above it

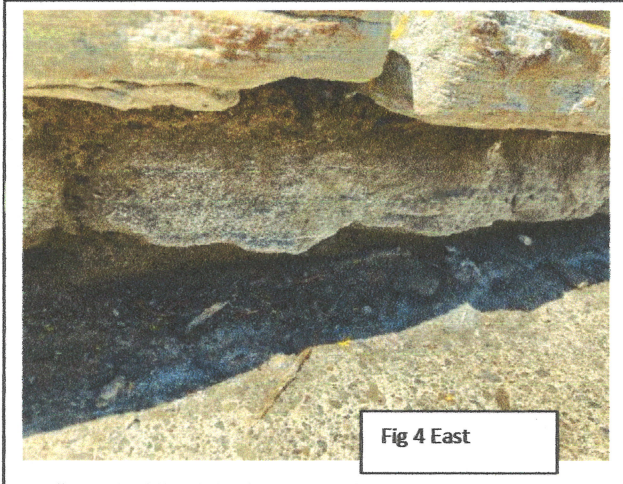
Salt damage to the mortar and stone vertical.

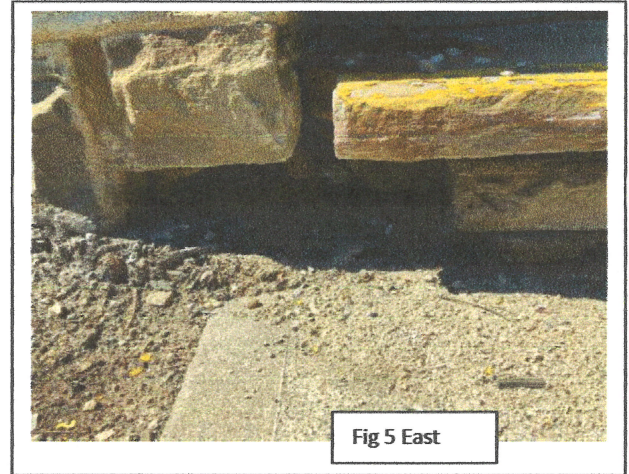
Missing Vertical support at ground level.

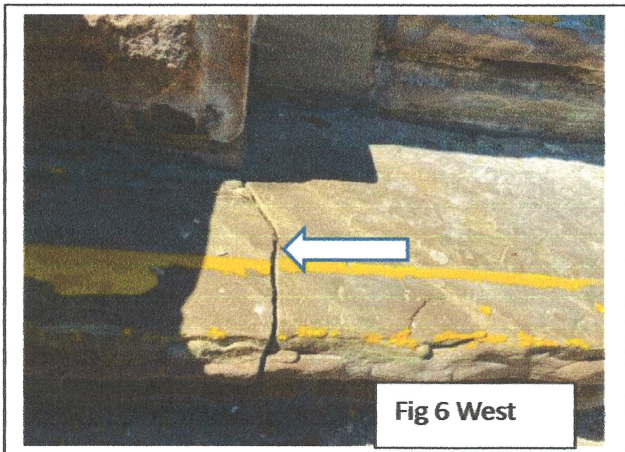
The cracked stone slab on the left possibly caused by the use of incorrect sealant (cement). The figure on the right shows surface damage caused by salt erosion of the stone slab. Both of these slabs will need to be replaced

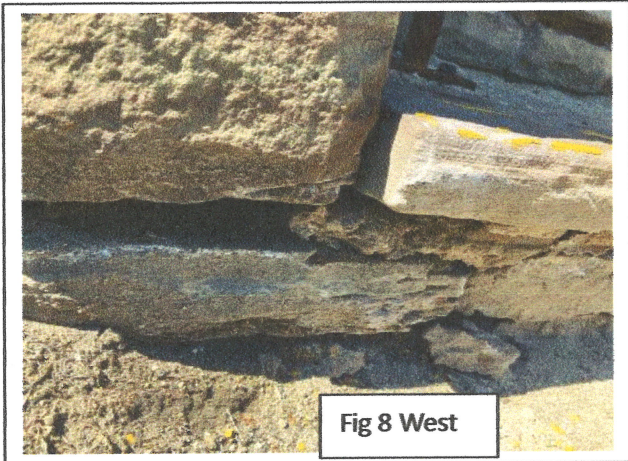
More examples of salt damage leading to missing mortar and the eventual washing out of the underlying sand. The photo on the right shows the missing vertical support at ground level caused by the complete lack of mortar to hold it in place.

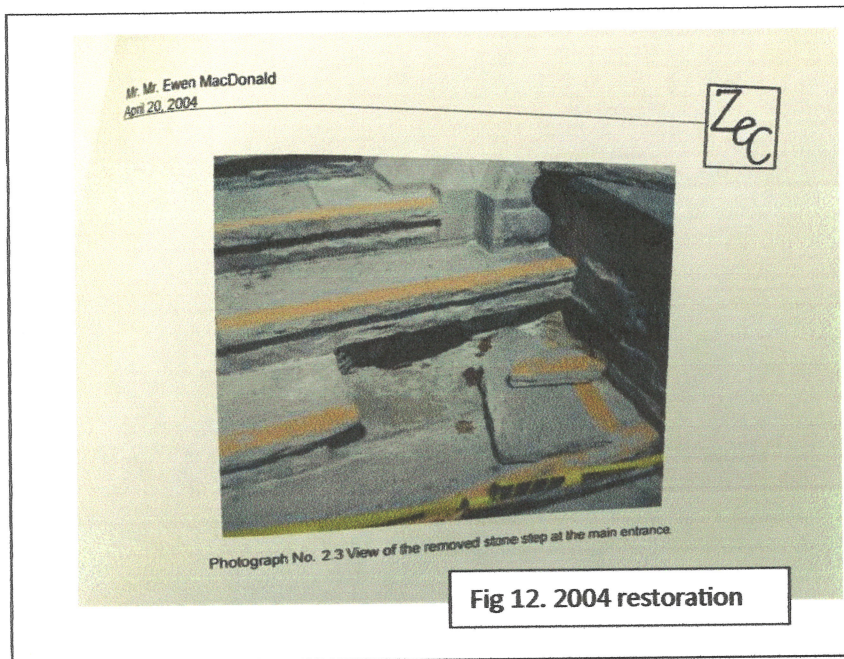
2004 restoration -mid construction – note the substructure of compacted gravel beneath the stone slabs. This is being replaced by a concrete substructure.

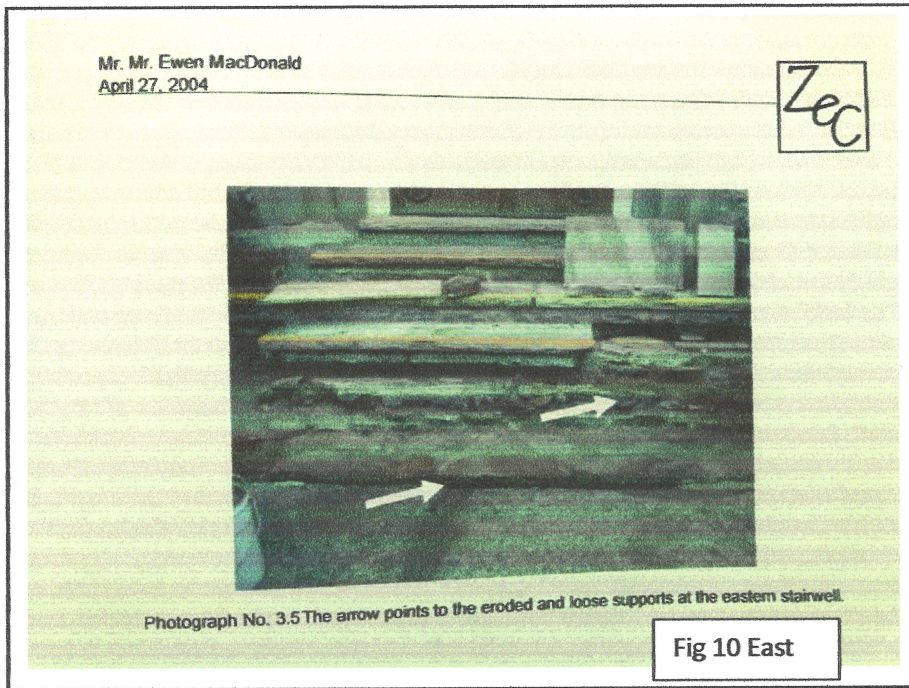
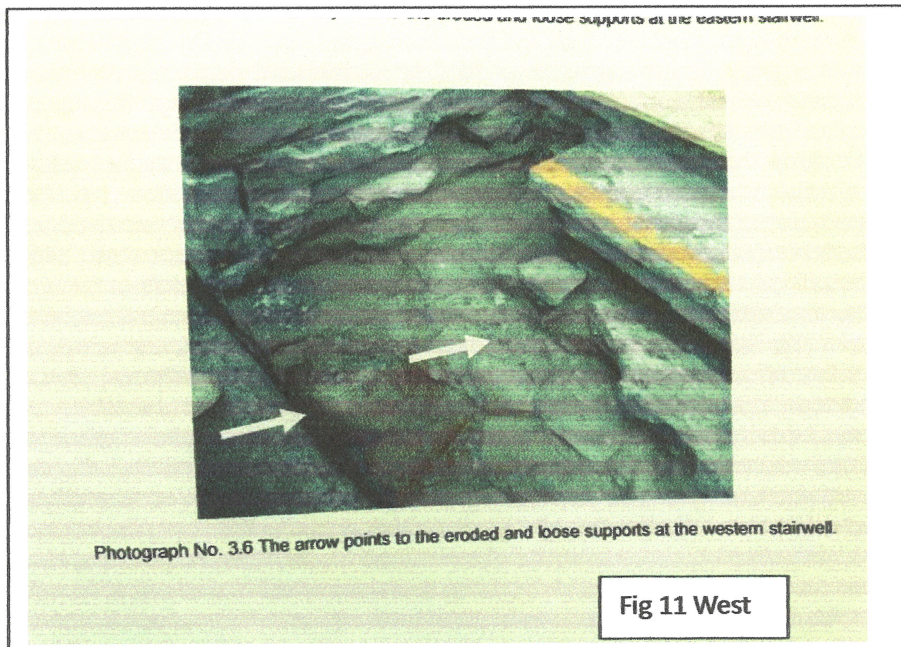
These two photos from the 2004 engineers report show the underlying stone platform that was repaired at that time and will be used again in this restoration
