**St Andrews Presbyterian Church**  
**Heritage Permit Application**  
**Eaves Repairs**

**Re: 44 Church St East (St. Andrews Presbyterian Church), Brampton, ON**  
**Exterior Eavestroughs/Gutters and Attic Condition Review**  
**Letter Report**

## Condition Review Report

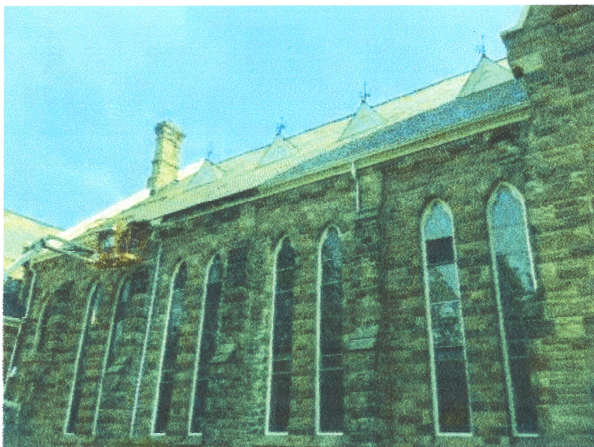
1. The eavestrough (gutters) consist of a 150mm (6") wide galvanized gutter attached to the edge of the roof with galvanized steel spike nails approximately 254mm (10") long and 406mm (16") spacing. Localized corrosion to the base of the gutter and general warping was observed to the majority of the north and west ends.
2. The slate roof above the eavestrough had a metal flashing approximately 900mm (36") edge metal flashing which appeared to be painted black galvanized metal flashing with drip edge, draining into the

gutter. Notched ends of the flashing around the gutter spikes were observed with general gaps/openings which are direct entry paths for water to enter below the fasteners and behind the gutter down the exterior wall.

3. Below the eavestrough is a wood crown moulding trim and fascia board, general weathering and wood rot was observed. At the north end, signs of pest/rodent damage was also observed.
4. The rafter ends where exposed at the north/west ends, contain areas of weathered ends with cracked/split ends which are generally not suitable for gutter faster re-attachment.
5. Generally warping to eavestroughs, tilted and rotated, indicative of sliding snow impact damage was noted on the north and west ends. The east elevation had 3 full rows of snow guards with limited damage to the eavestroughs where as the north and west and partial snow guards. The west side has 4 dormers where the sliding snow appears to collect which coincides with the gutter damage.

Photo 1: View of west elevation with zoom boom review .

2. **Priority Gutter and Fascia Board Repair (North, East, West) ..... Est. \$120K to \$160K + HST**

- a. Remove and replace existing gutter with a prefinished aluminum gutter at north, east and west ends.
- b. Further review and reinforce exposed/damaged rafter ends to support new gutter (Est. 25% rafter end locations).
- c. Replace the rafter end fascia board with a new sealed and painted board.
- d. Install new crown moulding
  - i. Option 1: Wood crown moulding painted
  - ii. Option 2: Aluminum crown moulding prepainted (low maintenance option)
- e. Roof edge repair – salvage roof edge metal flashing. Cut back and modify with a new drip edge and sealant.

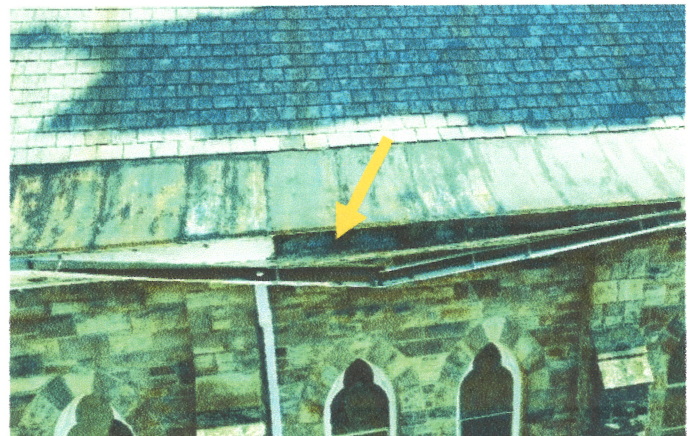
Photo 2: View of west gutter. Red arrow denotes exposed rafter ends prior to gutter section removal.

In our opinion, the observed damage is a result of a combination of water infiltration by-passing the gutter and causing water penetration / damage to the roof rafter joists ends and sliding snow impact damage. As water penetrates this area it has caused some wood decay/rot, reducing the effectiveness of the gutter spike fasteners which hold up the gutter. In addition, the sliding snow of the north/west sides, due to lack of snow guards, has caused additional damage which further exacerbated the roof gutter and edge condition and wood rot. The extent of the damage reviewed was mainly concentrated on the north and west elevations, sliding snow on the roof edge has a tendency to exert force/damage under certain climatic conditions, sliding snow will mimic an "avalanche effect". While the east side was only reviewed from ground level due to access issues with the boom, the east side was in generally better condition overall, which appears to be due to the presence of 3 full rows of snow guards. We recommend further review to the east side rafter ends and repairs be carried out accordingly. Should there be budget limitations, the east side could be post-poned or deferred with priority to the North and West sides. Recommended repairs:

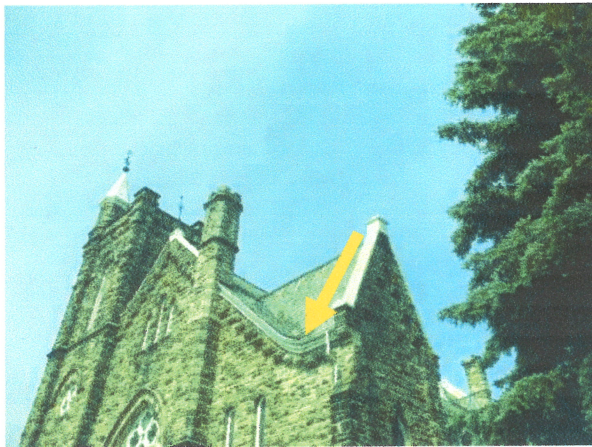
Localized review at the south corner were reviewed with the zoom boom – Refer to SK-03. The area is generally performing, signs of peeling paint and wood rot was observed to the wood crown moulding and gutter. Previous repairs to the roof edge flashing and slate shingles was observed (Refer to Photo 3 and 4 below). Signs of warped/damaged gutter was observed which appears to be from snow damage.

Photo 3: South elevation

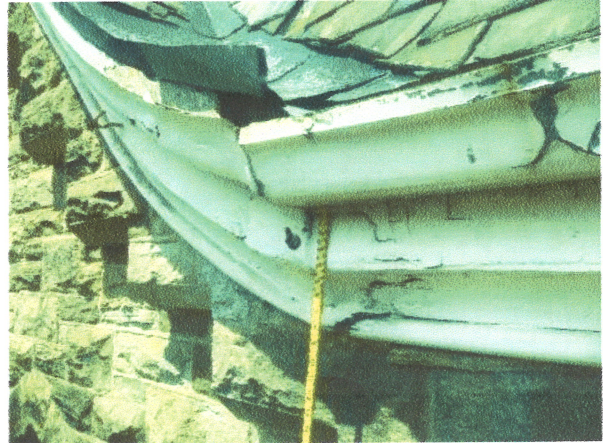
Photo 4: View at south-east corner.

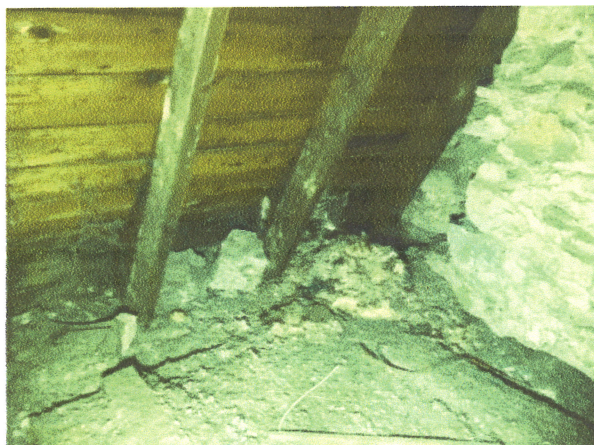
Access to the attic was provided via the south stairwell attic hatch near the bell tower. Generally, aged and weathered wood framing was observed with minimal water damage noted. Attic appeared to contain loose/blown insulation with varying depths of 150mm to 300mm (6" to 12") in depth. Limited review of the archway where accessible (Refer to Photo 5 and 6), Refer to structural report Photo 3 – Appendix B. Generally, the extent of rafter end damage is located on the exterior behind the gutter. There appears to be an air gap behind the edge of roof and plywood layer which appears to extend up 900mm (36"), at this area some ventilation/air leakage appears to be occurring.

Photo 5: View of attic at bell tower.

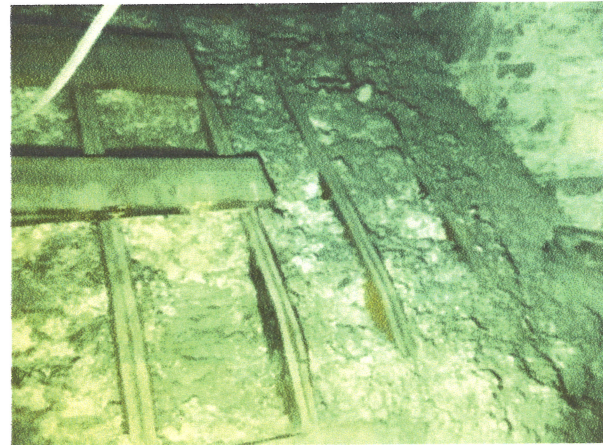
Photo 6: View of attic at archway.

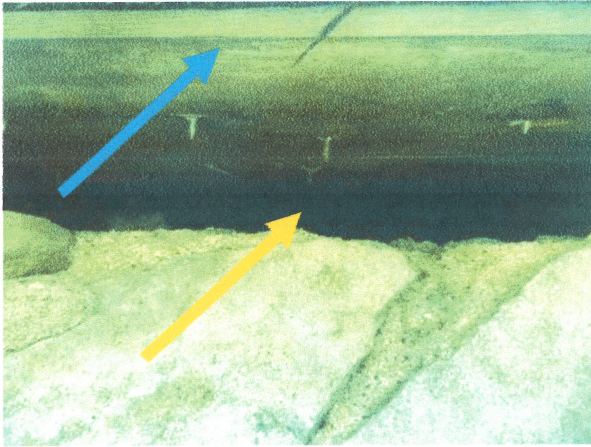
**Photo 7: View of roof plywood edge below gutter. Red arrow denotes gap between stone masonry wall and underside of sheathing. At this area, some air leakage/ventilation is occurring. Blue arrow denotes underside of plywood roof edge.**

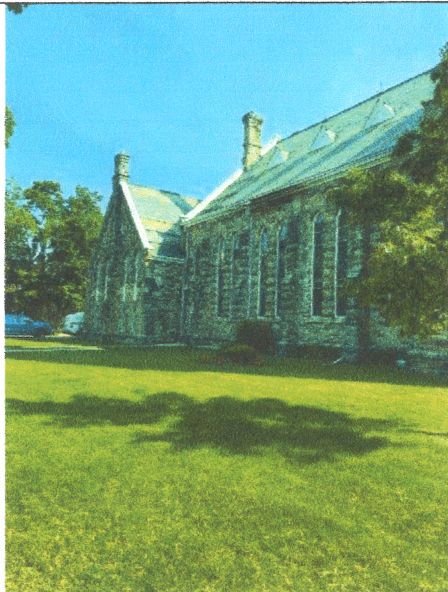
5. It was observed that at the south-west elevation the existing eavestrough was observed to be damaged.
6. At the time of our review, at the damaged area, the existing fascia board was partially removed to expose the existing roof rafters.

Photo 2 – Damaged eavestroughs on existing south-west elevation

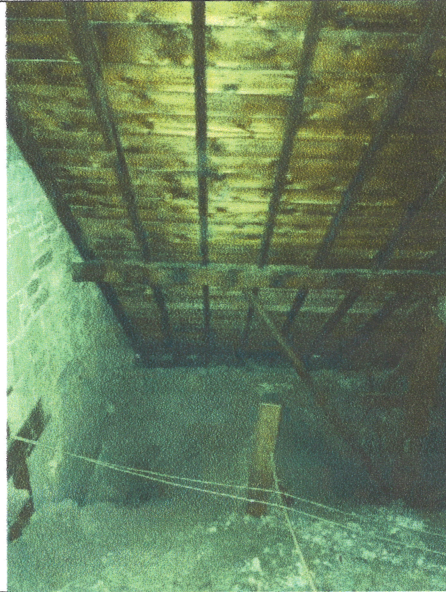
3. The building was noted to have been constructed in 1880 and was noted as being Heritage Designated.
4. The existing roof structure was observed through an existing ceiling hatch (limited access and visibility) to be conventionally sticked framed timber roof atop masonry stone masonry exterior walls.

Photo 3 – Existing roof framing

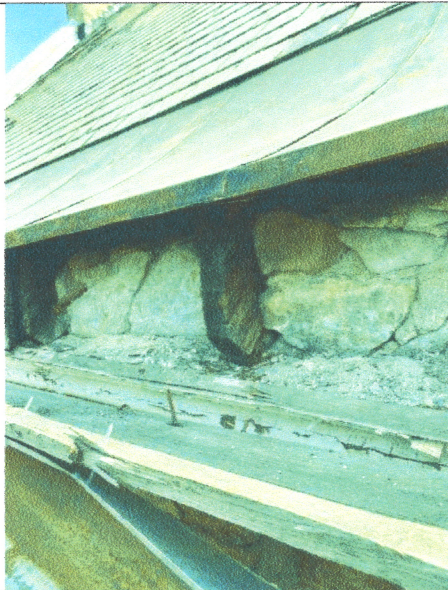
Photo 4 – Edge of existing roof rafters with existing fascia board removed.

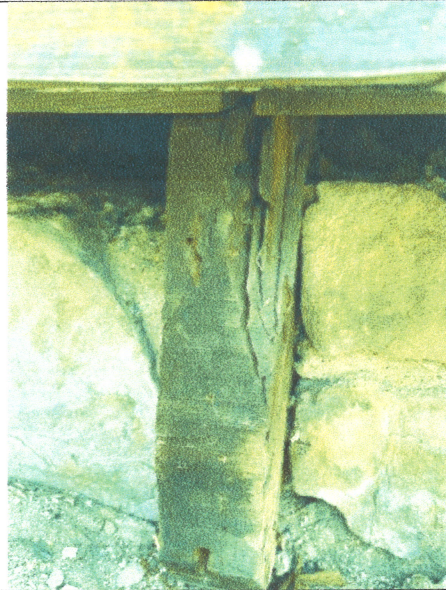
7. It was observed that at several roof rafters, the ends of the rafters were locally degraded likely due to moisture/water exposure and dry rot. The degradation was observed to be at the ends of the overhang and did not appear to extend along the end of the rafters over the existing masonry wall or into the ceiling space.

In our opinion, the damaged observed at the ends of the existing roof rafters is likely due to water infiltration but is very local to the ends of the rafters only. We recommend that the ends of the rafters be locally retrofit where damaged and a new fascia board be installed where required. Refer to the attached SK-01 for repair details.

Photo 5 – Dry rot/damaged ends of existing 2x12 rafter

NEW 2x4 EACH SIDE OF EXISTING DEGRADED ROOF RAFTER. NAIL AND GLUE TO EX RAFTER W/ 10d NAILS @ 8" C/C STAGGERED

NEW 6"x6"x14GA L-STRAP (BY SIMPSON STRONG TIE OR EQUIVALENT) NAILED TO 2X4 MEMBERS, TYP
