**8331 HERITAGE  
ROAD, BRAMPTON,  
ONTARIO  
MCCLURE  
FARMHOUSE**

**HERITAGE IMPACT  
ASSESSMENT**

FINAL REPORT - AUGUST 2023

PREPARED BY:  
ATA Architects Inc.

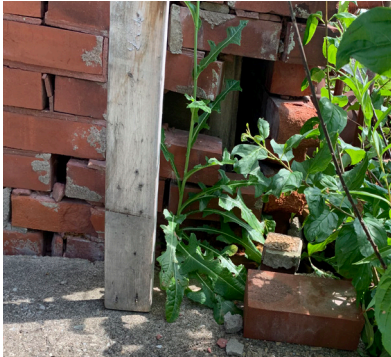
South Corner of the Front Porch

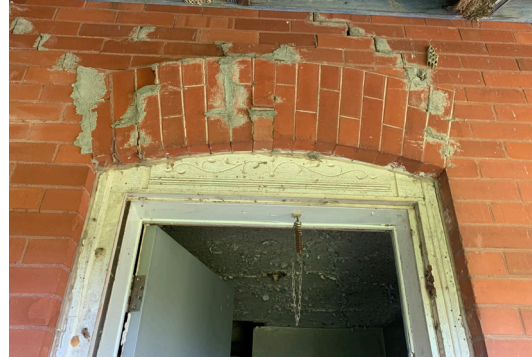
Main Entrance Doorway

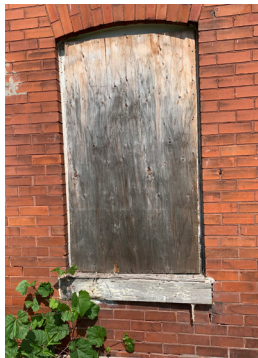
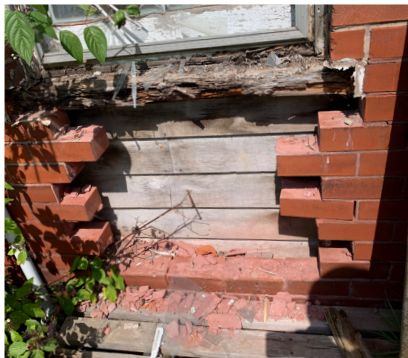
Figure 10  
Typical Brick Failures  
Source ATA Architects Inc.

Exterior South Wall - Brick Wall with 1"-3" Air Space Between Brick and Wood Cladding

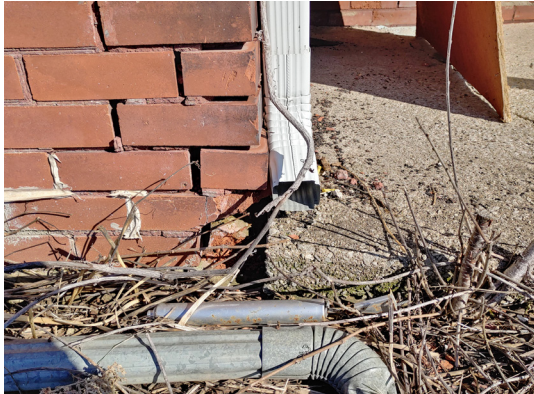
The brick rosettes were another distinctive feature. They remain largely intact but weathered and damaged by poor maintenance. As documented in 2020 Conservation report, the brick envelope has separated from the structural wood framing, leaving a gap between of 1-3 inches. This has resulted in extensive cracking of the mortar joints and dislocation of feature elements such as the arched voussoirs and the rosettes. Several of the brick corners near grade have been badly damaged and will require reconstruction.

Brick Corner

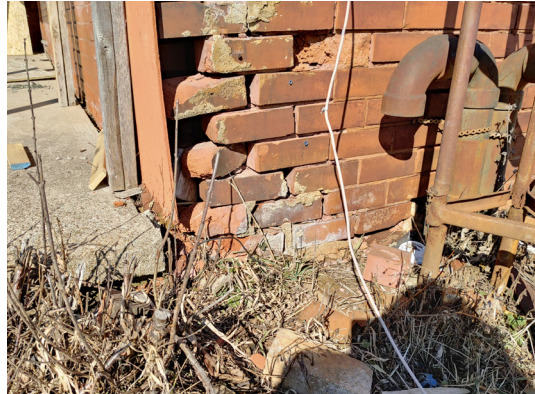
Brick Corner at Porch

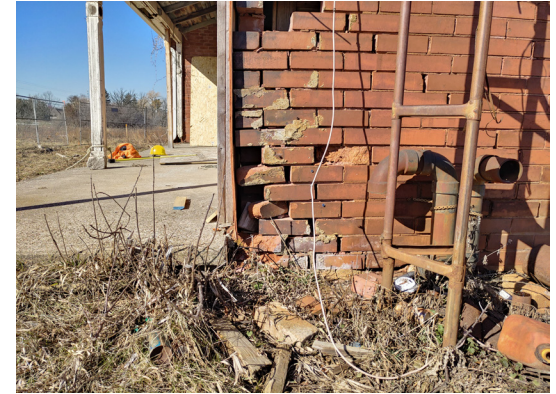
Porch

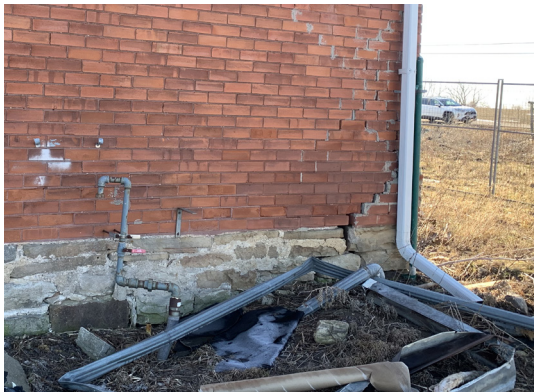
Foundation and Brick Corner, North Wall

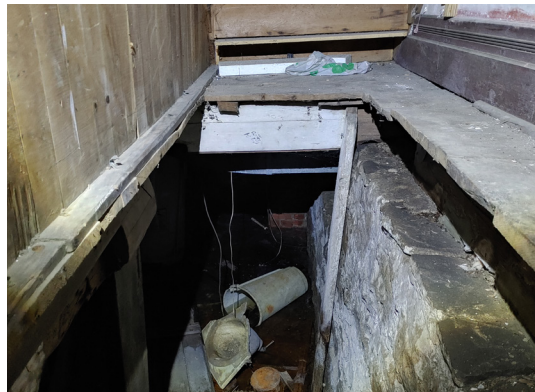
Flooded Basement

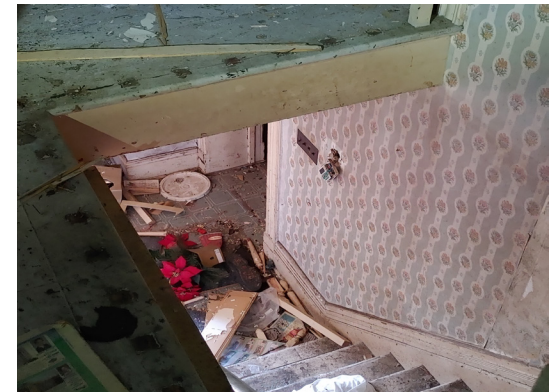
Main Stair

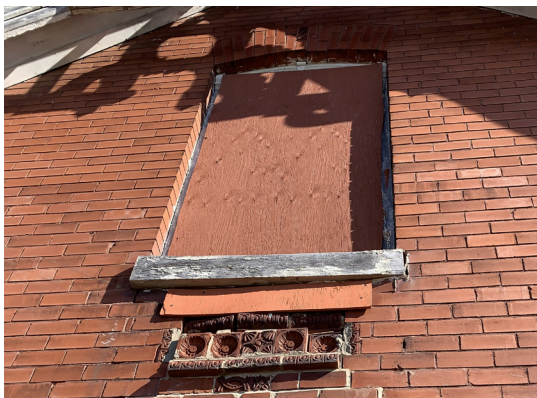
Gable Front - Cracks in and around patched Rosettes

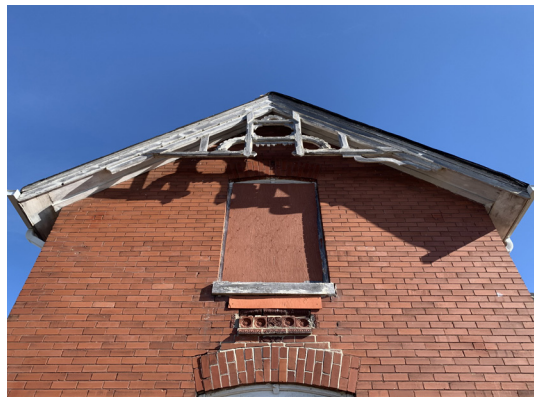
Front Gable

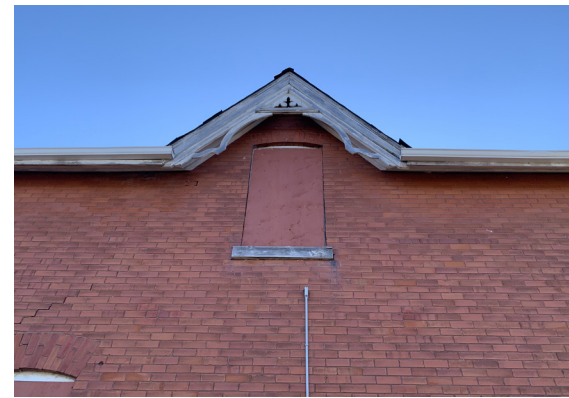
Gable Detail

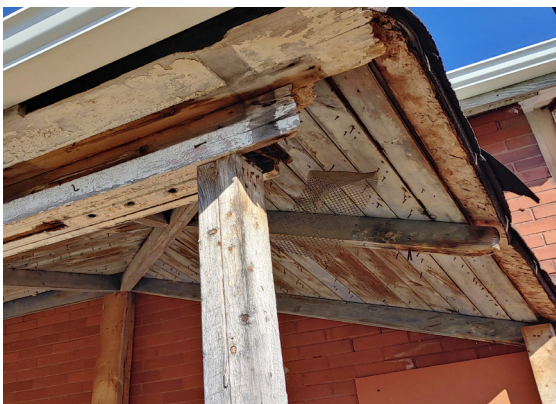
Remaining Evidence of the Porch Gingerbread

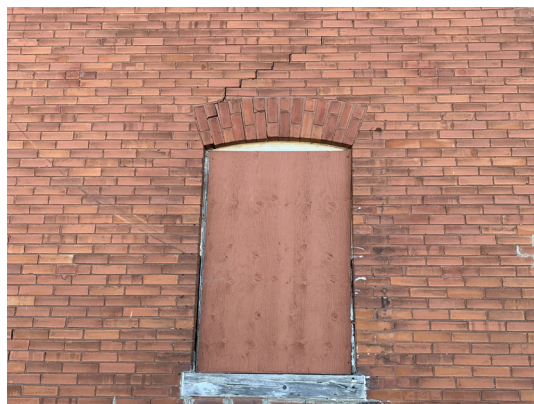
Window Masonry Cracks

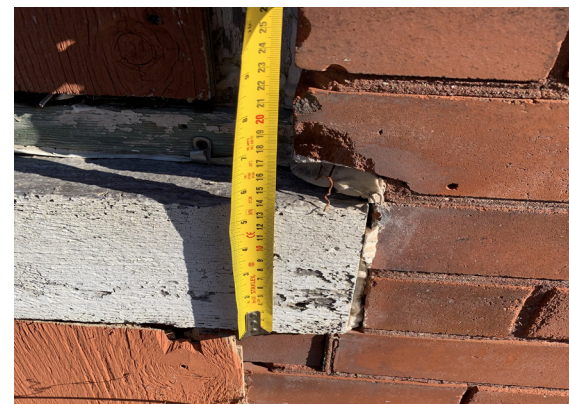
Although the original window openings remain in-place, there are few of the remaining windows that can be repaired and restored. The majority of windows have been lost. Some of the wood sills are salvageable, others have deteriorated due to prolonged weathering without a protective coating. The interior hand hewn beams and tenon join construction would likely be concealed in any rehabilitation of the McClure House and likely augmented with new construction materials to meet current Ontario Building code requirements.

Sill Detail/ Damage

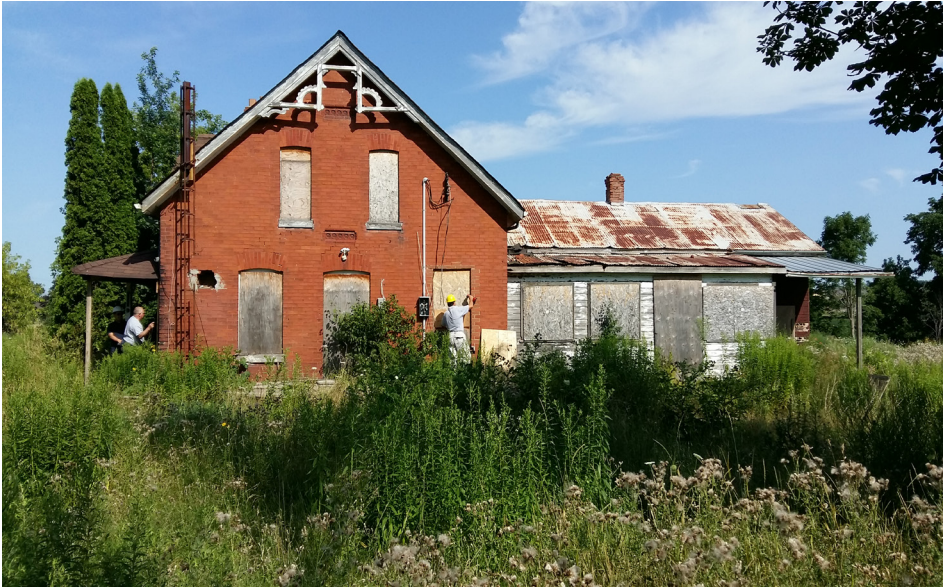
Figure 16  
Start of Additional Conservation Measures 2019  
Source ATA Architects Inc.

The condition of the house has been stabilized over the past three and a half years. The site was cleaned to discourage vandalism, all openings were boarded up securely, and a security fence was installed around the entire perimeter. New eavestroughs and downspouts were installed. The existing roof was covered with roofing felt. The existing chimney was covered at the top to prevent rodent access to the house. Since the original intent was to relocate the house, additional repairs and restoration/ rehabilitation of the house was to be postponed until the move was completed. The photographs of the current conditions illustrate that extended neglect of maintenance for the house over a prolonged time has resulted in substantial weathering and damage to both the exterior and interior of the house.
