8331 HERITAGE  
ROAD, BRAMPTON,  
ONTARIO  
MCCLURE  
FARMHOUSE

DATE: AUGUST 2023

PREPARED BY:  
ATA Architects Inc.

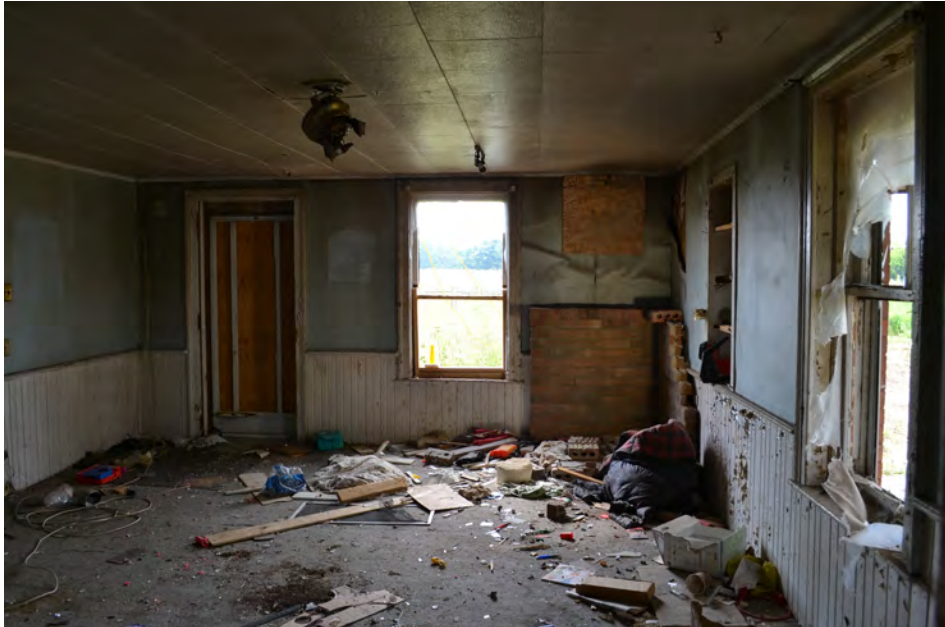
1.1) View of living room in original portion of the house to the south. The view looks towards a wood double-hung window, exterior door, and features a brick wood stove hearth. The wainscoting, and door and window trim are likely original but in poor condition with wood deterioration.

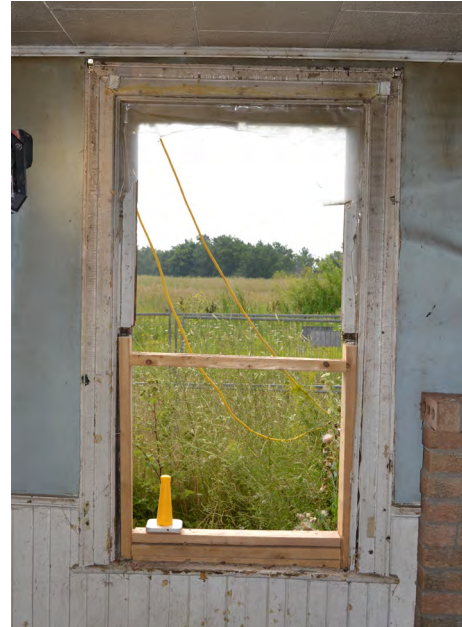
1.2) View of double-hung wood window on the south exterior wall in living room. The window is likely original but is very damaged and is missing a large portion of the window frame and muntins. The wood window trim and sill have some wood deterioration.

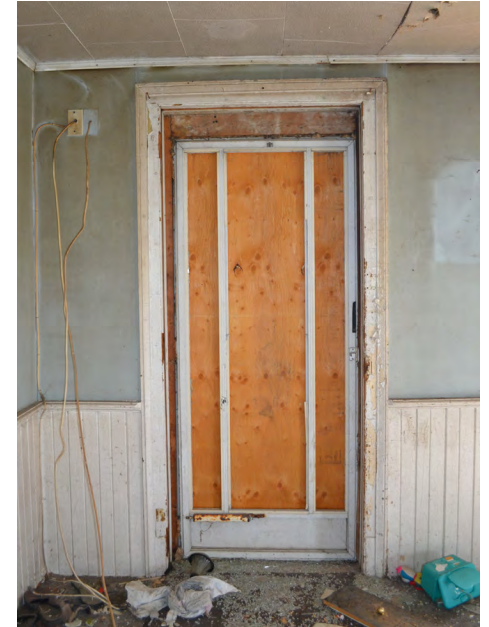
1.3) View of the door on the south exterior wall in living room. The door is missing and only the metal screen door remains. The door trim is damaged but able to be repaired.

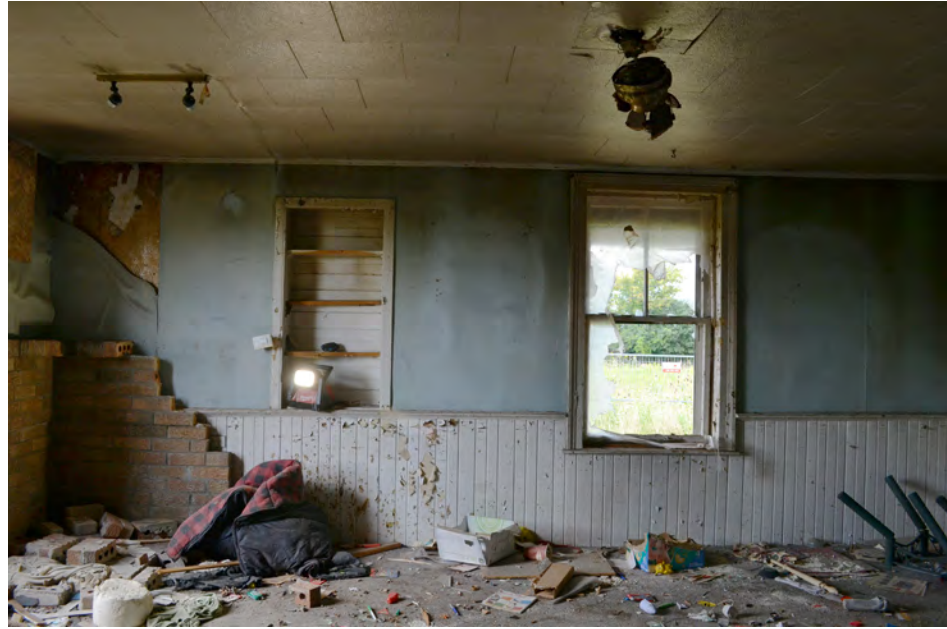
1.5) View of living room in original portion of the house to the west. The view looks towards a wood double-hung window and storage niche built into the exterior wall. This is likely a later addition as the wood trim does not match that of the windows and doors. The shelves and trim surrounding the niche are damaged.

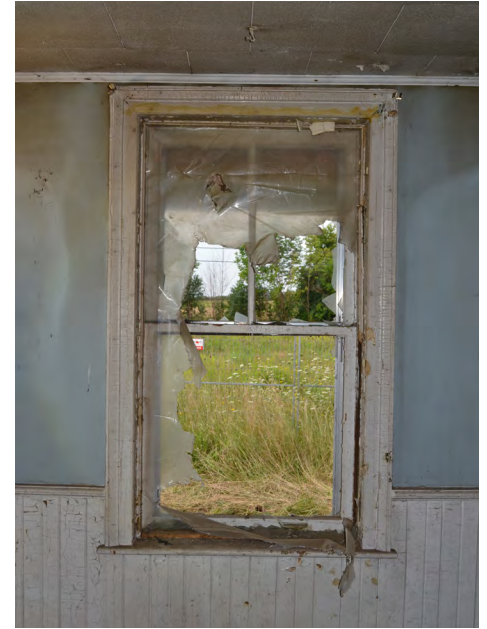
1.6) View of double-hung wood window on the north exterior wall in living room. The window is likely original and the entire window frame remains intact and is in fairly good condition overall, with some damage that is repairable. The window is missing muntins on the lower half, however these can be replaced. The wood window trim and sill have some damage and wood deterioration but are salvageable.

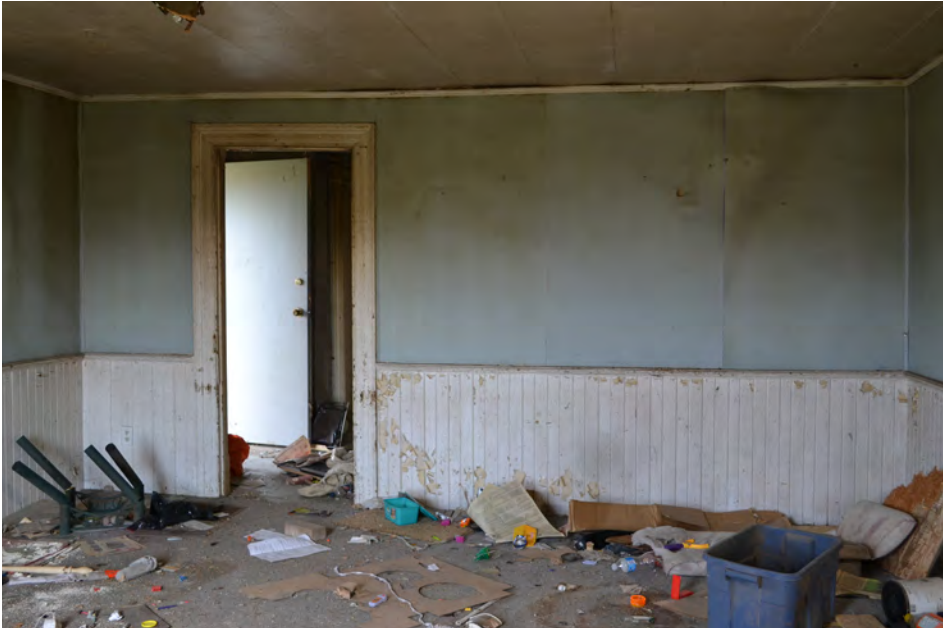
*1.7) View of living room in original portion of the house to the north. The doorway opens up to the foyer. The wood door trim has some deterioration but can be repaired. The wood wainscoting that runs the perimeter of the living room is in fair condition and much of the damage is limited to the paint which is flaking and alligatoring. The paint would need to be stripped to be able to fully assess the extent of the damage to wood beneath.*

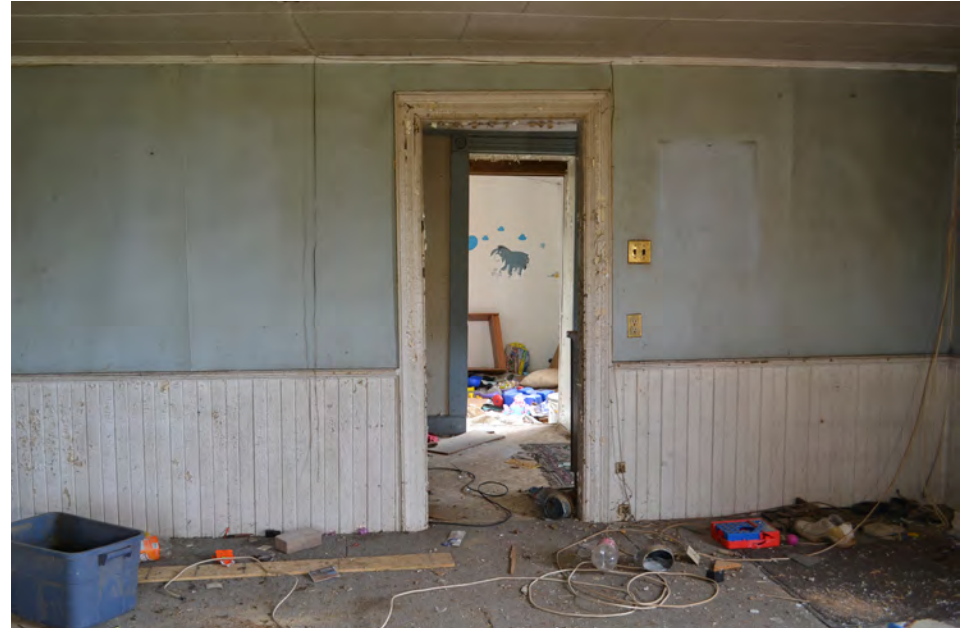
*1.8) View of living room in original portion of the house to the east. The doorway opens up to the second kitchen and schoolhouse at the rear. The wood door trim appears to have some deterioration but can be repaired.*

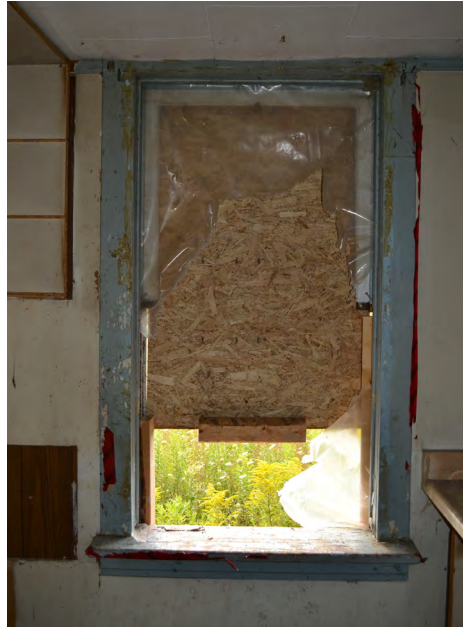
1.10) Closeup view of the window in Kitchen 2. The window sash and much of the window frame is missing, as are the muntins.

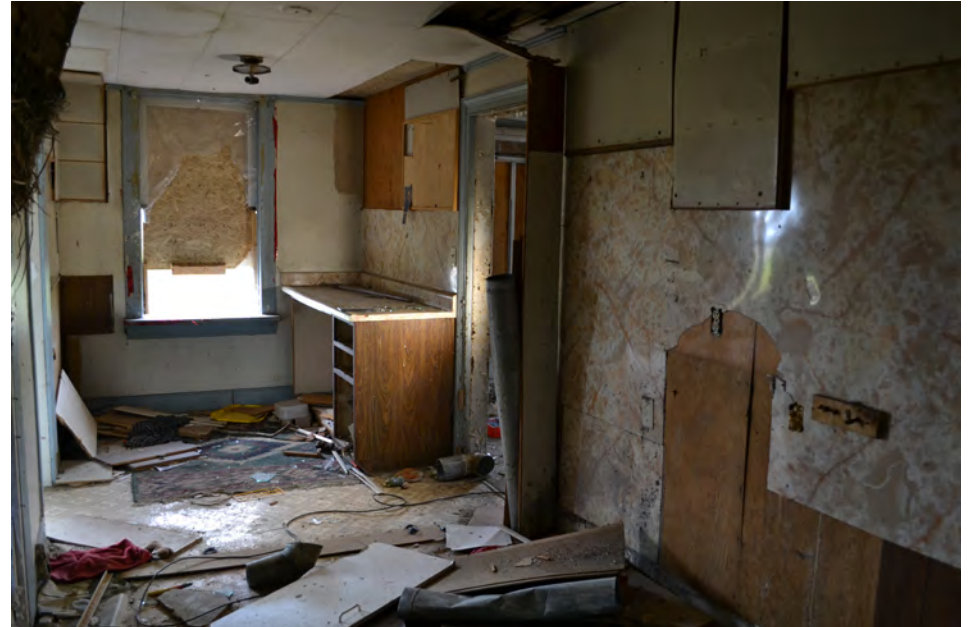
1.11) View of Kitchen 2 in original portion of the house to the south-west. Framed doorways on either side open up to the living room and school house addition. The demolished kitchen millwork lies on the floor.

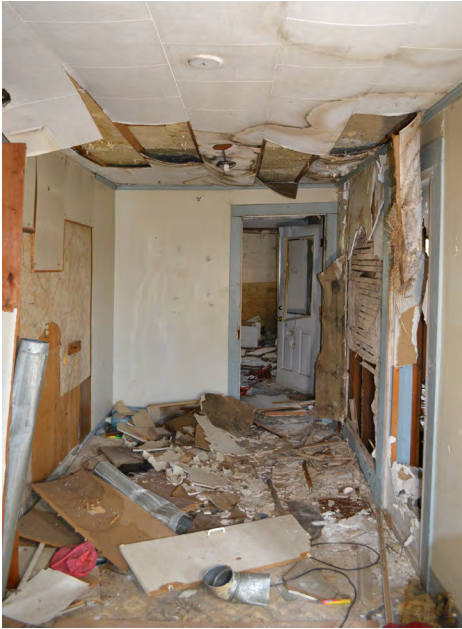
1.12) View of Kitchen 2 to the north, looking towards the corridor to Kitchen 1. The ceiling tiles have mold and water damage. There is a large hole in the wall between Kitchen 2 and the school house addition, where the plaster and lath are broken.

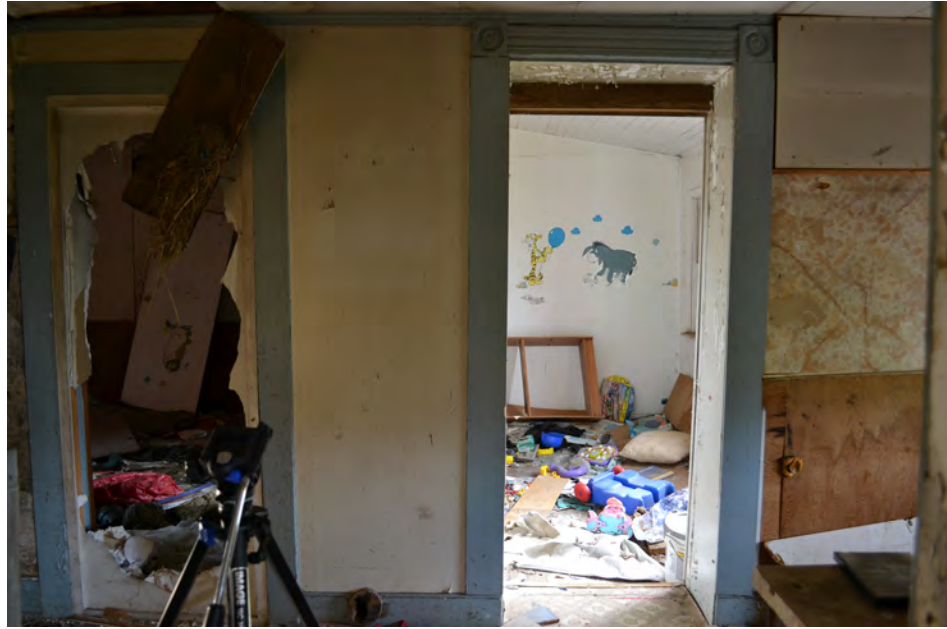
1.13) View of Kitchen 2 to the east, looking towards the school house addition. The wood door trim at the entry to Room 2 of the school house features bullseye corner blocks and the beaded casing at the top frame. The door trim and baseboard trim are both in good condition.

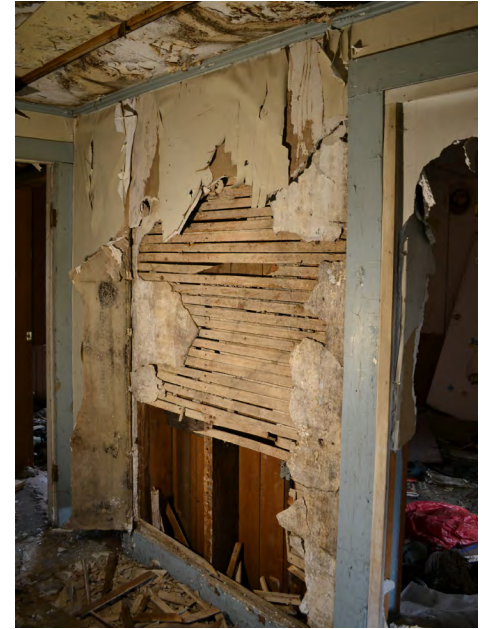
1.14) Close-up of damaged wall between Kitchen 2 and the school house addition.

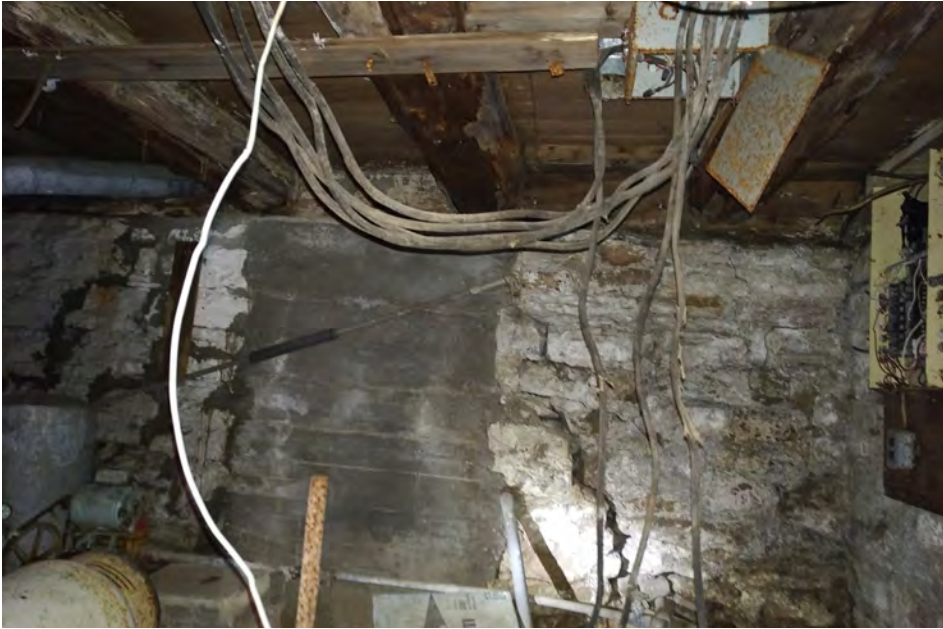
1.19) View of basement beneath original portion of house. The fieldstone foundation is unfinished and exposed throughout. A hole was made at one point and later patched up.  
Source: Tacoma Engineers, November 24th, 2017.

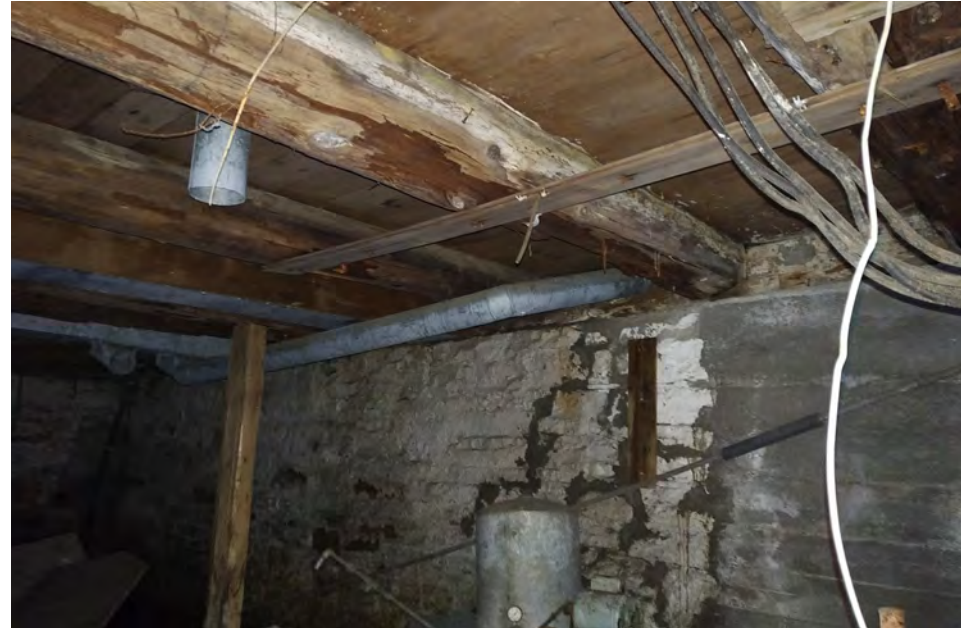
1.20) View of basement beneath original portion of house, looking to east. The framing of the ground floor is exposed indicating that the floor structure is framed with hand-hewn beams.  
Source: Tacoma Engineers, November 24th, 2017.

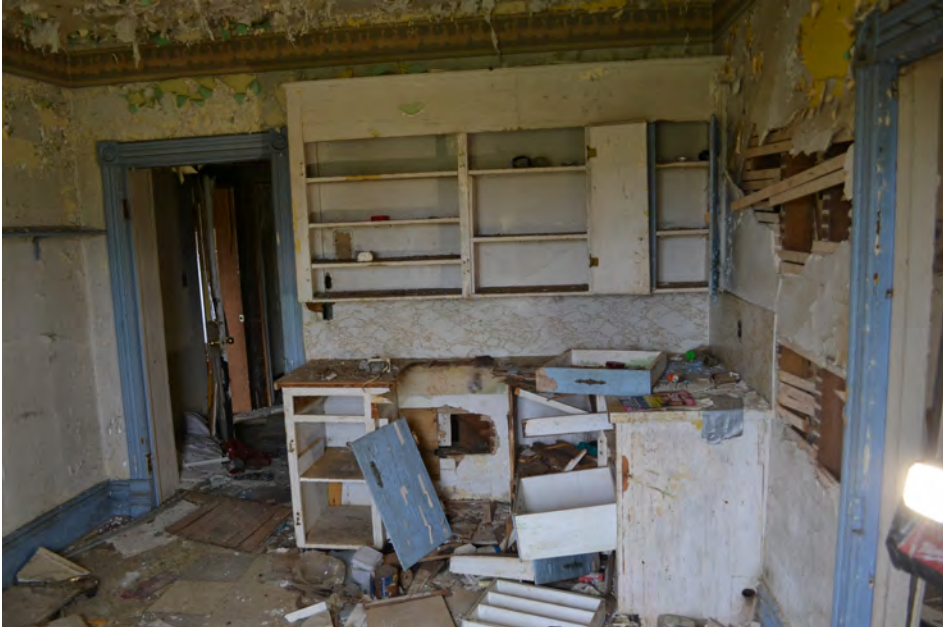
*1.21) View of Kitchen 1 in the later addition to the north of the house, looking to the south. The kitchen millwork consisting of upper and lower wood cabinets is damaged.*

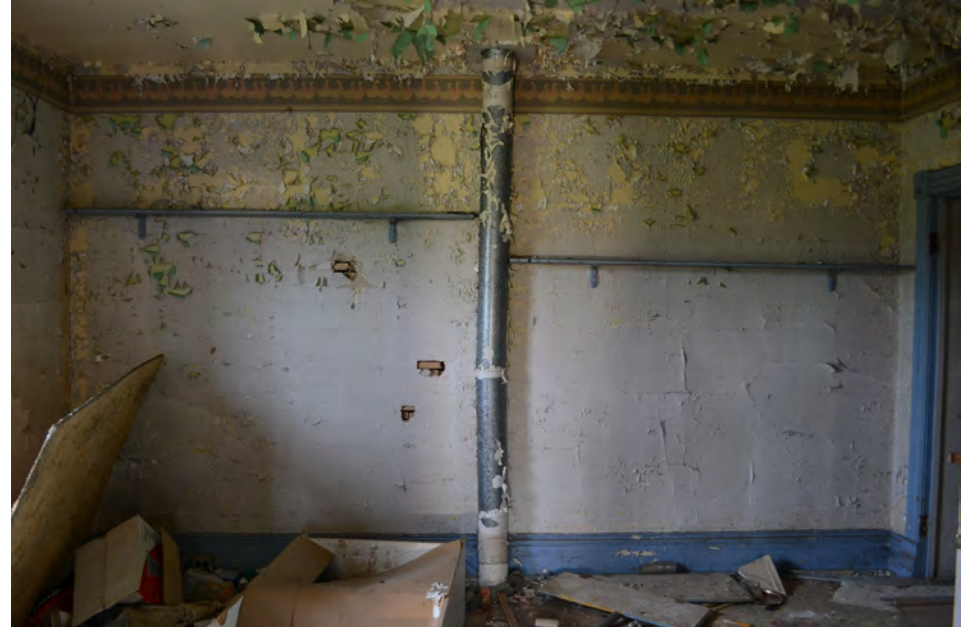
*1.22) View of Kitchen 1 to the east. There is unsightly peeling, cracking, and flaking of paint from the walls and ceiling. Cracks in the plaster expose the wood lath beneath. A duct runs from floor to ceiling against the east exterior wall of the later addition.*

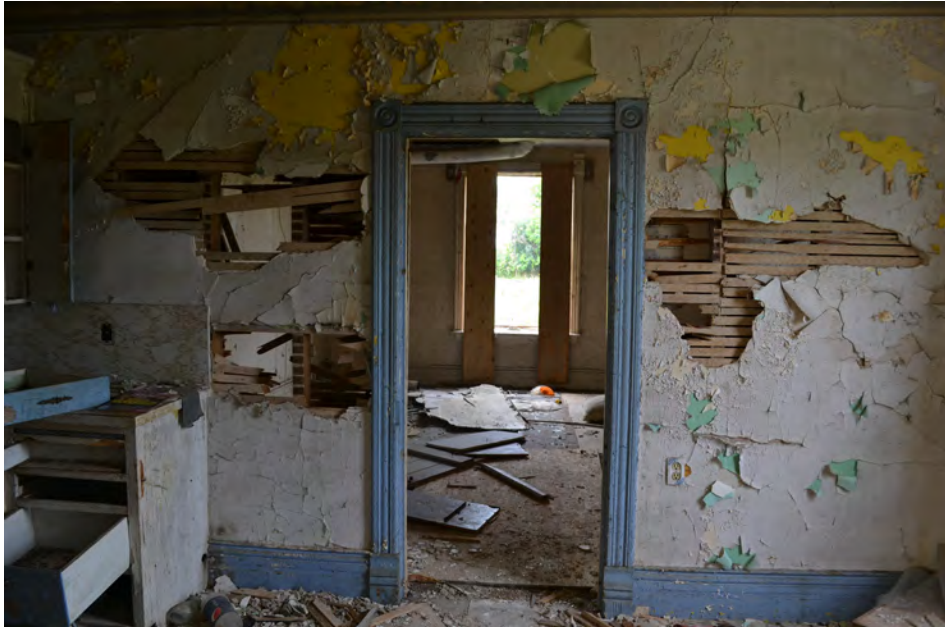
1.23) View of Kitchen 1 to the west, looking towards the dining room at the front of the house. A beaded casing trim frames the doorways with bullseye corner blocks at the top. Plinth blocks are placed at the base of the door trim. Both the door trims and baseboard trim in Kitchen 1 are in good condition. On either side of the doorway, the partition between the two rooms is damaged with broken plaster and lath, and open holes in the wall.

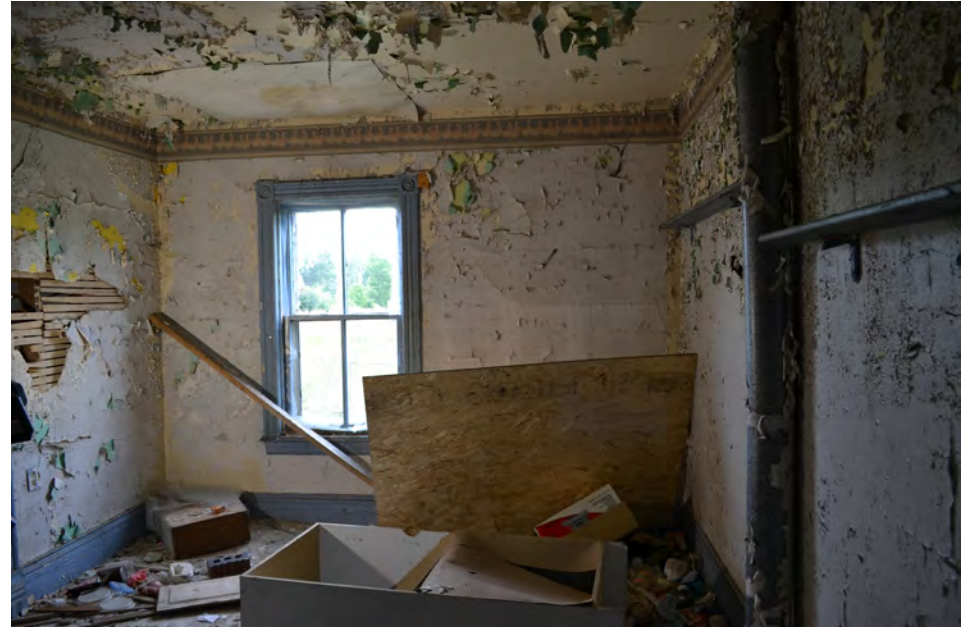
1.24) View of Kitchen 1 to the north. The early wood window remains intact. The wood trim is the same as that framing the doorways and is in good condition.

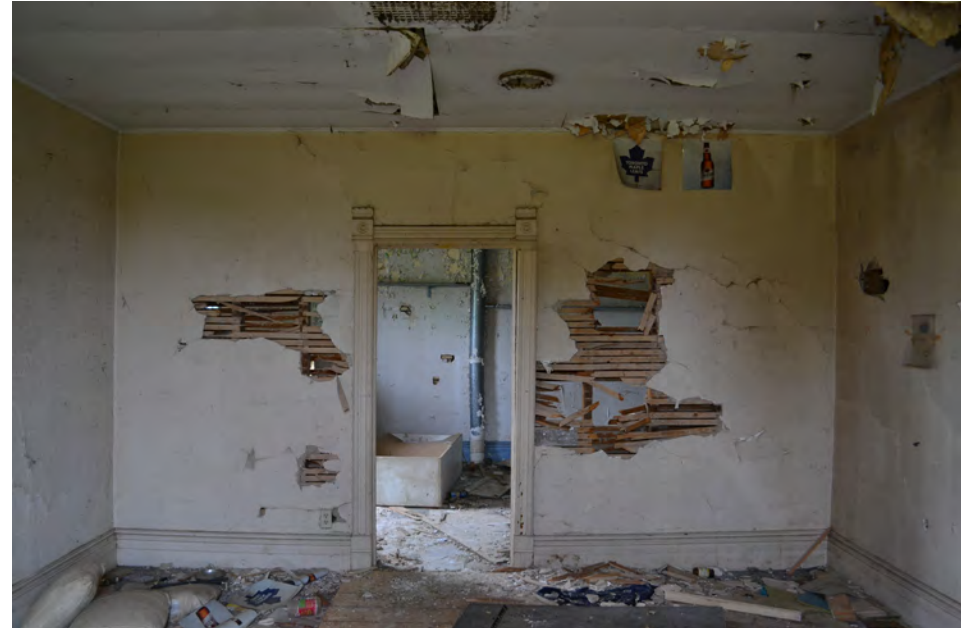
1.27) View of dining room in the later addition to the north of the house, looking to the east. The doorway is framed with a similar trim to that of the adjoining kitchen, a beaded casing featuring bullseye rosette corner blocks and plinth block. There is likewise damage to the plaster and lath on this side of the partition.

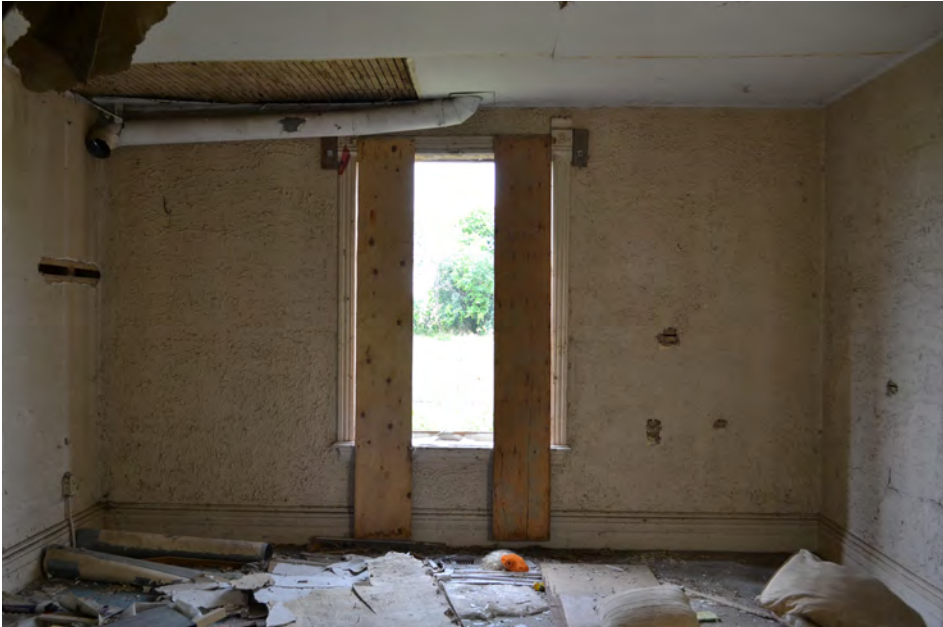
1.28) View of dining room looking to the west. The early window is partially boarded up, but it appears much of the window sash is missing. The window trim remains in good condition. Plaster has fallen off the portion of ceiling to the left of the window, exposing the lath beneath.

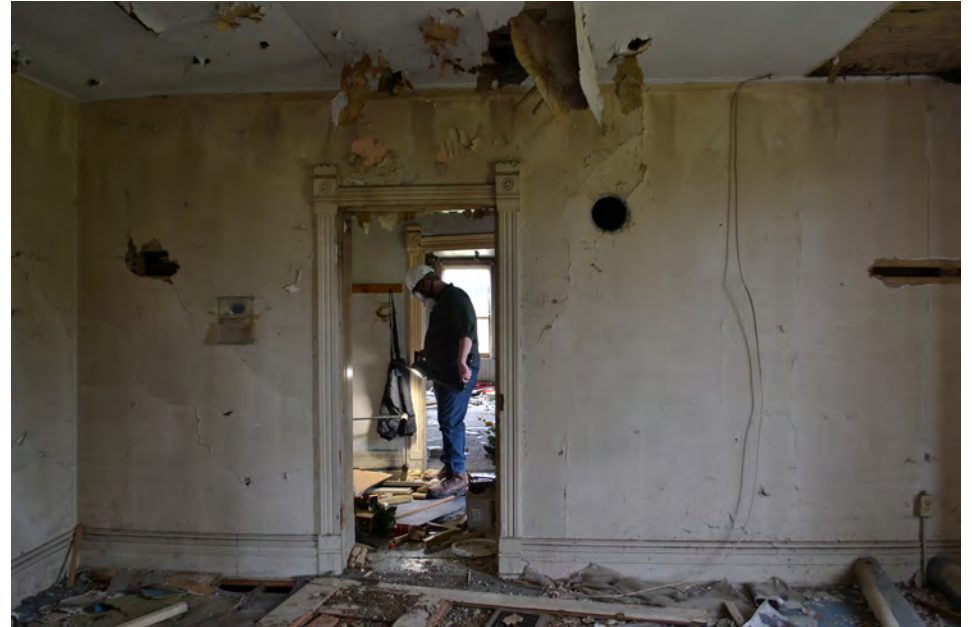
1.29) View of dining room looking to the south. The doorway opens up to the entrance foyer. There are holes in the wall where plaster has fallen off, and where a former duct once ran. The ceiling plaster is damaged and falling.

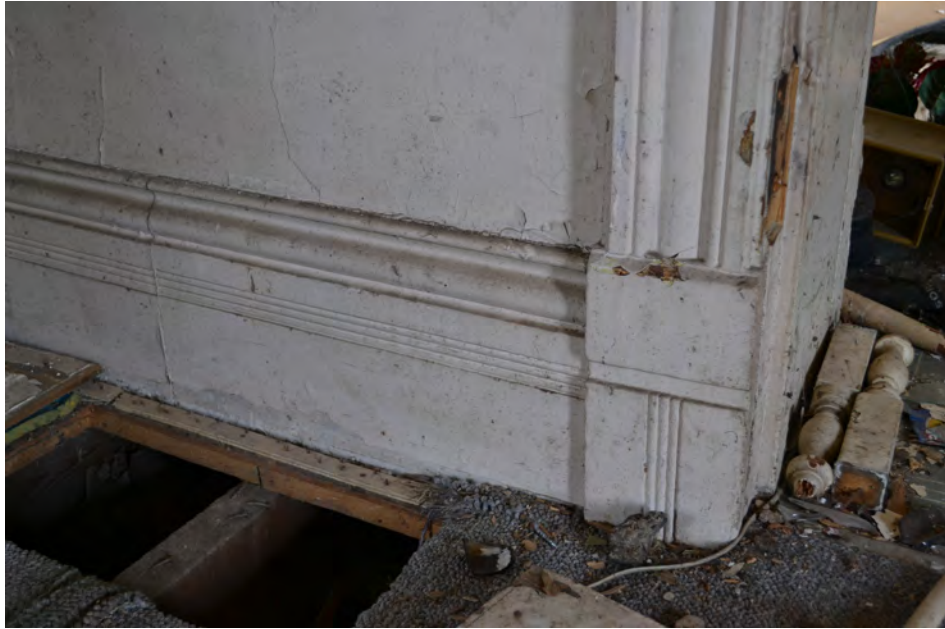
1.31) Close-up view of the baseboard trim and plinth block, both in fairly good condition throughout the dining room. There is a hole in the floor boards likely left by a large vent.

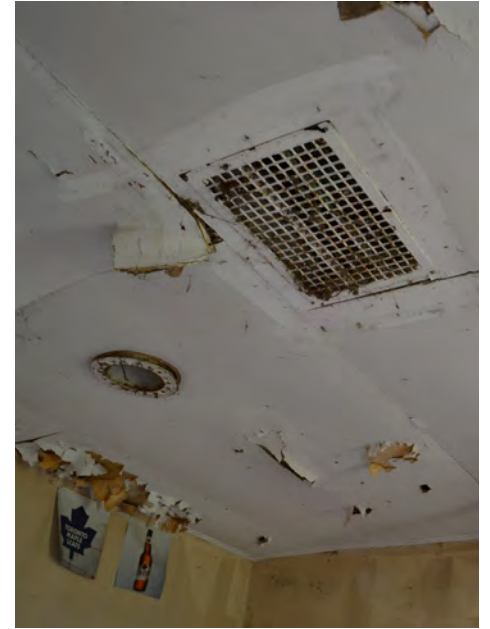
1.32) Openings within the ceiling of the dining room likely for duct work or a vent.

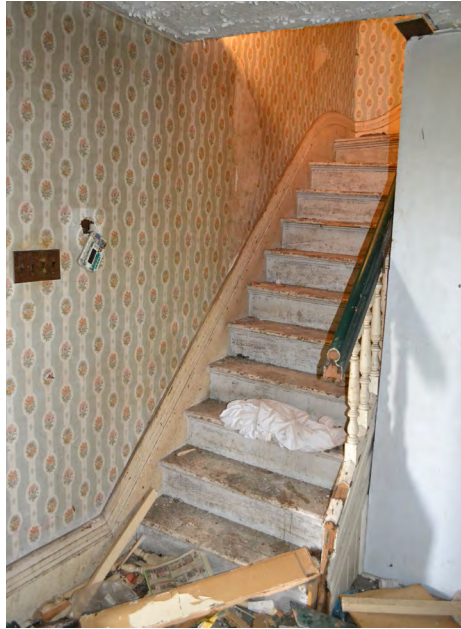
1.32) View from the bottom of the staircase to the 2nd floor. The lower portion of the railing is missing, but a portion remains intact.

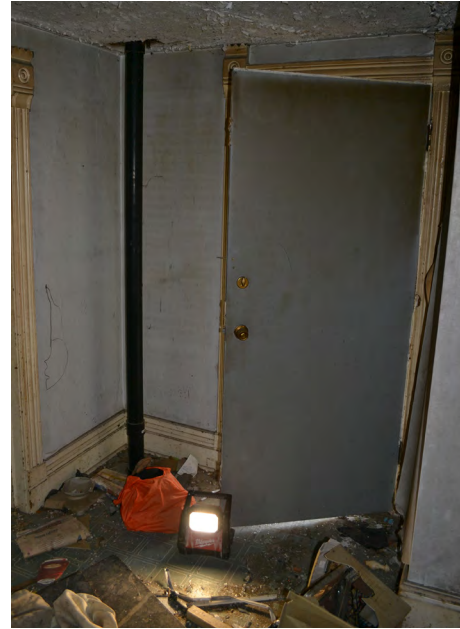
1.33) View from the foyer looking to the entrance doors to the west. Front door is a solid flat panel wood door, unlikely the original. To the left, a pipe runs vertically from floor to ceiling.

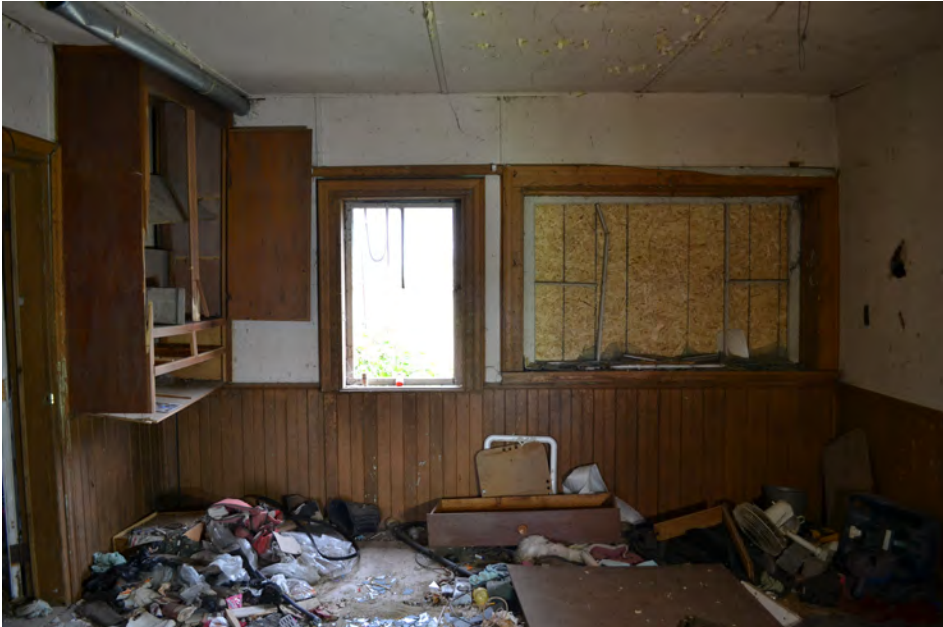
1.35) View of Room 1 of school house addition to the rear, looking to the north. The casement window to the left is intact and is in fair condition. The window to the right has been boarded up; much of the sash is missing and the frame is damaged. Wood wainscoting wraps around the room.

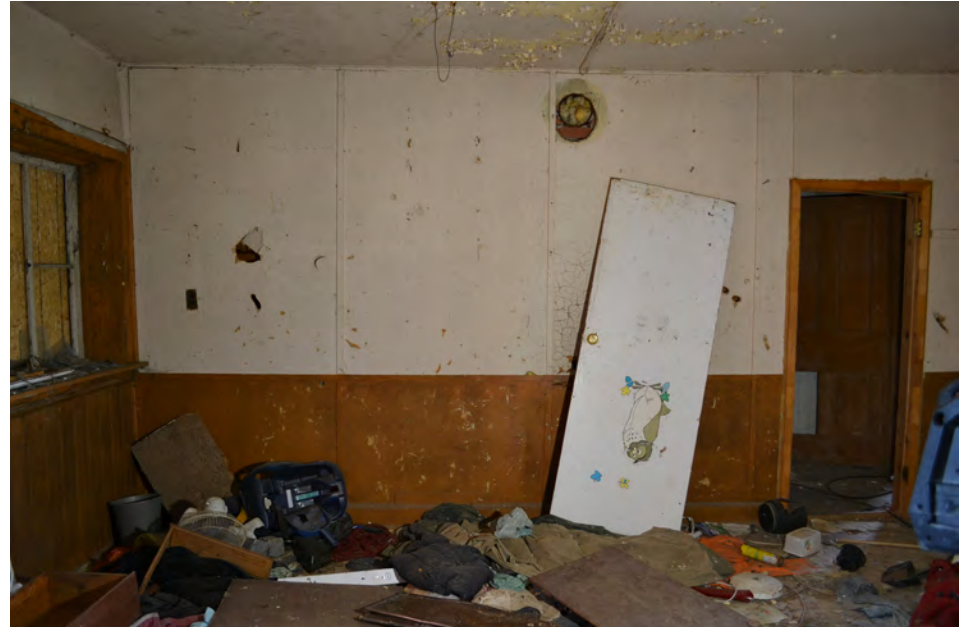
1.36) View of Room 1 of school house, looking to the east. There are small holes in the wall where the plaster has broken or from duct openings. The door has been removed from the frame.

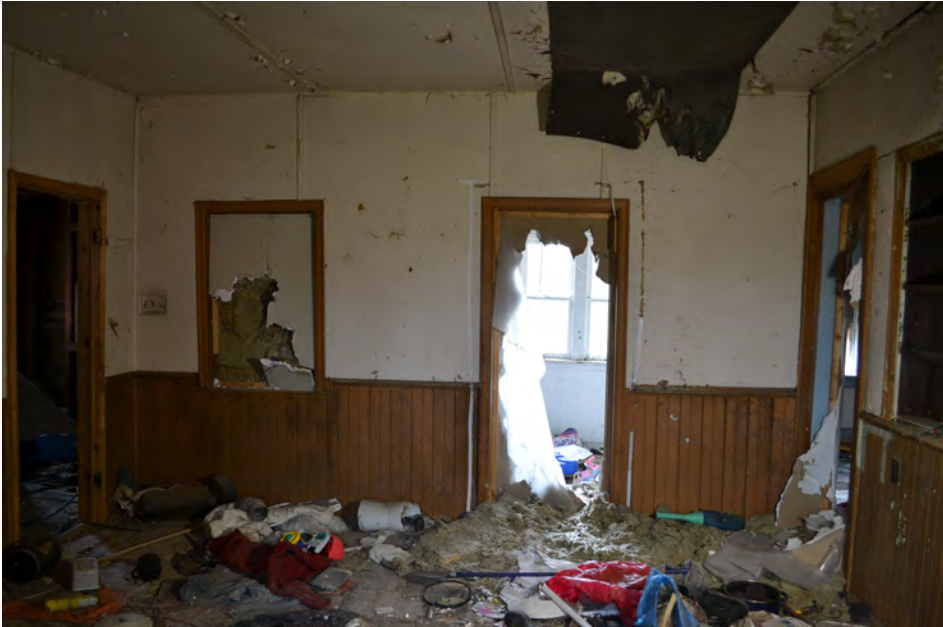
1.37) View of Room 1 of school house, looking to the south. The gypsum board used to board up the doorway and former window had been broken. A portion of the ceiling is falling off. Insulation from these cavities covers the floor.

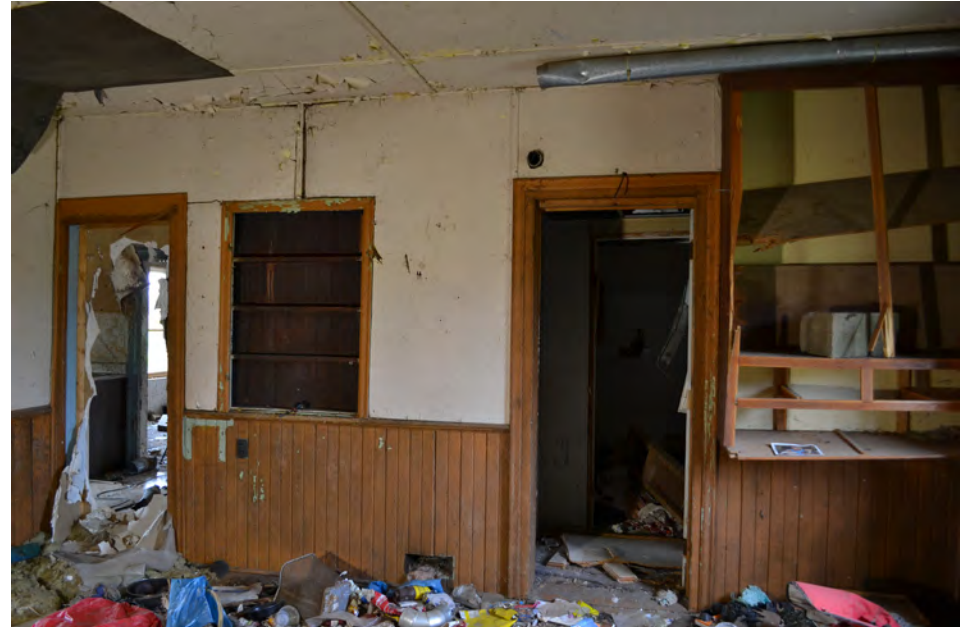
1.38) View of Room 1 of school house, looking to the west. The doorways open up to Kitchen 2 in the original portion of the house. A storage niche with shelving has been built into the adjoining wall. The door trim used in the school house is less detailed than that in the rest of the house. The trims are in fair condition.

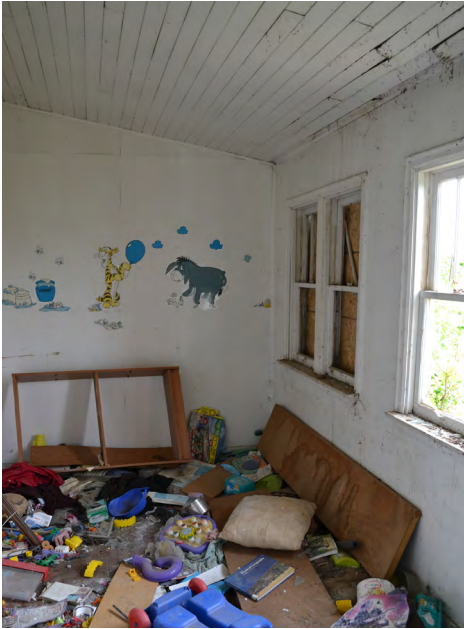
1.39) View from Room 2 of school house addition to the rear, looking to the south-east. There are two double single-hung windows on the south wall. One window is boarded up, the other is open. While missing muntins, the window frame, sill and trim on both are intact.

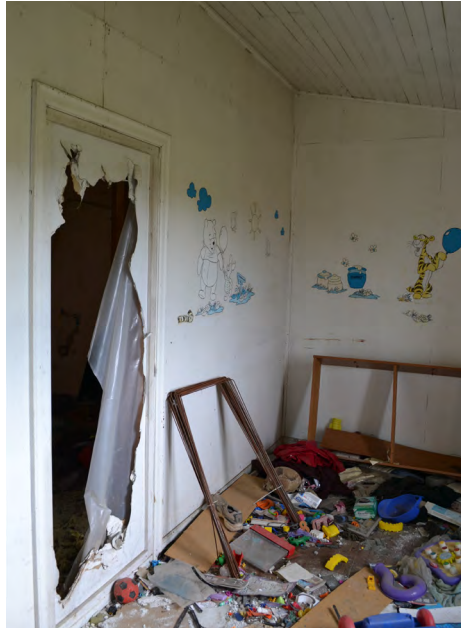
1.40) View from Room 2 of school house, looking to the north-west. Gypsum board covering the doorway to Room 1 has been broken through.

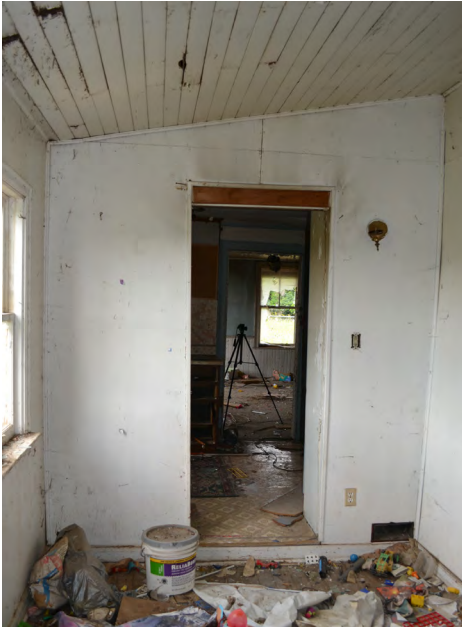
1.42) View from Room 2 of school house, looking to west. The room is 1 step down from the original portion of house. Sloped ceiling with wood board finish. Door trim is missing from the doorway to kitchen 2.

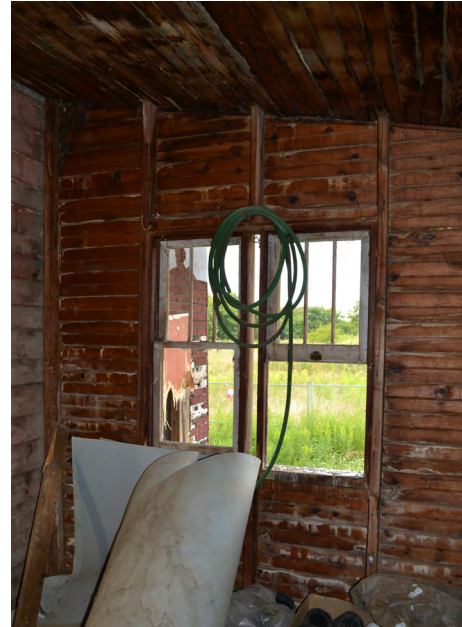
1.44) View of Room 3 of school house, looking to east. Double single-hung windows are missing parts of sash.

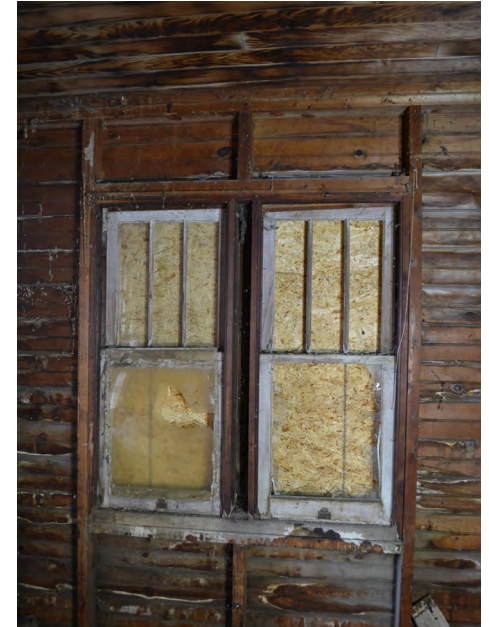
1.45) View of Room 3 of school house, looking to south. Windows are boarded up but remain mostly intact.

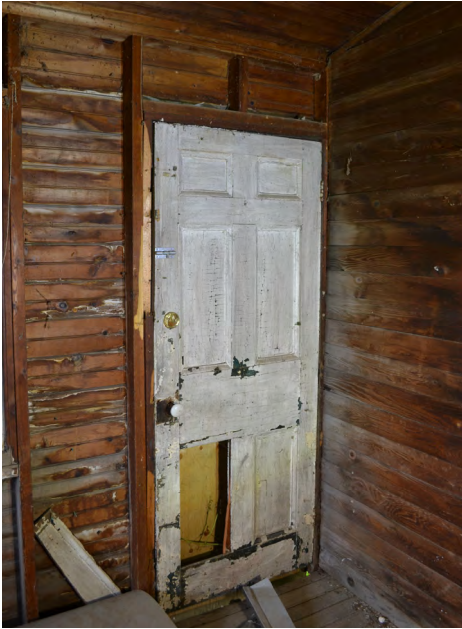
1.46) View of Room 3 of school house, looking south. Door to exterior is boarded up and missing a lower panel. Walls of room are unfinished with framing studs visible.

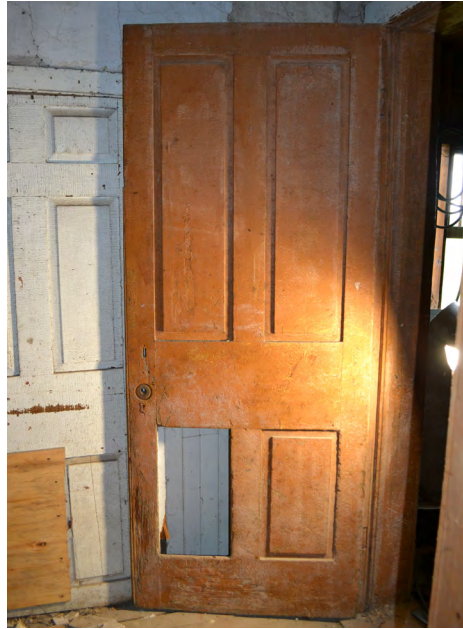
1.47) View of door between Room 3 and corridor of school house. The wood door is deteriorated and missing the one lower panel.

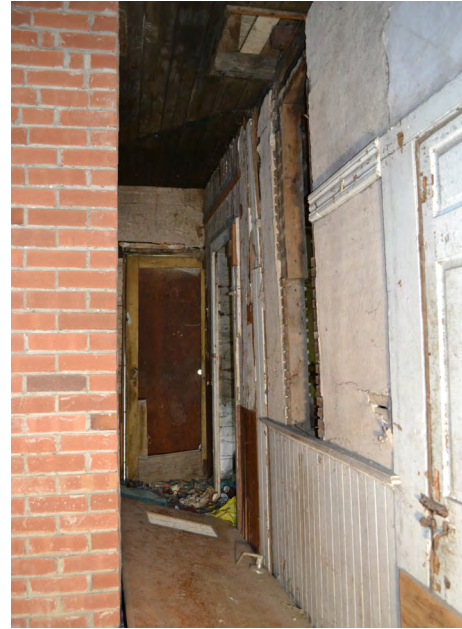
1.48) View from school house corridor looking to north. Windows between the corridor and rooms are boarded up. There is hole in the ceiling, likely from an access hatch or vent.

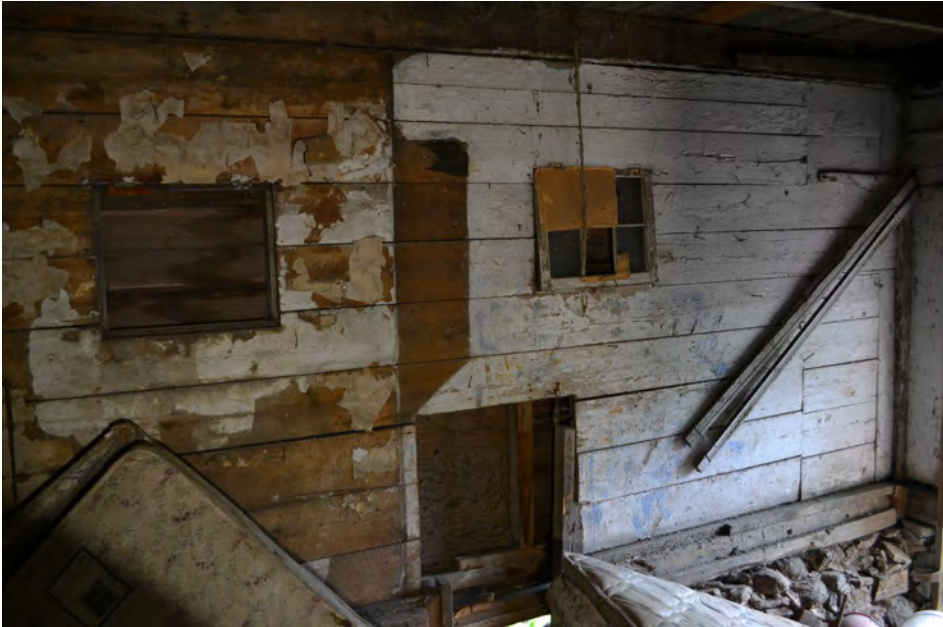
1.50) View of Room 4 of school house addition to rear, looking to west. Existing windows are boarded up, and deteriorated or missing. The wood siding cladding the interior is damaged in areas.

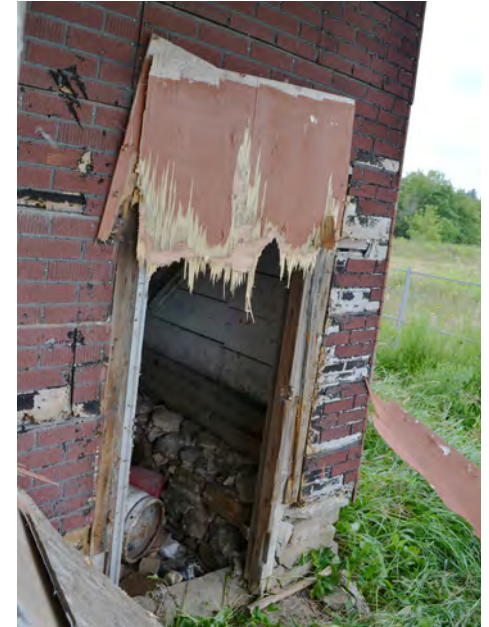
1.52) View from rear porch addition to school house looking to interior of room 4. The brick veneer cladding is falling off. The door is missing from the frame. The fieldstone foundation is exposed on the exterior.

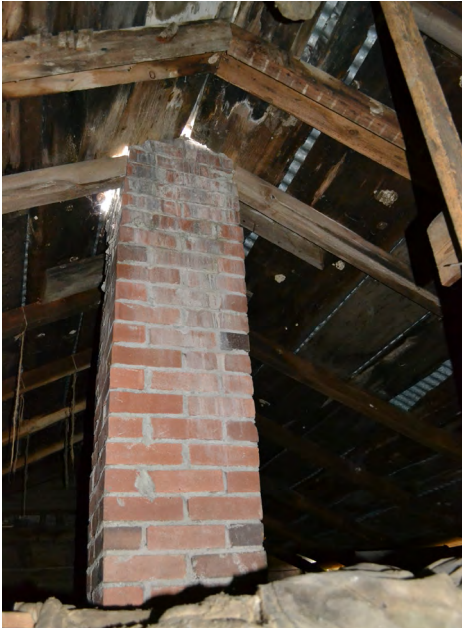
1.56) View of the brick chimney passing through the attic of the school house. The brick is stained but otherwise in good condition.

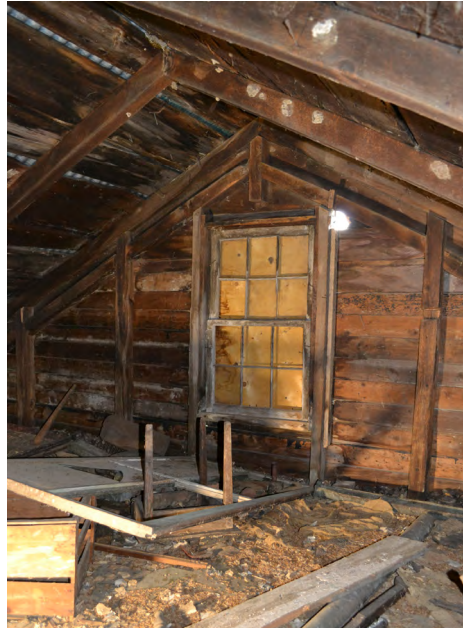
1.57) View of attic above the school house, looking to the east. A 6-over-6 double hung window is boarded up but intact. The walls and ceiling are left unfinished revealing the heavy timber post-and-beam structure.

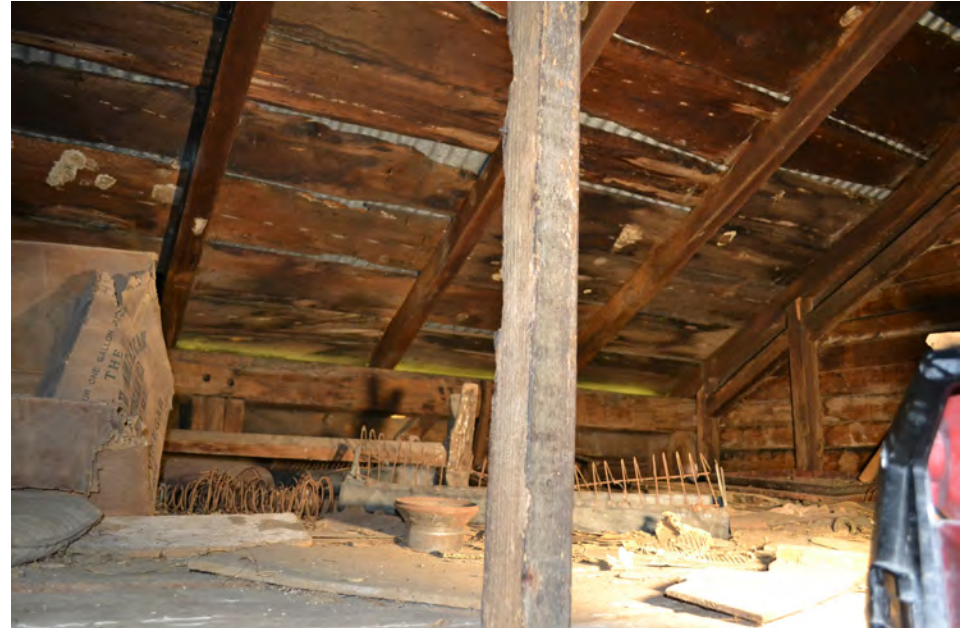
1.58) View of attic above the schoolhouse, looking to south-west. Visible are the roof rafters and the aluminum sheet roofing peeking through the deteriorated wood decking.

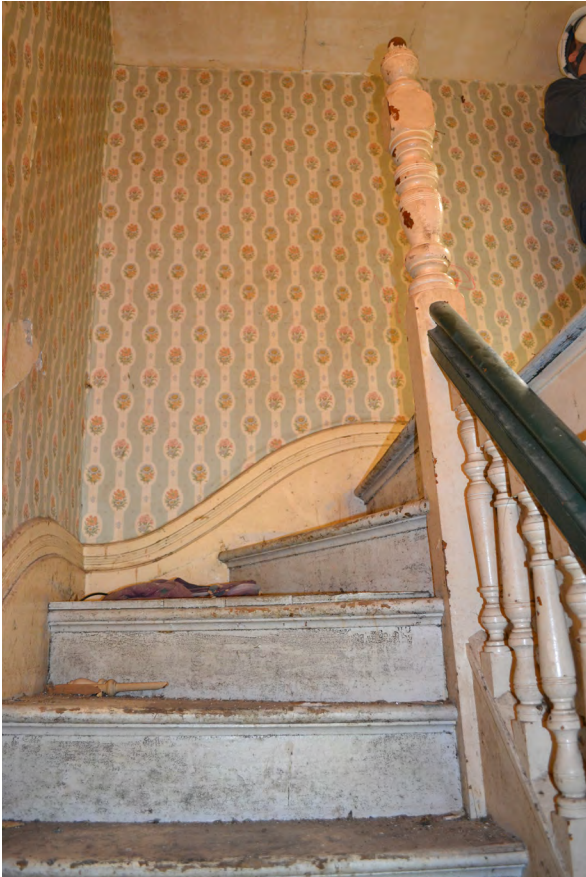
*2.1) View up the stairs. Some of the railing components are damaged or missing but a portion is still potentially salvageable. Baseboard along stair still in fairly good condition.*

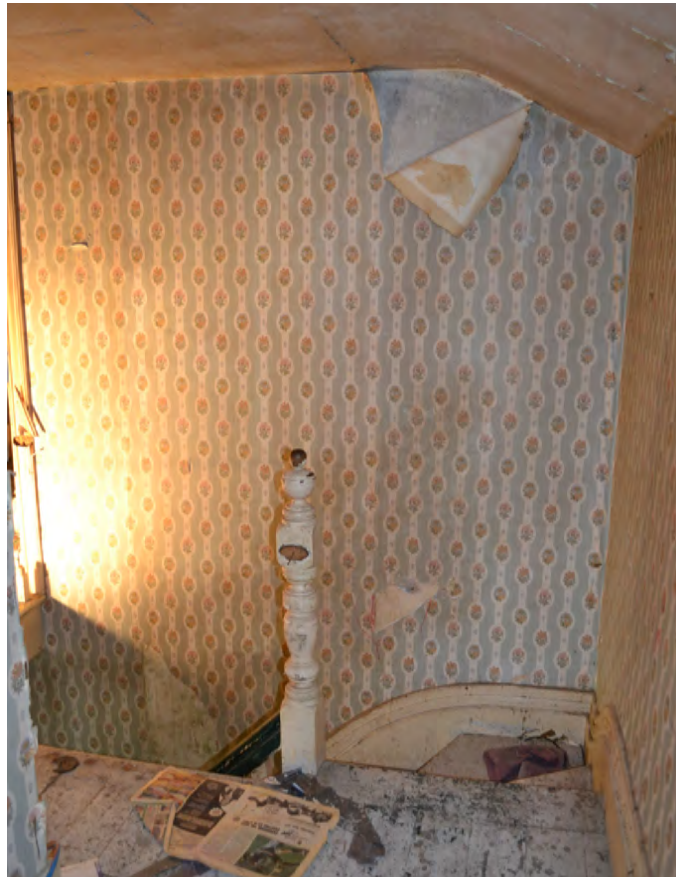
*2.2) View from corridor/landing at the second floor looking back to the top of the stairs. Guard rail is gone.*
