8331 HERITAGE  
ROAD, BRAMPTON,  
ONTARIO  
MCCLURE  
FARMHOUSE

DATE: AUGUST 2023

PREPARED BY:  
ATA Architects Inc.

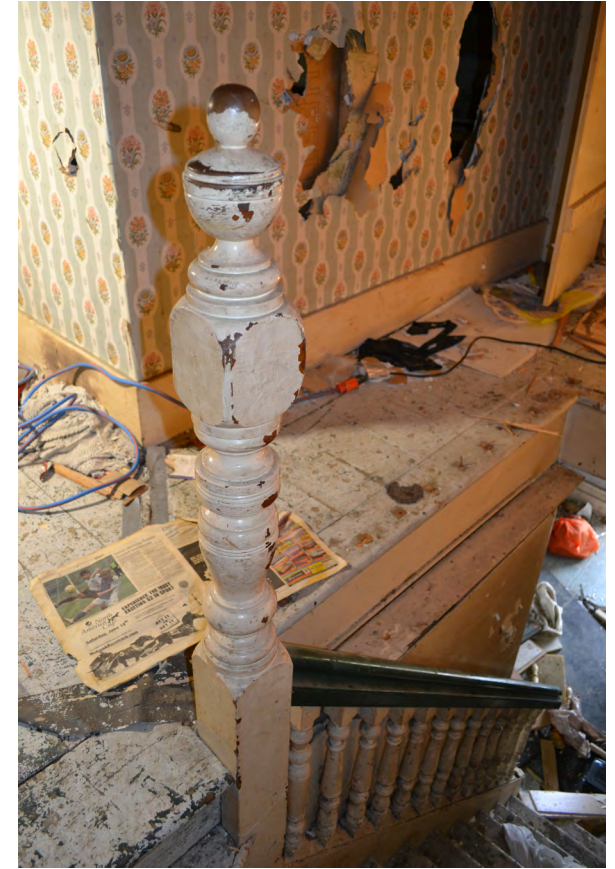
2.6) Newel post at the top of the stairs and many of the spindels in the balustrade are still in good condition. The guardrail along the second floor landing no longer exists.

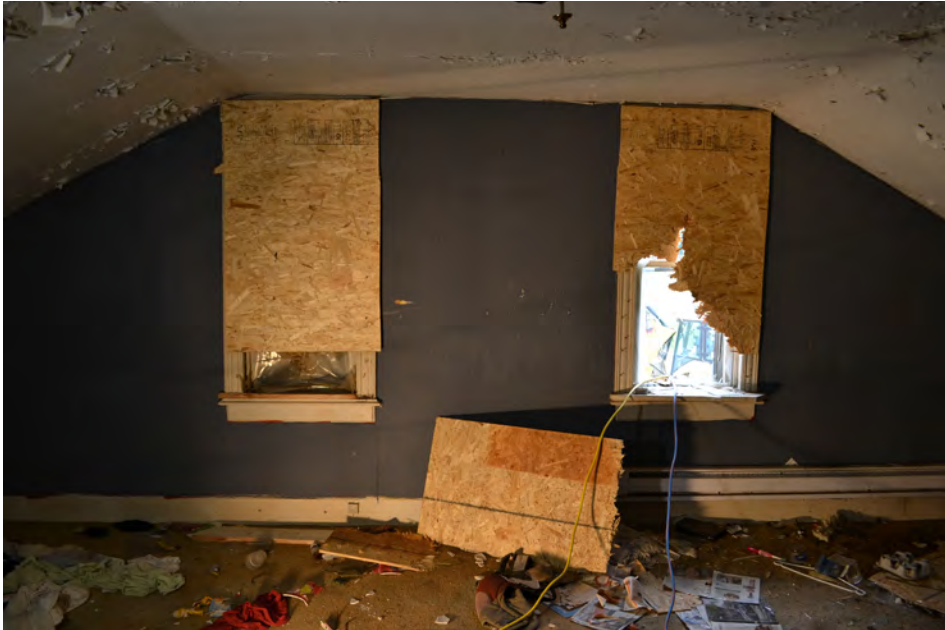
2.7) View towards south wall of Bedroom 1. Room contains sloped ceilings, minimal contents or decoration beyond window and door trims and baseboard. Two windows remain in the second floor, boarded up. One window was partially uncovered and sashes were visibly in poor condition.

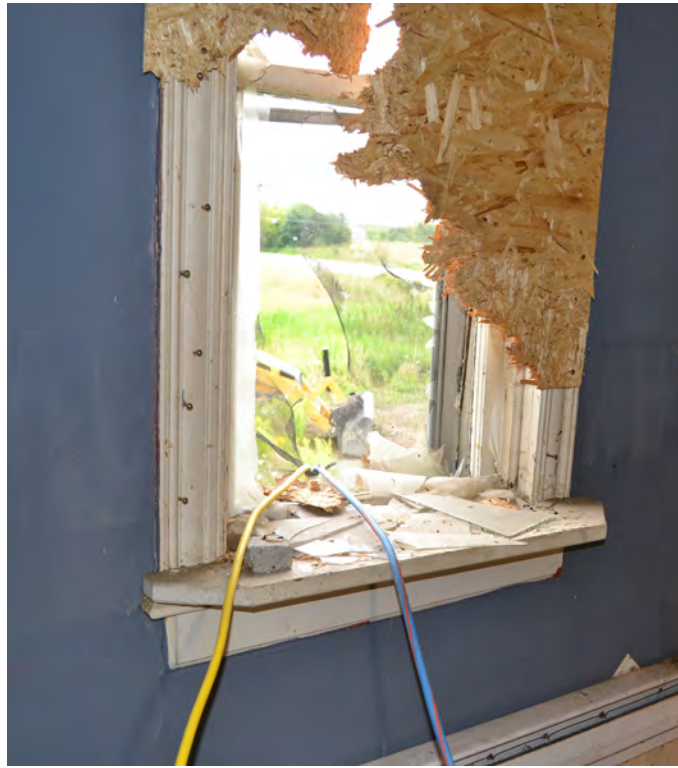
2.12) Remnants of one of the two windows in the room. The sash has sustained significant damage. The window trim and sill though are still in fairly good condition.

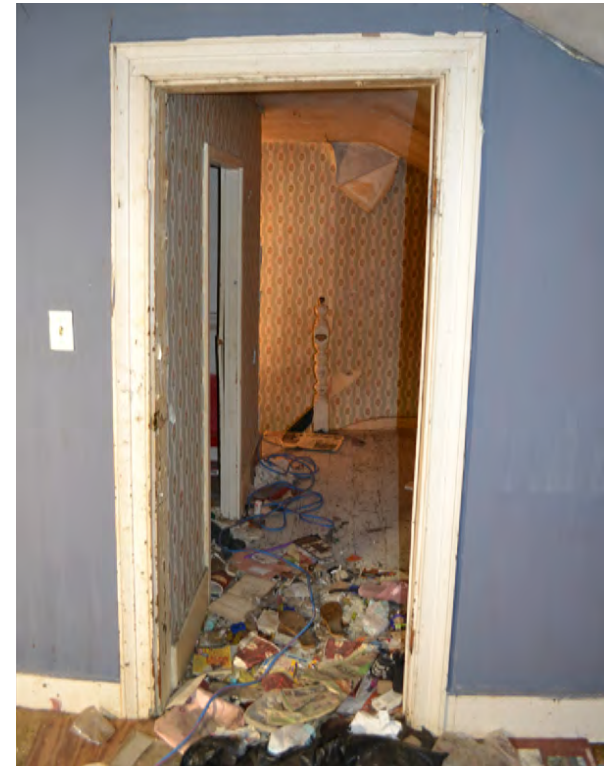
2.13) Door trim is still in fairly good condition, along with the baseboards.

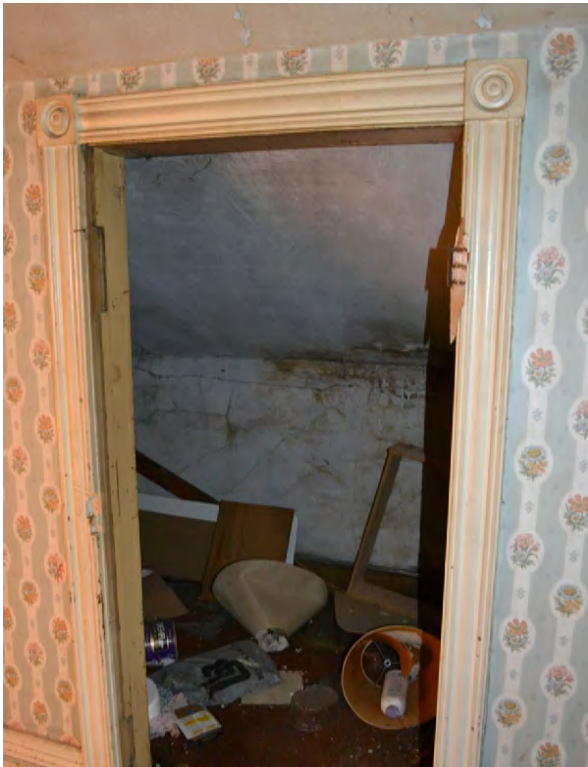
2.17) View from corridor into the storage space. Door trim is fairly ornate and still remaining in good condition.

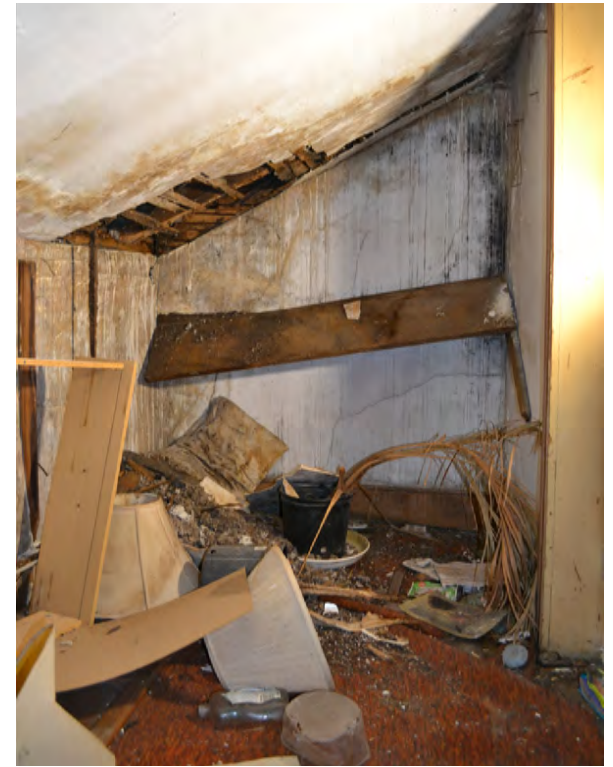
2.19) View to the south wall of the storage space. Damage is visible to the ceiling, plaster has fallen away and lath behind is visible.

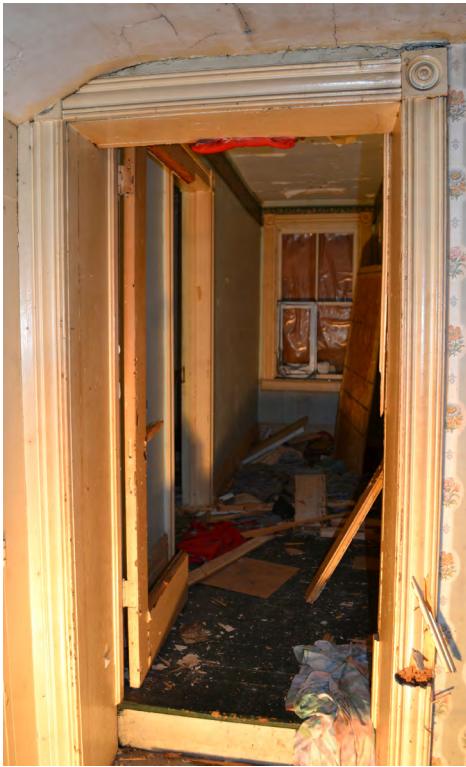
2.20) View into the hallway looking north. The north section of the second floor is two steps higher than the south. The wood trim around the door is fairly ornate but it has been damaged when the guard rail was removed. Bare floor boards are visible in the hallway. One window is visible in the north wall.

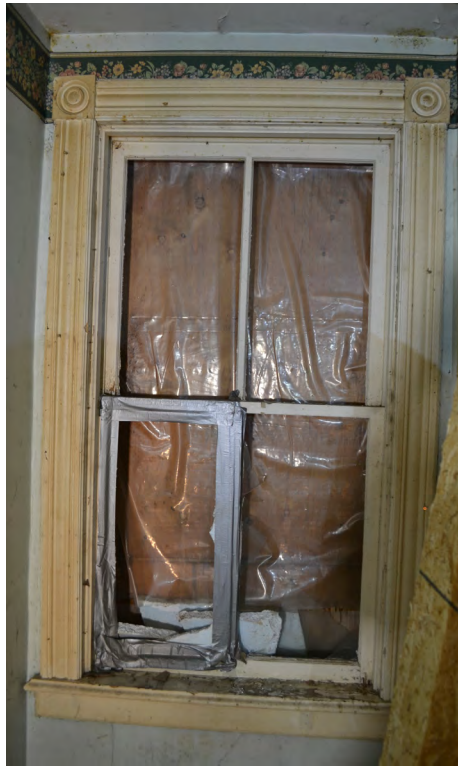
2.21) Existing window. Wood trim and sill are in good condition. Sashes appear to be reasonably intact though the glass is no longer present.

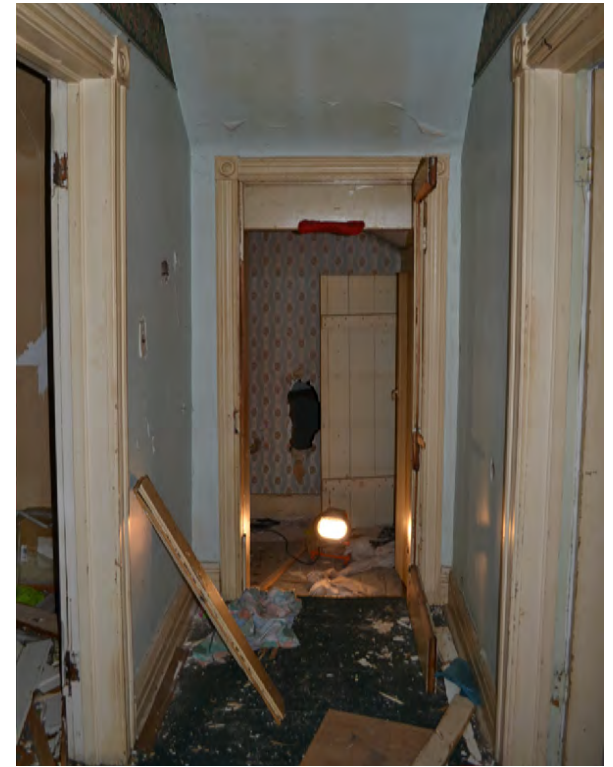
2.22) View south through the hall towards the stairway. A door once stood in the door frame but only its remnants remain. Ceiling slopes down towards the door. The head of the door appears to sit higher than the ceiling in the southern section of the second floor. It appears someone has tried to pad the edge of the ceiling in the transition to protect against bumping a head against the edge.

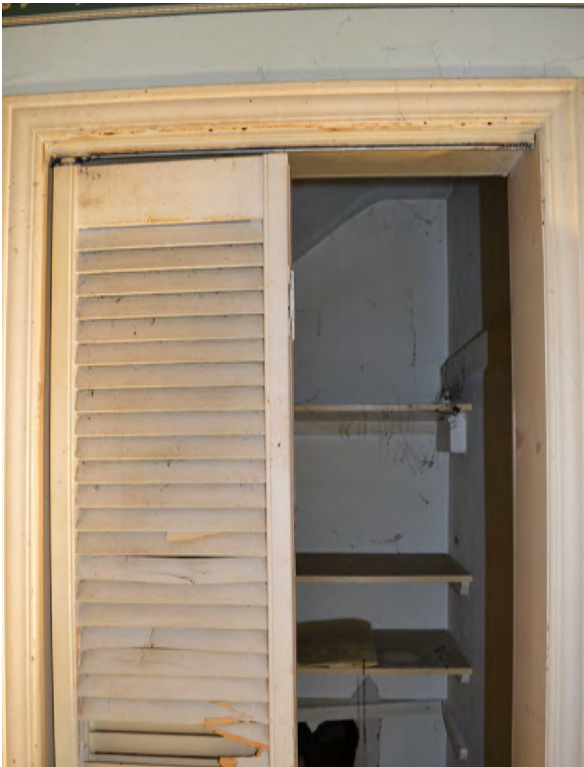
2.23) Closet in the north end of the hallway. Ceiling slopes within it. The bifold door is missing part of itself. The trim is intact and in fairly good condition.

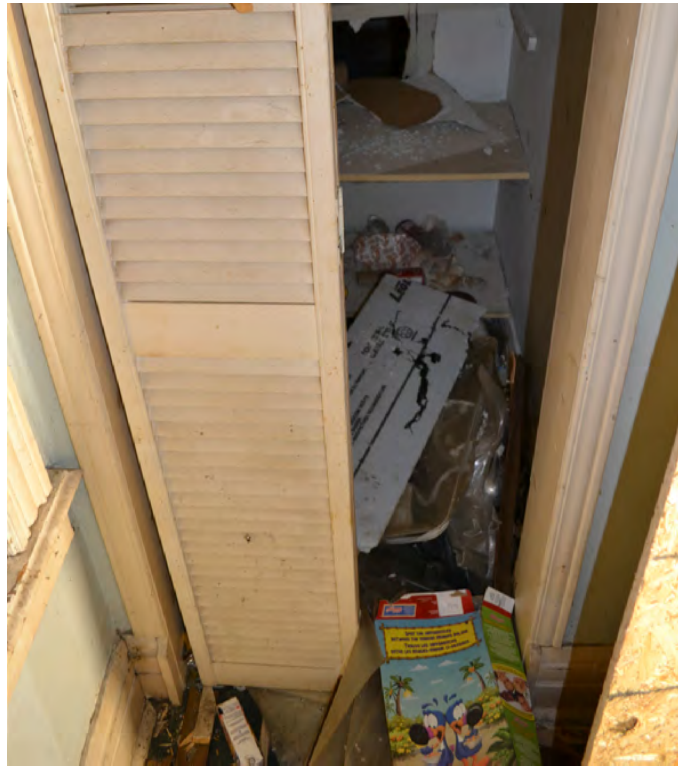
2.24) Closet in the north end of the hallway. The bifold door is missing part of itself. The trim is intact and in fairly good condition. Baseboard appears to be in fairly good condition.

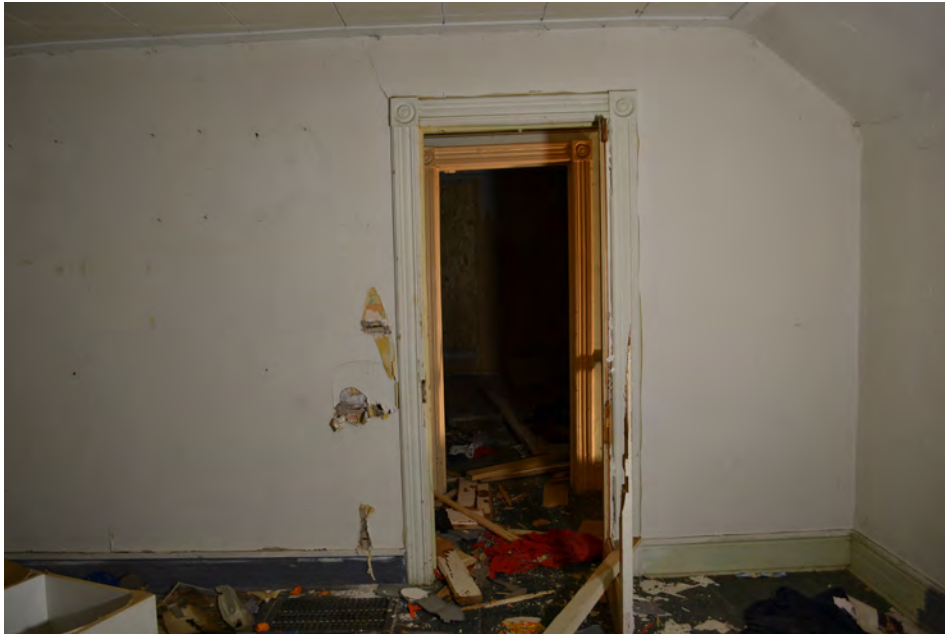
2.27) View in Bedroom 2 towards the east wall. Door way out to the hallway is visible. Decorative wood trim surrounds the doorway, appears in relatively good condition..

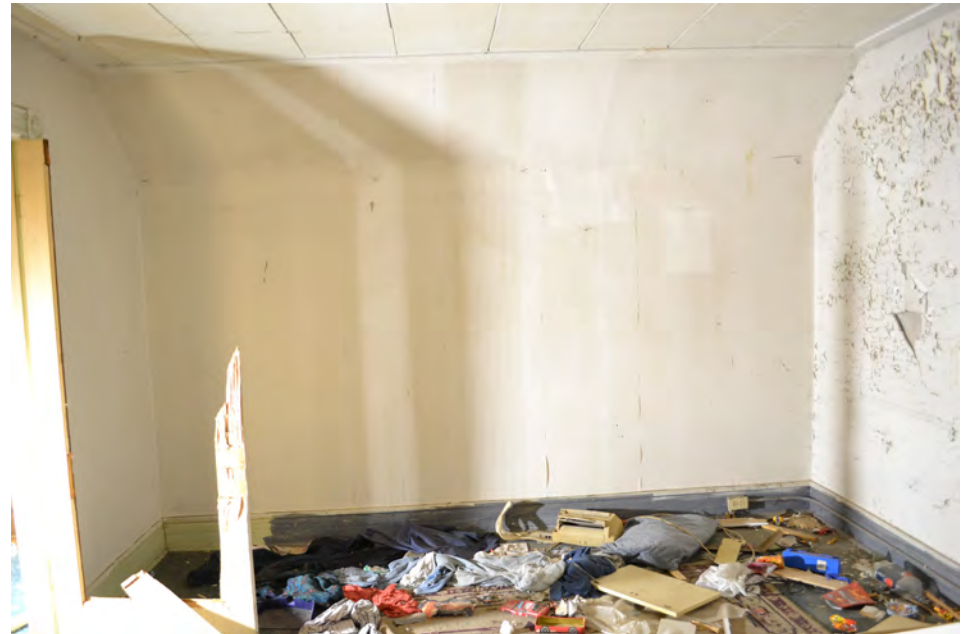
2.28) View in Bedroom 2 towards the south wall. On the left hand side of the photo the remnants of the door can be seen. It has been significantly damaged.

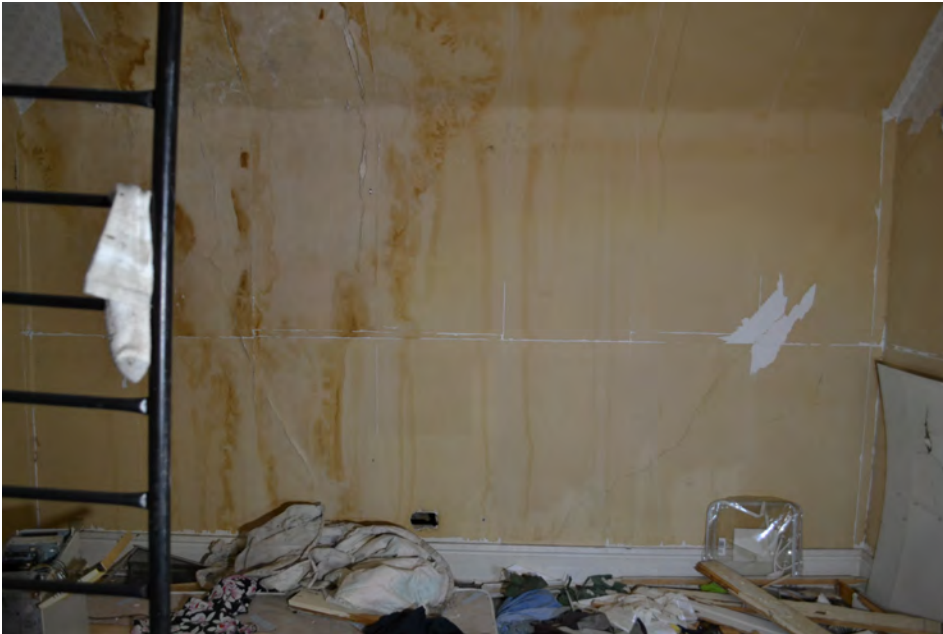
2.32) Bedroom 3, view of south wall. Signs of water damage.

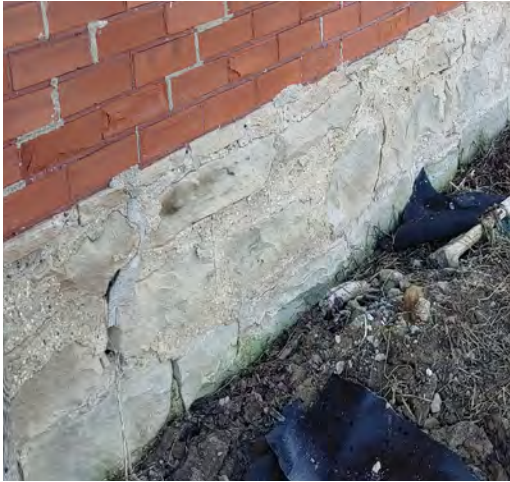
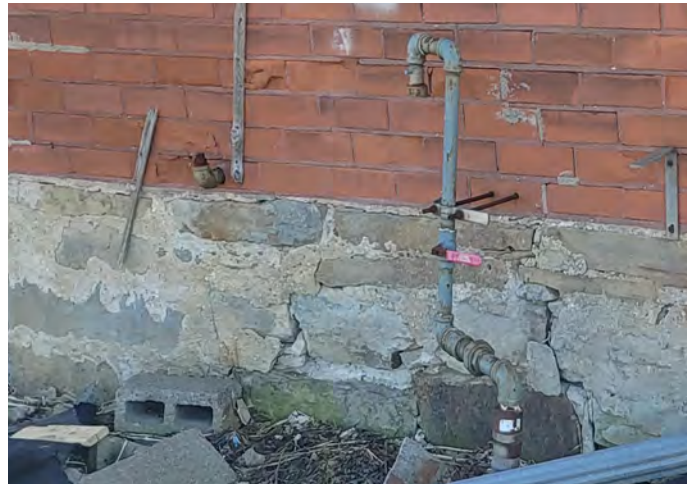
3.3  
Fieldstone Foundation Stone - Taken by  
ATA Architects, February 14, 2023

Material	Importance	Plan	Use
Fieldstone Foundation Stone	Material is associated with heritage homes, not easily replicated with new materials.	Careful dismantling of the exterior wall, it is recommended to stack stone in wire baskets or wood containers, not loose piles. Remove any remaining mortar.	For cladding the foundation of commemorative structures.
Handhewn Beams	Noted as a character contributing attribute.	Remove dust and dirt as well as check for wood rot.	For restoration projects. Material is recyclable. Provide to City of Brampton or Architectural Salvage Companies.
Wood Planking	Recyclable material.	Remove nails from wide planking from floor, walls, and roof. Stack with spaces to allow for air circulation between wood.	For restoration Projects. The material is recyclable. Provide to City of Brampton or Architectural Salvage Companies. Multiple applications, including furniture.

Some stone may be needed for commemorative structures. Similarly, the foundation stones should be cleaned of mortar, washed, and put into wire or wooden bins. The majority of the stone salvaged will likely be used for either a base for a commemorative plaque or as cladding of the foundation of a commemorative structure. Salvage stone material based on future use and separate into bins according to size.
