# PRELIMINARY DESIGN REPORT NO.2

WILEY BRIDGE

CLAIREVILLE CONSERVATION AREA

**PROJECT NO 10009703**

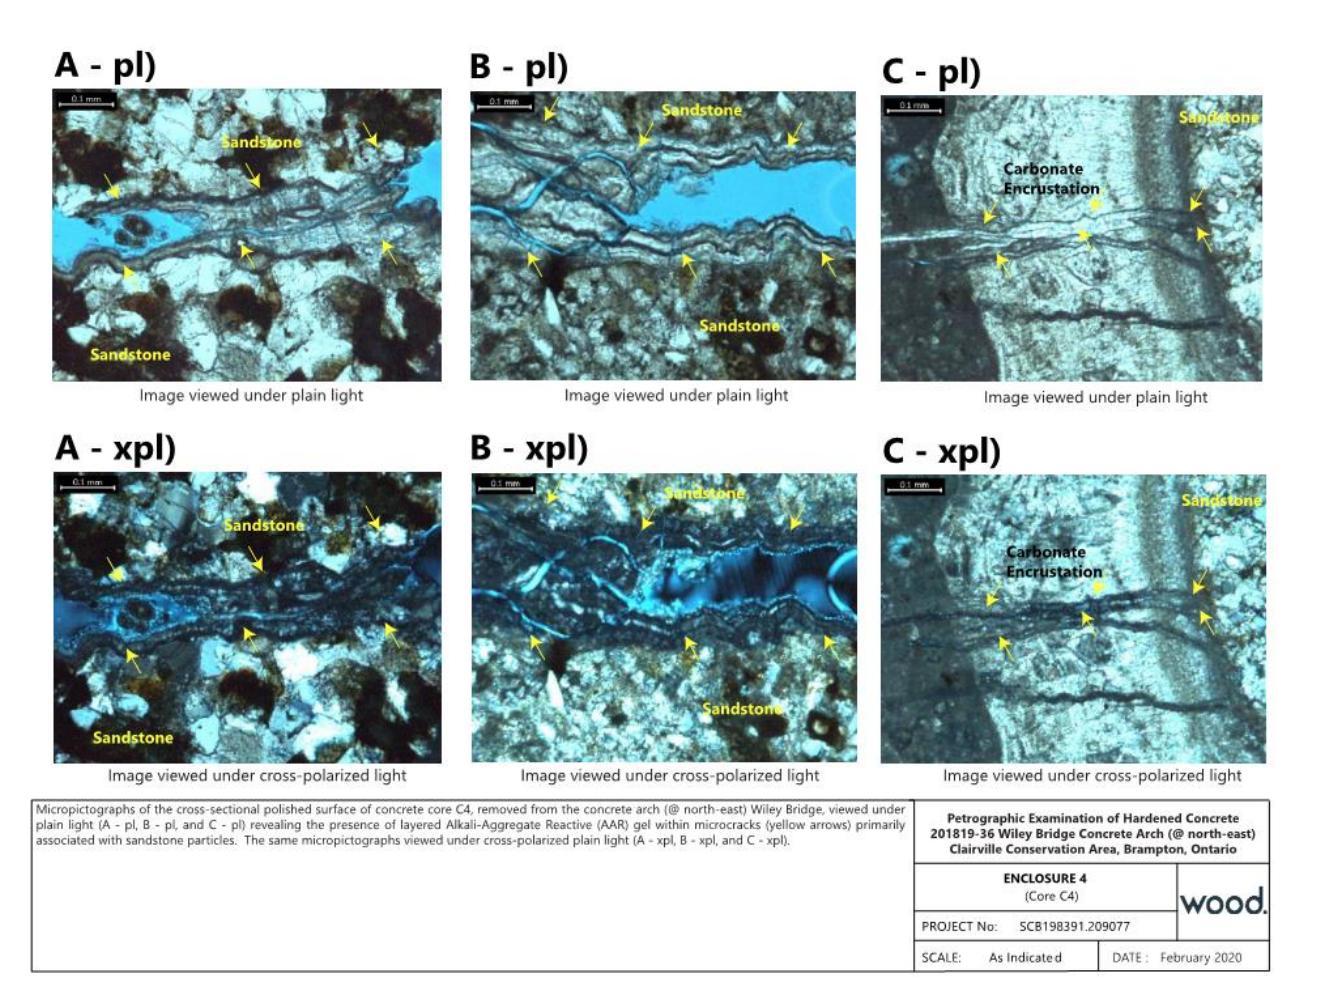
A petrographic analysis was carried out to investigate whether or not the concrete in the arch ribs are AAR infected. Appendix D contains the Petrographic Analysis Report, which tested the concrete core sample extracted from the northeast corner of the arch.

The presence of AAR was confirmed in the concrete core sample as highlighted in the blue regions shown in the Figure 1. AAR occur when aggregates in concrete react with the alkali hydroxides in concrete producing a hygroscopic gel which (in the presence of moisture), absorbs water and leads to expansion and cracking in concrete overtime. Unfortunately, once AAR starts, there are no remedial measures to stop or reverse the process of deterioration.

Figure 1 – Micropictographs of Cross-Sectional Polished Surface of Concrete Core (by Wood Environmental & Infrastructure Solutions, a division of Wood Canada Limited)

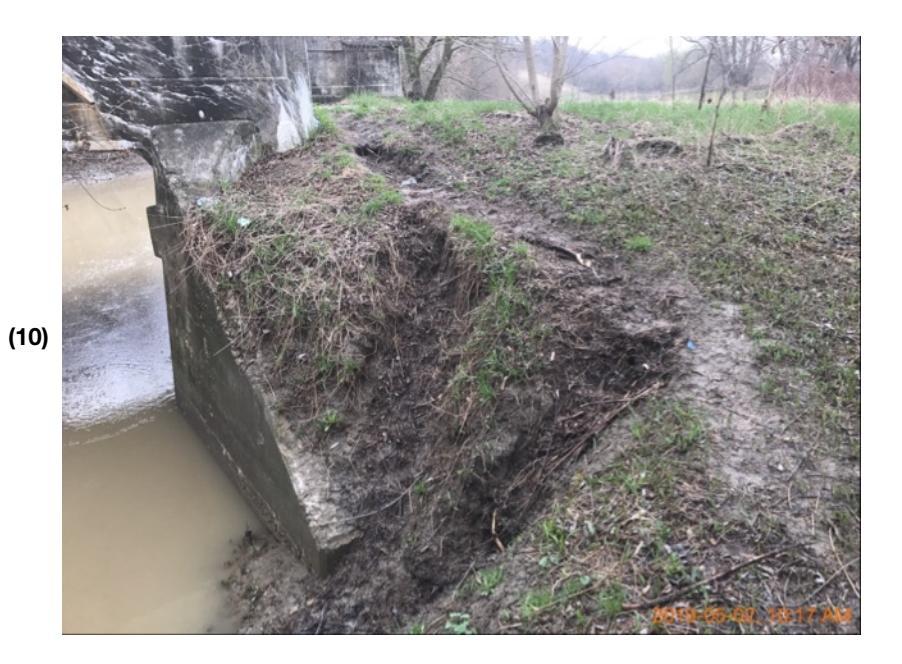
Medium erosion and material loss were noted in the northeast embankment along the retaining wall (see Photograph 10). An erosion hole was noted in the in the southwest embankment, adjacent to the retaining wall (see Photograph 19).

## Northeast embankment. Note the severe erosion.

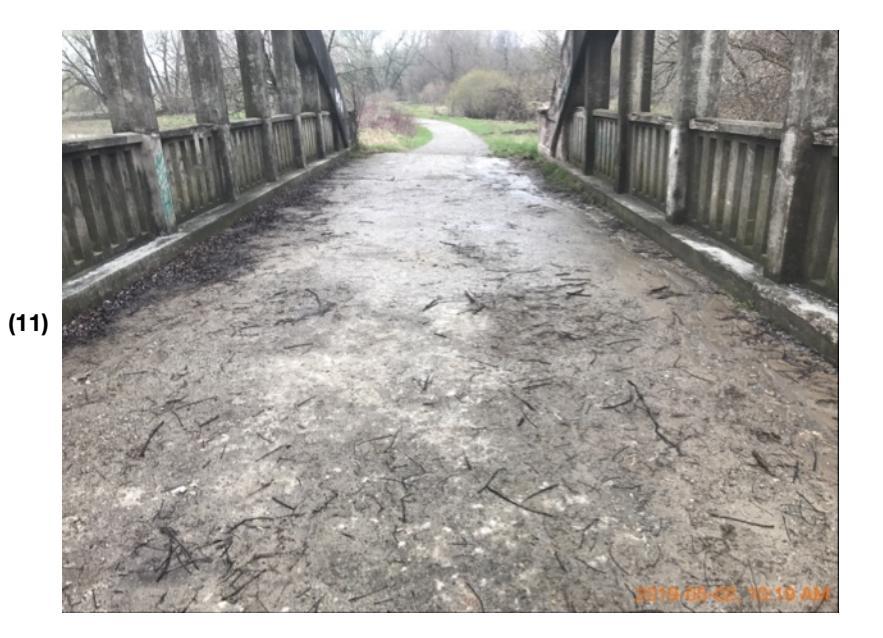
Deck wearing surface (looking north). Note the debris accumulation along the curbs.

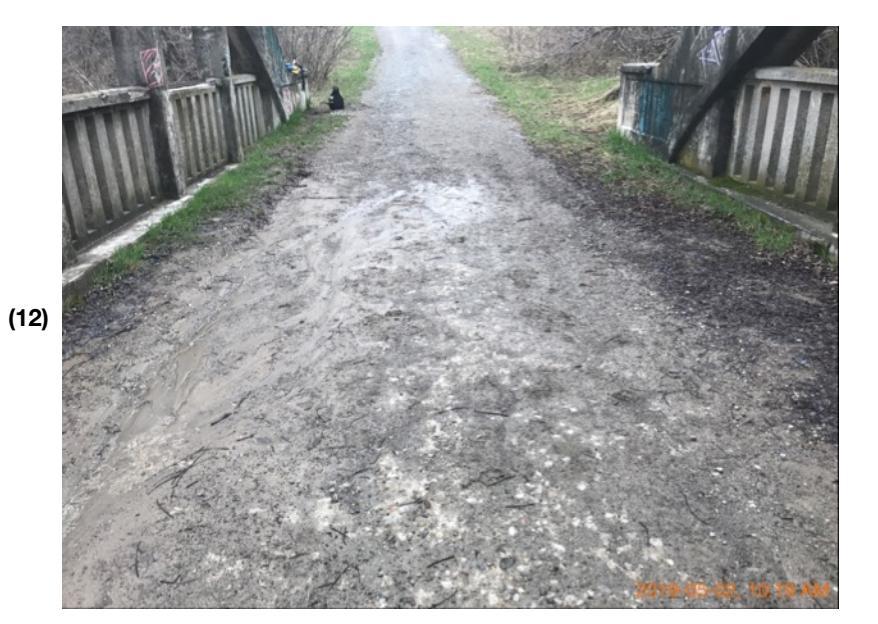
Deck wearing surface (looking south). Note the debris accumulation along the curbs.

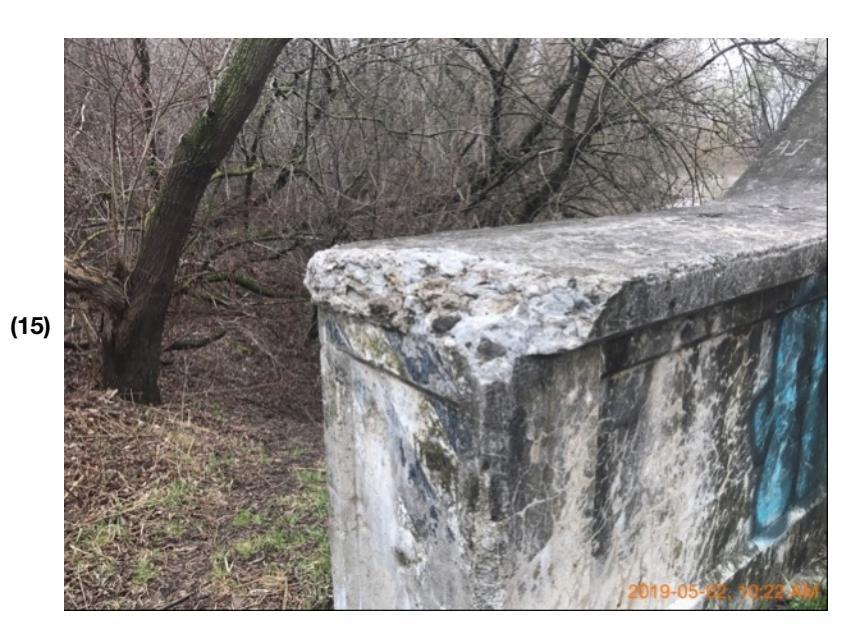
Spalled concrete with exposed aggregate along the outside face of the west arch rib, near the south approach (see Photograph 18). Spalled concrete, concrete delamination and frost action (or potential ASR) was noted along the top and inside face of the west arch rib (end), near the south approach (see Photograph 15).

Spalled concrete and potential ASR along top and inside face of west arch rib (end) near south approach.

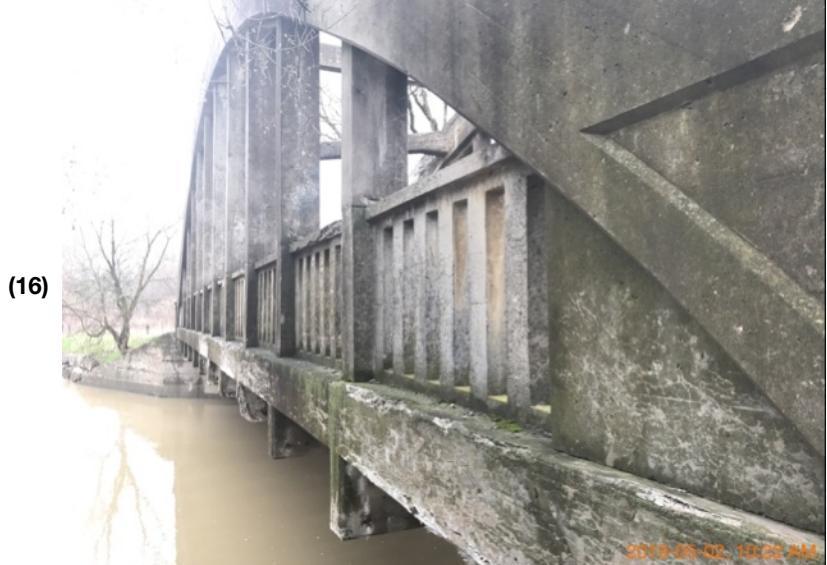
Concrete cracking with efflorescence staining, and potential ASR in east truss (looking south).

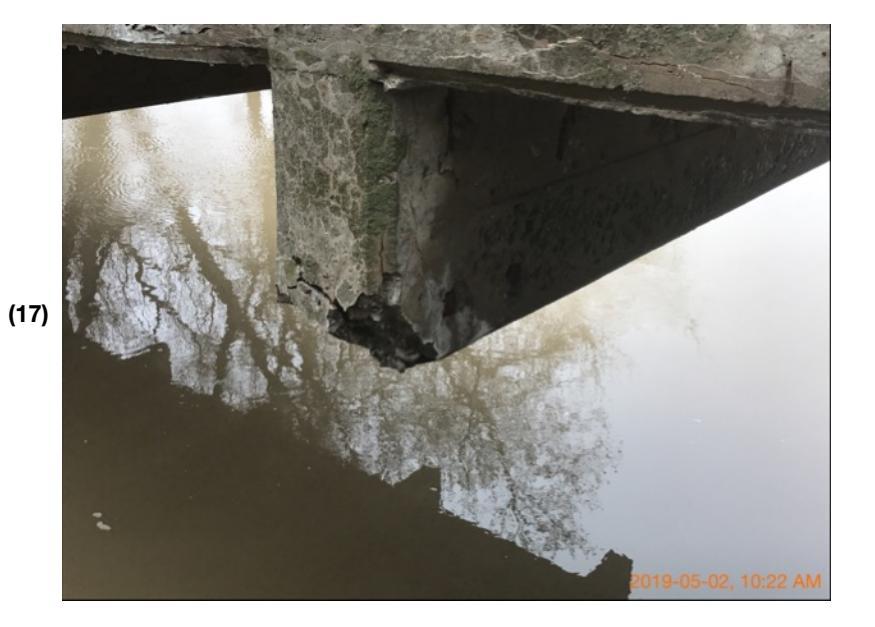
Spalled concrete noted in east fascia was noted in a few floor beam locations (see Photograph 17).

Spalled concrete in east end of floor beam.

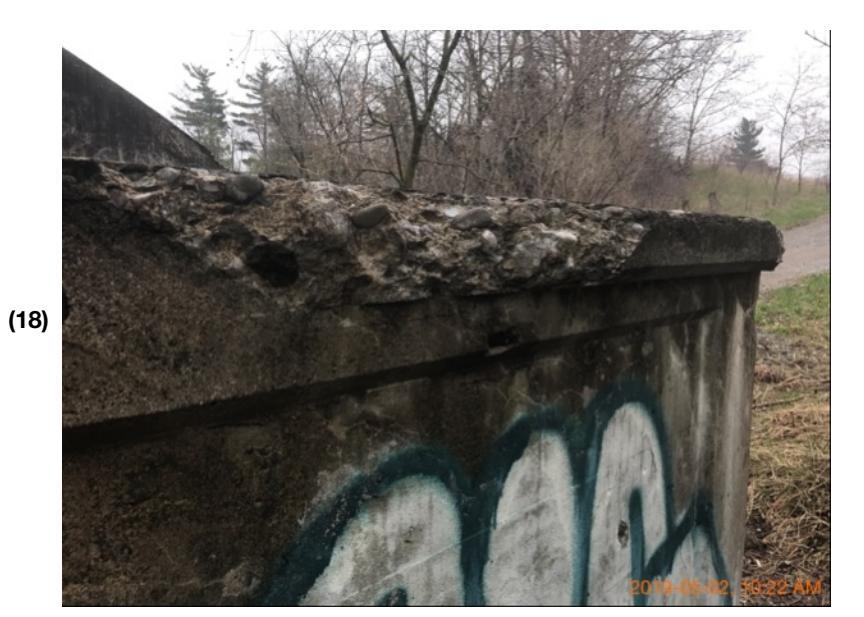
Spalled concrete with exposed aggregate along the outside face of the west arch rib, near the south approach. (19)

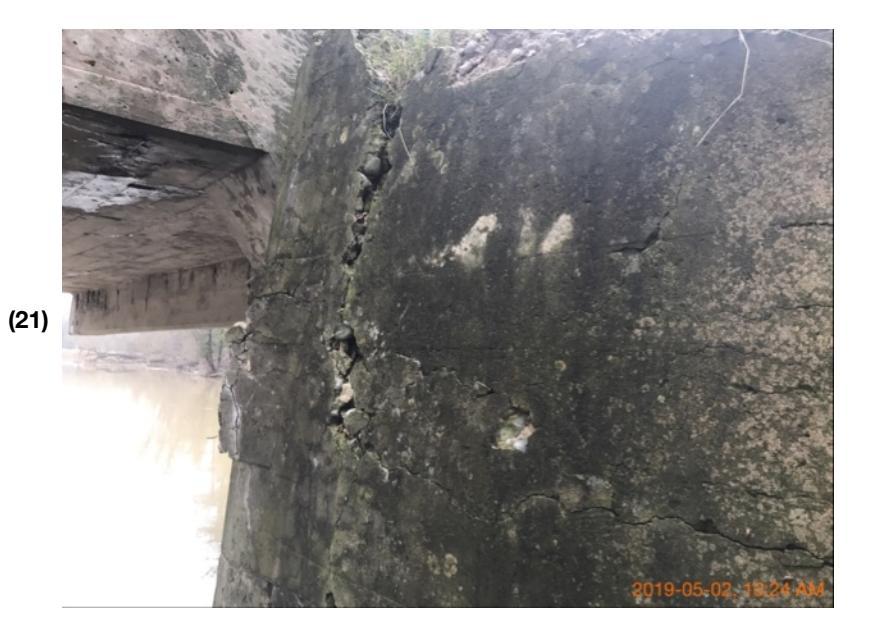
Concrete cracking and honeycombing with exposed aggregate in southwest retaining wall.

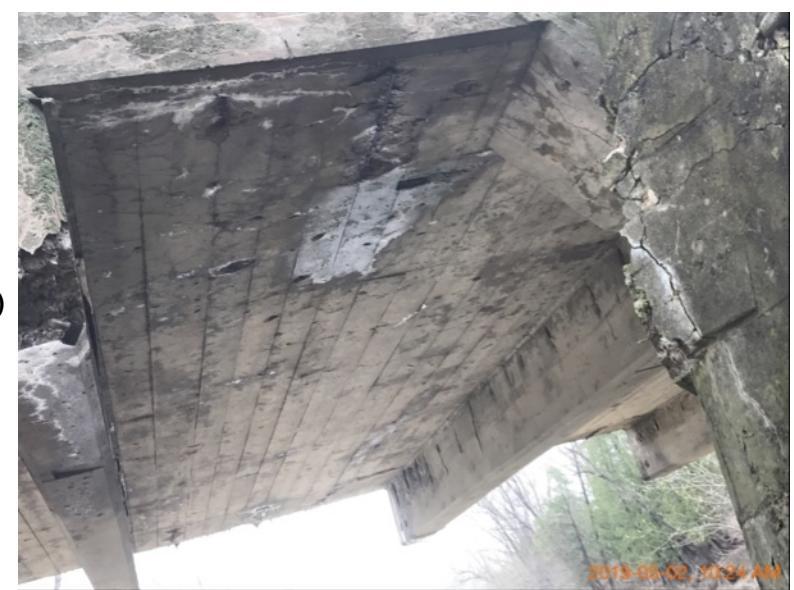
Wet staining and concrete delamination in deck soffit adjacent to south abutment.

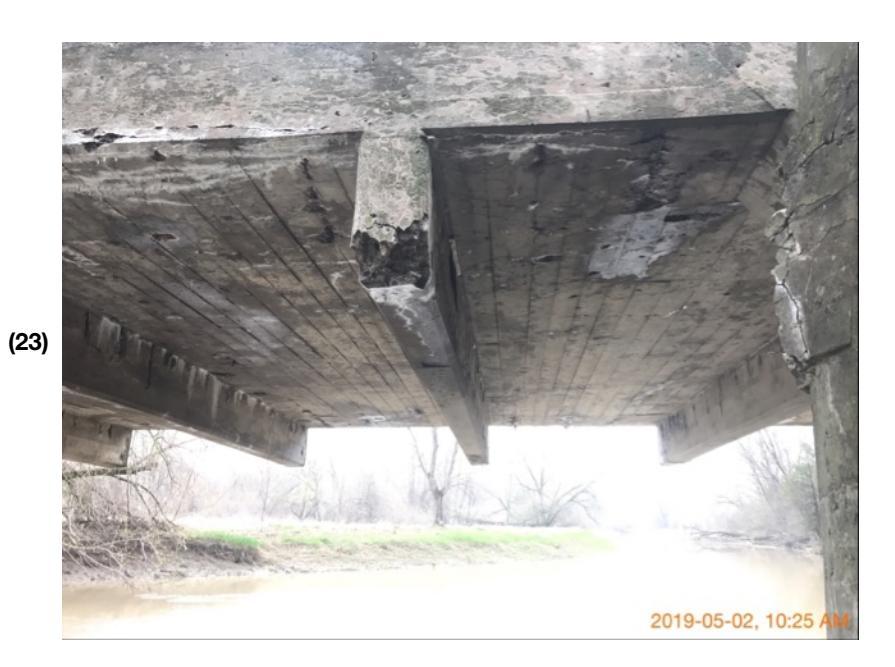
Spalled concrete in west fascia of truss floor beam (3rd floor beam from south abutment). Note the adjacent cracked concrete with efflorescence staining.

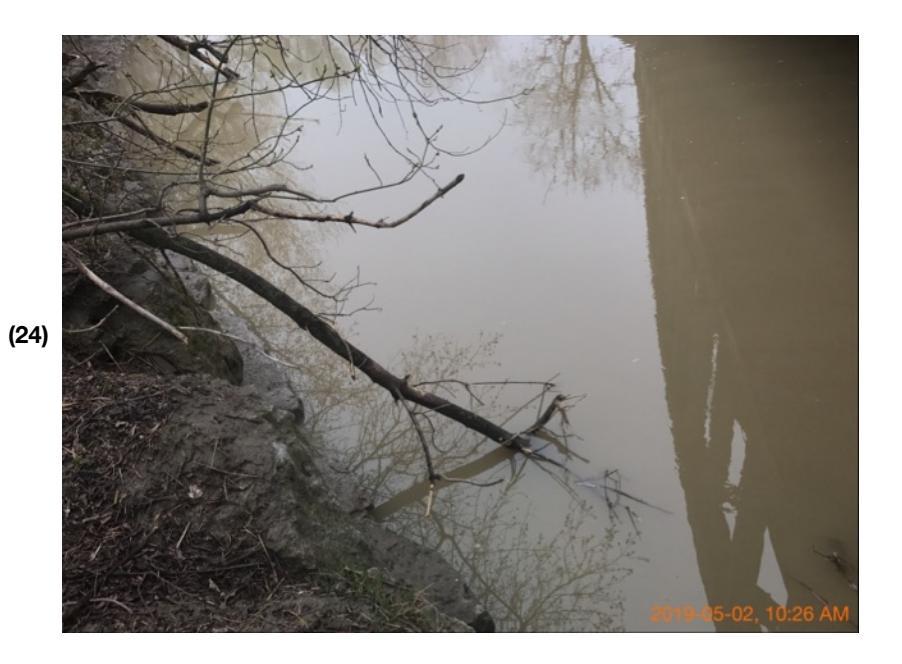
Local tree failure encroaching waterway near southwest embankment.

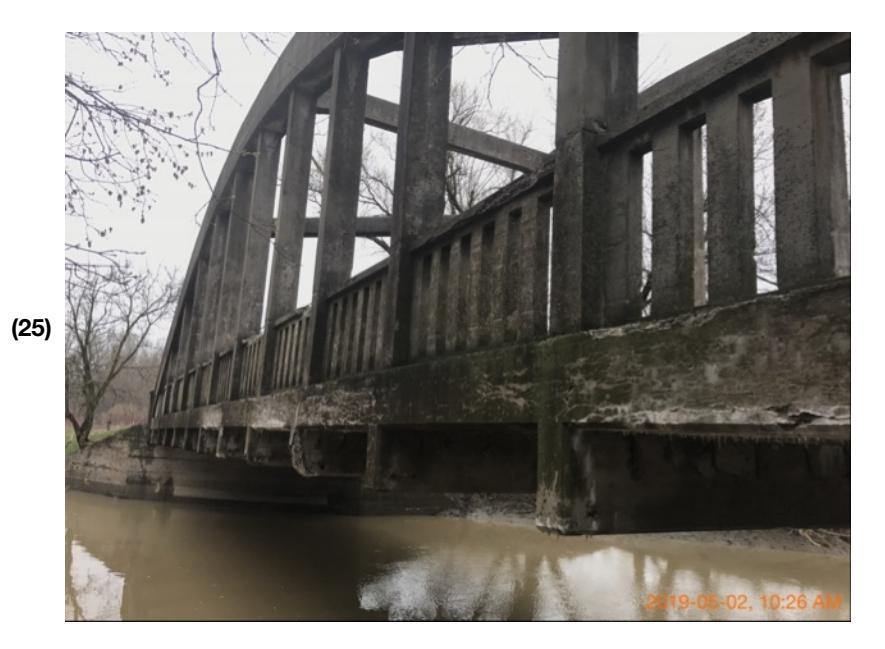
West fascia (looking north). Note the concrete cracking with efflorescence staining (potential ASR).

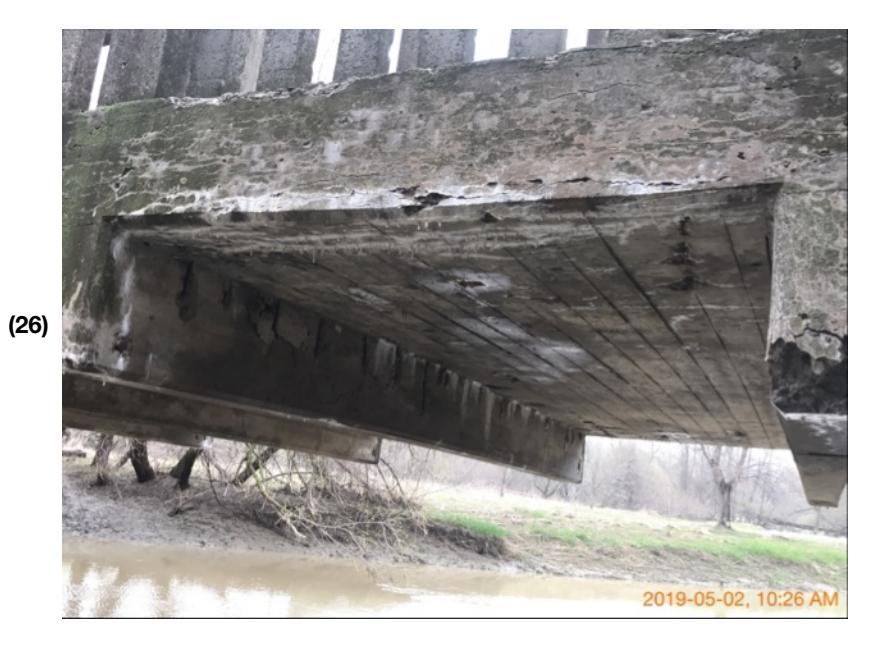
West fascia and deck soffit. Note the concrete cracking with efflorescence staining (potential ASR).

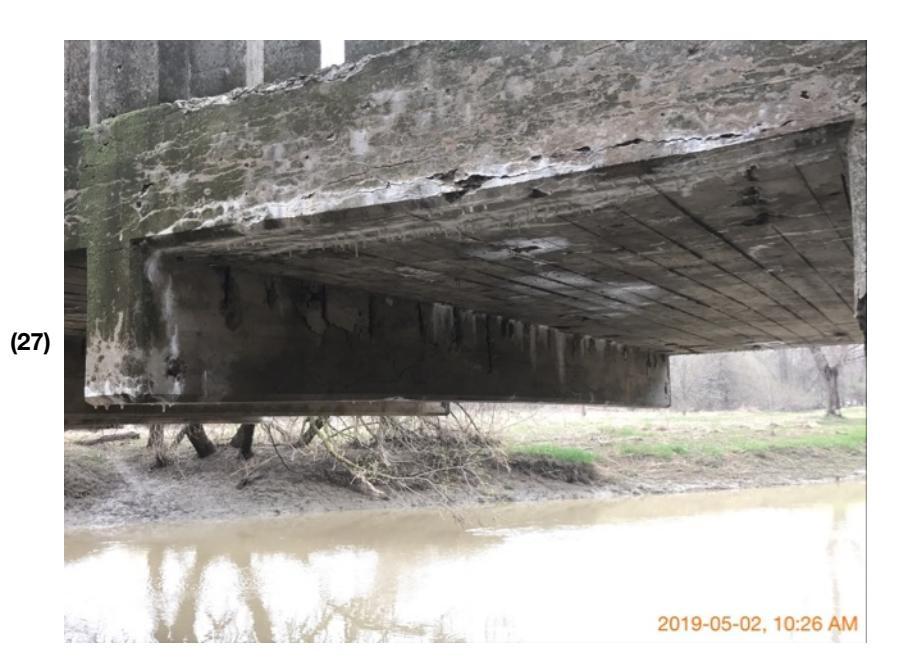
Spalled concrete with exposed corroded reinforcement in floor beam. Note the efflorescence staining (potential ASR).

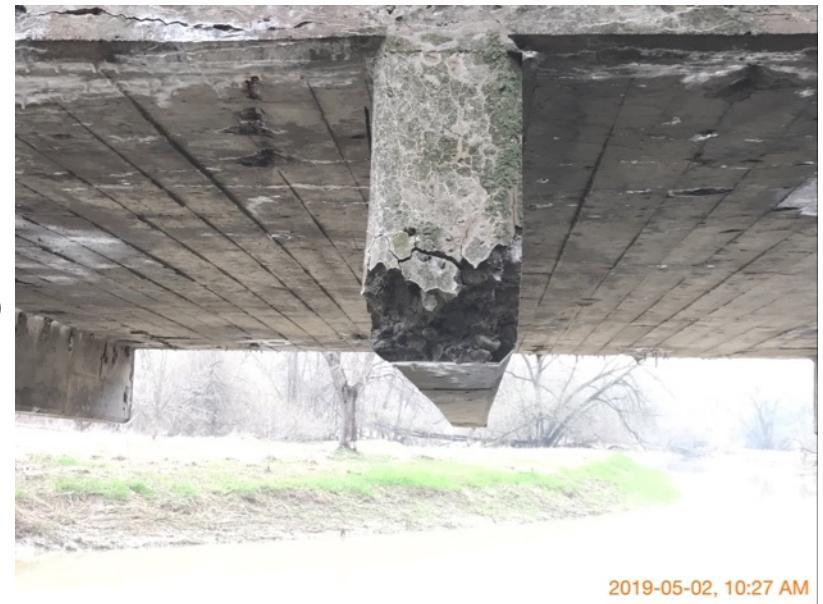
Spalled concrete and concrete cracking with efflorescence staining was noted in the west end of the floor beam in approximately five (5) locations (see Photograph 28).

Spalled concrete in west fascia of truss floor beam (6th floor beam from south abutment). Note the adjacent cracked concrete with efflorescence staining.

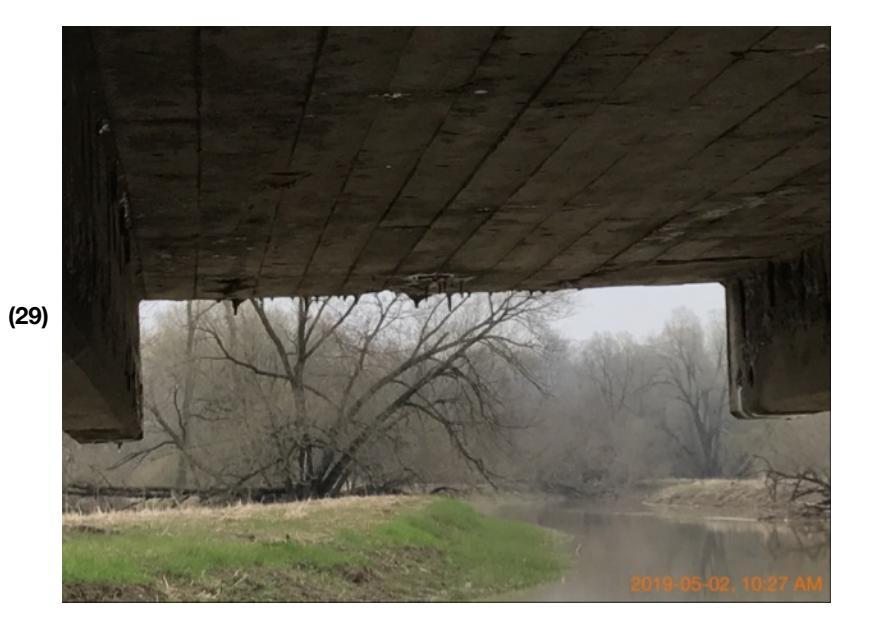
Concrete delamination and wet staining in deck soffit (5th bay from south abutment).

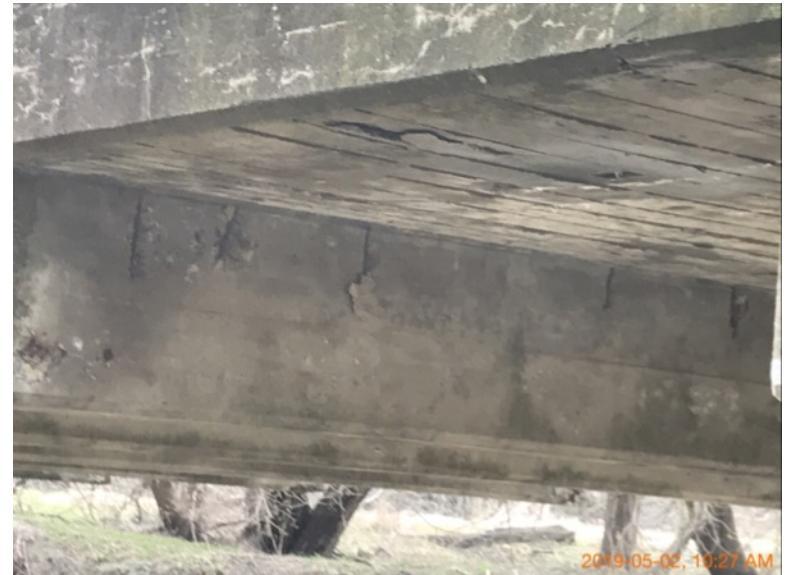
Spalled concrete with exposed corroded reinforcement in floor beam. Note the delaminates concrete in the deck soffit.

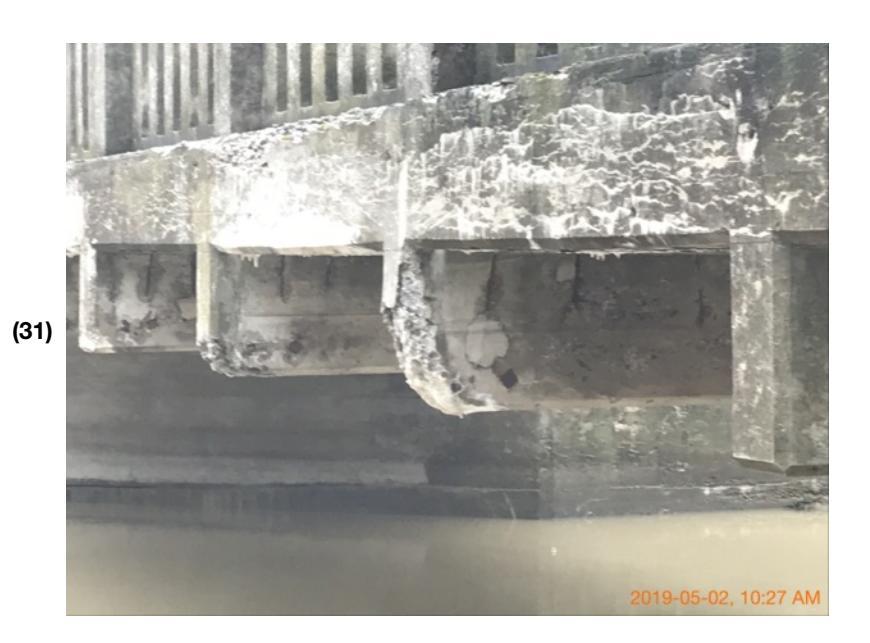
West fascia (6th bay from south abutment). Note the honeycombing and concrete cracking with efflorescence staining.

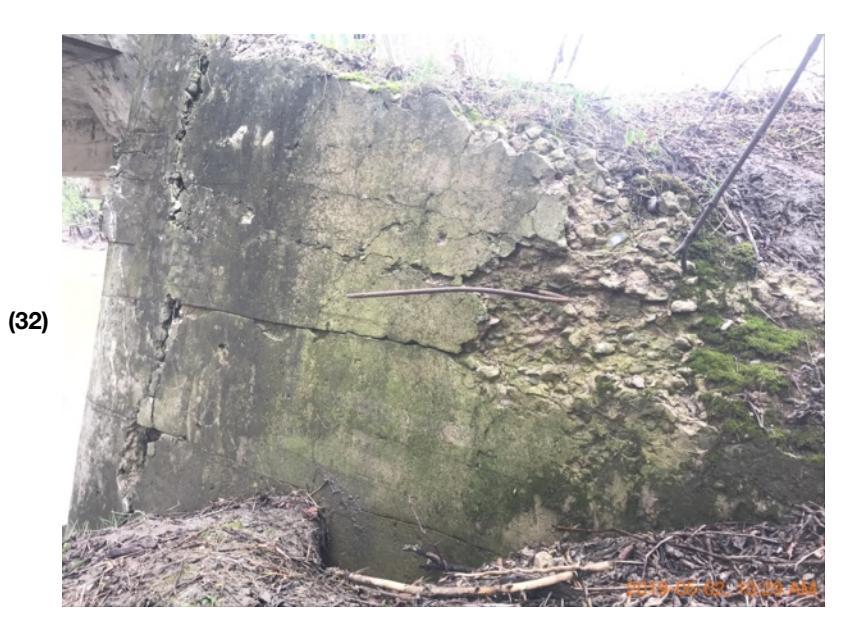
Southwest retaining wall. Note the horizontal crack, exposed / failed corroded reinforcement, and concrete disintegration.

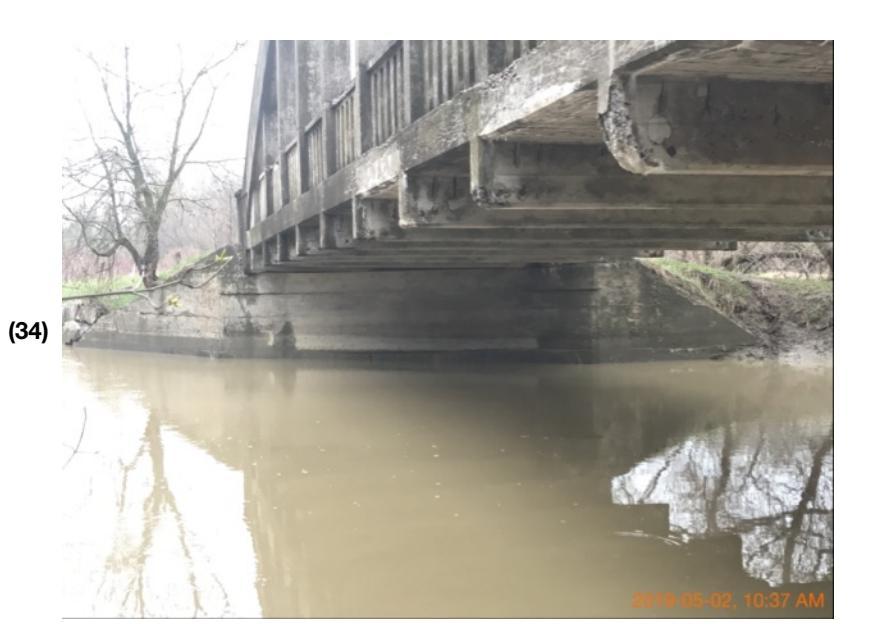
Wet staining and concrete delamination in deck soffit (7th bay from south abutment).

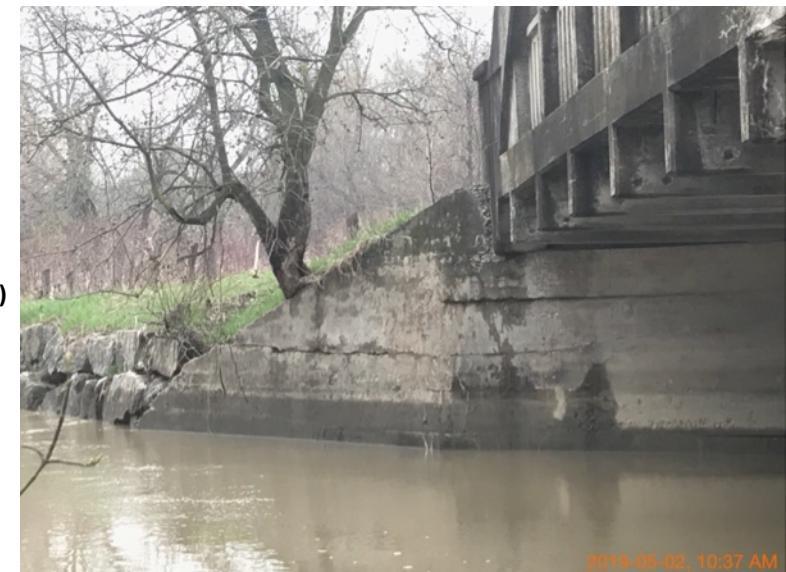
Concrete scaling, severe honey combing, concrete cracking with efflorescence staining, and a wide vertical and horizontal cracking spanning the full width of the northwest retaining wall was noted (see Photograph 35).

Northwest retaining wall. Note the wide horizontal crack and the tree in contact with the wall.

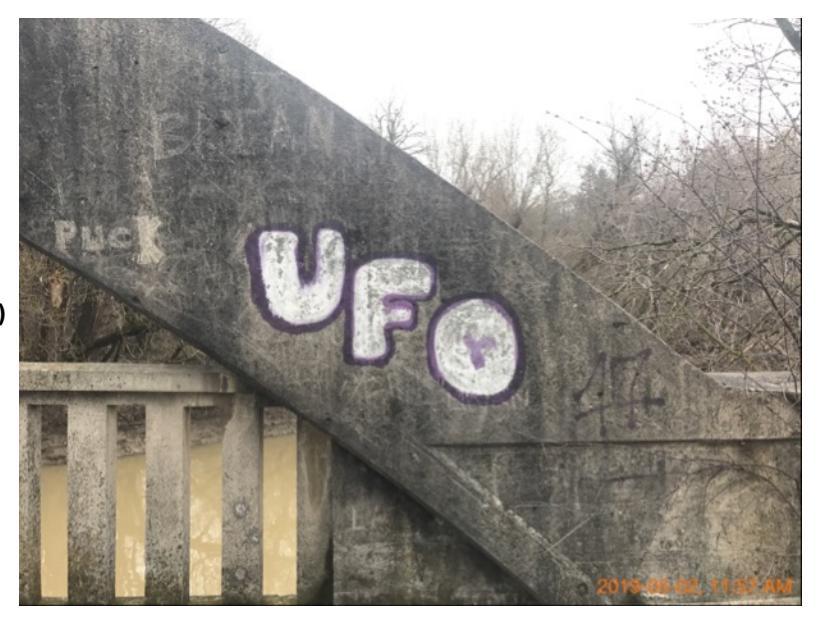
Graffiti damage noted on the inside face of the west arch rib, near the north approach.

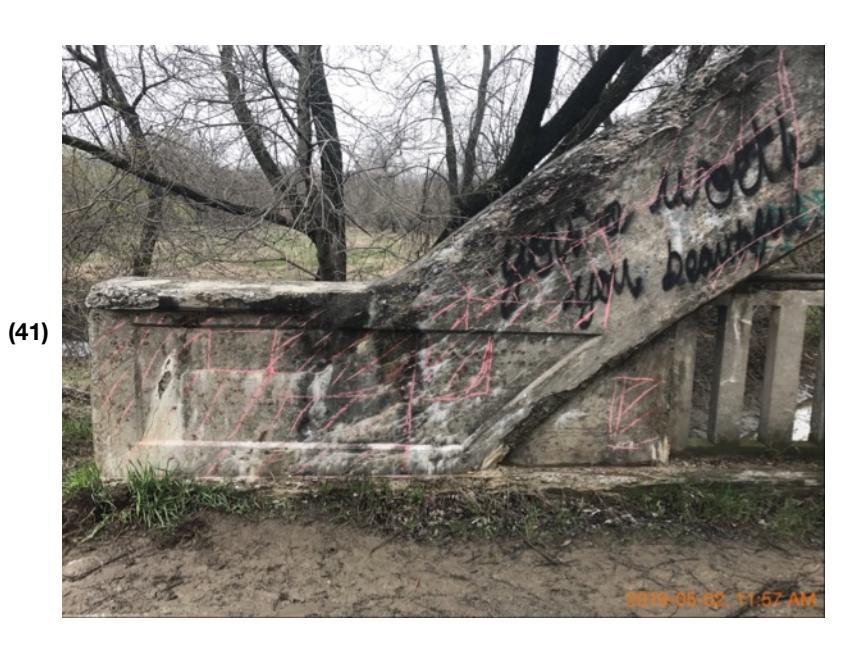
Concrete delamination and concrete cracking with efflorescence staining (potential ASR) along inside face of east arch rib, near the north approach.

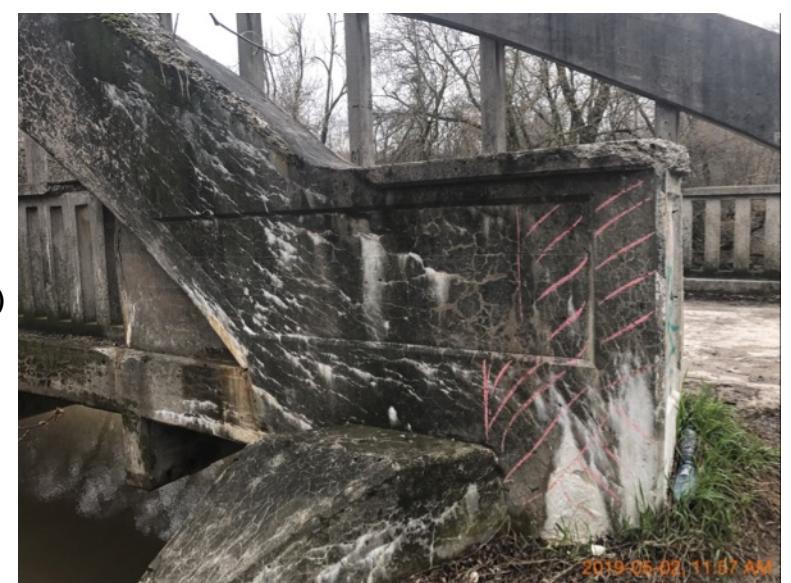
Concrete delamination and concrete cracking with efflorescence staining (potential ASR) along the outside face of the east arch rib, near the north approach.

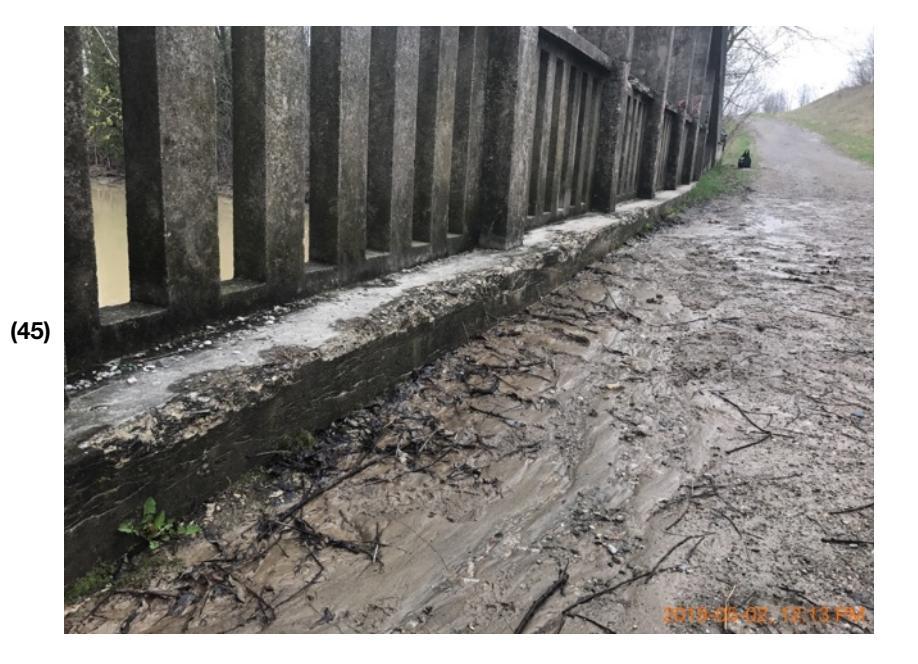
Honeycombing was noted along the inside face of the east curb over three (3) bays near the midspan. Abrasion damage was noted along the inside face of the east curb (see Photograph 45).

East curb (looking south). Note the abrasion damage along the upper corner.

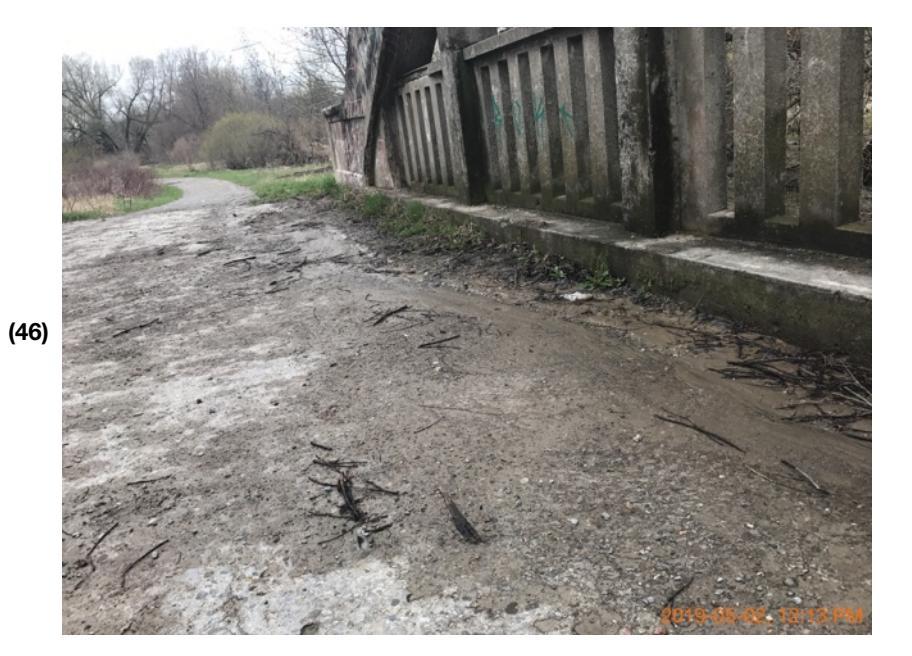
Debris accumulation along east shoulder.

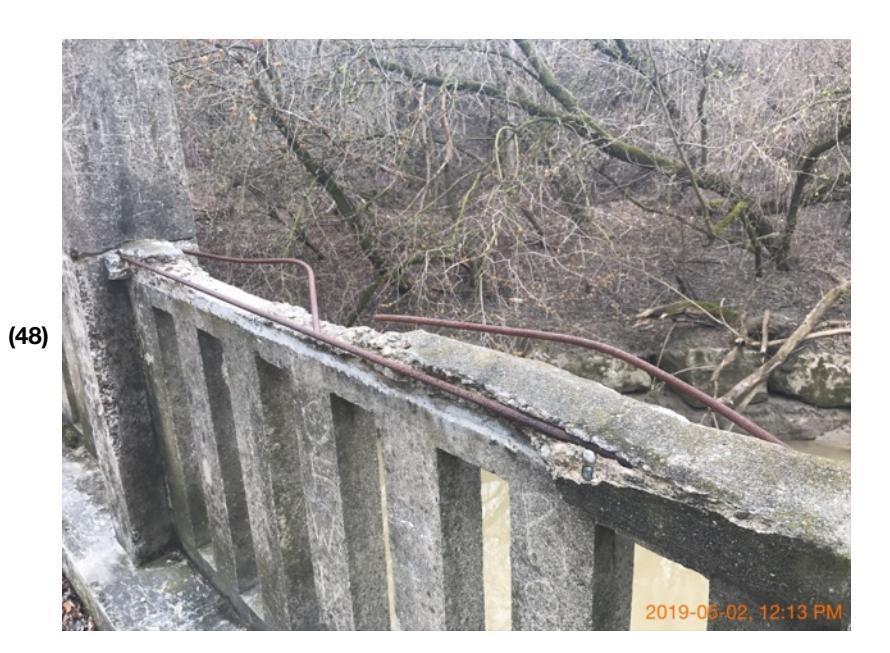
Section loss, spalled concrete and exposed / failed corroded reinforcement in west parapet rail (upper rail).

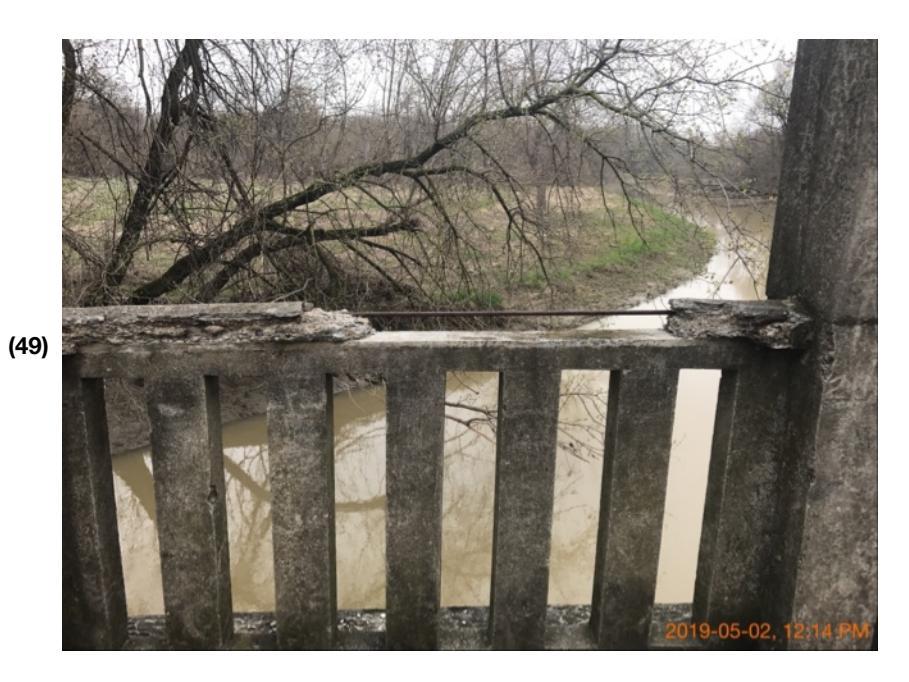
Section loss, spalled concrete and exposed corroded reinforcement in east parapet rail (upper rail).

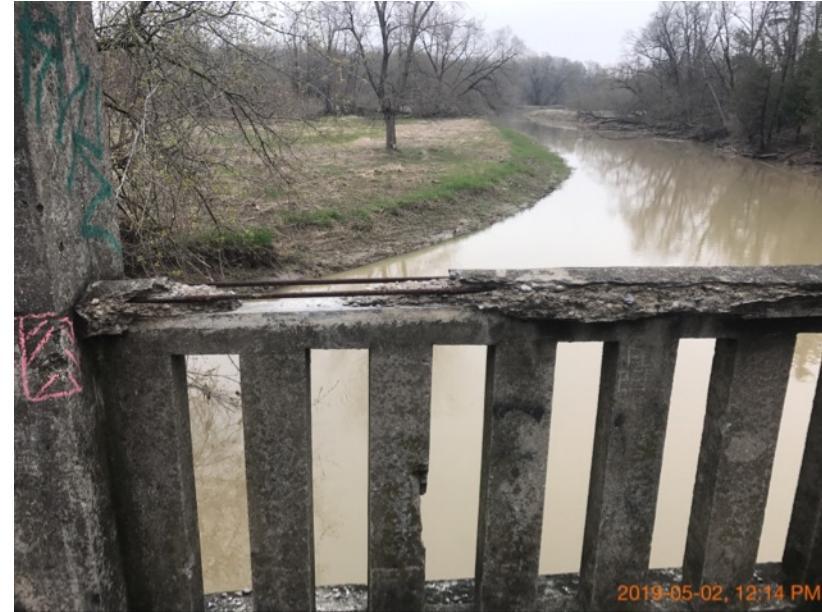
Section loss, spalled concrete and exposed corroded reinforcement in east parapet rail (upper rail).

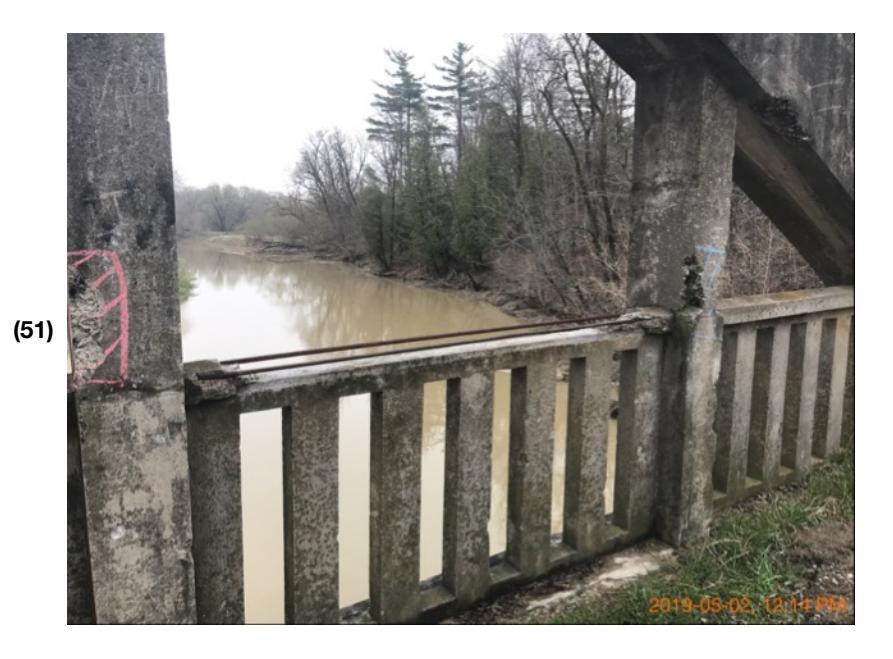
Complete section loss in upper rail of east parapet wall (near south approach). Note the exposed corroded reinforcement.

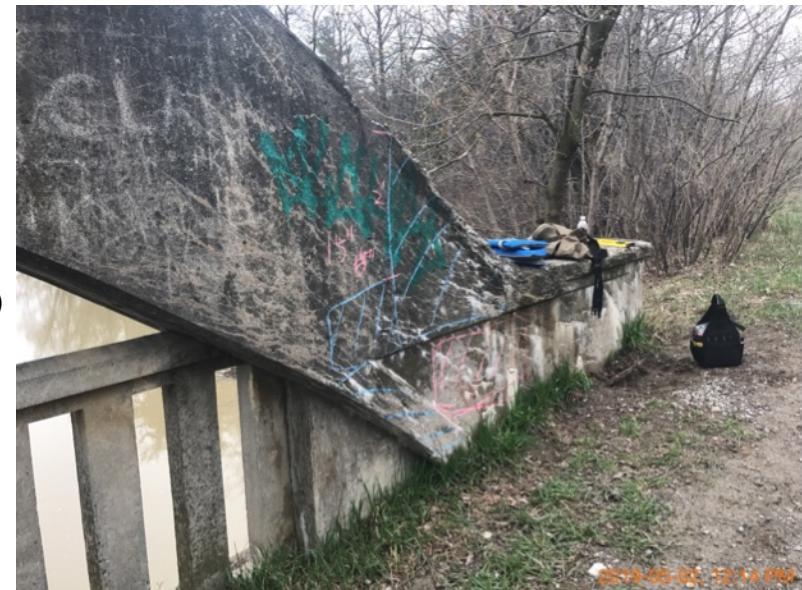
Concrete delamination and cracking with efflorescence staining along the inside face of east arch rib, near the south approach.

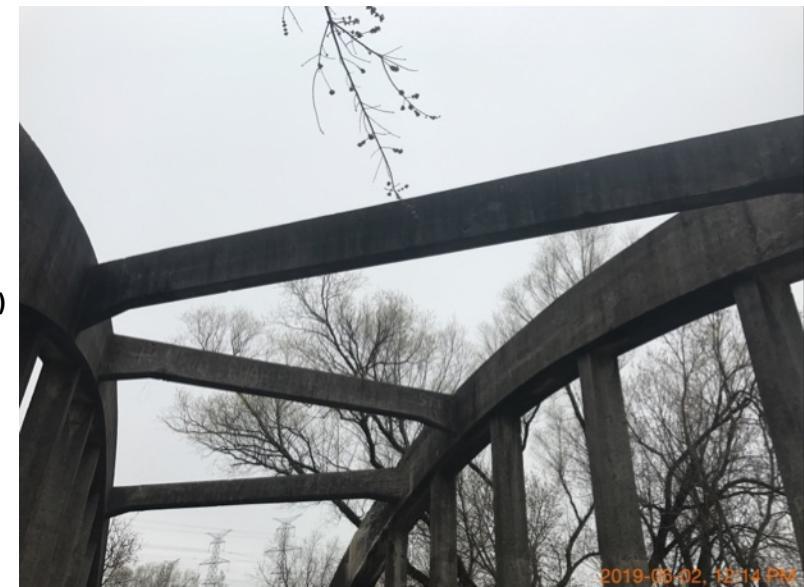
Graffiti damage at inside face of west arch rib, near the south approach.

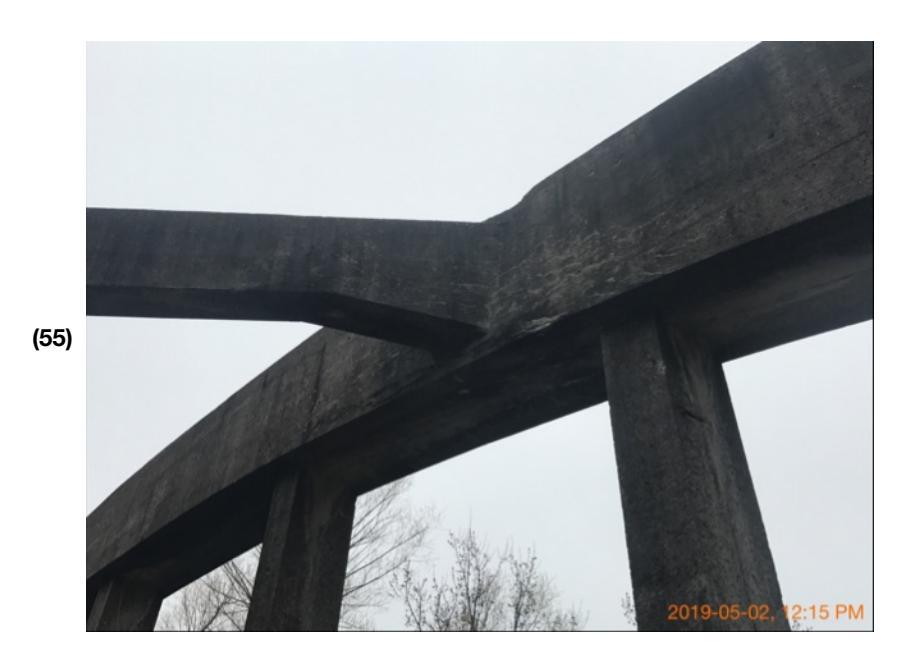
Concrete cracking with efflorescence staining along the inside face of east arch rib near the sway bracing.

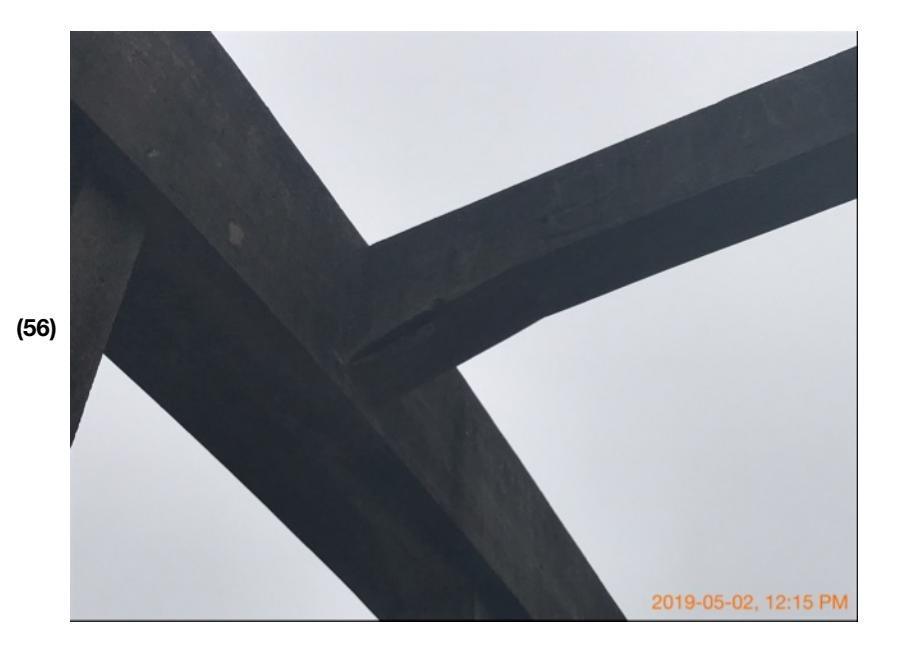
Exposed corroded steel reinforcement was noted in the one (1) of the sway bracing members near the east arch rib (see Photograph 56).

Exposed corroded reinforcement in sway bracing near the east arch rib.

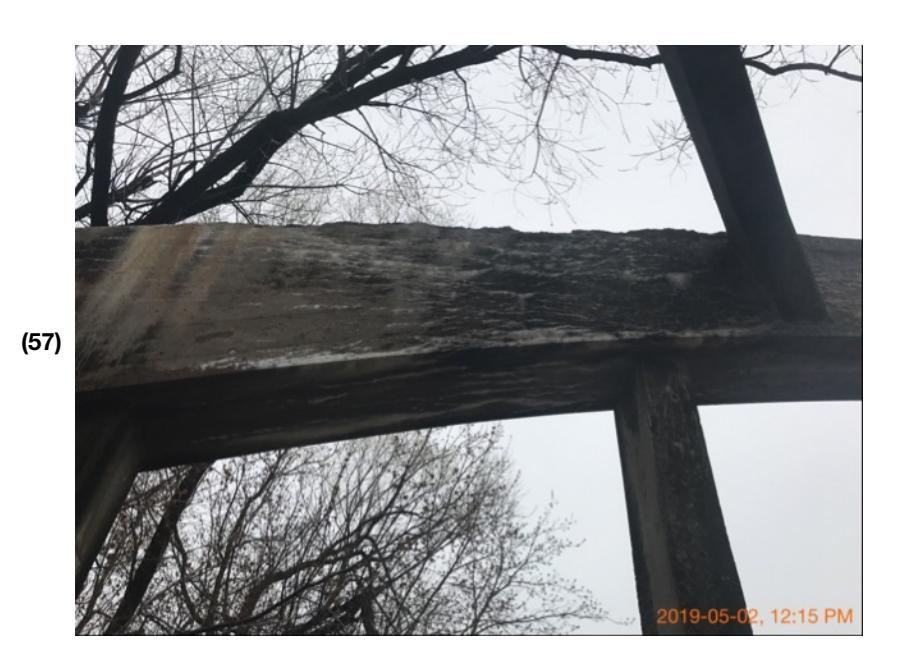
Concrete cracking with efflorescence staining (potential ASR) at inside face of east arch rib near the north sway bracing.

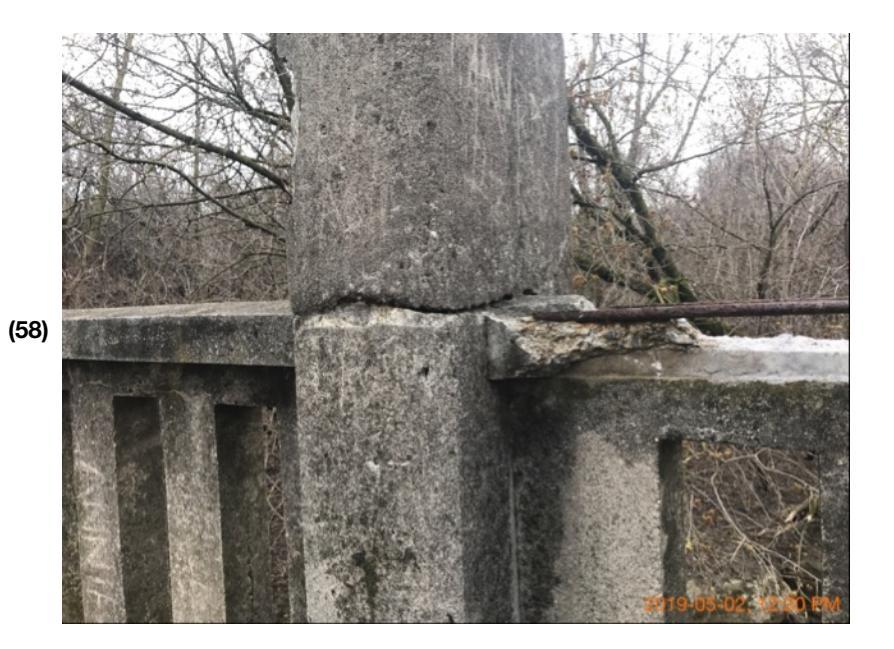
Wide cracking in easy vertical member near parapet wall (typical for west verticals).
