# PRELIMINARY DESIGN REPORT NO.2

WILEY BRIDGE

CLAIREVILLE CONSERVATION AREA

**PROJECT NO 10009703**

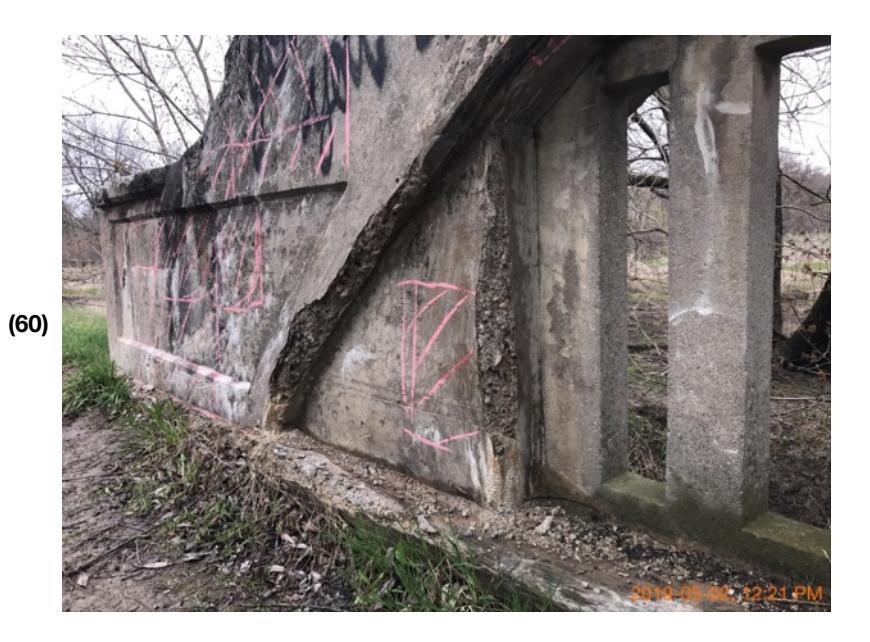
Concrete delamination and disintegration at the inside face of east arch rib, near the north approach.

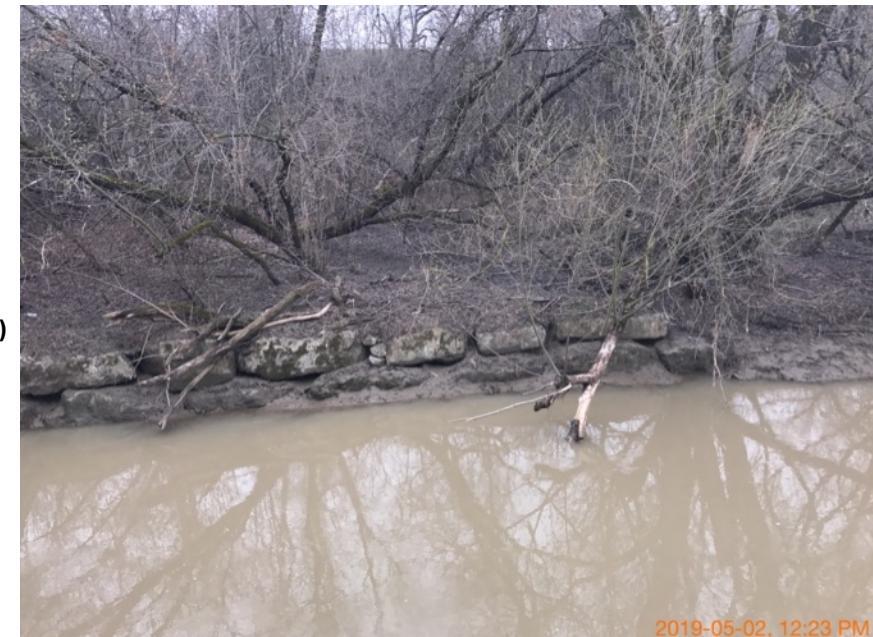
Failed trees in watercourse along south shoreline (upstream / west of bridge).
