**Project Address:**  
**7605 Creditview Road, Brampton, Ontario**

Prepared by:  
Stephen Shelton ON-0542AT, TRAQ 1589  
8 August 2021

## Arborist Report - 7605 Creditview Road, Brampton, Ontario

Summit SKS Limited have been retained by the property owner to prepare this Arborist Report and Tree Protection Plan for 7605 Creditview Road in Brampton, Ontario. The tree assessment was completed on the 3rd day of August 2021.

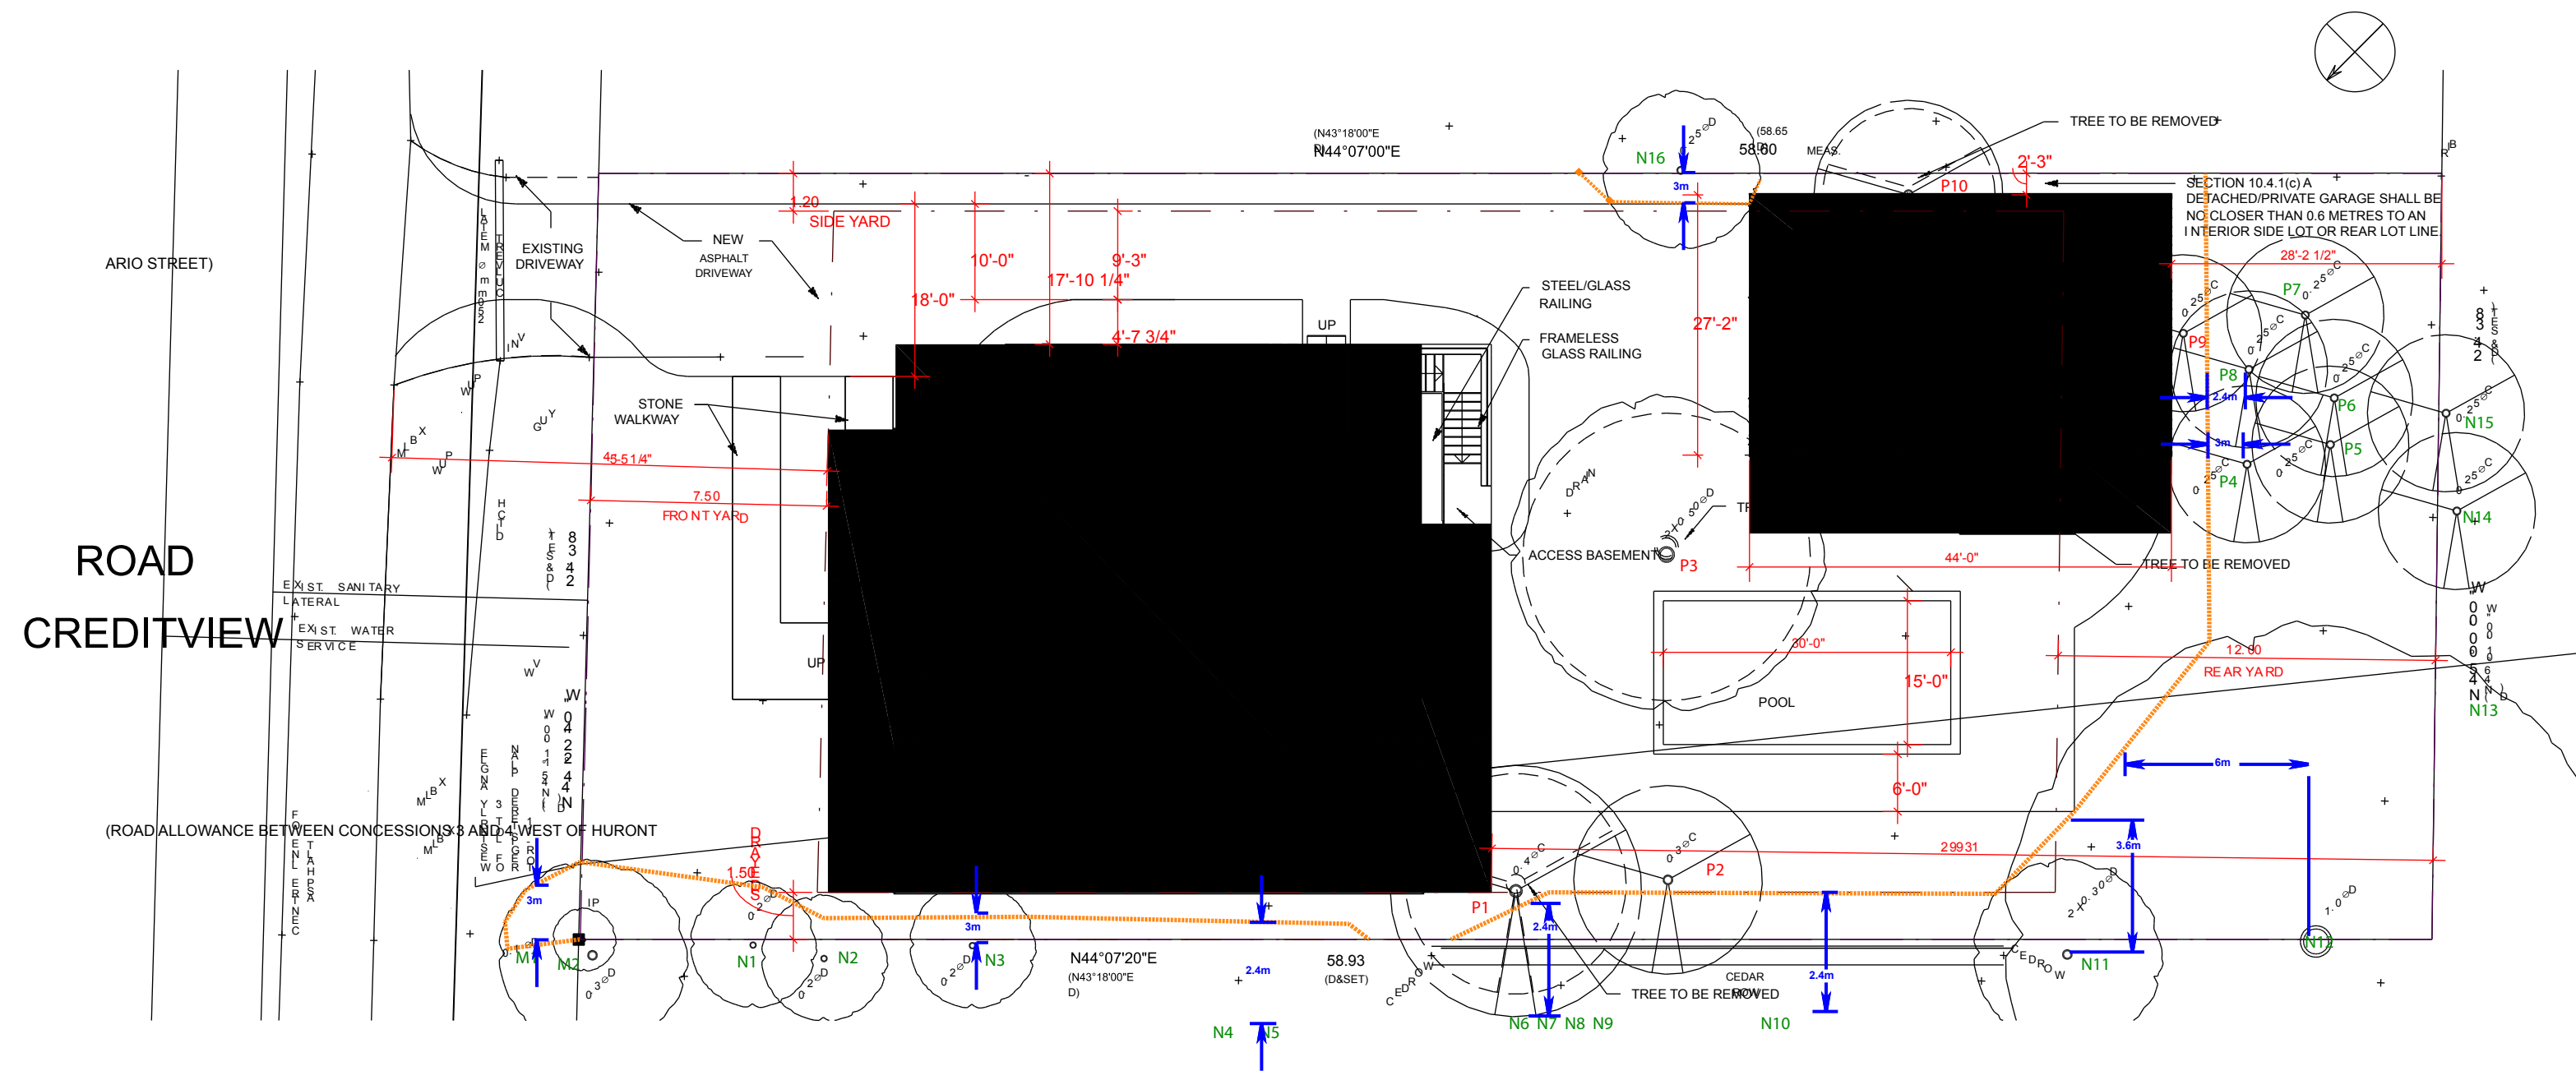
Tree Protection Plan

Tree number P1 is a 39cm dbh Spruce Blue that is growing near the south east corner of the proposed dwelling. This tree is in poor condition and recommended for removal based on the proposed development.

Tree number P2 is a 32cm dbh Spruce White that is growing near the south side of the backyard. This tree is in poor condition and recommended for removal based on the proposed development.

Tree number P9 is a 29cm dbh Fir Balsam that is growing near the east side of the proposed garage. This tree is in poor condition and recommended for removal based on the proposed development.

Tree number P10 is a 38cm dbh Spruce White that is growing near the north side of the proposed garage. This tree is in poor condition and recommended for removal based on the proposed development.

**All protective tree hoarding shall be installed prior to commencement of any construction activities as per municipal specifications.**
