Special Meeting Agenda

Brampton Heritage Board

The Corporation of the City of Brampton

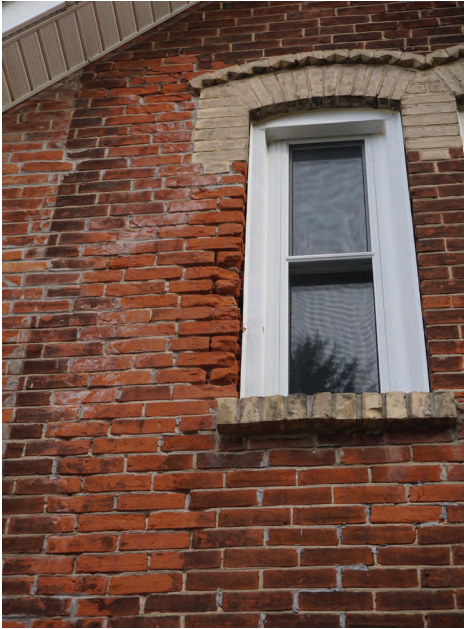
Detail view of deterioration, weathered brick at window edge.

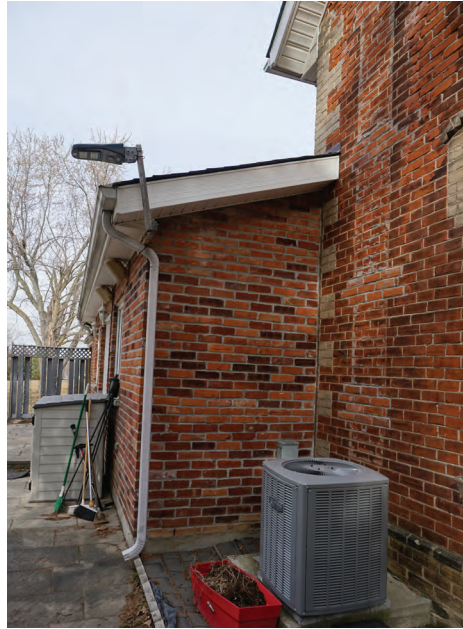
Latest addition, masonry repair visible on the brick gable.

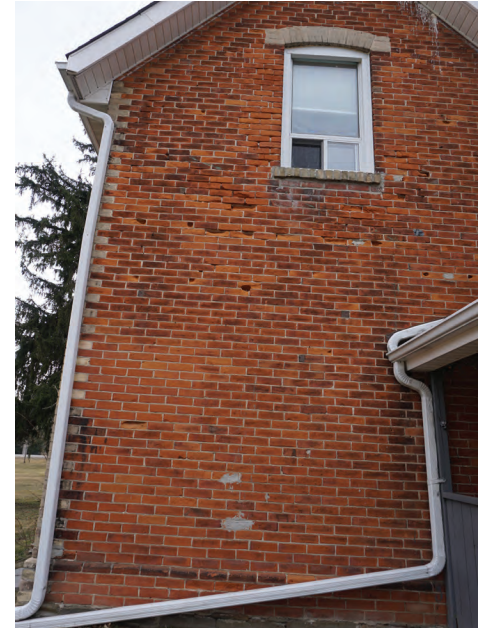
Brick damage along window

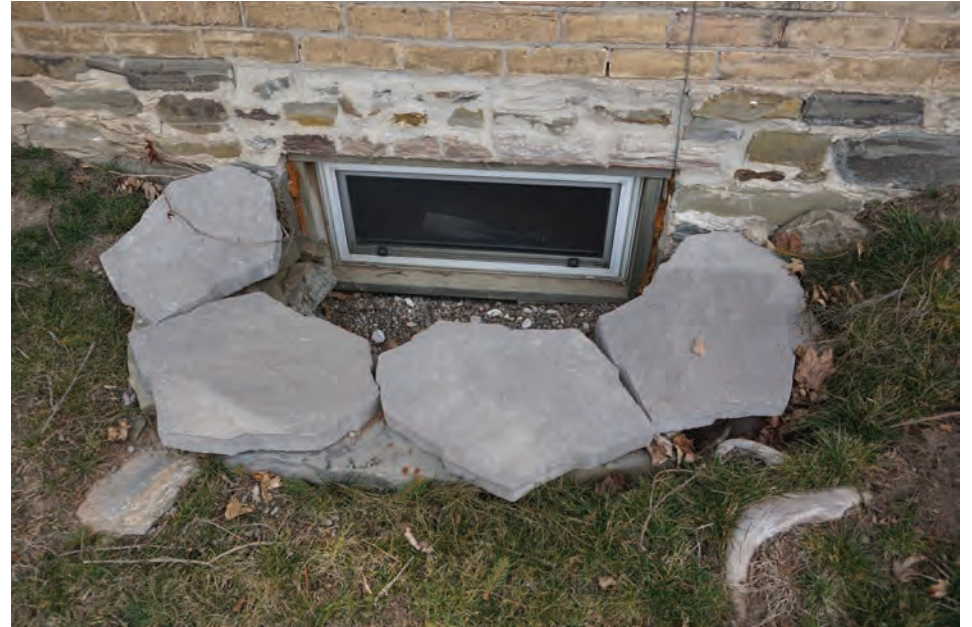
Pressure treated wood framing / drystone light well.

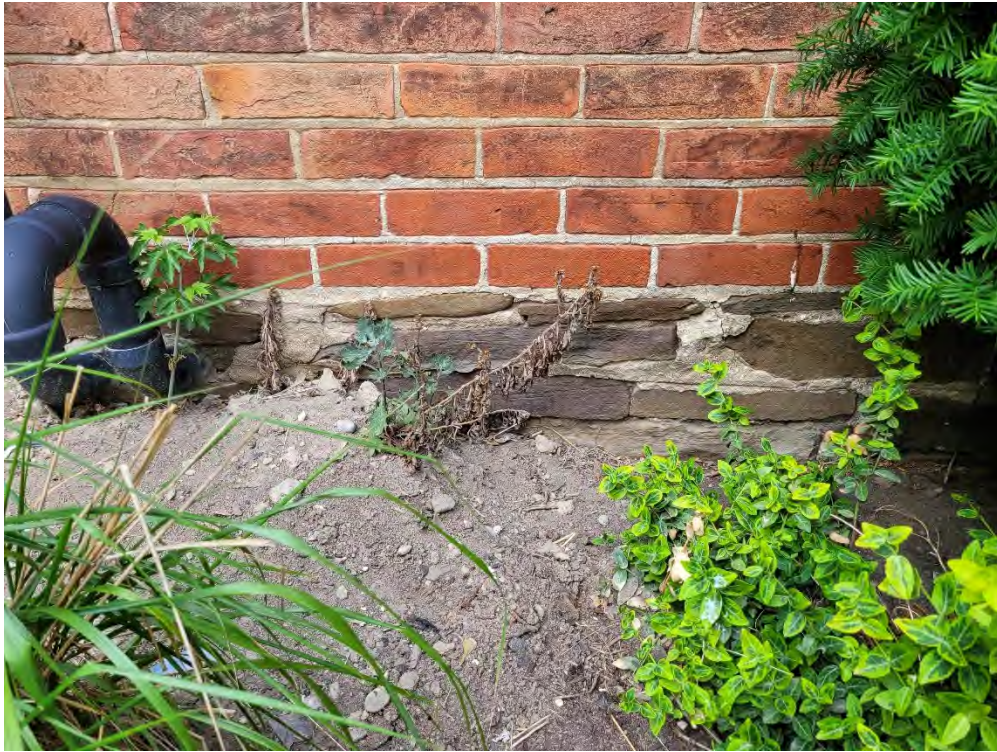
Figure 20: Coursed split fieldstone foundation

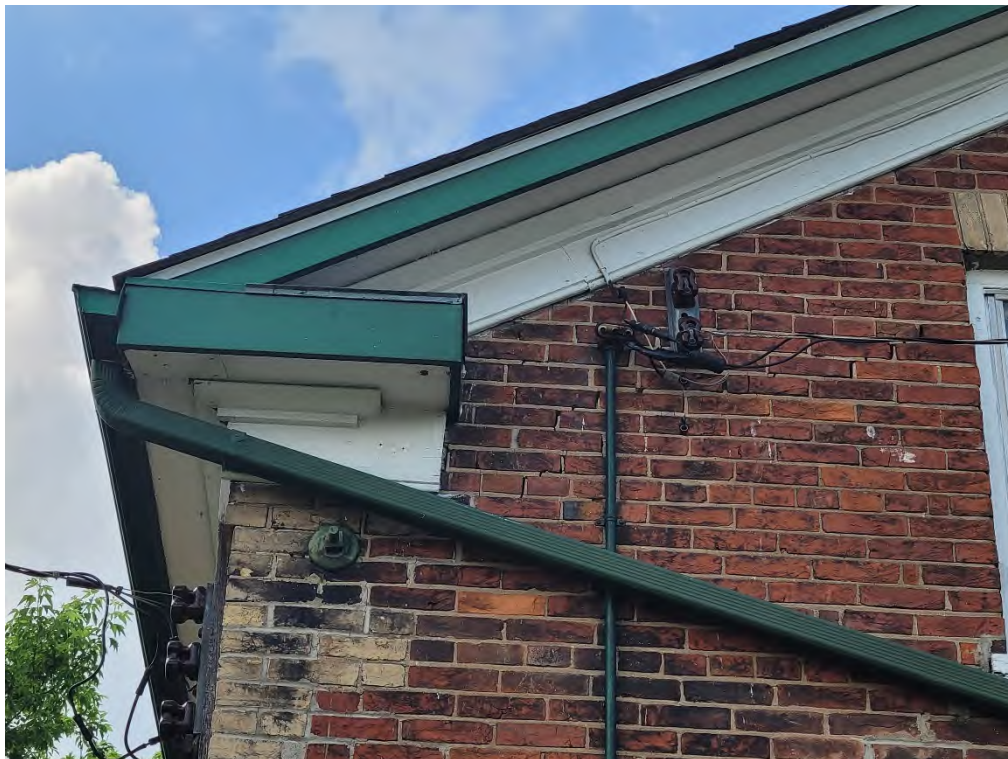
Figure 21: Projecting eaves and verges of the main block with cornice return, moulded frieze and soffit, plain fascia, prefabricated rainwater leader, and tie rod

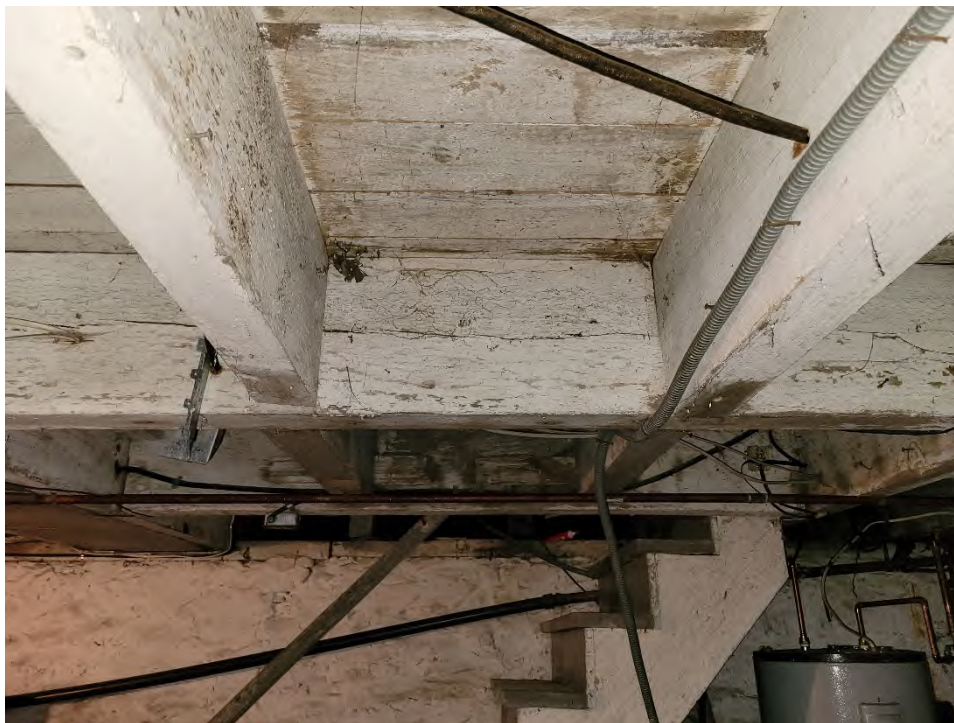
Figure 56: Exposed floor joists left in the rough in the south half of the main block

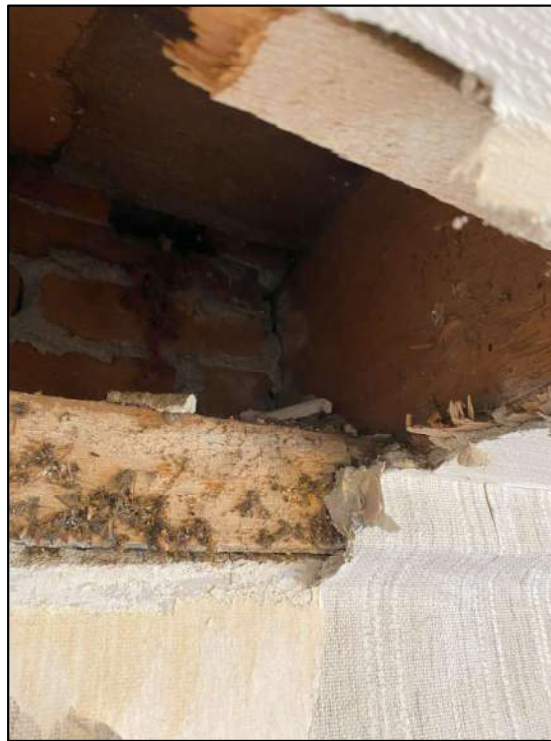
A section of ceiling finishes was removed at the southwest corner of the building and approximately at the middle of the south wall (refer to Photograph 2). Due to the absence of damage or evidence of movement, it is unlikely that the deflection on the second floor was caused by an outward movement of the wall after construction. It is assumed that the wall was built out of plumb. Refer to Section 5.5 Exterior for further discussion on the condition of the south wall.

Photograph 2: Section of removed ceiling finishes at the middle of the south wall

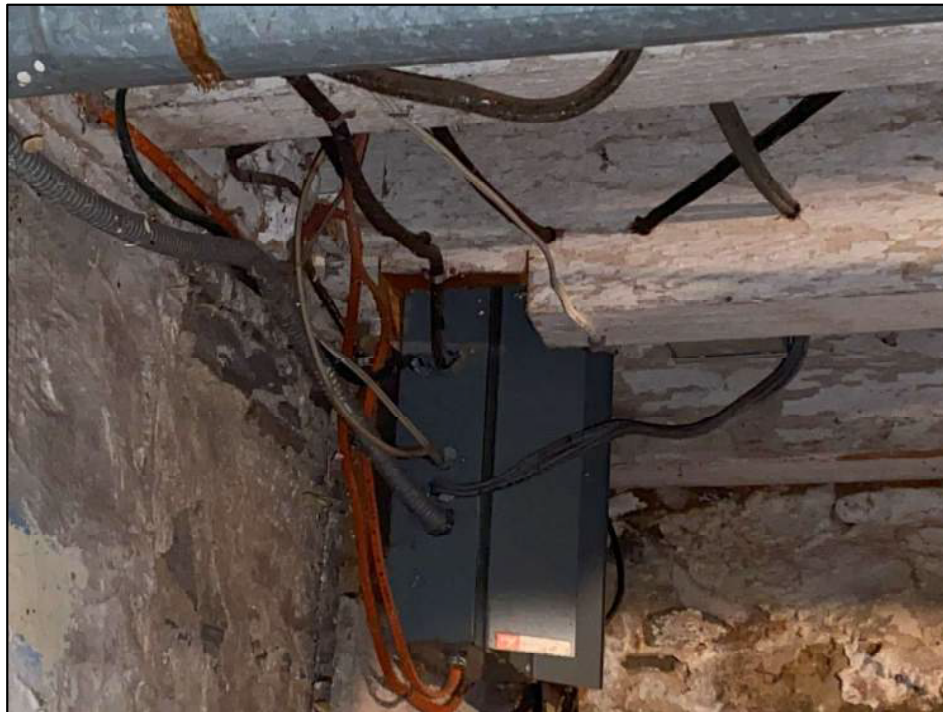
One shoring post was installed to support a cut joist, and others to support other localized areas of floor. It is unlikely that the shoring posts bear on footings.

Photograph 3: Notched joist behind furnace

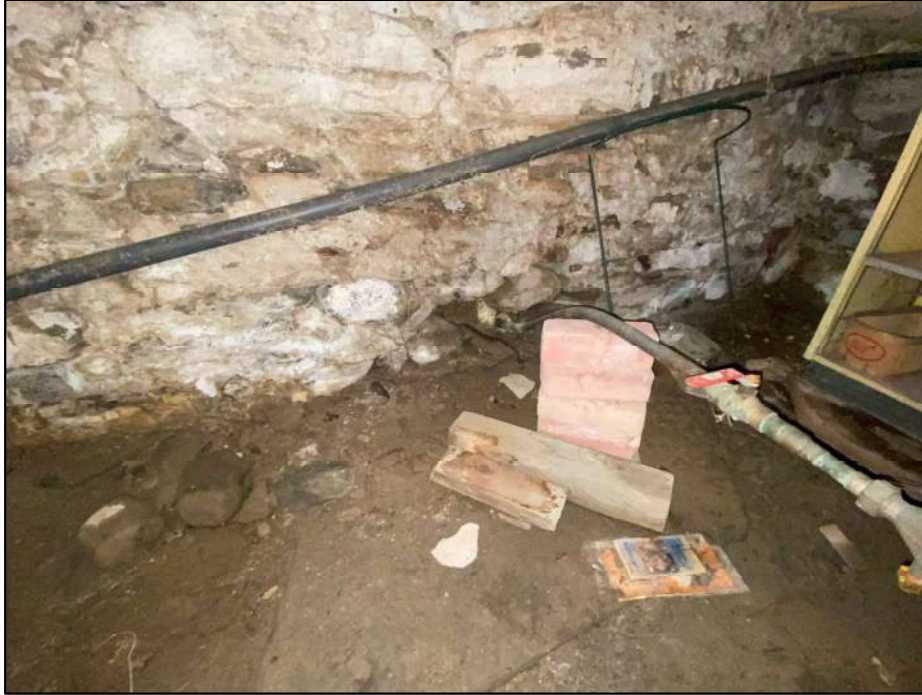
Photograph 4: Undermined section of foundation wall

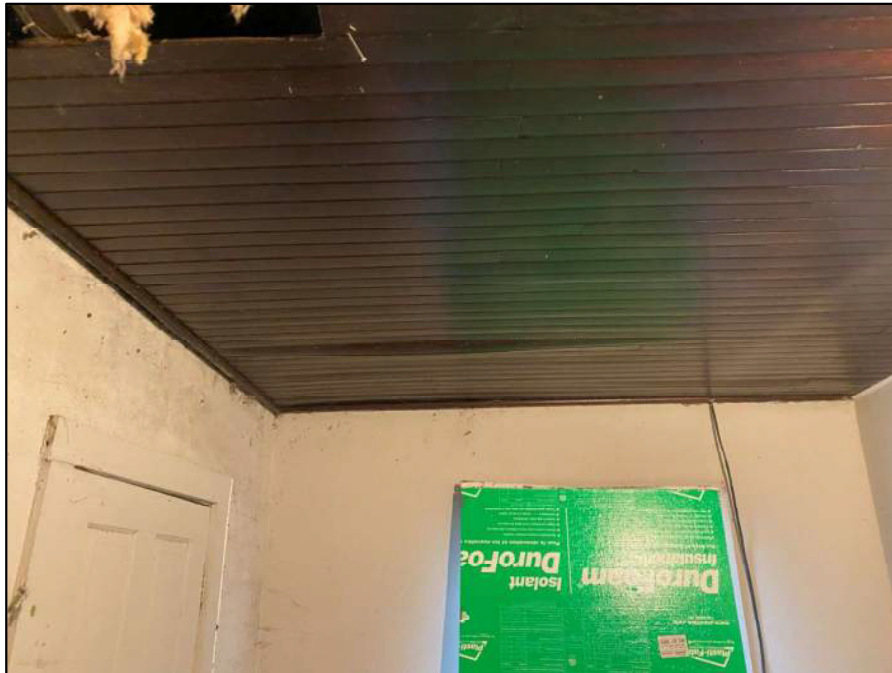
The finishes in the summer kitchen were generally of poor quality and/or in poor condition. Water damage was noted to the ceiling and floor finishes, as seen in Photograph 5 and 6, which could pose a larger concern to the underlying structure.

Photograph 5: Water damage to ceiling finishes

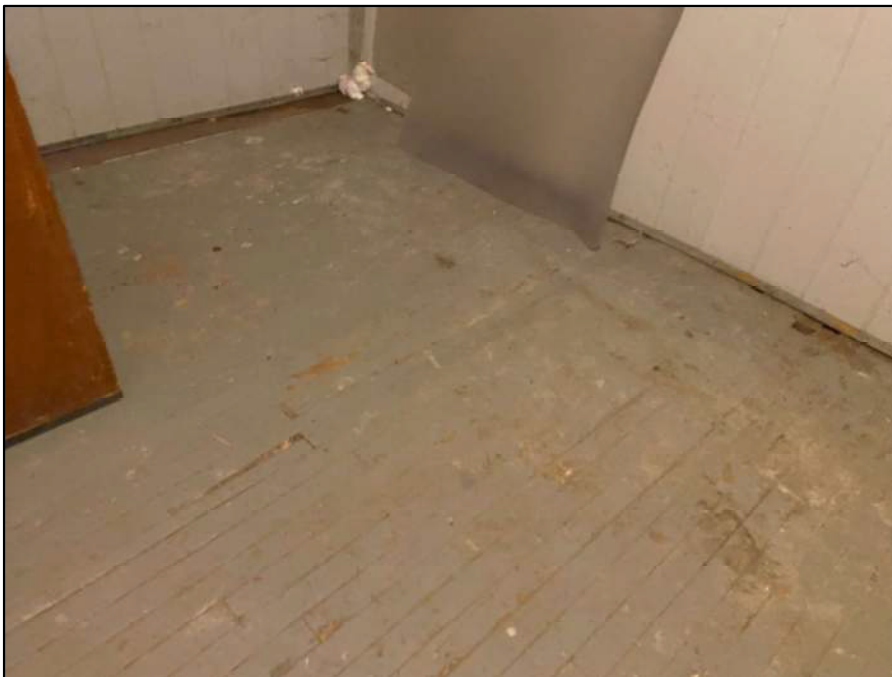
Photograph 6: Water damage to floor finishes

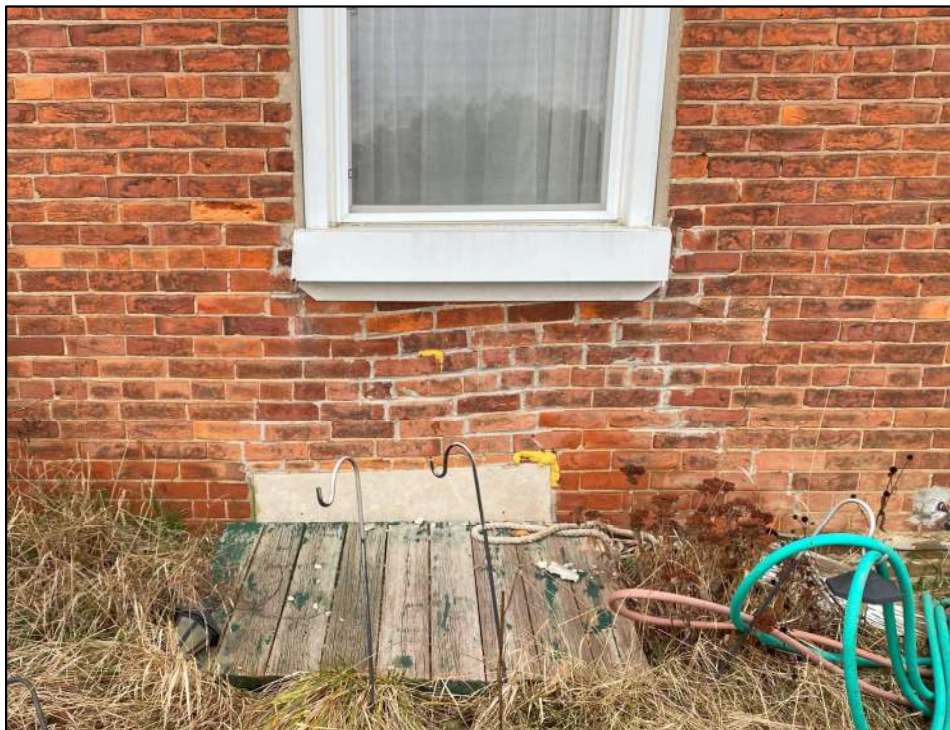
Photograph 9: Inconsistent coursing

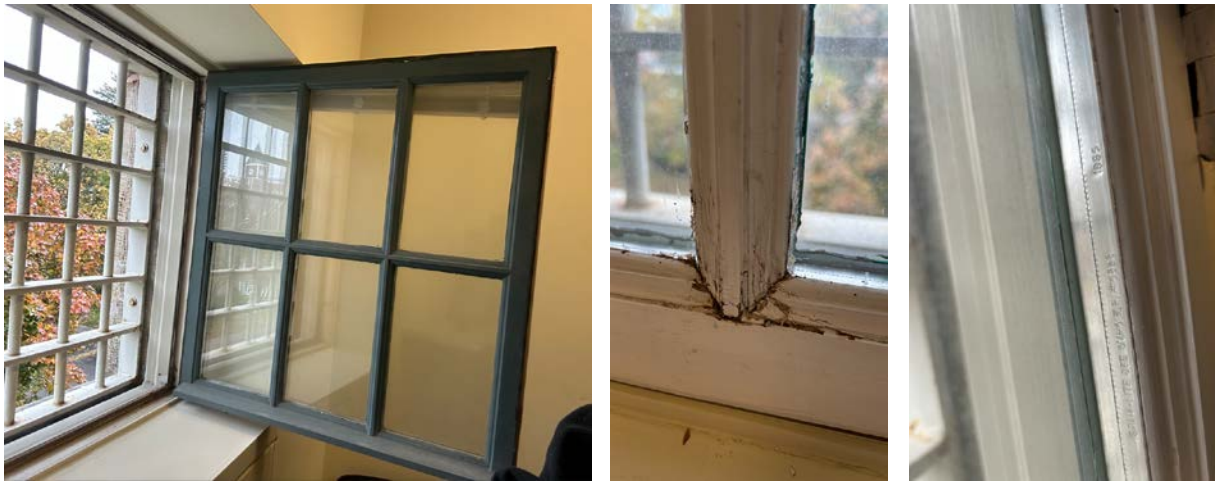
Typical existing window conditions to be replaced
