Brampton Heritage Board

69 ELLIOTT STREET,
BRAMPTON, ON
BRAMPTON MEMORIAL ARENA

HERITAGE IMPACT ASSESSMENT
AND
HERITAGE CONSERVATION PLAN

PROJECT: HERITAGE CONSERVATION PLAN FOR 10431 THE GORE ROAD, CITY OF BRAMPTON, ONTARIO		
TITLE: LOCATION OF THE STUDY AREA		
LEGEND: <div><div></div> STUDY AREA</div>		
NOTES: THIS DRAWING SHOULD BE READ IN CONJUNCTION WITH THE WOOD ENVIRONMENT & INFRASTRUCTURE SOLUTIONS Report No. OCUL2118. ALL LOCATIONS ARE APPROXIMATE. REFERENCES: BASE AERIAL MICROSOFT® BING™		
<div>0 75 150 225 m</div> <div>SCALE:1:6,750</div>		
CLIENT: CACHET DEVELOPMENTS (EMERALD CASTLE) INC 361 CONNIE CRESCENT, SUITE 200 CONCORD, ONTARIO, L4K 5R2		
wood. Wood Environment & Infrastructure Solutions 50 TROOP AVENUE UNIT 300 DARTMOUTH, NOVA SCOTIA B3B 1Z1		
DWN BY: CD	CHK'D BY: HC	DATE: 2 JUNE 2022
DATUM: WGS 84	PROJECTION: UTM ZONE 17	PROJECT No.: OCUL2218
REV No.: 0		FIGURE No.: 1

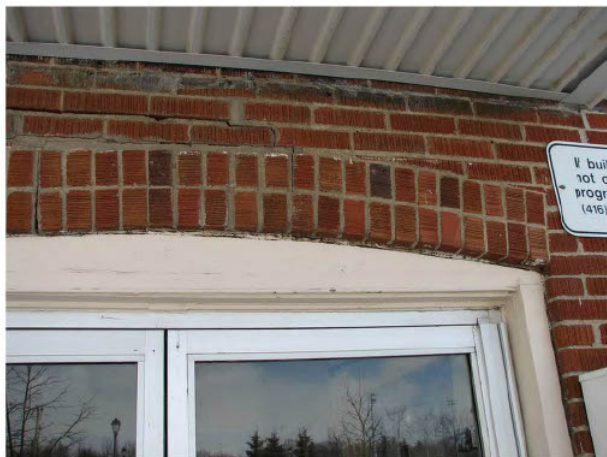
Detail showing portion of masonry wall on front façade. This image shows the brick arch of the east entrance. Note step crack. Masonry repairs are required.

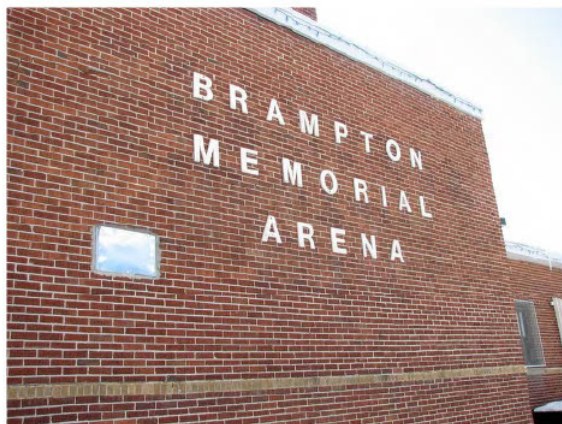
Detail of frontispiece on front façade with original "Brampton Memorial Arena" lettering. Every effort should be made to retain this detail. If letters are replaced in future, the 1950s era typeface and form must be replicated. Alterations that would result in new openings being cut into the masonry walls should be avoided. Masonry repairs should only be made using compatible mortar mix, taking care to match original colour and mortar profile.

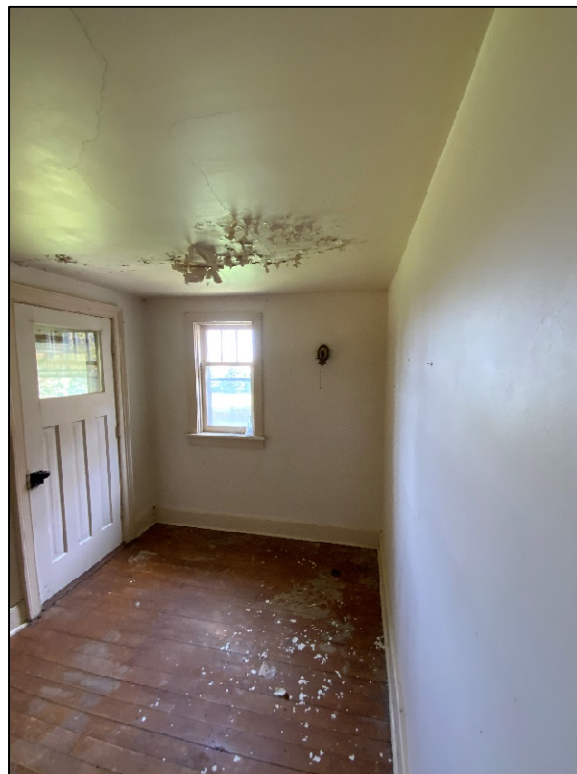
The asphalt shingles are at or near the end of their service life. Several shingle tabs were missing at the time of the review and limited evidence of water ingress was noted on the second floor ceiling.

Photograph 1: Minor ceiling damage

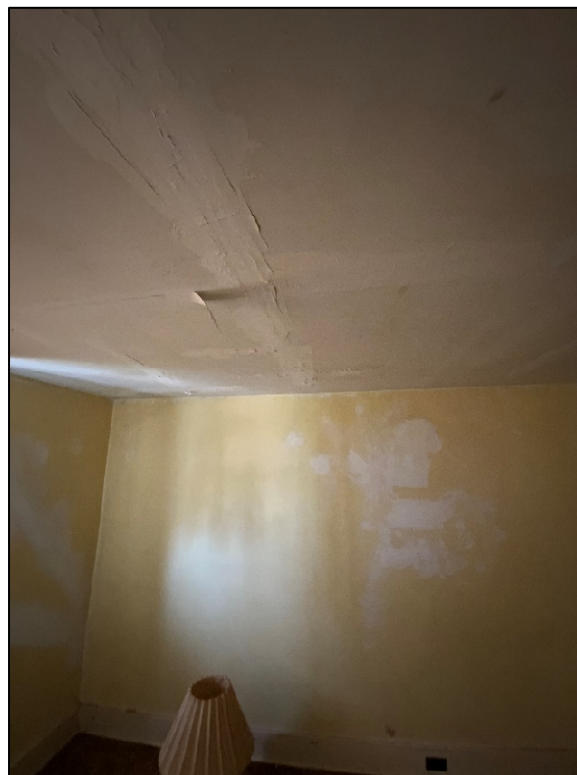
Floor finishes, where present, are in poor condition. Cracking is visible in several locations including walls and ceilings.

Photograph 2: Previously repaired ceiling damage

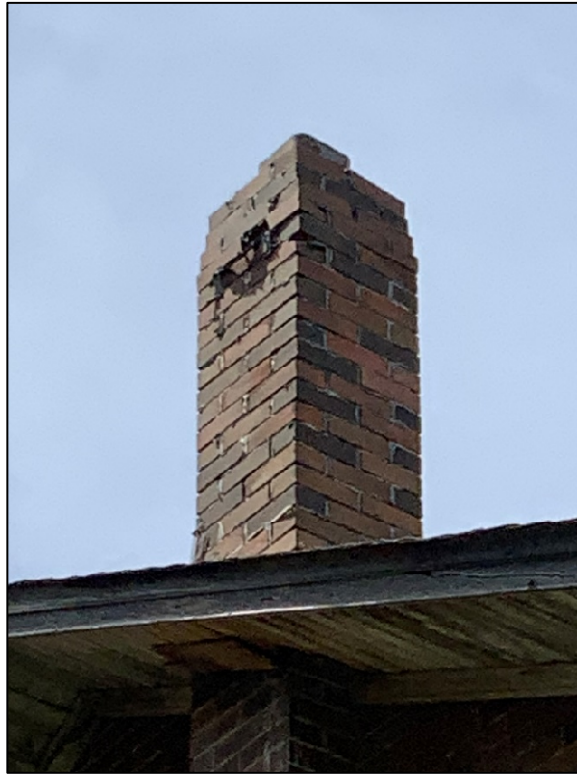
The chimneys are in fair condition for the majority of the height, with some open mortar joints; however, the upper 5-6 courses of each chimney appear to have sustained some damage and several bricks appear to be loose.

Photograph 4: Damaged masonry at southeast chimney (typical to both chimneys)

This could be the result of freeze-thaw damage due to the increased exposure of these elements. In cases where the chimneys are no longer required to vent mechanical equipment, the reduction in secondary heat can lead to accelerated deterioration.
