Cultural Heritage Impact Assessment

7699 Creditview Road

Churchville Heritage Conservation District

City of Brampton, Ontario

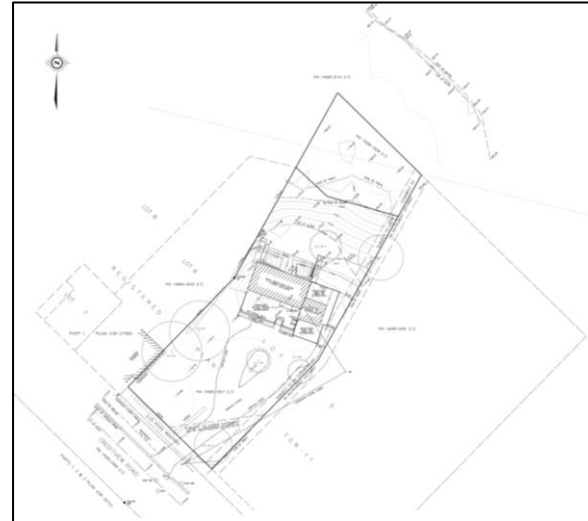
Figure 7 - Topographical Survey of Part of Lot 5, Registered Plan TOR-11. (J. D. Barnes Limited, dated August 5, 2021)

The land title abstracts indicate that the subject property (7699 Creditview Road) as shown in a recent topographical survey drawing (Figure 7) is the smaller of two properties created from Lot 5 about 1969, the larger being 7695 Creditview Road.

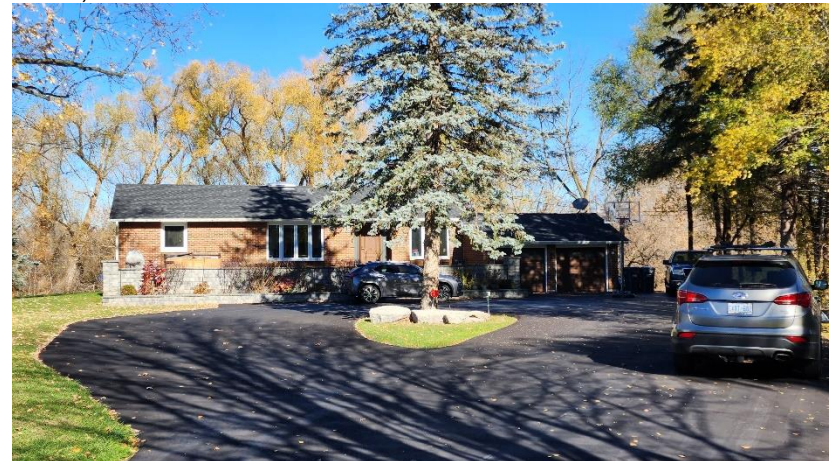
Figure 10 - View of the red brick 1970's bungalow and garage just before the driveway divides to go around the spruce tree. (RHC 2022)

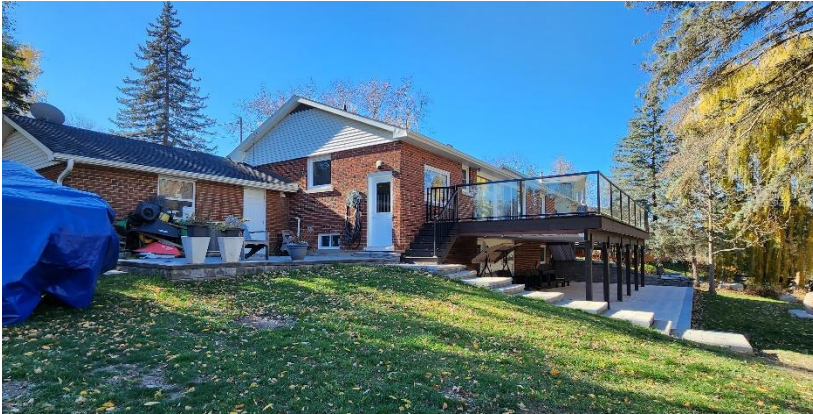
From the rear of the dwelling the land slopes down toward the river. The dwelling has the appearance of a two storey dwelling on this elevation with a full walk out with large windows, sliding patio doors and deck with glass guards and covered concrete pad below. A second concrete pad continues behind the two-door garage and connect both a door from the back of the garage and a door into the side of the dwelling.

Figure 13 - This view shows the of the relationship of east and north elevations of the end wall of the main dwelling to the offset garage wall. (RHC 2022)

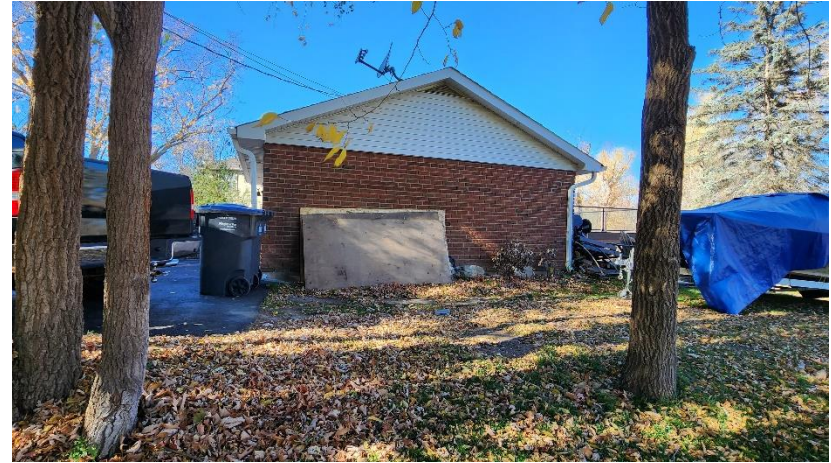
Figure 14 - East elevation showing the brick wall with siding filled gable a ridge vent of the end wall of the garage. (RHC 2022)

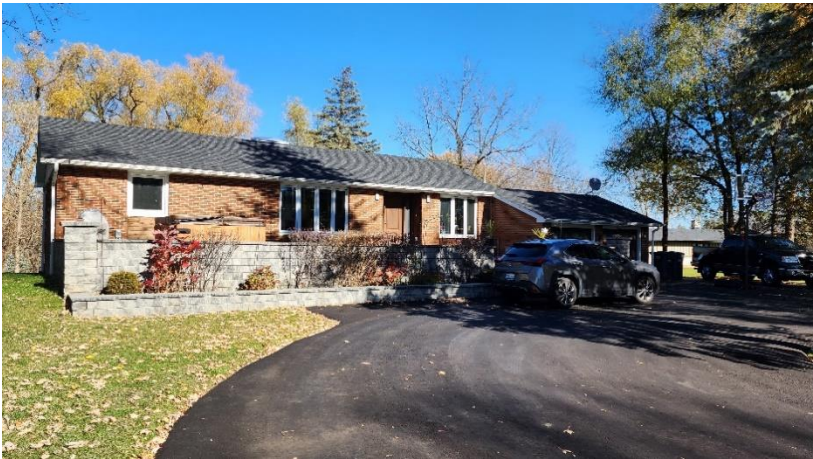
The dwelling on the property is a side gable red calico rough brick bungalow with raised basement and forward presenting offset two-door garage. The interior has not been documented as part of this assessment as it is not an identified contributing architectural style and the proposed addition with only be removing the two-door garage.

Figure 15 - The façade of the raised bungalow. (RHC 2022)

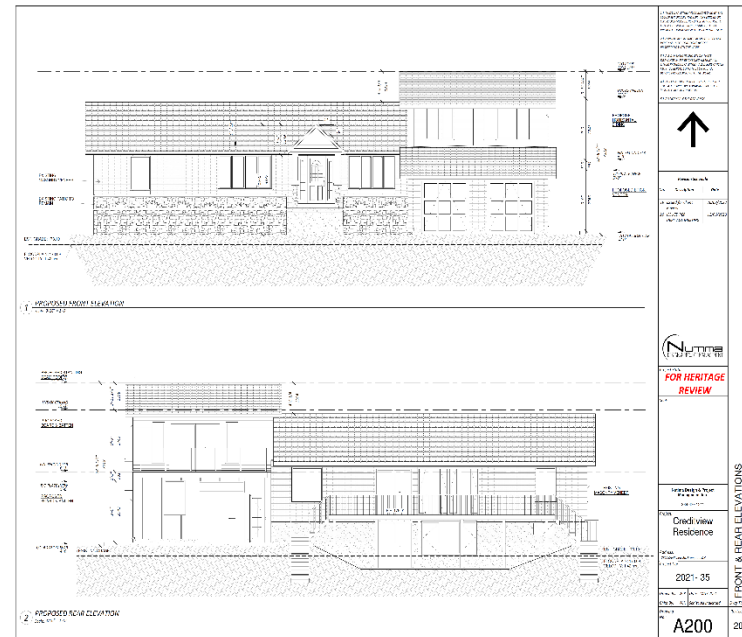
Figure 17 - Front and rear elevations of the proposed addition to the original dwelling.(Nutima 2023)

From the front the addition appears to match the side gable pitch of the existing dwelling but then lowers to nearly flat for the balance of the garage roof. The roof line for the upper floor is drawn back and kept low in keeping with the horizontally oriented design of the original dwelling.

A projecting front gable is being introduced on the original dwelling to mitigate the more forward projecting garage by drawing attention to the front door which is recessed.

The rear elevation includes a deck off the upper floor and concrete pad below both with patio style sliding glass doors similar to those on the original dwelling. The siding below the deck changes to more of a vertical board and batten style. Overall the visible roof is reduced and the glazing increased.

It is recommended that the proposed roofline be altered to reflect the same 6"/12" roofline of the existing dwelling rather than the proposed 5"/12" and 2 ½"/12" rooflines. The hood above the front door would benefit from a lower pitch as well to further reflect the low horizontal lines of the existing dwelling.

As the second floor of the proposed addition is over symmetrically placed garage doors it is recommended that the windows above be centred above each door with windows similar to one another to provide some balance. The windows on the upper left are separated rather than coupled like the other windows on the façade of the existing dwelling and are recommended to be coupled.

It is recommended that the cladding for the addition be a close match and oriented on the addition in the same horizontal pattern as the existing dwelling.

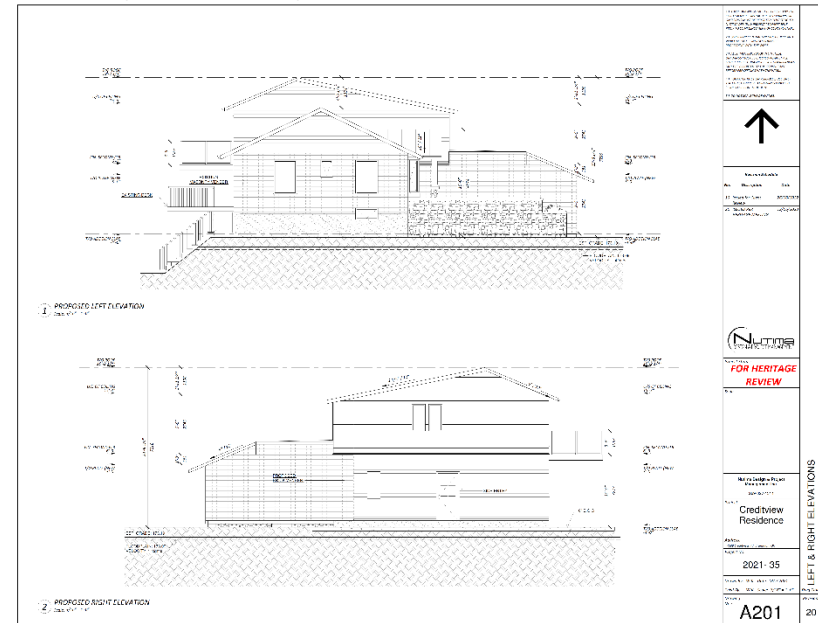
Figure 18 - East and West elevations showing the proposed addition. (Nutima 2023)

The west elevation is unchanged although the addition can be seen beyond it.

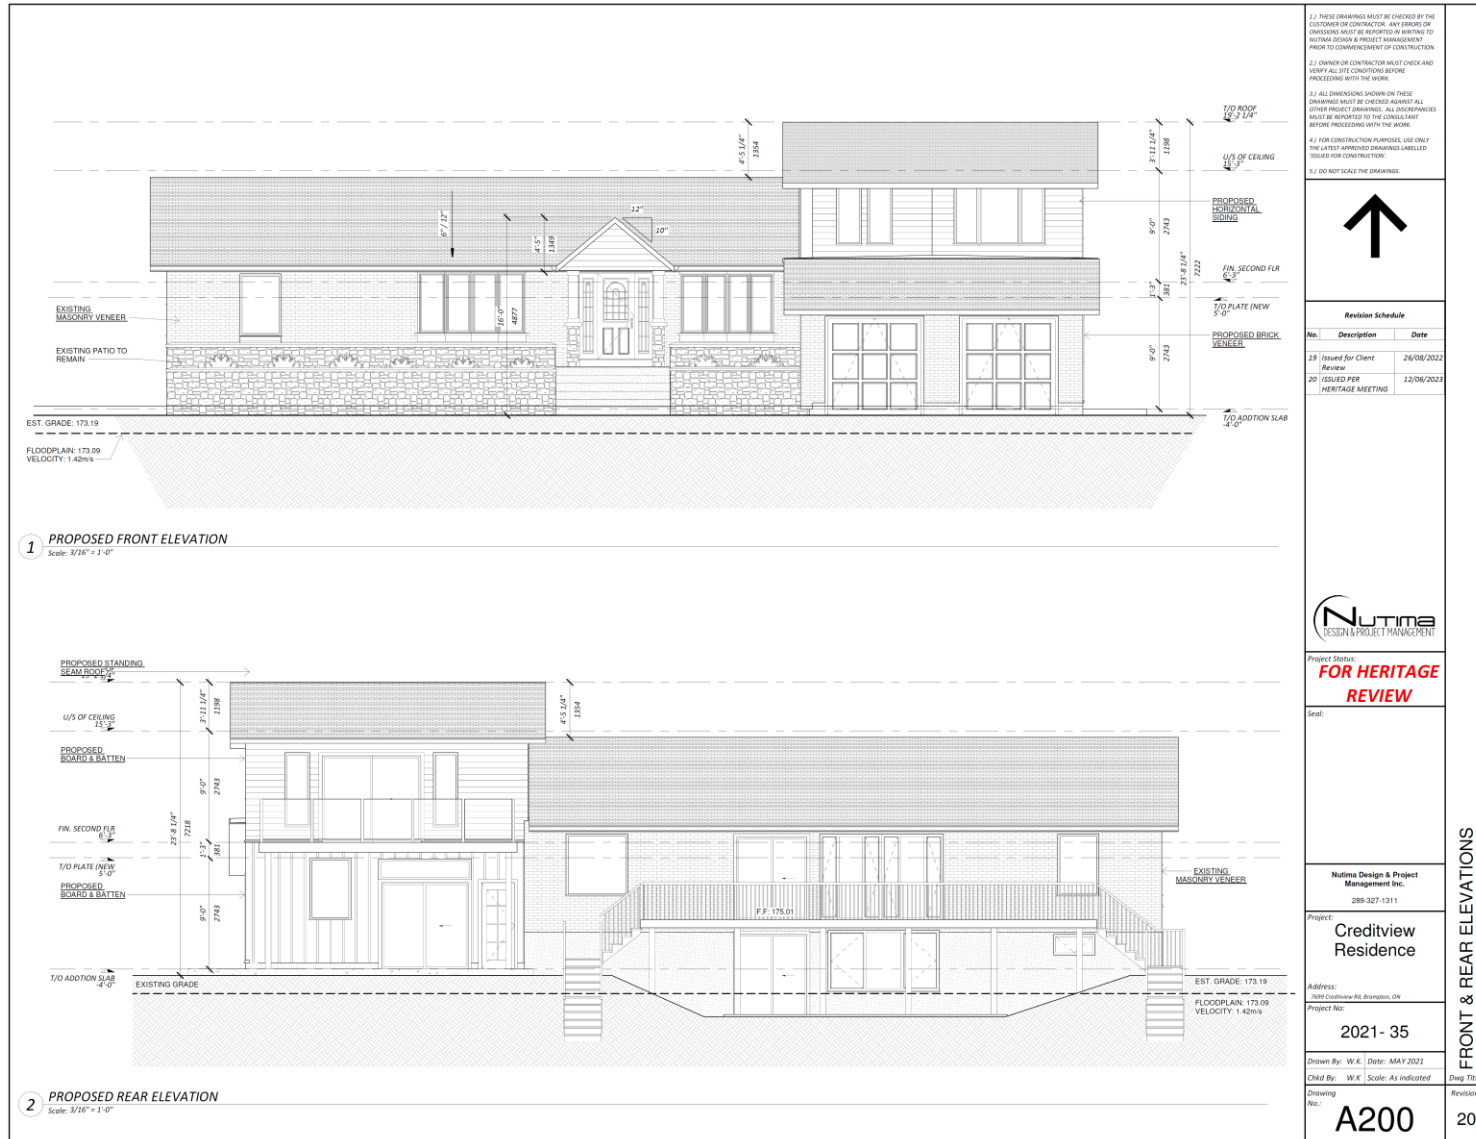
Figure 24 – Front and Rear Elevations A200 (Nutima Design 2023)

It is noted that there appears to be errors on the elevations (A200) as there is an unexplained double line lacking cladding and another line vertically between the upper windows that do not appear to be shown or explained in the balance of the drawing set and should be corrected.

It is noted that there appears to be errors on the elevations (A200) as there is an unexplained double line lacking cladding and another line vertically between the upper windows that do not appear to be shown or explained in the balance of the drawing set and should be corrected.
