**Heritage Impact Assessment** of 7749 Churchville Road Brampton Ontario

7749 Churchville Road  
City of Brampton  
Region of Peel  
Ontario  
L6Y OH3

**Project** 2023-15

**Final Report**

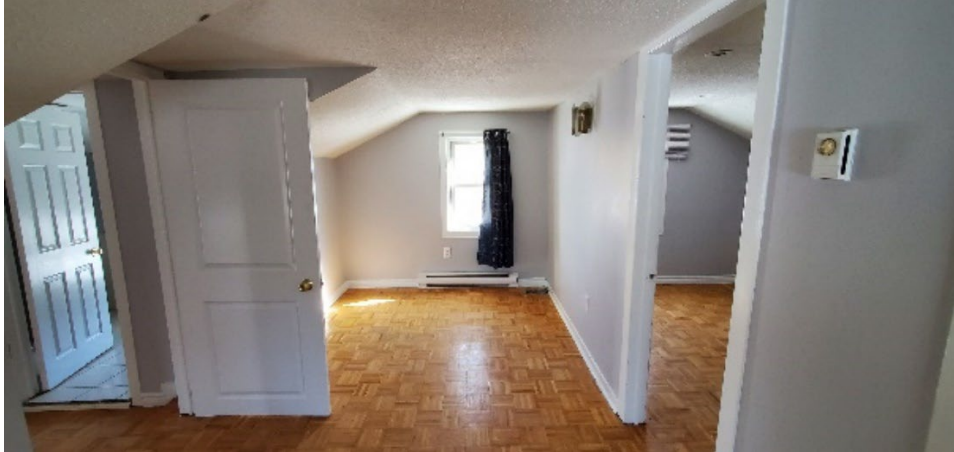
Second Floor: view south in front section with south original bedroom wall.

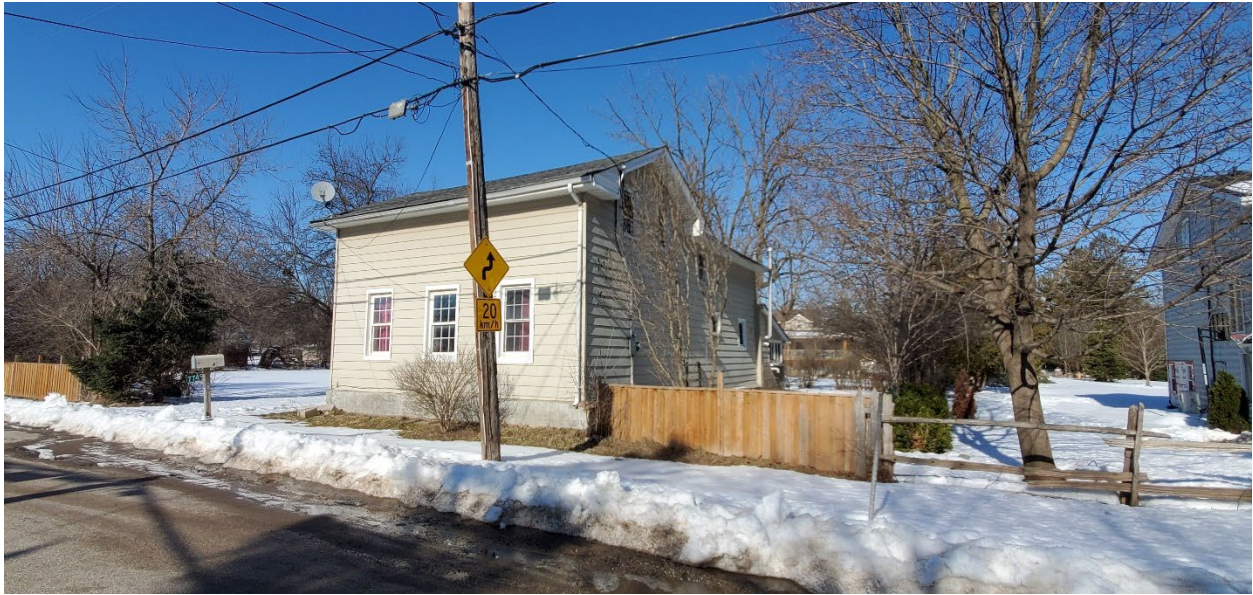
West Elevation

Partial view showing siding, replacement vinyl windows, eave detail and new bathroom windows.

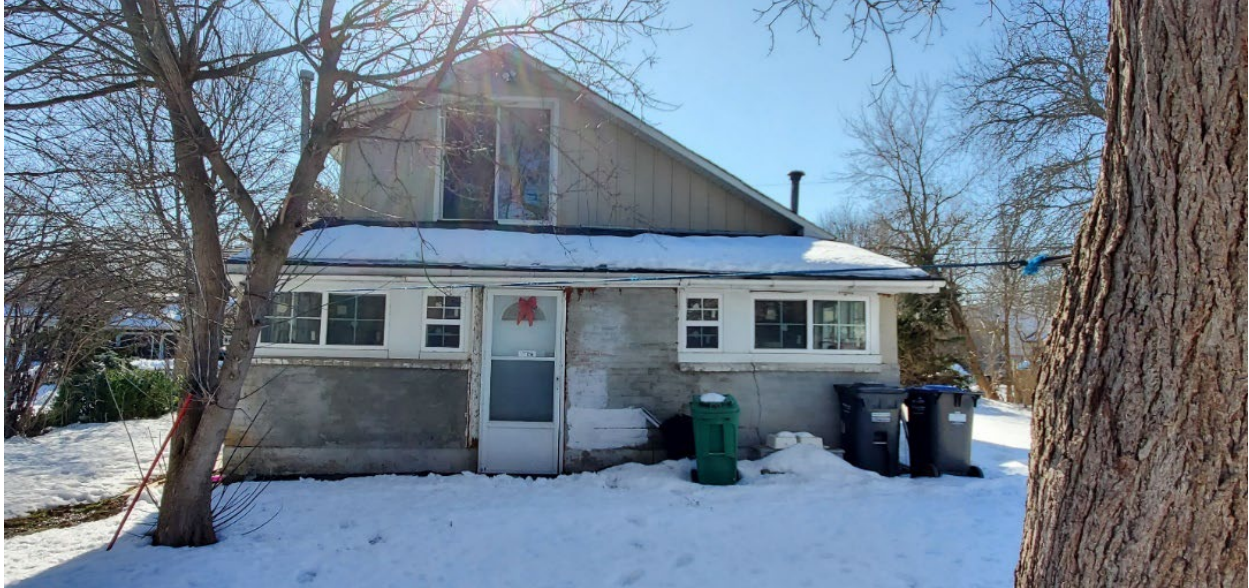
East Elevation

East Elevation: Note sliding glass door and crack in wall

There is a sliding glass door opening onto the rear single storey roof which is dangerous and has never been permitted under any building code. The roof, eavestroughs and downspouts should be maintained to keep moisture away from the foundation. Adequate maintenance and ventilation from the washroom and kitchen to the exterior would be helpful to maintain stable moisture control in the building.

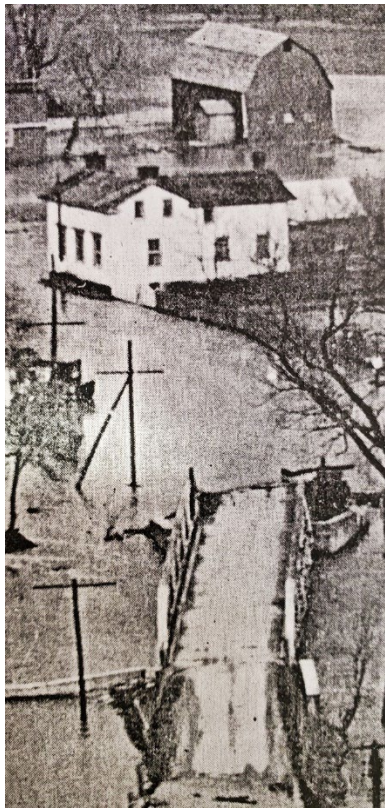
Subject property April 5, 1950 Flood water 12 feet above normal. Photograph Peel County Archives.

Note Building shape and windows and barns on Lot 13.

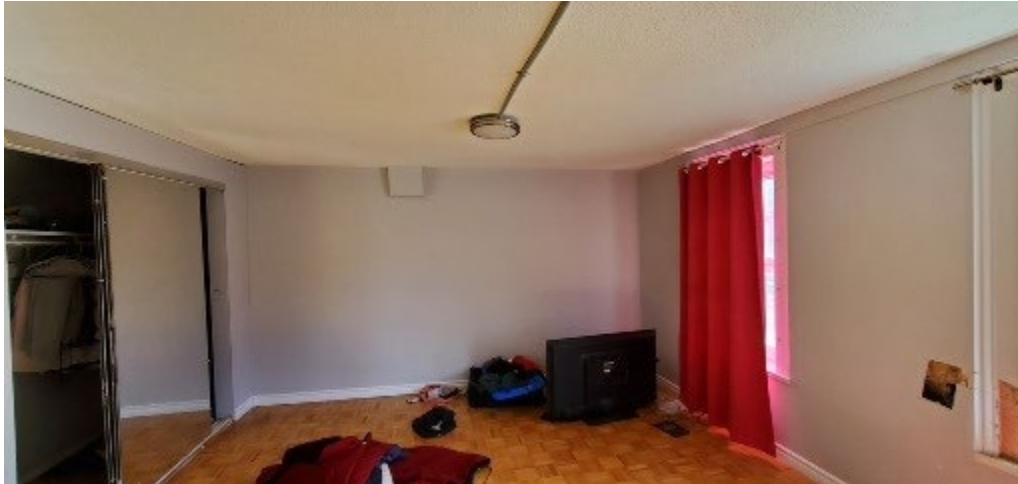
This is a photograph of the south gable at the front of the building. A central window on the wall would preclude a central fireplace or stove. The early photographs show a substantial chimney in the centre of all the gable elevations. The location of the kitchen and its relationship to the parlour and or dining room are important to derive the social construct of the space. The photographs also show the chimneys in the front gable ends are larger than those required for stove so the fireplaces may have been removed when stoves were adopted. This indicates an earlier date to the building as the inefficient fireplace was soon replaced by stoves when they became available.

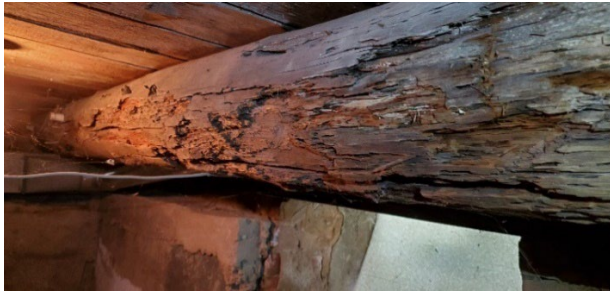
Front Section Dryrot in Hewn Log Beams

1. Demolition is not recommended.
2. Relocation of the building is not recommended at this time
  - a. Relocation may be worth considering at a future date because the survival of the design and building techniques are more important than its original location
3. Designation of the building under part IV of the Ontario Heritage Act is recommended  
The structure meets all (9) criteria under Ontario regulation 9/06 needed for Designation  
Designation carries with it eligibility for Heritage Incentive grants
4. Restoration is recommended

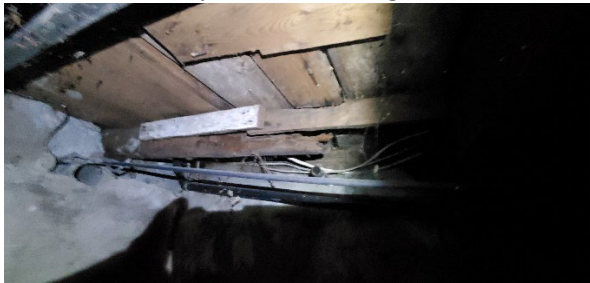
Dry rot and decayed floor timbers

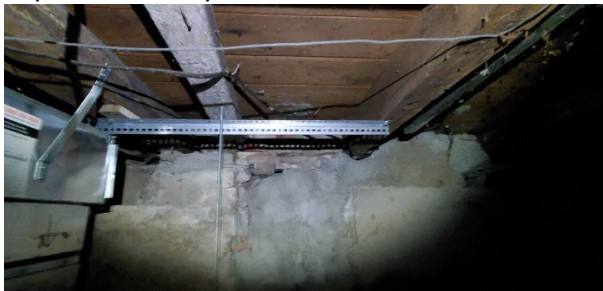
Rear Section Squared Timber Beams
