COLE FARMHOUSE, 10690 Hwy. 50 Cultural Heritage Impact Assessment

22 May 2014

ISSUED TO BRAMPTON HERITAGE BOARD

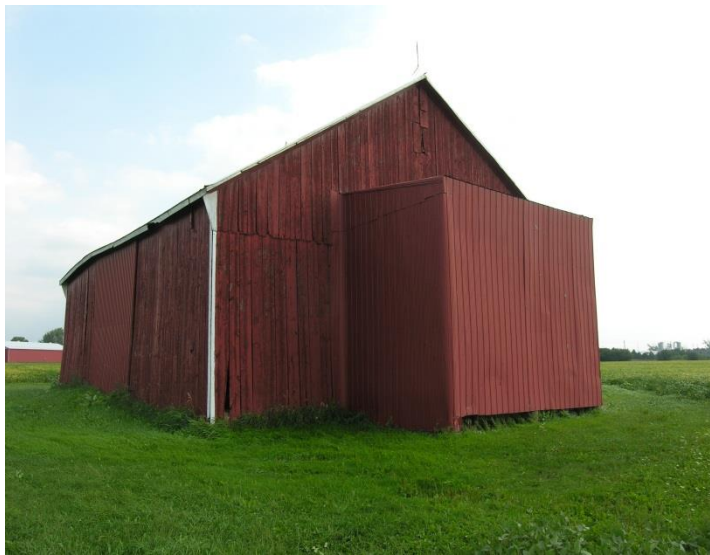
Figure 19 Farm Structure-6, Drive Shed

Farm Structure 6 (Figure 19) is separately located on the west side of Coleraine Drive. This portion of the farm forms part of the historical lot boundaries under the ownership of Thomas Cole (Figures 46 and 47). Although the historical lot boundary was later bisected by Coleraine Drive, the farming operations for the western and eastern parts still remain under the same ownership. This structure is a former drive shed and is now used for storage of equipment and supplies.

This farm structure currently incorporates new metal cladding on top of the original board-and-batten wood cladding. The difference in materials is disguised by a red opaque paint, with corners highlighted by a white-finished board. Metal cladding was used on portions serving as the farm structure's extensions. The structural form is composed of two rows of H-framing with traditional lumber construction joinery. However, these details have been reinforced by modern hardware and/or new lumber. The structure's lack of thermal and moisture protection has definitely contributed to its bowing and general deformation.

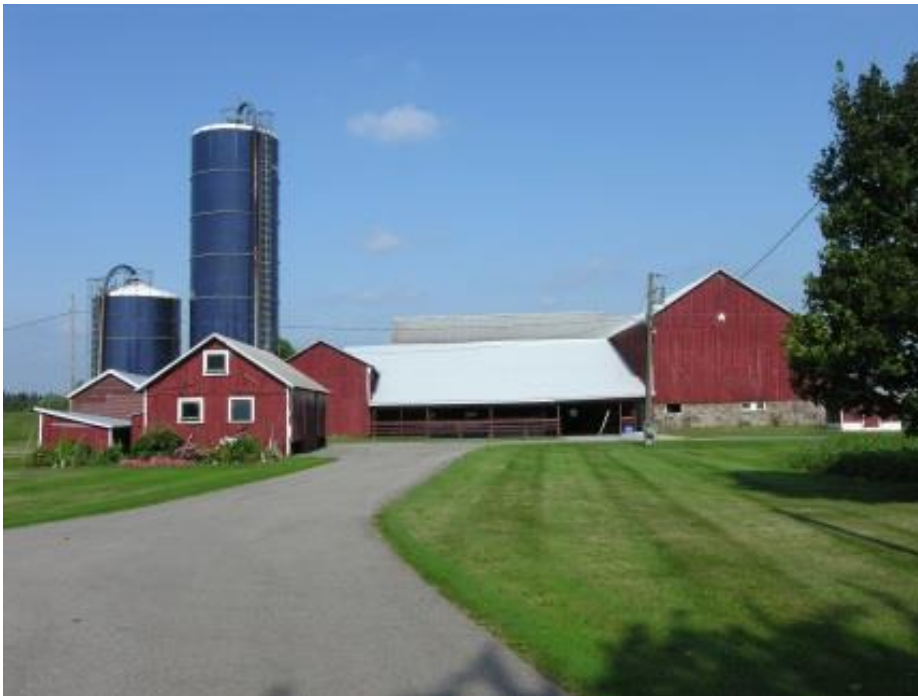
Figure 20 South Elevation of
Farm Structure-A

Farm Structure-A (see Figure) is the largest outbuilding on site composed of several wings. It is a barn complex comprised of three gable structures on the west ('W-GS', Figures 21 and 31), east ('E-GS', Figures 24, 28, 29 and 30), and north ('N-GS', Figures 26, 27, 30, and 31) portions that are joined by a central stall barn (Figure 22). These structures were previously built separately, but were joined by ad-hoc construction of abutments on the roof and at the former exterior walls.

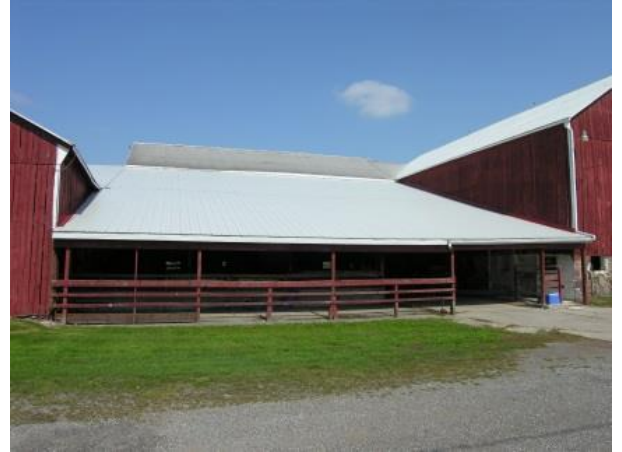
Figure 22 Central barn

The central stall barn (Figure 22) typifies a "free stall barn" with minimal enclosed walls that allowed sufficient ventilation and sunlight for livestock. This was obviously a later addition as it is supported by the former exterior walls of the pre-existing gable structures, 'W-GS', 'E-GS', and 'N-GS' (see Figures 25 and 26). Exposed wood framing (Figure 23) supports the steep, corrugated metal roofing that terminates at the bottom part of 'N-GS' structure's fascia (Figure 22).

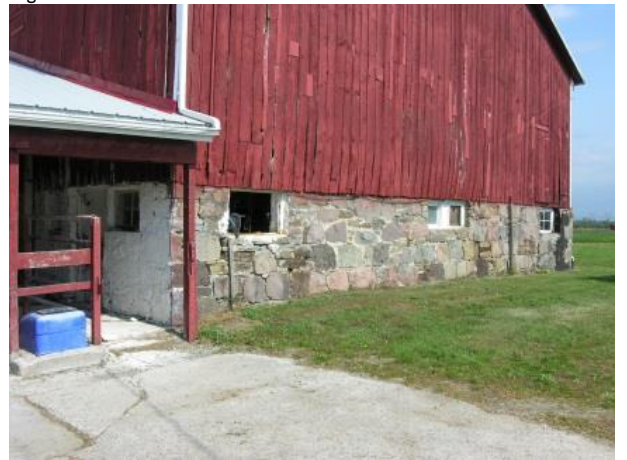
Figure 24 E-GS

At close inspection, the exterior lapped boarding of 'E-GS' is bowing at specific sections (Figure 24). However, the interior heavy timber framing components remain in good condition. These components are mostly unfinished, but have appeared to remain intact. The interior heavy timber framing is comprised of five bays of post-and-beam H-framing, wherein the wood posts that abut the parallel, longitudinal walls are joined by tying girts below the roof plate. The wood posts and the tying girts are all nearly equal in dimensions – square sections that are approximately 10-1/2" x 10-1/2" – and are secured using mortise and tenon joints. This type of joint critically relies on pin size and location to resist withdrawal. It could fail at (1) the pin, (2) the tenon relish or mortise cheek, (3) mortise face, (4) pin hole, and (5) post. The timber framing found in 'E-GS' are showing split cracks, most visibly at locations (3) and (5). The location and orientation of the split cracks are parallel to the longitudinal side of the posts and/or beams, indicating failure with shear forces.

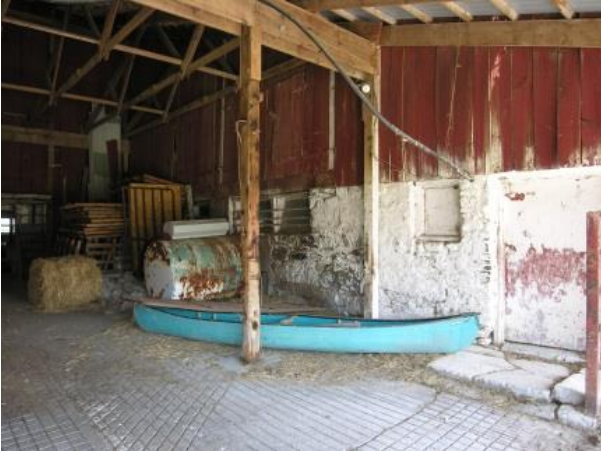
Figure 25 E-GS, west wall

The masonry base walls of the structures, 'N-GS' and 'E-GS', are comprised of concrete hollow blocks (CHB) and fieldstone respectively, while their upper walls are comprised of painted wood cladding (Figures 29 to 31). The southern wall of 'N-GS' and the western wall of the 'E-GS' enclose the interior space as a result of the integration of the 'central stall barn'. These interior walls have punched openings, obviously used for former windows and doors (Figures 25 and 26) when these walls were exterior. 'E-GS' displays abrupt changes in construction details (1) in the type of stone used for its east and north base walls - primarily fieldstones with patches of CHB (Figures 29 and 30), and (2) in its roofing angle, which alters at approximately 2.5 metres from its east wall (Figure 29).

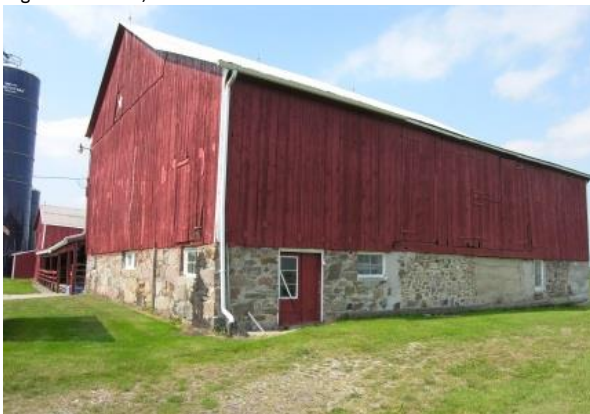
Figure 29 E-GS, east wall

- deterioration of its original materials, such as the integral exposed wood framing and bowing clapboard, and
- alterations to its form and massing, i.e. the altered forebay (Figure 29).

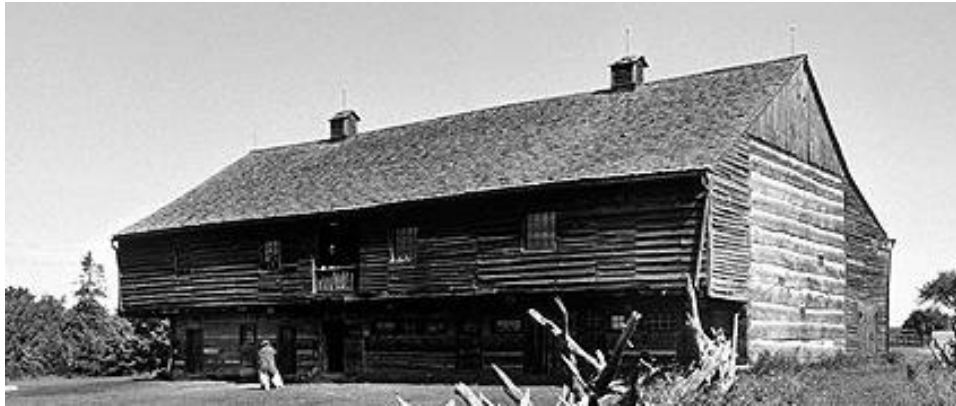
Figure 32 **Schmidt-Dalziel Barn**, built in 1809, Vaughan, ON (The Canadian Encyclopedia, Historical Foundation, 2007)

The existing conditions of 'E-GS' provide evidence of it being a modified 'Pennsylvania Dutch Barn' (Figure 32), a barn style, typical among Canadian barns⁷, especially in Southern Ontario⁹, characterized by a projecting overshoot, or 'forebay'⁸, with closely-spaced H-bent framing and tying joints (Figure 28). This barn type would also typically incorporate hexagram symbols (Figures 29 and 30), painted or carved into wood for decoration and symbolism of spiritual beliefs⁹.

- Of these outbuildings, the only structure belonging to the property's historical period is 'Barn Structure-A', which typifies a commonly-used "Pennsylvania Barn" style throughout Ontario (Figure 32). The significance of these outbuildings is found in its context, which will eventually change.

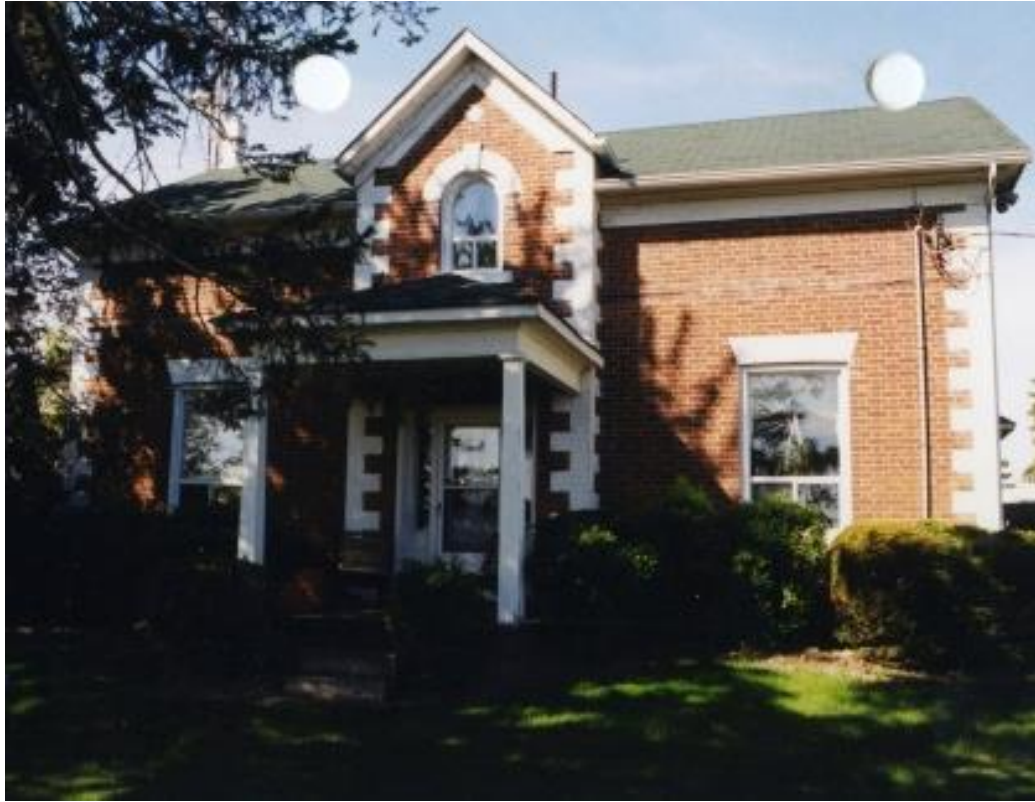
Figure 33 **East elevation** historically the formal main entry façade.

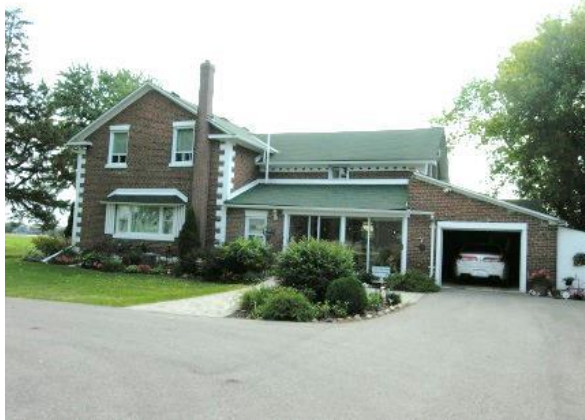
Figure 34 **North elevation** currently the front entrance showing numerous alterations/additions behind the original house form including the 'ell', an enclosed porch and garage.

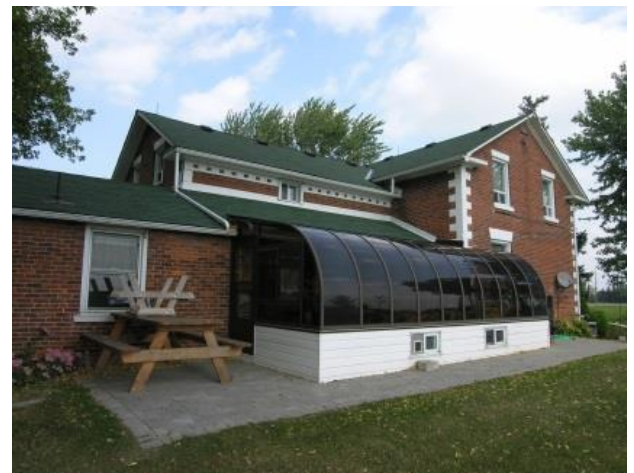
Figure 35 **South elevation** showing considerable alterations at the rear (west) portions behind the original rectangular (east) house block.

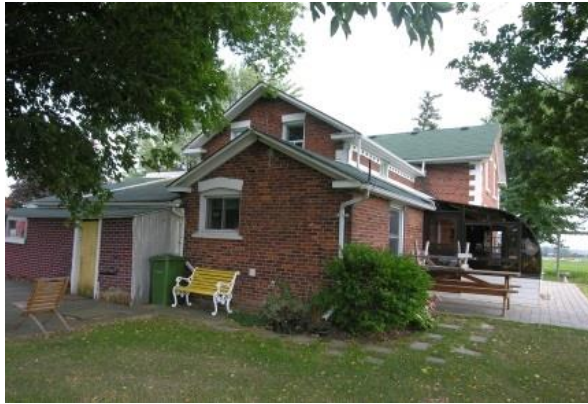
Figure 36 **West elevation** showing the numerous additions to the rear 'ell' of the side shed-roof additions (north and south), a glass greenhouse (south), the garage (north-west) and 1-storey gable-roof shed (south-west).

The west side of the house (Figure 36) also incorporates a haphazard one-storey shed, clad with corrugated sheet metal, and brick veneer. This shed appears to be in poor condition, and its brick veneer and roofing structure are deformed and misaligned, with the base, exposing exterior sheathing that has severely rotten. The combined additions of the one-storey metal-clad shed against the garage (north-west) and the one-storey gable-roof shed (south-west) cover the original west gable end of the 'ell' or 'T' extension from the original rectangular (front) portion of the house. The garage interiors show different wall materials and their former openings, etc. (Figure 39), which demonstrate the series of additive extensions and alterations at the rear (west) of the original rectangular house footprint.

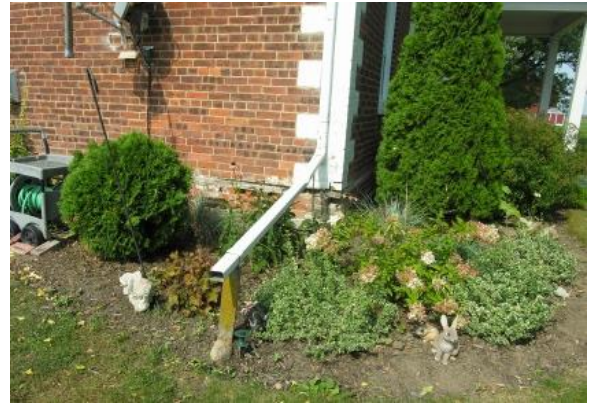
Figure 37 **South-east corner, detail** showing exposed wood plate at ground floor.

Throughout the exterior cladding, a wood plate of the stud framing is exposed at the ground floor, approximately 24 inches from the ground, 4- to 6-masonry units high (Figure 37). This exposed wood plate recurs on the second storey, underneath the sills of the windows (Figure 38). These wood plates, being continuous around all sides of the front (east) rectangular house block present curiosities about their purpose. These sill plates, as they are called in wood framing to brick veneer construction, appear to date from and as part of the construction of the original farmhouse still within the nineteenth century. On the south elevation of the farmhouse, the second floor wood plate terminates at approximately 69 inches from the left-hand edge of its wall plane (Figure 38). At this terminal point, brick staining occurs diagonally on the masonry brick face (Figure 38). This particular staining, along with the exposed wood plate, strongly suggests the previous incorporation of a wrap-around porch with a hip roof, which is common to the Ontario Gothic style (Figure 42). The ground and second floor sill plates would therefore have served as “nailers” for the porch framing of its deck joists and roof rafters respectively.

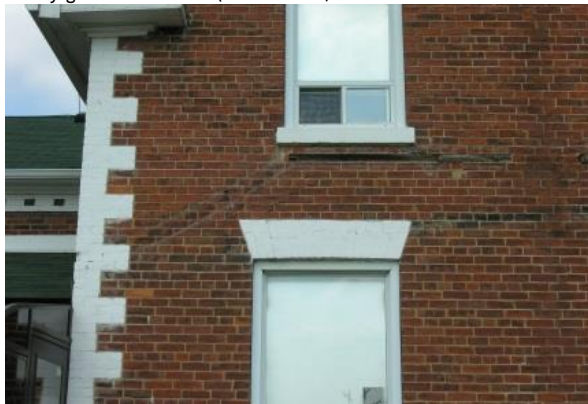
Figure 38 **South wall, detail** showing exposed wood plate at second floor window sill and "staircase crack."

The house itself is generally in sound condition. It may require minor restoration to correct the water drainage systems and masonry deterioration in isolated locations (Figure 38). Stains occur on areas with improper or insufficient water drainage, especially underneath roof valleys and corners. The rear (south) wall also displays “staircase cracks”, following the lines of failed mortar joints (Figure 38). The poor integration of later additions (Figures 34 to 36), which are ad-hoc, impacts the cultural integrity of the Cole Farmhouse structure.

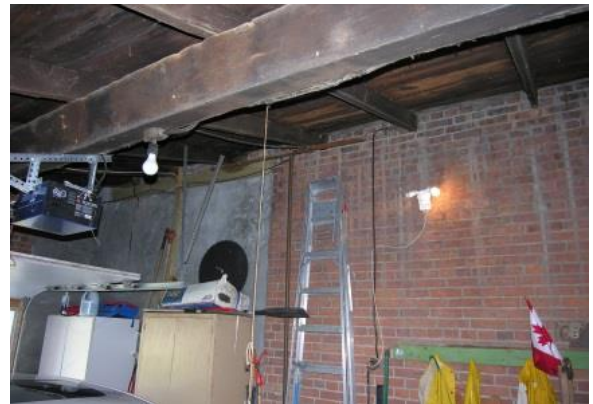
Figure 39 **Garage interior** showing difference in wall materials of the various additions and alterations.

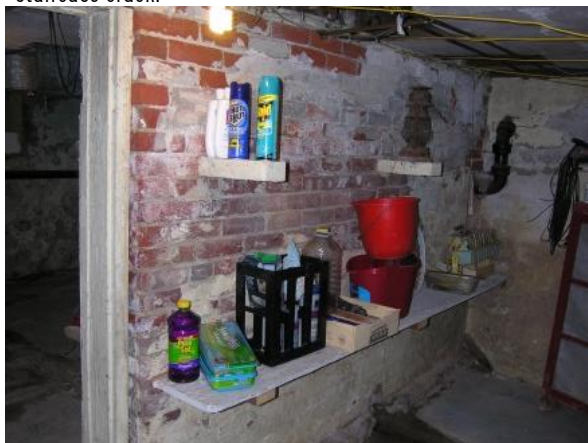
Figure 40 **Basement interiors** showing combination of wall construction in fieldstone and brick.

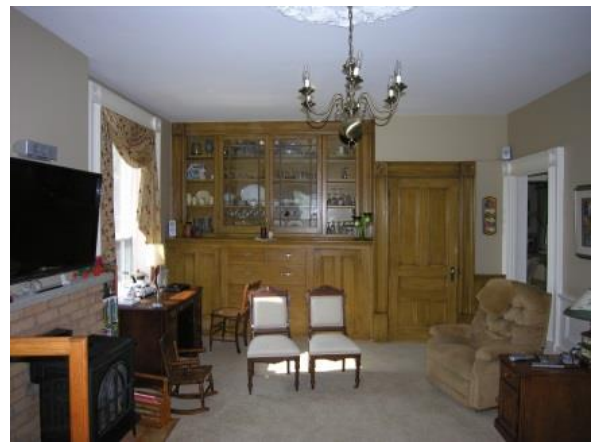
Figure 41 **Ground floor interiors** showing the historic wood trim has been retained.

The interiors of the original main rectangular house (Figure 41) retain their historic trim – window casings, door frames, baseboard, etc. This trim work appears to date from the late nineteenth century, probably from the time of the upgrades to the residence making it more Italianate-like. The main house also incorporates a low headroom unfinished basement (Figure 40) which exhibits further modern upgrades evident in the exposed ductwork and electrical wiring. No severe cracks were observed, although mould growth, and water stains were found in isolated areas, hence, indicating water penetration and ineffective or lack of dampproofing.

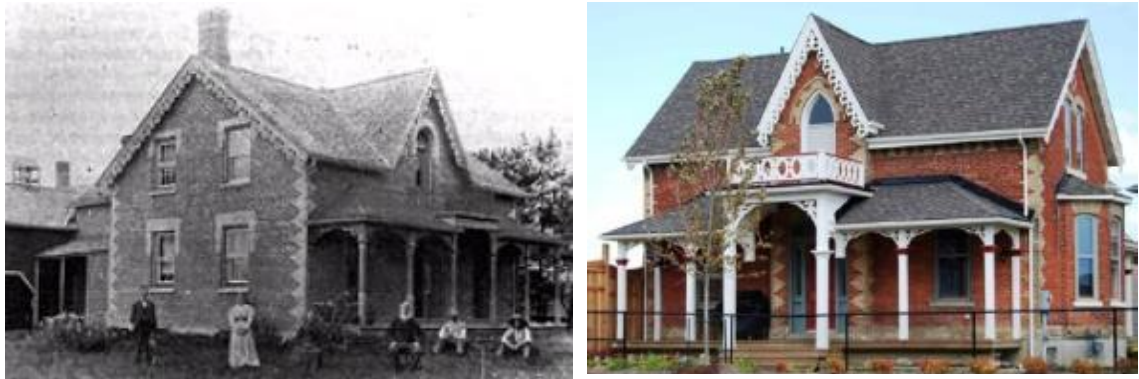
Figure 42 **George Elliot Farmhouse (c.1860s), 120 Sled Dog Road, Brampton**, example of Ontario Gothic Cottage

The previous incarnation of the house would have been an early settler’s two storey Ontario Gothic Style farmhouse, similar to other historic homesteads (Figure 42) found in Peel County (now Region) and throughout Southern Ontario. The more modest Ontario Gothic homestead from the original farm settlement, in the 1860s, appears to have been subsequently upgraded with features which reflect the later Italianate Style of the 1880s. These Italianate features are particularly reflected by: the east elevation’s classical central porch, which presumably replaced the previous wrap-around porch. The evident Italianate “upgrades” which are still extant would have included:
