RE: HERITAGE MEMO -PERMIT APPLICATION FOR HERITAGE STONE WALL REPAIRS, BUILDING 9 (JAIL) WINDOW REPLACEMENT, MISCELLANEOUS SITE IMPROVEMENTS INCL. WOOD FENCE REPAIRS, ACCESS LADDER AND HVAC SCREENING RELOCATION at PEEL MUSEUM & ARCHIVES 7-9 WELLINGTON ST E, BRAMPTON, ON, L6W 1Y1

DOCUMENTS REFERRED TO: PROJECT DRAWINGS HC SERIES HC 01-HC 04; STRUCTURAL PERMIT DRAWINGS S01-S03; HERITAGE SPECIFICATION SECTIONS

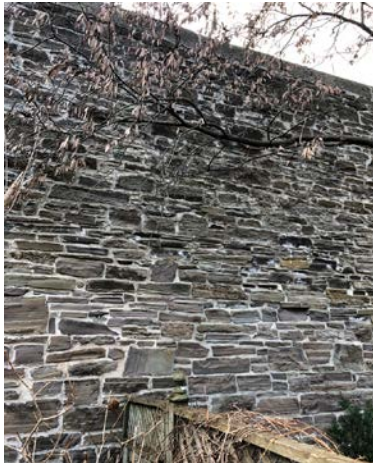
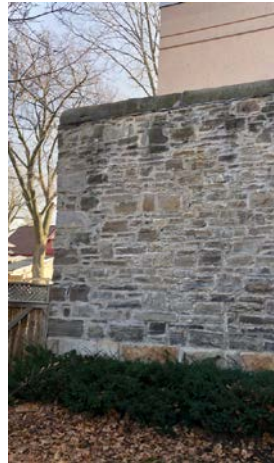
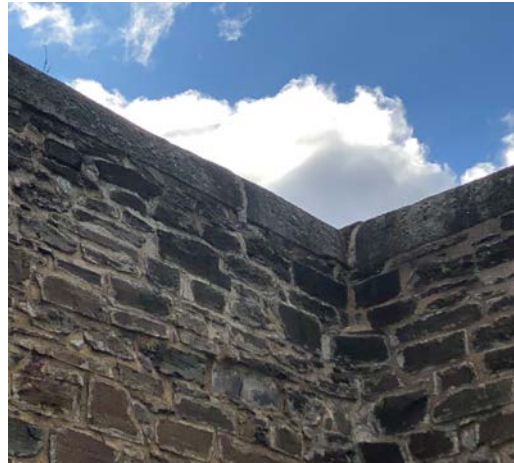
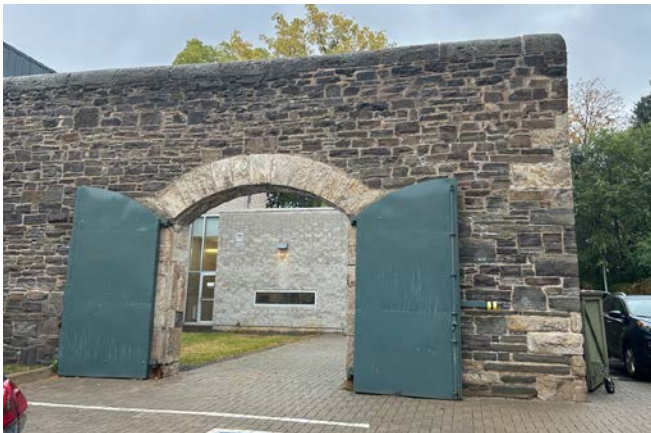
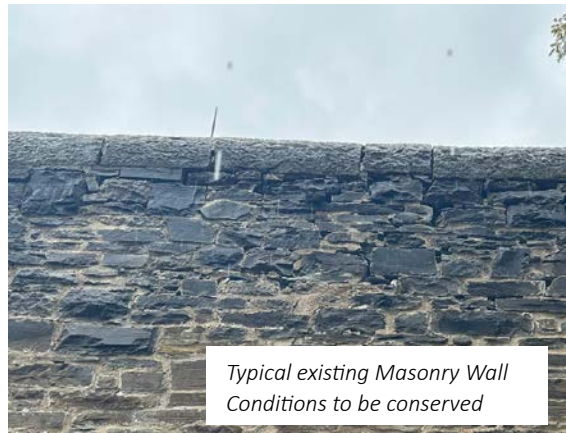
The primary material of the wall is limestone rubble, with some cut stone units framing the opening at the southwest. Parts of the wall have been incorporated into the recent contemporary additions. During the investigations phase of the project, a field and laboratory test was carried out in to determine the hardness and general composition of the existing mortar (Report available upon request). Further to this information, the specified repointing mortar mixes shall be a lime-based mortar, weaker than the existing masonry units. Replacement bedding mortars shall meet structural requirements.

It is likely that previous mortar repair campaigns have occurred and not all of these have been using compatible material. Where found, these incompatible materials will be removed as per the procedures outlined on the drawings to minimise damage to the heritage material and replaced with the specified restoration mortar.

The cleaning of the Heritage Masonry wall shall be by the gentlest means possible and specified to be executed without damage to the substrate. Cleaning shall achieve an agreed 'level of clean' to be

determined by initial trials and to the acceptance of the Heritage Architect. Portable steam cleaning equipment, e.g. the Doff “Integra®” cleaning system (or approved equivalent) system capable of delivering super heated water up to 150°c at low volume and low pressure through fine nozzles shall be used. Cleaning shall include removal of atmospheric staining, soluble salts (efflorescence), organic and biological staining metallic stains including copper (cupric) iron (ferrous) staining, residual paints, bitumens and tars, and other localized soiling e.g. pigeon droppings/ guano, wasp nests, limescale, graffiti etc. Aggressive abrasive cleaning systems e.g. high-pressure sand or grit blasting equipment are not acceptable and shall be rejected

Masonry units shall be repaired and retained, unless where damaged beyond repair or if structural integrity is severely compromised. If replacement materials are required, suitable replacements will need to be sourced based on analysis and sampling of the existing brick and stone. The use of salvaged material from elsewhere on the building is an option and can be considered if clean, usable stock is available without compromising the heritage attributes of any other part of the building. At the upper wall cornice stones, a through wall flashing will be introduced to address an ongoing cause of deterioration to the upper-level masonry joints.

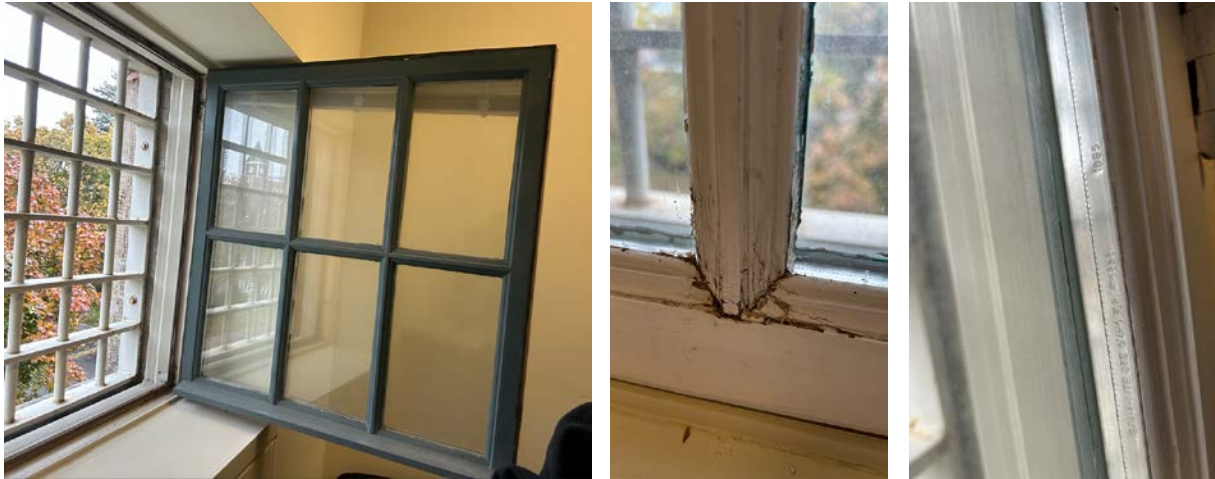
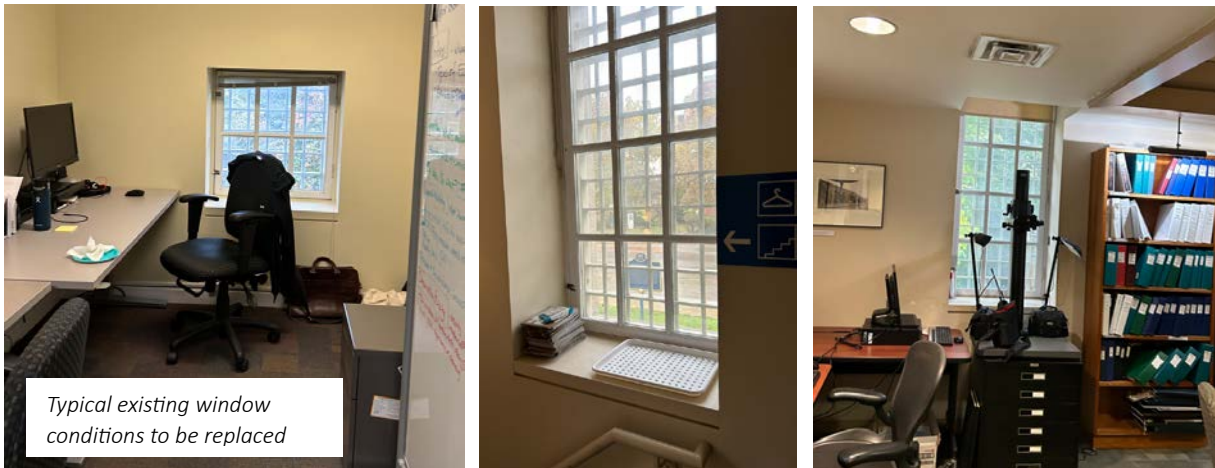
The existing jail building windows date from approximately the mid 1980s. It is not known whether the inward opening side hung casement configuration is original. What is currently proposed is a like-for-like replacement of the existing windows which date back to the mid 1980s. The existing windows are 10-15 years beyond their serviceable life and are in typically worn or tired condition, with failing coatings, evidence of water ingress, deteriorated components, expired gaskets and IGUs and poor operability.

Typical existing window conditions to be replaced

The proposed Heritage Style replacement windows are of high quality, thermally broken wood construction with double glazed insulated glass units. They will offer substantially increased thermal and

acoustic performance and increase occupant comfort in the offices. The design and proportions of the windows in terms of profiles, glazing dividers and paint colours are consistent with and complementary to the Heritage proportions. Installation of the windows will be done from the interior of the space, eliminating the need to remove the exterior jail bars and impact the heritage masonry. Interior finishes will be impacted, however these are all recently installed and of modern materials. See typical interior photos above. To anticipate any unforeseen deterioration that may be revealed during the window replacement, structural repairs have been detailed in the project drawings. These repairs will not be carried out unless deemed necessary during structural engineers review on site.
