Project # 21-060-03Prepared by PE/JQ/EC/JG

Apple Factory Developments Inc. #203-2061 McCowan Rd Toronto ON, M1S 3Y6 416-282-2296

ERA Architects Inc. #600-625 Church St Toronto ON, M4Y 2G1 416-963-4497

ISSUED: 10 SEPTEMBER 2024

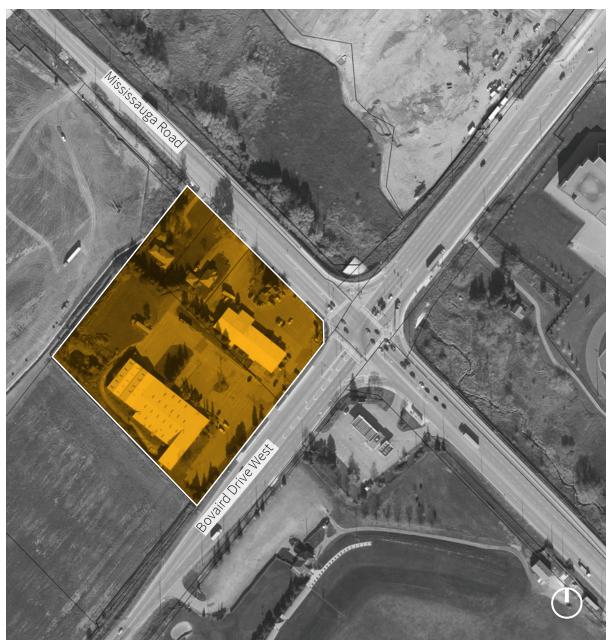
Aerial image showing the Site shaded orange (Brampton Geohub, 2022; annotated by ERA).

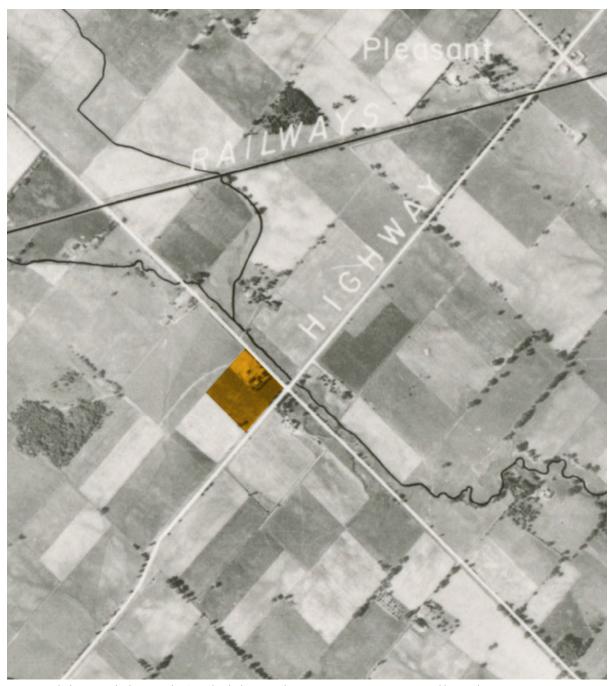
1954 aerial photograph showing the Site shaded orange (McMaster University; annotated by ERA).

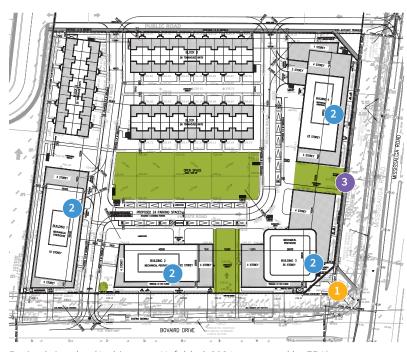
Revised site plan (Architecture Unfolded, 2024; annotated by ERA).

The purpose of this Interpretation Plan is to communicate and interpret the tangible and intangible cultural heritage value of the Site, based on the thematic framework distilled in Section 4. The proposed interpretation program includes the following installations:

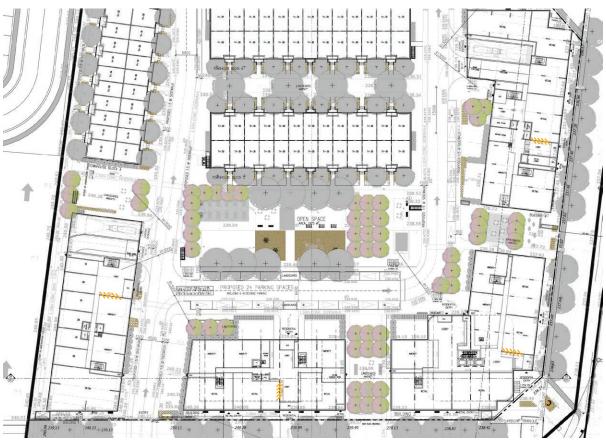
Ground floor plan showing the four potential locations for the salvaged brick wall, indicated with orange hatches. Note that only one location will be selected (Architecture Unfolded; annotated by ERA).

This installation consists of a feature wall within one of the proposed lobby spaces composed of salvaged bricks from the farmhouse, commemorating its cultural heritage value while recycling building materials. To achieve this, the bricks would be sliced into tiles and applied to the wall as a veneer, replicating the original brick pattern (stretcher bond and mortar joints).

Four potential locations have been identified: a 7.5-metre wall in the lobby of Building 1, a 6.8-metre wall in the lobby of Building 2, a 7.3-metre wall in the lobby of Building 3, and a 7-metre wall in the lobby of Building 4 (all approximately 4.5 metres in height).

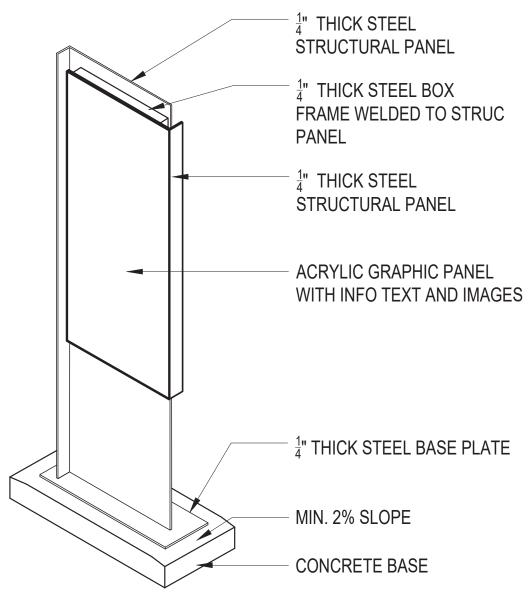
Schematic plaque design (ERA, 2024).

This installation consists of a freestanding plaque in the public realm interpreting both of the Site's historical themes. An initial schematic design for the plaque has been developed by ERA as part of this plan, which will be further refined and detailed in fabrication drawings at a later stage.

Measuring 1.2 metres in width and 2.3 metres in height, the plaque is composed of a structural steel panel with an acrylic graphic panel atop a concrete base (refer to Appendix II for full drawing set). The plaque may include the following text and visuals:

- Text detailing the history and evolution of the Site and the Township of Chinguacousy, including the area's Indigenous history, the establishment of a farmstead on the site in the 19th century, and its transition to commercial use in the mid-20th century.
- Historical maps, archival photographs, and/or other archival materials.

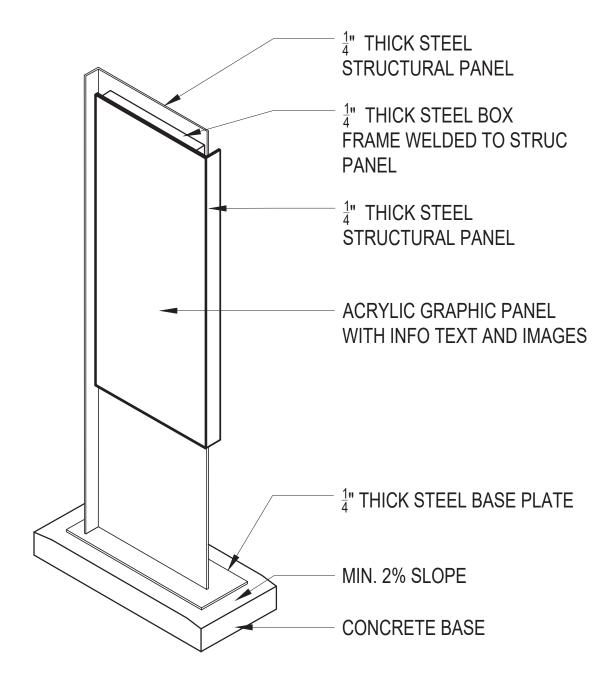
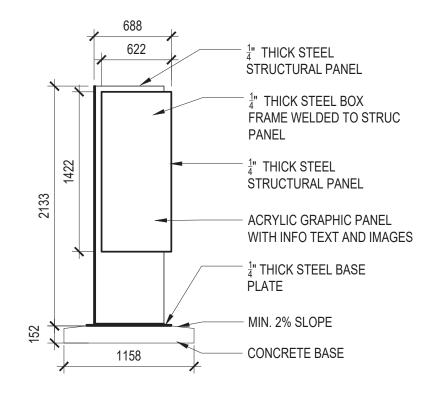
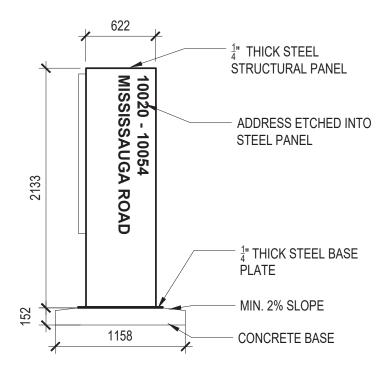
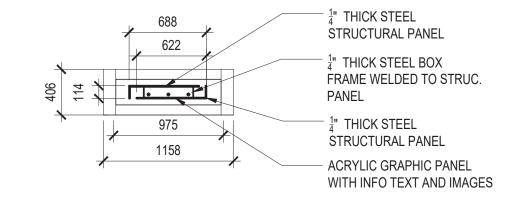
APPENDIX II: PLAQUE CONCEPT DESIGN (ERA)

AXONOMETRIC DIAGRAM

FRONT ELEVATION REAR ELEVATION TOP VIEW

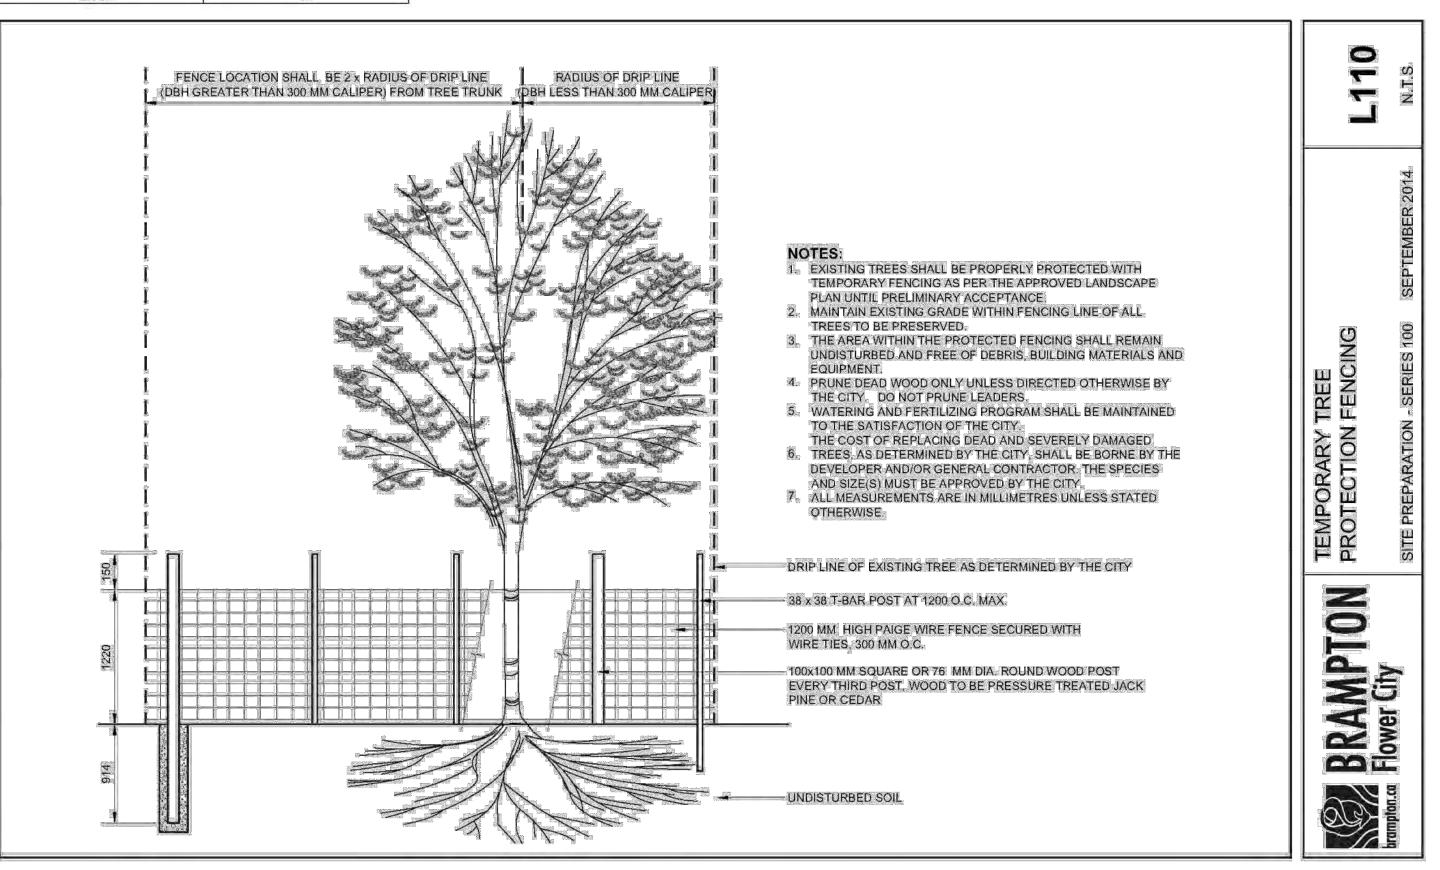
Tree Protection Fencing
