# **Etobicoke Creek Trail Damage**

**Damage sustained to the Etobicoke Creek Trail in Mississauga from the storm event of July 16th, 2024.**

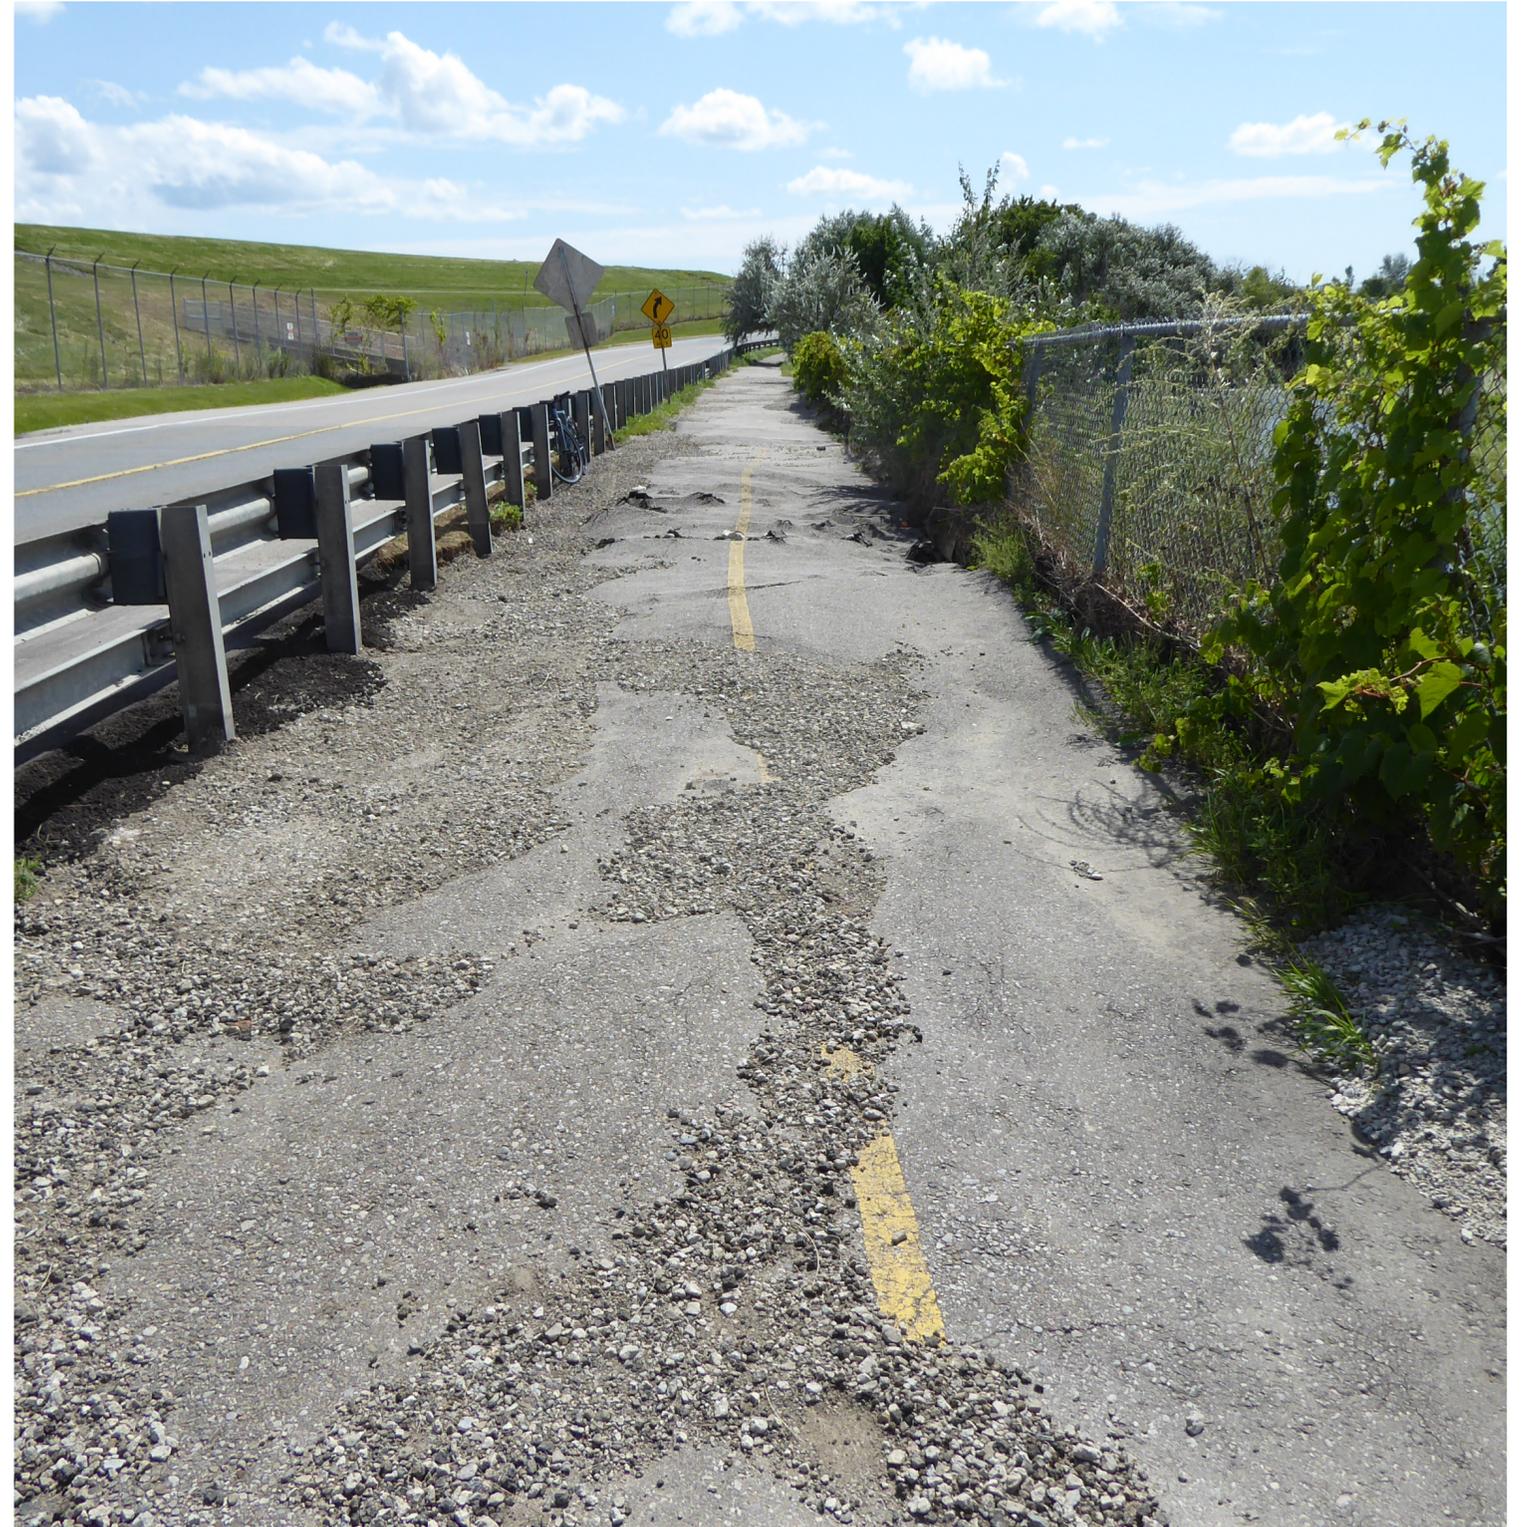
**Location #1**  
**Asphalt path surface**  
**damaged and foundation**  
**gravel compromised. Gravel**  
**washed on to pathway.**

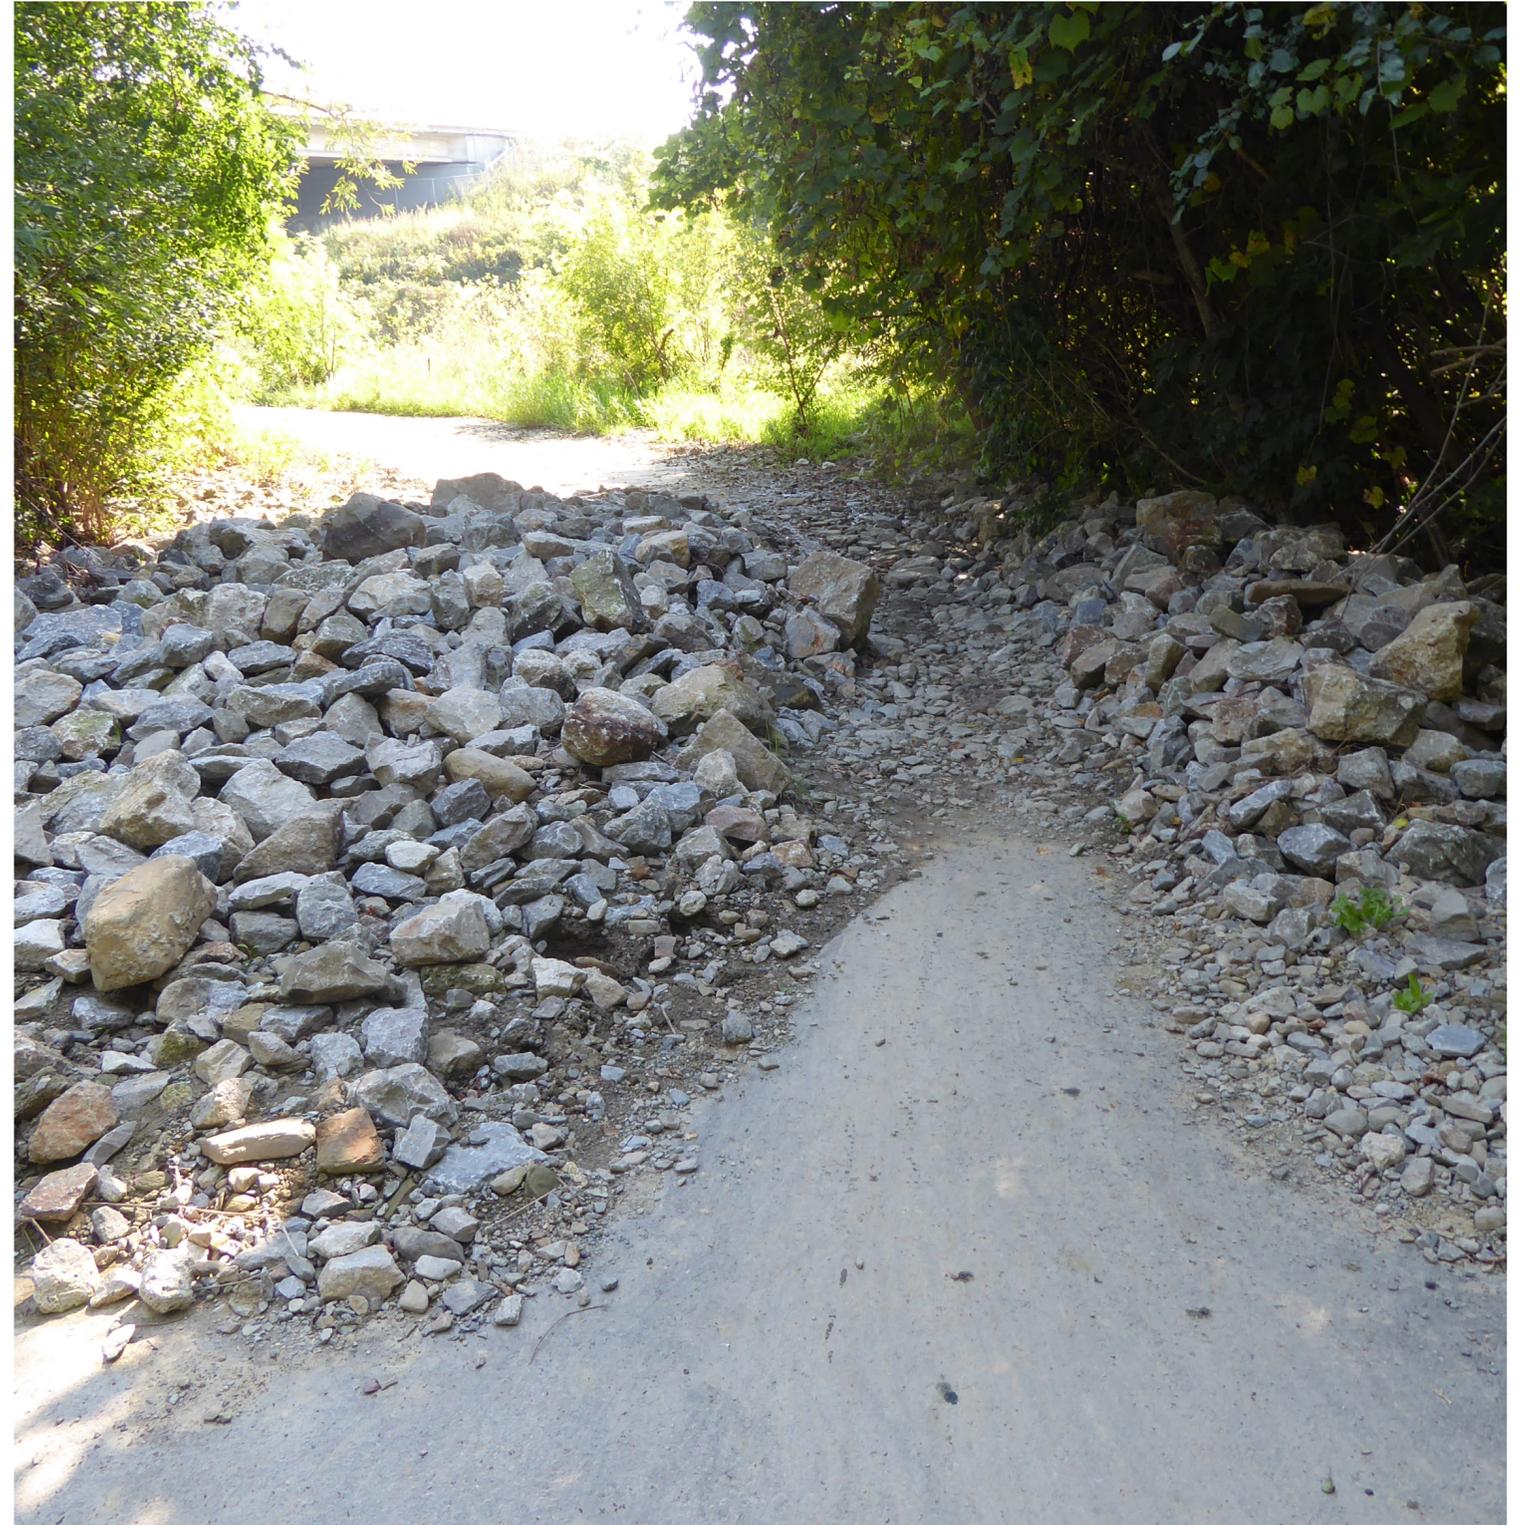
## **Location #2**

**Rock avalanche from rebuilt ravine, the airport south runway storm water drainage channel. A pathway had been cleared through the rubble, by trail users.**

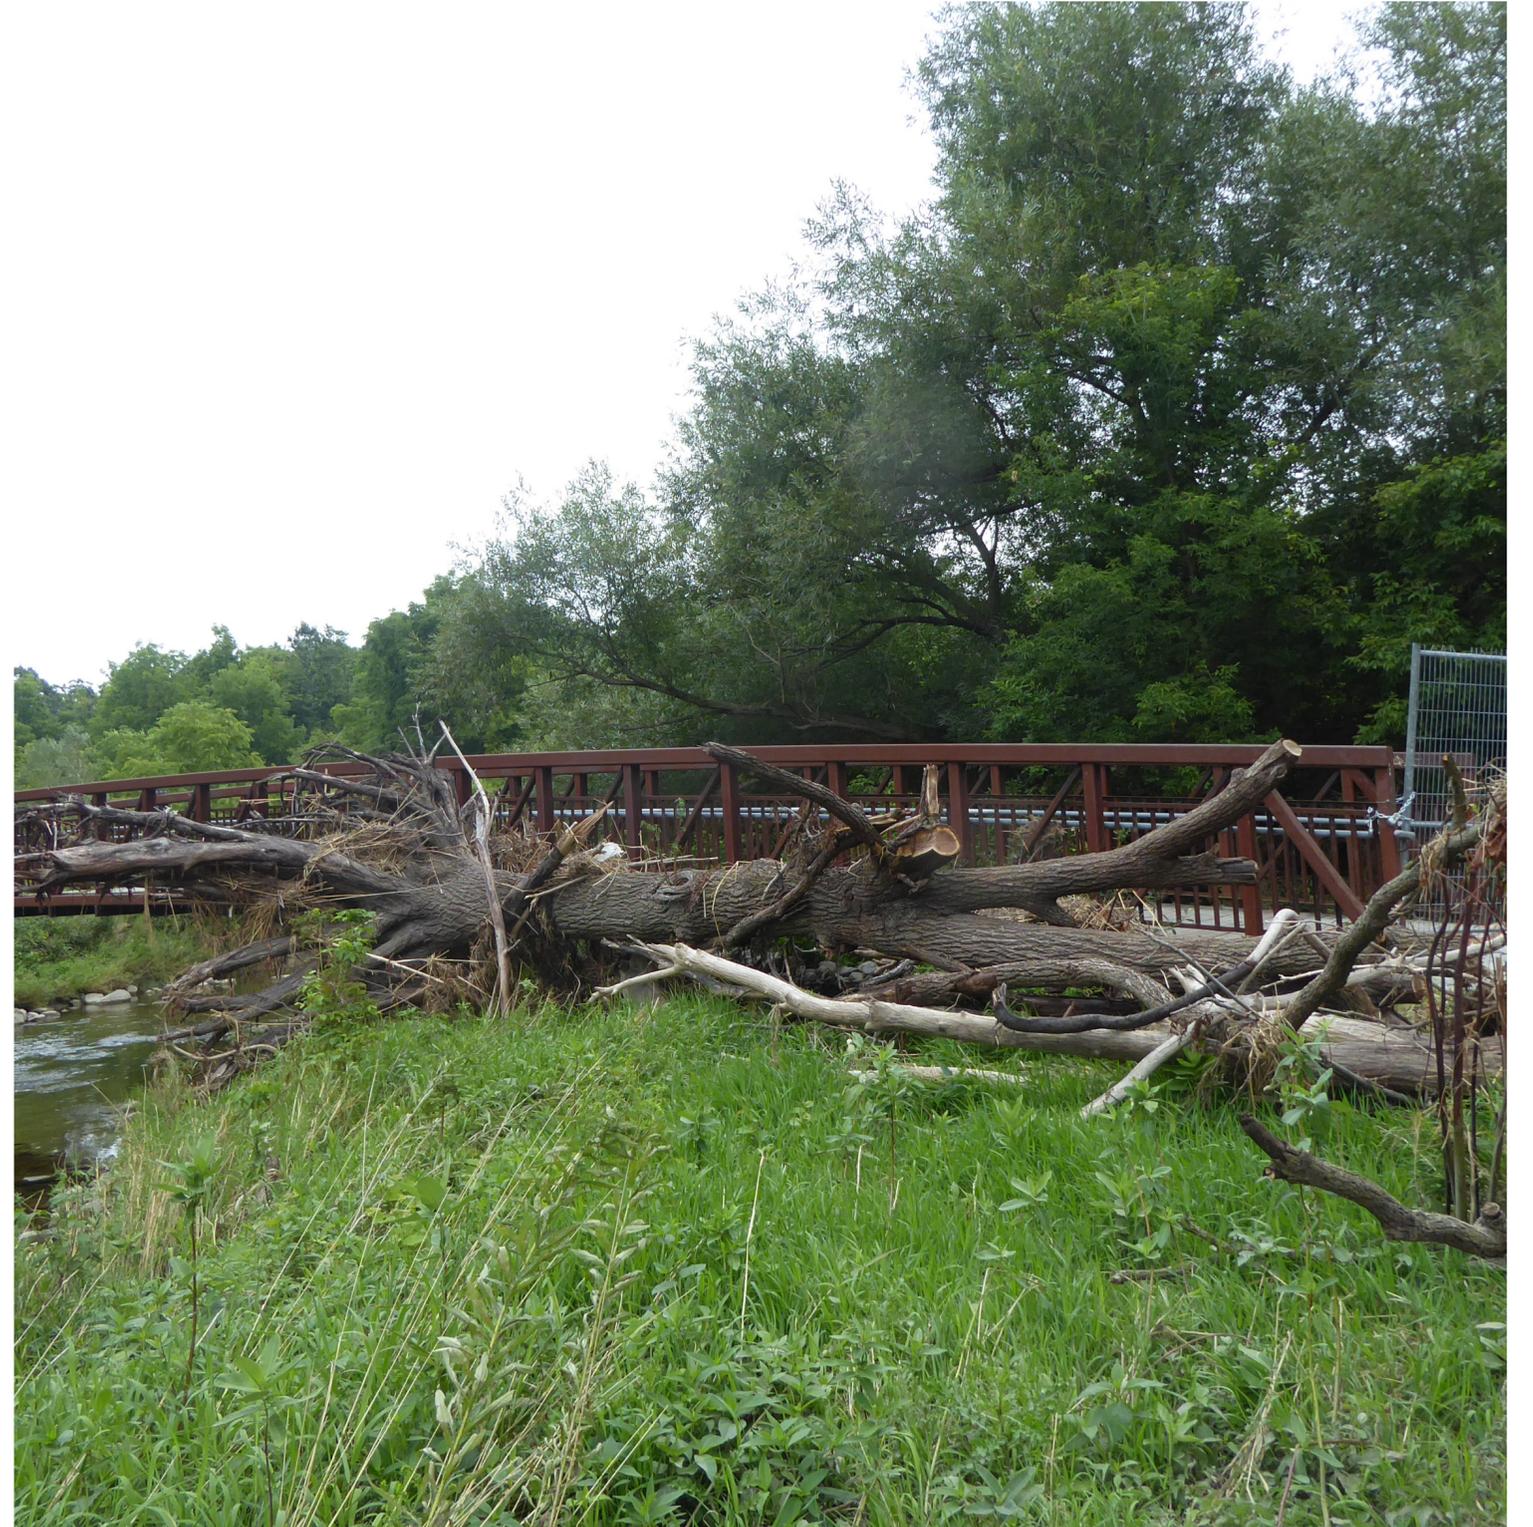
# **Location #3**

**Large tree uprooted and washed down the creek to impact the bridge abutment.**

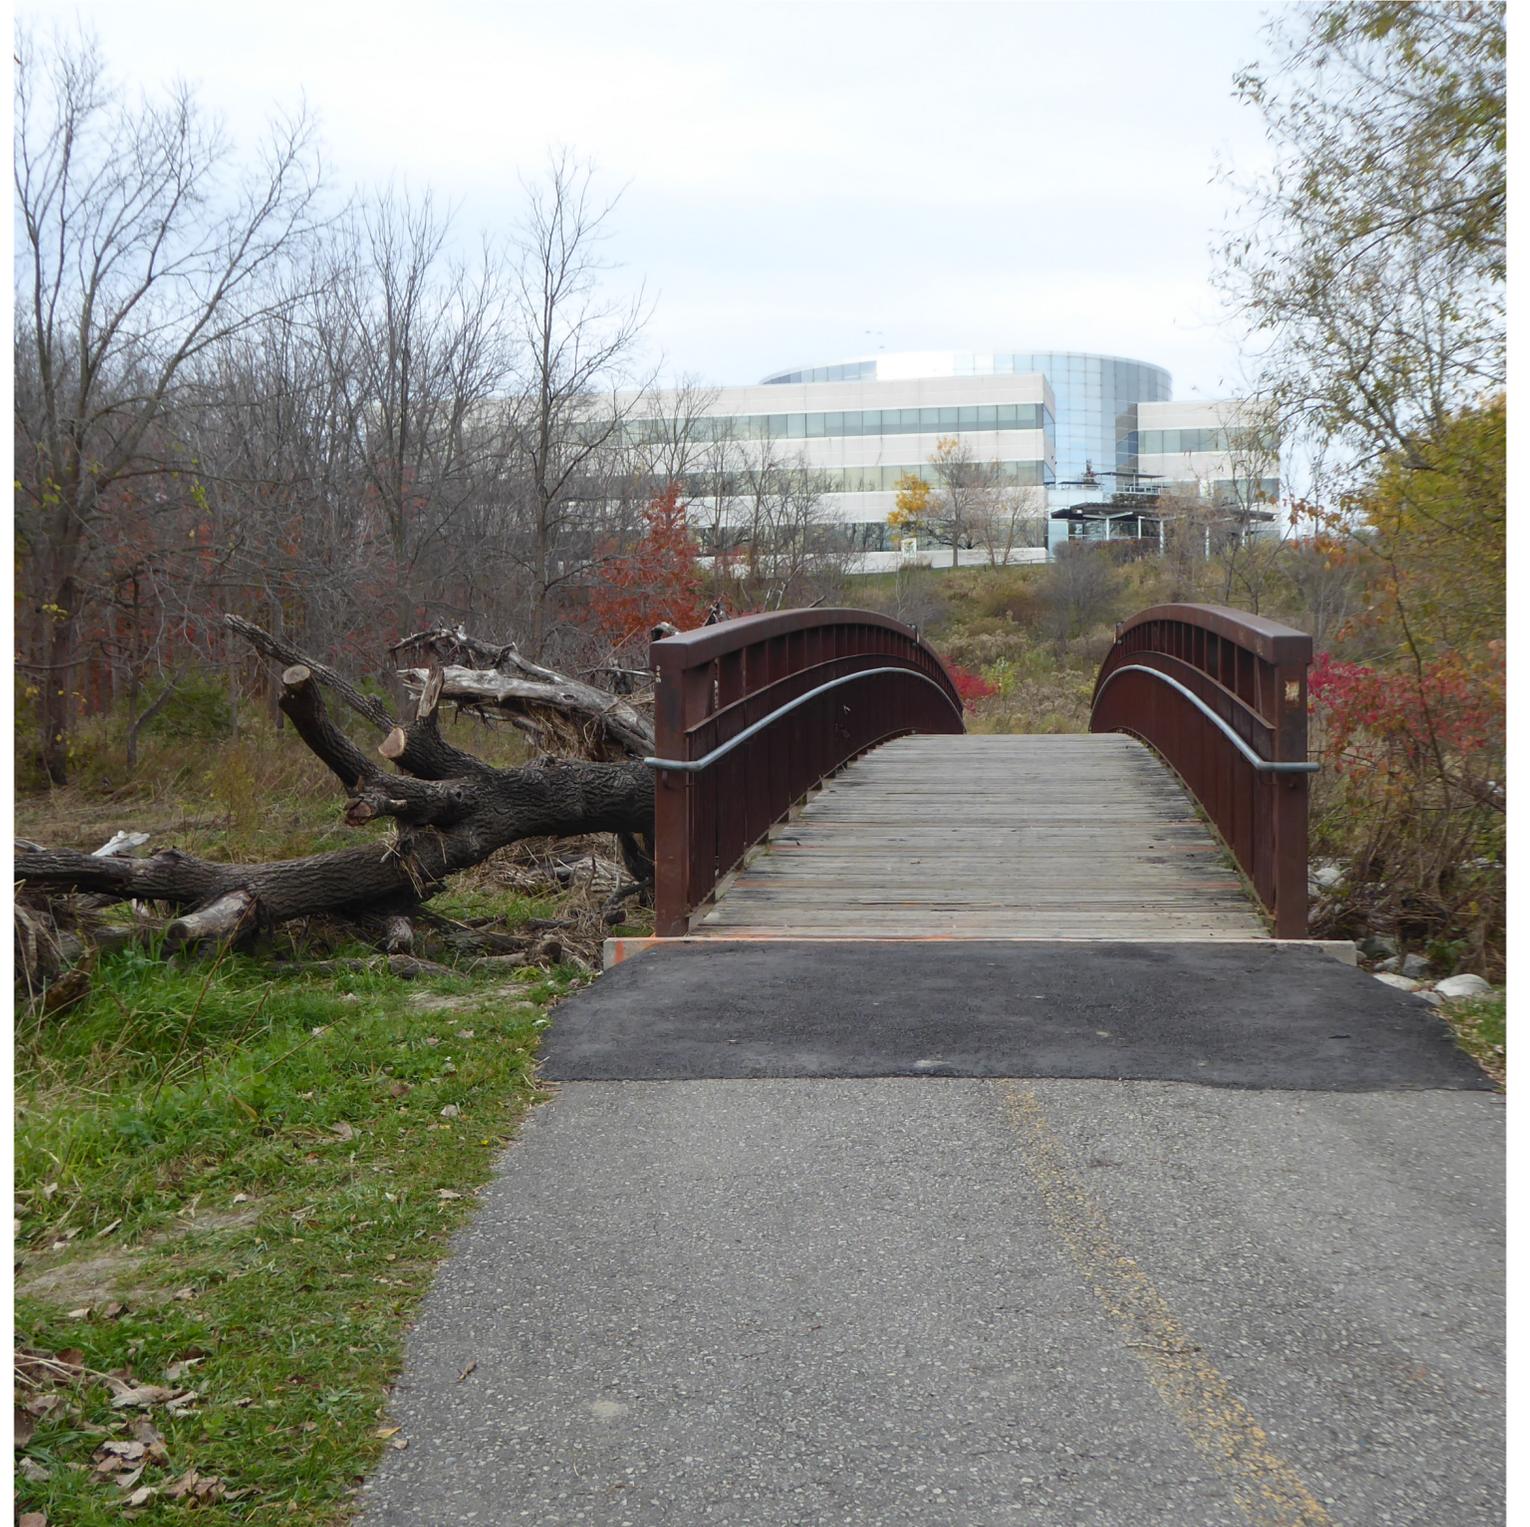
- This visit to the Etobicoke Creek Trail showed significant progress.
- The bridge at location #3 was reopened, with the 50 foot tree still wedged against it.

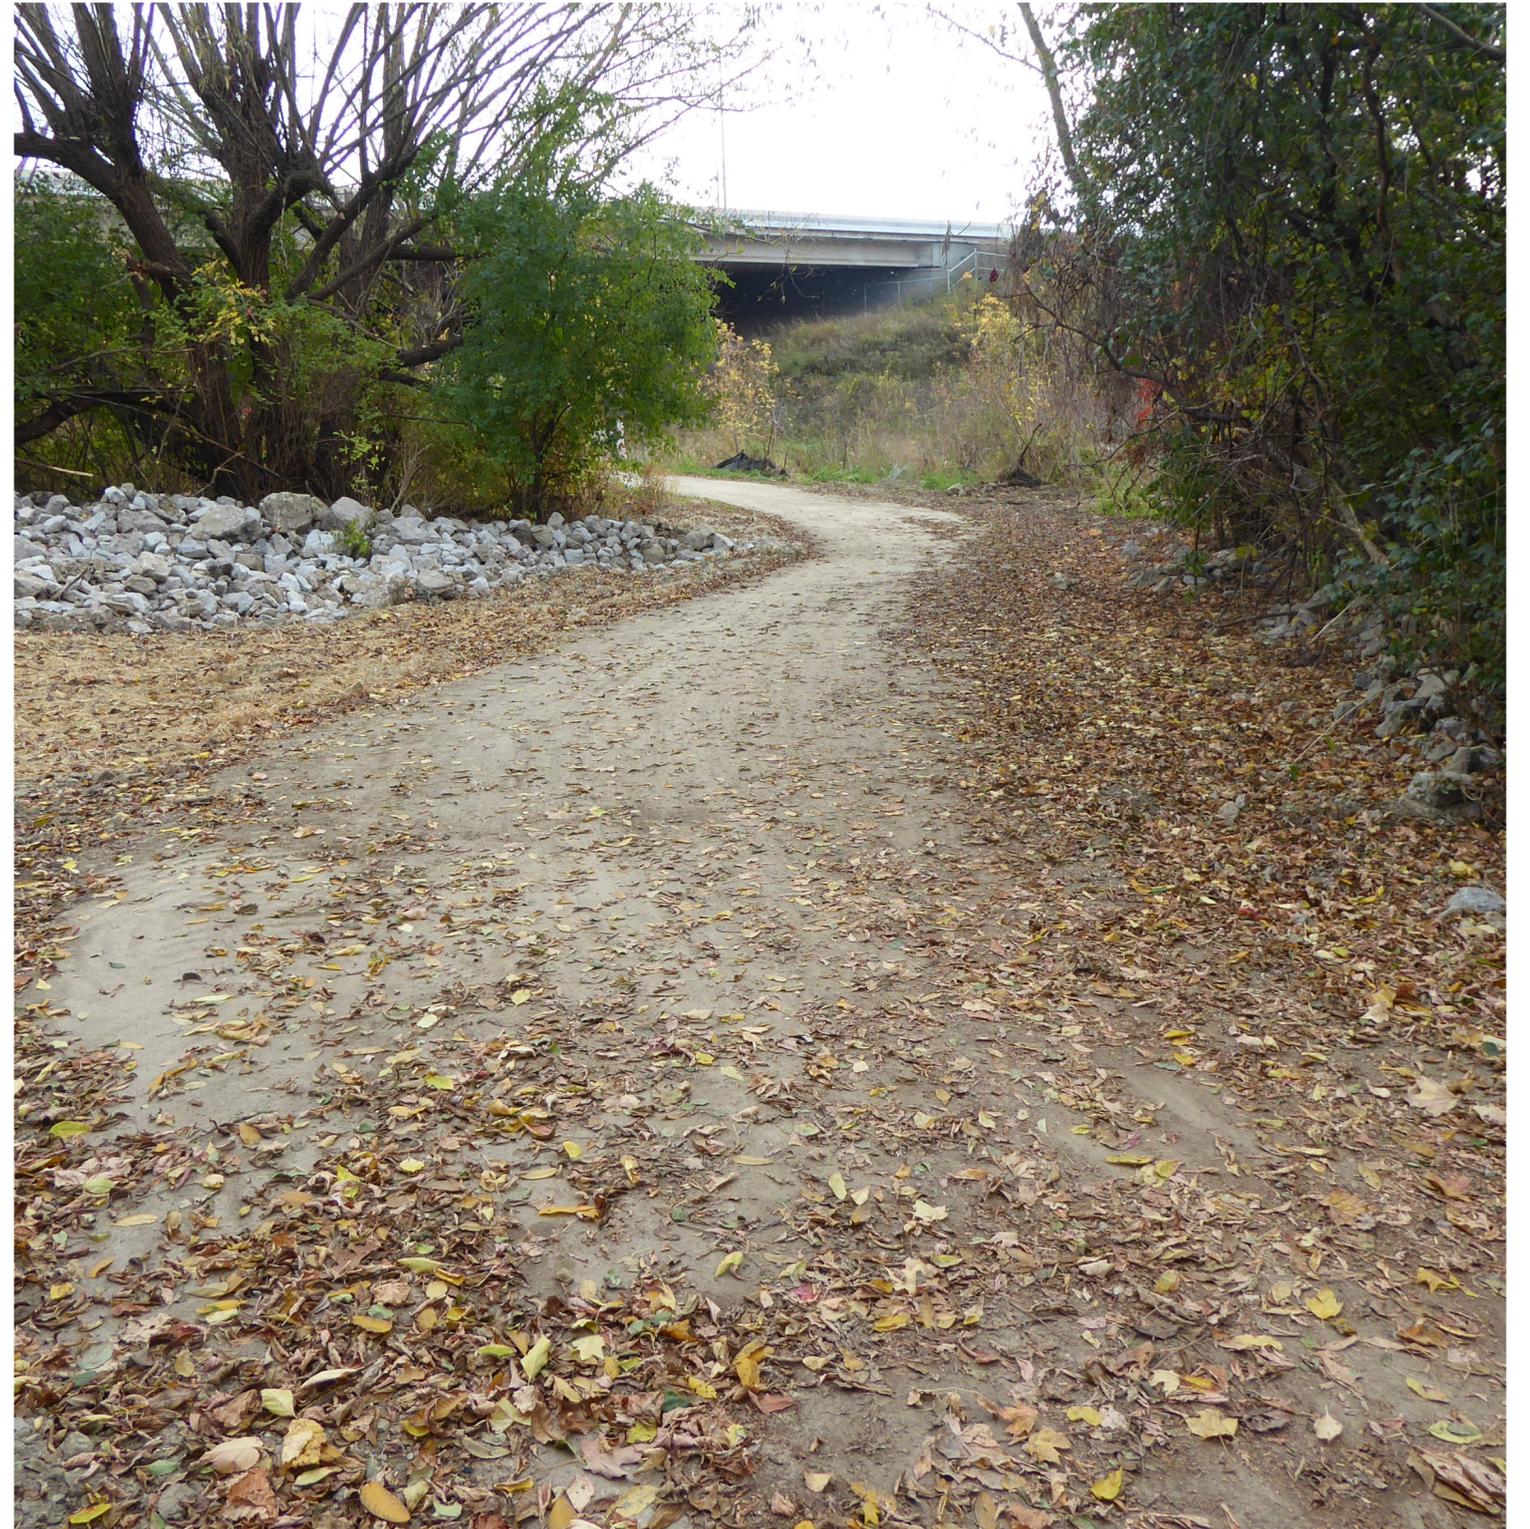
## Location #2

- The rocks had been moved off the trail by heavy equipment and returned to the airport south runway storm runoff channel.

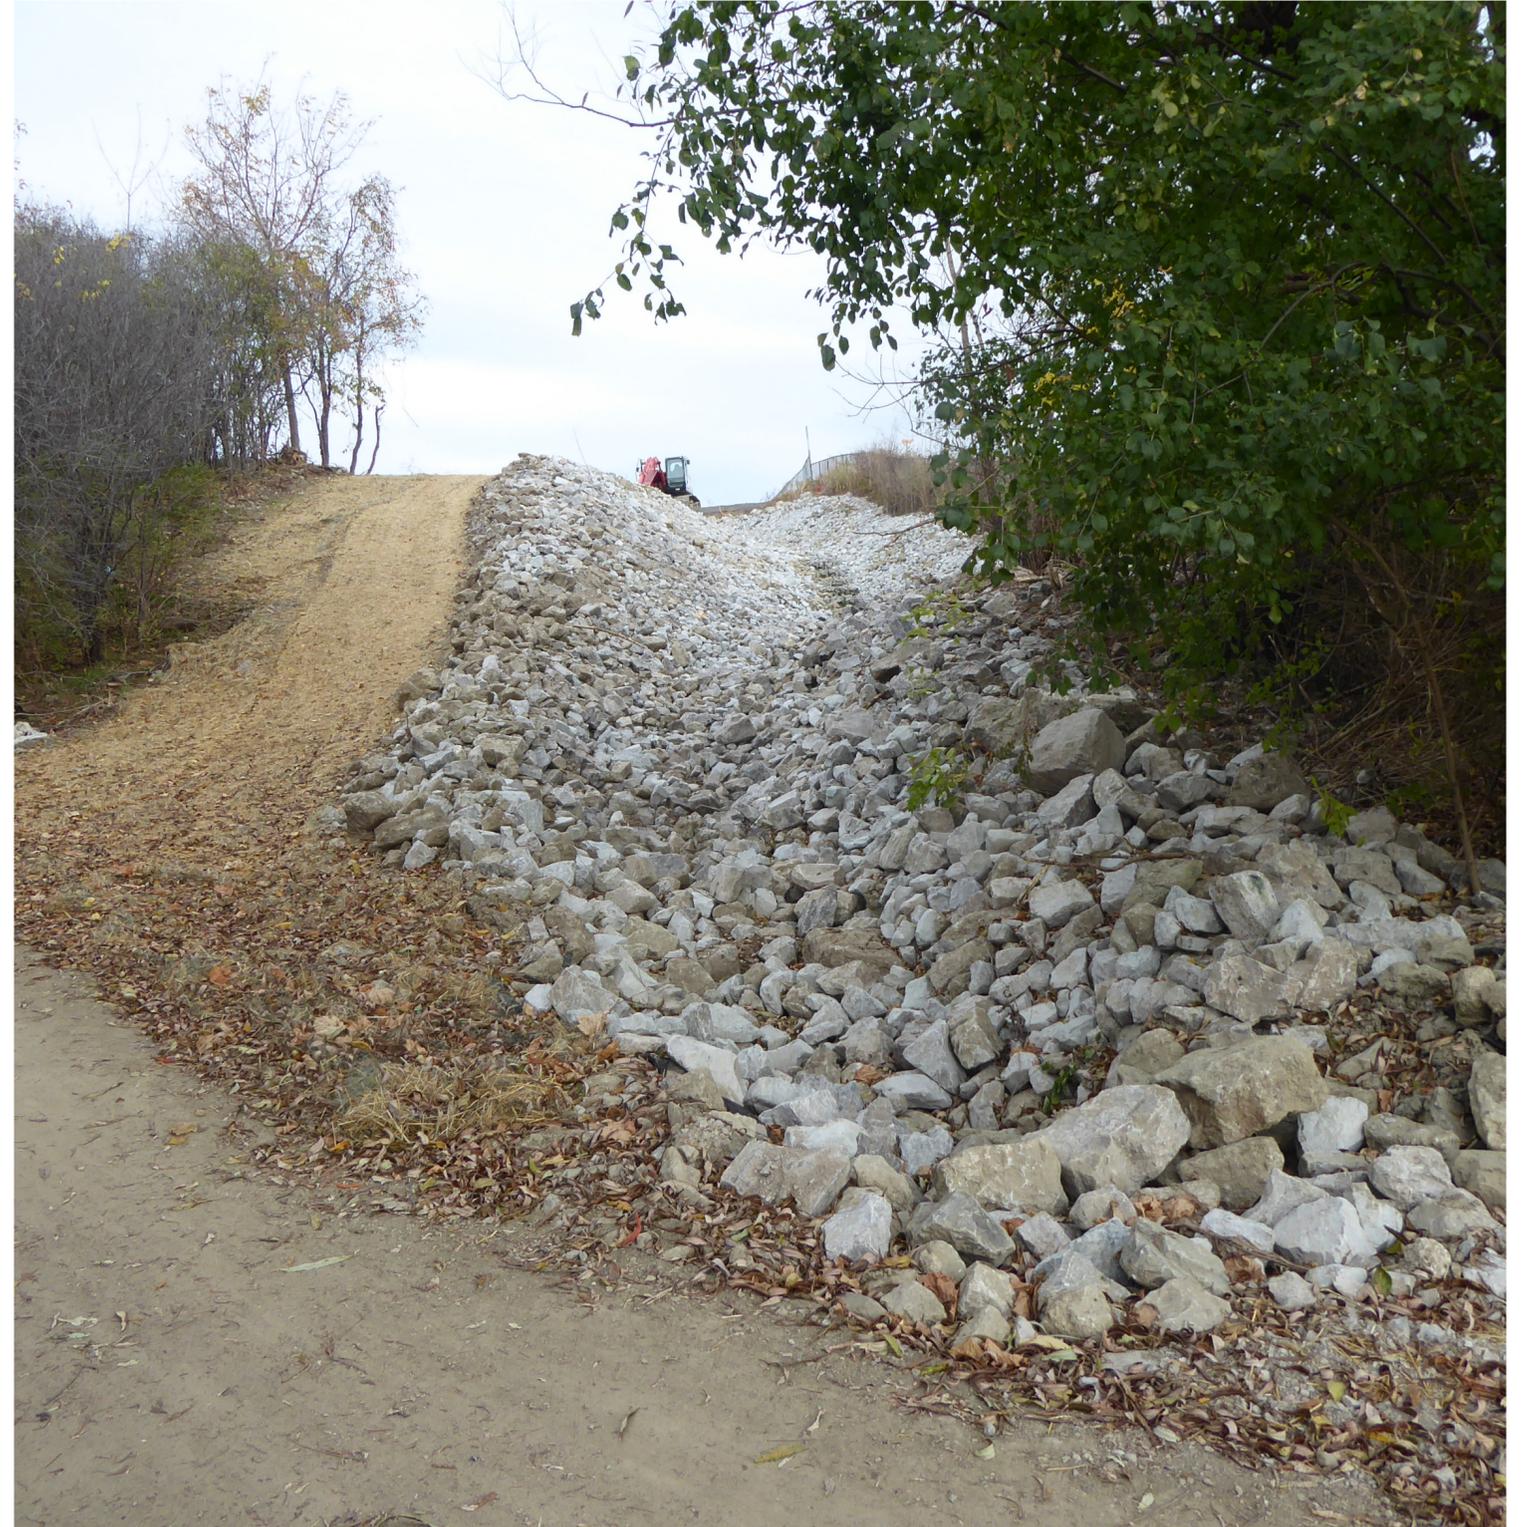
## Location #2

- The south runway stormwater drainage channel.
- Work still in progress.

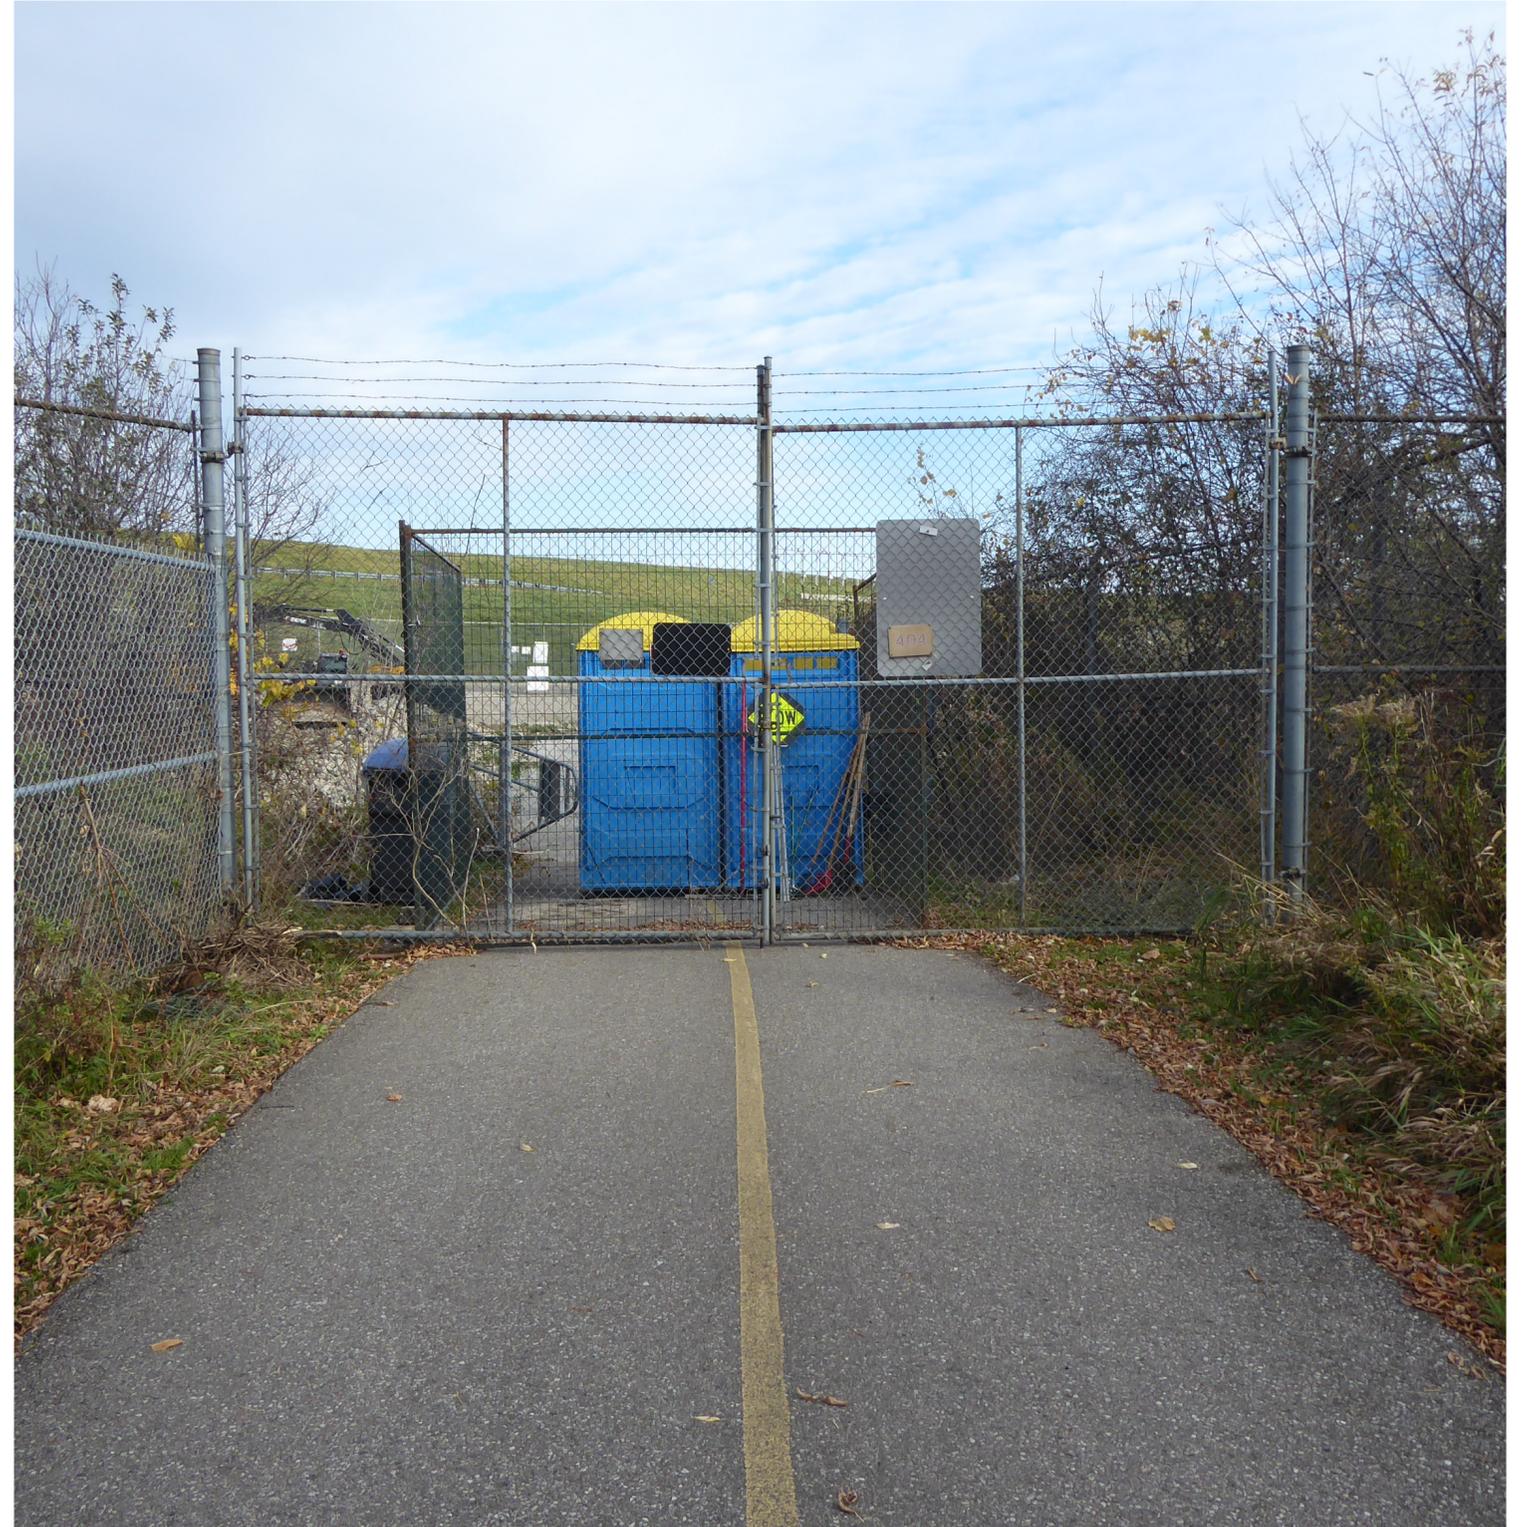
# Work Remaining

- The main airport runway drainage channel, near location #1 is being rebuilt, resulting in trail closure.
- Work was ongoing as of October 26th, 2024, so should be completed soon.

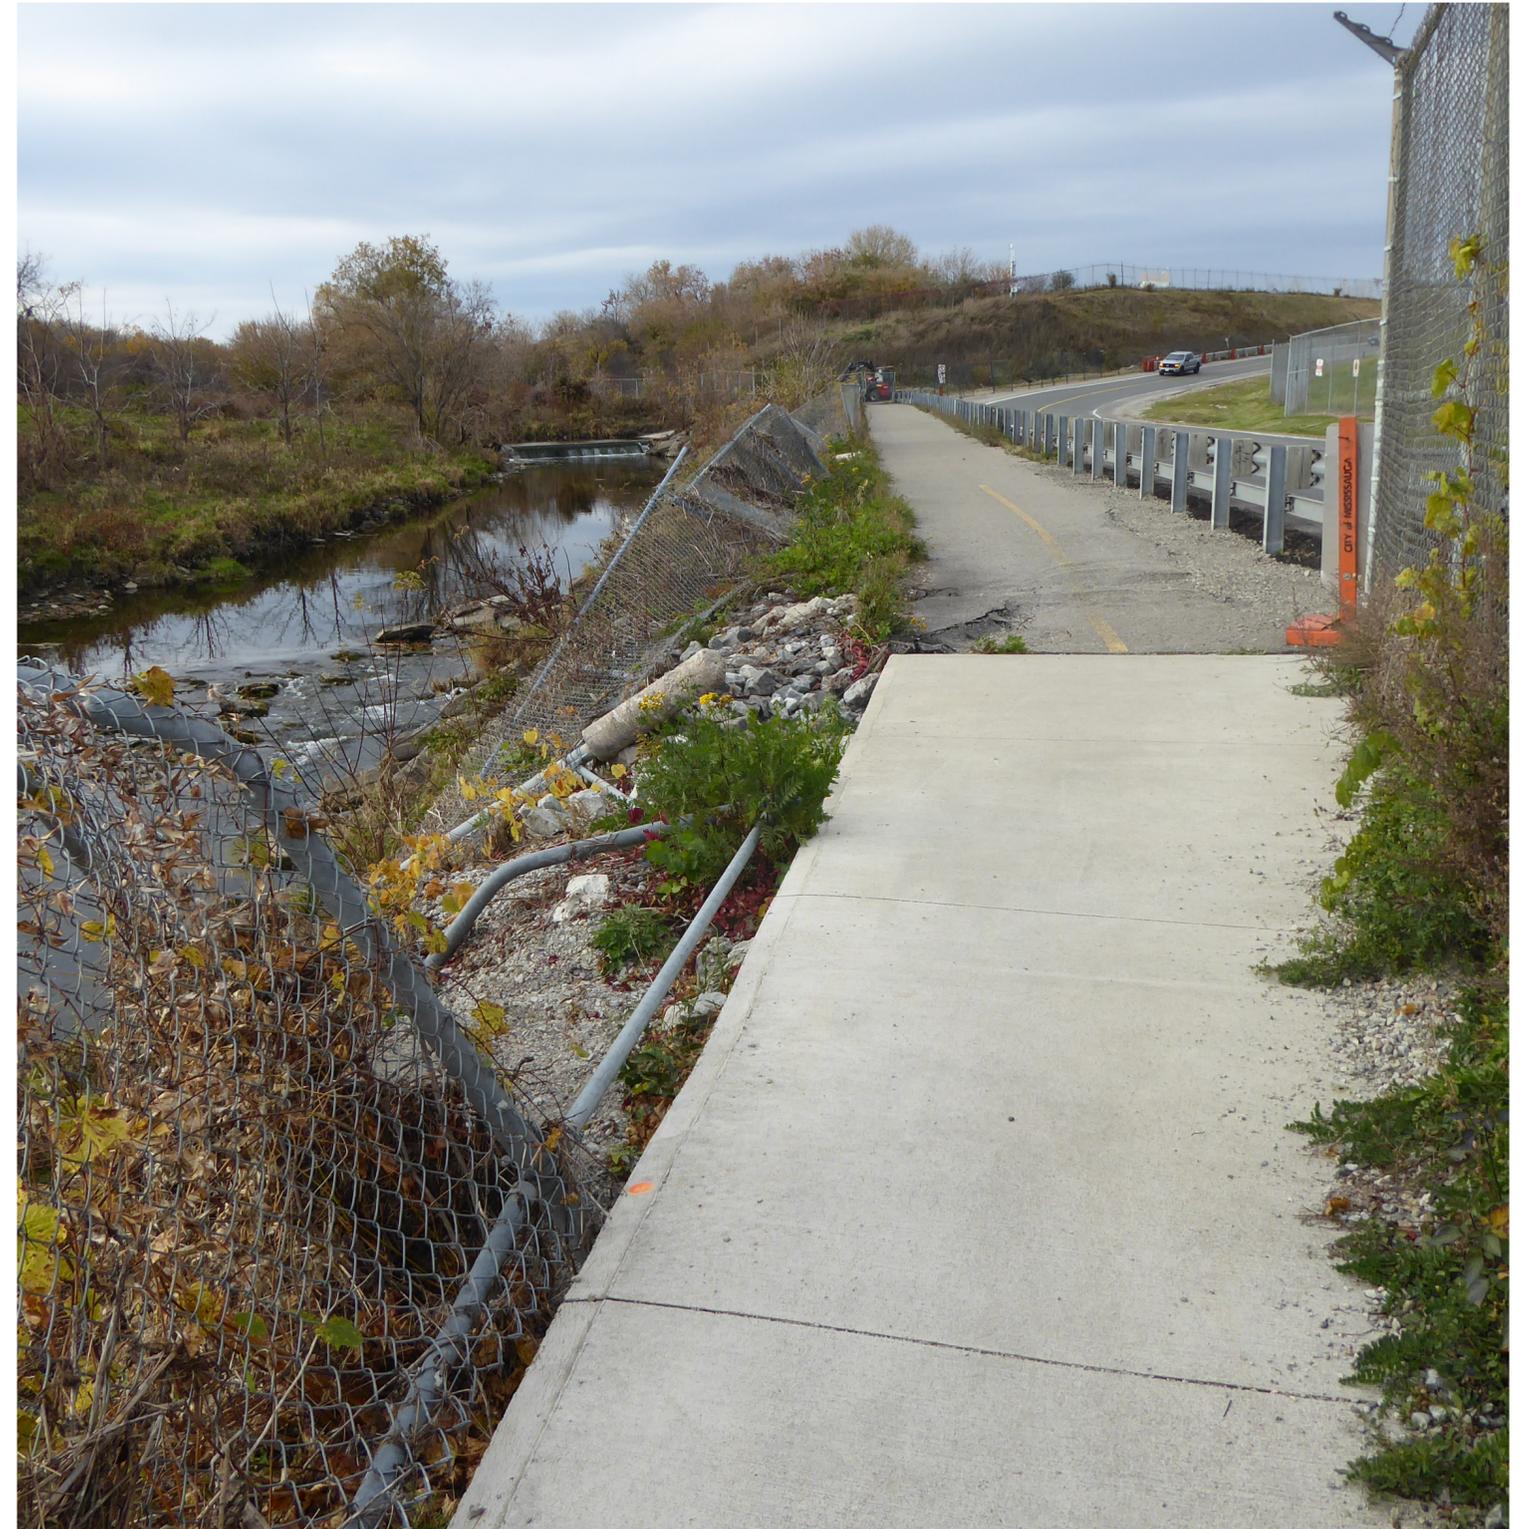
## Trail surface and foundation repair.

- This is a look at location #1, in a northerly direction.
- My assumption is that the Mississauga 311 response was referring to this general area.

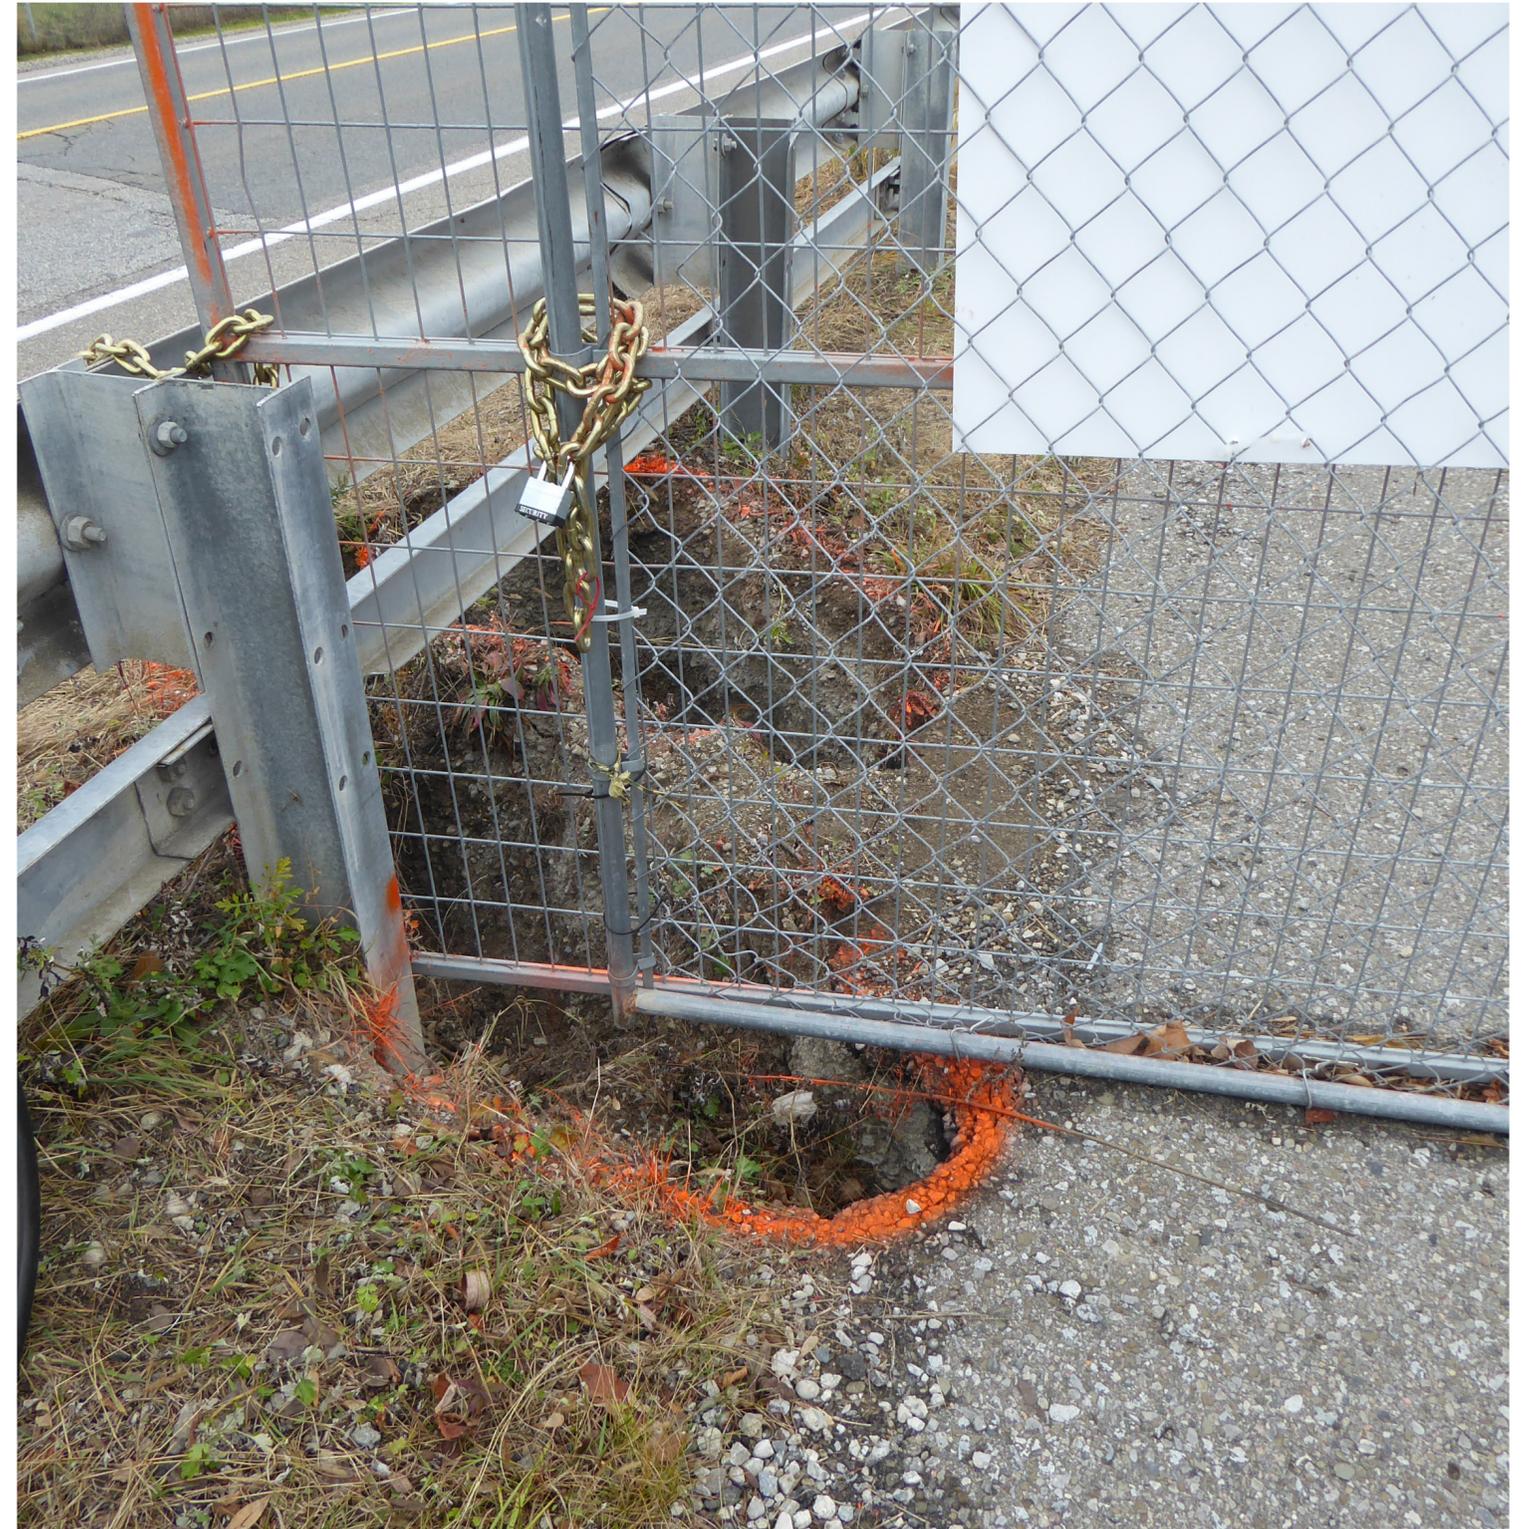
**November 15th, 2024 visit.**

- A new closure of the trail was instituted when it was found that subterranean erosion was continuing at location #1.
- The erosion was on both sides of a drainage pipe that ran under both the roadway and the path. This has compromised the substantial retaining wall that supports the west side of the path.
