HERITAGE CONSERVATION PLAN

7 Church Street East
City of Brampton, ON

FINAL REPORT

Date: 7 January 2025 (Revised 4 February 2025)
Project #: LHC0483

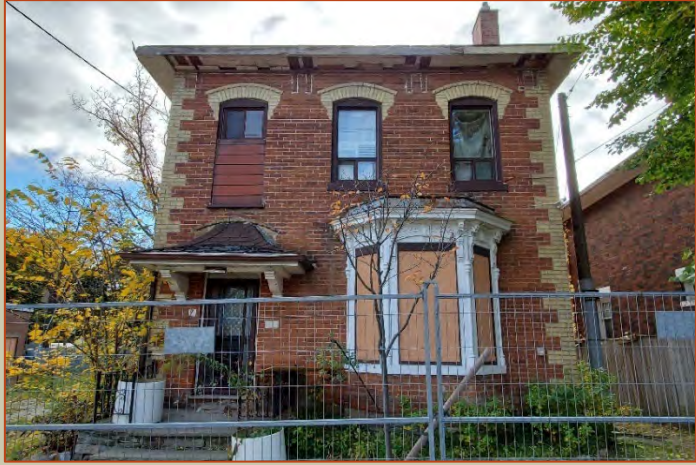
Attribute	Description	Condition	Photograph(s)
Two-storey construction (Image 1 through Image 6)	The two-storey construction of the house is intact and in good shape.	Good

<p>Northwest elevation</p>

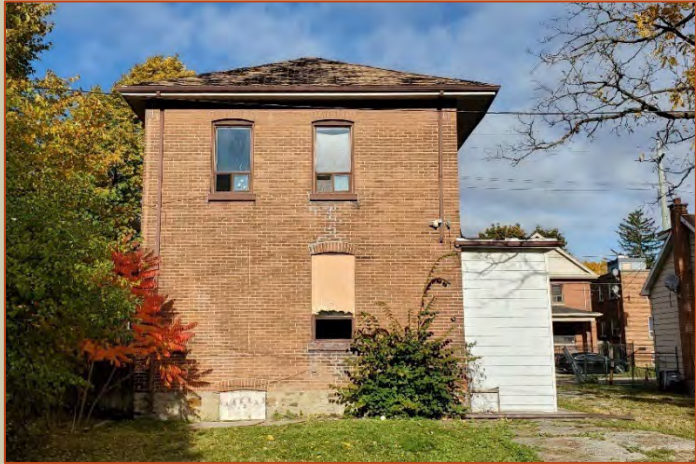
<p>Southeast elevation (see Image 1 through Image 6)</p>

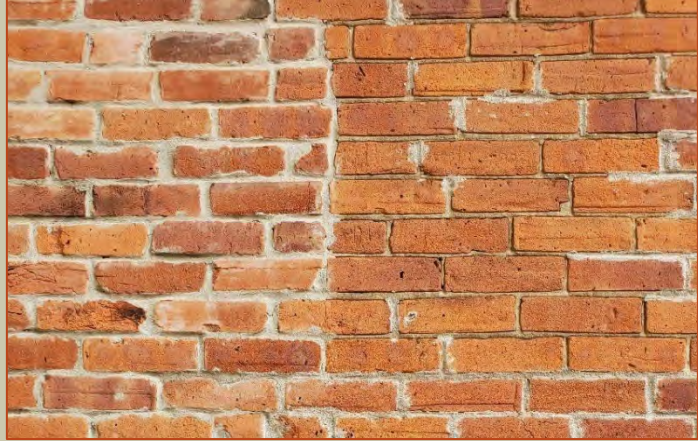
Attribute	Description	Condition	Photograph(s)
Rectangular plan	The house's rectangular plan is intact and in good shape.	Good	See Image 2, Image 3, Image 5, Image 6
Red brick cladding	<p>The house's red brick cladding is generally in good shape; however, some deterioration is present.</p> <p>Cracked brick/mortar joints, cracked/broken bricks, mortar joints with varying degrees of degradation, hard water staining, and efflorescence are all present.</p> <p>Repointing/mortar joint repair has been previously completed in select locations. In most cases, the mortar used to repoint/repair does not match the existing mortar.</p> <p>The condition of the red brick cladding remains fair despite this observed damage.</p>	Fair – Good

<p>Brick on southwest elevation</p>

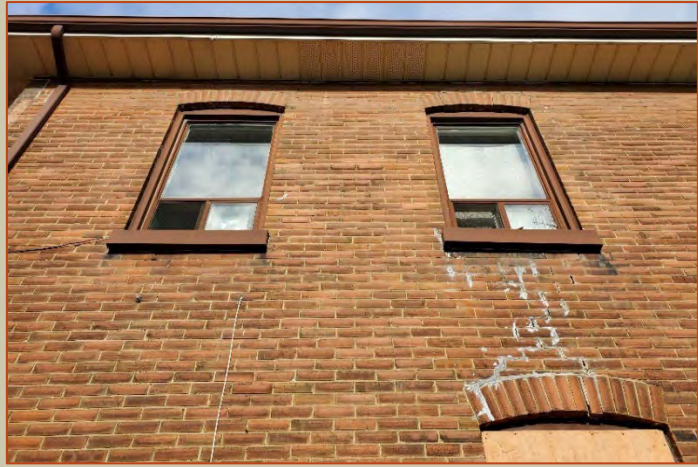
<p>Brick on southeast elevation See Image 7 through Image 11</p>

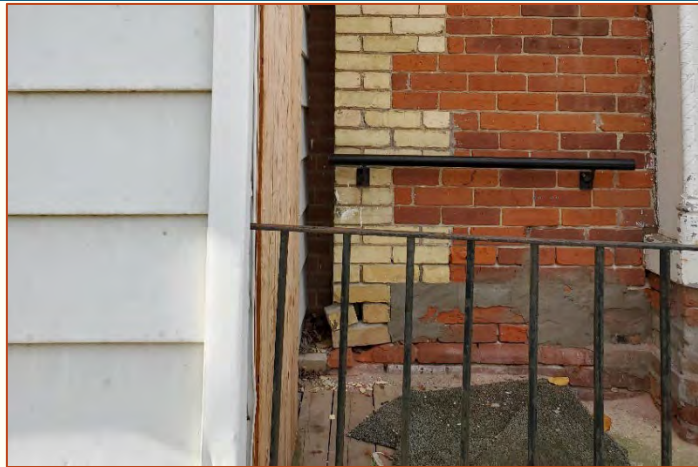
Attribute	Description	Condition	Photograph(s)
Light-coloured quoins and segmented window voussoirs	<p>Quoins: The house's light-coloured quoins are generally in good shape; however, some deterioration is present.</p> <p>Mortar joints with varying degrees of degradation, hard water staining, and efflorescence are all present. Despite this deterioration, the condition of the quoins is generally fair to good.</p> <p>Notable mortar joint degradation is at the base of the voussoir on the southeast corner of the house. Here, the condition is poor.</p> <p>Segmented Window Voussoirs: The house's light-coloured segmented window voussoirs are generally in good shape with minimal observed deterioration.</p> <p>Cracked mortar joints are present on the voussoirs over the first storey window on the</p>	<p>Quoins:</p> <p>Poor – Good</p> <p>Segmented Window Voussoirs:</p> <p>Fair – Good</p>

<p>Quoin on southeast corner of the main house</p>

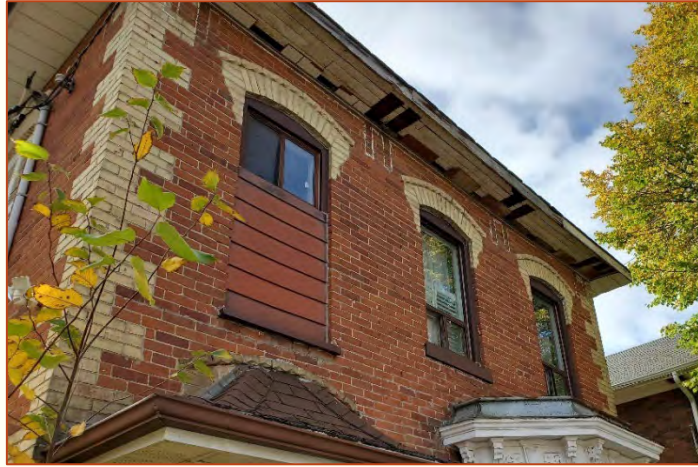
<p>Quoins and voussoirs on the northwest elevation</p> <p>See Image 12 through Image 16</p>

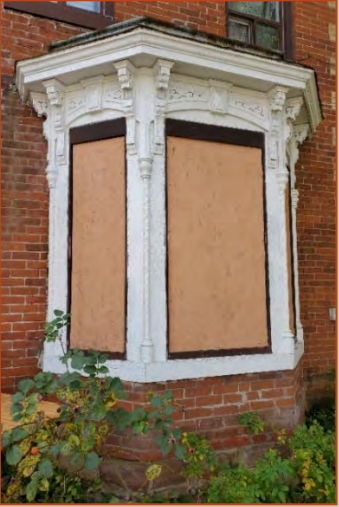
Attribute	Description	Condition	Photograph(s)
	house's northeast elevation. The condition of the voussoir remains fair despite this observed damage.		
Two bay windows with decorated wooden frames	<p>The house's two bay windows with decorated wooden frames are both generally in fair shape.</p> <p>There are some cracks and chips in the wood frames and cracking of the white paint.</p> <p>The roofs are rusting/oxidizing in certain locations.</p> <p>Degraded mortar joints are present in certain locations around the structural openings.</p>	Fair

<p>Northwest bay window</p>

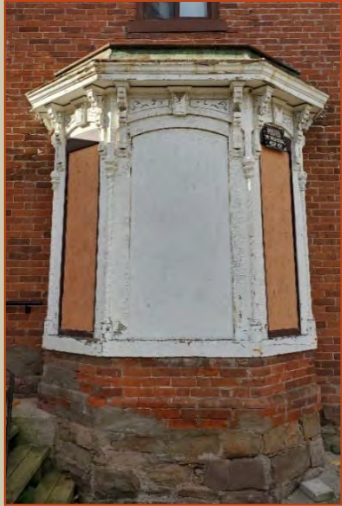
<p>Northeast bay window See Image 17 through Image 23</p>
Hipped roof	<p>The house's hipped roof is generally in poor to good shape. There are no evident structural issues with the roof (i.e., no visible sagging) and the eave and soffit on the northeast, southeast, and southwest elevations appear to be in good condition.</p> <p>The wood soffit on the northwest elevation appears to be in poor</p>	Poor – Good

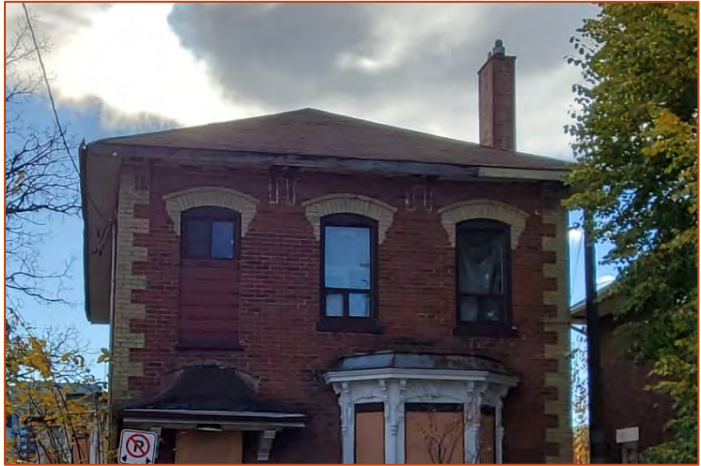
<p>Hipped roof over northwest elevation</p>

Attribute	Description	Condition	Photograph(s)
	<p>condition.</p> <p>The asphalt shingles on the roof appear to be in poor condition.</p>

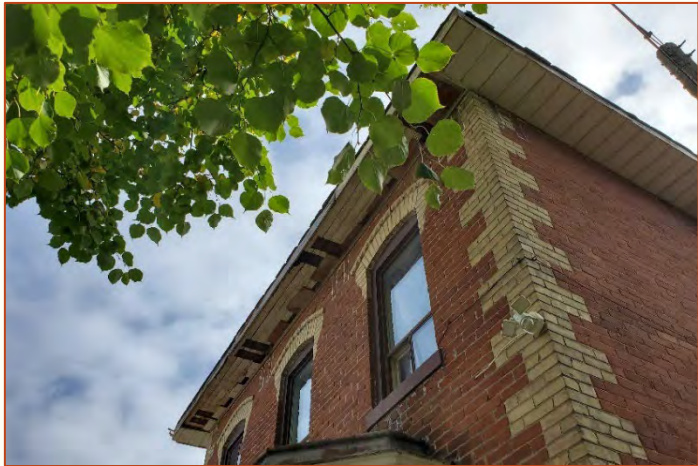
<p>Hipped roof over northwest and southwest elevations See Image 24 through Image 27</p>
<p>Wooden canopy over the entrance door</p>	<p>The wooden canopy over the entrance door is generally in poor to good condition.</p> <p>The wooden frame appears to be in good condition; however, the paint is cracking.</p> <p>The canopy has a metal soffit and eavestrough. The shingles on the canopy are in poor condition.</p>	<p>Poor – Good</p>

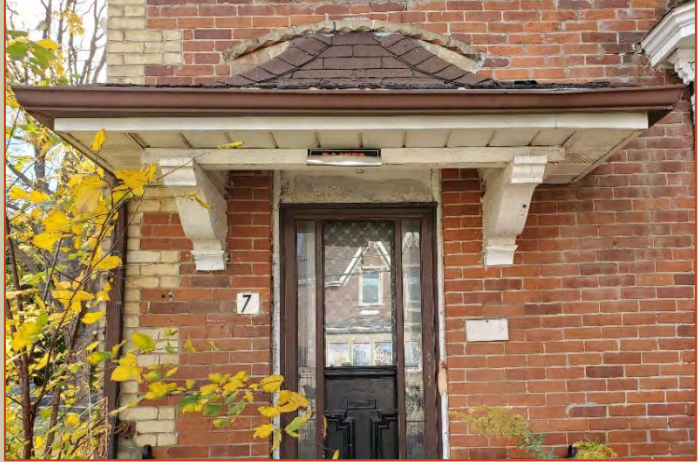
<p>Main entrance See Image 28</p>

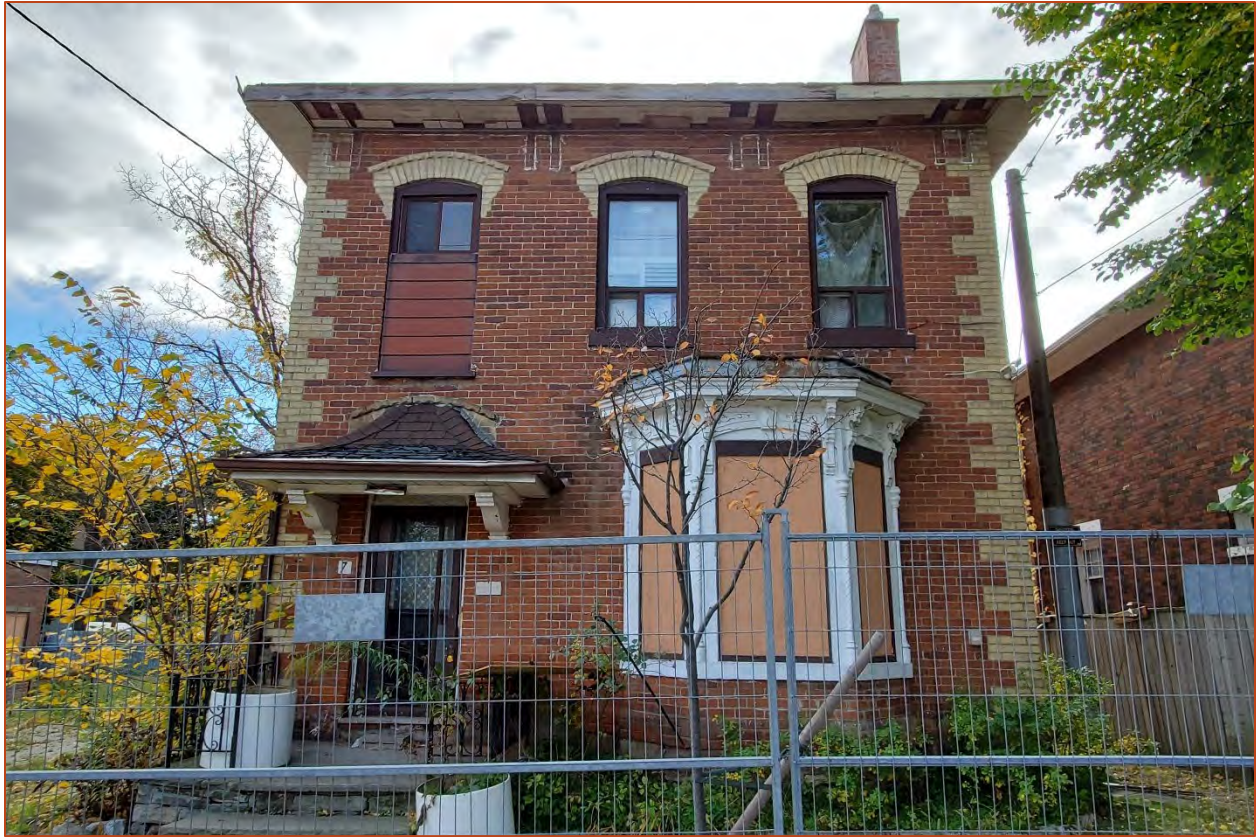
Image 1. View southwest showing the two-storey construction of the house on the Property

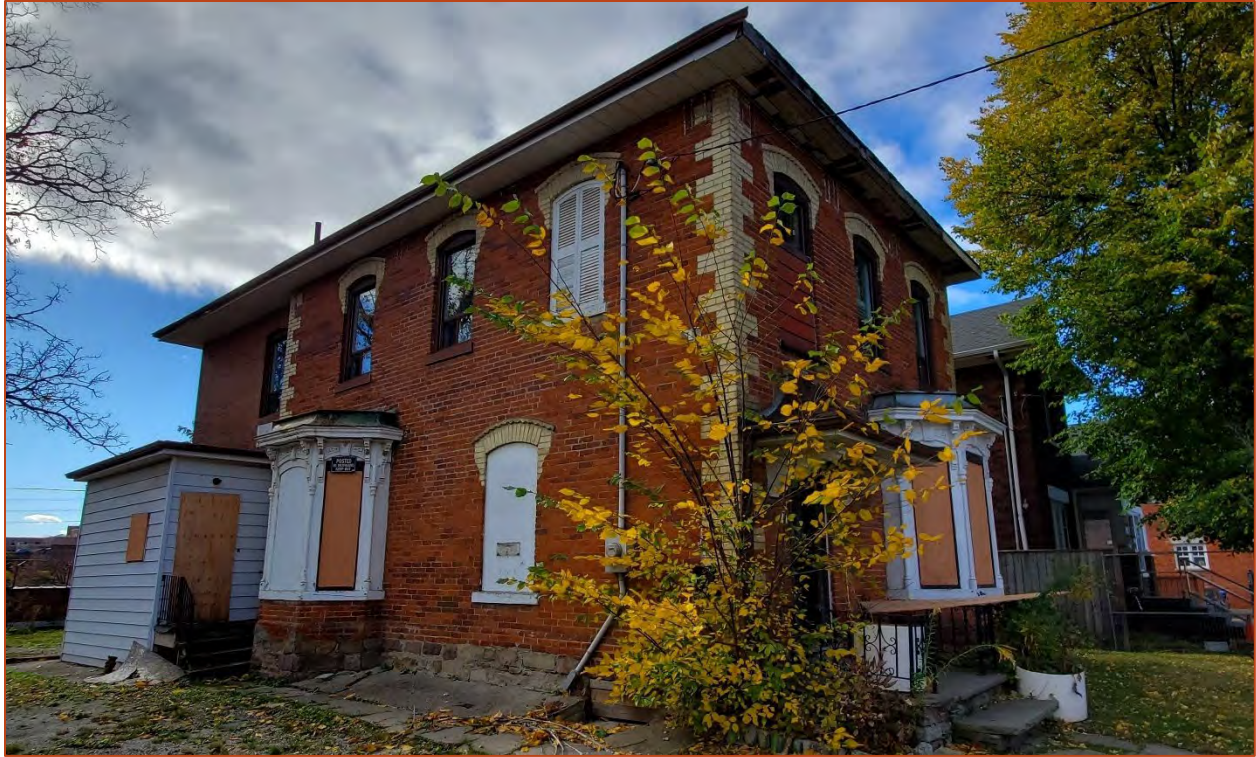
Image 2. View south showing the showing the two-storey construction and rectangular plan of the house on the Property

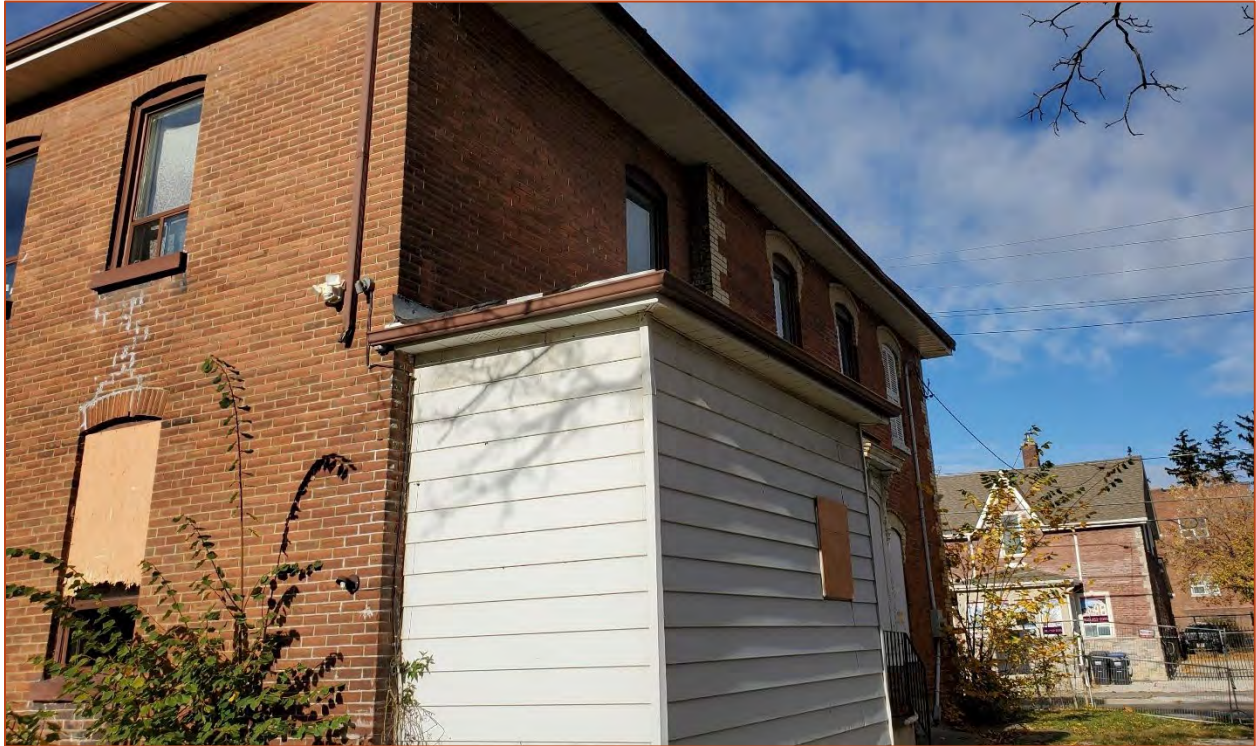
Image 3. View northwest showing the showing the two-storey construction and rectangular plan of the house on the Property

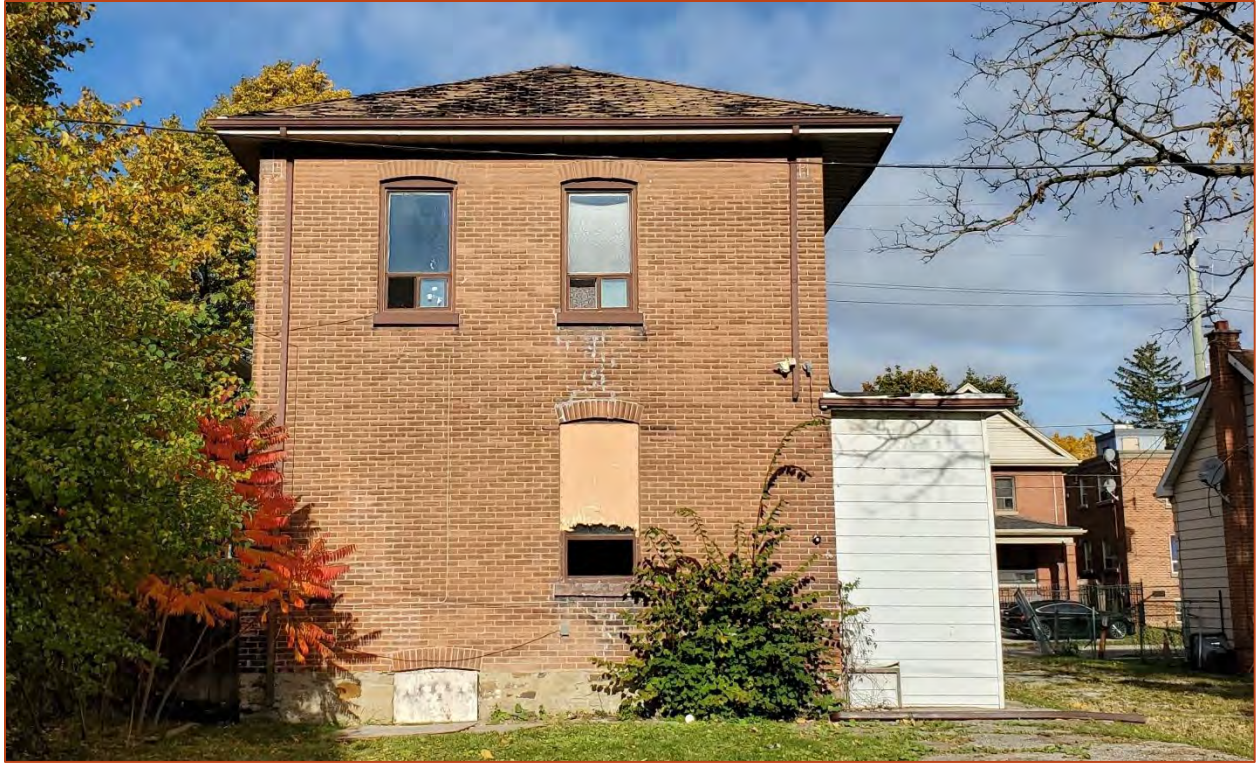
Image 4. View northwest showing the two-storey construction of the house on the Property

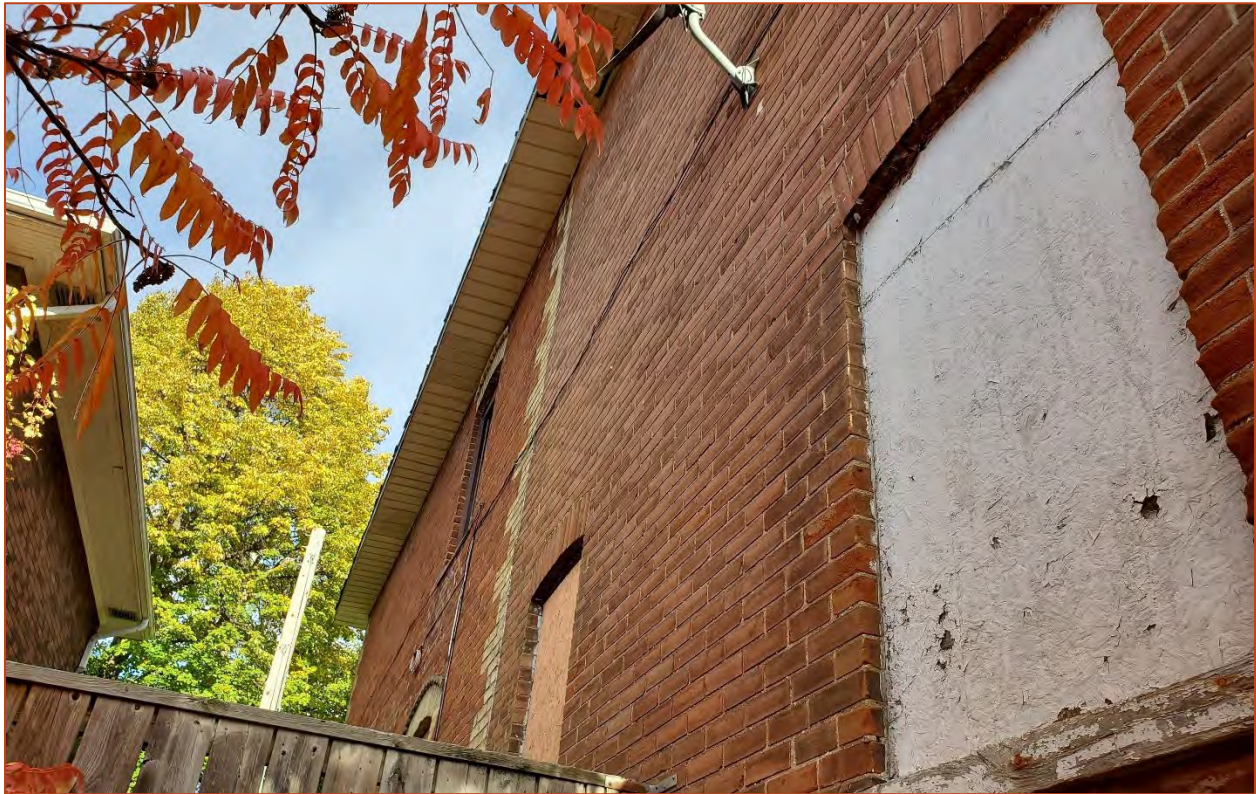
Image 5. View north showing the showing the two-storey construction and rectangular plan of the house on the Property

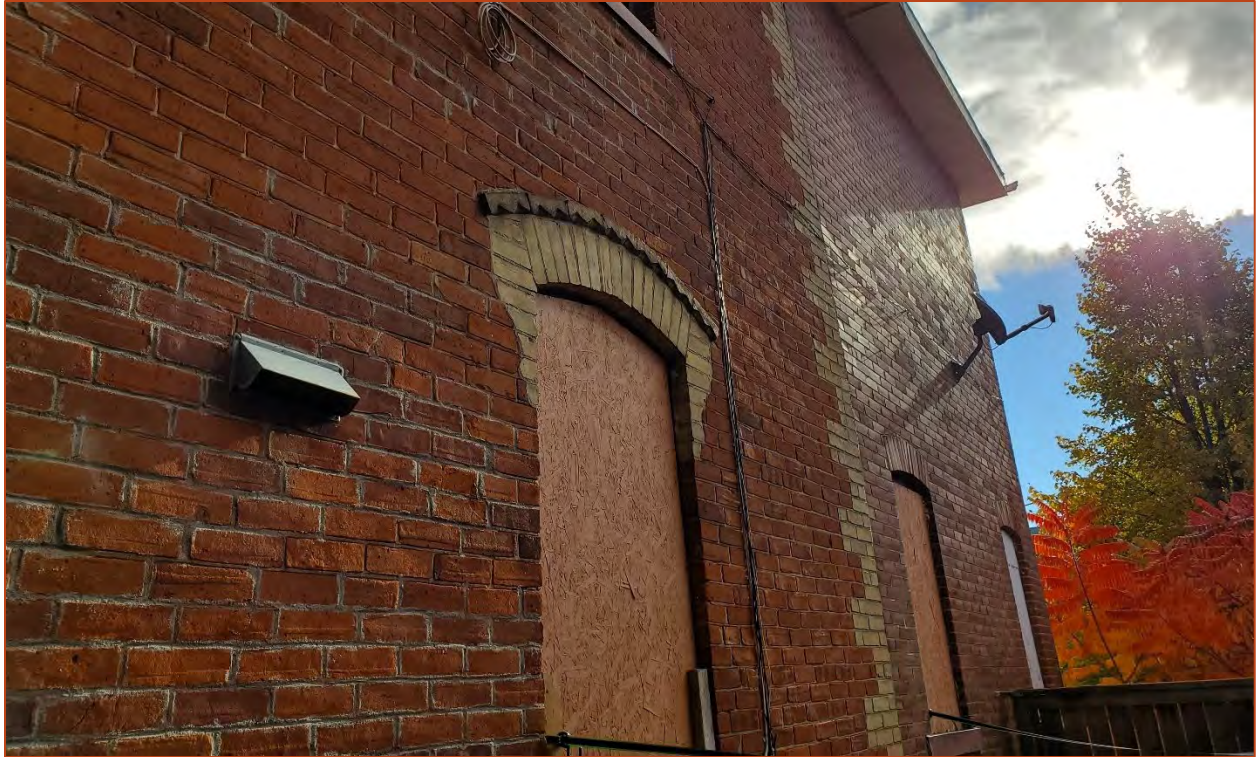
Image 6. View southeast showing the showing the two-storey construction and rectangular plan of the house on the Property

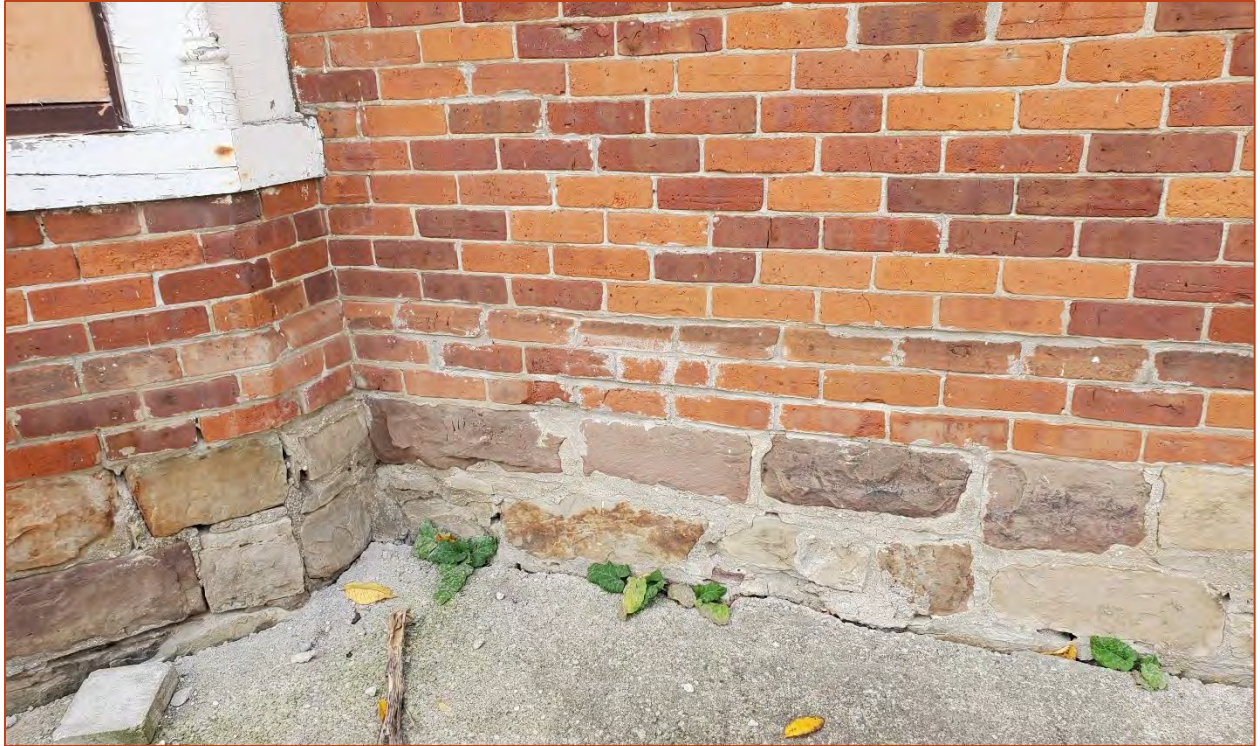
Image 8. View southwest showing the condition of the red brick cladding on the northeast elevation of the house on the Property

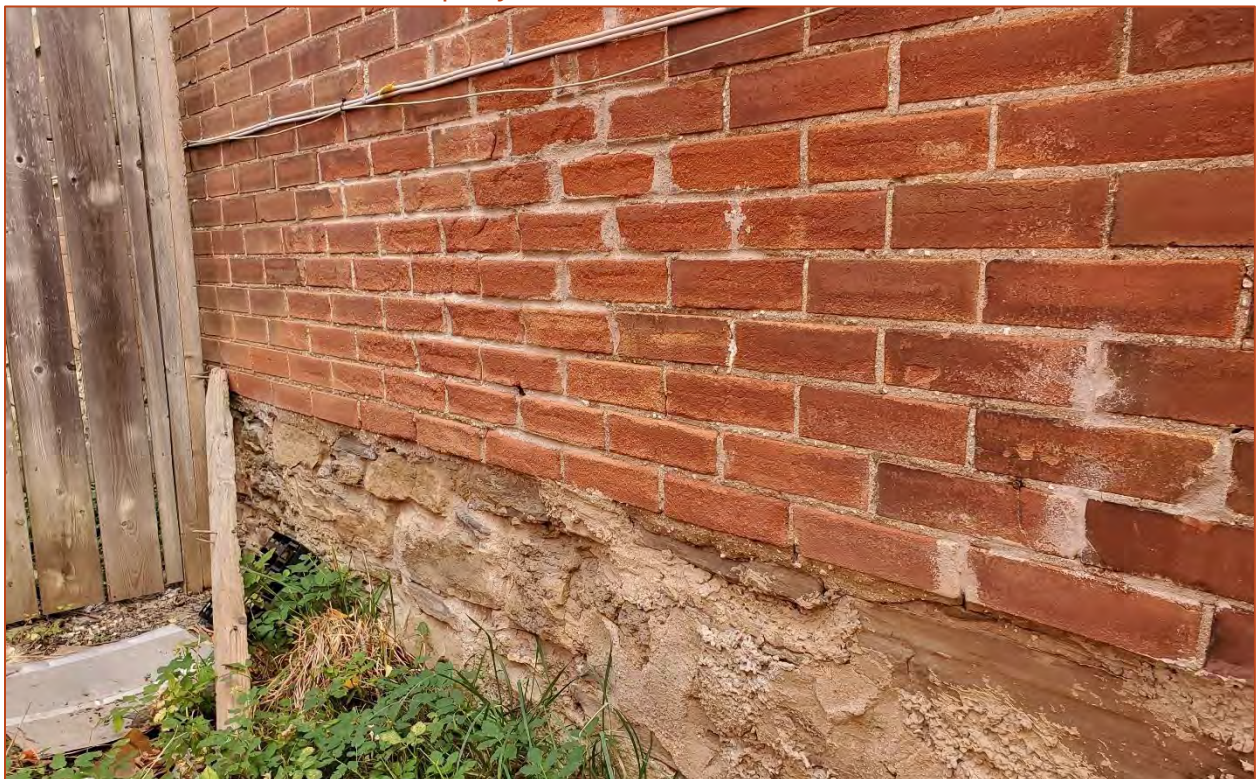
Image 9. View north showing the condition of the red brick cladding on the southwest elevation of the house on the Property

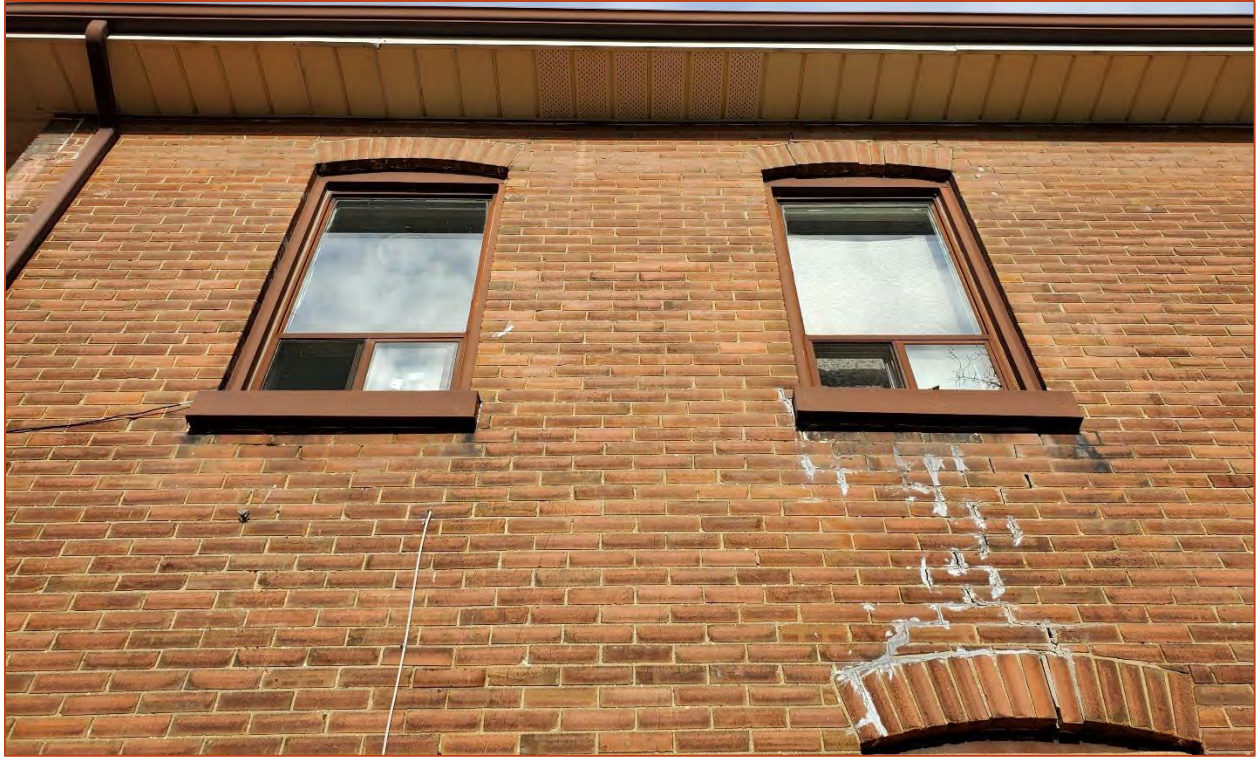
Image 10. View northwest showing the condition of the red brick cladding on the southeast elevation of the house on the Property

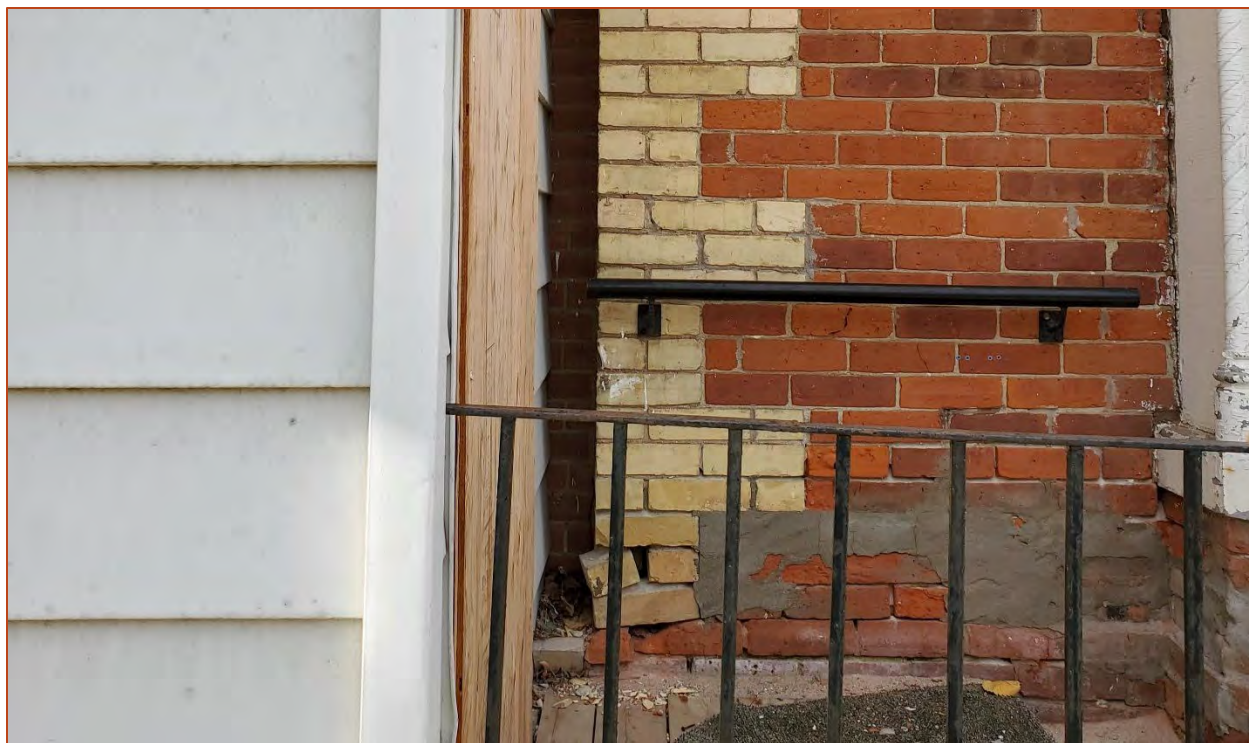
Image 12. View northwest showing the buff brick quoin on the southeast corner of the main house on the Property

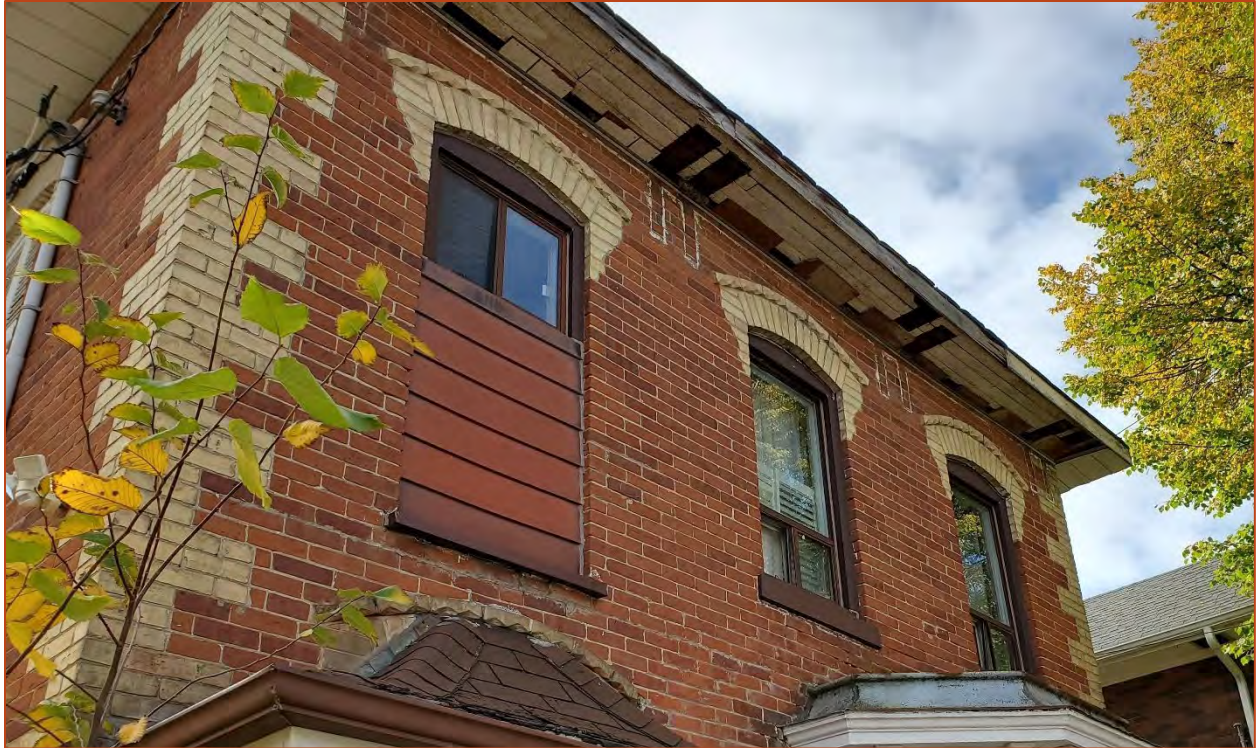
Image 14. View south showing buff brick quoins and voussoirs on the northwest elevation of the house on the Property

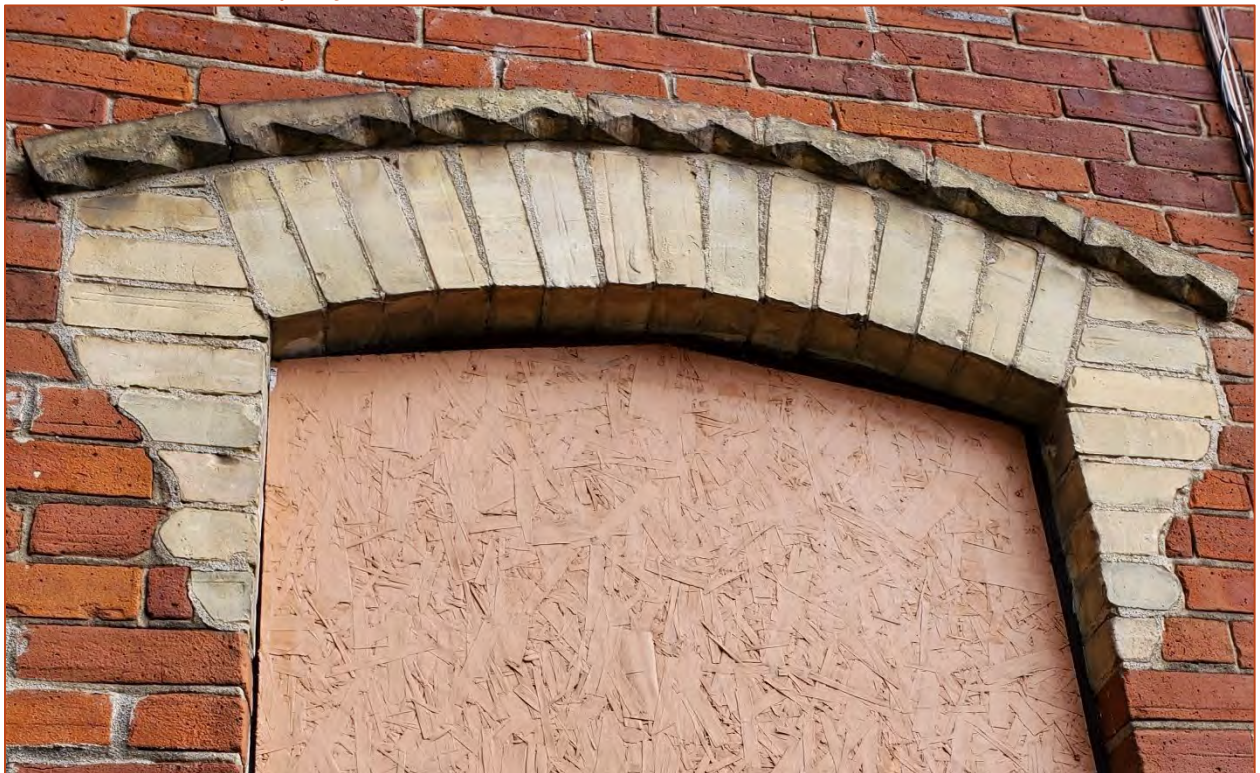
Image 15. View northeast showing the buff brick voussoir over the first storey window on the southwest elevation of the house on the Property

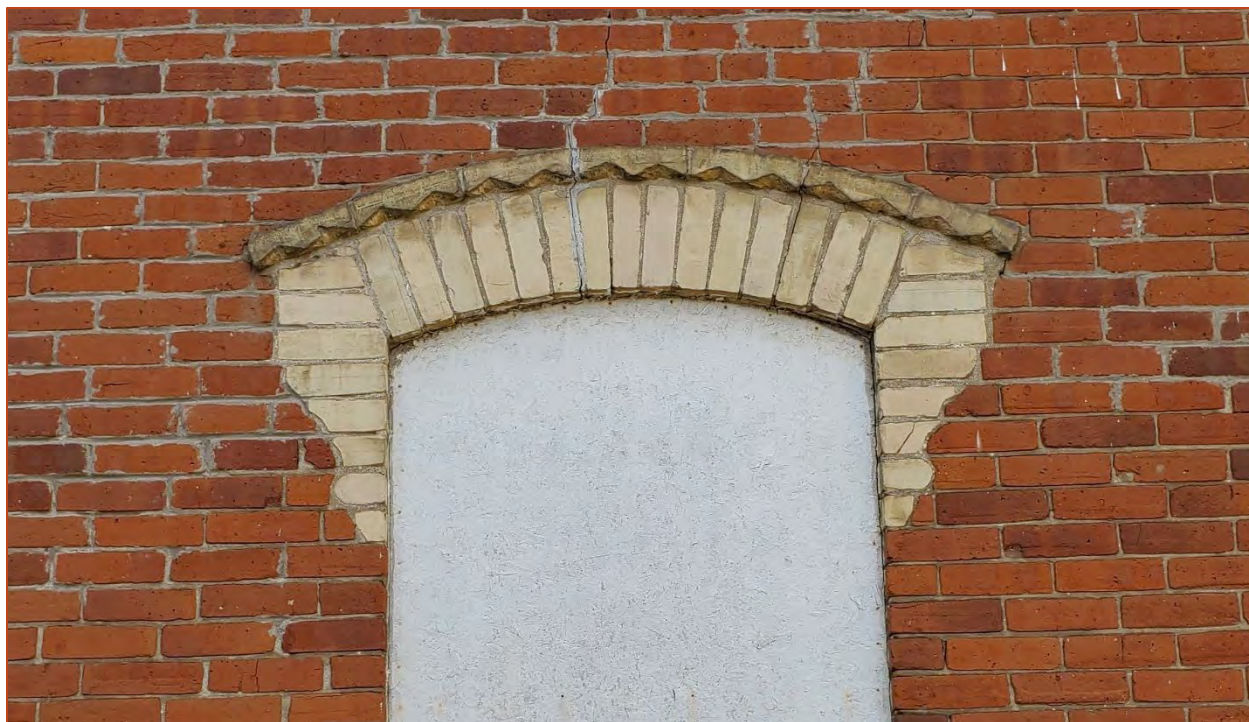
Image 16. View southwest showing the buff brick voussoir over the first storey window on the northeast elevation of the house on the Property

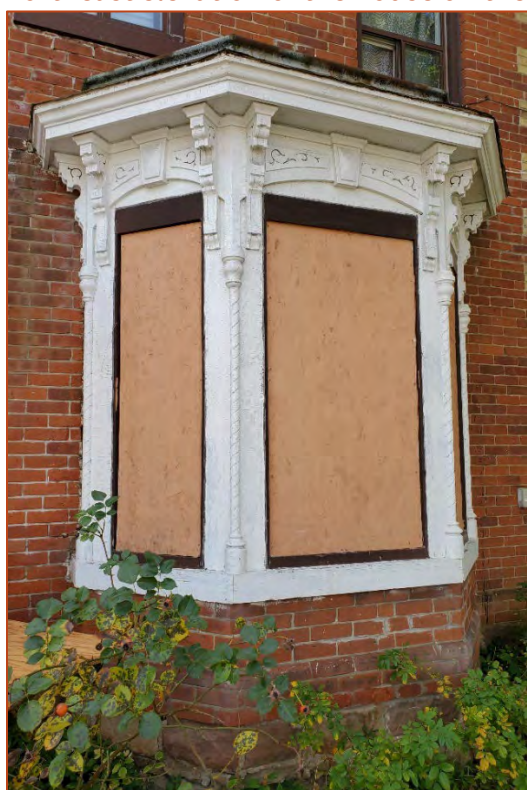
Image 17. View south showing the condition of the bay window on the northwest elevation of the house on the Property

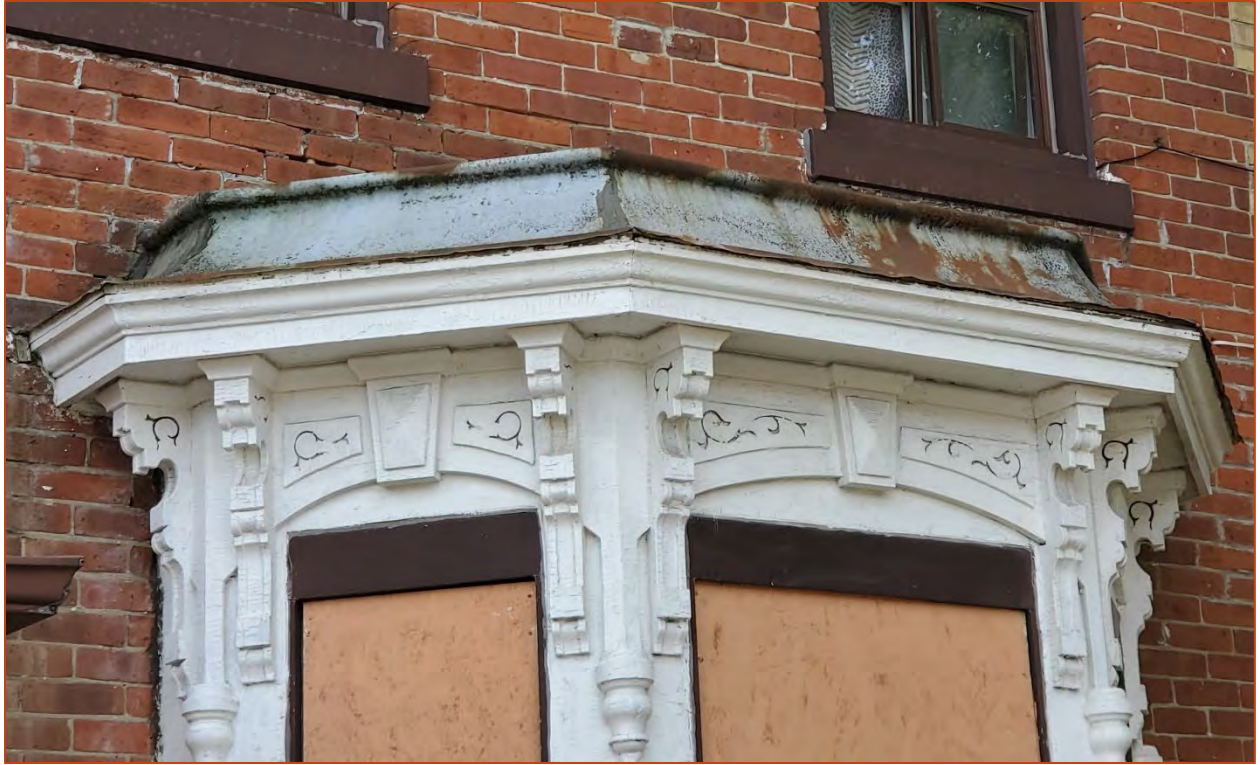
Image 18. View south showing the condition of the of the bay window on the northwest elevation of the house on the Property

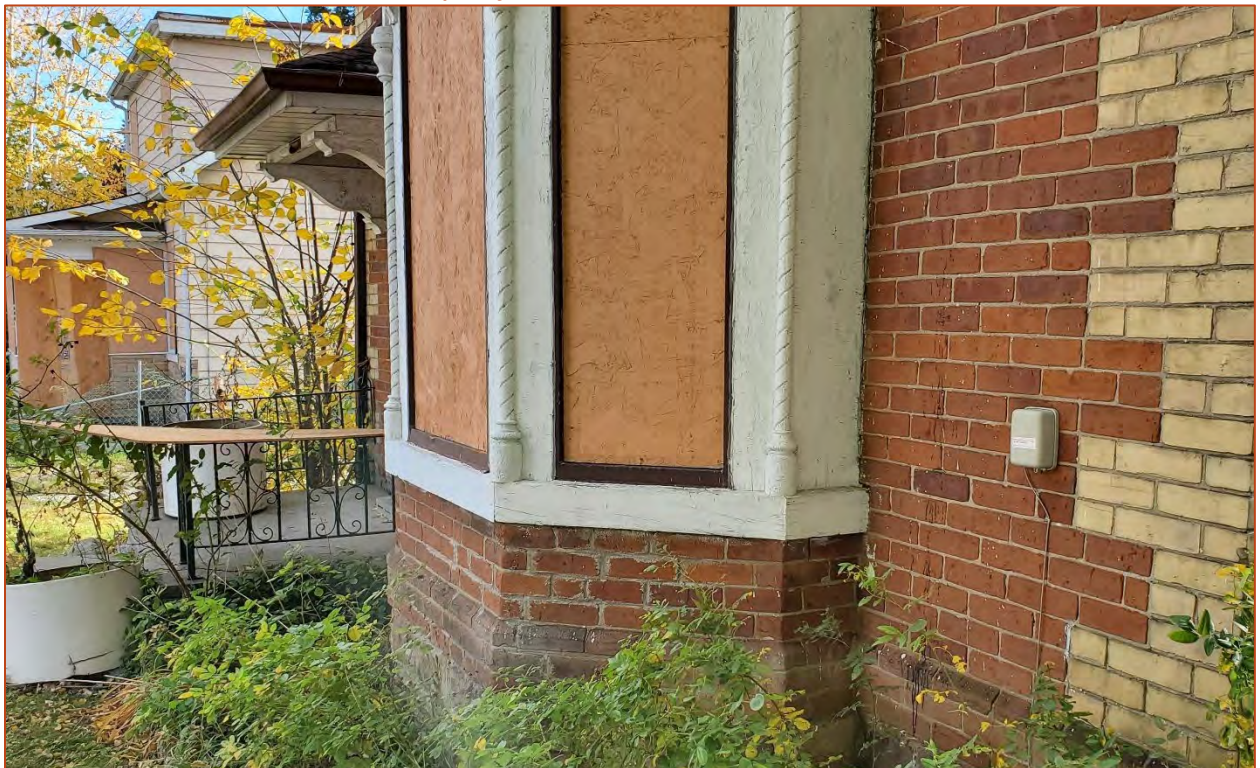
Image 19. View east showing the condition of the of the bay window on the northwest elevation of the house on the Property

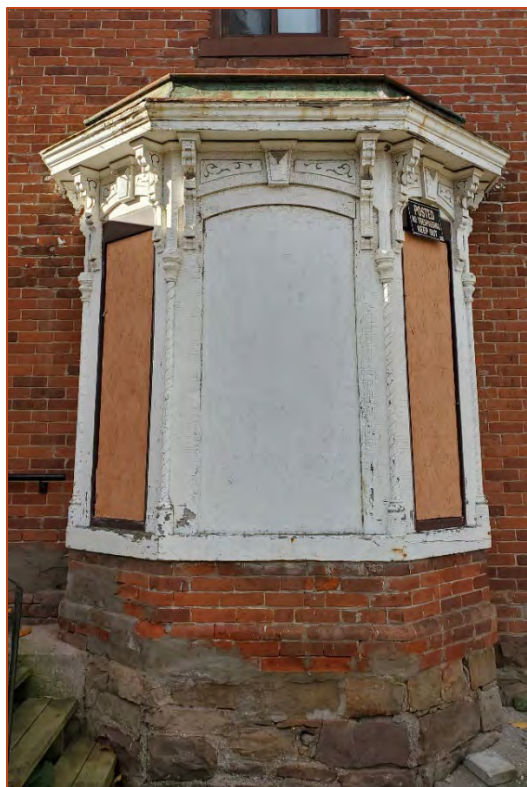
Image 20. View southwest showing the condition of the of the bay window on the northeast elevation of the house on the Property

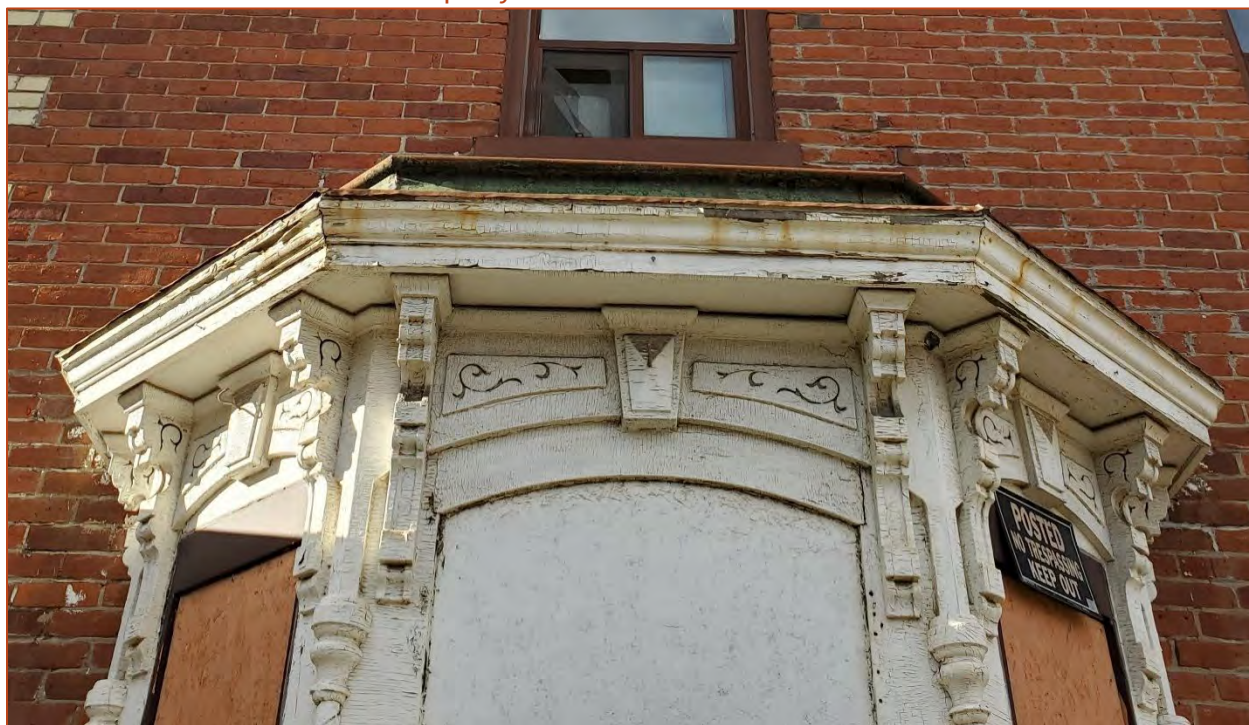
Image 21. View southwest showing the condition of the of the bay window on the northeast elevation of the house on the Property

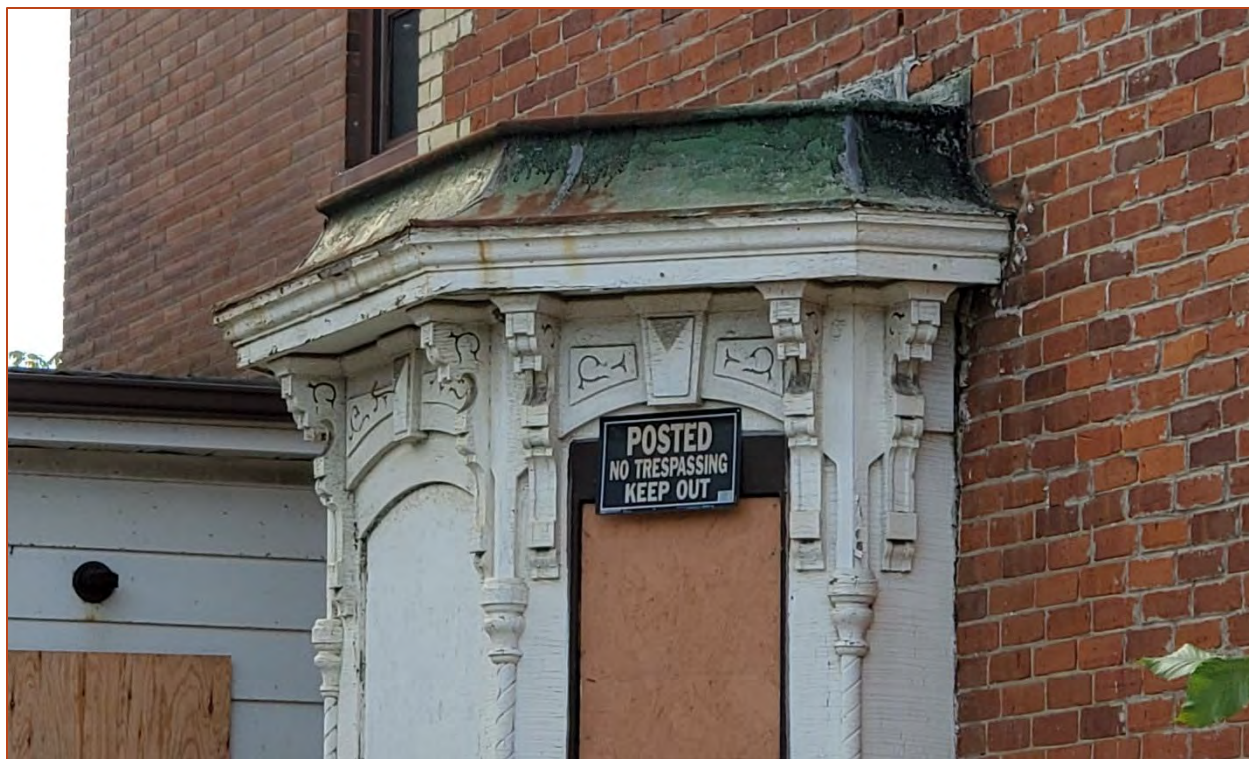
Image 22. View south showing the condition of the of the bay window on the northeast elevation of the house on the Property

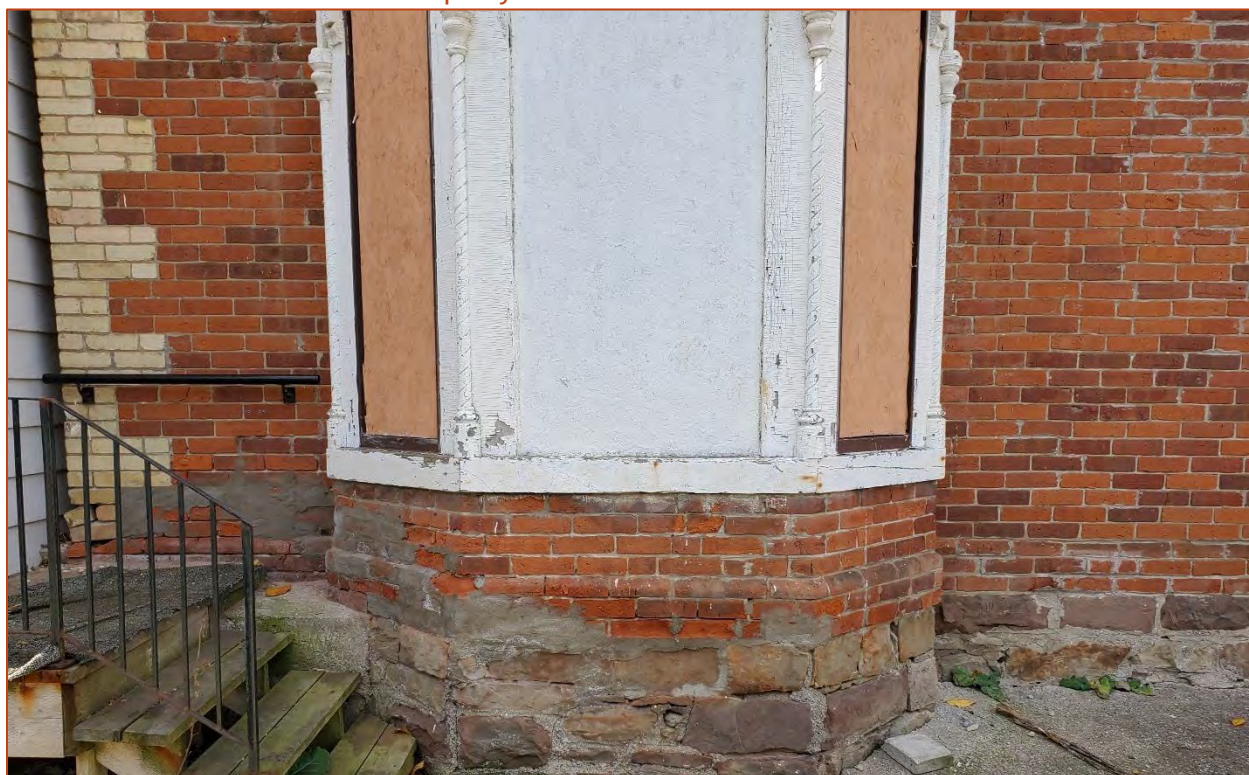
Image 23. View southeast showing the condition of the of the bay window on the northeast elevation of the house on the Property
