HERITAGE CONSERVATION PLAN

7 Church Street East
City of Brampton, ON

FINAL REPORT

Date: 7 January 2025 (Revised 4 February 2025)
Project #: LHC0483

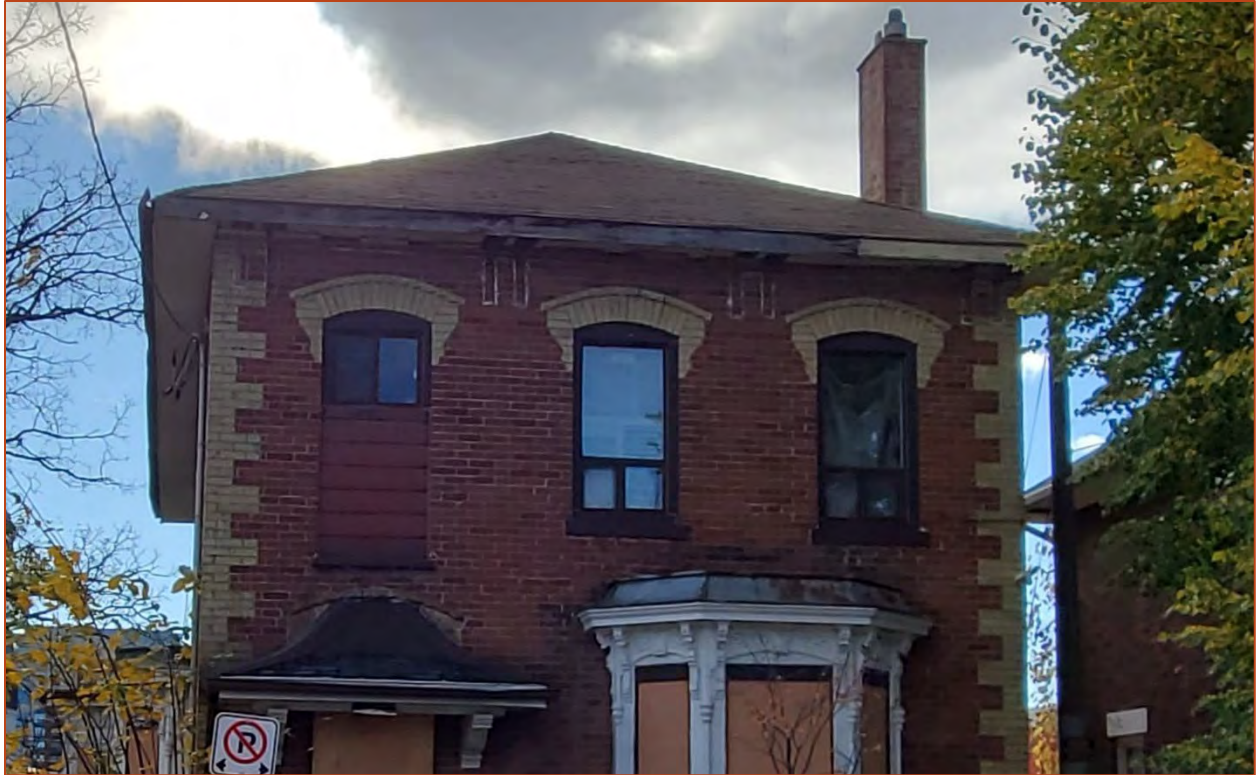
Image 24. View southeast showing the condition of the hipped roof on the house on the Property

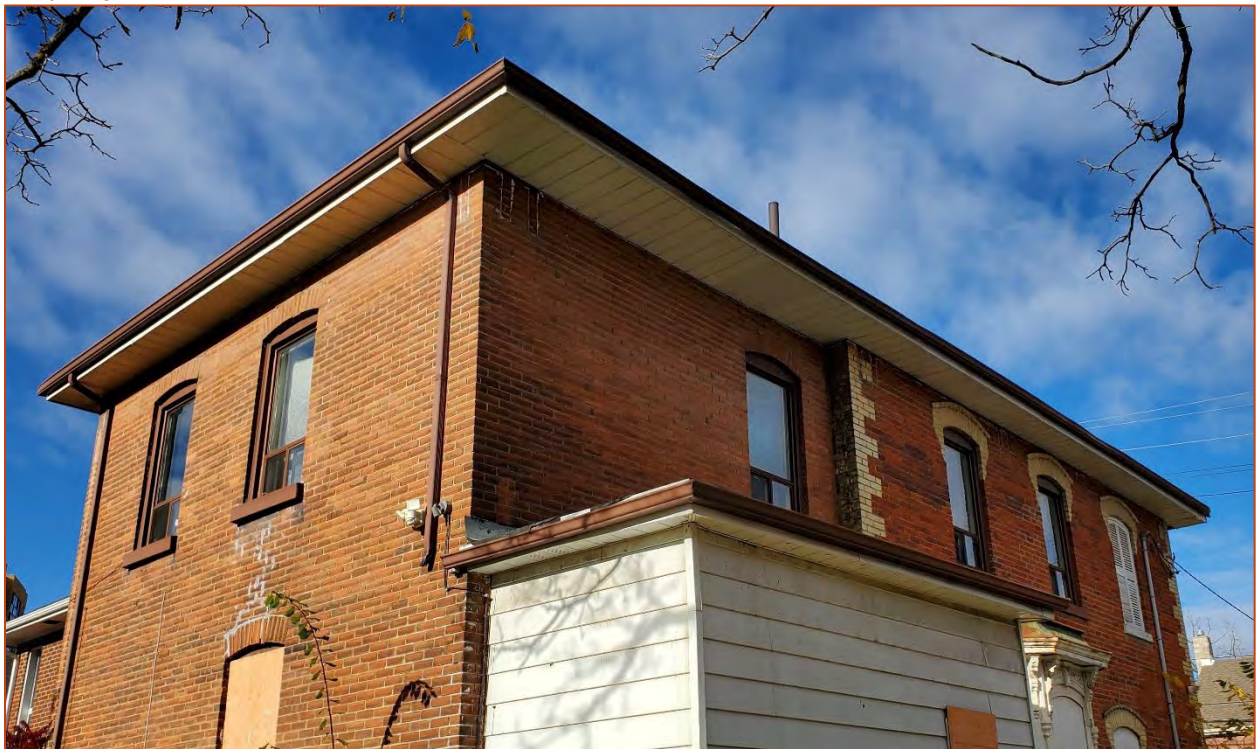
Image 25. View northwest showing the condition of the hipped roof on the house on the Property

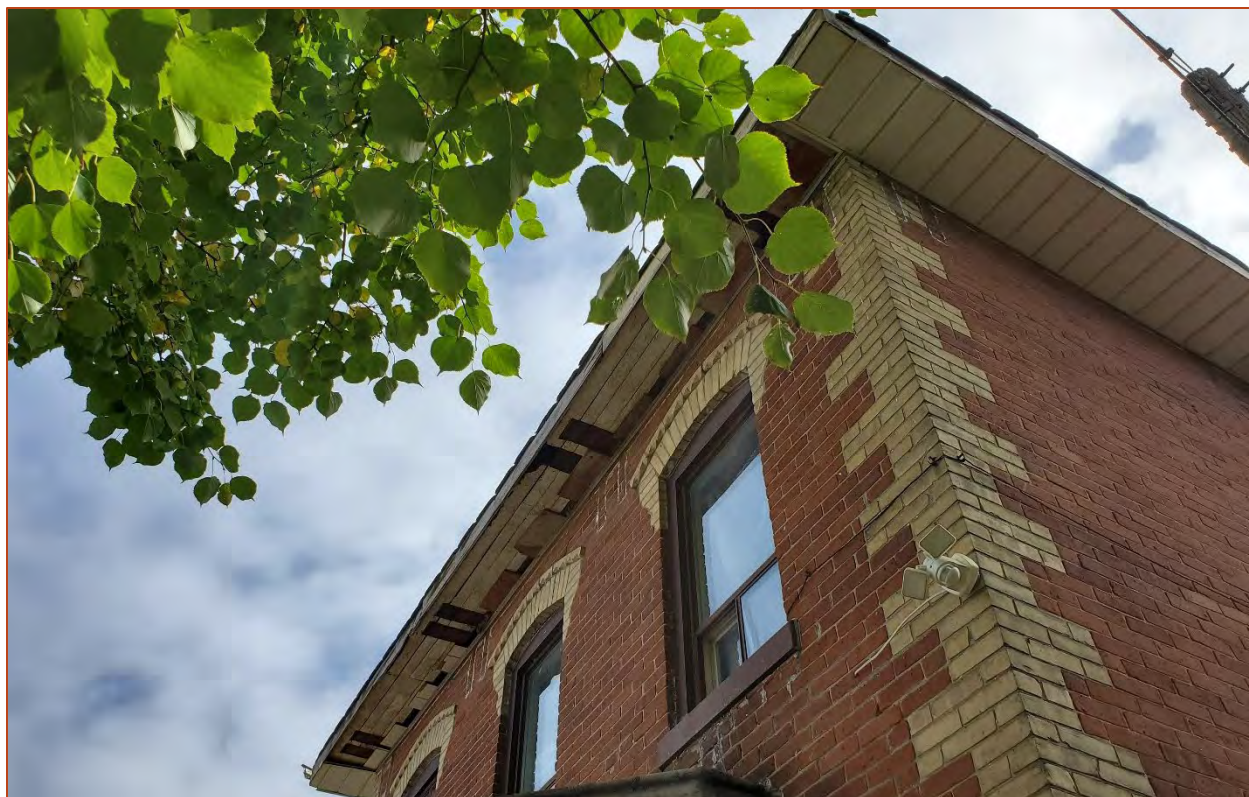
Image 26. View east showing the condition of the hipped roof on the house on the Property

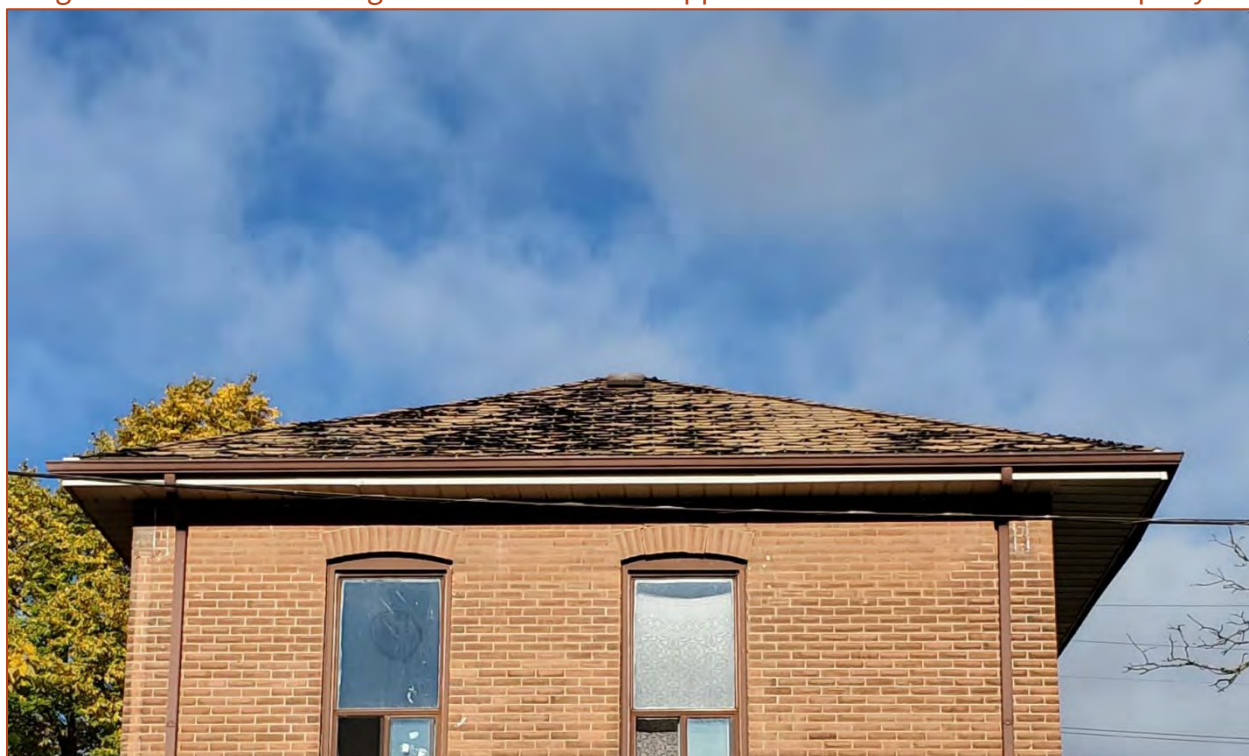
Image 27. View northwest showing the condition of the hipped roof on the house on the Property

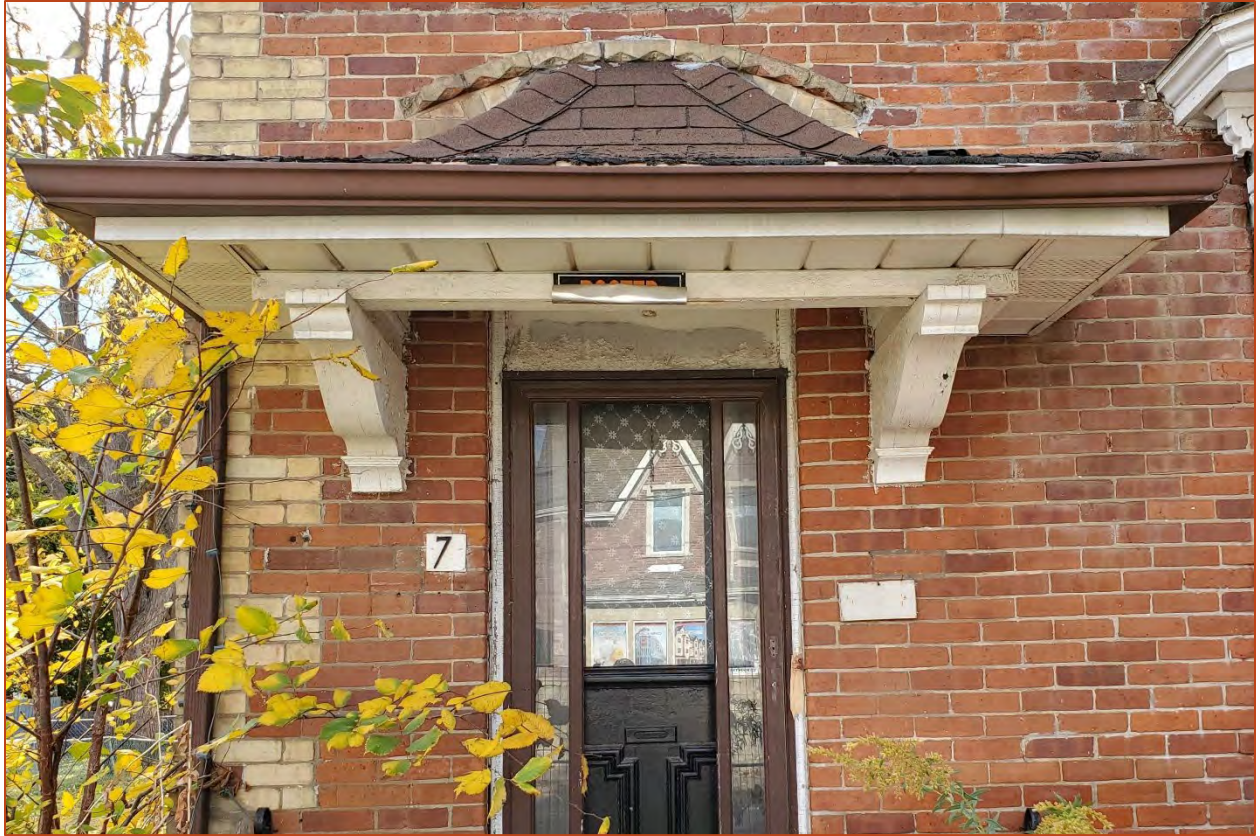
Image 28. View southeast showing the condition of the main entrance of the house on the Property
