HERITAGE IMPACT ASSESSMENT

**10980 HIGHWAY 50, 5556 COUNTRYSIDE DRIVE AND 10900 COLERAINE DRIVE
CITY OF BRAMPTON, ONTARIO**

ASI File: 20CH-048

May 2020
(Updated September 2021)

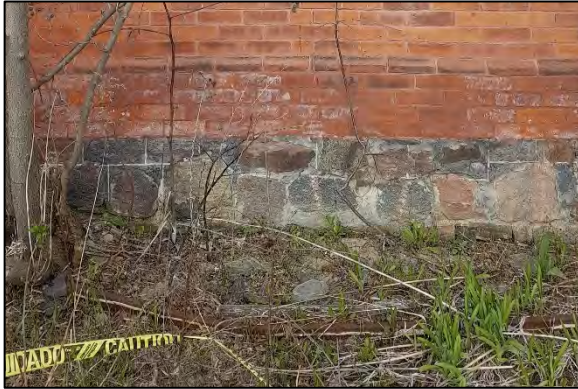
Figure 18: Granite foundations (ASI 2020)

The subject residence rests on granite foundations (Figure 18) and features an L-shaped footprint created by a projecting bay on the front elevation. The medium-pitched hipped roof features asphalt shingles, minimal roof overhang, and wooden soffit. A modern chimney (Figure 19) is located on the south elevation and features an external brick stack. A historical photograph of the house (see Figure 8)

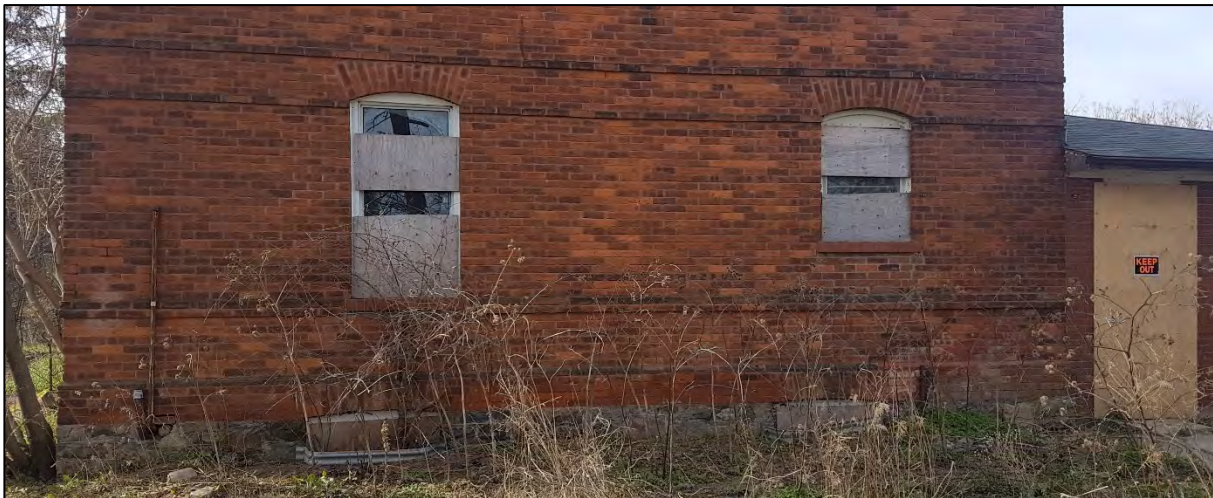
Figure 20: Brick bands on the north elevation (ASI 2020)

shows that a chimney was formerly located on the north elevation. The brick exterior features bands of projecting brickwork and a projecting brick drip course on the front and side elevations only. The five bands of projecting brickwork are as follows: one band, composed of two courses of raised brickwork, is in line with the main floor window sill; the next two bands are composed of single courses of raised brickwork, and are in line with the top of the main floor windows, and just above the main floor brick voussoirs; the fourth band is composed of two raised brick courses, and is in line with the top of the second floor windows (Figure 20); and the final band is composed of a single course of raised brickwork, and is located just below the eaves.

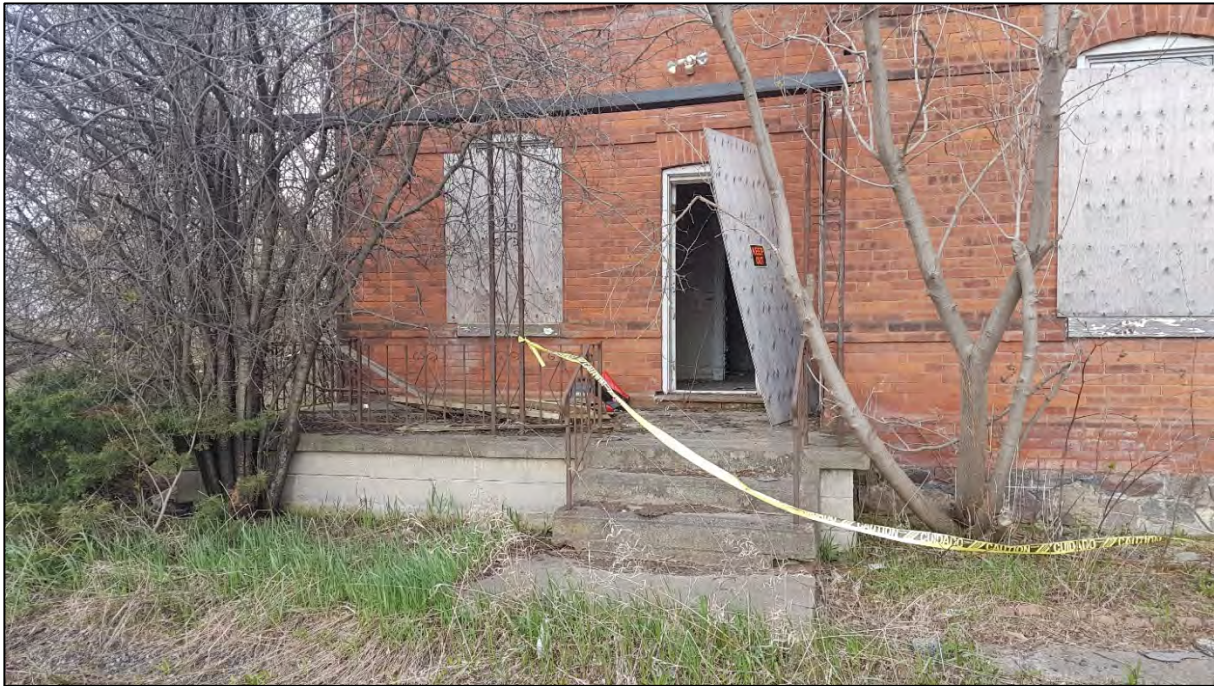
Figure 21: Concrete porch and front entrance (ASI 2020)

Alterations to the house include: the replacement of original windows with modern materials; modern porch with concrete base and steel railing on front façade; new chimney on the south elevation; and construction of a modern, single-storey accretion at the rear of the building. The gable-roofed profile of the original, one-and-a-half storey rear kitchen tail is visible in the brickwork on the west elevation.

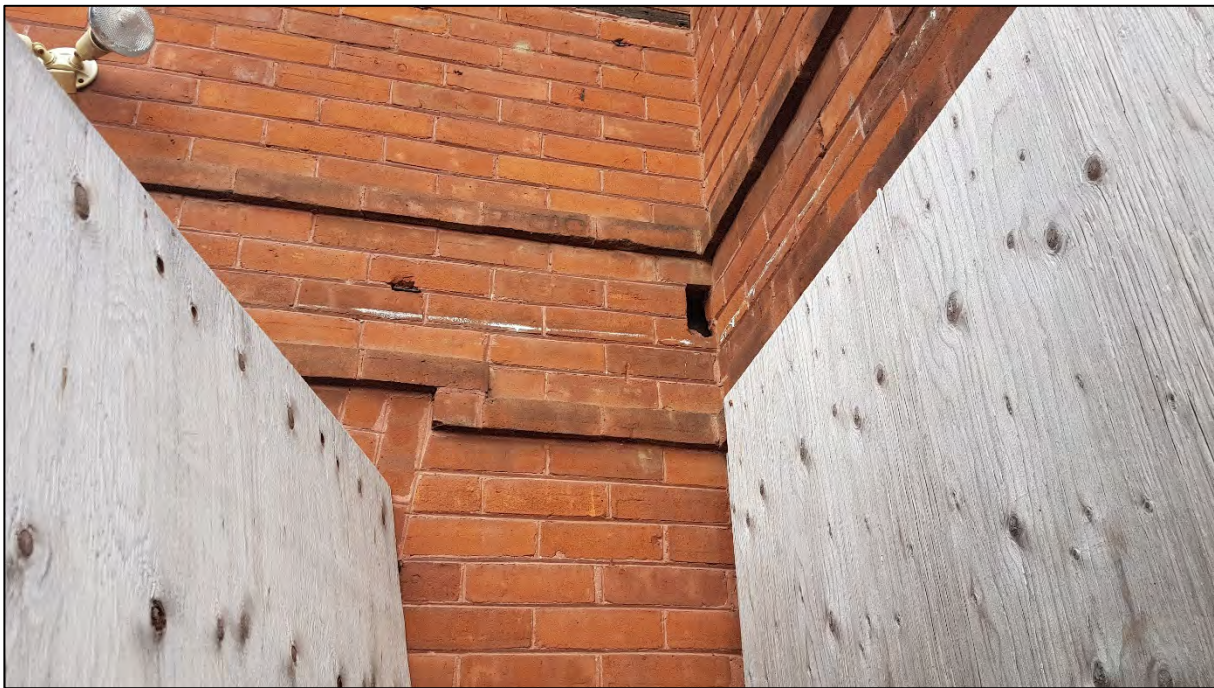
Figure 22: Joist hole where the original porch roof connected to the farmhouse (ASI 2020)

A single storey, circa 1960s, rear brick addition with concrete foundations and low hipped roof has been added to the west façade of the house, replacing the original kitchen tail (Figure 16). The original front porch, which extended across the front façade from the projecting bay to the southeast corner of the house, has also been removed. In its place is a modern porch (without a roof) with concrete foundations and steel railings around the perimeter (Figure 21). Evidence of the former covered porch is visible in the brick work, just above the first storey windows (Figure 22).

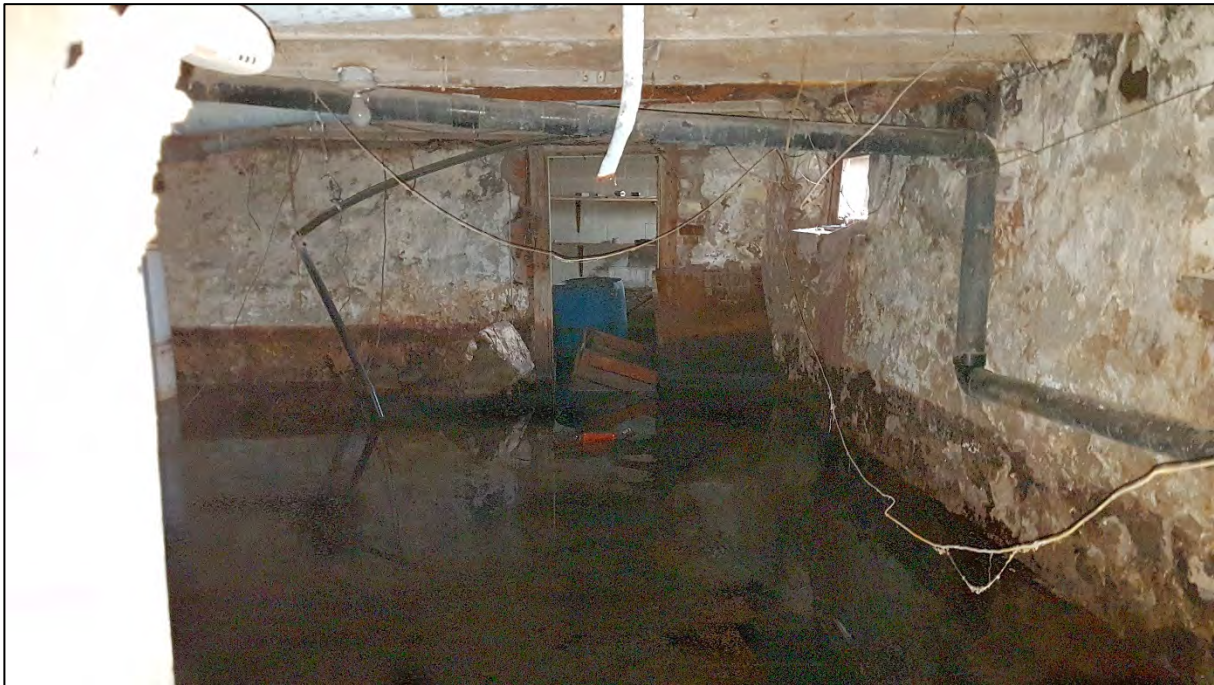
Figure 27: Basement (ASI 2020)

The condition of the house appears to be moderate, as some of the exterior brickwork is deteriorating from water damage. Internal investigations revealed that the basement is flooded.

The subject dwelling at 10980 Highway 50 in the City of Brampton features a basement, main floor, and upper floor. Given that the basement was flooded, it was not accessed during this assessment. A quick cursory assessment was made from the bottom step of the stairs, where it was possible to confirm that the foundations were stone, the windows were modern although in their original wooden frame, and the floor joists above were sawn (Figure 27).

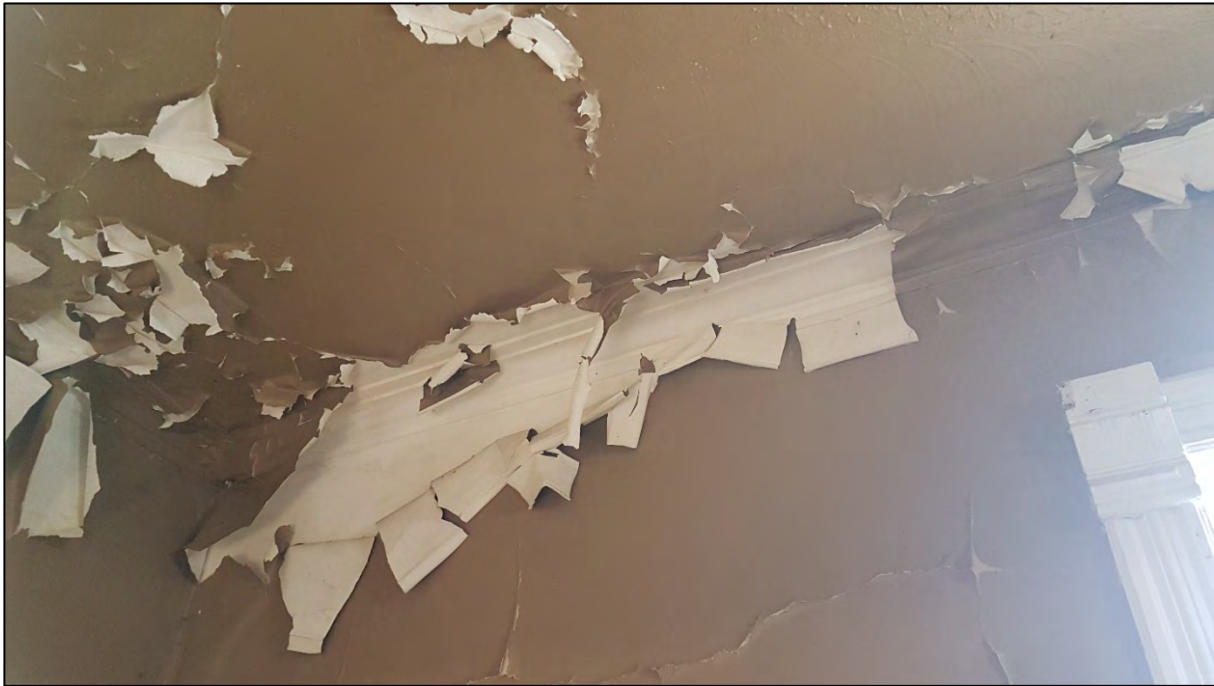
Figure 31: Crown moulding in the den (ASI 2020)

Decorative features found on the main floor include: the decorated plaster ceilings in the parlour and den (Figure 34); crown molding in the parlour and den (Figure 31); evidence of former crown molding in the upstairs bedrooms (Figure 53); elaborate, fluted molding around the doors and windows in the parlour, the side casing of both windows and doors capped by decorative capitals; and fluted molding around the doors; and windows with bullseye rosette corner blocks are located throughout the rest of the house in original part of the main floor and the second floor (Figure 54). There are some differences between window moldings, concerning the quality of the carpentry and variations in type of window sills/aprons, which suggest that some of the trim has likely been updated over time. The baseboards

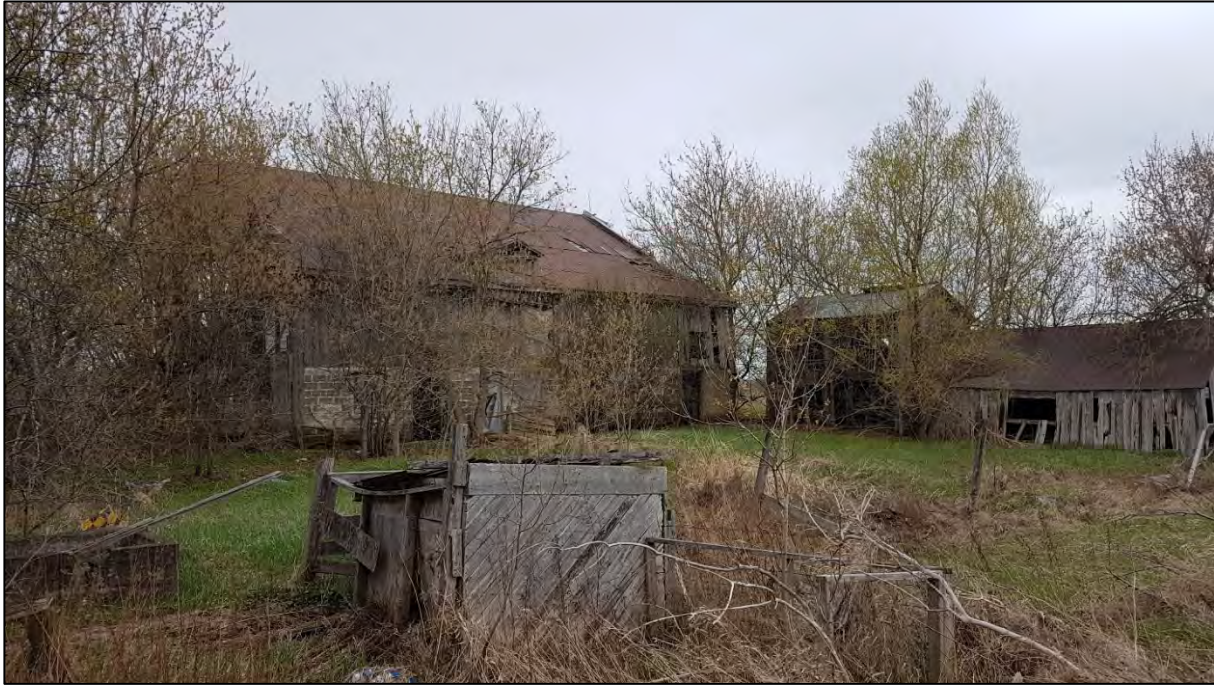
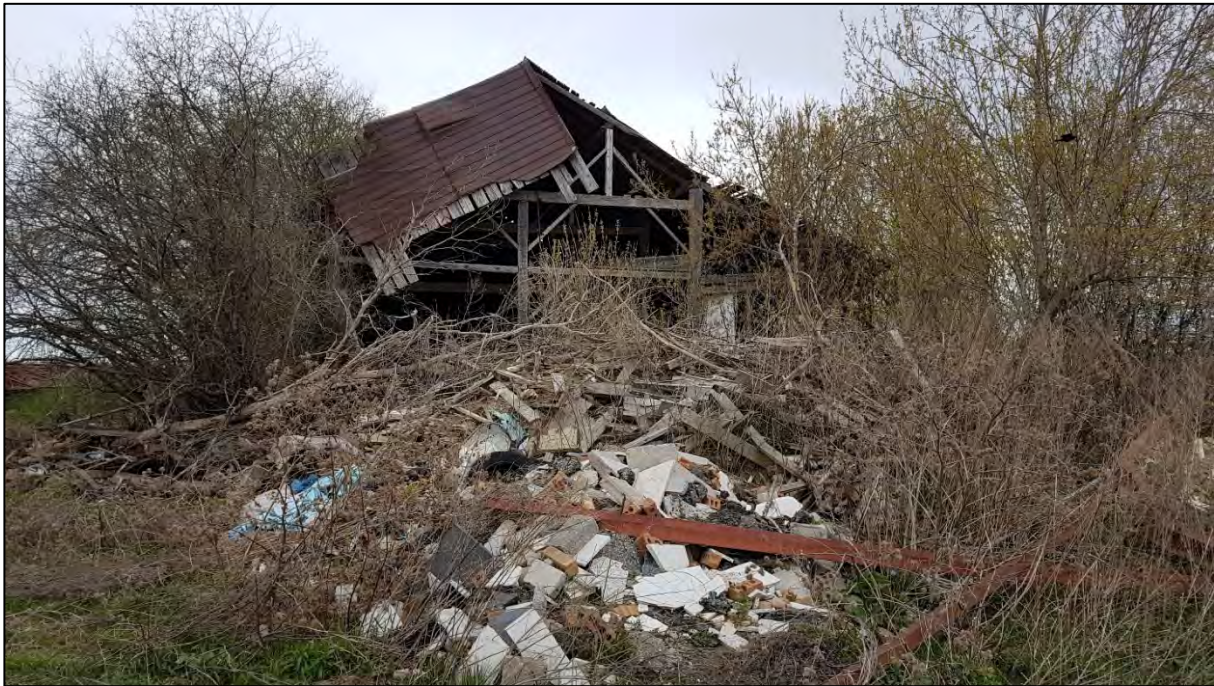
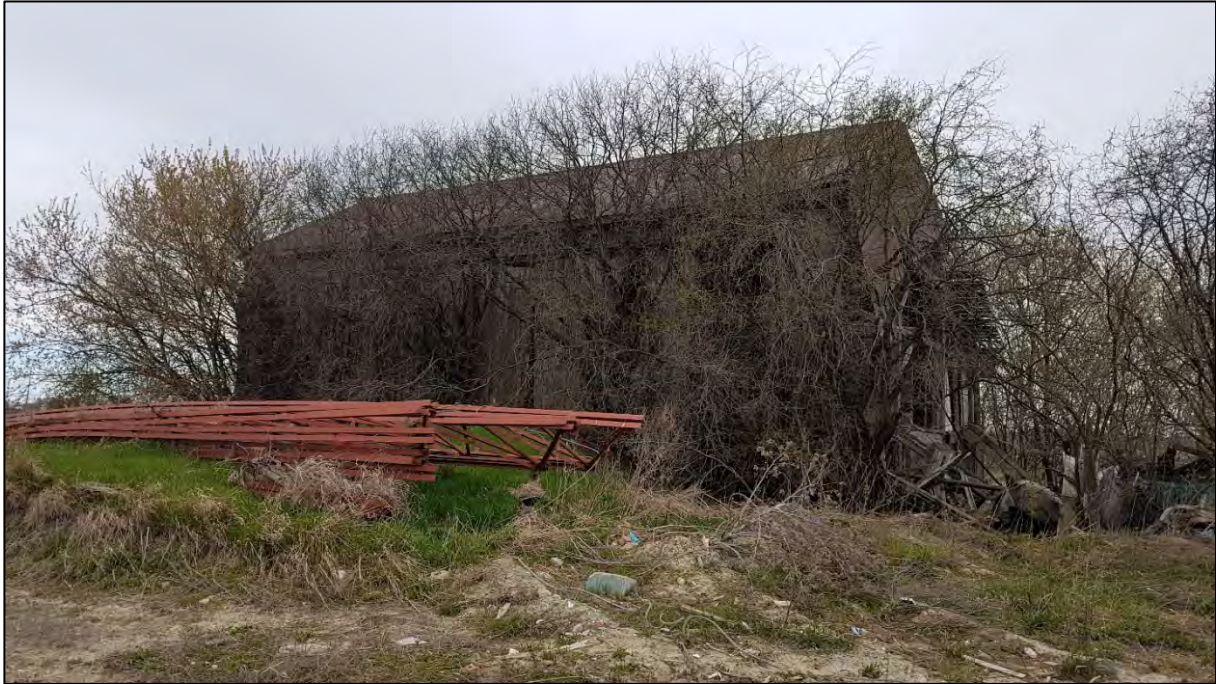
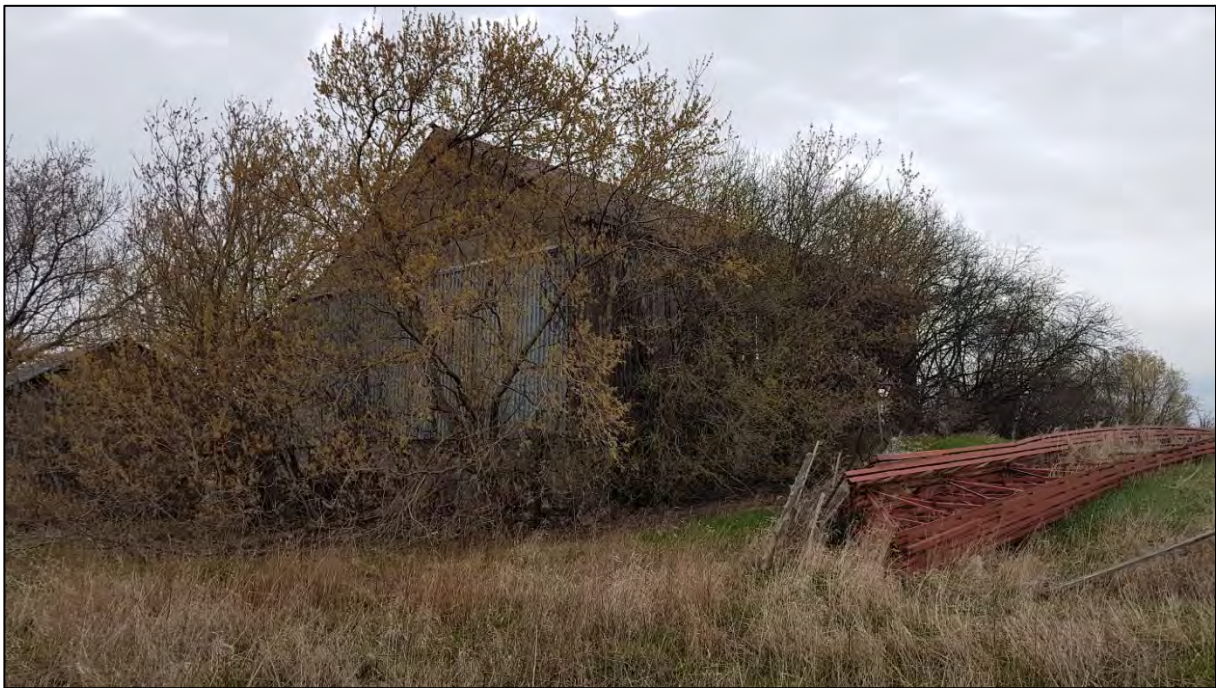
The barn (Figure 55 to Figure 68), located northwest of the farmhouse, is comprised of three different structural areas that appear to have been altered at different times as the farm has evolved over time. The southern portion of the barn was partially collapsed at the time of field review. This section does not rest on foundations and features hewn structural uprights, sills and beams with pin connected joints. While there are a number of hewn structural members that have empty mortises, this is more likely a result of the recent structural failure and collapse rather than an indication that this section of the barn was at one time reclaimed from another structure. A review of aerial mapping confirms that this section of the barn had a gable roof. The northern part of the barn features a rectangular footprint with gable roof, metal roofing material, and stone foundations on the north, west, and part of the south elevation. A view of the barn interior from the collapsed section to the south confirmed that the northern part of the barn also features hewn structural elements with pin connected joints. A lean-to addition has been made to the east elevation and the east elevation is composed of concrete blocks and poured concrete. Given that the stone foundations on the north elevation were noted to support both the northern portion and the eastern elevation of the barn, these structures were likely constructed at the same time, and the concrete found on the east elevation is probably the result of twentieth-century modifications or repairs. A single, gabled dormer is located on the east elevation. Most windows on the barn were blocked with plywood, while the doors were not secured.

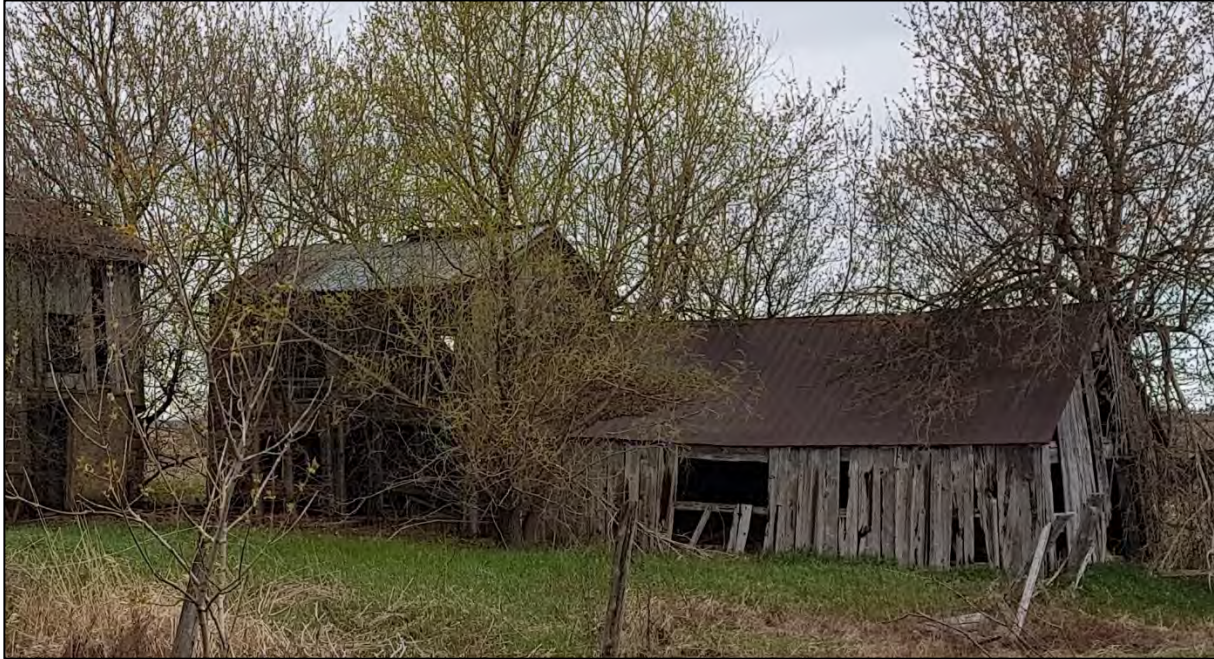
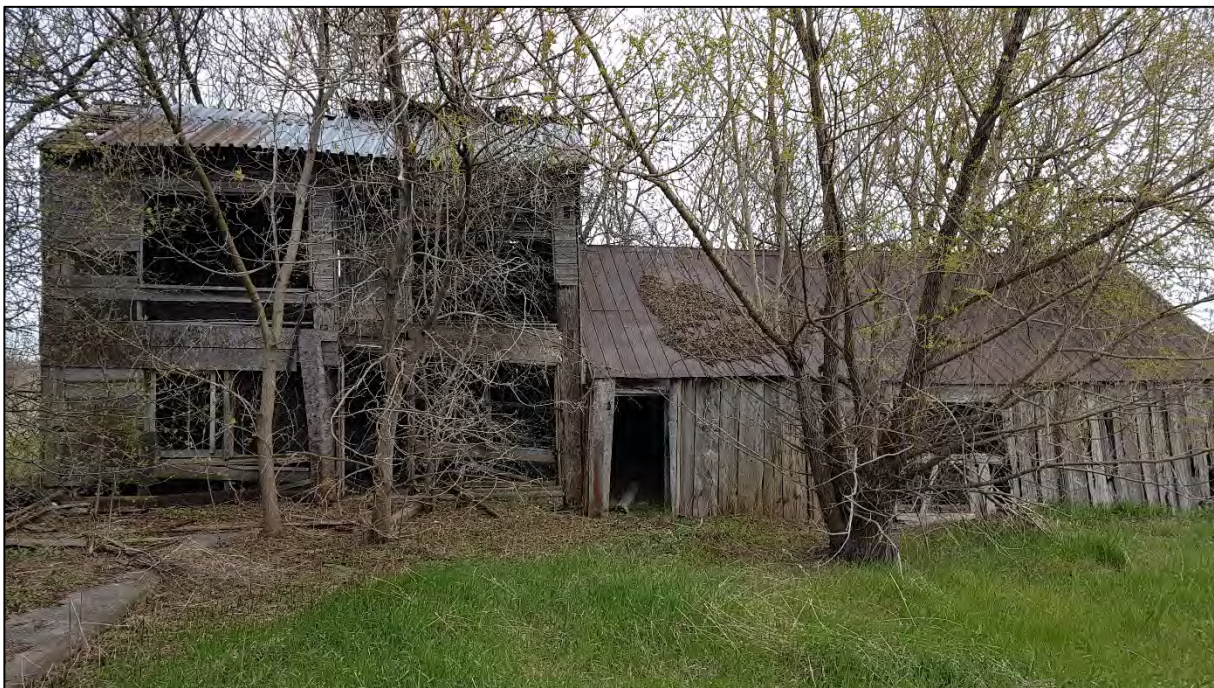
Figure 69: Henhouse and Driveshed (ASI 2020)

The two-storey frame structure known as the henhouse is located northeast of the barn (Figure 69 and Figure 70). The dilapidated structure features frame construction with wood siding, poured concrete foundations, gable roof with metal roofing material, and wire netting over the large window openings on both levels of the south elevation. No openings were identified on the north or west elevations.

Historical accounts of the property indicate there used to be three large henhouses on the property (Stewart [...]: 144-146). Attached to the east elevation of the henhouse is a one storey driveshed. This frame structure features a gable roof with metal roofing material, wide vertical board siding, and door openings on the south and east elevations.

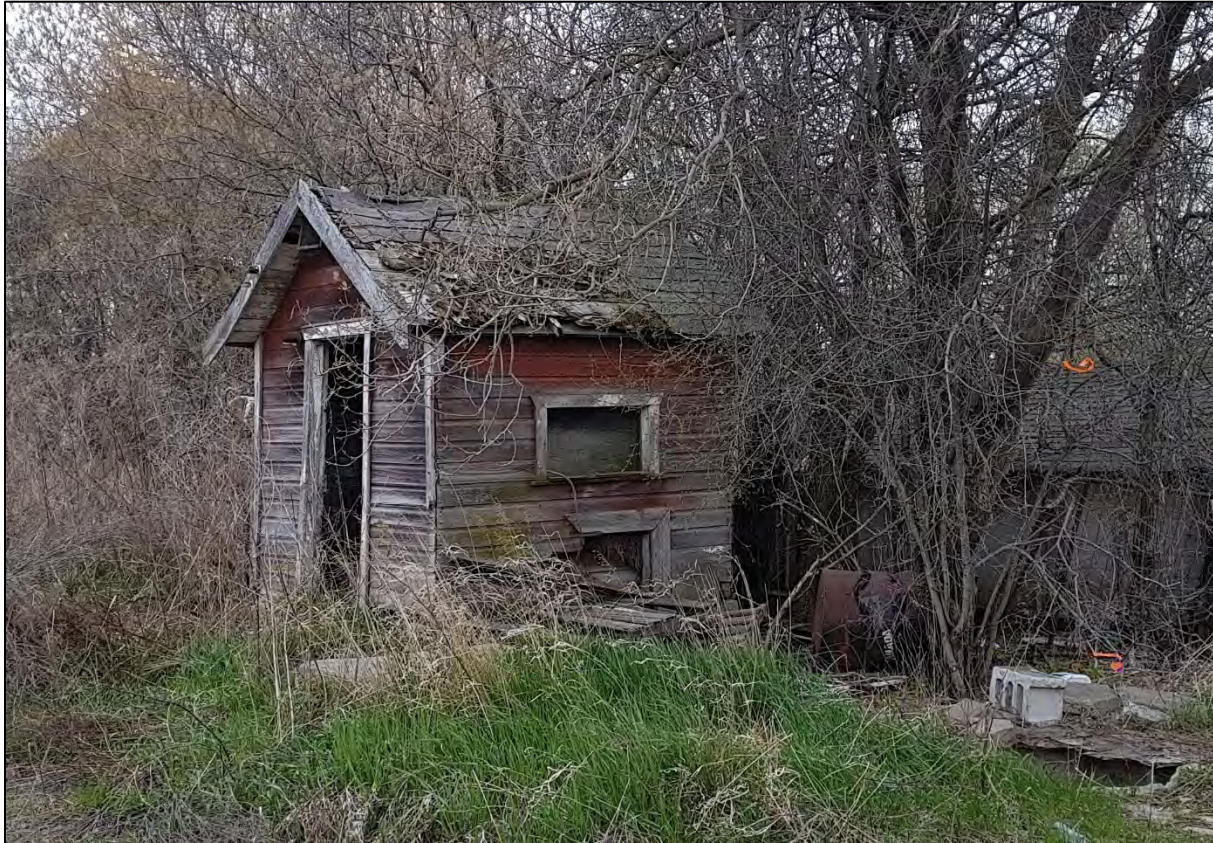
Figure 71: Milkhouse (ASI 2020)

A small, gable roofed frame milk house (Figure 71), named as such according to archival descriptions of the property, is located southeast of the barn, in the area between the farmhouse and the barn, on the north side of the driveway. Historic photographs reveal that this structure was present in the early twentieth century (see Figure 10). Eight-gallon cans of milk were carried by wheelbarrow to the milk house every morning, where they were lowered into a deep vat filled with cold water for storage. When the milk truck came, they were moved out on to the concrete pad or 'milk stand' to the east of the milk house (Stewart [...]: 142).

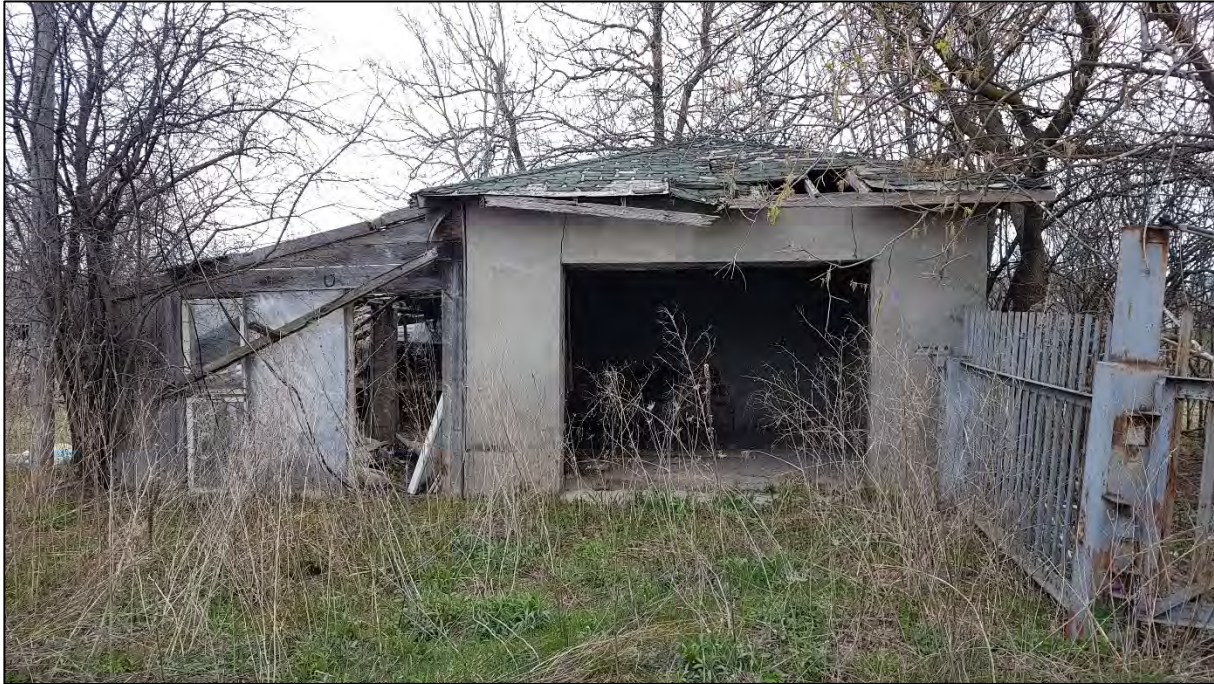
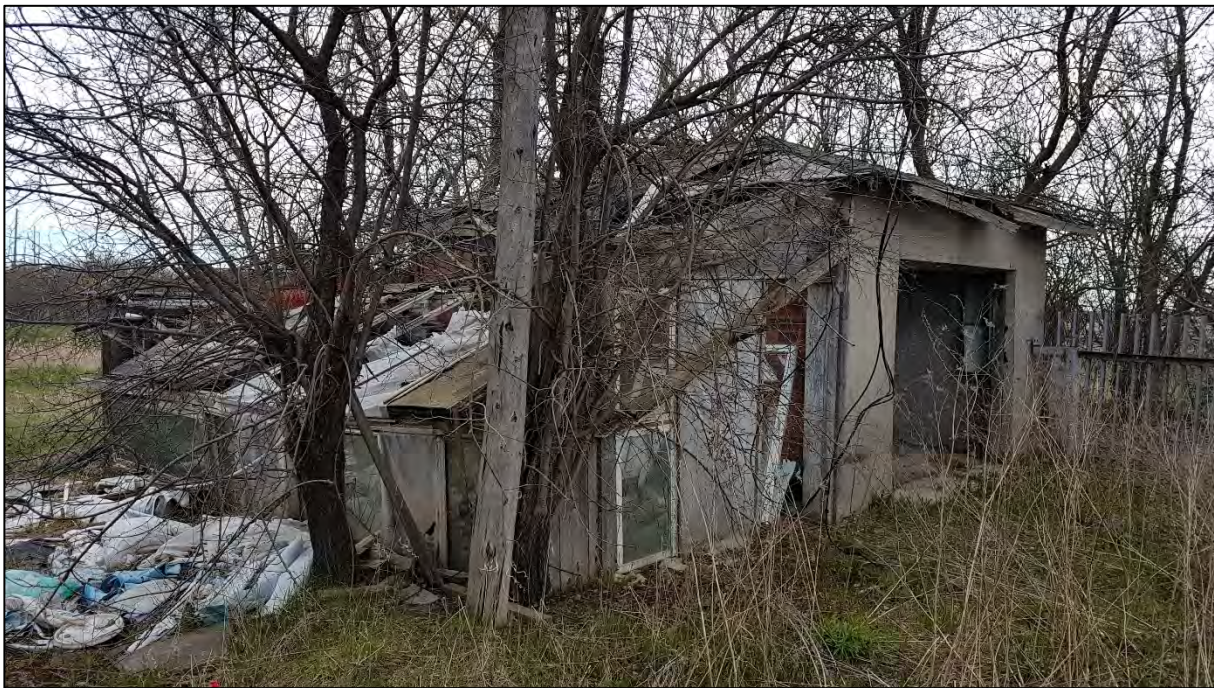
Figure 72: Detached garage (ASI 2020)

A detached garage built to house a single car (Figure 72 and Figure 73), is located just east of the farmhouse, on the north side of the driveway. The brick structure features a hipped roof, stucco siding which was likely a modern modification, and a dilapidated greenhouse attached to the west elevation of the garage. The garage likely dates to the early twentieth century.

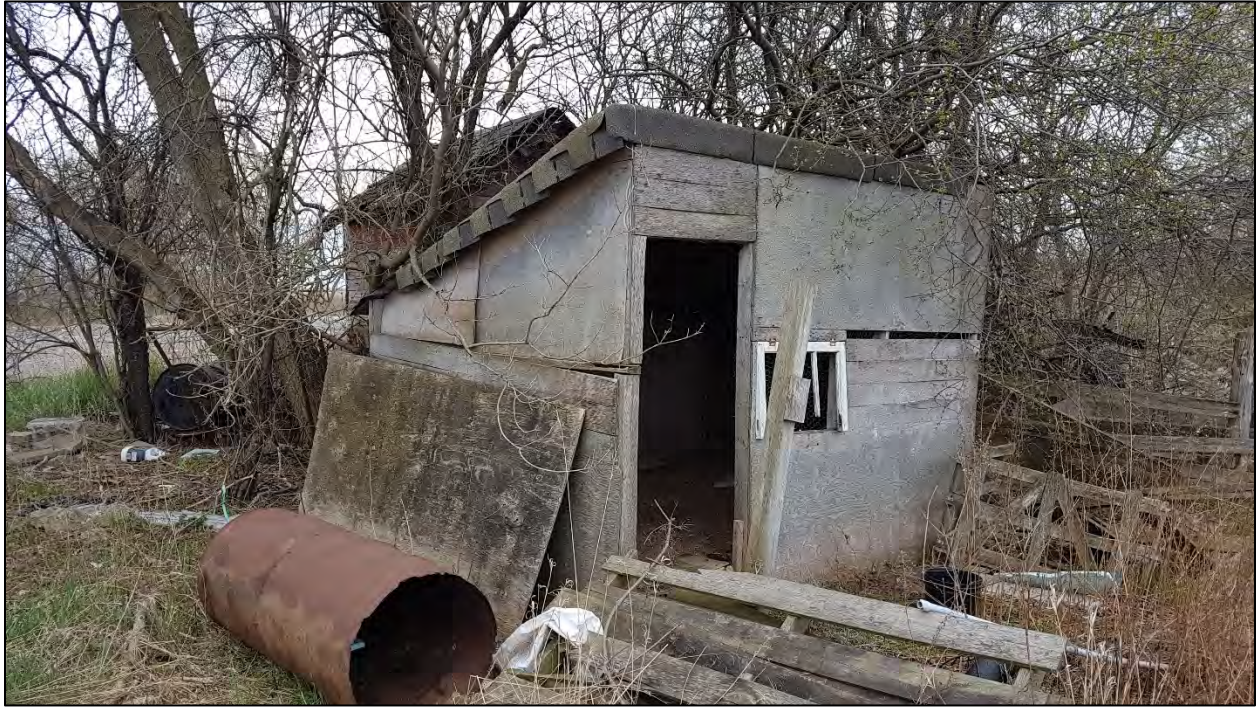
Figure 74: Frame shelter (ASI 2020)

Located towards the southwest corner of the study area is a dilapidated, frame shelter with a salt-box roof (Figure 74). The shelter is located south of the barn, on the edge of the fields which extend to the west and south of the main farm complex.

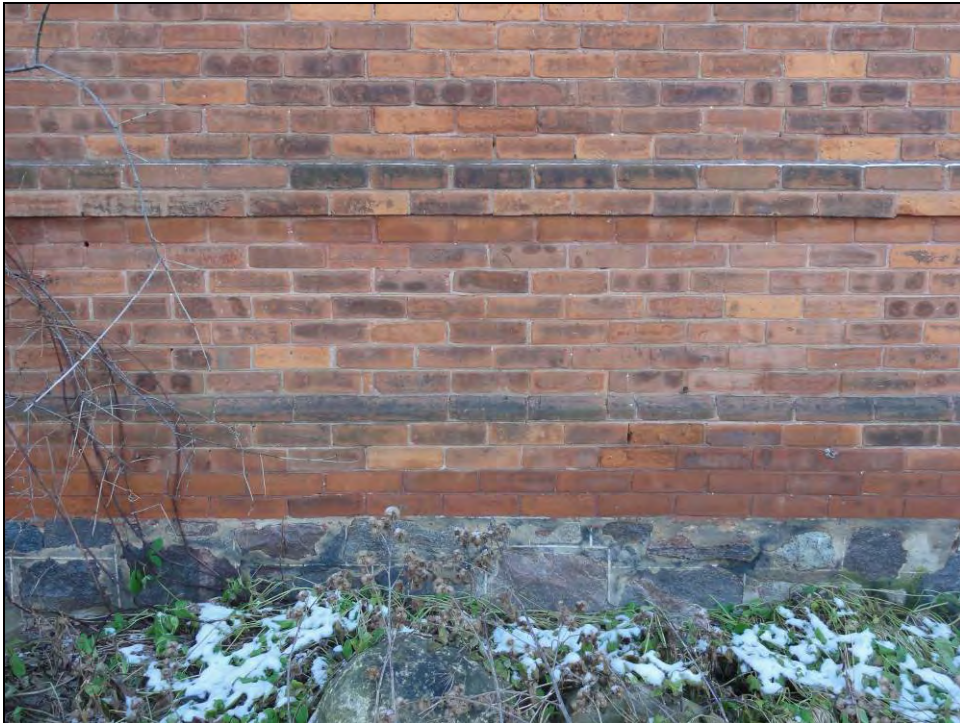
Plate 7: Detail of stone foundations, bands of projecting brick, and brick drip course above the foundations.

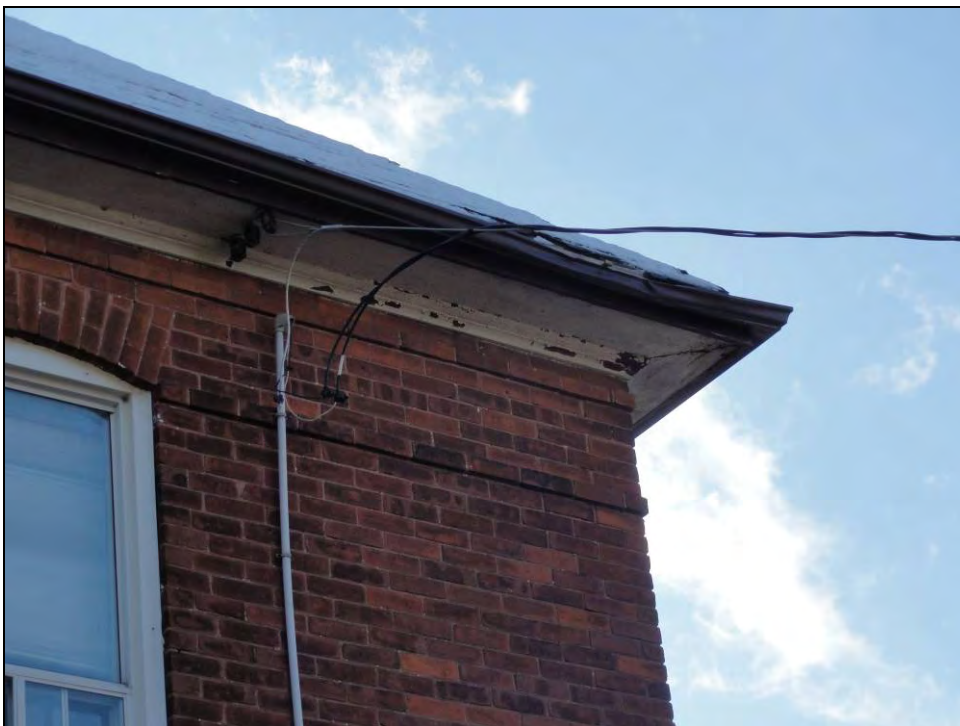
Plate 8: Detail of the brickwork, minimal roof overhang, and wooden soffit.

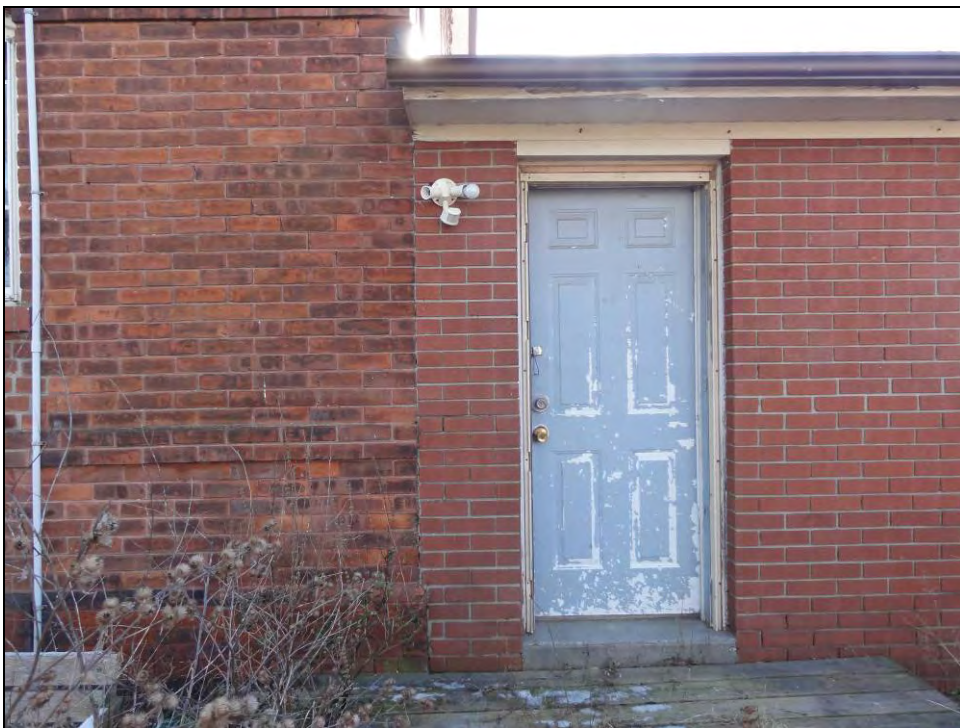
Plate 12: View of side entrance located on north elevation of the modern accretion. Note the change in brickwork between front and back sections of the house.

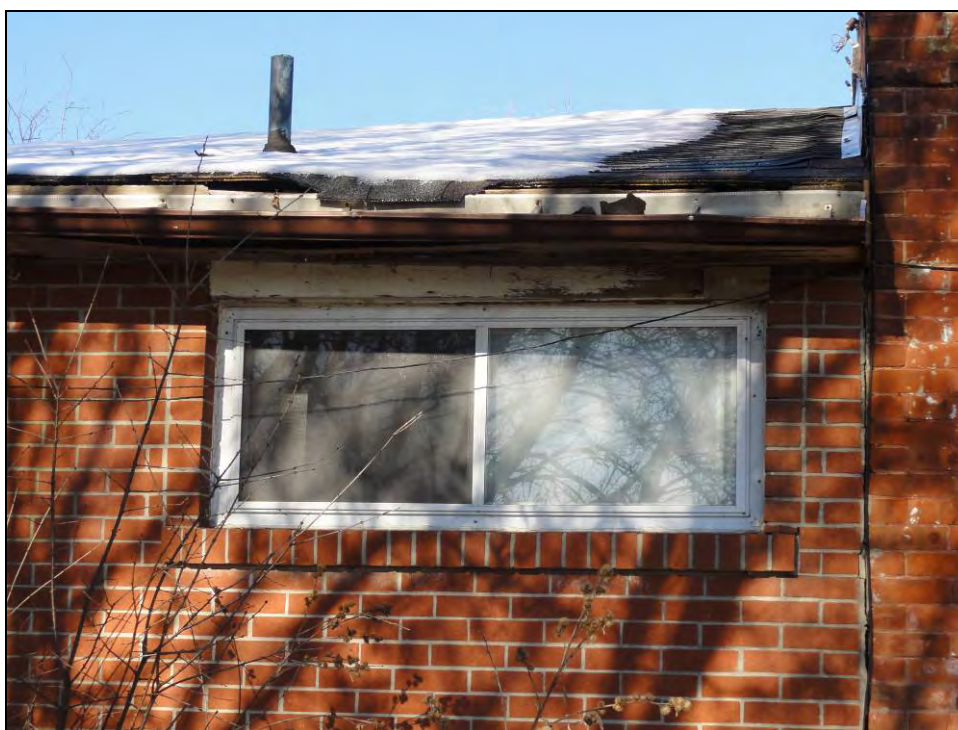
Plate 16: View of modern, side-sliding sash window in c.1960s rear accretion. Note the change in brickwork between front and back sections of the house.

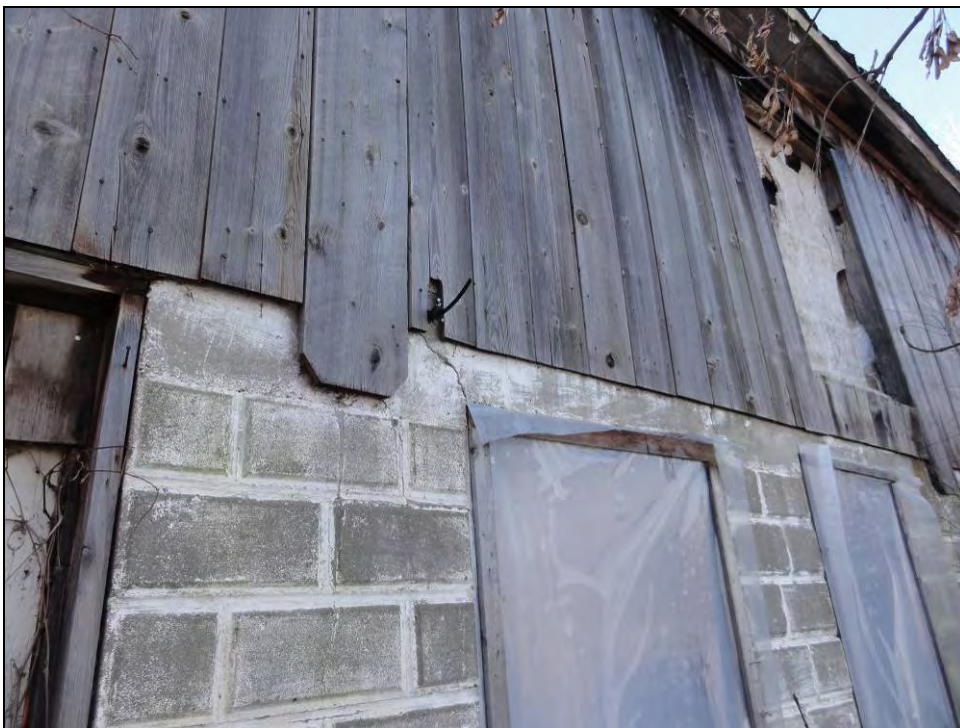
Plate 56:
Concrete block
foundations on
east elevation.

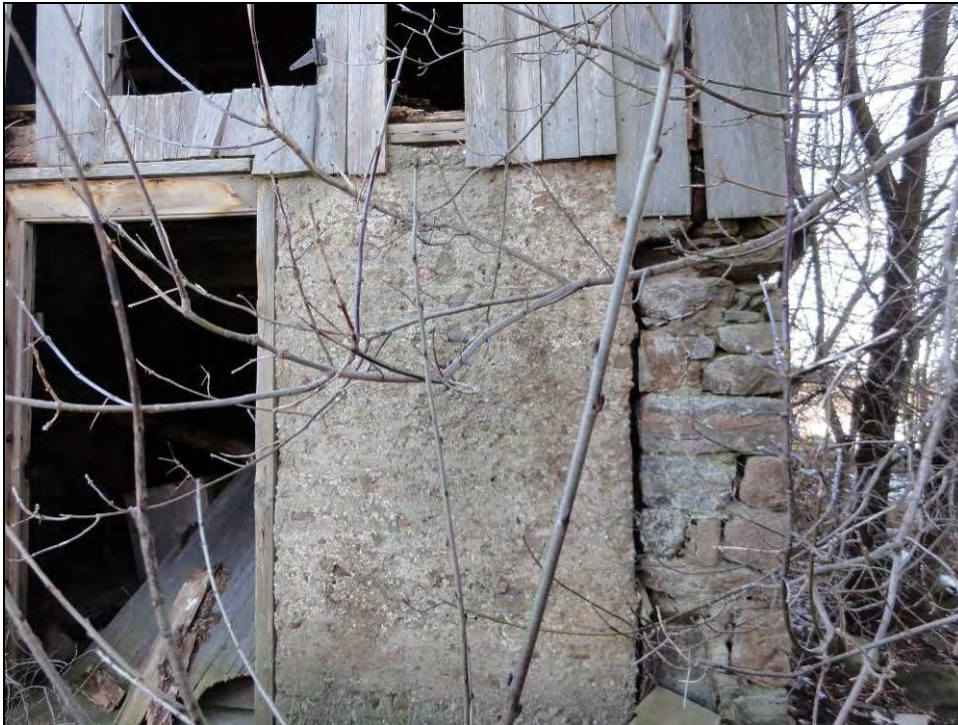
Plate 57: East elevation of barn, north corner, showing stone and poured concrete foundations.

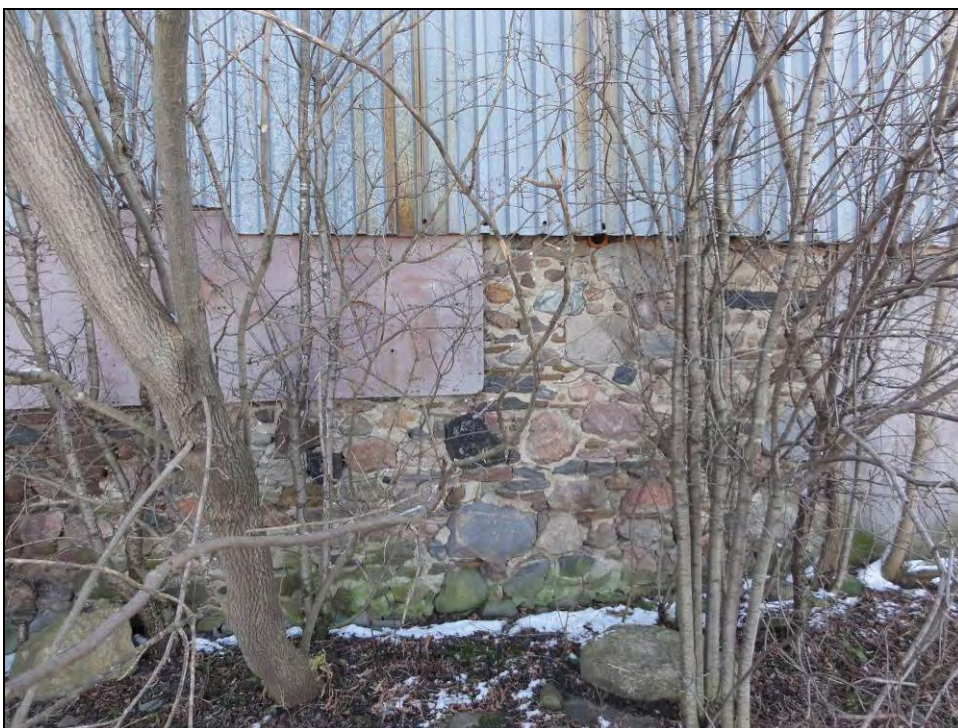
Plate 58: Detail of stone foundations on the north elevation, and blocked up windows.

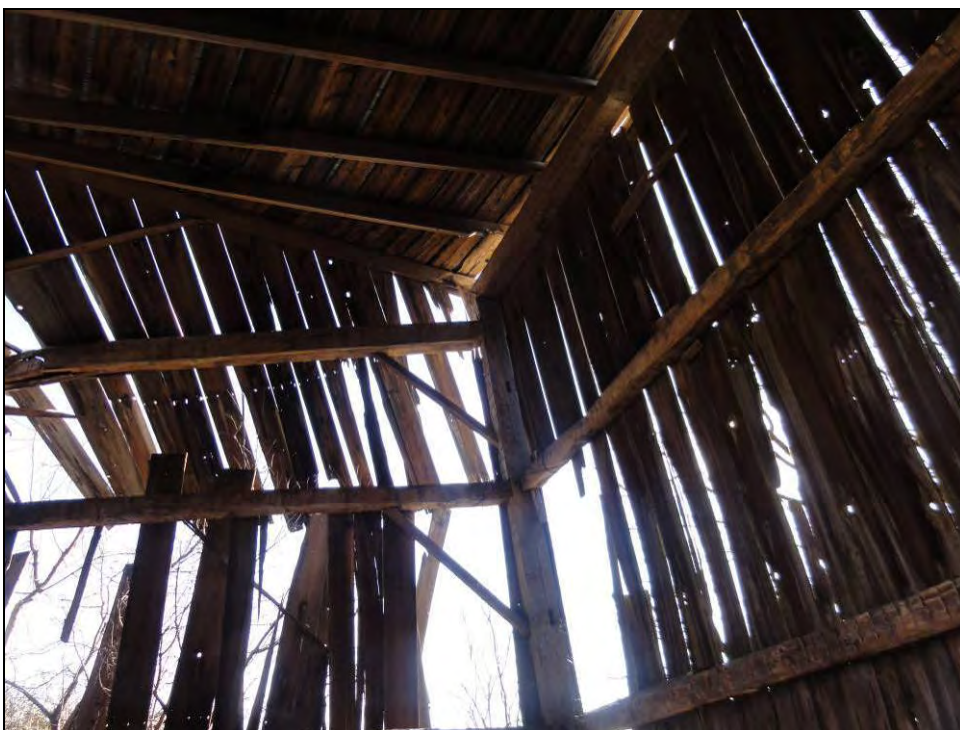
Plate 60: View of southwest corner of collapsed portion of barn.

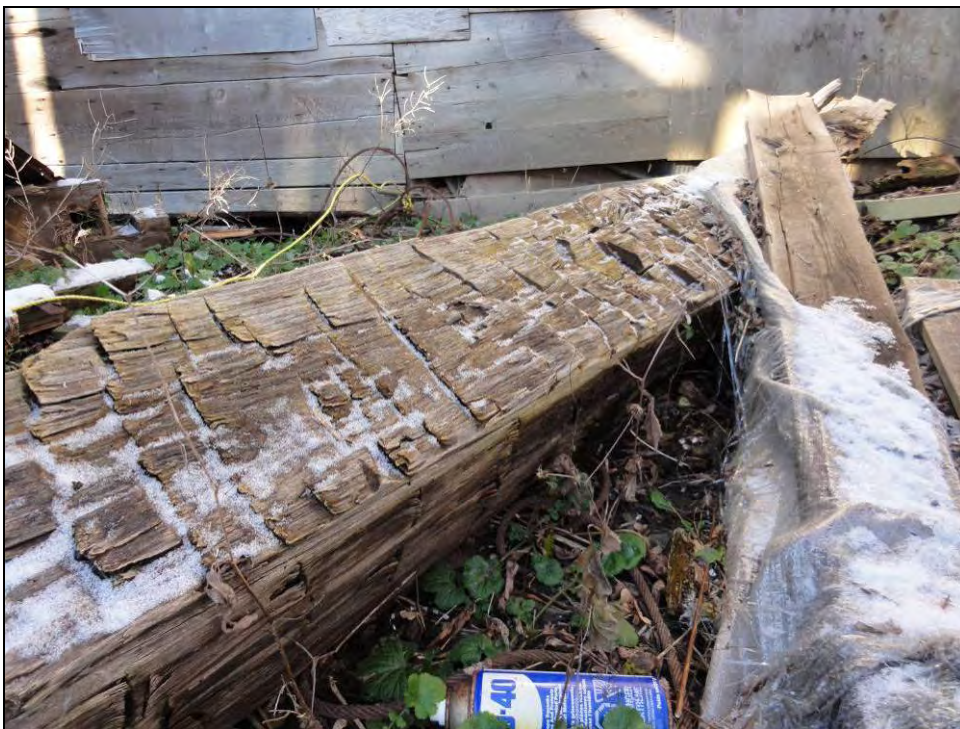
Plate 63: Detail
of hewn
structural beams
that have
collapsed.
