1030 Queen Street West, Brampton, Ontario

## Former Springbrook Valley School

Issued: December 2020

# HERITAGE IMPACT ASSESSMENT

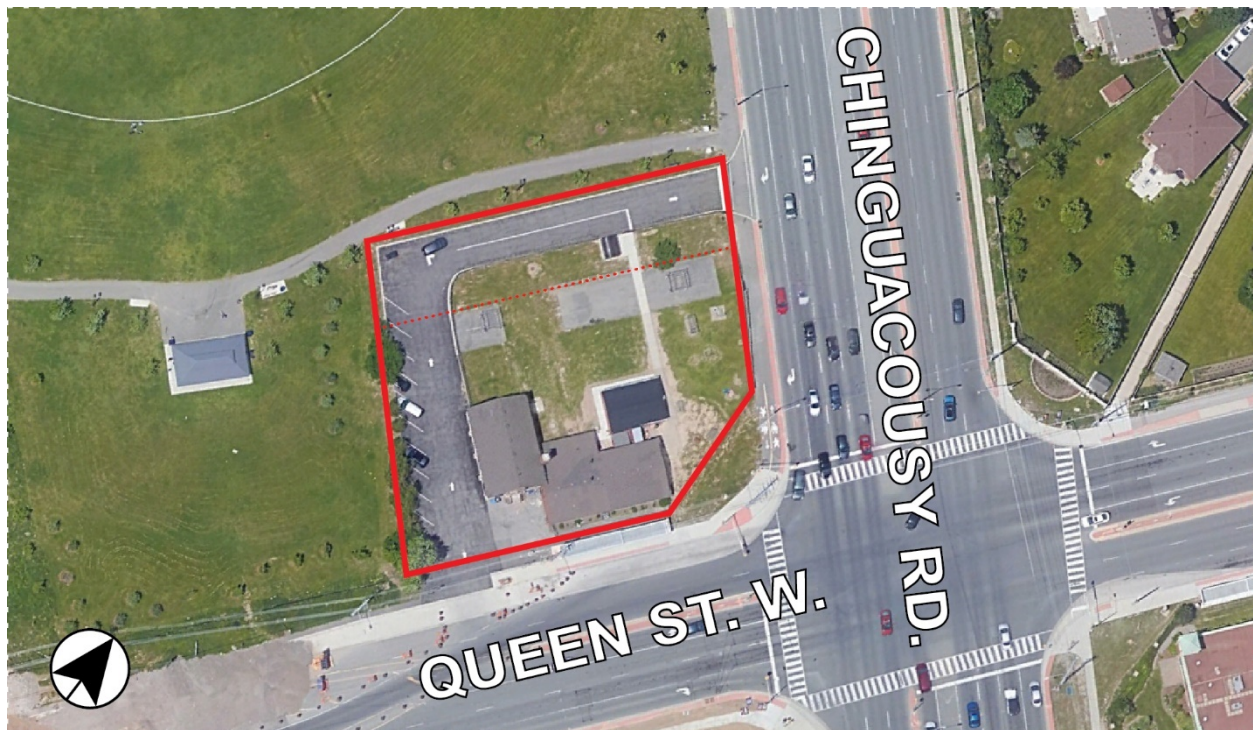
Figure 3: Aerial photograph showing the approximate extents of the subject property in red (Google 2020).

The rectangular site has a chamfered southeast corner, and contains three interconnected buildings based near the property's southern limit (Figure 3). The original 1874 Schoolhouse has a set of 1-storey brick additions extending east from its southeast corner, north of which is a second 1-storey frame addition. These are referred to as 'Schoolhouse', '50s additions', and 'portable' respectively throughout the remainder of this HIA. Behind these structures is a grassed outdoor area with several asphalt pads, a concrete walkway and covered bus shelter (Figure 4). The outdoor area contains a small but mature tree, and retains a number of benches, picnic tables, and trellis shelters. A chain link fence separates this area from the asphalt parking lot and driveway running along with the west and north edges of the site respectively.

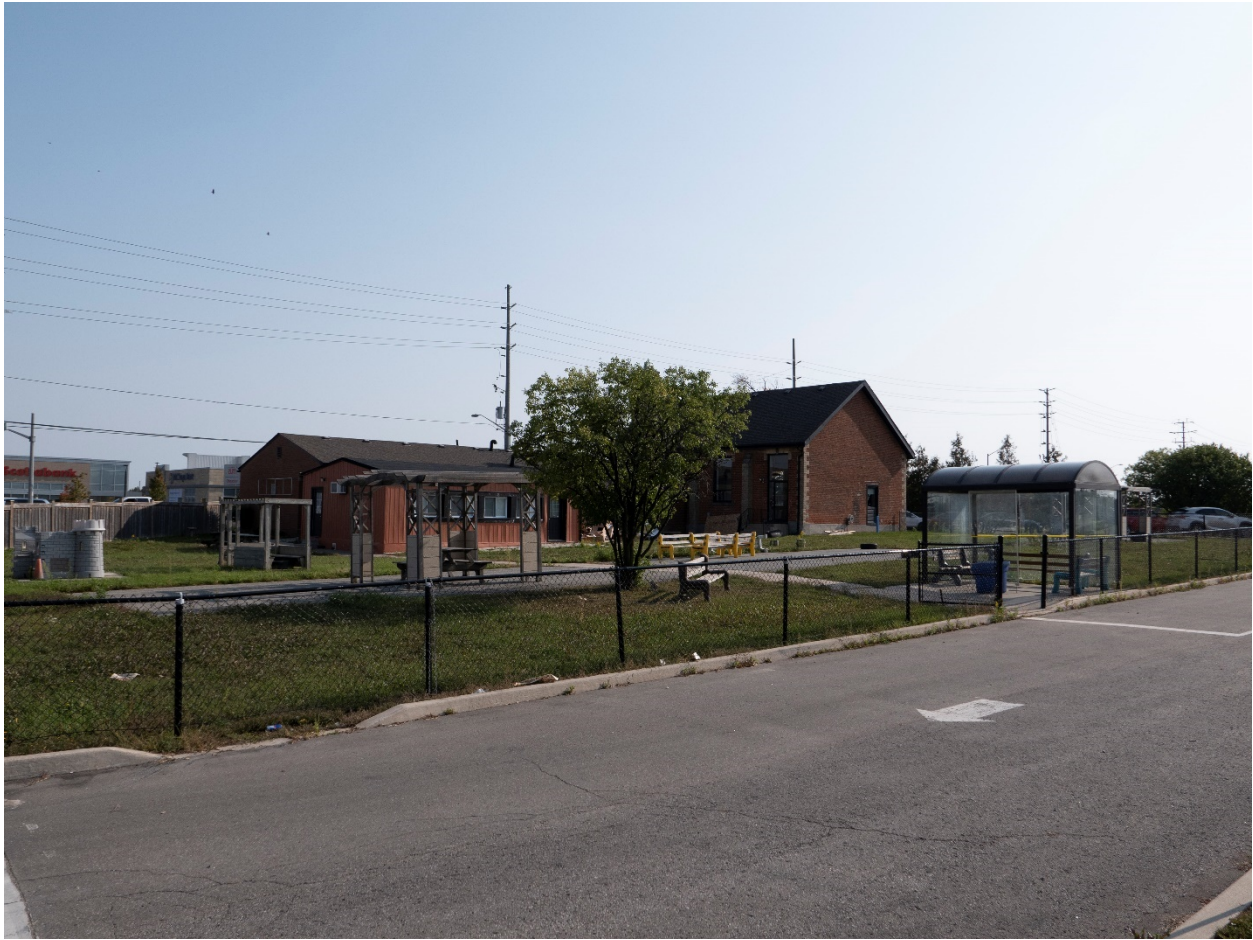
Figure 4: View to the rear of the school buildings, showing the grassed outdoor area.

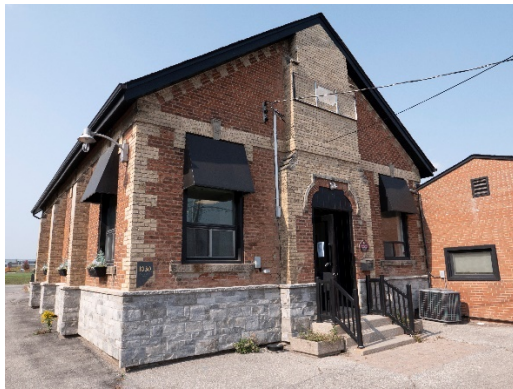
Figure 5: The main elevation of the 1874 Schoolhouse.

The Schoolhouse is a tall, 1-storey brick building rising to a side gable roof and facing south onto Queen St. W (Figure 5). The principal (south) elevation has a 3-bay design, with a central doorway flanked by windows. The doorway is set within a projecting frontispiece that once rose to support a belfry above the gable peak. The west elevation is four bays, each with a window and separated by three buttresses (Figure 6). The east elevation originally had a similar configuration, but its southern two bays have been obscured by the 1950s additions (Figure 7). Its north bay has also been converted from a window to a door. The north elevation was originally a blank wall, but had a door opening punched through the brick at some point (which now serves only as a window) (Figure 8).

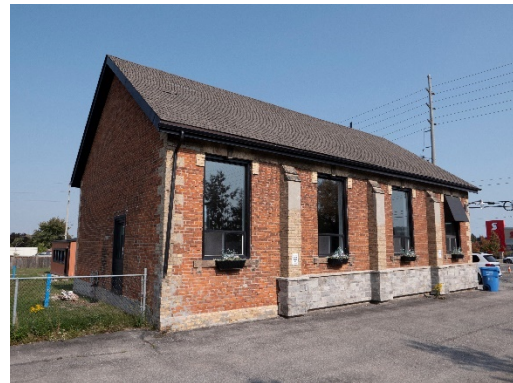
Figure 6: The west elevation of the 1874 Schoolhouse building, with the original brickwork visible on the closest bay where the veneer wall has been removed.

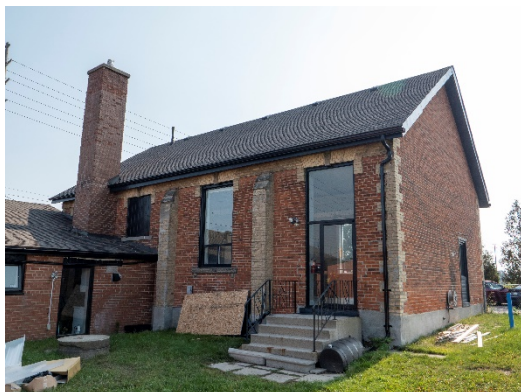
Figure 7: The east elevation of the 1874 Schoolhouse building, showing one original and three modified window openings.

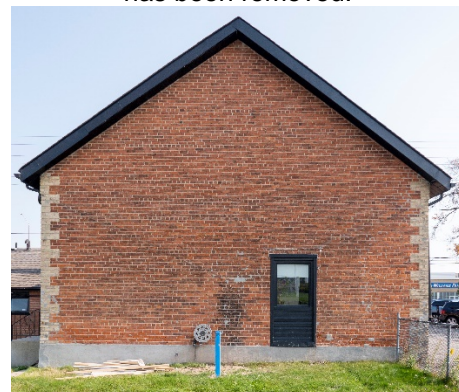
Figure 8: The north elevation of the 1874 Schoolhouse building, showing unoriginal door opening and some scarring to the left.

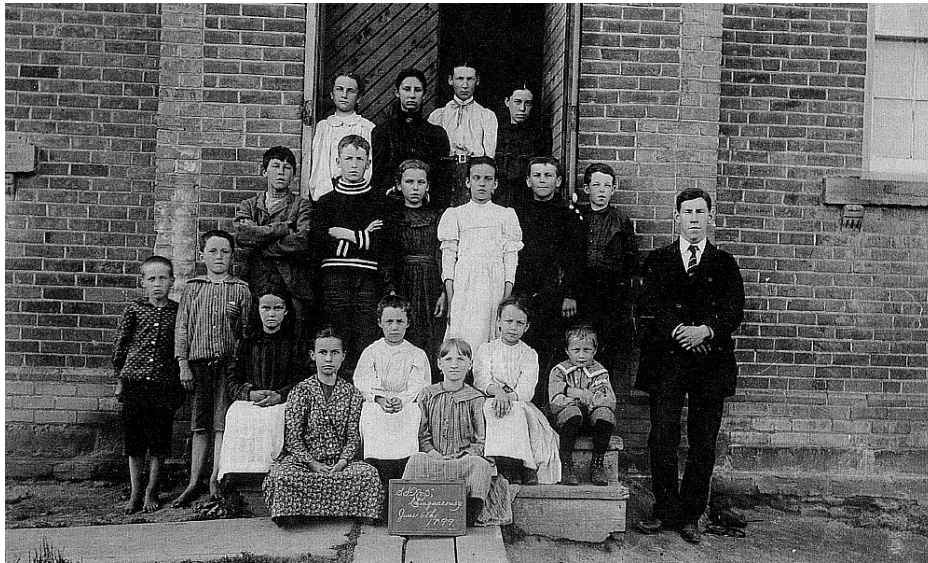
Figure 9: Archival class photo from 1899. The original sandstone and brick foundation condition is visible on both sides of the students. Historic door surfaces are also seen at rear ([www.ontariohistory.org](http://www.ontariohistory.org)).

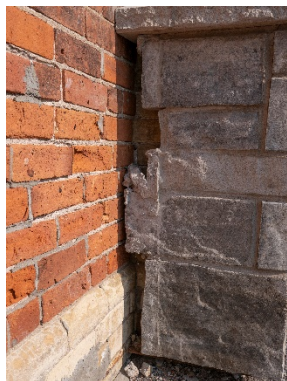
Much of this foundation condition is obscured by parging on the north and east elevations, and a false stone foundation wall at the base of the south and west elevations. This veneer wall was added in the late 1990s or 2000s, is historically inaccurate, and may be contributing to the premature deterioration of historic masonry behind (Figure 10).

Figure 10: Historic brickwork is visible in behind the veneer stones, and the previously covered brickwork to the left shows spalling and mortar loss.

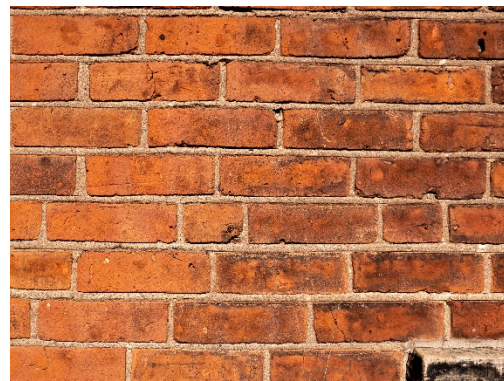
Figure 11: A section of intact mortar. Some degree of horizontal tooling is evident by lines demarcating horizontal and vertical joints.

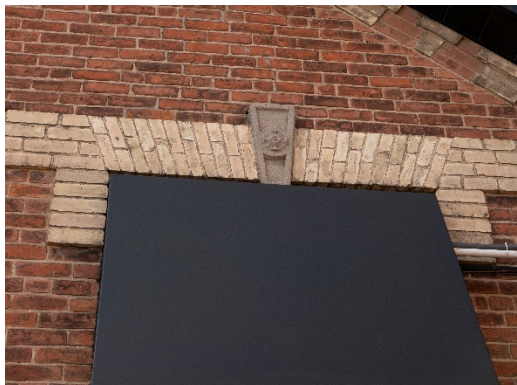
Figure 12: Typical eared jack arch as seen on the south elevation, aligned with the projecting band course and embellished with a cast keystone.

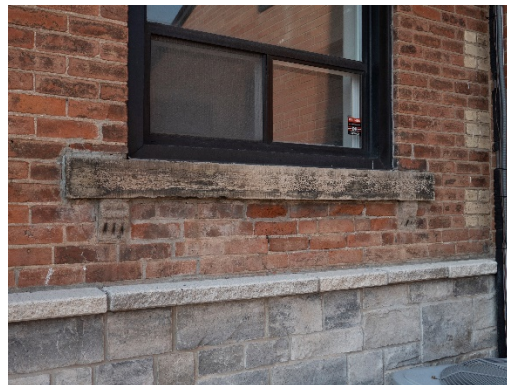
Figure 13: Typical window sill seen on the south elevation, with tooled sandstone sill above two cast masonry brackets. The high deterioration of the brackets is common to the entire structure.

Window openings are rectangular, topped by buff jack arches with ears and further embellished by cast keystones (Figure 12). Original openings have sandstone sills with bush-hammered faces and tooled margins, below which are pairs of cast brackets (Figure 13). Additional sandstone elements include capstones on the buttresses, transition stones on the belfry frontispiece and hood mould above the main entrance (Figure 14). These units feature similar tooling patterns to the sills. Current windows are ahistorical replacements with one large light over two smaller operable lights. Some feature fixed black awnings. Archival photographs show the historic (and likely original) window arrangements: a pair of fixed, 4-light frames are set above similarly sized and operable 4-over-4 sash windows below (Figure 15). Screens seen in a 1945 photograph are the likely source of rust staining on some sills.<sup>17</sup>

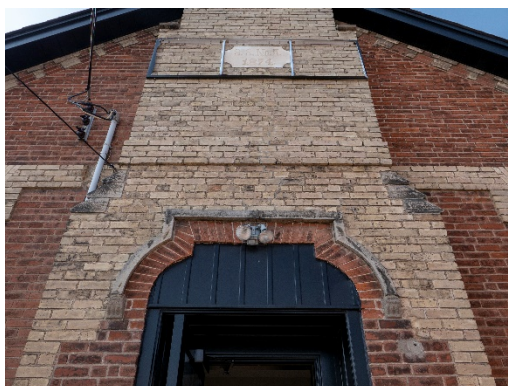
Figure 14: The projecting entry frontispiece, showing sandstone transition stones and hood mould. Despite its elaborate shape, the hood mould is built from three pieces of stone.

The front door is set at the bottom of the projecting frontispiece and set within a shouldered arch opening distinguished by its arch brickwork and sandstone hood mould, which terminates with the same cast brackets found under the window sills. The current door is contemporary metal panel-style with a large light on top.

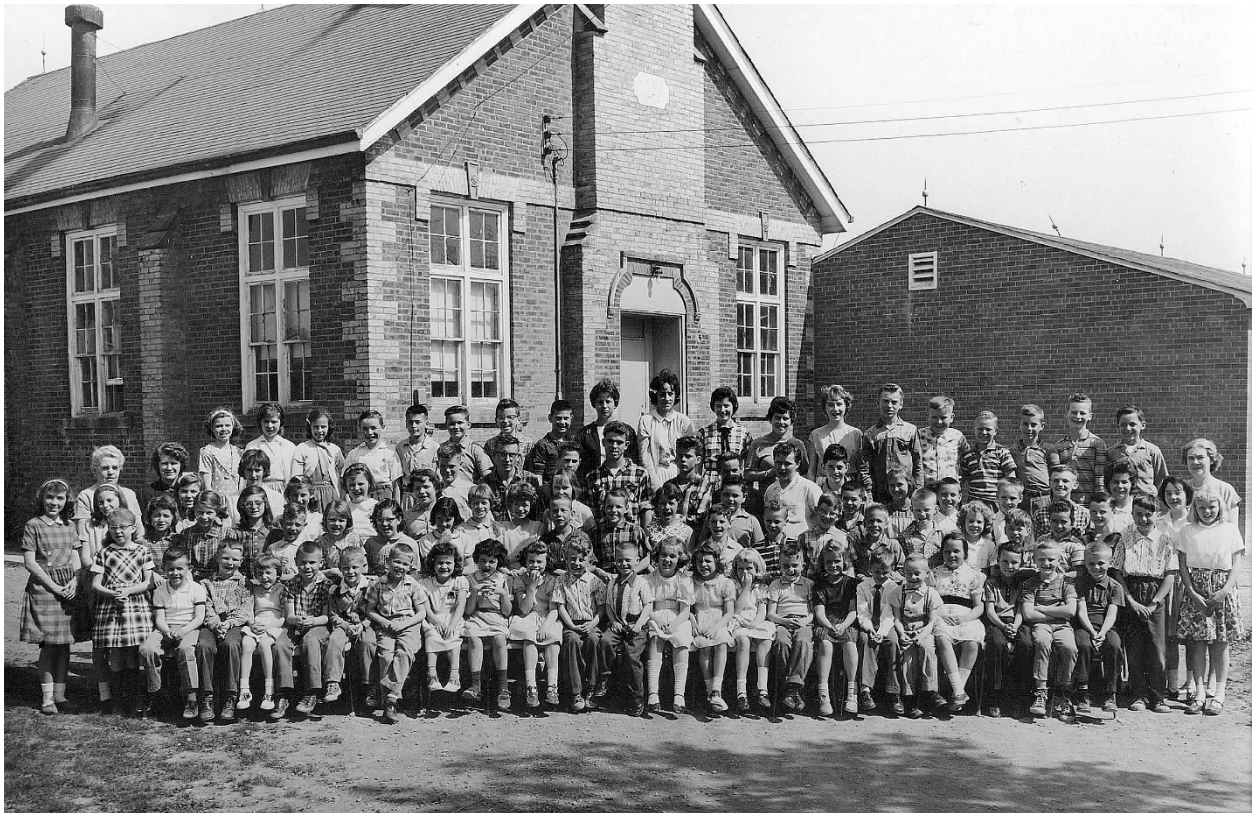
Figure 15: 1962 class photo showing the historic window configuration in background. Note also the stove pipe ([www.ontariohistory.org](http://www.ontariohistory.org)).

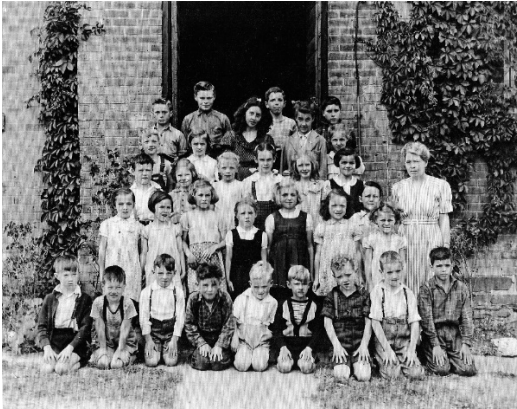
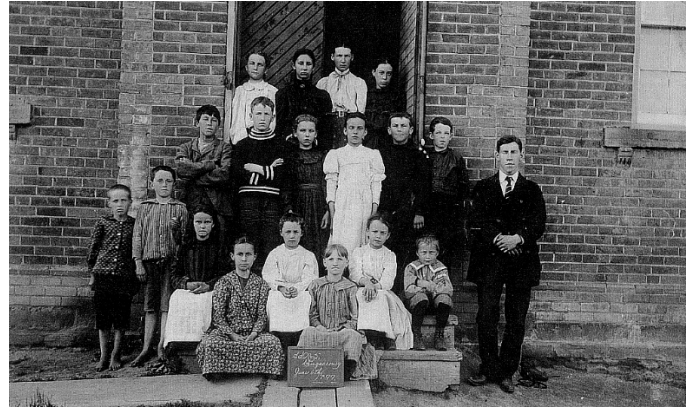
Archival images show an earlier configuration (seen as late as 1899 and altered by 1962) of double plank-and-board doors (Figure 16; see also Figure 17). The exterior boards were set at a 45° angle, and affixed to a backing of horizontal boards.

Figure 16 & Figure 17: 1946 photograph showing the assembly method of the historic doors.

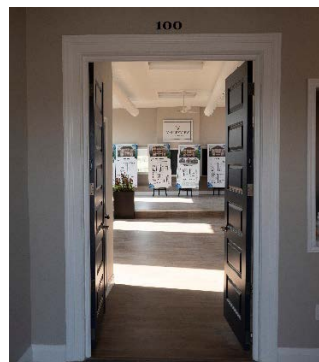
Figure 19: Mouldings on the doorway leading to the main classroom.  
Note unoriginal baseboards and new frame built within the original to support current doors.

Entering the Schoolhouse from the principal door, historic doorways lead to an office at the west, and the main schoolroom directly north (Figure 18; Figure 19). East is a corridor representing the connection between the Schoolhouse and 1950s additions via a staircase. Much of the historic structure has been removed at this point of intersection between the two structures. A staff room / kitchen contains the exposed bottom portion of the chimney, along with a cast iron Drummond and Reeve door for cleaning out the furnace flue (Figure 20).

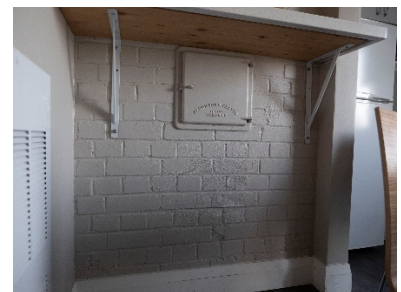
Figure 20: The base of the large 1950s chimney remains visible within the staff room.

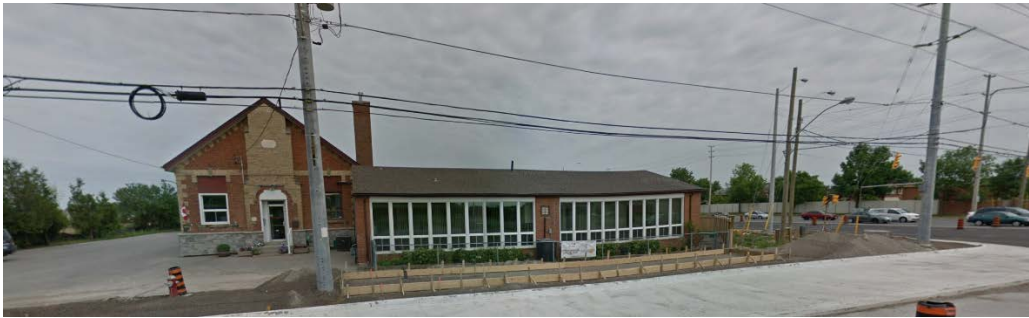
A 1-storey set of continuous shallow-gabled additions intersect the southeast corner of the Schoolhouse and extend east roughly 20 metres. A corridor runs the length of the additions, with washrooms and a staff room to the north, and two classroom spaces on the south. The red brick structure is simple, featuring two long banks of windows along the south elevation, and a separate offset glazed entry recessed into the east elevation (Figure 21). The brickwork is laid in common bond with header rows every six courses.

Figure 21: 2012 Google image showing the 1950s additions prior to construction of transit shelter obscuring the current view. Differences in roof sag are seen between the two sections, along with a zipper joining suggesting different times of construction (Google 2012).

Terraprobe's Phase One EA for the site notes this structure was built in two parts during the 1950s.<sup>18</sup> This claim is supported by aerial imagery from 1968 clearly showing two different colours of roof cladding for the structure, and an obvious line in the brick joints between the two window banks (Figure 22). Aerial imagery from 1954 is less clear, but appears to show the original Schoolhouse without any additions present.

- a. 1950s, 1-storey south-east addition (Figure 21), &
- b. North of the 1950s additions - a short, 1-storey structure identified as a 'frame addition' on the undated R-Plan (Figure 23).

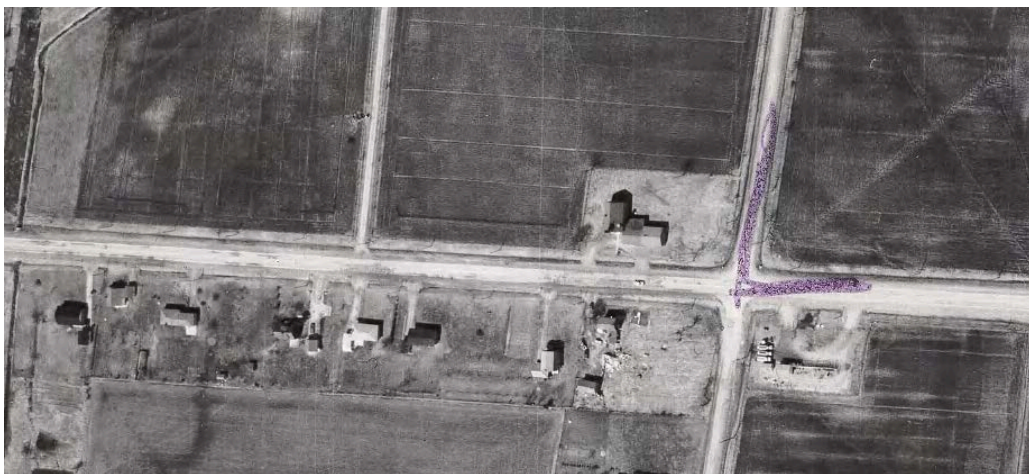
Figure 22: 1968 aerial photograph showing the school property on the north side of Queen St. W. The additions show two different colors of roof material.  
(City of Toronto Archives: Series 12, File 1968, Item 2088).

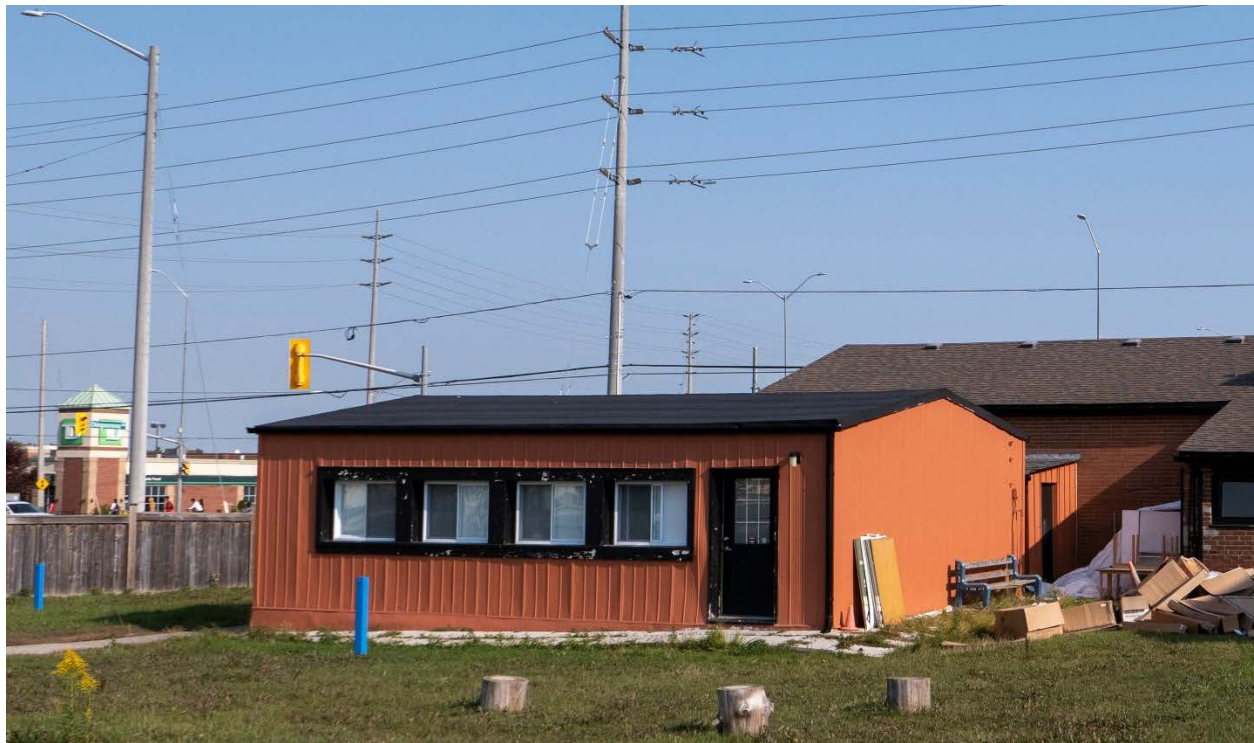
North of the 1950s additions is a short, 1-storey structure identified as a 'frame addition' on the undated R-Plan. It has a very shallow gable roof, and is clad with vertical ochre metal siding (Figure 23). There are four windows and a door on the north elevation, a door on the east elevation, and an enclosed connection south the 1950s additions. Terraprobe's Phase One EA suggests a brick addition in this same location was built in the 1980s and rebuilt in 2007. This HIA has not confirmed this timeline.

Figure 23: View of the ochre portable addition

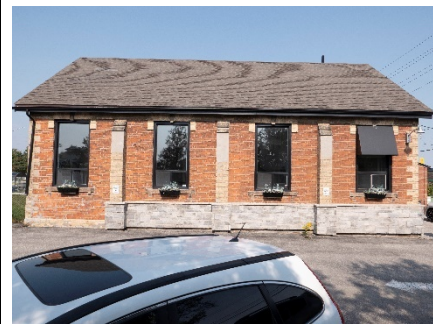
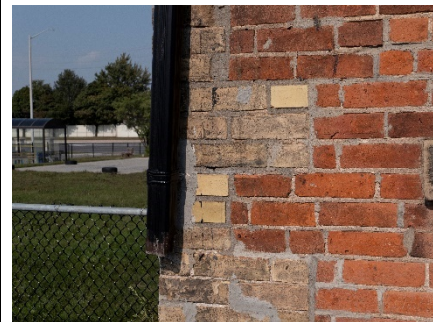
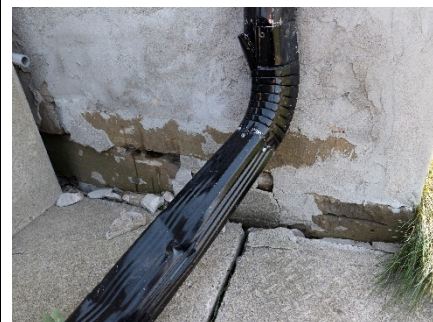
The asphalt shingles and fascia / soffit cladding are in good condition overall, with only one section of about 6-8 disturbed shingles on the west side observed, along with a small section of shingles mismatched in colour. The drainage system's eaves are in good condition; however, the downspouts are poor being damaged and bent on the east side, and disconnected entirely at the west. These conditions prevent water from being properly drained away from the Schoolhouse.

While not a critical maintenance concern, the downspouts should be repaired such that water is reliably discharged a suitable distance from the Schoolhouse and does not saturate the brickwork on parging / foundations. As well, all construction supplies / refuse resting against the historic building should be removed and stored elsewhere. Investigations to the condition of brick / foundations beneath the veneer wall and parging should be undertaken prior to determining any conservation scope. The structural integrity of the historic structure and its physical suitability for relocation must be professionally assessed to inform the building's relocation method and strategy.

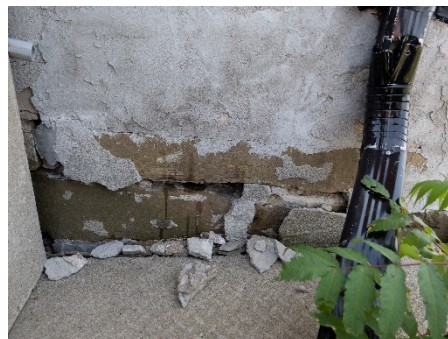
Visible foundations show slight erosion and delamination of sandstone, and significant loss of joints. It is unclear whether this condition is common to other obscured foundations, or advanced due to the damaged adjacent downspout.

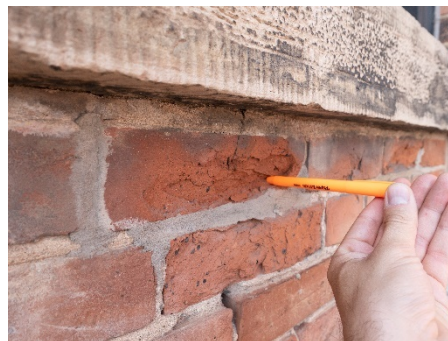
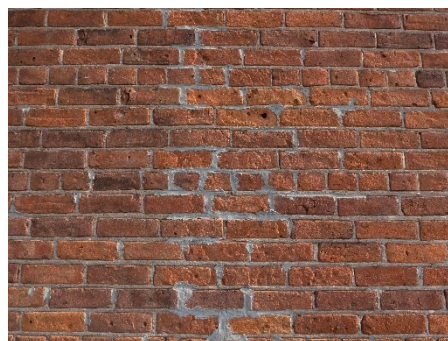
Overall the brickwork is in fair condition. Chipping and weathering is common in some cases exposing imperfections in the units, though generally not to a point that they are unsound. Spalling is seen in localized areas throughout the building, going back nearly 2cm in extreme cases. The condition is most common closer to grade, or adjacent to obvious mortar repairs suggesting physically incompatible cements have been used. Cracked units are seen near common stress points (where window jambs meet sills) or relate to larger structural forces. A number of bricks have had names or initials carved into them, a charming reminder of the site's long services as a school. Large areas of brick are obscured by parging, overpointing and a veneer wall and could not be reviewed. Several replacement buff bricks were observed in the northwest quoining. Scarring and staining related to former additions or attachments are visible on the north elevation. A number of signs and utilities are attached to the brickwork, often fastened directly into the bricks rather than the mortar joints.

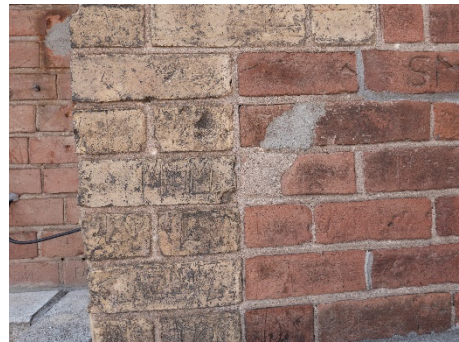
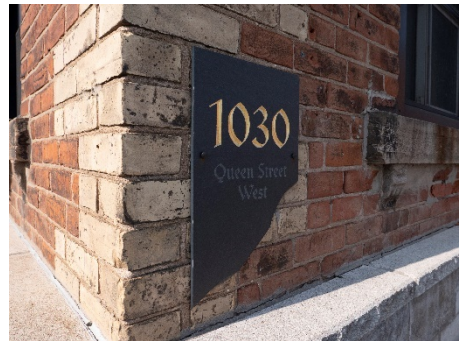
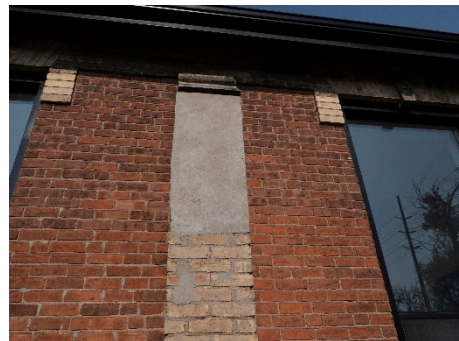
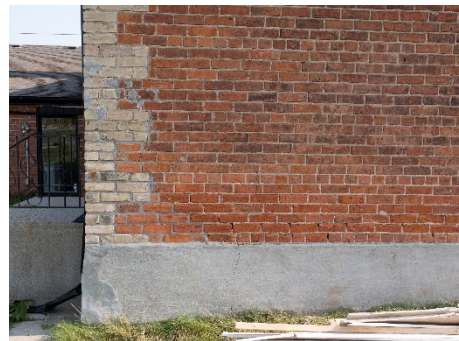
Improper mortar repairs are found throughout the elevations, and should be investigated to determine whether they are physically incompatible with the historic brick. The quoins on the north elevation have a large amount of mortar repair suggestive of significant cracking in the past. An open zipper crack remains visible on the east quoining, continuing into the parged foundations. Instances of over-pointing or parging are found throughout in small and large areas throughout the Schoolhouse.

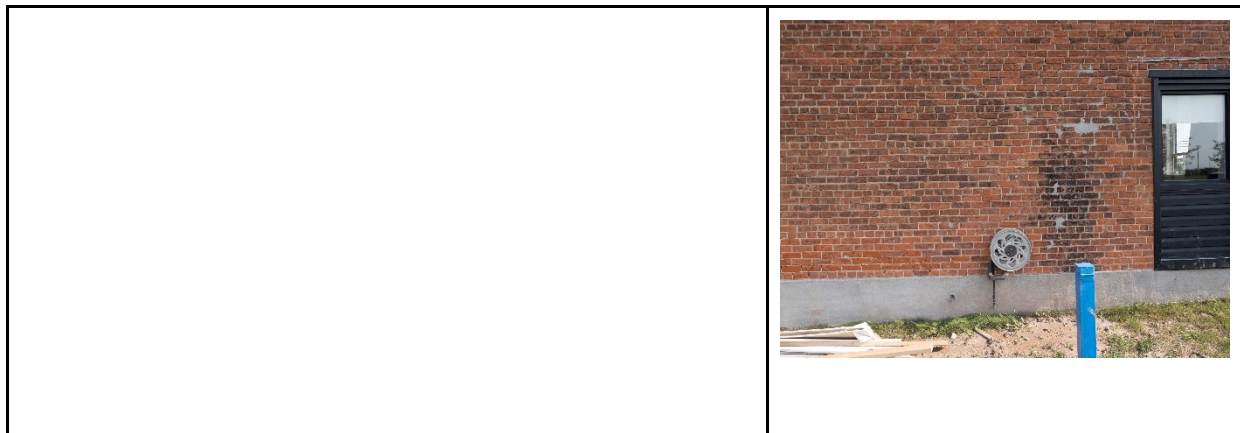
**Sandstone Sills, Drip Mould, Capstones***Description:*

All windows have rectangular sandstone sills of a brown / grey colour bush-hammered with tooled margins.

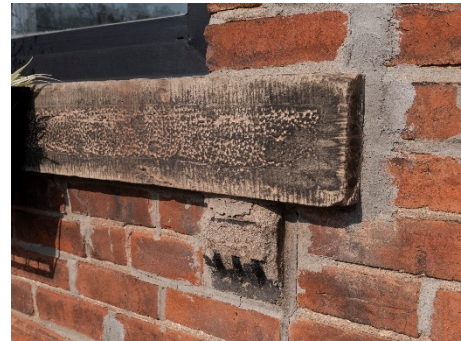
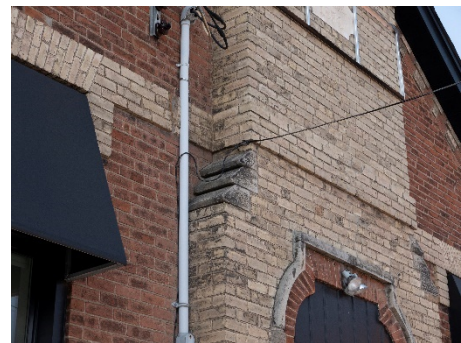
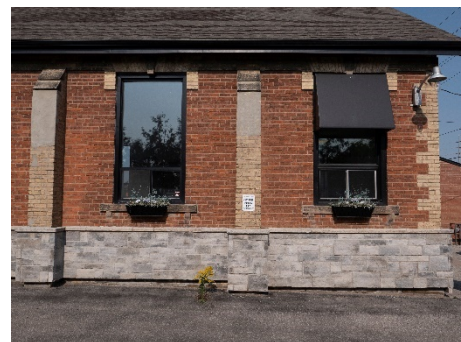
Sandstone components are in fair condition, typically displaying erosion, chipped / cracked arises, and staining while remaining sound overall. Some buttress capstones appear to have been overpointed or parged around the joints.

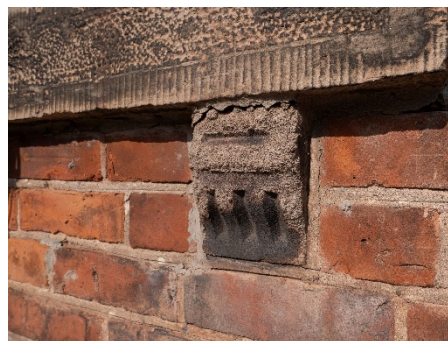
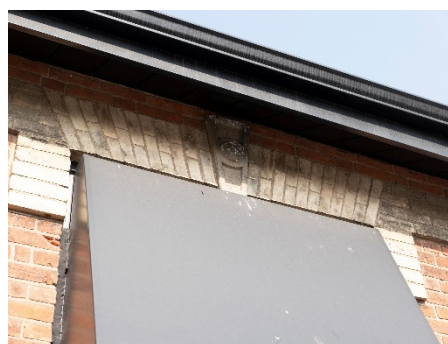
The brackets are typically in poor condition, the upper halves being badly deteriorated with the bottoms deteriorating less quickly or heavily stained. The keystones are generally in good shape, displaying a sound crust and light soiling from the atmosphere and animal droppings.

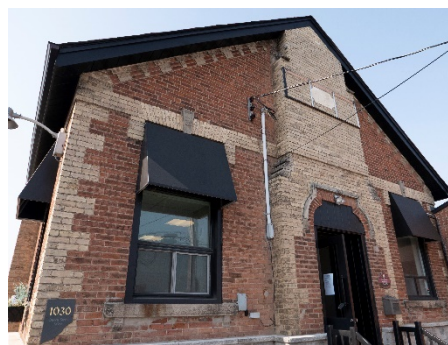
Original wood windows have been replaced by contemporary units characterized by a large single light above two operable panels. Two windows on the east elevation have been infilled, one with vertical cladding and the other with bricks. Openings on and adjacent to the south elevation have fixed black awnings.

Replacement windows and fixed awnings are in good condition.

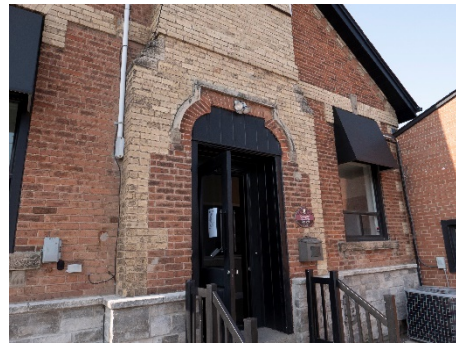
Doors on the south and east elevation are in good condition.

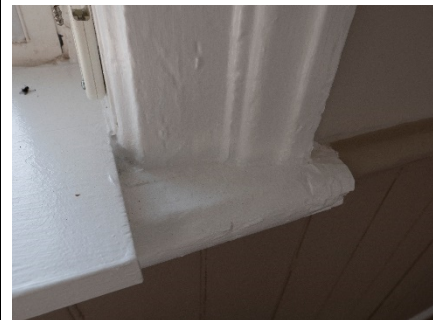
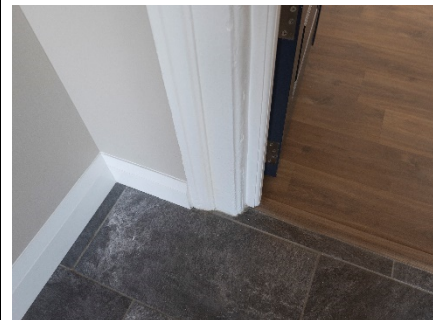
Historic mouldings are in worn but sound condition, with layers of paint somewhat obscuring the legibility of the profiles. Newer door frames have been added within the original frames, partially obscuring the original composition.

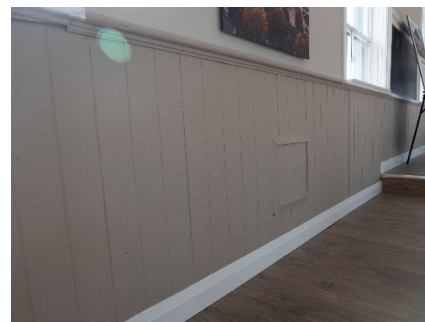
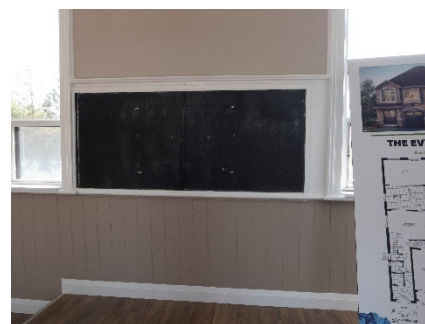
Wainscoting is in worn but good condition, with certain areas showing greater wear to the wood beneath. Chalkboards and framing are in fair condition.

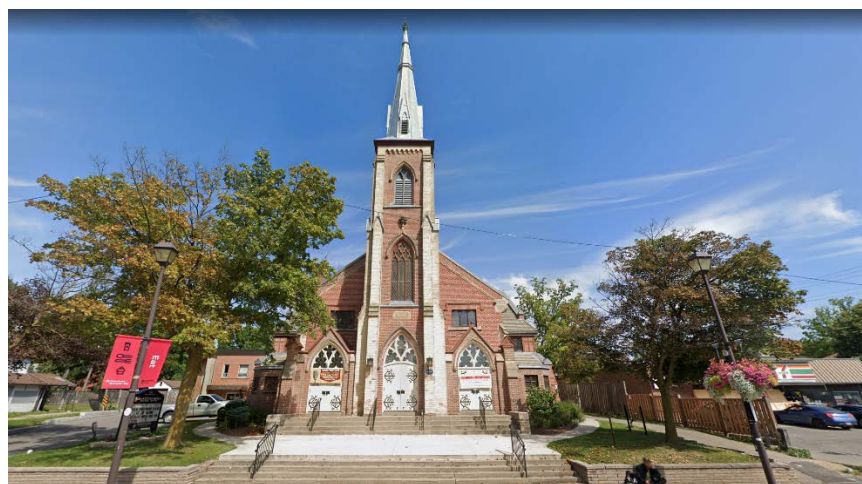
Figure 30: Grace United Church at 156 Main St. N. in Brampton, showing similar use of brick and stonework to the 1874 Schoolhouse (Google Maps).

Both use a red / buff brick combination similar to that of the Schoolhouse, with buff used for buttresses, arches and gable accents. A brown - grey stone is used on both for cap and transition stones on buttresses. This stone's colour is similar to that of the Schoolhouse, as are the shape and tooling pattern. Both churches also feature central date stones with scalloped corners, and online imagery for Christ Church suggests a similar horizontal tooling on the mortar joints as seen on the Schoolhouse (Figure 31). While these characteristics and features are common to Victorian building practice in the vicinity, they do support the involvement of Perry and McCullough.

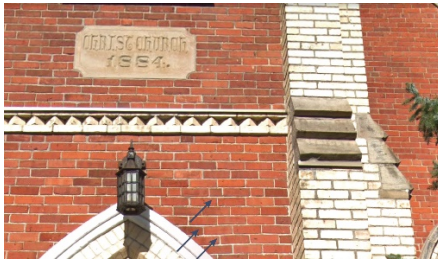
Figure 31: 2019 Google image detail of Christ Anglican Church at 4 Elizabeth St. N. in Brampton, highlighting the dichromatic brickwork, sandstone elements, and date stone. Blue arrows indicate where horizontal tooling on mortar joints matches that observed at the Schoolhouse.

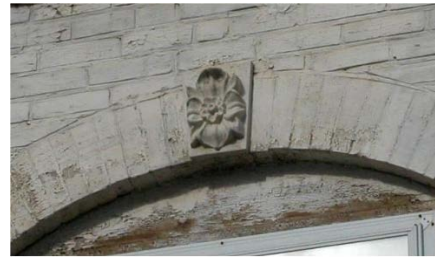
Figure 32: Image of an arch at the Haggartlea Estate in Brampton, showing the keystone which might be a cast stone detail. The photo also shows horizontal tooling in the surrounding brick joints similar to that of the Schoolhouse (Heritage Report: Reasons for Designation Haggartlea 28 Elizabeth Street North).

A potentially more significant similarity is observed on the remains of the Haggartlea Estate (built c.1870), which Jesse Perry executed brickwork on according to his son Samuel.<sup>39</sup> Haggartlea is primarily brick, but contains a number of keystones decorated with floral motifs. A detail photograph shows that the design lacks undercuts, which would have lent well to casting (Figure 32). Given the lack of other decorative masonry on the building, using precast keystones would have provided obvious economic benefits. If Haggartlea's keystones are in fact cast, this would represent a stronger connection to Springbrook Schoolhouse than the design features noted above. While cast stone developed into a very common building material in the early 20th century, its use in an 1870s Ontario context is less documented. In 1968 an artificial cast stone was patented in the United States under the proprietary name of Frear Stone, and by 1871 the product was being shown at the Provincial Exhibition.<sup>40,41</sup> It is unclear whether the cast stone on the Schoolhouse was in fact Frear Stone or another product, however the use of the method on two buildings suggests a continuity of builder given the relative newness of the technology at the time. Haggartlea also shows evidence of a scalloped date stone and horizontal tooling on masonry joints as discussed above. Thus, examination of the built record provides a number of similarities supporting the attribution to Jesse Perry and William B. McCullough as builders.

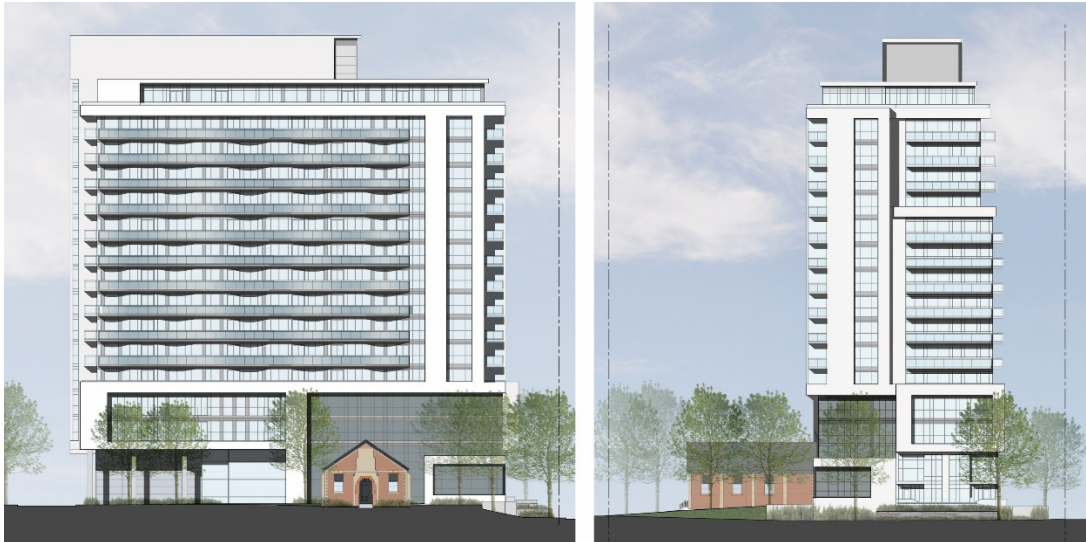
Figure 37: Proposed Front (South) and Side (East) Elevations of the new residential development showing the relocated Heritage Resource facing Queen Street West.

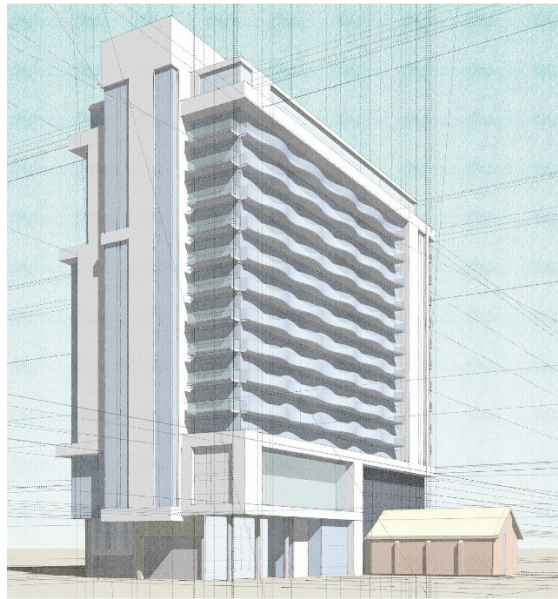
Figure 38: Proposed South-West of the new residential development showing the relocated Heritage Resource facing Queen Street West.  
(Source: Urban Design Brief TCA, GSAI & SBK Landscape Architecture November 23<sup>rd</sup> 2020. Annotated by AREA)

- The primary face of the proposed building is parallel to the primary road (QSW) which helps in reinforcing the street edge. Maintaining the front elevation of the relocated heritage Schoolhouse parallel to QSW helps in preserving the existing heritage streetscape and context.
- The base element of three storeys has been designed in the built form of the new development to reinforce pedestrian scale (Figure 38). The base can be distinguished easily through the changing materials. A winter protection for access to the building has also been provided.
- On the secondary road (CR), the building will be setback from the property line to provide private amenity space for ground-related dwelling units. The private amenity space will be demarcated by low perennial planting (Figure 39).

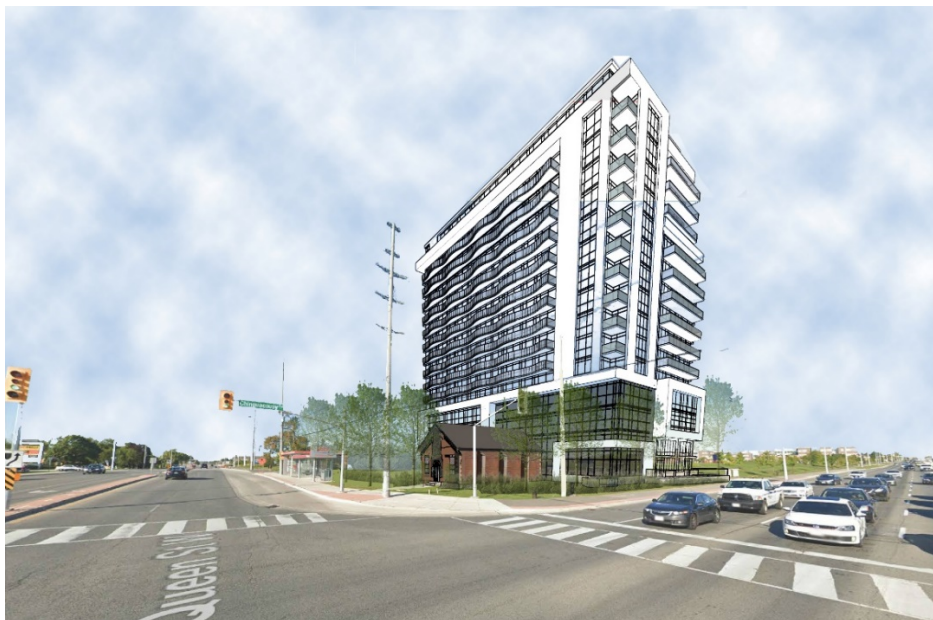
Figure 40: Conceptual South-East View of the new residential development showing the relocated Heritage Resource facing Queen Street West.  
(Source: Tregebov Cogan Architecture, November 2020) \*

\*This is an in-house 3D model with photo montage. When this proposal goes through further approval, the Heritage Consultant would review and comment on the proposed cladding of the new building to verify that they are compatible with the heritage building.

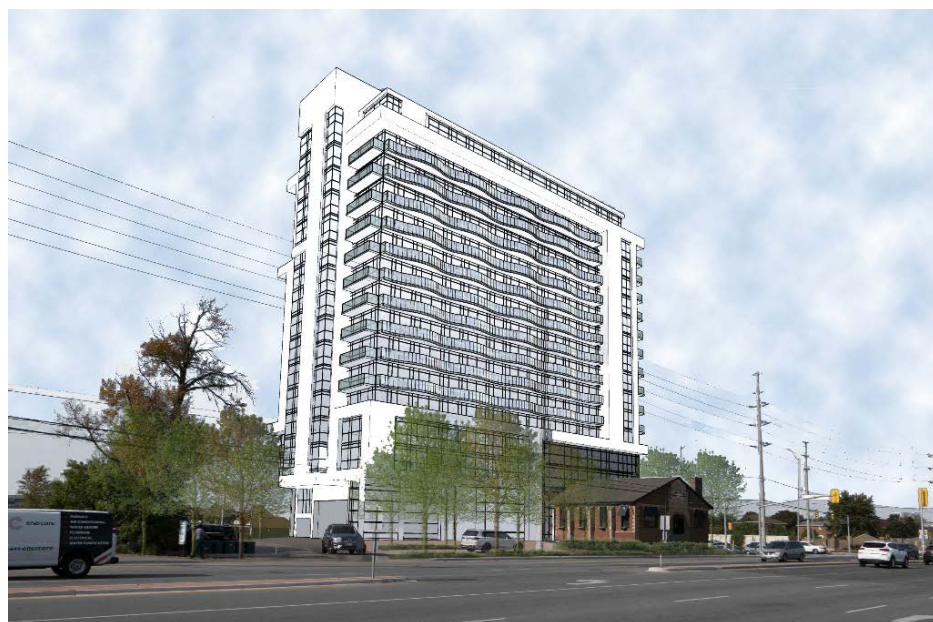
Figure 41: Conceptual South-West View of the new residential development showing the relocated Heritage Resource facing Queen Street West.  
(Source: Tregebov Cogan Architecture, November 2020) \*
