8280 Heritage Road, City of Brampton, Ontario

Samuel McClure Octagonal House

Issued: June 2021
Rev.: July 12, 2021

HERITAGE IMPACT ASSESSMENT

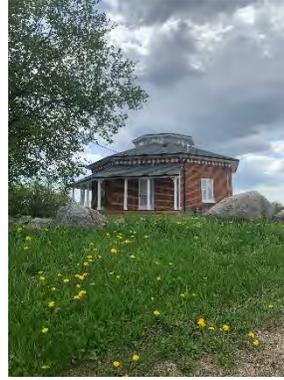
Figure 14: View showing the elevated position of the McClure House (with respect to its surrounding sloping terrain) viewed from Heritage Road (across the road) looking south-west.

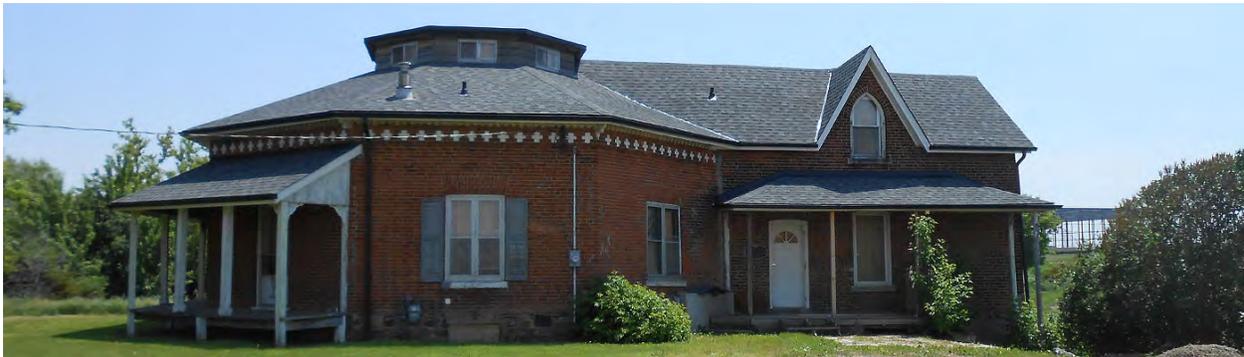
Figure 19: View facing southwest of McClure House showing the rear Victorian Gothic tail which was demolished in 2019 due structural instability issues.

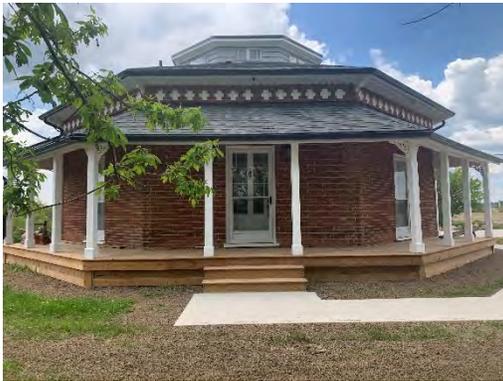
Figure 21: The main elevation (east) of the McClure House shows the original Flemish bond brick and decorative brick white cruciform pattern, wooden dentils, eaves supported by fretwork brackets and wrap around porch (2 elevations). The original French double doors are located in each of the three sides which face the road but, after the alterations in 2019, additional glass panel doors were added in front of the original doors.

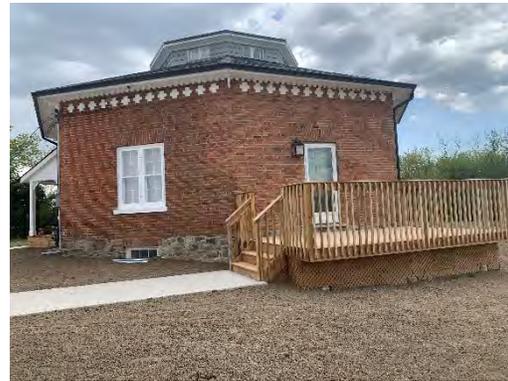
Figure 22: The west elevation of the McClure House building showing the rough fieldstone foundation, restored rear brick wall and the later added pathway and wooden deck.

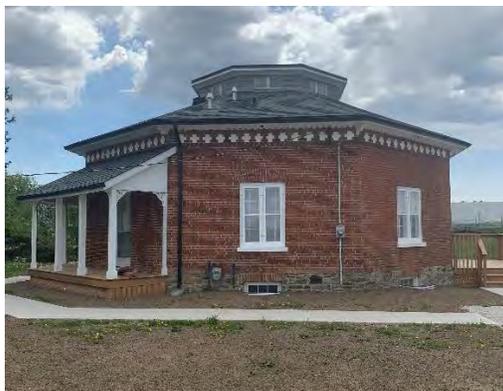
Figure 23: The north elevation of the McClure House building, showing original window openings with new replacement windows and roof drainage accessories. Note the window on the left does not include historic shutters which were present originally (See Figure 19).

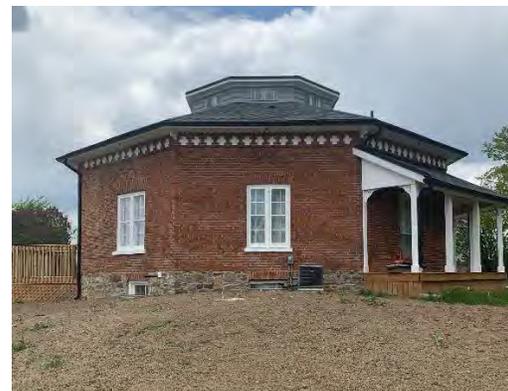
Figure 24: The south elevation of the McClure House building, showing change in site levels with the house on an elevated position and the adjacent low flat site levels.

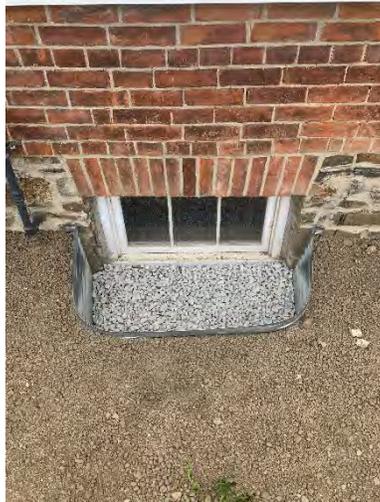
Figure 25: The west elevation of the McClure House building showing the fieldstone foundation (approximately 2 ft. high) capped by a flat arch head with a single order of soldier brick voussoirs, which is followed by a course of bricks laid in English bond. A window well was also recently added to prevent dirt and debris from entering through the basement window.

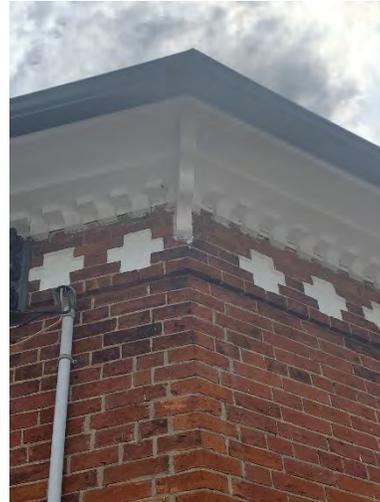
Figure 26: Dentils and a projecting band of decorative brickwork containing a contrasting white brick cruciform motif is present below the eaves.

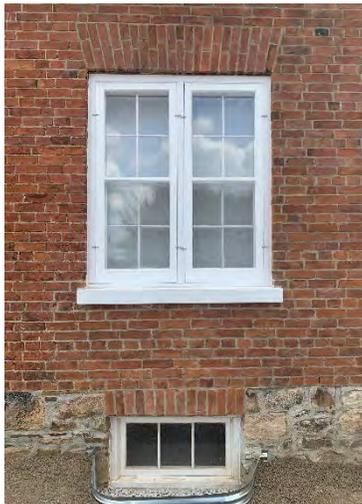
Figure 27: All doors and windows except the basement windows have jack arch heads formed by alternating soldier and rowlock brick voussoirs.

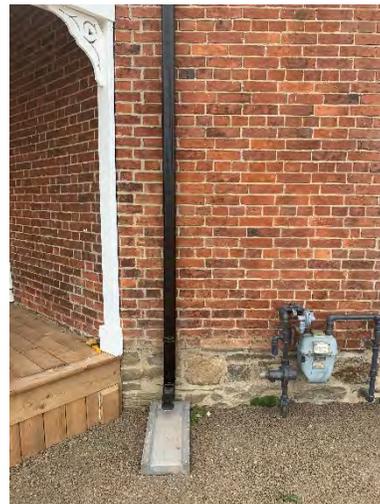
Figure 28: The exterior walls include red brick laid in English Garden Wall bond – three stretcher courses between each header course.

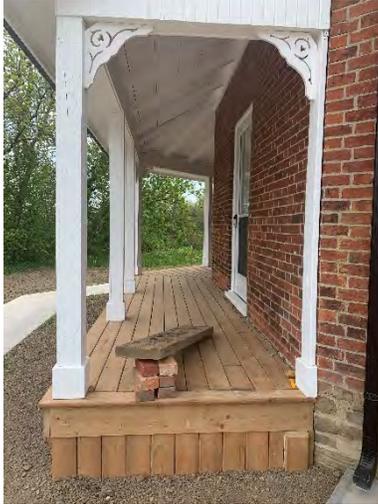
Figure 29: Verandah on the east façade with decorative wood square posts and brackets. The wooden deck level with the top of the fieldstone foundation is a recent addition to the house.

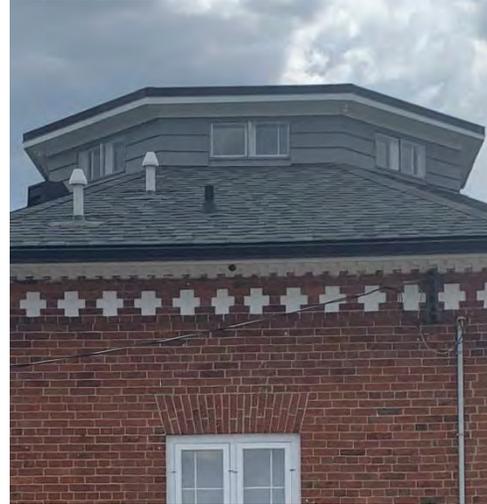
Figure 30: Restored asphalt shingle roofing and new roof vents. Hipped roof lantern has rectangular casement windows and contemporary wood siding as a cladding material.

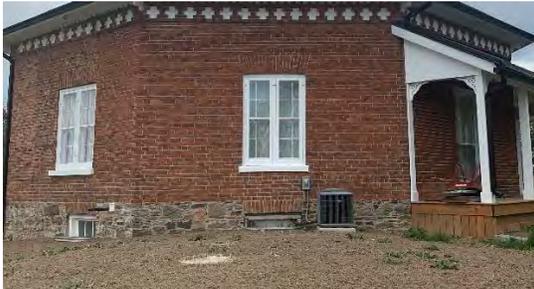
Figure 31: Rectangular windows topped by jack arches. The current replacement windows are double-hung windows with multi-pane sashes.

Window openings are rectangular, topped by jack arches (Figure 31). Original openings have wood sills which have been repaired and restored. Current windows are replacement reproductions with four-over-four double-hung sashes. Archival photographs show a similar historic (and likely original) window arrangement (Figure 19) and an earlier configuration of double French doors (Figure 20). The roof uses asphalt shingles, with fascia and a plain soffit. Archival photos show a chimney penetrating the roof on the west side (Figure 20). Currently the house does not feature a chimney.

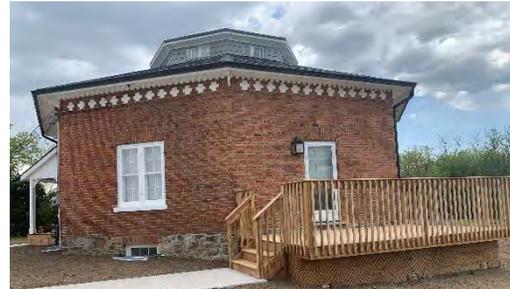
Figure 32: Recently added new wood deck and steps on the rear west façade with simple picket fence accessed by concrete pathway.

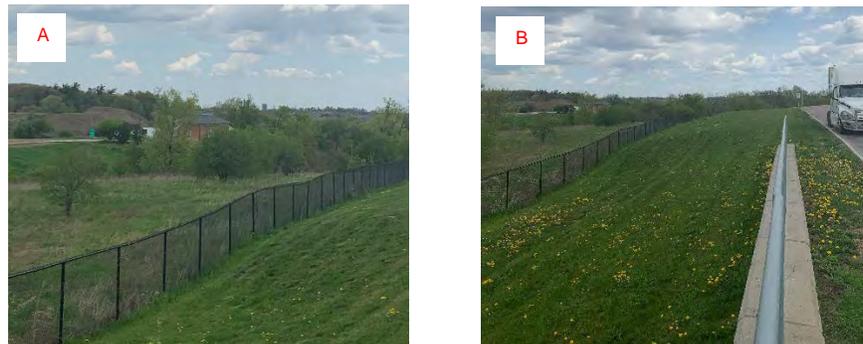
Figure 40: Landscape backdrop for the McClure House showing the existing trees, fence, evergreen trees and the existing CULTECH system with the high slope down to the 8280 Heritage Road property.

The above landscape mitigation elements already exist and do not require any further supplementary measures. These landscape features of the existing trees and vegetation, the high grassy slope and the floodplain stormwater pond are successful mitigation measures to buffer the Octagonal House from the 8050 Heritage Road property. Nevertheless, the current proposed SPA package does also provide further landscaping of a few trees and further shrubs as indicated in the Landscape Drawings (Appendix D). Therefore, no further mitigation measures are needed or proposed related to landscaping.
