## Heritage Report: Reasons for Heritage Listing

**6 Isabella Street**

**September 2021**

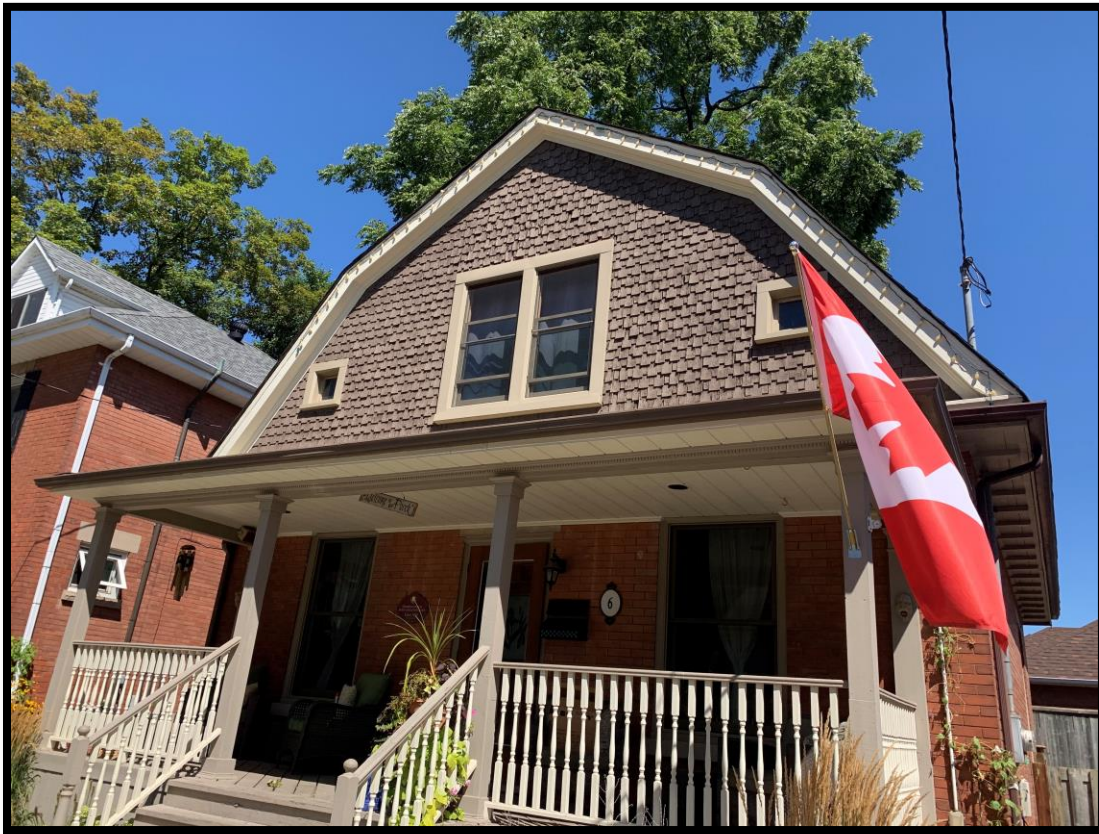
*Photo 1: Front including gambrel roof and porch*

apparent in the smooth brick façade, the sash, paned windows, and balanced design. The Dutch Colonial Revival style is most evident for this dwelling in its distinct gambrel (“barn”) roof.

- Distinctive Dutch main gable with decorative wood shingles;
- Distinct side windows in the main gable;
- The cornice is decorated with small non-structural decorative blocks;
- The close proximity of the building to the front lot line;
- Decorative treatment of porch enclosure.

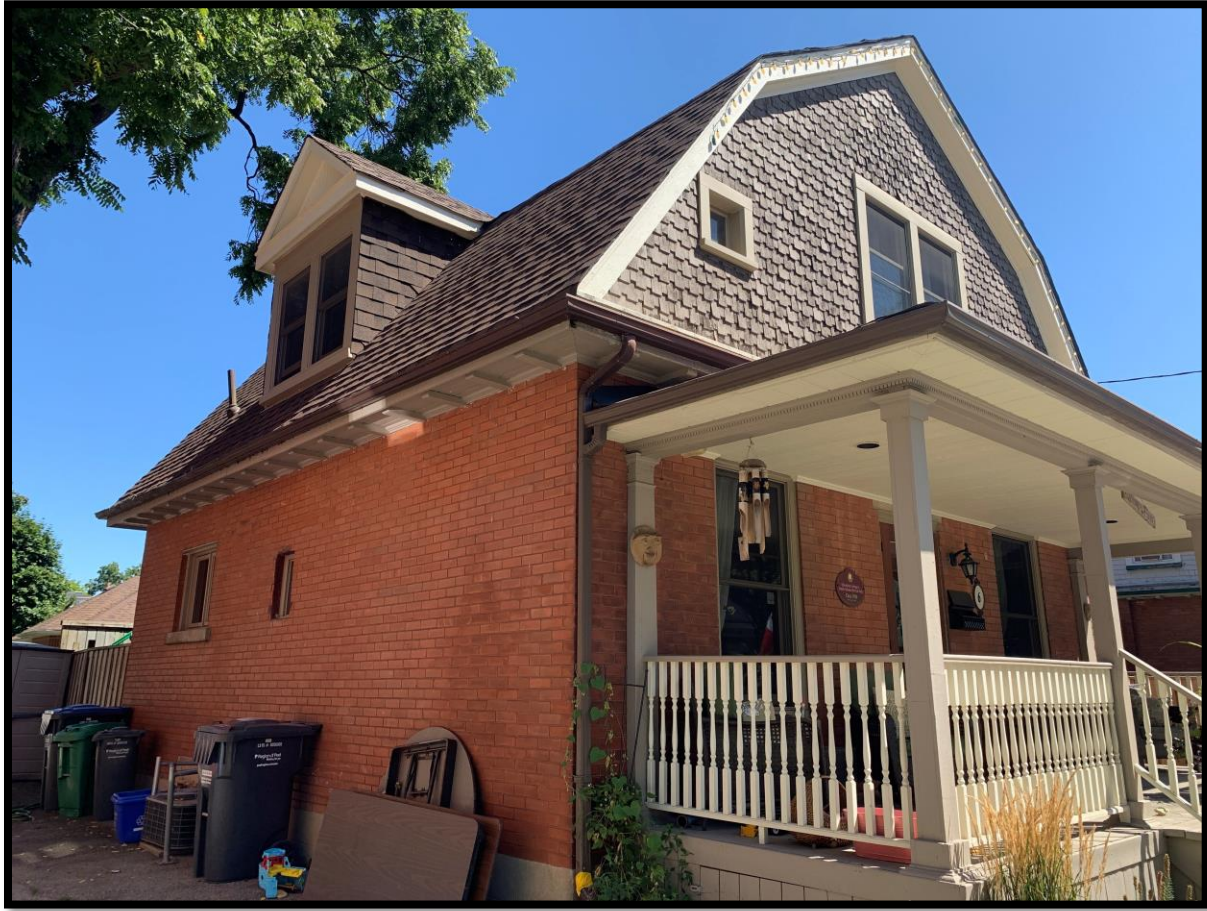
*Photo 2: Front/side including porch and roof dormer*

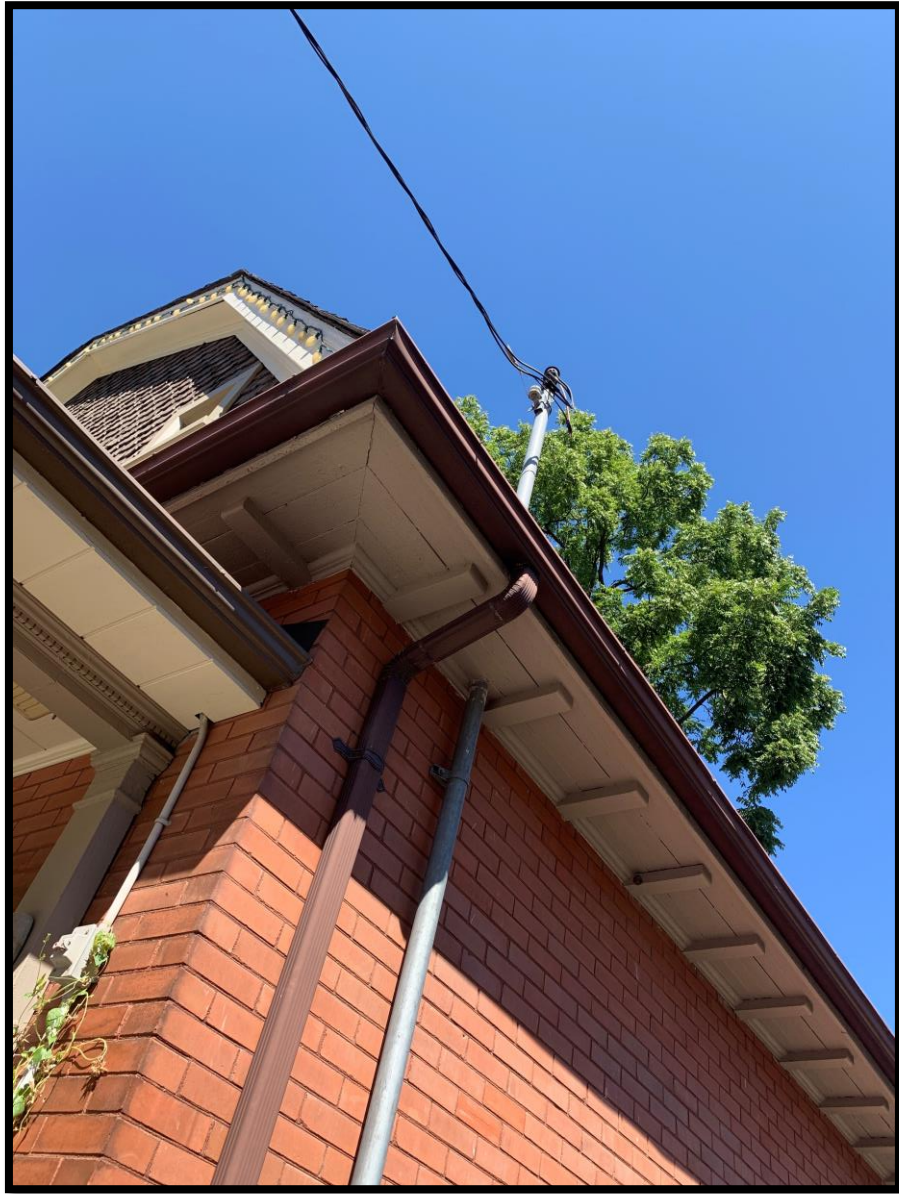
*Photo 3: Corner showing cornice with modillion block*

The house has an architectural twin located at 18 David Street, which abuts the property on the east side. The architectural style is distinguished by a street facing gable roof with medium brown, wood shingle cladding. The cornice is decorated with small modillion blocks. Unlike its twin building, the house at 6 Isabella Street has a large open porch, covered by a roof with the front bedroom protruding over it. The house is constructed with a single colour of brick and single sash windows on both the first and half storey. The front gable also contains two small square windows that are assumed to provide additional light for the half storey. This house is one of those located on Isabella Street that has a significant architectural value and for which the design elements have been maintained in a high quality matter. The property is located within the Downtown Brampton Secondary Plan (Area 7).

house of this type. This is expressed in the sculpted wood-shingle cladding in the gable roof, the decorative modillion blocks under the eaves, and the the decorated beam supported by the posts of the front porch.
