# Concrete Bowstring Bridges

Examples of Rehabilitation throughout southern Ontario

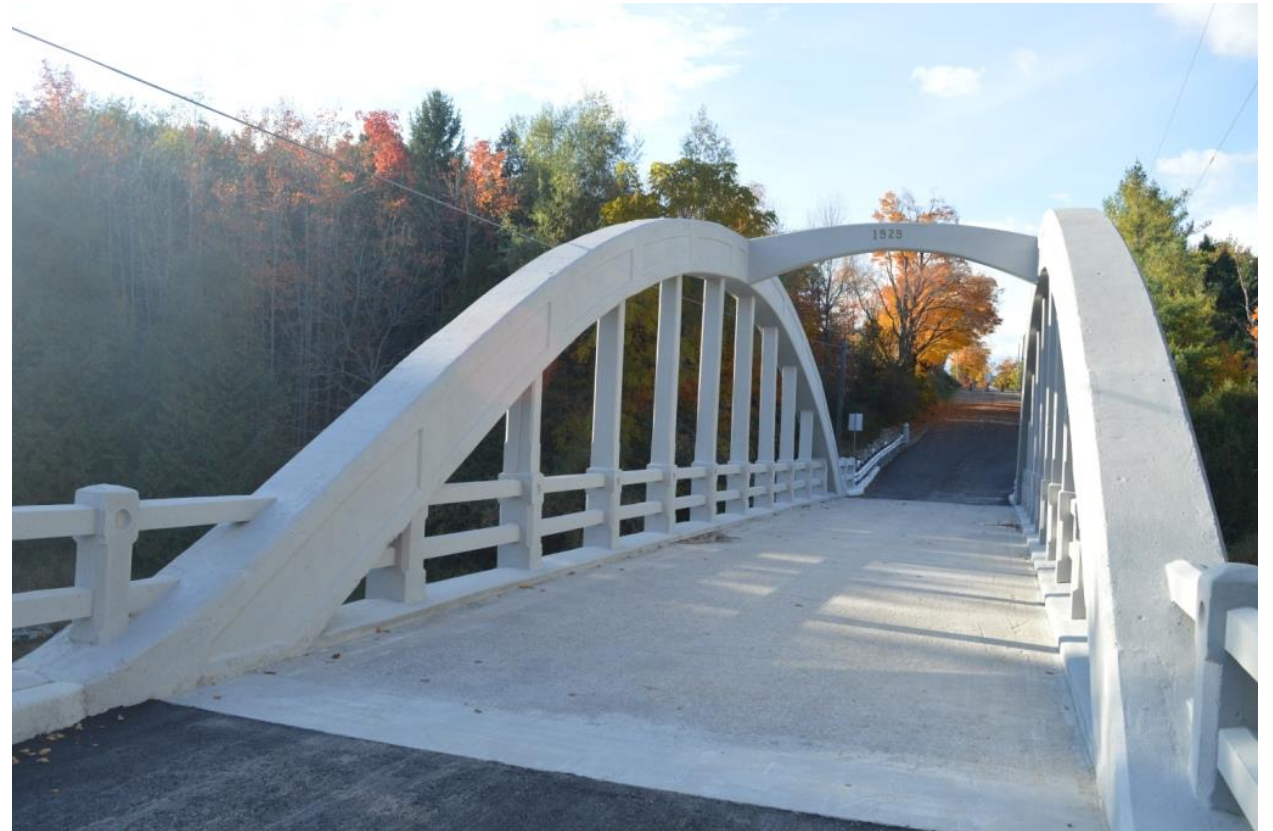
# Irvine Street Bridge

- Township of Centre Wellington
- Rehabilitated in 2014
  - Repairs to arches, railing, deck, soffit, and re-facing the abutments and wing walls
  - Cost approximately \$850,000

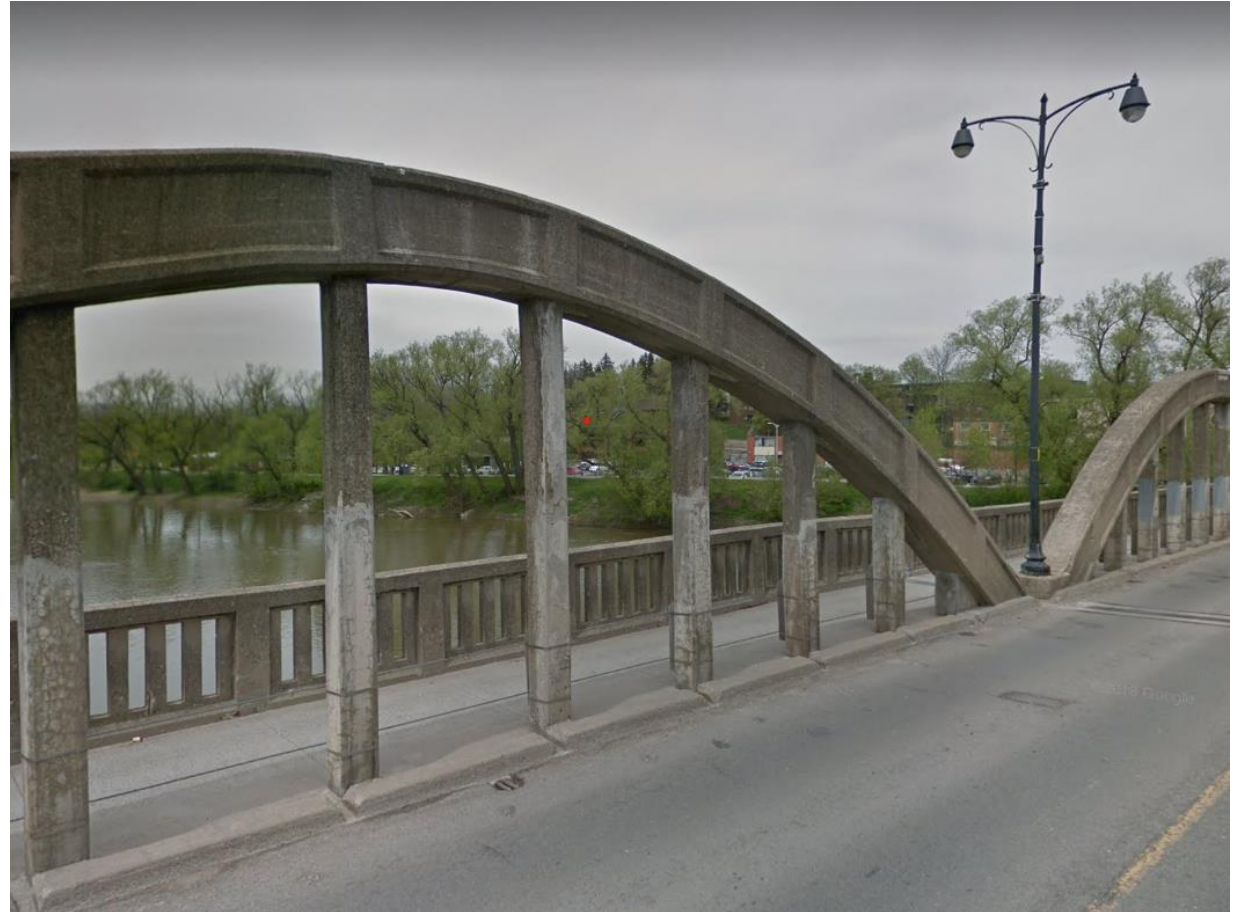
# Argyle Street Bridge

- Caledonia
- Rehabilitated 10-15 years ago
  - Rebar was beginning to rust
  - Corrosion from road salt on concrete
- Beginning to see wear on bridge from traffic and salt use and starting to see corrosion and concrete delamination

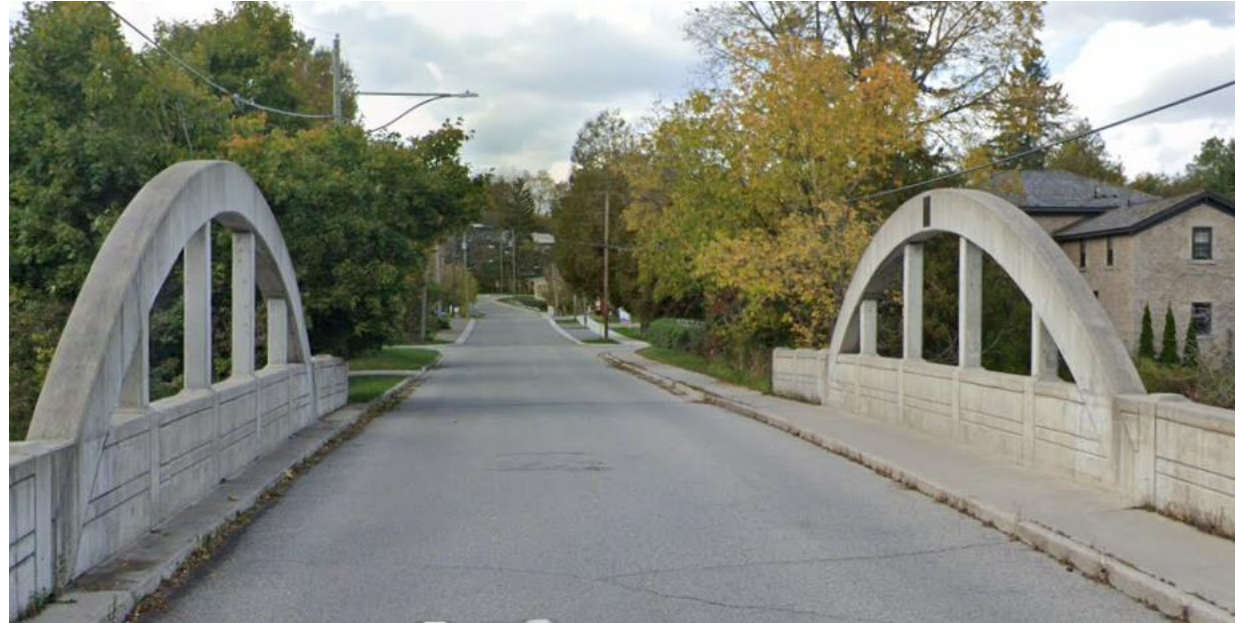
# Eden Mills Bridge

- York Street, Eden Mills
- Sympathetic Replacement
  - Arches and railings are “false” and not structural
  - Railing was filled in to conform to safety requirements of the Bridge Code
  - Solid wall seems very prominent

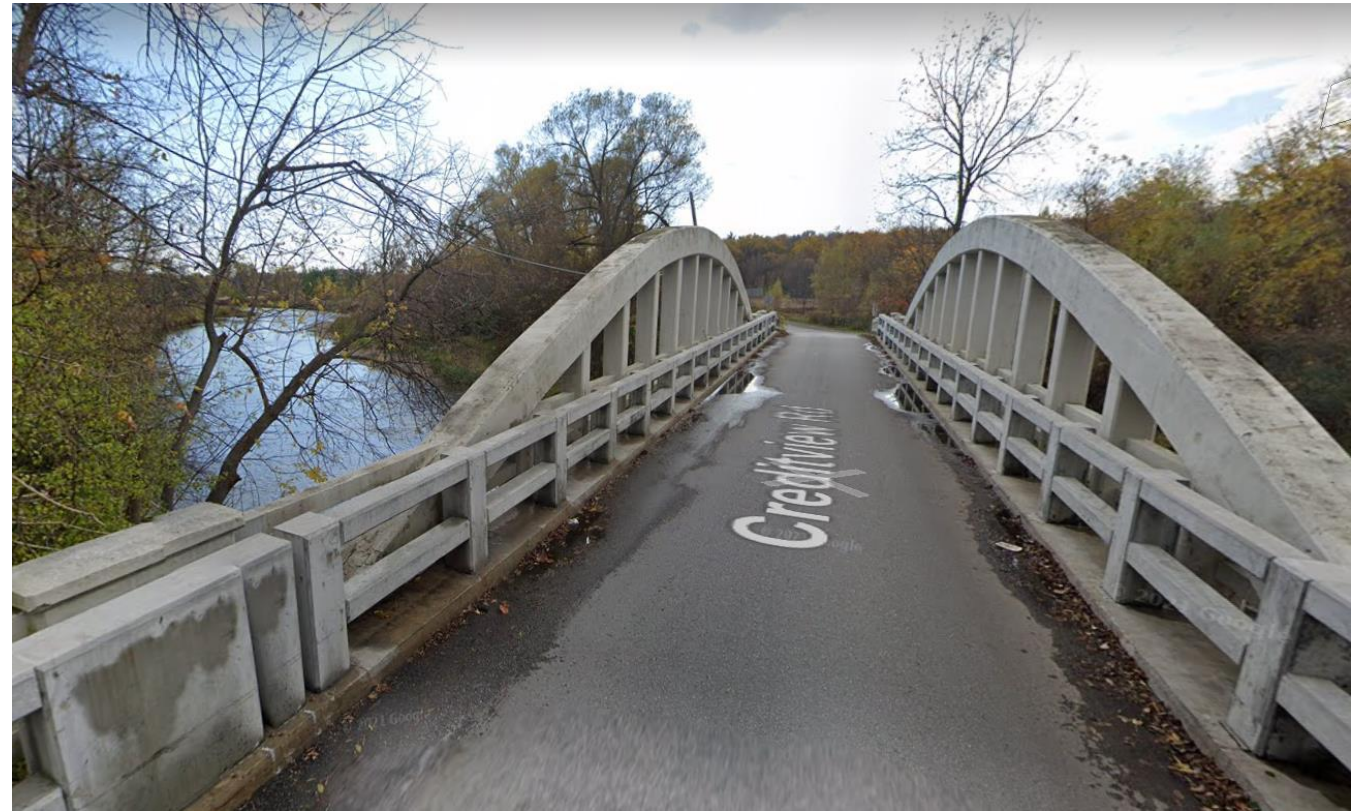
# Creditview Road Bowstring Arch Bridge

- Creditview Road, Brampton
- Rehabilitation 2005
  - Cost \$618,000 in 2005 (approximately \$850,000 today)
  - Double railing required to conform to traffic safety requirements
  - Removal and replacements of concrete deck
  - Rehabilitation of bowstring arches
  - Work on the abutments
