**Heritage Report:  
Reasons for Heritage Designation**

**1030 Queen Street West  
Former Springbrook Valley School  
June 2021**

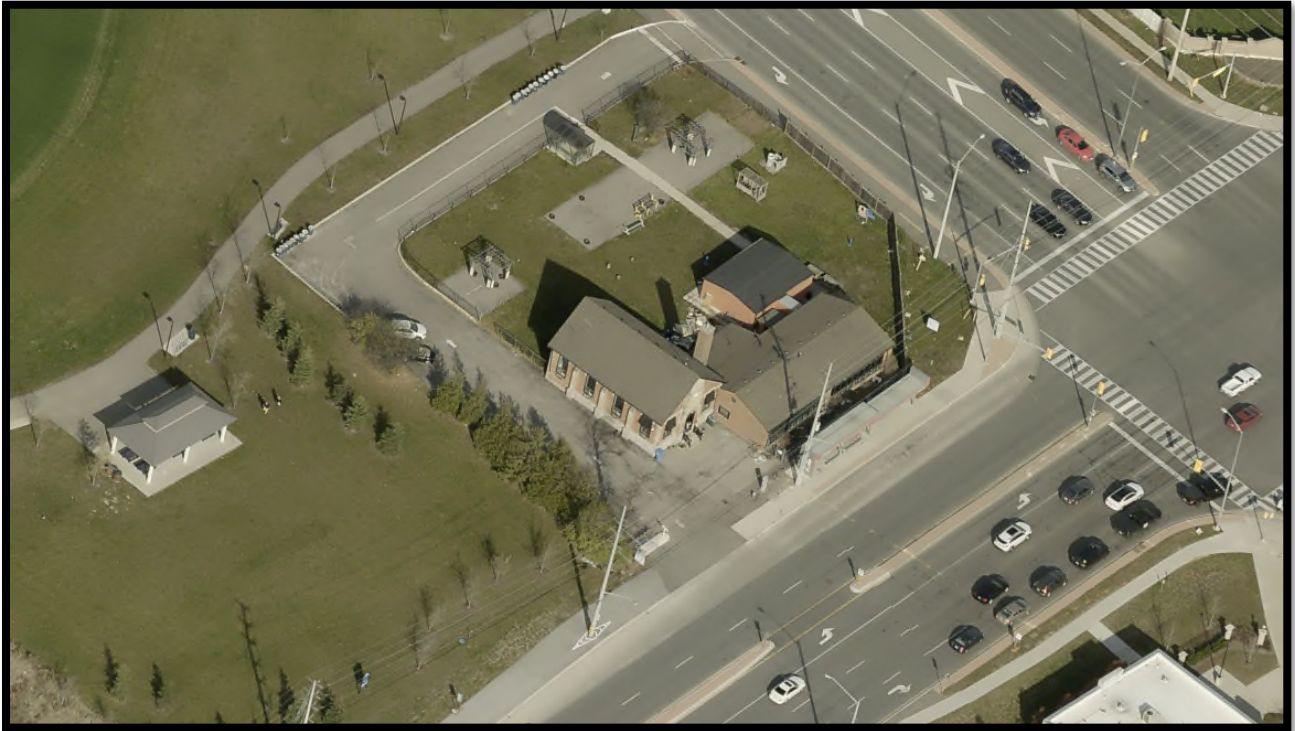
**Figure 4:** 1968 aerial photograph showing the school property on the north side of 1030 Queen St. W. The additions show two different colors of roof material. (City of Toronto Archives: Series 12, File 1968, Item 2088).

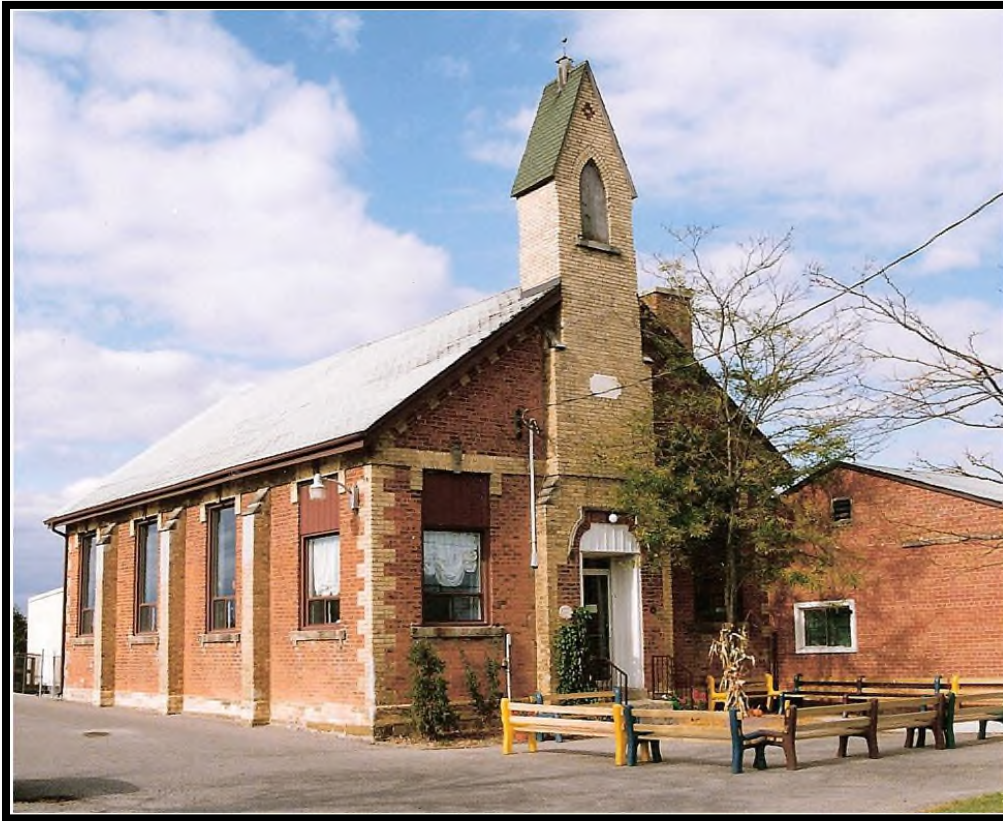
**Figure 5:** 1030 Queen Street West Schoolhouse photograph with the belfry in 1998  
(Source: Region of Peel Archives)

- Alterations to entry features including stairs, removal of belfry
- Alterations to exterior arrangement of historic windows and door openings
- The building which original sat on raised sandstone foundation, most of which is presently obscured by parging and veneer masonry

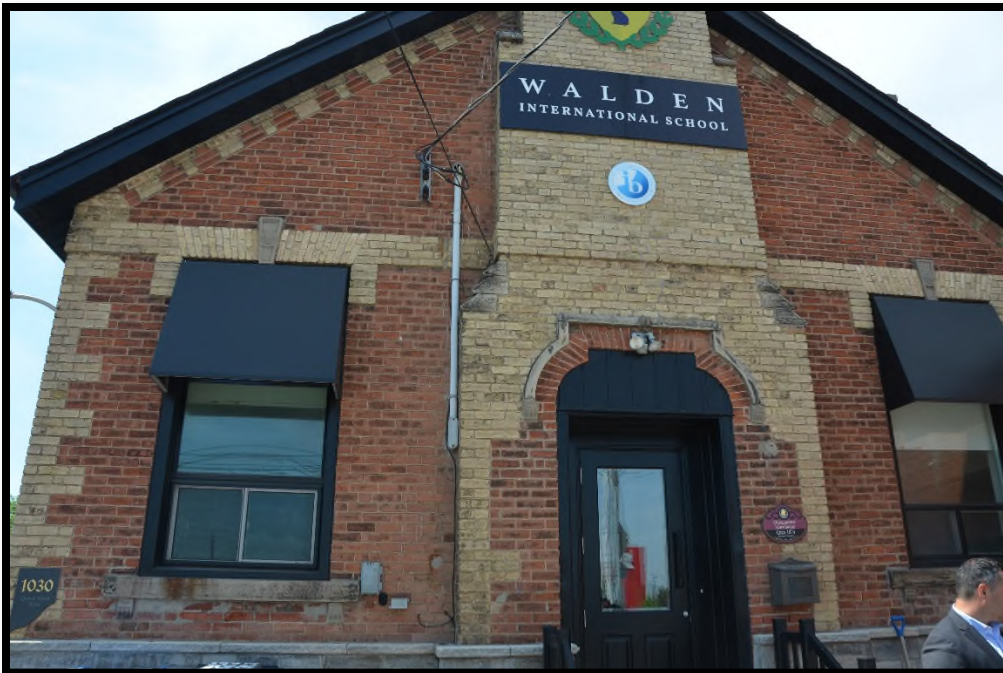
**Figure 6:** The main elevation of the 1874 Schoolhouse.

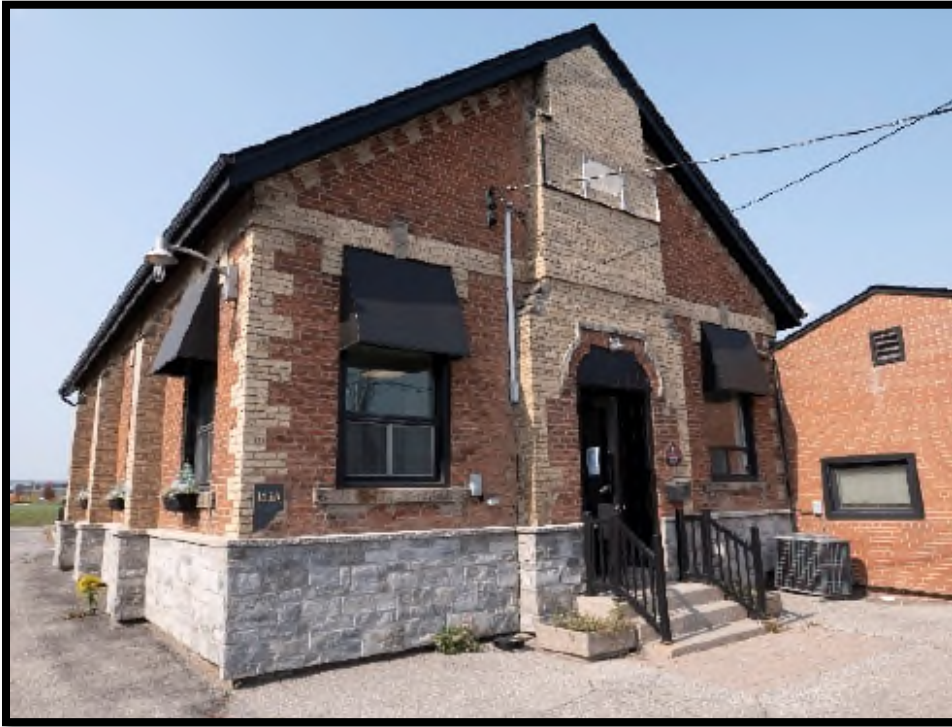
**Figure 8:** The west elevation of the 1874 Schoolhouse building, with the original brickwork visible on the closest bay where the veneer wall has been removed.

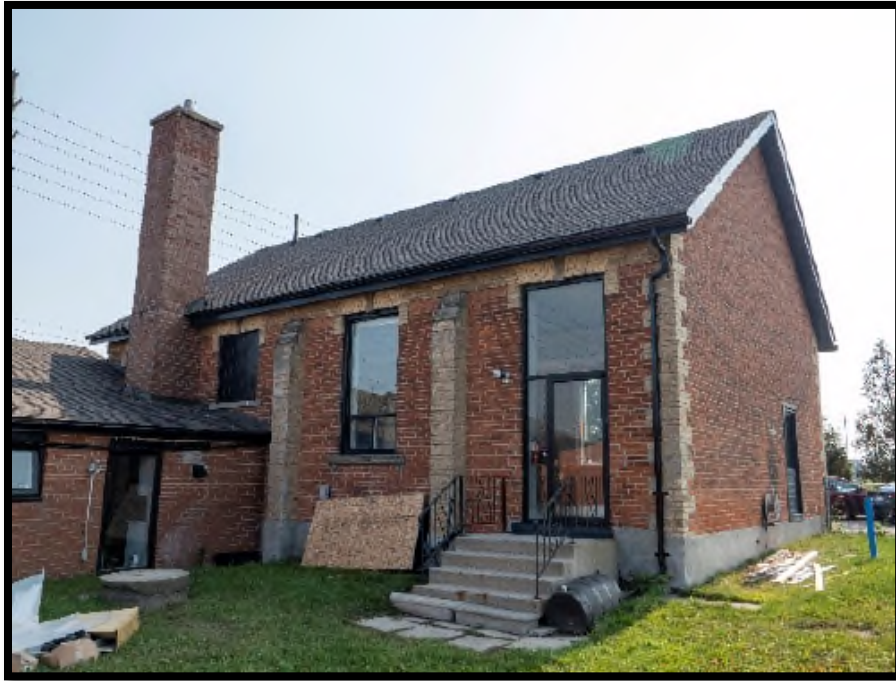
**Figure 9:** The east elevation of the 1874 Schoolhouse building, showing one original and three modified window openings.

- Addition of two building wings, not identified as heritage attributes, to the original schoolhouse
- Door opening on north elevation of the schoolhouse
- South end of the east elevation of the schoolhouse was previously punctured (around 1950's) to connect into the former addition

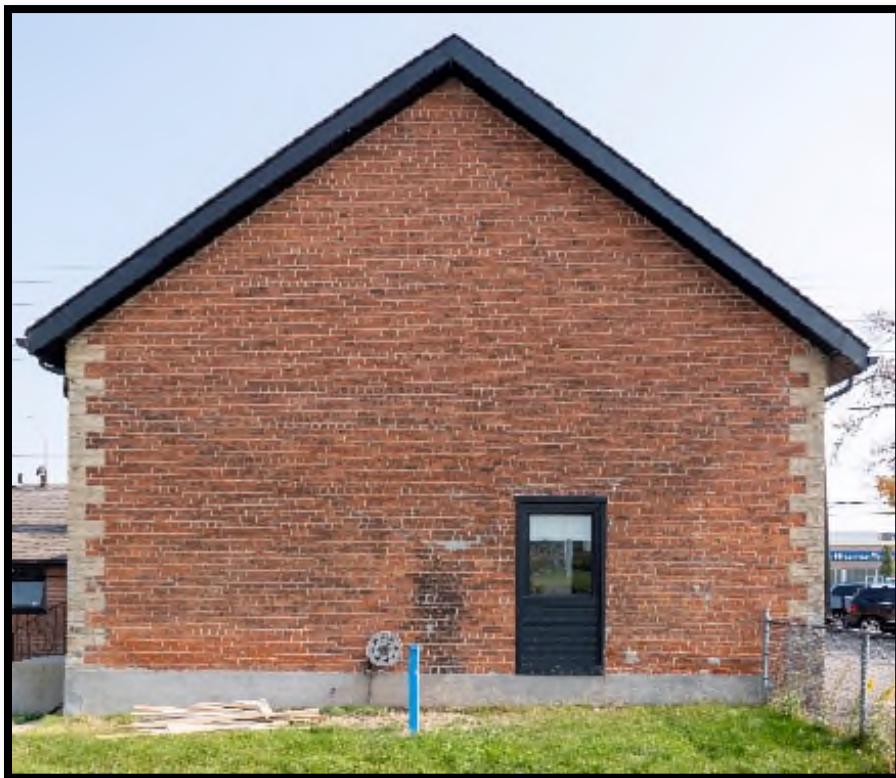
**Figure 10:** The south elevation of the 1874 Schoolhouse building, showing unoriginal door opening and some scarring to the left.

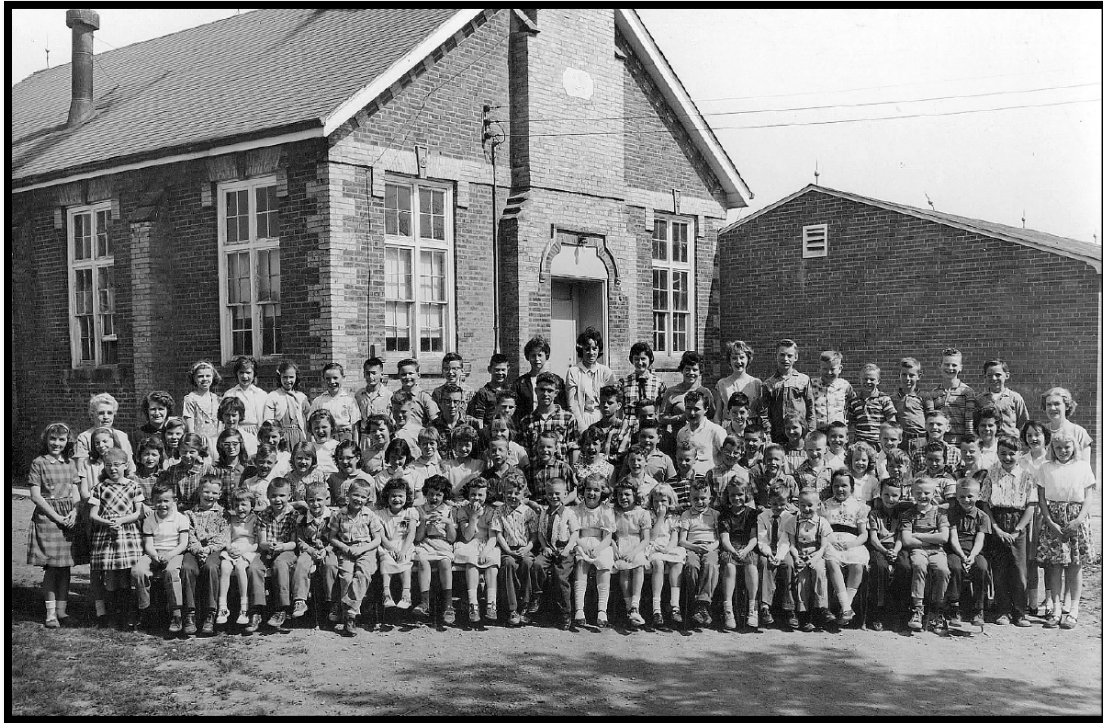
**Figure 13:** 1962 class photo showing the historic window configuration in background. Stove pipe in the picture is also noteworthy. ([www.ontariohistory.org](http://www.ontariohistory.org))
