HERITAGE IMPACT ASSESSMENT

for **15 Bramalea Road**

Brampton
(GBCA Project No: 17040)

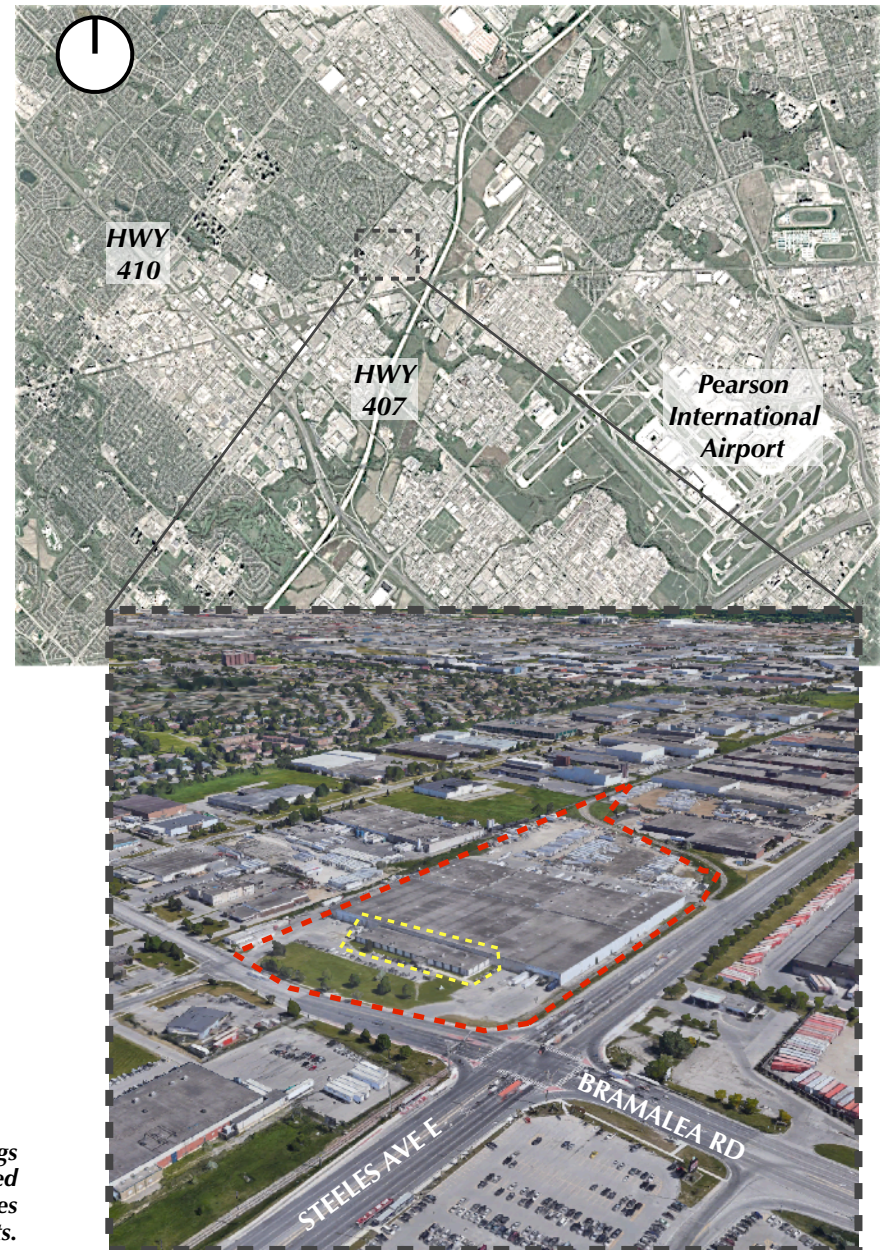
Aerial views of the subject site in a larger context (above) and its immediate surroundings (below). Red dashed boundary delineates the subject site and the yellow dashed boundary shows the one-storey front wing identified as having heritage value. Images retrieved by Google Earth, with annotations by GBCA Architects.

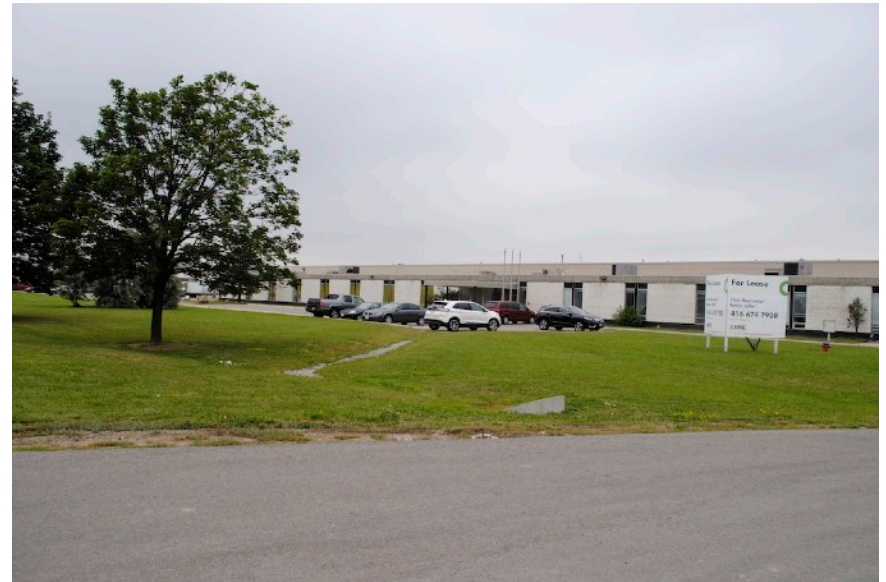
Top right:

Looking from the intersection of Bramalea Road and Steeles Avenue, towards the development site. The one-storey front wing, fronting Bramalea Road, is visible at a distance.

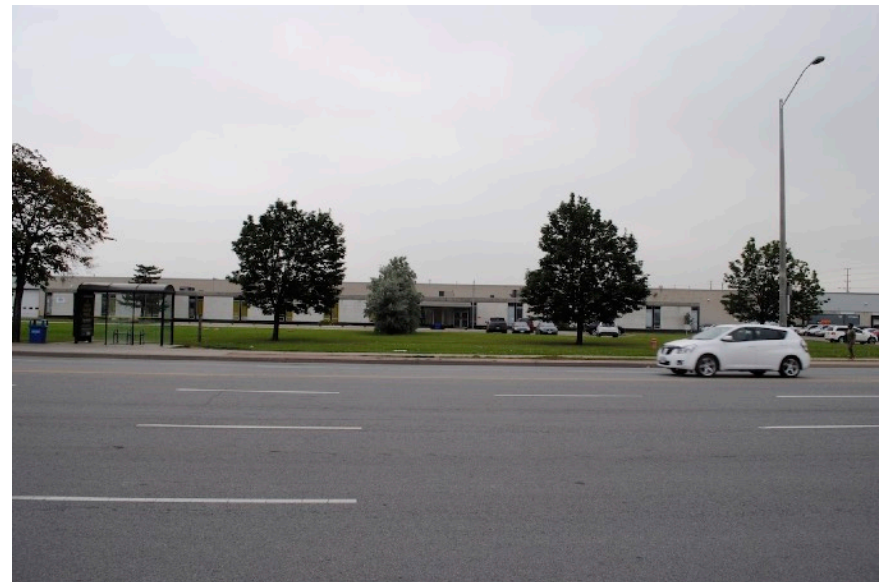
Bottom right: Same view as above, looking from Bramalea Road. The one-storey front wing, fronting Bramalea Road, is visible in the distance, yet obstructed by trees.

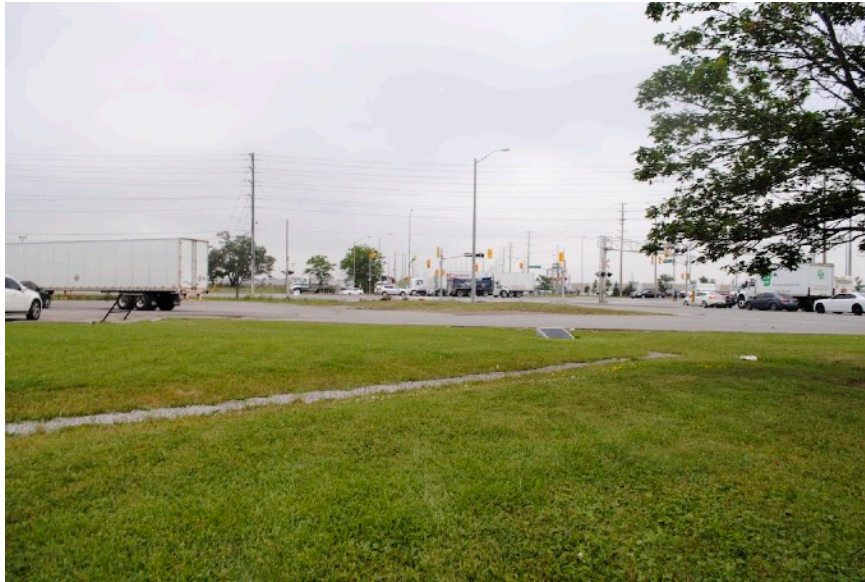
Looking south, from the intersection of Bramalea and Steeles, showing the existing industrial character surrounding the site.

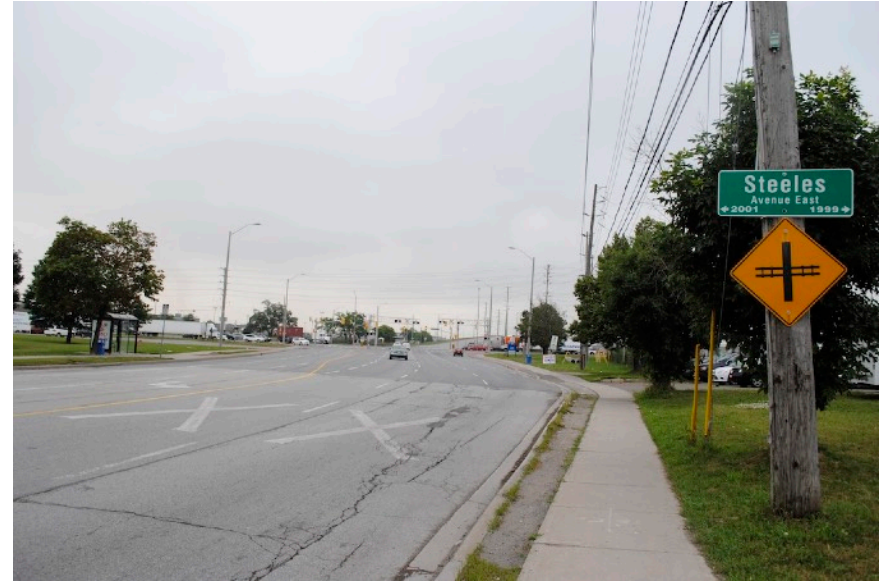
Looking southeast on Bramalea Road. The development site is on the left (not visible on the photograph).

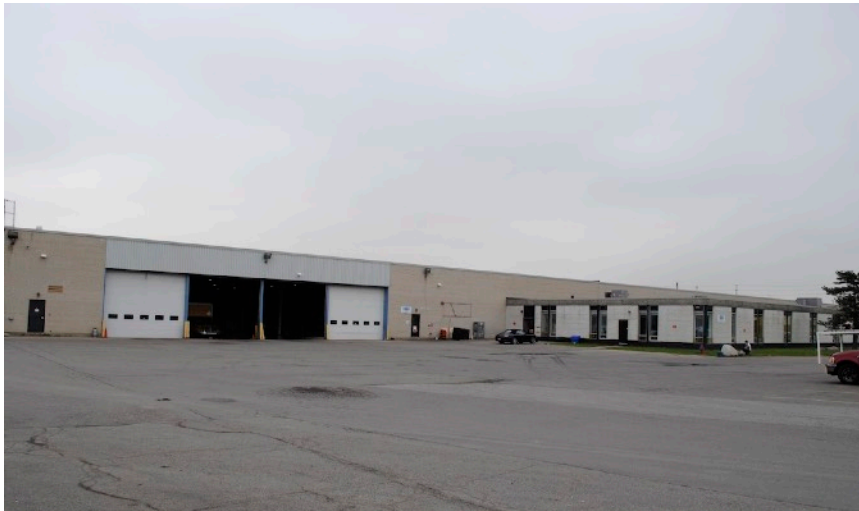
Looking towards the warehouse building, taken from the development site. The one-storey portion of heritage value is shown on the right.

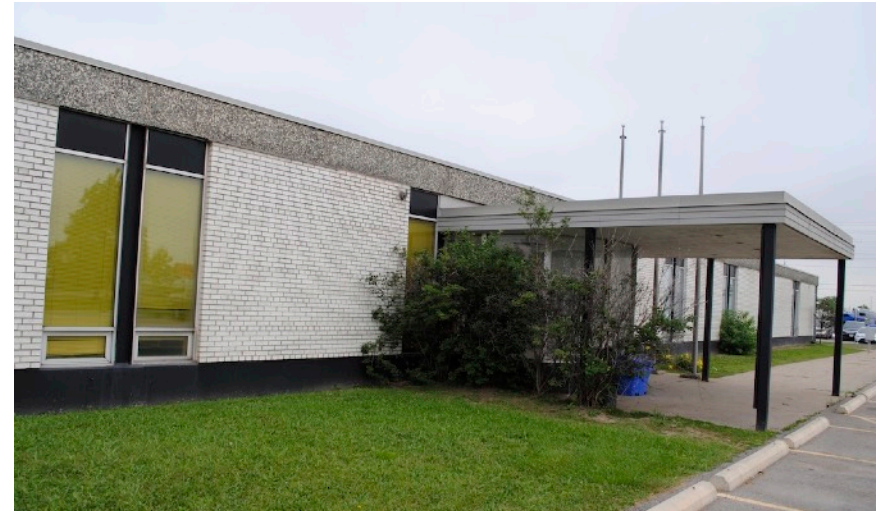
Close-up view of the one-storey front wing of heritage value, showing the extended canopy.

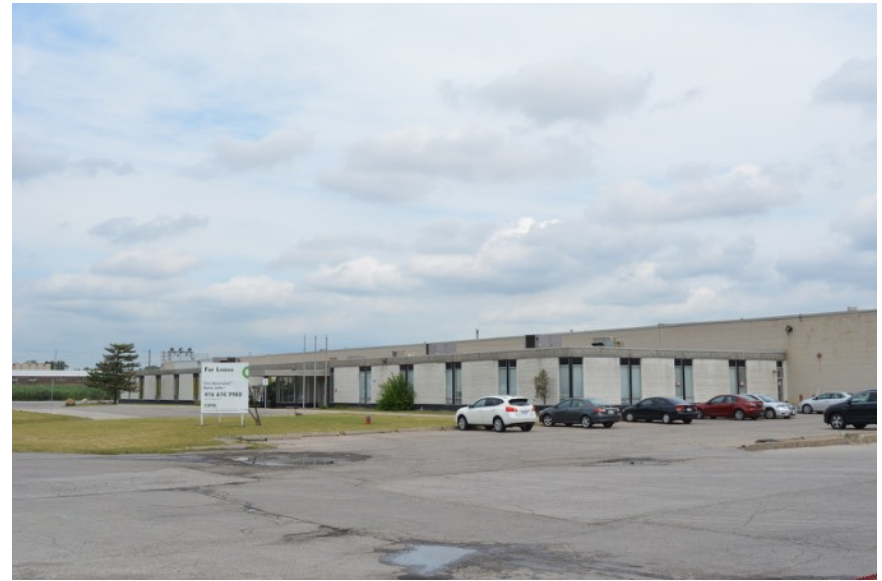
Overall view of the subject site, as seen from the corner of Steeles Avenue and Bramalea Road

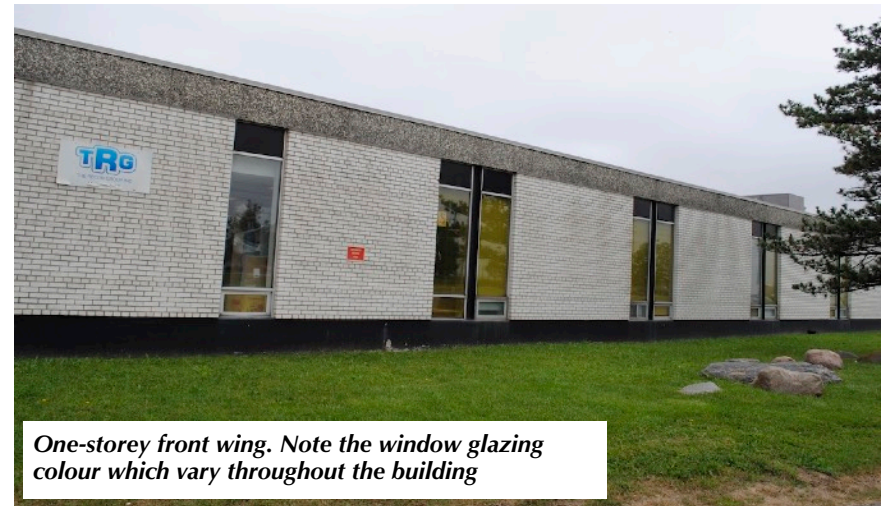
One-storey front wing. Note the window glazing colour which vary throughout the building

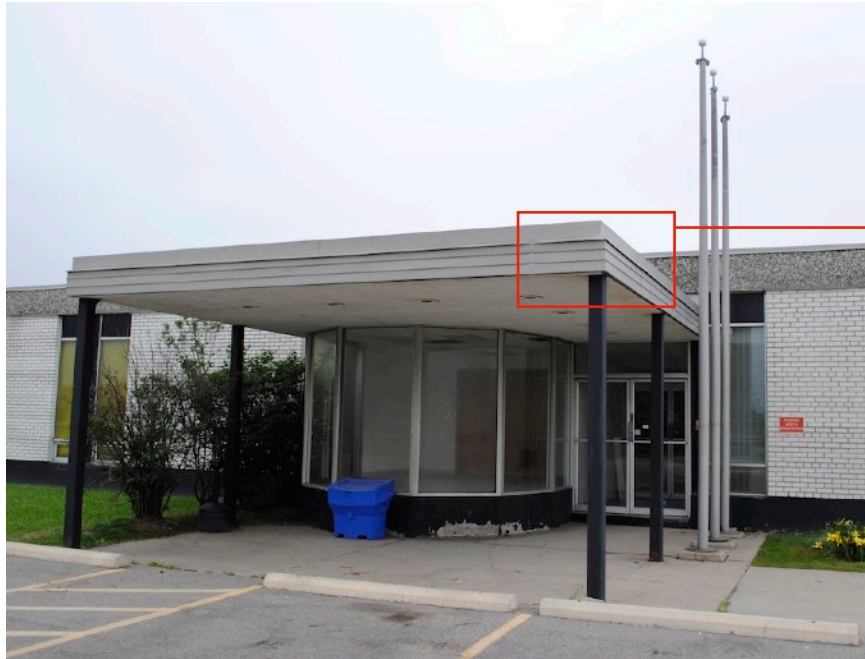
Top left:
 Overall view of the canopy, steel columns, display bay windows and flagpoles. Note the paint flaking at the base of the bay windows, exposing the concrete material. All other features are in good condition.

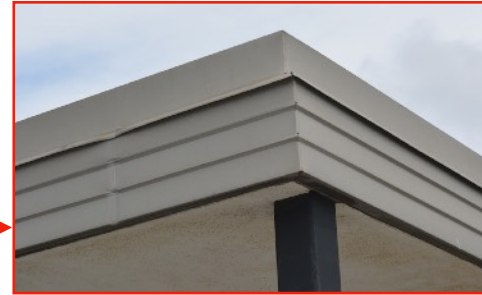
Close-up of a corner of the canopy, showing seam details of the metal flashing. Note the damage on the left

The canopy is built of open web steel joists and covered with a corrugated metal panel with a standard roof membrane on the top and finished with stucco on the underside. The siding consists of prefinished metal flashing. The canopy's roofing, after more than 50 years, is approaching the end of its life cycle. Materials are of standard construction and are not of significant design value to warrant their integration with the new building. Further, the metal siding is damaged (dented), and can not be repaired. The canopy is recommended to be removed and recreated, in a similar shape and size. The metal flashing will include the seam detail that is shown on the sides and new recessed lighting fixtures will be provided underneath the canopy.

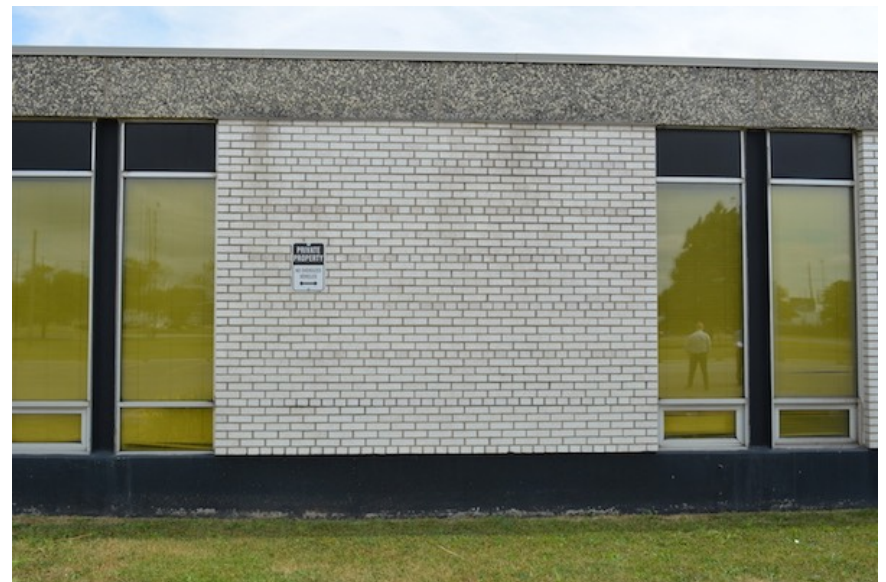
Bottom right: View of a typical brick veneer panel. Size is approximately 4 metres wide by 3 metres high (42 courses). Double windows are laid in between brick veneer panels and separate by painted steel columns. Note the brick veneer shows dirt in the upper portions, typical in many panels. The "private property" signage has a fastener drilled into a brick, which will require repair. This condition is seen in some panels. Note the windows have a yellow tint, which could not be determined if they are original to the building. The lower sashes vary in thicknesses, depending on their operability.

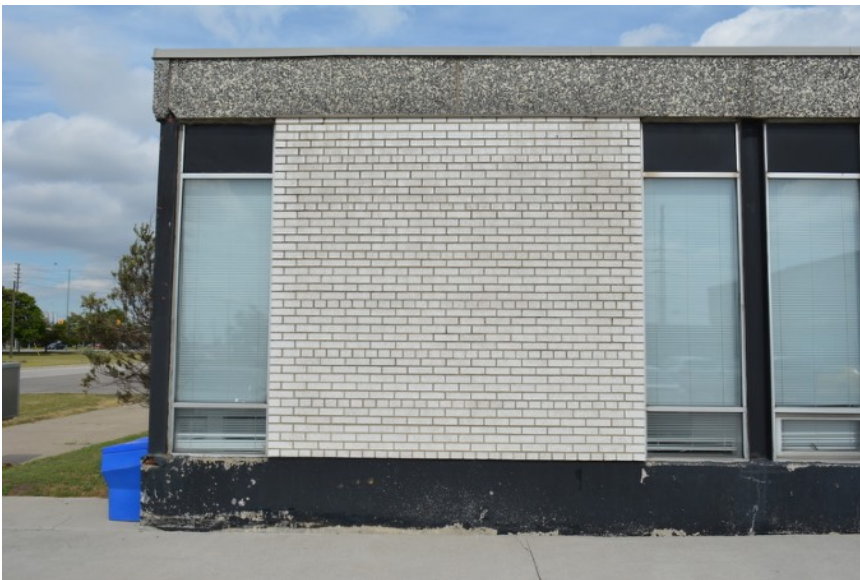
Bottom left:

View of a portion of the south elevation, at the corner. Note the paint flaking from the base and the cracking of the concrete base and aggregate panels, exposing the steel column to further corrosion and deterioration.

The steel columns in between the windows, at the corners and supporting the canopy all show rust near the bases as a result of the cracking of the base. **It is possible that upon dismantling, additional issues may be uncovered that will require consideration. Based on their current condition and the fact that these columns do not hold significant value,** their reuse is not recommended. To mitigate their removal, they can be reproduced in a similar size, shape and colour. Their reproduction will have no impact to the aesthetic of the design.

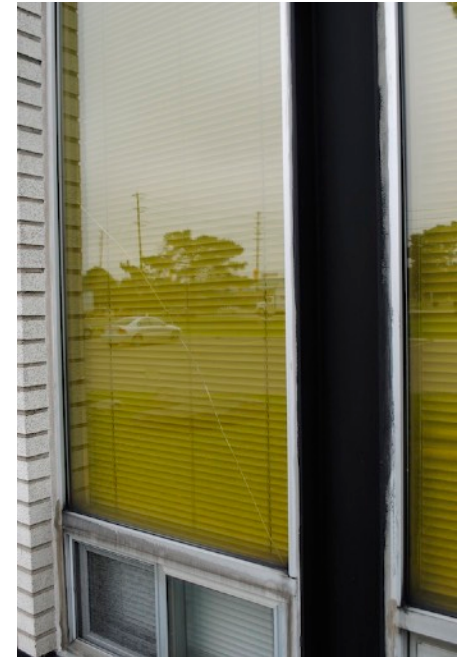
Top right:

Detail of an aluminum window, showing a crack in the single glazing. Note the width of the caulking around the window frame.

The windows, including the display case and main entrance are aluminum framed and single glazed, which do not comply with current code requirements for energy efficiency. The style of the windows and doors are modern and do not hold significant material value to warrant a retrofit of double glazing, which is nevertheless not possible in an aluminum frame. They are recommended for removal. To mitigate the removal, they will be

replaced with new replicas, respecting the same characteristics, including dimensions, size of mullions, material, colour and fenestration patterns, which will conserve the design quality of the building and comply with current building requirements.

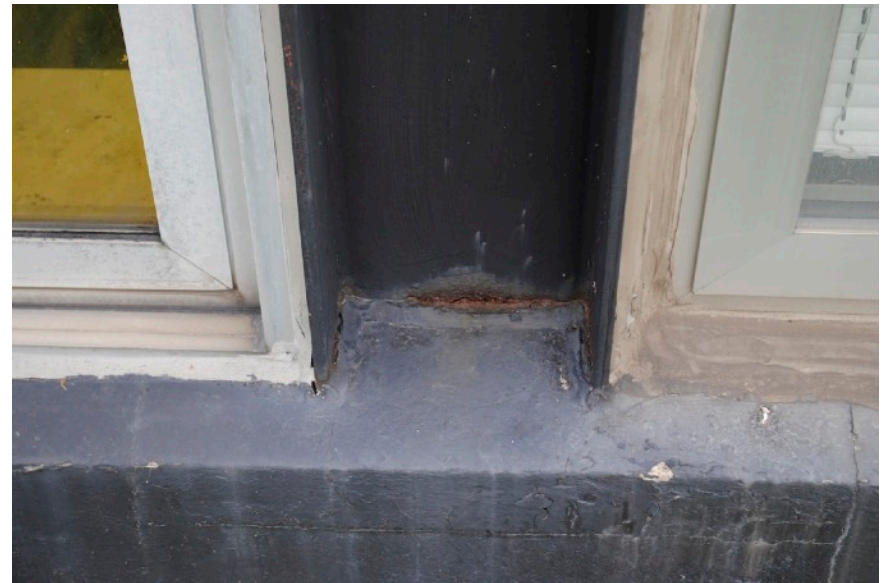
Bottom right:

Close-up view of a steel column with an I-shape profile, separating two windows, which shows initial rusting. Note the very crude application of sealant around the window frame on the right. Window sashes vary in width and may be an indication that some sashes were replaced.

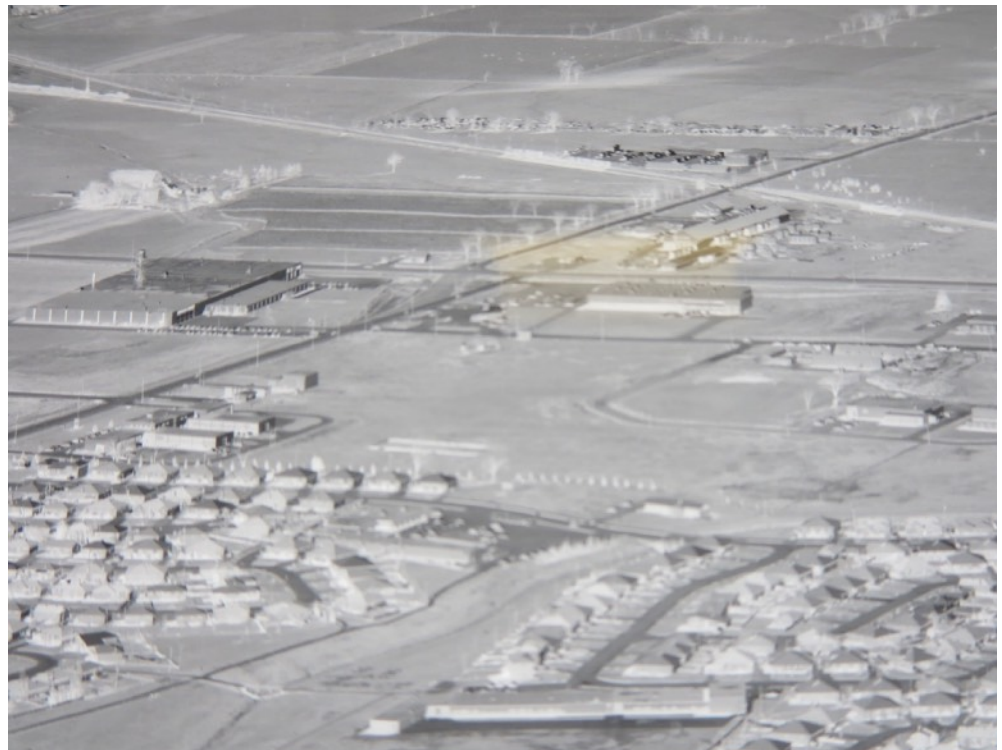
1965 aerial view of Bramalea Satellite City, looking east. The Simmons Canada Company building is shown on the left.
