# INACCESSIBLE BUS STOPS REPORT (WARDS 2&6 OF BRAMPTON)

**PURPOSE:** To find obstacles to accessibility affecting bus stops, and to identify inaccessible bus stops (to riders with mobility issues) located in Wards 2&6 of Brampton.

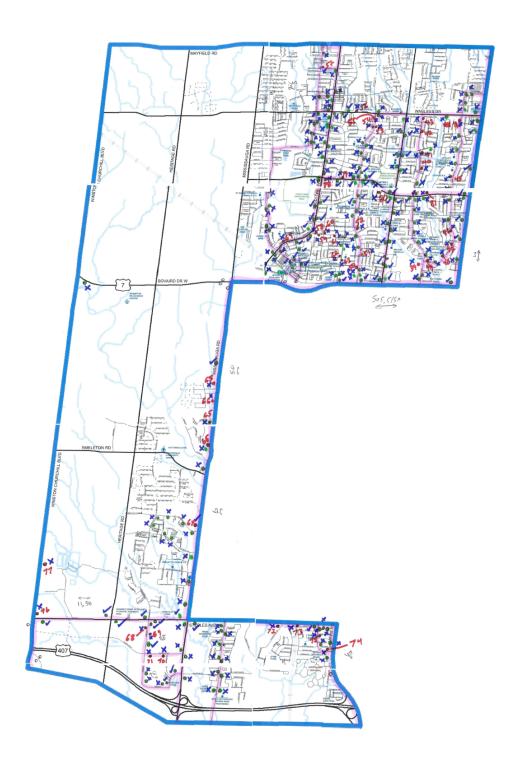
### **WARD 6 MAP WITH BUS STOP OBSERVATIONS**

**OBSERVATIONS:** Please see the maps in the appendices. Please note:

- Green dot means that the stop is accessible
- Red dot means the stop is not accessible
- Blue check mark means that there is a bus shelter at the bus stop
- Blue 'x' means there is no bus shelter at the bus stop
- Red number beside the inaccessible bus stop indicates its number in the photo appendices
