***HERITAGE REPORT:
REASONS FOR HERITAGE DESIGNATION***

***Kilpatrick-Young House
23 Centre Street South***

December 2009

Jim Leonard
Heritage Coordinator
Planning, Design & Development

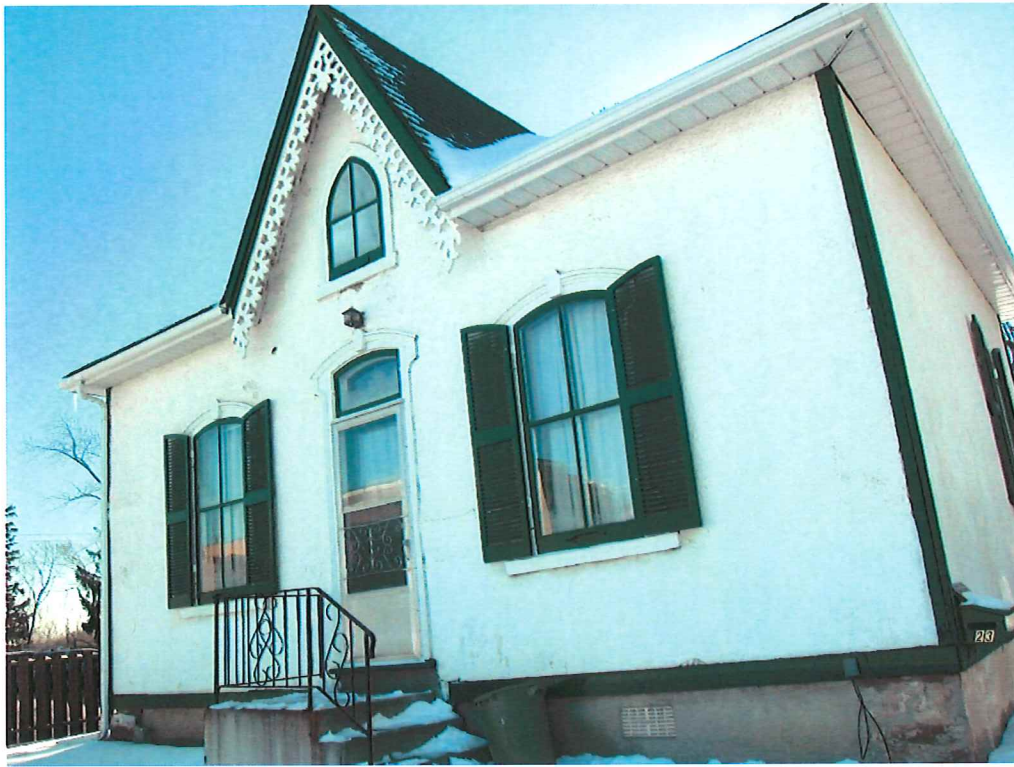
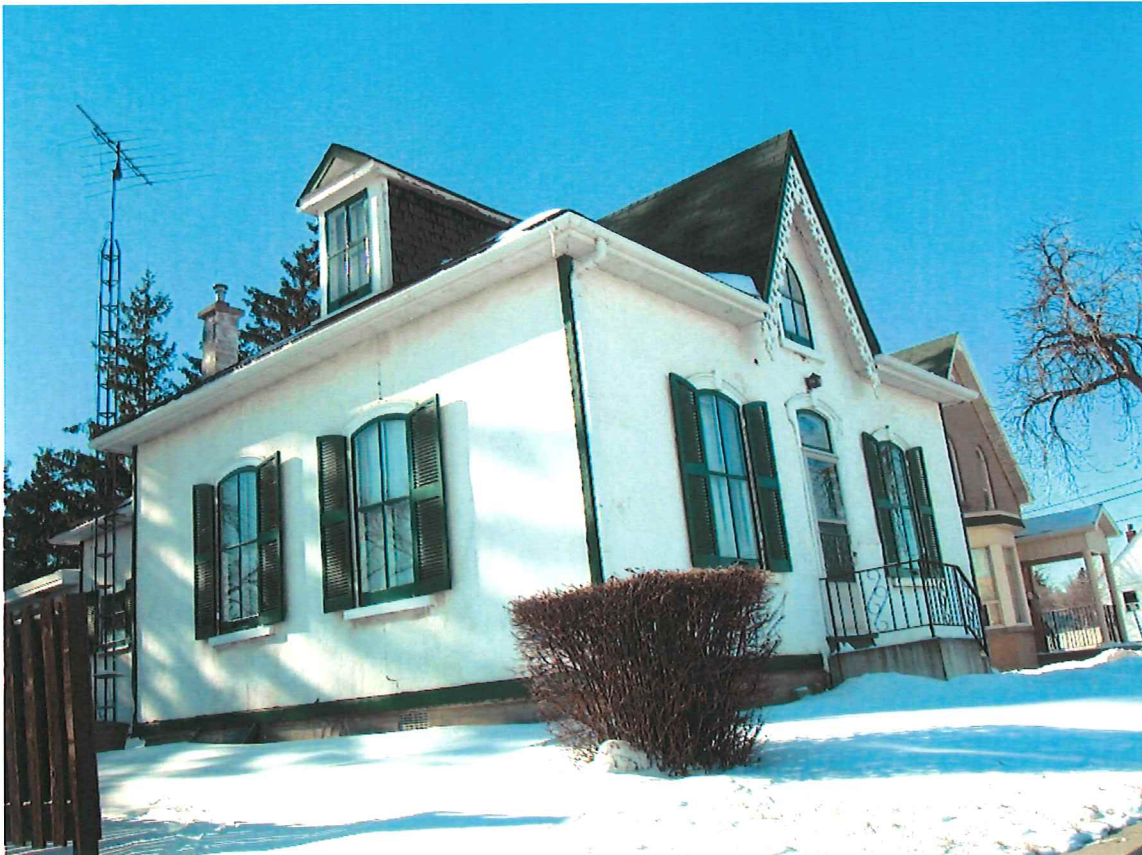
Figure 1 and 2: Views of principle façade of subject property showing fenestration, main entrance, front gable dormer window as well as lawn, and existing landscaping elements.

The front façade of the house has a three bay fenestration on a centre hall plan with a central, gabled dormer with a pointed or "Gothic" window opening inside the dormer. The house has a moderately pitched cottage or hip roof which is typical of the Regency Ontario Cottage style. The primary exterior cladding is pebble-dash stucco. Most windows have gently segmented arched openings and 2 over 2 wood sashes with eared moulded wood surrounds. Enclosed porches, clad in metal siding, are located off the rear wing of the house and also the north side façade. A gabled roof dormer projects out of the roof on the south side elevation.

- well articulated three bay front fenestration;
- steeply pitched front gabled wall dormer with pointed Gothic window;
- highly decorative vergeboard decorating front dormer;

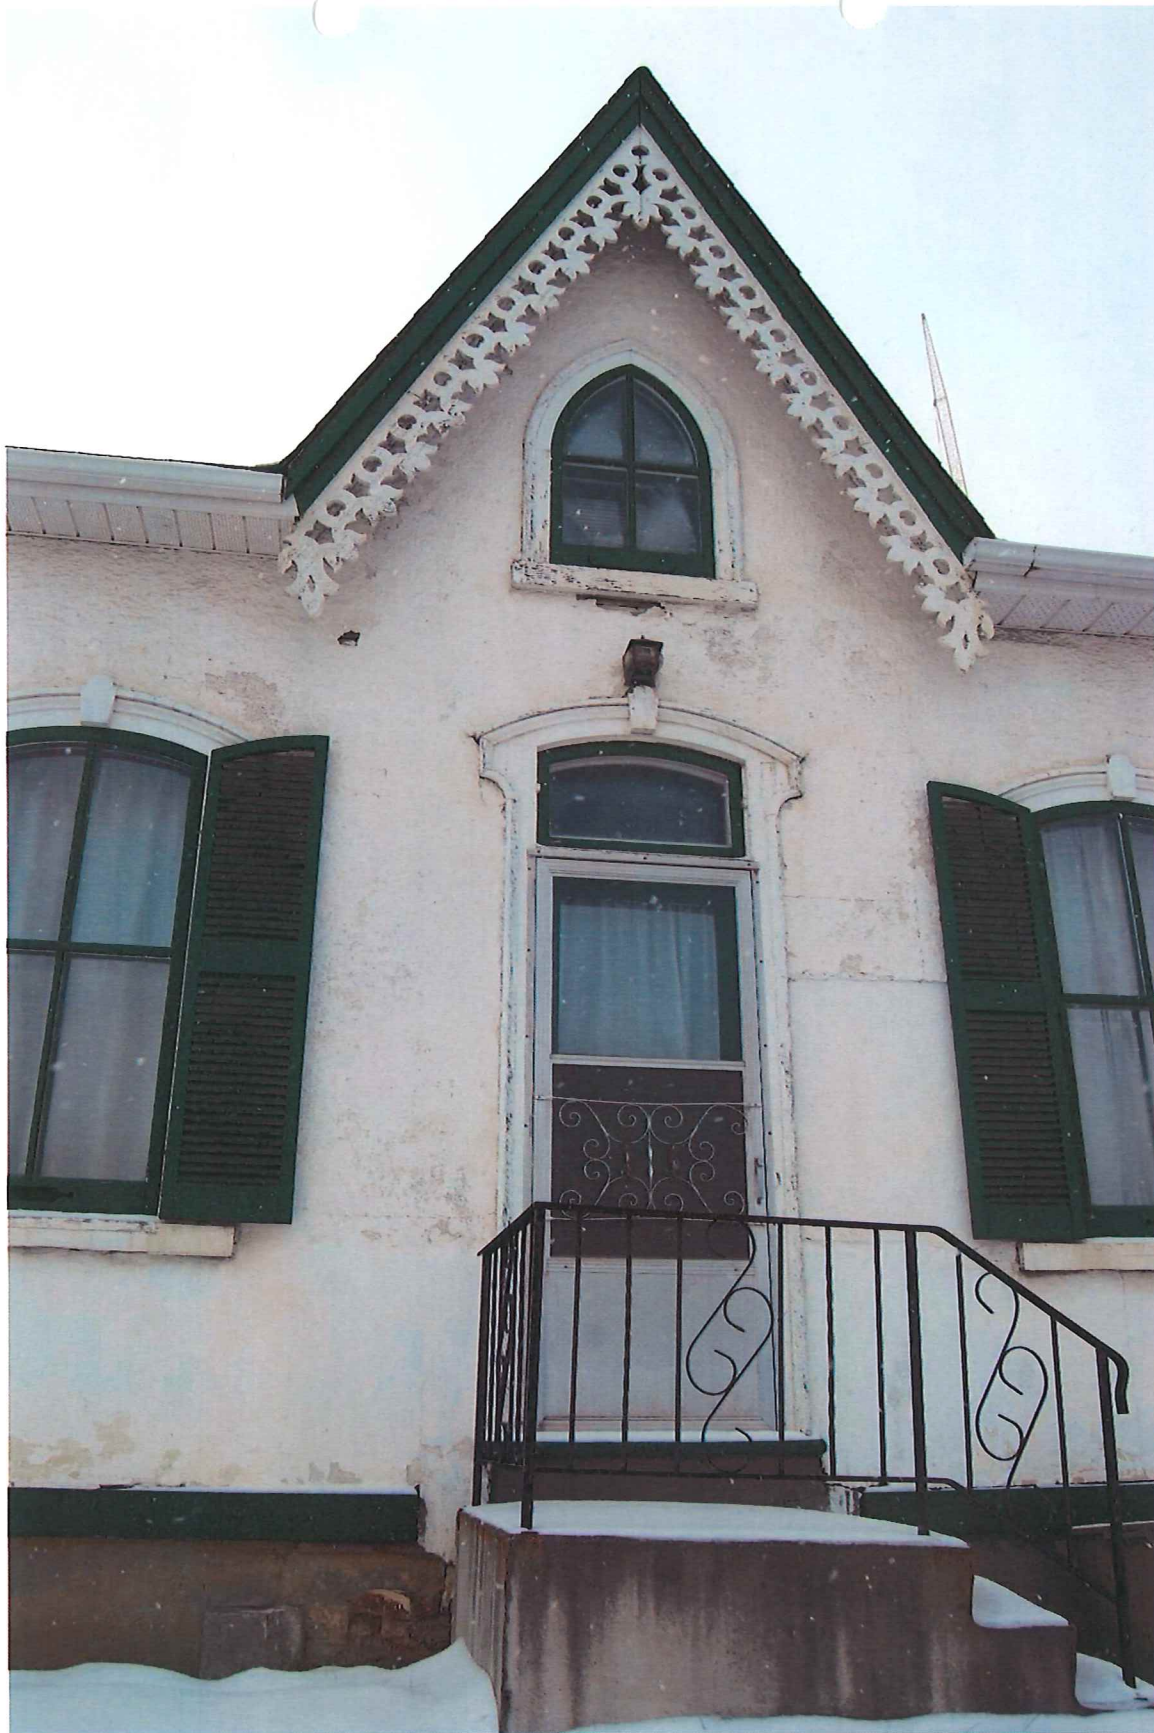
Figure 3: Detail shot of single-leaf front door, fixed transom and moulded eared architrave surrounding door opening; also the gabled wall dormer with pointed Gothic window and highly decorative wood vergeboard trim.

The house also reflects a high degree of craftsmanship. The front facade is particularly well articulated by the central door, gabled dormer window with decorative vergeboard and a pointed Gothic window (elements shared with its stylistic cousin, the Ontario Gothic style). Also noteworthy is the eared main door architrave, moulded eared wood trim surrounding most windows and main door, also the wood storm windows, and the highly decorative vergeboard that decorates the front dormer,

- wood shutters and associated hardware;
- 2/2 wood sash windows, with eared wood window surrounds and wood sills;
- paneled, single leaf front door, door opening, moulded eared surround and fixed transom;

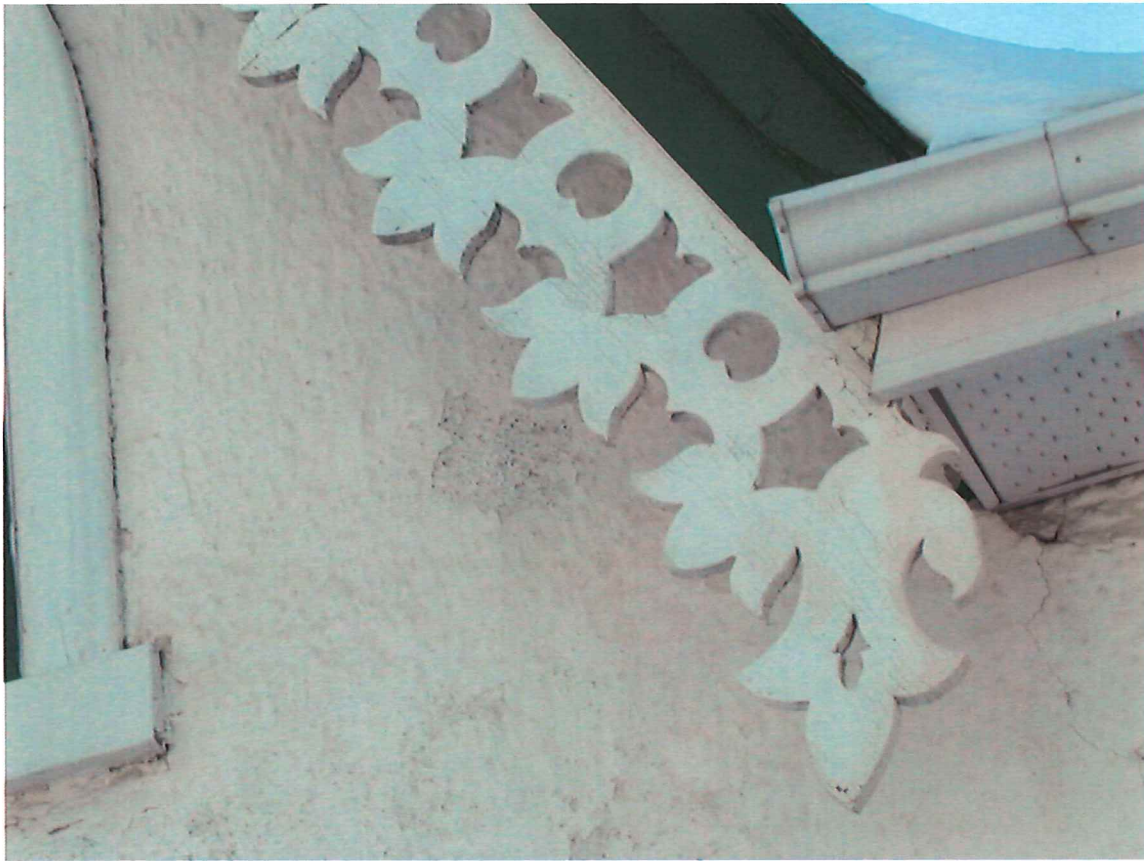
Figure 4: Detail of decorative vergeboard on front gabled wall dormer.

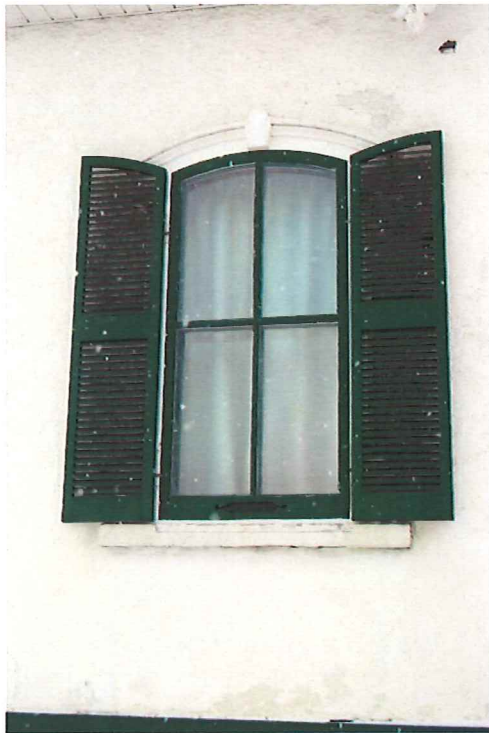
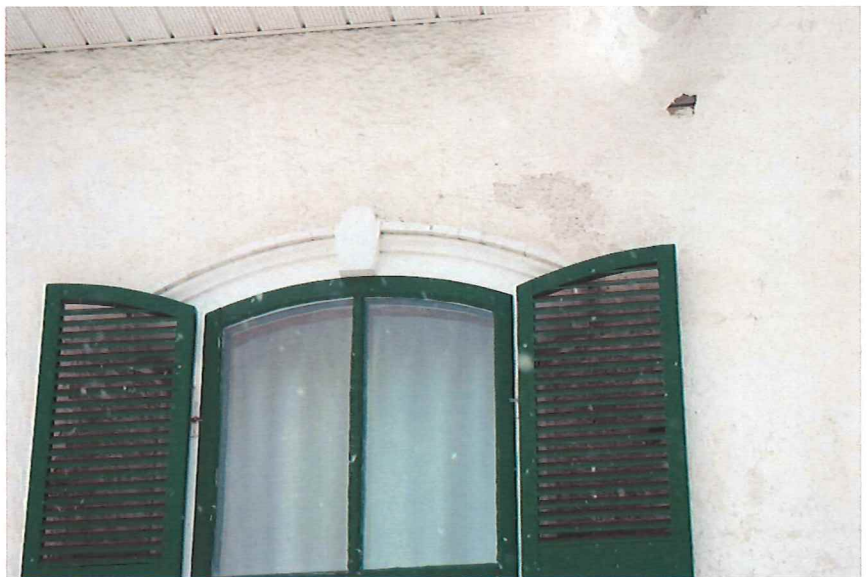
Figures 5 and 6: Details of south side showing moulded window surround, segmented arch over window, storm and wood shutters

- all window openings; most of which having eared architraves and gently segmented arches, moulded trim elements and sills;
- wood storm windows with decorative vent openings through bottom rail;
