**HERITAGE IMPACT  
ASSESSMENT**  
for  
**31-33 George Street North  
(including 28 Elizabeth Street North)**  
Brampton, ON  
(GBCA Project No: 21003)

Date of First issue: 15 October 2021  
Date of Second issue: 10 May 2022  
**Date of Third issue: 11 August 2022**

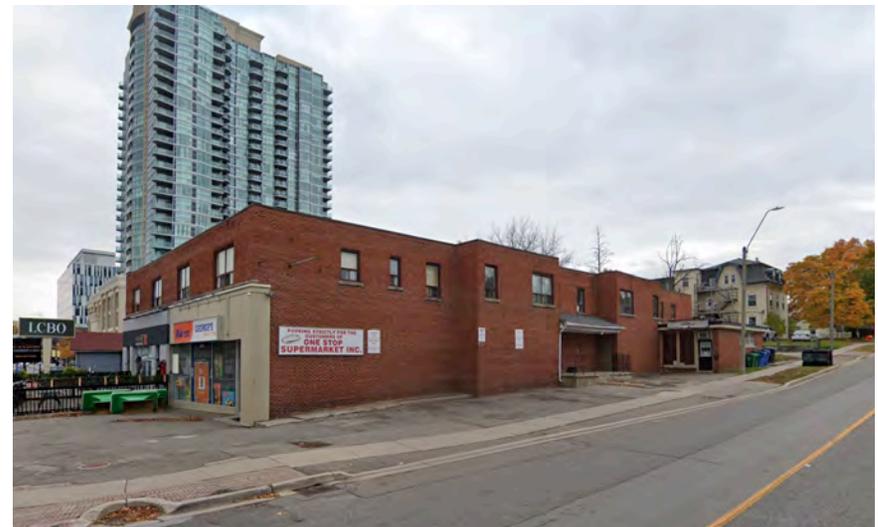
View of the development site, looking south along Nelson Street W, showing grade change between commercial structure at 31-33 George St N and Haggertlea (far right)

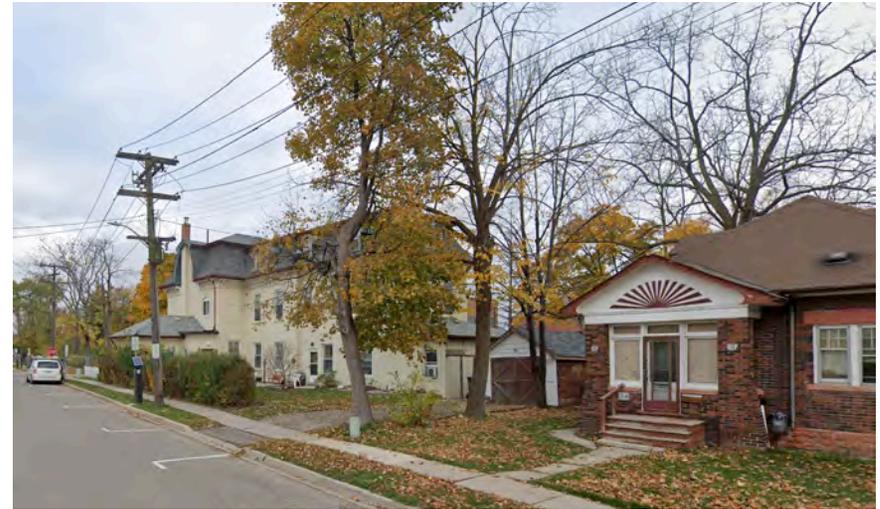
View of the development site, looking north to Haggertlea from Elizabeth Street North, showing the building's original south elevation, and extensions, with stand alone one-storey frame garage to the east. 24 Elizabeth Street North is in the foreground.

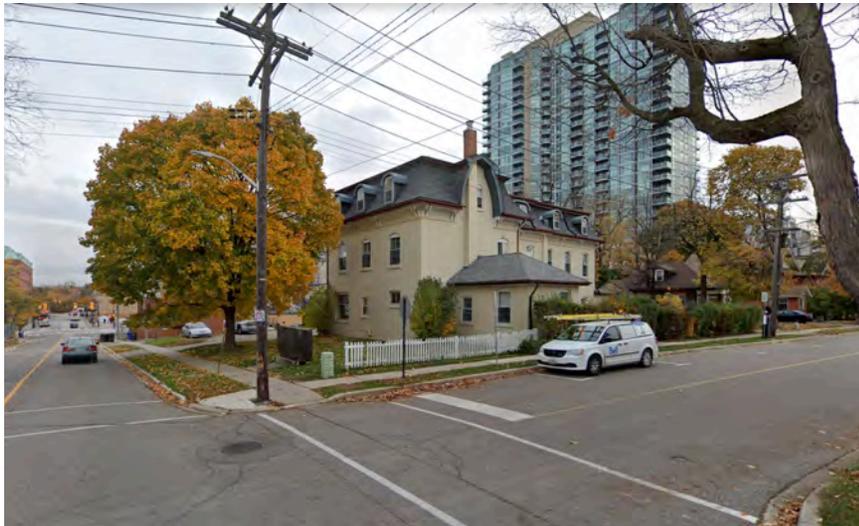
View of development site, looking towards Haggertlea from Nelson and Elizabeth Streets intersection, showing the one-storey c.1911 extension along Elizabeth Street North.

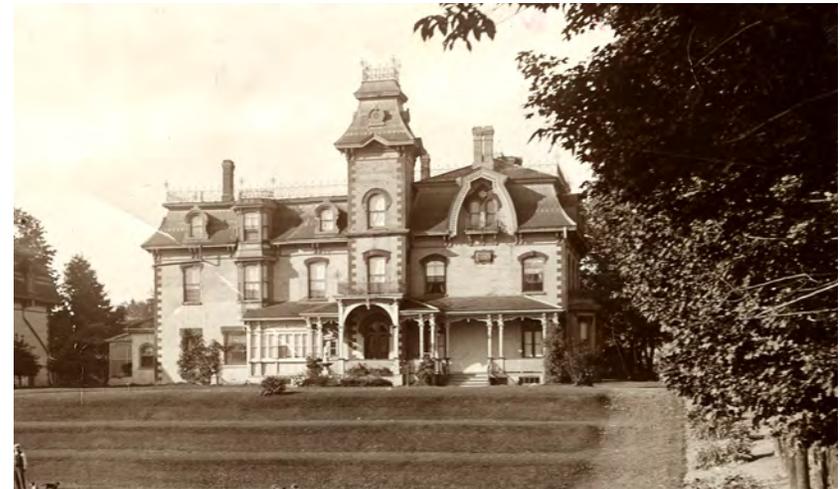
*View of the main elevation, n.d., showing the one-storey brick extension, prior to c.1925 extension, at east elevation with rounded-arch window; the north elevation veranda, with original one-storey wood cladding at sunroom; tower detailing; and bay window at west elevation; which corresponds to c.1910 photo.*

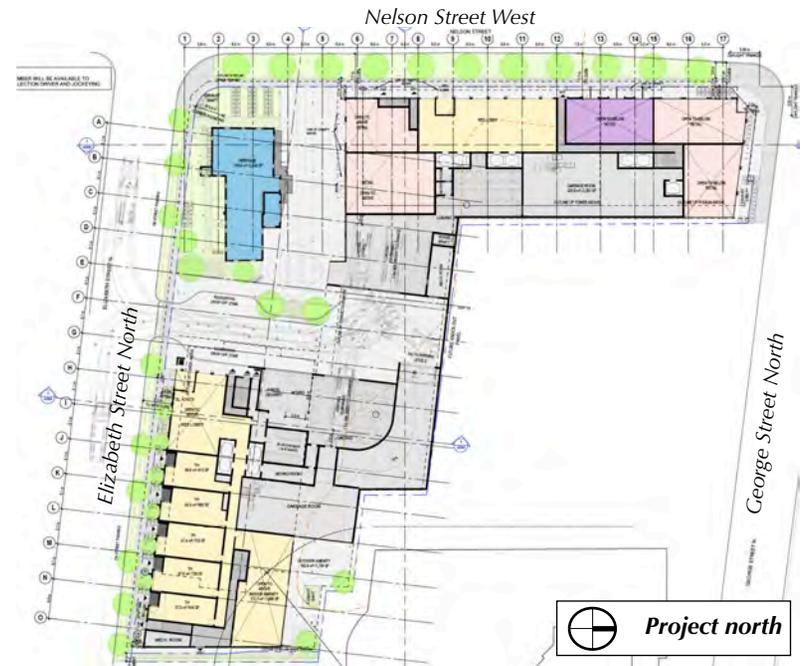
*Ground floor plan of the proposed development, showing the proposed podium adjacent to the existing Haggertlea building, with adjacent public plaza adjacent to the former main facade (Sweeny & Co Architects AZ205 dated 2022.08.05).*

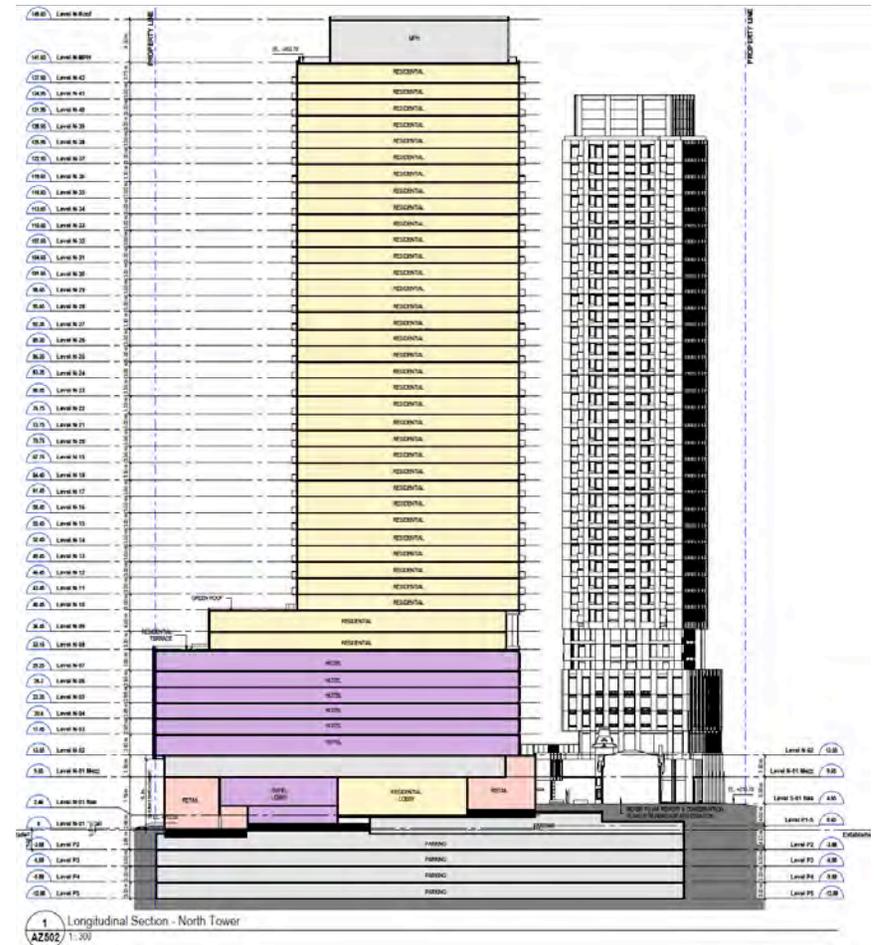
Section of the proposed development, parallel to Nelson Street, showing the proposed podium adjacent to the existing Haggertlea building, with adjacent retail programming at ground floor, and parking levels below. The adjacent public plaza provides an intermediary space of approximately 12m between the former main facade of Haggertlea and two-storey podium step-back. The Tower 2 beyond Haggertlea, fronting Elizabeth Street, is shown here as an outline. (Sweeny & Co Architects AZ502 dated 2022.08.05)

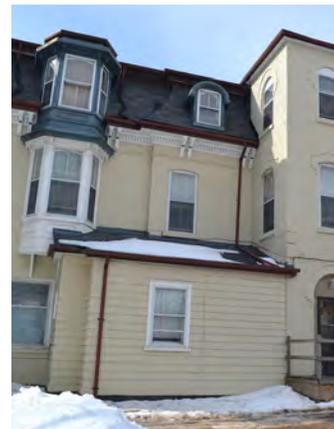
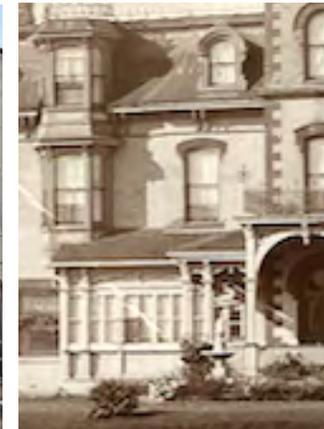
- (left) View of north extension, existing condition showing non-sympathetic wood cladding and new window unit.
- (right) Archival documentation showing original design of north extension, c.1900, as extension of original veranda.

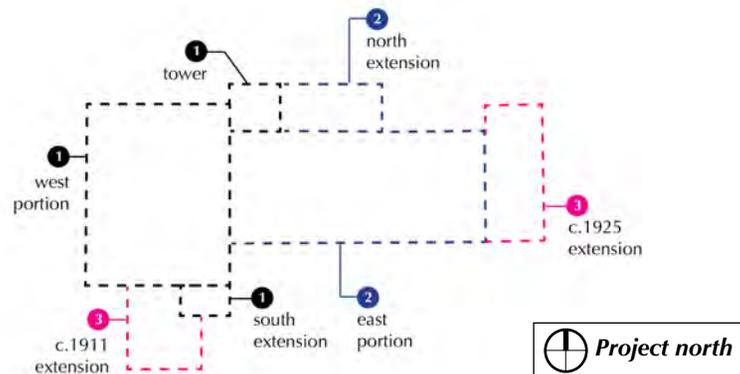
Key Plan of Haggertlea Building Phases and naming conventions for the purpose of this report. Refer to Section 2.2 ‘Architectural Background’ for details.

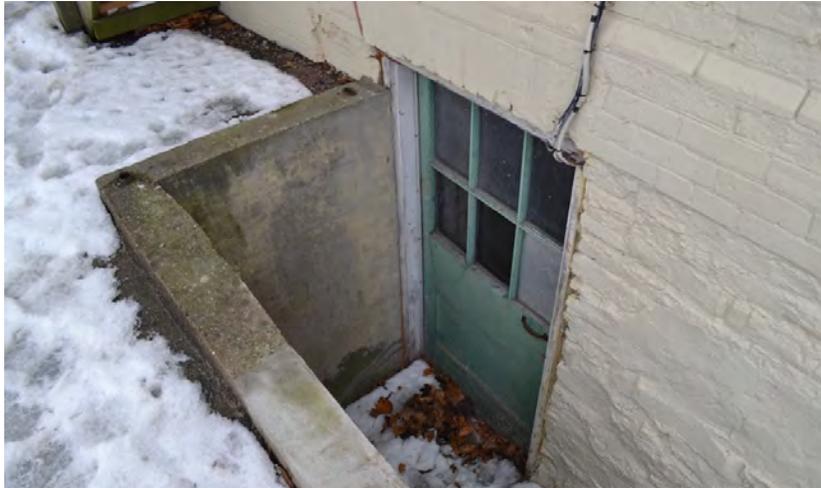
Basement entrance at main elevation, showing extent of brick infill at rubble stone foundations.

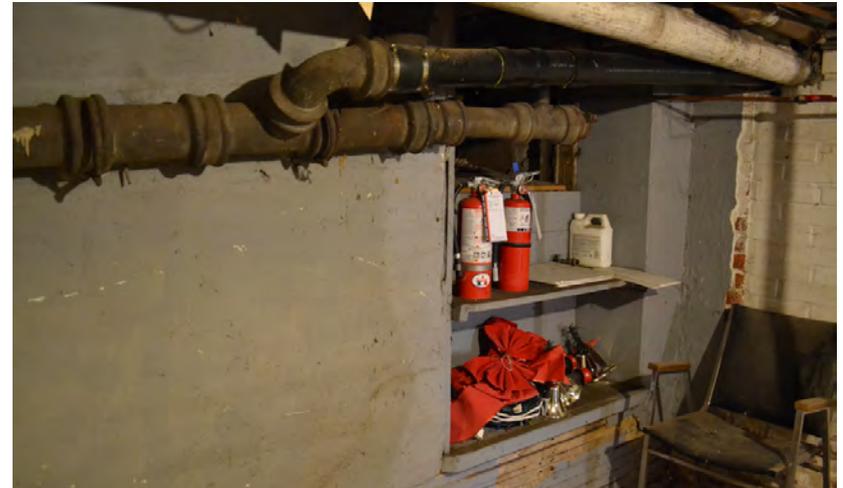
West portion rear foundation wall, view from interior, showing lath and plaster, and altered window opening (adjacent to later south and c.1911 extensions along Elizabeth Street North).

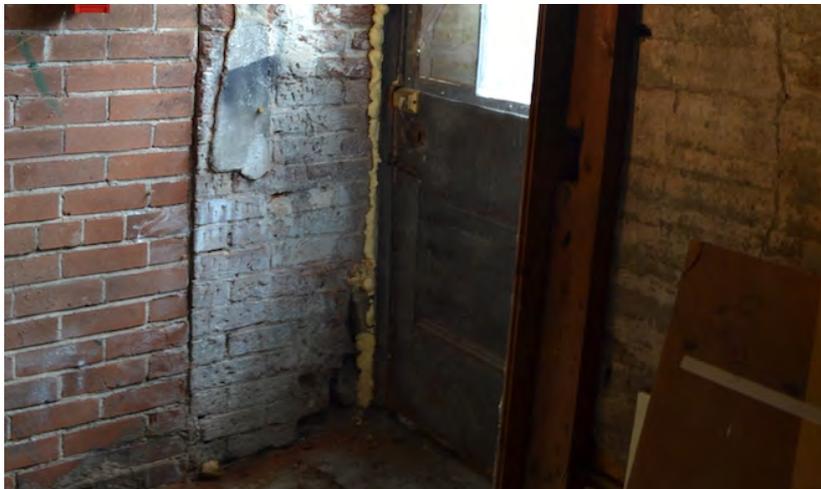
Basement entrance at main elevation, view from interior, showing extent of brick infill at rubble stone foundations, with new adjacent brick interior partition wall.

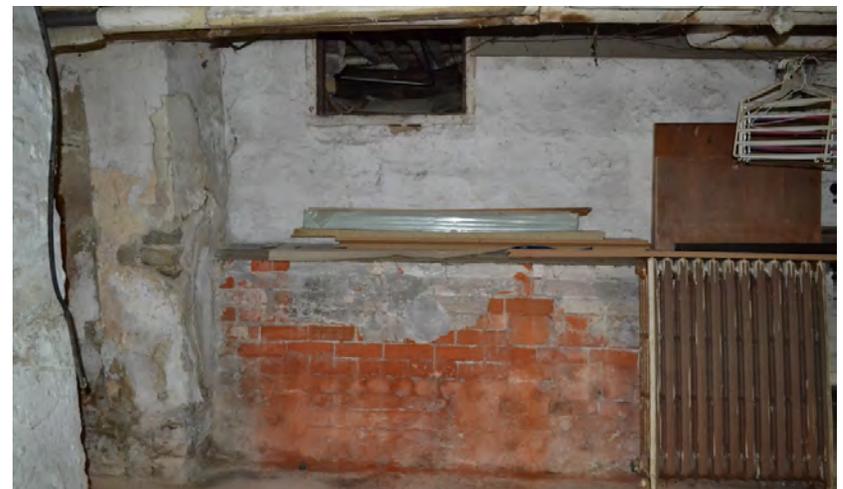
East portion main elevation foundation wall, view from interior, showing opening within original rubble stone foundation at left, and the continuous brick buttress.

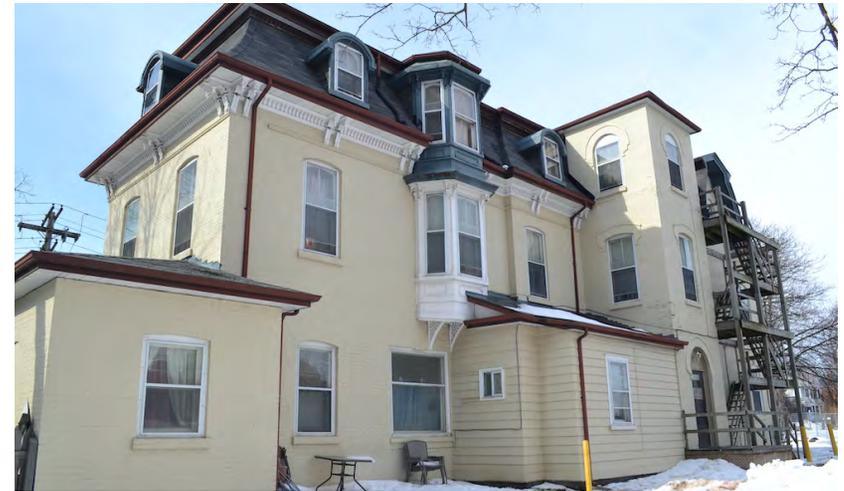
*View of the main (north) elevation, showing tower, east portion, north extensions, and c.1925 extension.*

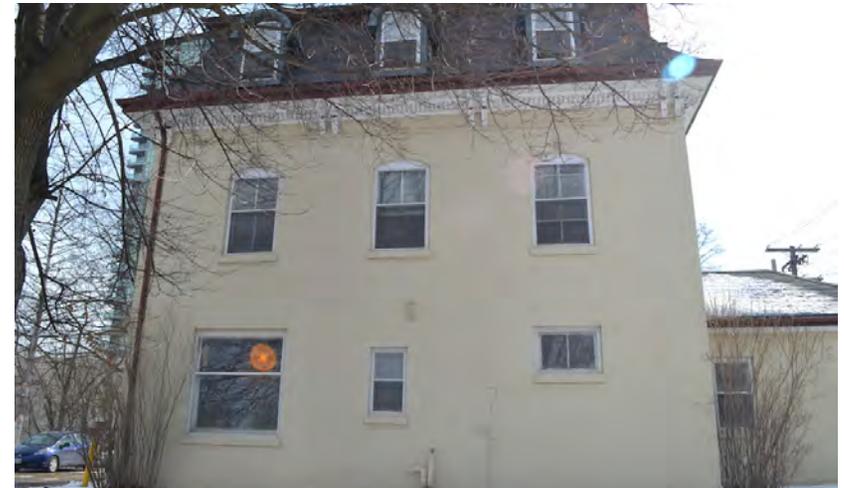
*View of west elevation (along Nelson Street West), showing west portion, and c.1911 extension to the far right.*

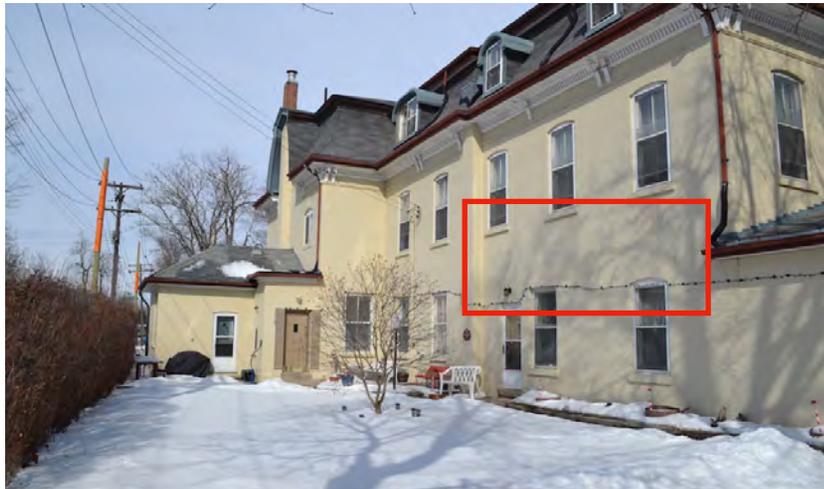
*The east portion displays a significant bulging of the exterior brick wall at the second floor level, above the original extent of the one-storey "running bond" (clip-bond) brick construction, above which a second floor with exterior common bond brick walls was constructed.*

- Remove non-sympathetic contemporary wood fire escape and porch along the main elevation.
- Stabilize and repair brick masonry wall where bulging of brick was noted at south elevation; install helical ties where required. The area may need to be carefully dismantled and reconstructed based on detailed investigations.

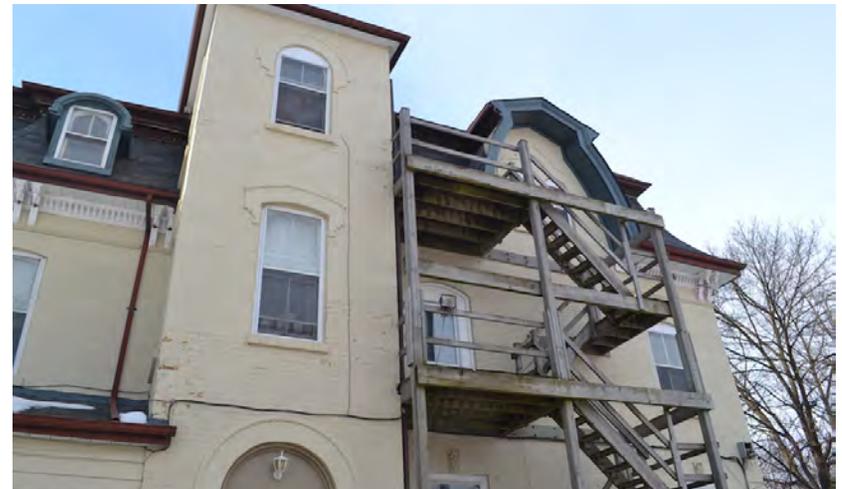
- Several failed brick voussoir components observed at west portion, typically in fair to poor condition.
- Chipped and cracked bricks at voussoir dripstone moulding (tower).

*Chipped and cracked bricks at voussoir dripstone moulding of second floor window; Localized areas of deteriorated brick at tower elevations to be further investigated; non-sympathetic wood fire-escape to be removed, and adjacent masonry investigated.*

- Repair brick voussoirs; these may need to be dismantled and re-set where required.
- Repair bricks where damaged and repoint mortar joints, where required.

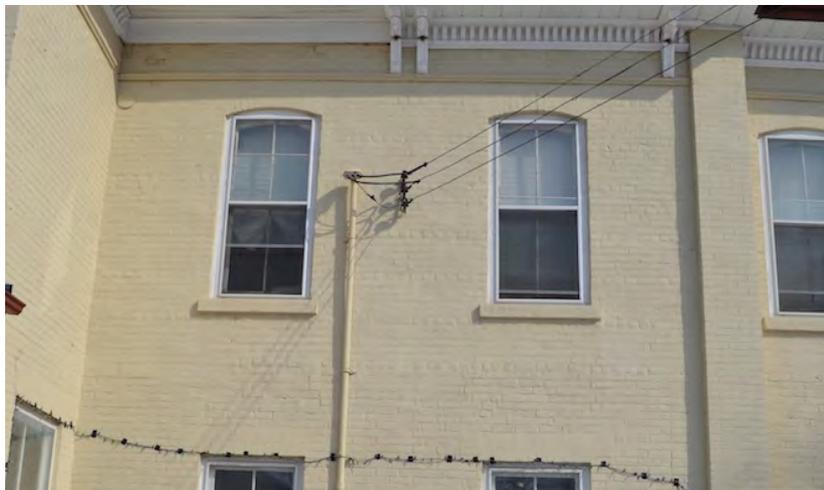
*Cracks found throughout at window sills, voussoirs, and arches (flat and segmental). Significant continuous crack to be examined along the east portion Elizabeth Street N elevation, shown above.*

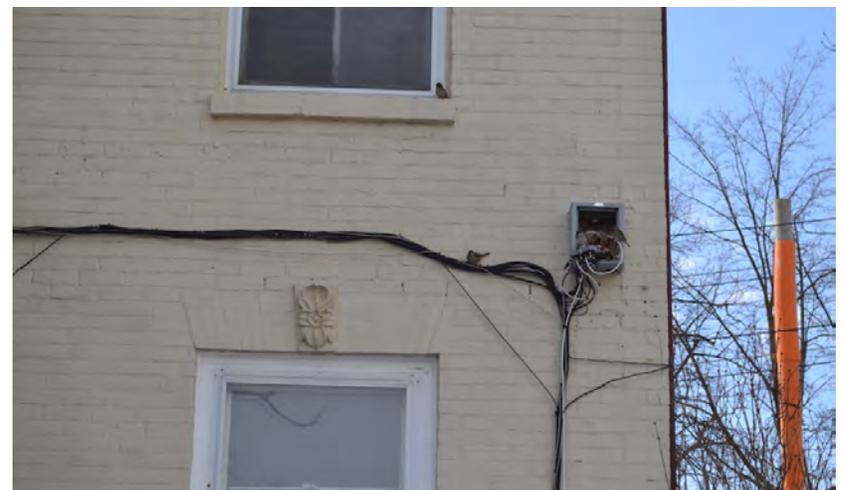
*Stepped crack above brick voussoir, typical (shown: main facade ground floor at west portion); typical miscellaneous electrical units to be removed from masonry; chip at second floor stone still.*

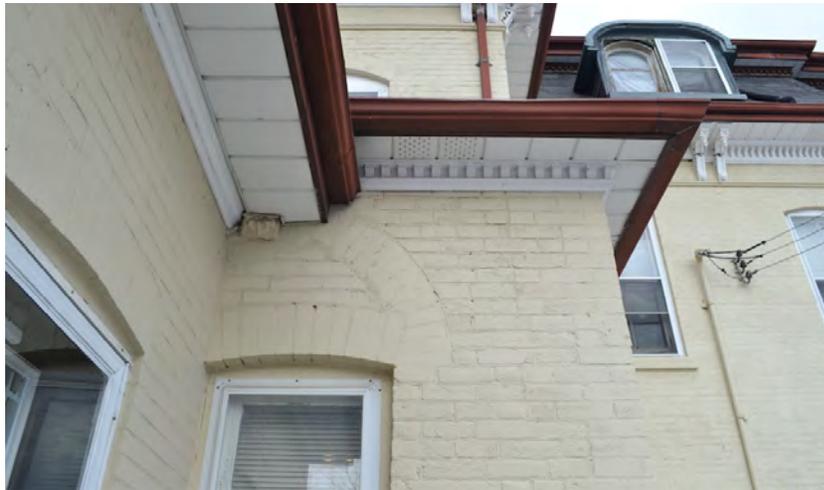
*Obstructed brick voussoir and flower-themed keystone combination at ground floor window, where c.1911 extension abuts the original one-storey south extension the (rear) Elizabeth Street North elevation.*

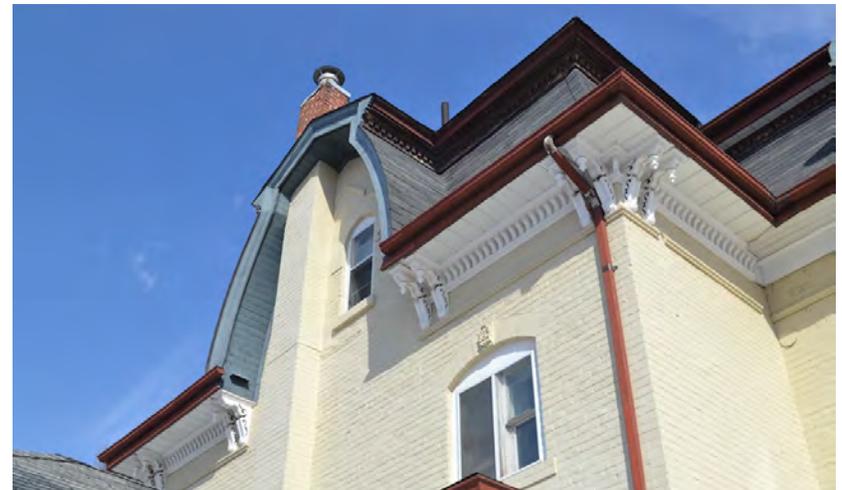
*Chimney obstructing previously paired window with combined brick voussoirs at third floor (attic) of west portion, along the Elizabeth Street North elevation; Showing altered window rough opening and non-sympathetic contemporary window at second floor, above original south extension.*

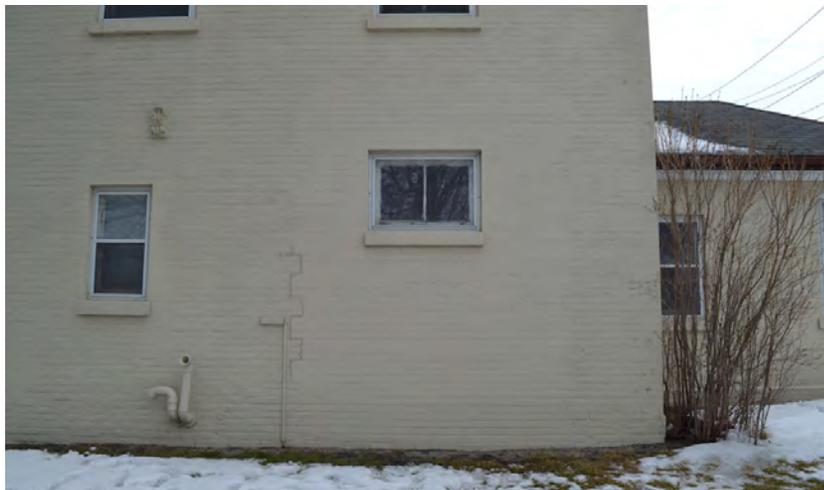
*Non-sympathetic contemporary window at West elevation, at the location of an original one-storey bay window (since removed) showing recent non-sympathetic repointing repairs at joint line between original and non-original brick of infill at removed one-storey bay window.*

- Further investigations are to be completed as to the feasibility of restoring the original bay window(s) along the West elevation.
- The removal of existing, non-original, fenestration and door openings at ground level will need to be evaluated once interior programming is confirmed. Further investigations are to be completed where archival documentation is limited (south elevation).

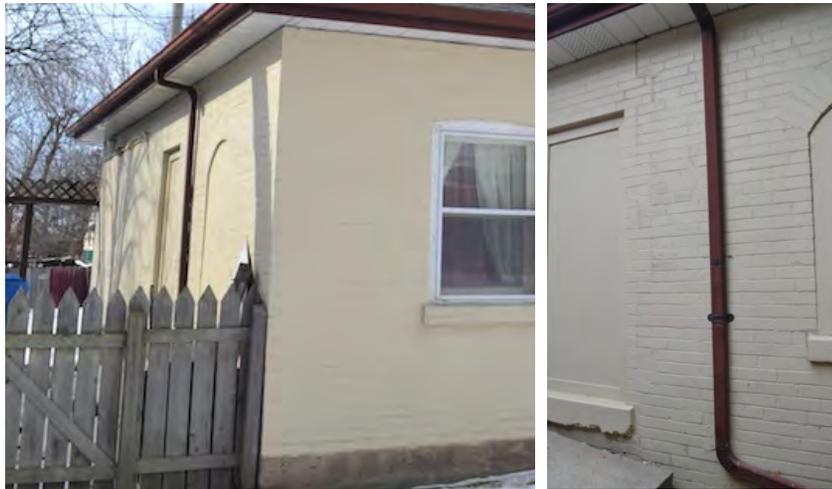
*(left) Showing one-storey brick c.1925 extension east elevation, with detail at (right) showing the continuous joint line between infilled doorway and window which differentiates the brick bond construction types: running bond on left, toward the south elevation; and inconsistent common bond at right, toward the main elevation.*

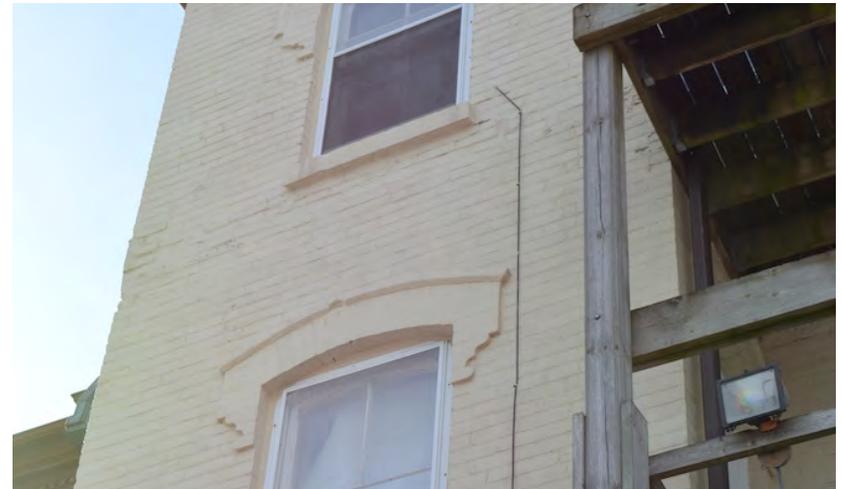
- Deteriorated brick at localized areas in poor condition, to be investigated at tower and main elevation (east portion).
- A moderate number of mechanical penetrations and anchor holes were observed at all elevations.

*Detail view of brick deterioration at main (north) elevation tower, typical localized condition at the tower, and chipped brick dripstone at second floor voussoir; showing area between second and third floors.*

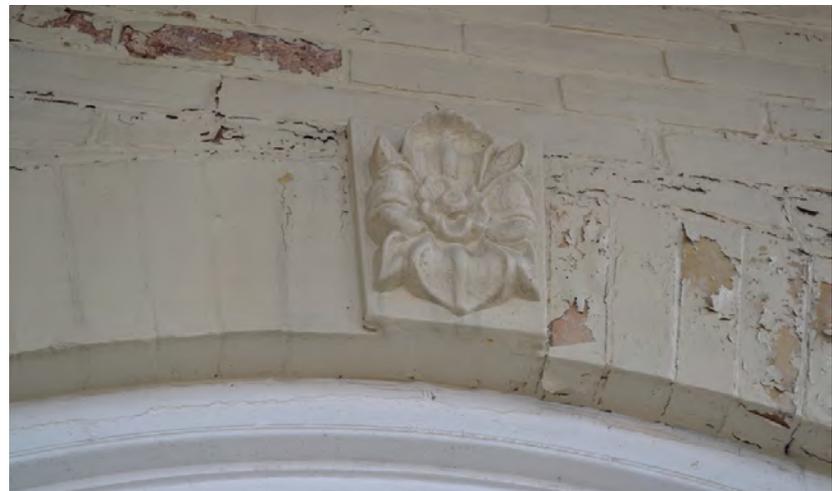
*Paint flaking throughout; showing second floor window at main elevation, west portion, and characteristic flower-themed keystone set within segmental arch.*

- Remove paint from bricks and clean all surfaces; exposing original diachromatic brickwork.
- Conserve all original window units; including the two-storey detailed bay window with brackets and spindles; repair where required.

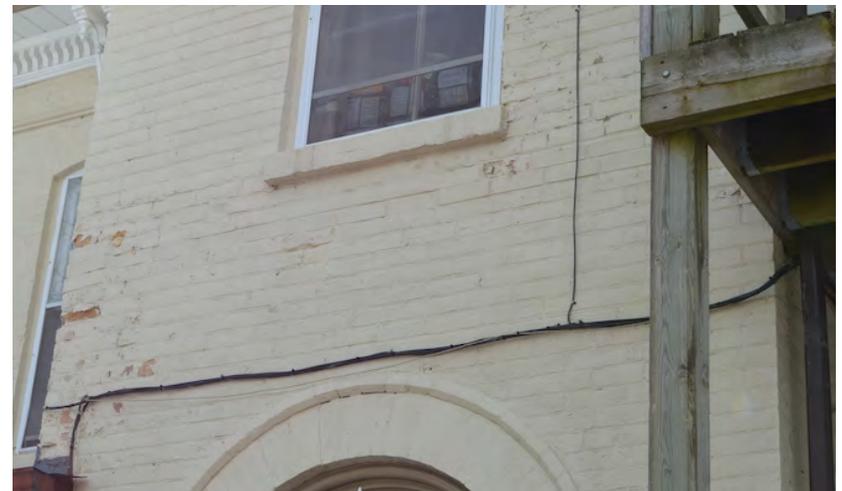
*Detail view of brick deterioration at main (north) elevation tower, typical localized condition at the tower, showing area between ground and second floors.*

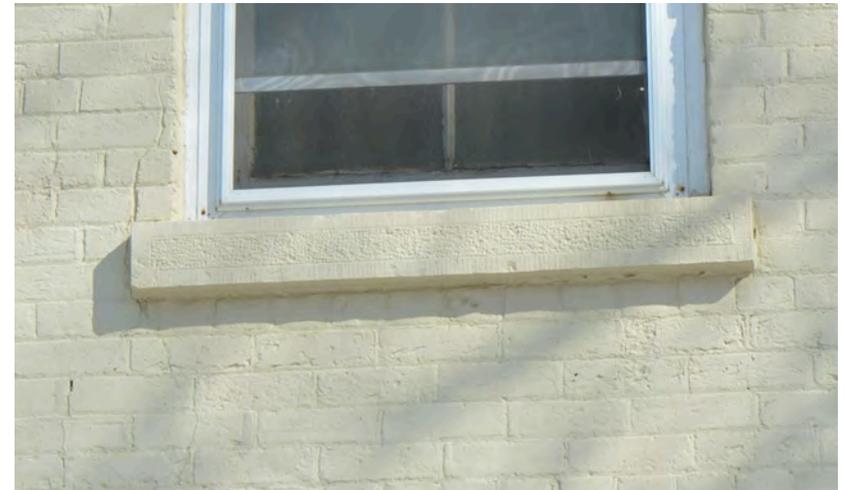
*Detail view of punched sill, typical of second floor at east portion, as well as two units found at ground floor of c.1911 extension (west and south elevations).*

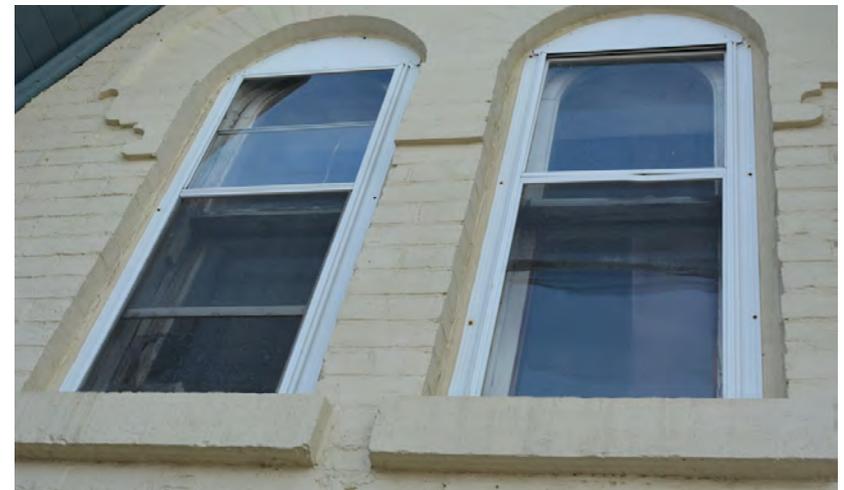
*Detail view of typical stone sill, with minor chips; showing condition at main (north) elevation, third floor paired windows.*

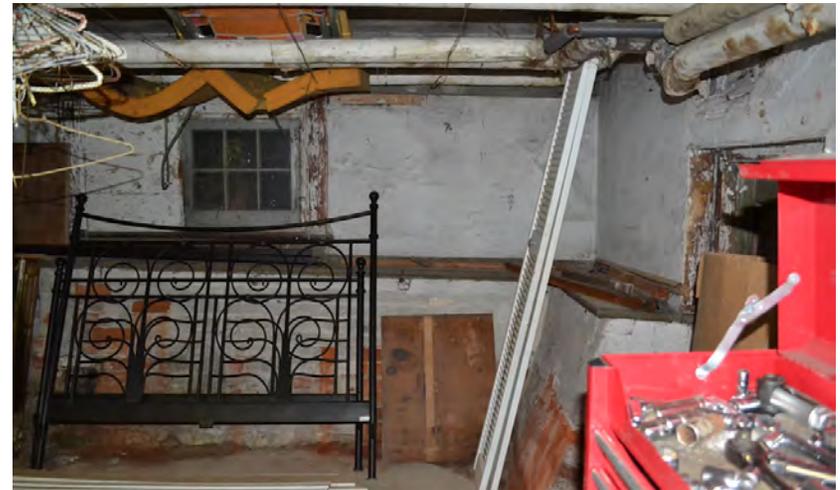
*Original six-pane window at basement level of east portion, no longer with access to its adjacent exterior space (at main elevation).*

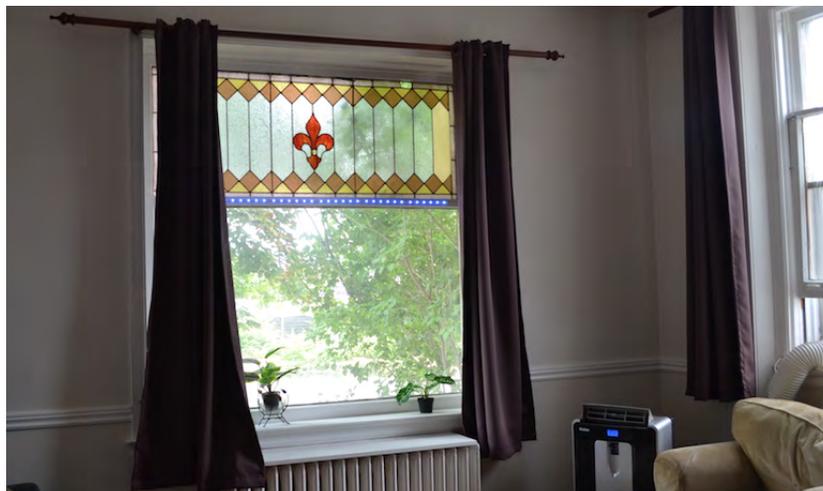
*Interior view of the Nelson Street West leaded-glass window at ground floor of west portion. Though a non-original window opening (previously a one-storey bay window), this window glazing has been identified as a heritage attribute.*

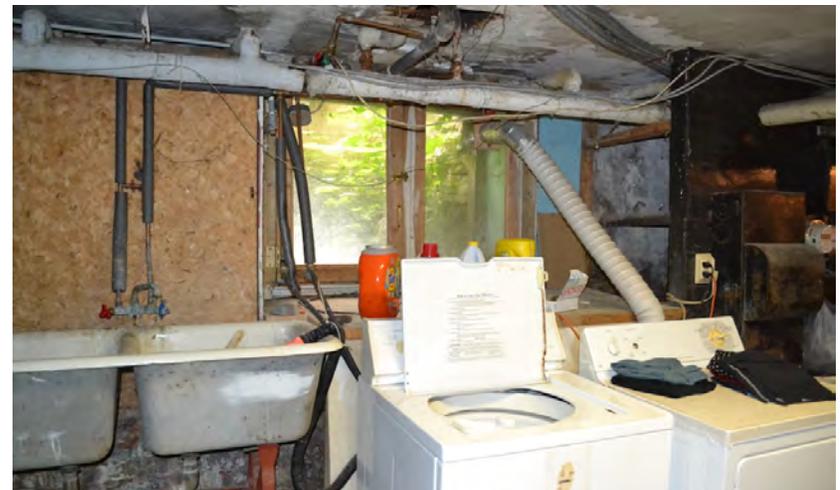
*Original rough opening with new casement window at basement level of east portion (south elevation).*

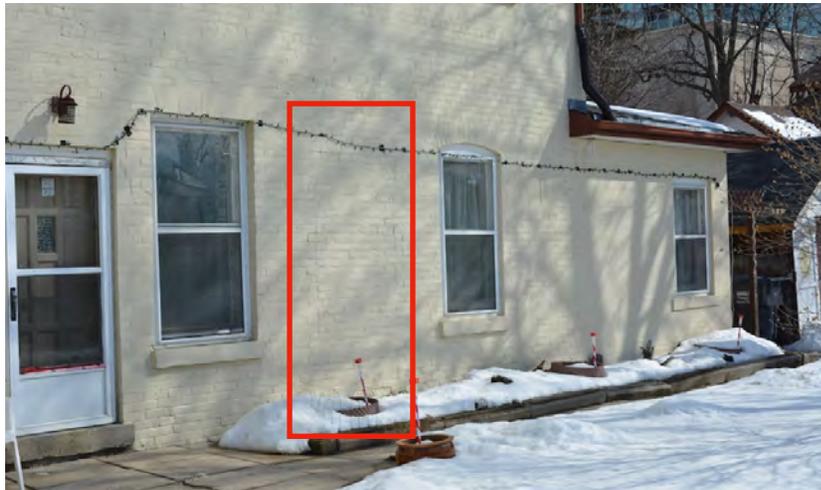
View of the south elevation windows and non-original door at east portion. This area has seen alterations in its fenestration, as shown by brickwork investigations (there was likely a door previously situated at area highlighted red).

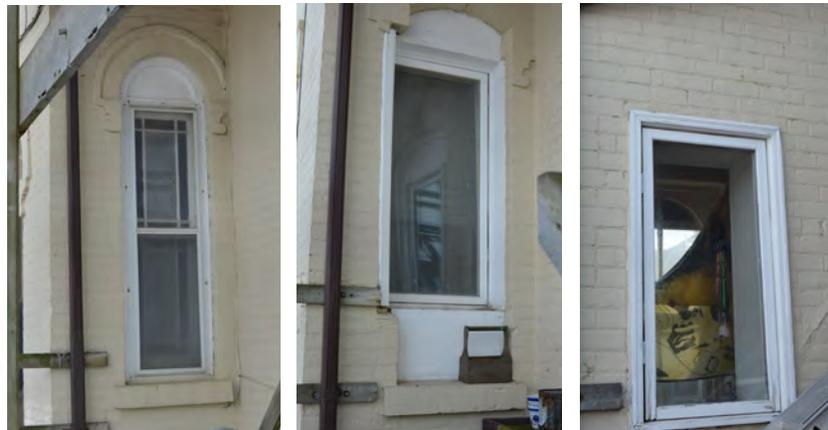
(left) View of original tower ground floor (main elevation) window with coloured glazing set within wood muntins, within rounded arch wood frame.  
 (mid) Altered second floor tower (main elevation) window, with modifications made to its rough opening to accommodate new frame.  
 (right) Typical non-original window at third floor tower (main elevation) and removed section of mansard roof, adjacent to the new fire escape.

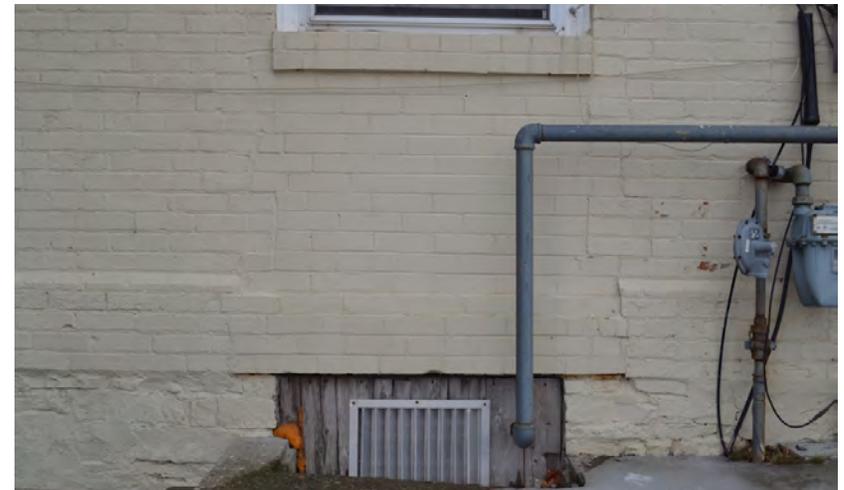
Alterations made to the ground floor windows at main elevation, where previous doorway rough openings were infilled with new brick, at removed veranda, showing a disruption in the original brick chamfer at building's base. New brick sills are additionally typical at these alterations.

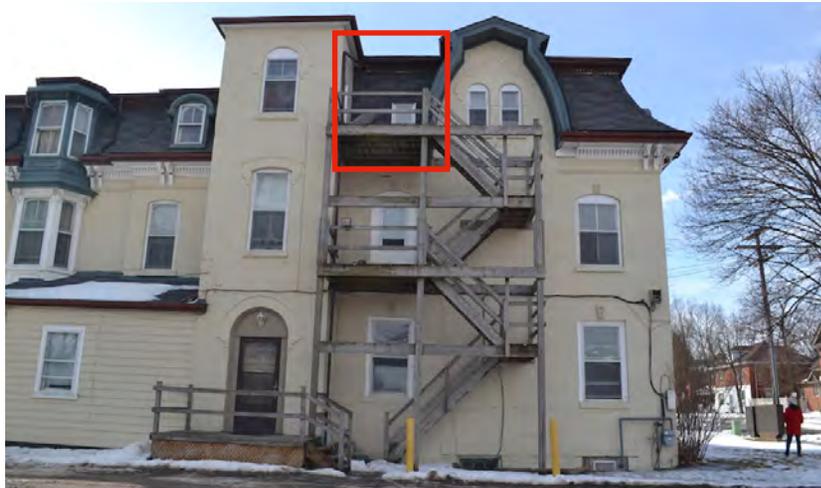
*View of main elevation, showing area where mansard roof removed, highlighted red, today replaced with elevation of asphalt finish.*

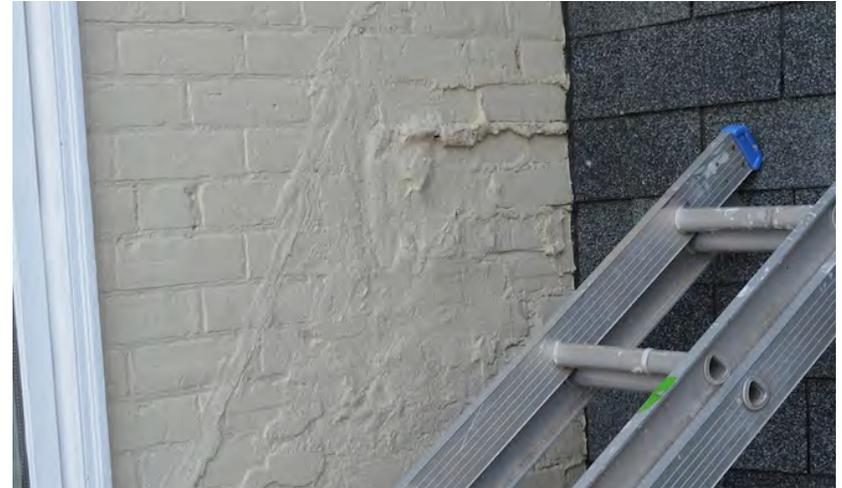
*Remnants of removed mansard roof section visible at adjacent tower brick elevation (main elevation).*

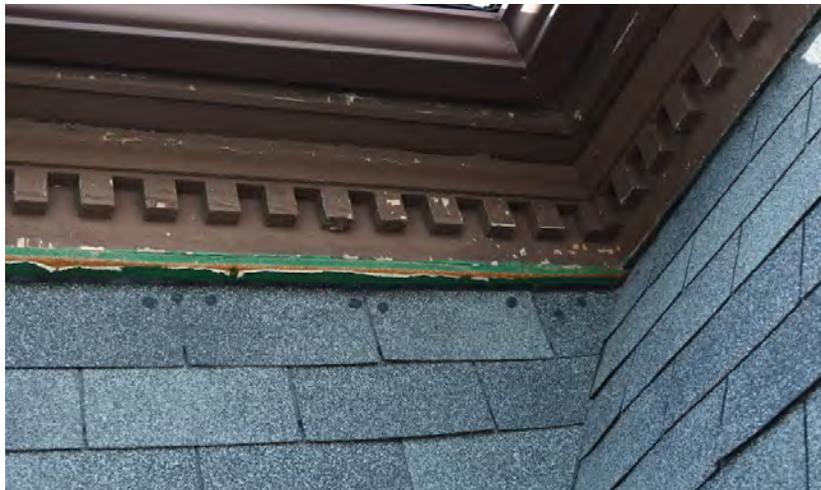
*Detail view of main elevation, where convex mansard dormer meets the new asphalt elevation; showing typical wood cornice with dentils.*

- Restore missing decorative cornice details, including wood brackets and dentils, to match existing.
- Restore missing iron cresting where applicable at existing and/or restored condition to match archival documentation.

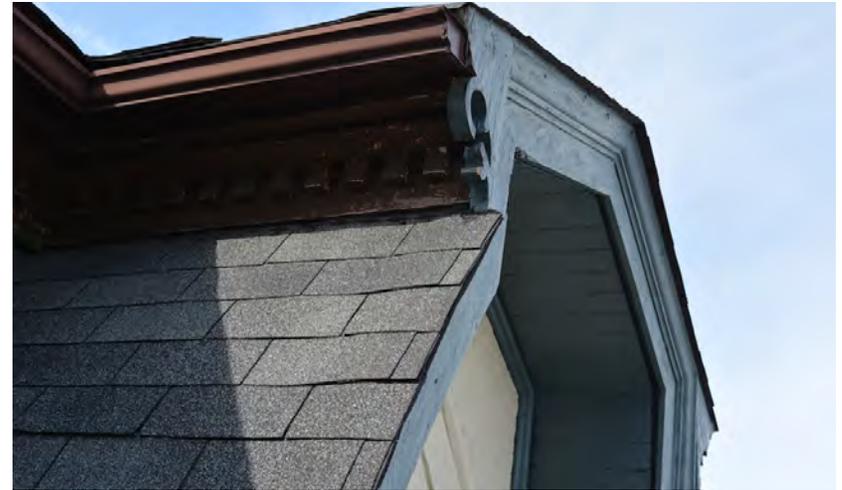
*Detail view of typical mansard dormer trim detail with bracket; note the original wood soffit is intact (view of main elevation)*

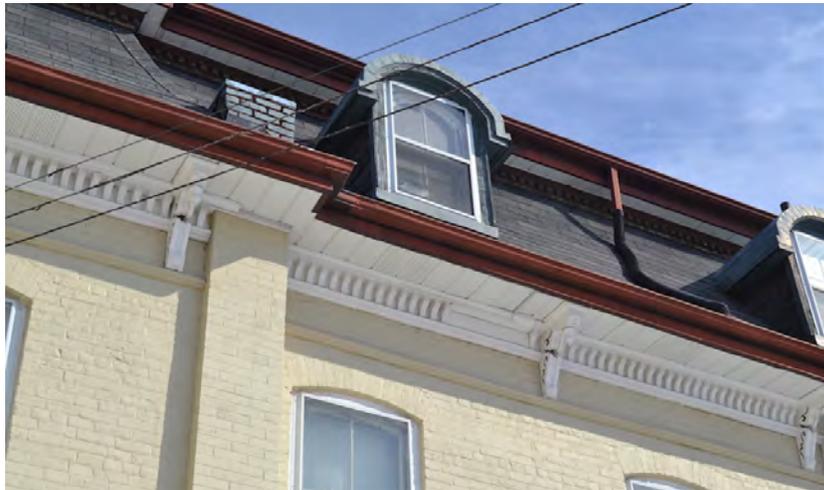
*View of south elevation at east portion, showing continuous concave mansard roof profile and typical hooded dormer window; typical missing wood dentils and bracket at cornice*

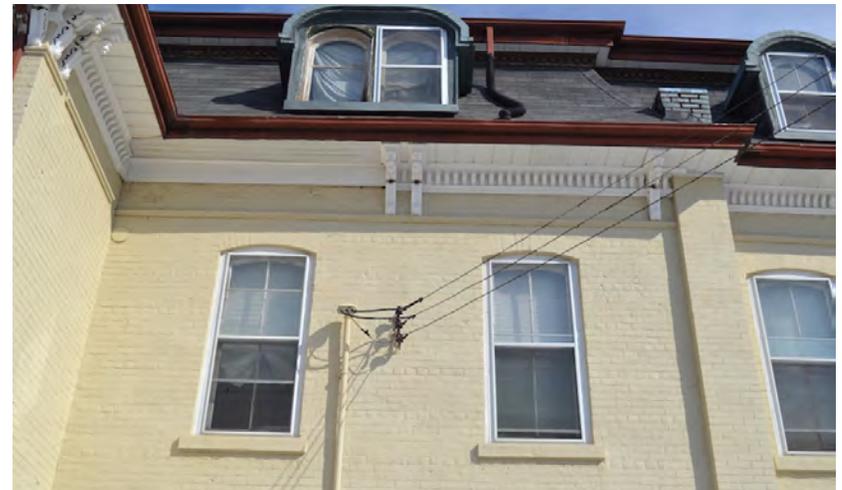
*View of south elevation, showing the a-typical dormer type which consists of paired windows; typical missing section of dentils at wood cornice.*

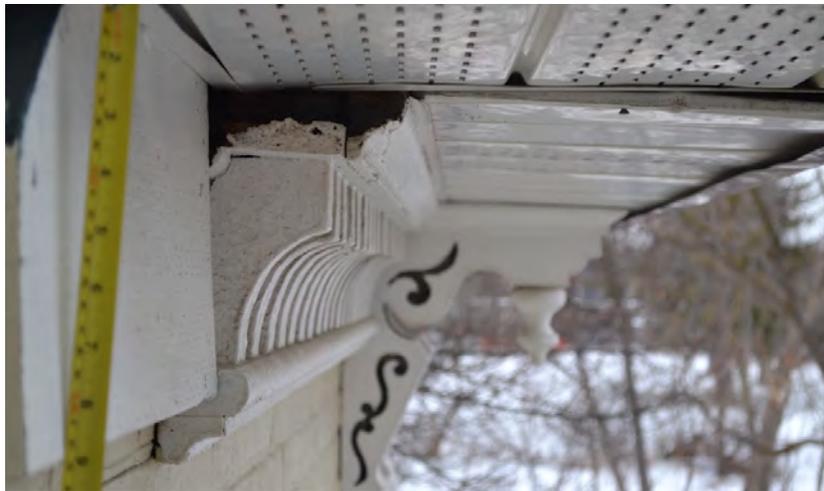
*Detail view of the wood cornice at eave of mansard roof, showing missing section of dentils along the main elevation, and new (typical) non-compatible soffit material.*

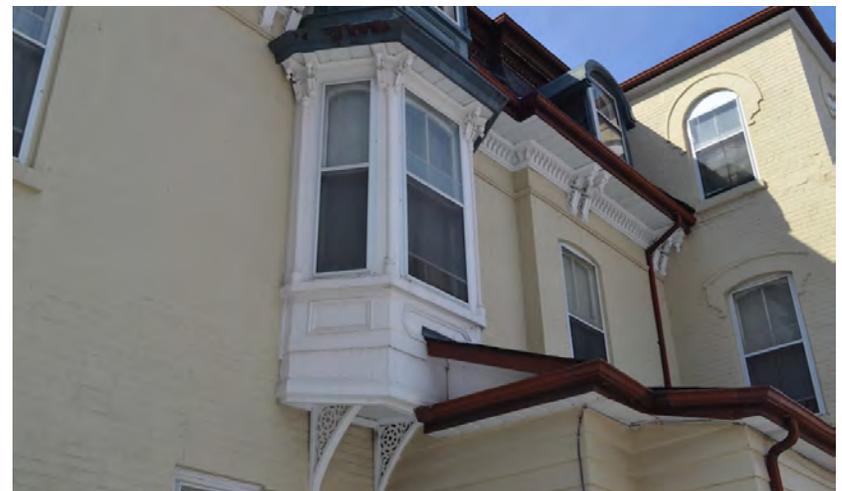
*View of the two-storey bay (oriel) window at main elevation of east portion, showing the wood detailing that appears to be in fair condition. Though original wood soffit is intact, its framing to be investigated at possible sag.*

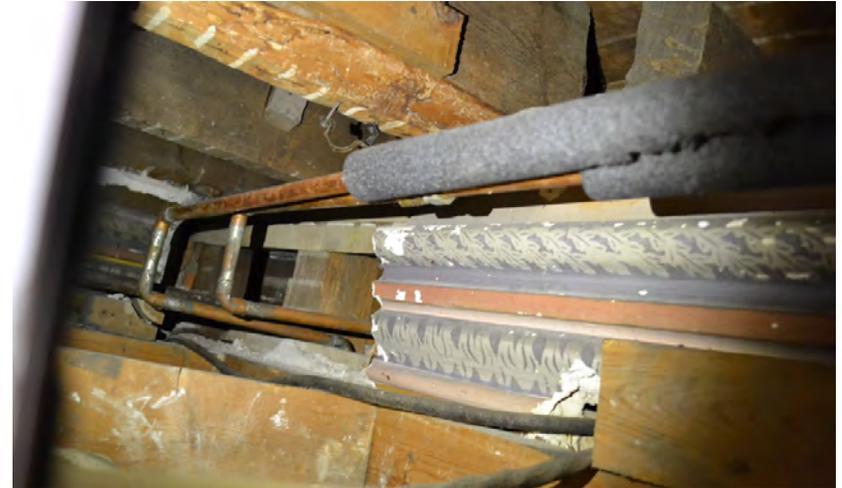
*Partial remnants of the presumed original painted plaster crown mouldings remain tucked away within the new drop-ceiling of west portion adjacent staircase.*

- Further investigate the extent and condition of the original painted crown moulding trim found within the west portion's hall, for possibilities of conservation within the new interior design.

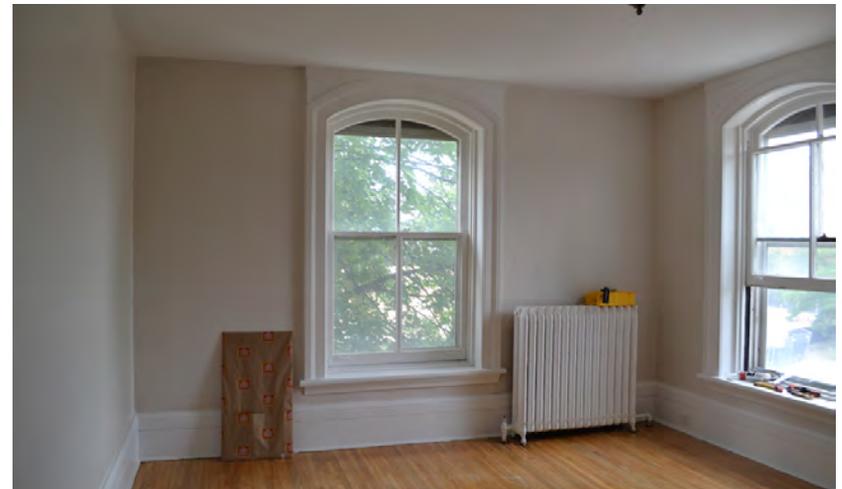
*Interior wood casing trims and sills largely remain throughout, and appear in good condition. View of interior showing North and West elevation, second floor windows of the west portion.*
