Conservation Plan, Clark/McClure House, 10244 Mississauga Road, City of Brampton, Ontario

Project number: 2022-003

Report Date: Sept 2022

Proponents: Argo TFP Brampton II Limited

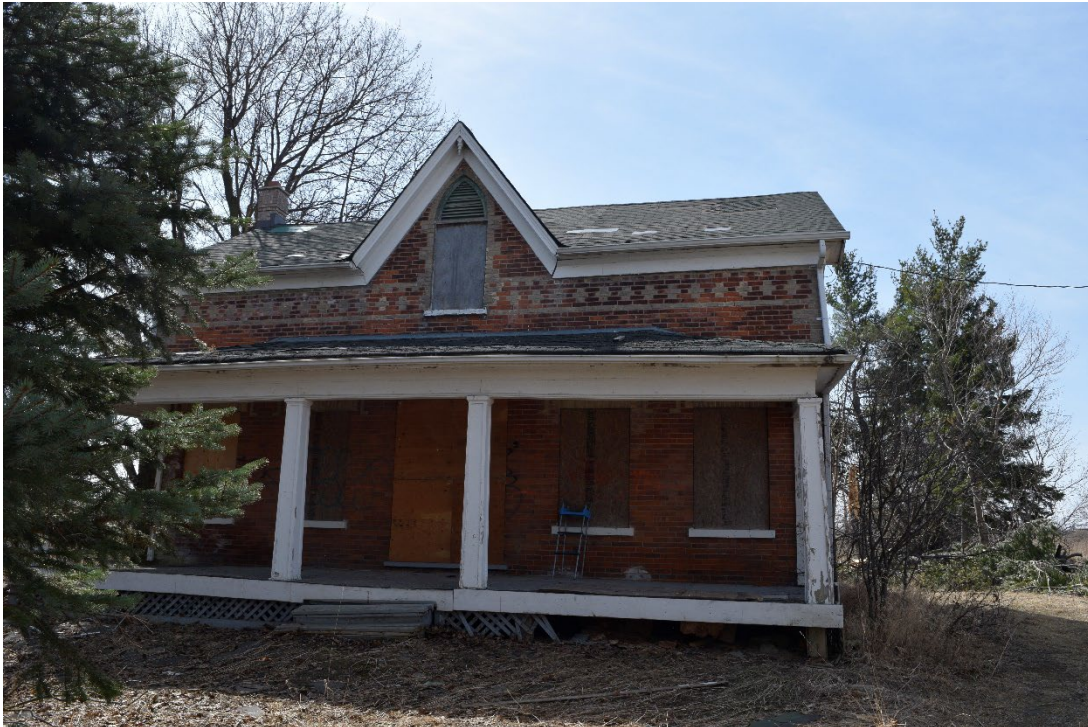
Image 1: Front façade of Clark/McClure House as seen at 10244 Mississauga Road

The Clark/McClure House is a one-and-a-half storey, red brick residential structure constructed in the Gothic Revival architectural style. The house is a fine example of the Gothic Revival style, presenting a five-bay façade with center gable. The house is originally of double brick construction, primarily of red brick, utilizing buff brick quoin accents at corners and at structural openings. The structure also displays dichromatic details at the lower edge of the eaves and around the lancet window in the center dormer.

The structure is well proportioned and as such is visually pleasing. The Clark/McClure House has been subject to modifications since construction, but retains its overall charm through the retention of drop pendent, louvered lancet center gable window, and returned eaves. The disassembly process by Sedgwick Marshall Heritage Homes Ltd. revealed that the front veranda was not original to the structure and was concealing the original rectangular transom located at the front door.

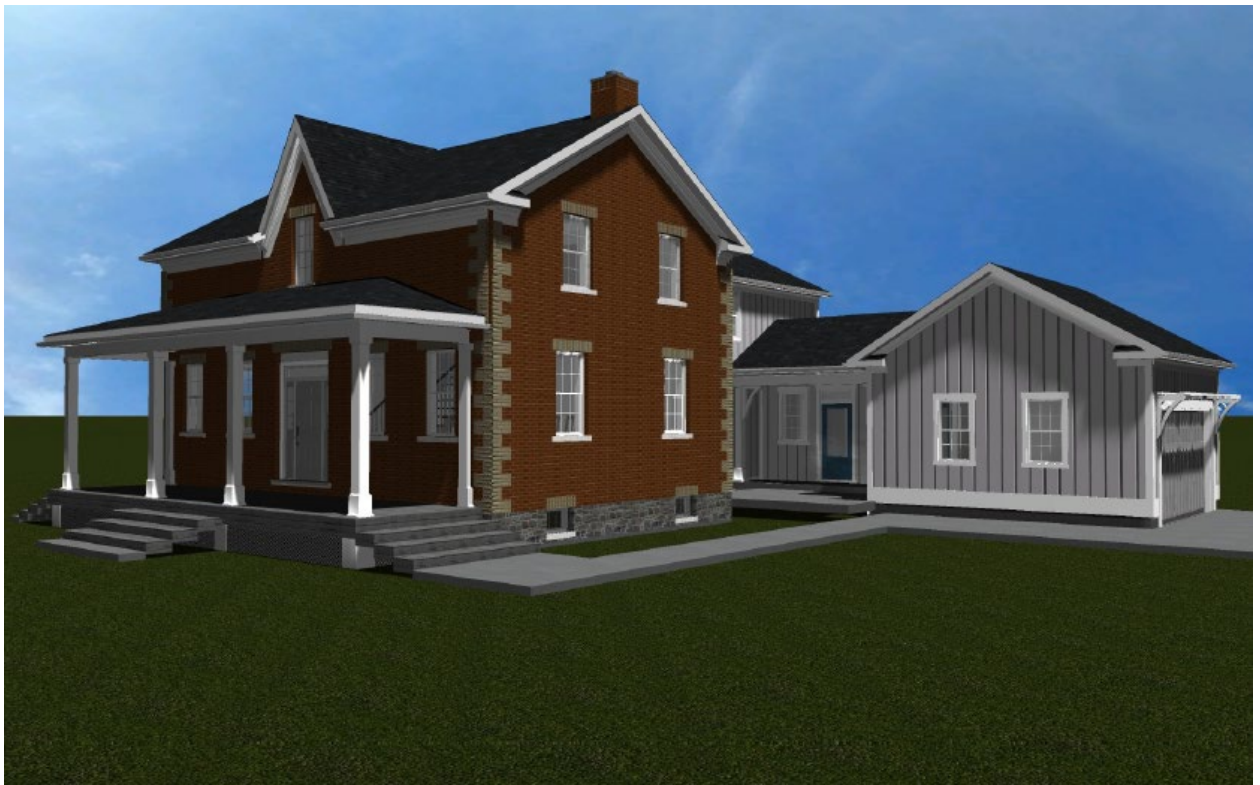
Image 2: 3D rendering of the restored Clark/McClure House with modern rear addition

Detailed construction plans and 3D renderings of the reconstruction and augmentation of Clark/McClure have been prepared by Sedgwick Marshall Heritage Homes Ltd. (Appendix B)

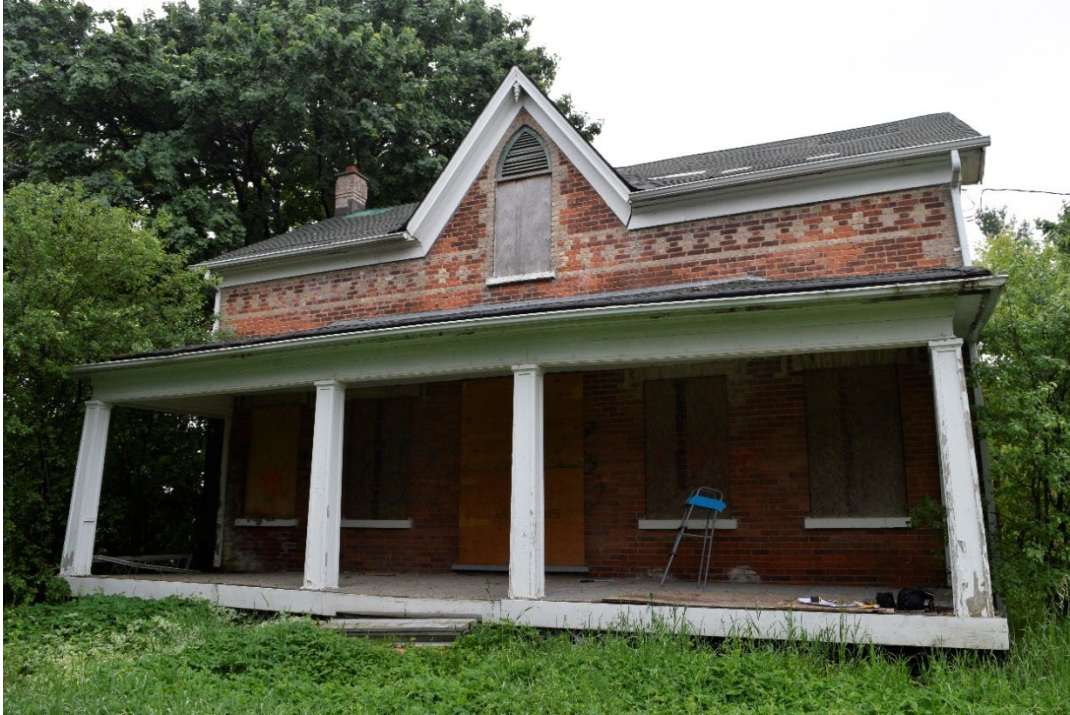
Image 3: Front façade and veranda of Clark/McClure House

*Deconstruction process revealed front veranda to be later addition, reconstruction will include a temporally correct veranda designed to showcase original front entrance transom and window voussoirs.

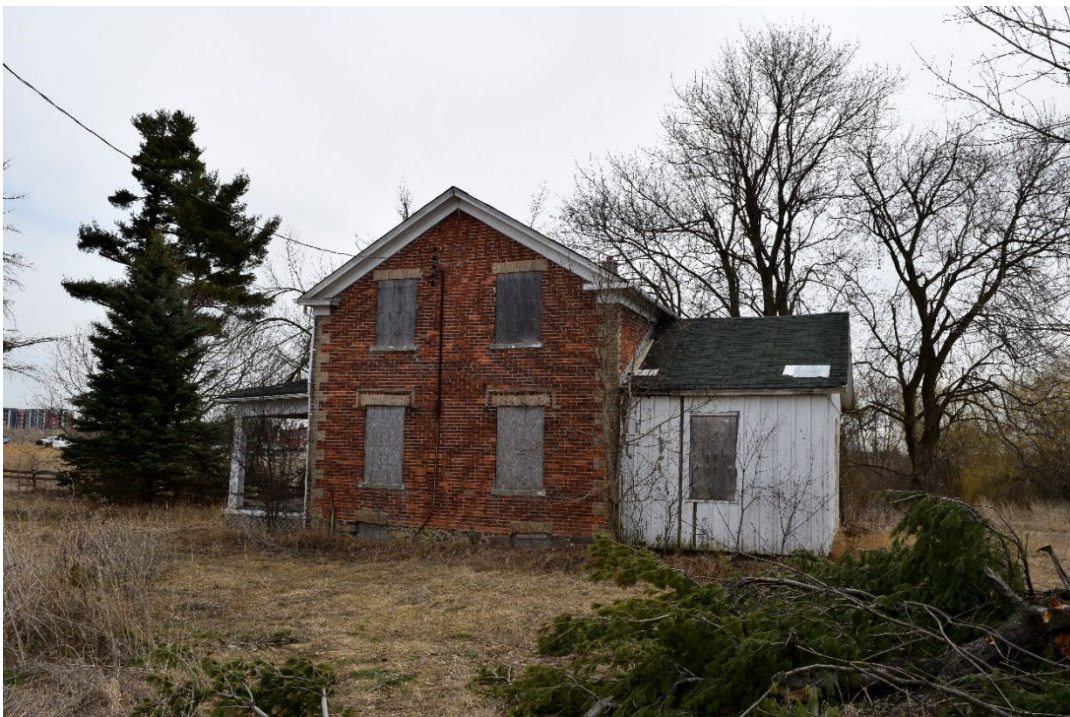
Image 4: North face of Clark/McClure House, note rear addition is not subject to retention or salvage

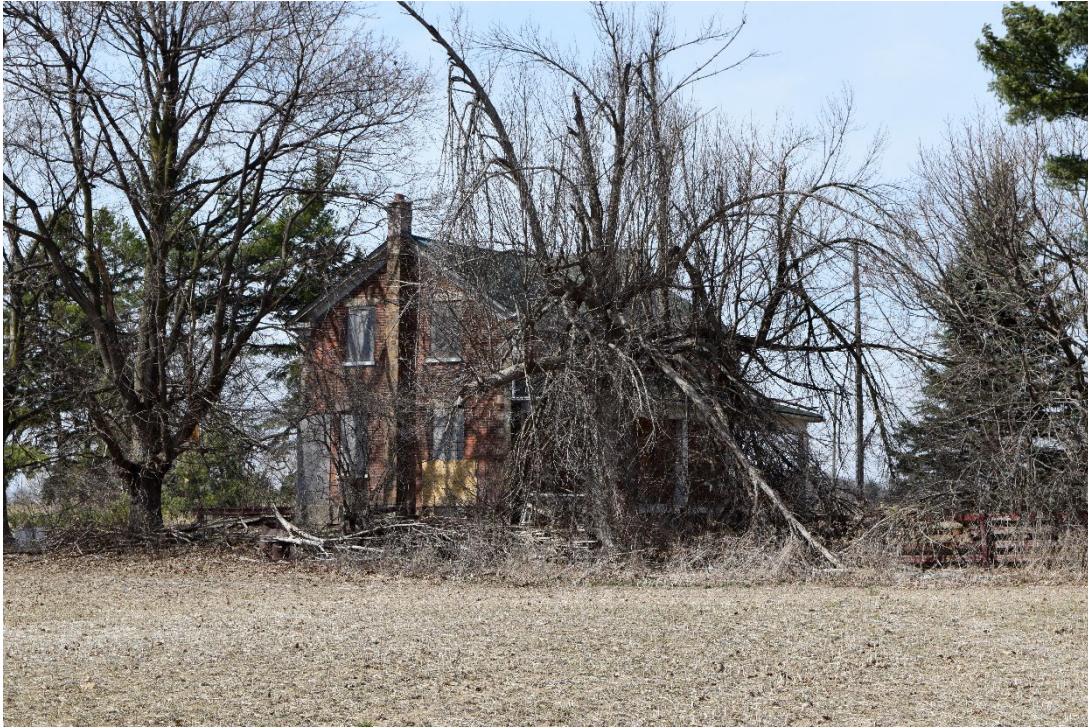
Image 5: South face of Clark/McClure House, note brick chimney is not subject to retention or salvage

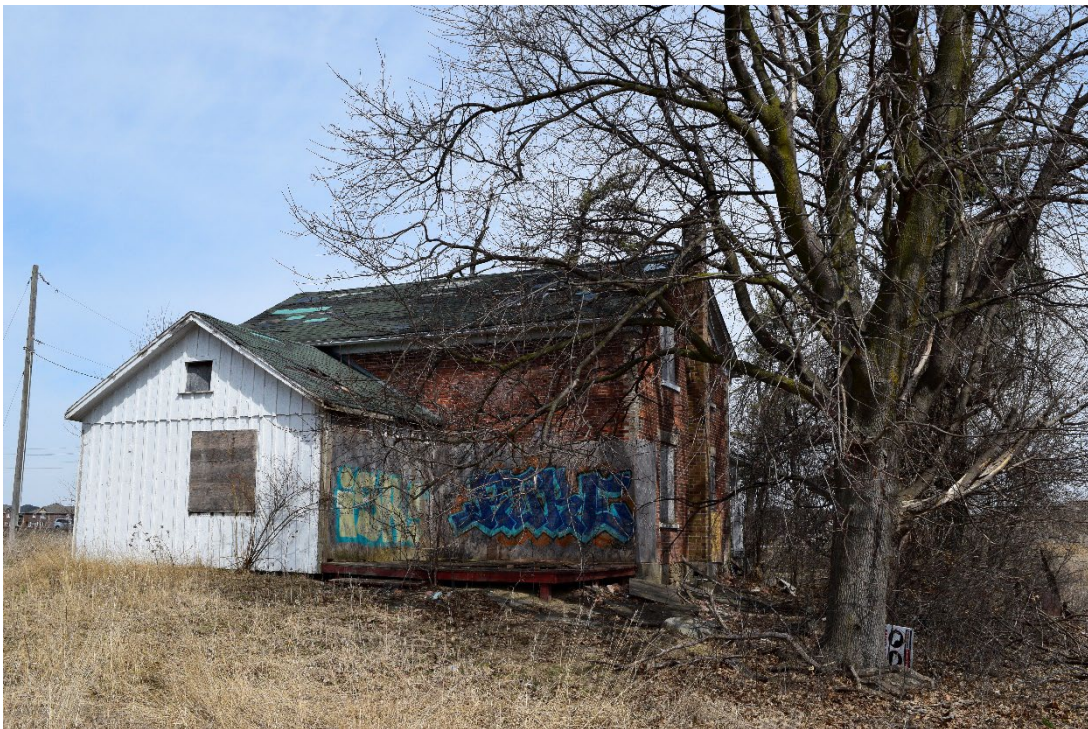
Image 6: West face of Clark/McClure House, note plywood hording is concealing a structural opening that will need to be included on architectural plans

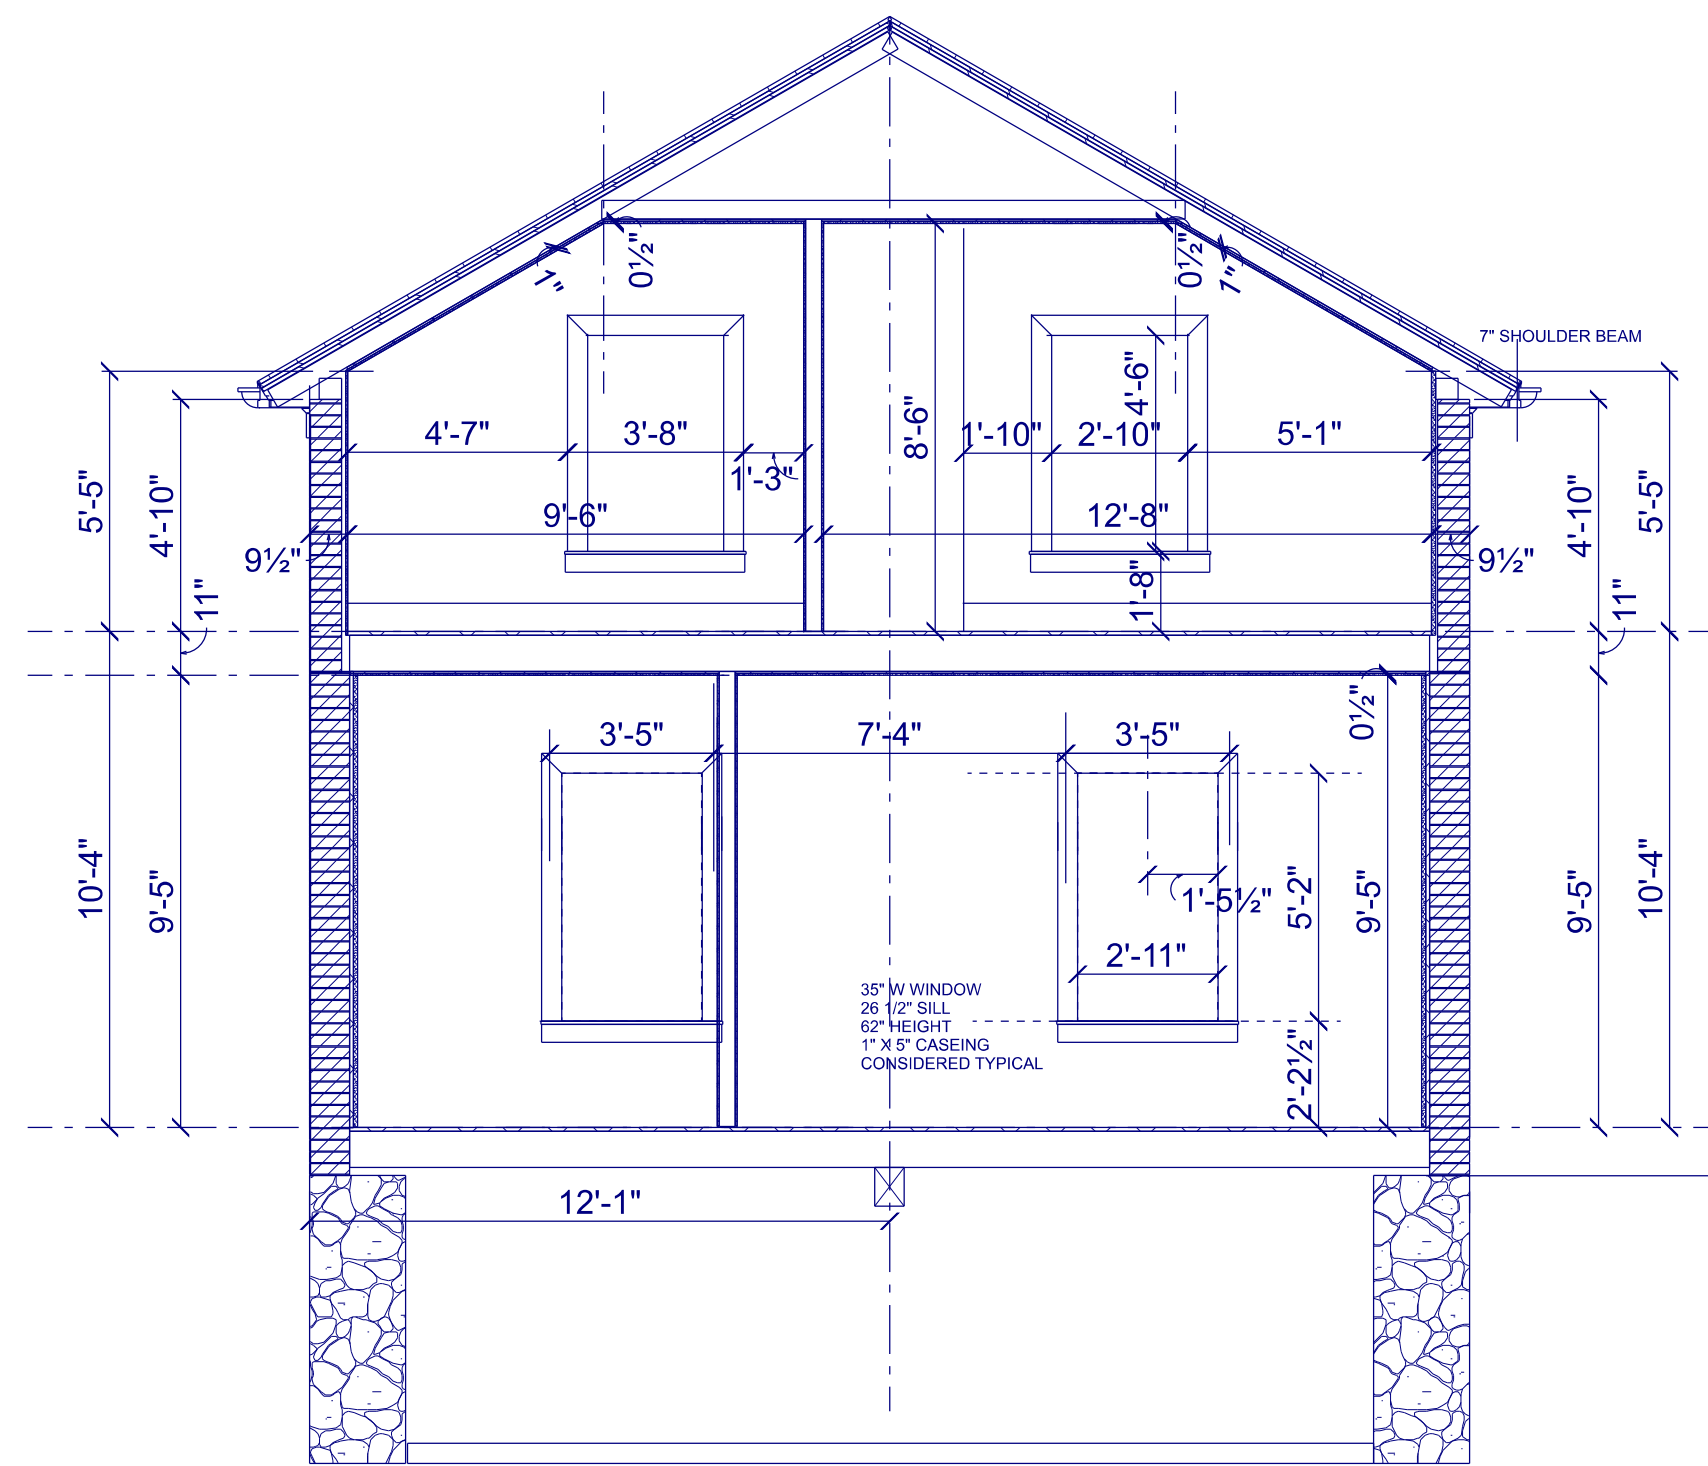
SECTION OF AS FOUND

THERE WOULD BE HISTORICALLY A CHIMNEY AT EACH GABLE END THAT ARE NOT PRESENT BUT INSIDE BREASTS ARE VISIBLE THESE CHIMNEYS SHOULD BE REINSTATED.

CLASSICAL EAVE RETURN IN GOOD TO FAIR CONDITION

RUBBLESTONE FOUNDATION

BASEMENT WINDOW TAPERED SOLDIER ABOVE STONE (WHITE BRICK ON NORTH RED BRICK ON SOUTH) COURSING HAS SETTLED

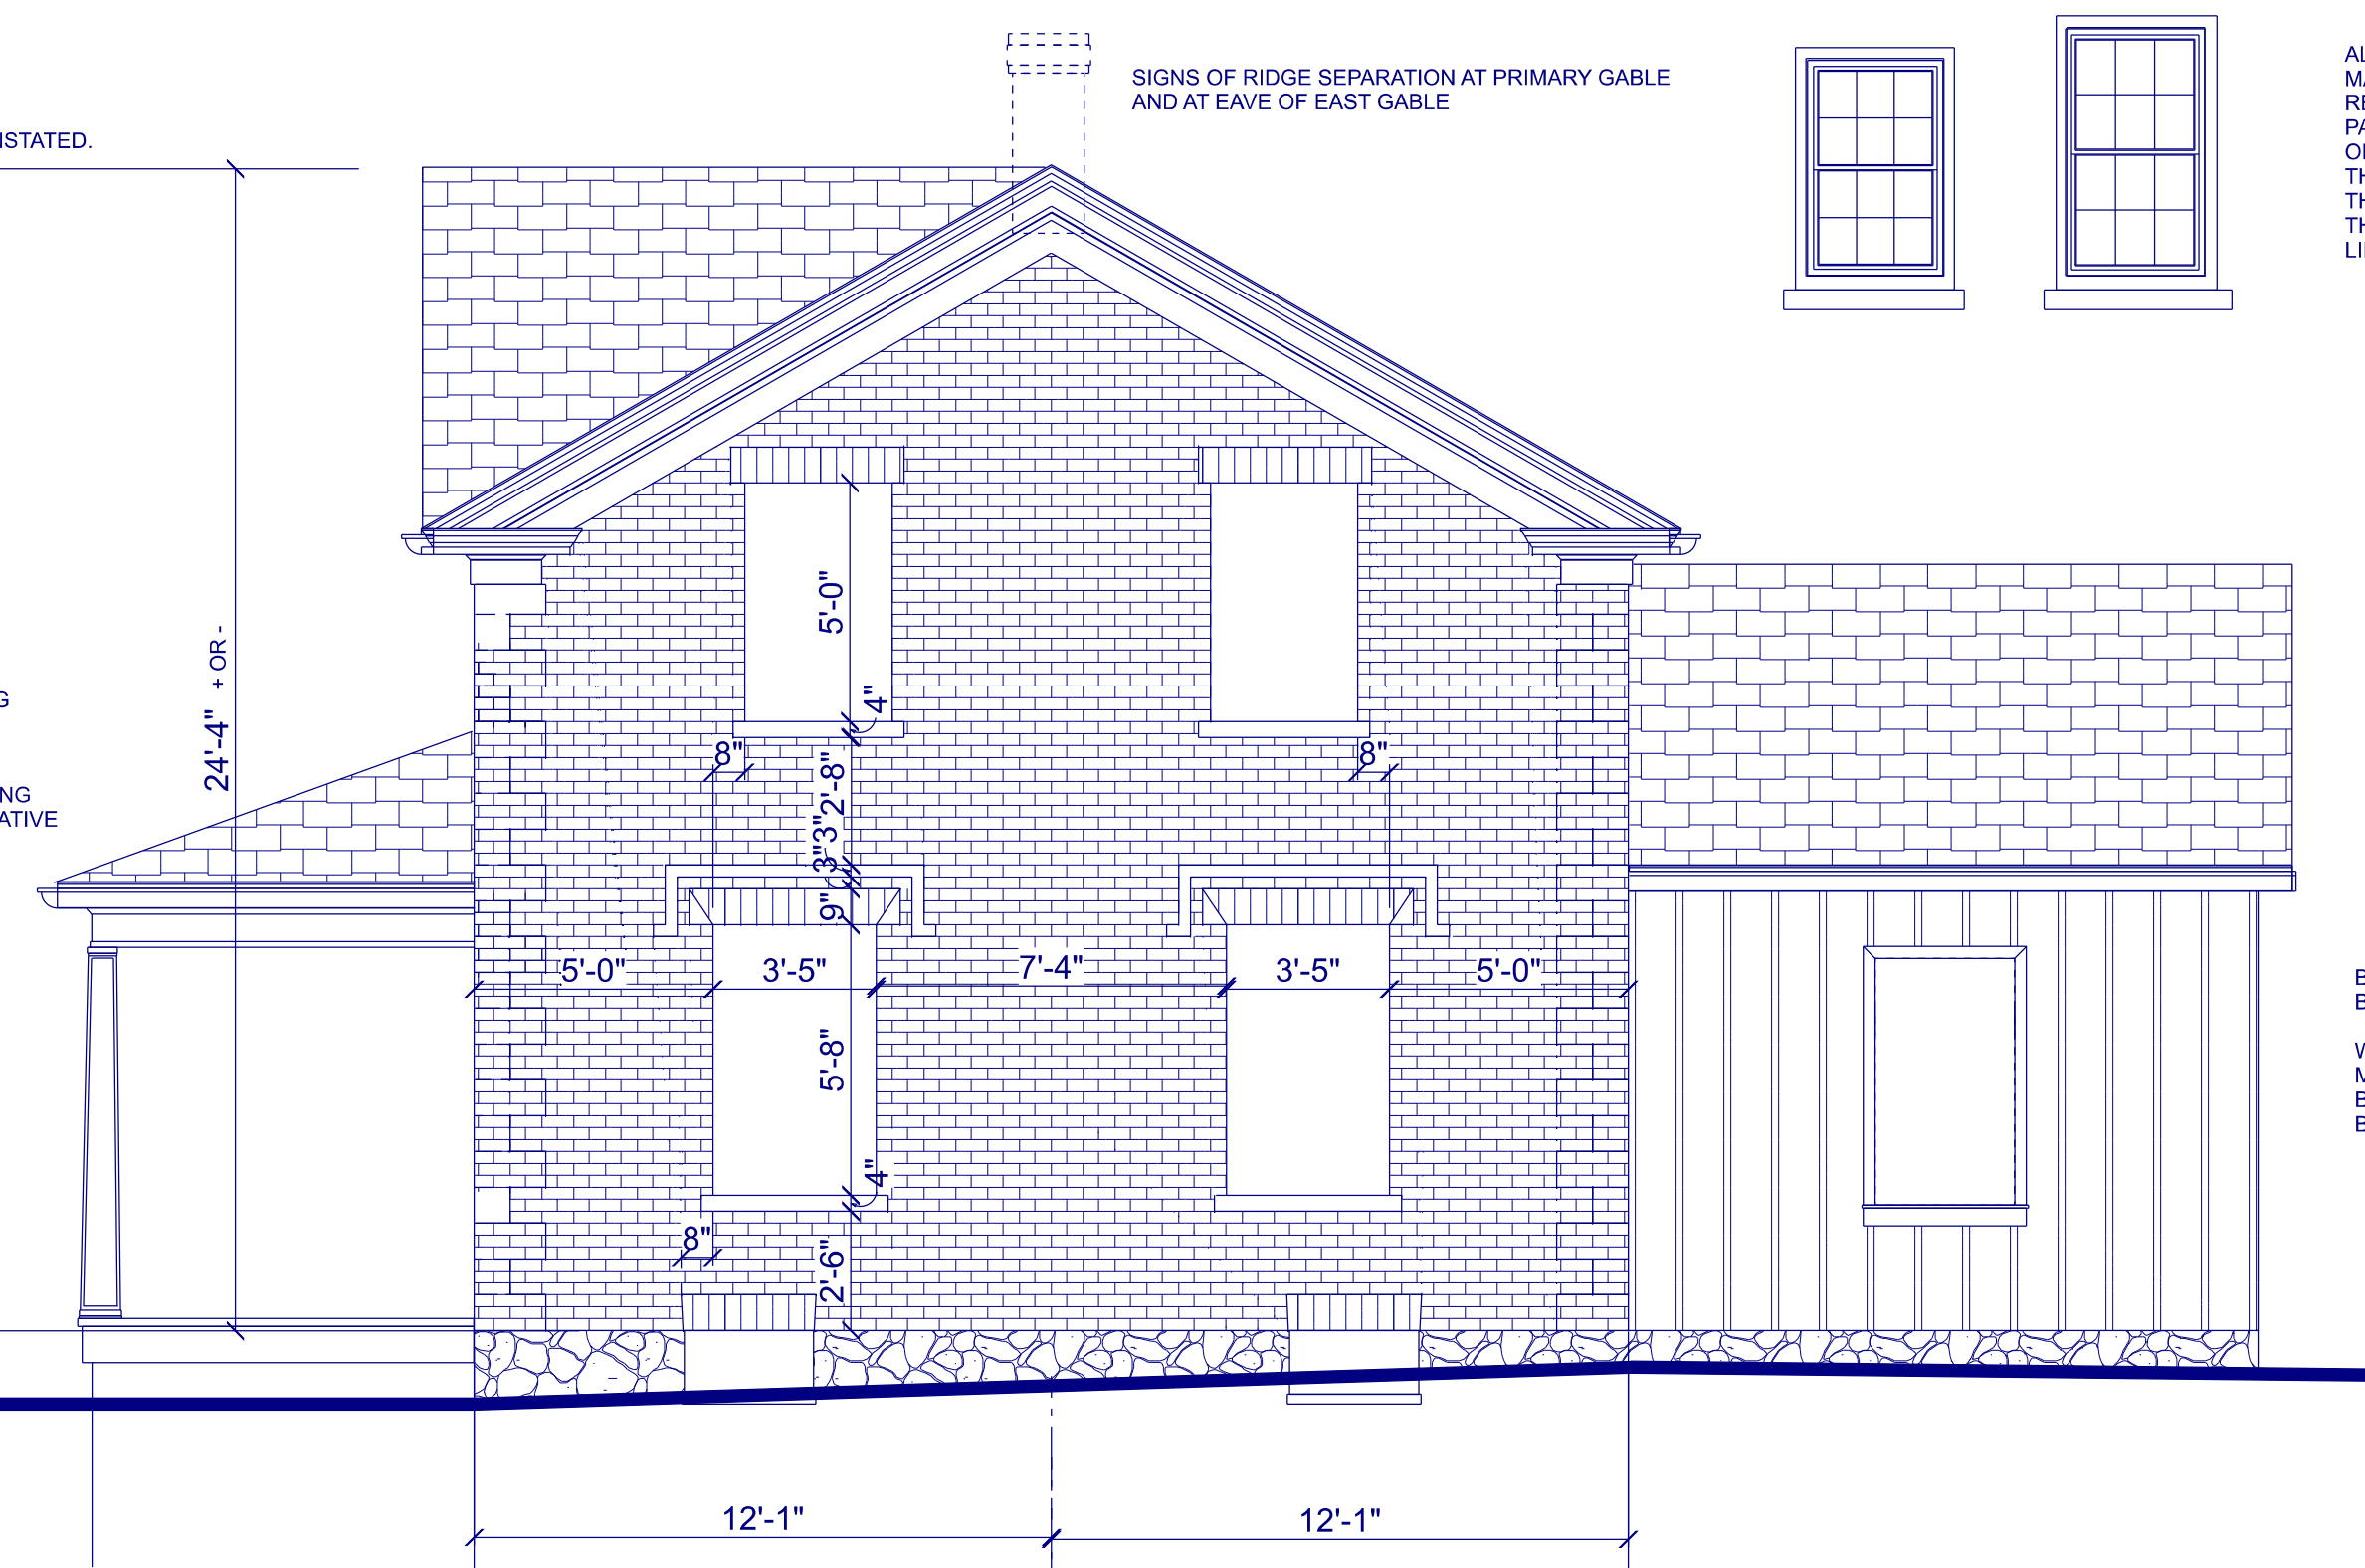
NORTH FACADE AS FOUND

SIGNS OF RIDGE SEPARATION AT PRIMARY GABLE AND AT EAVE OF EAST GABLE

ALL EXISTING WINDOWS IN MAIN HOUSE HAVE BEEN REPLACED BUT THERE ARE PARTIALLY VISIBLE. EXAMPLES OF 6 OVER 6 WINDOWS IN THE BACK KITCHEN AND THIS SEEMS IN KEEPING WITH THE CLASSICAL REVIVAL LINES OF THE HOUSE

BOARD AND BATTEN ON BRICK FILL. ROUGH SAWN FRAME

WINDOWS AND DOORS MUCH OBSCURED WITH BOARDING AND SO INDICATED BASED ON SITE QUES

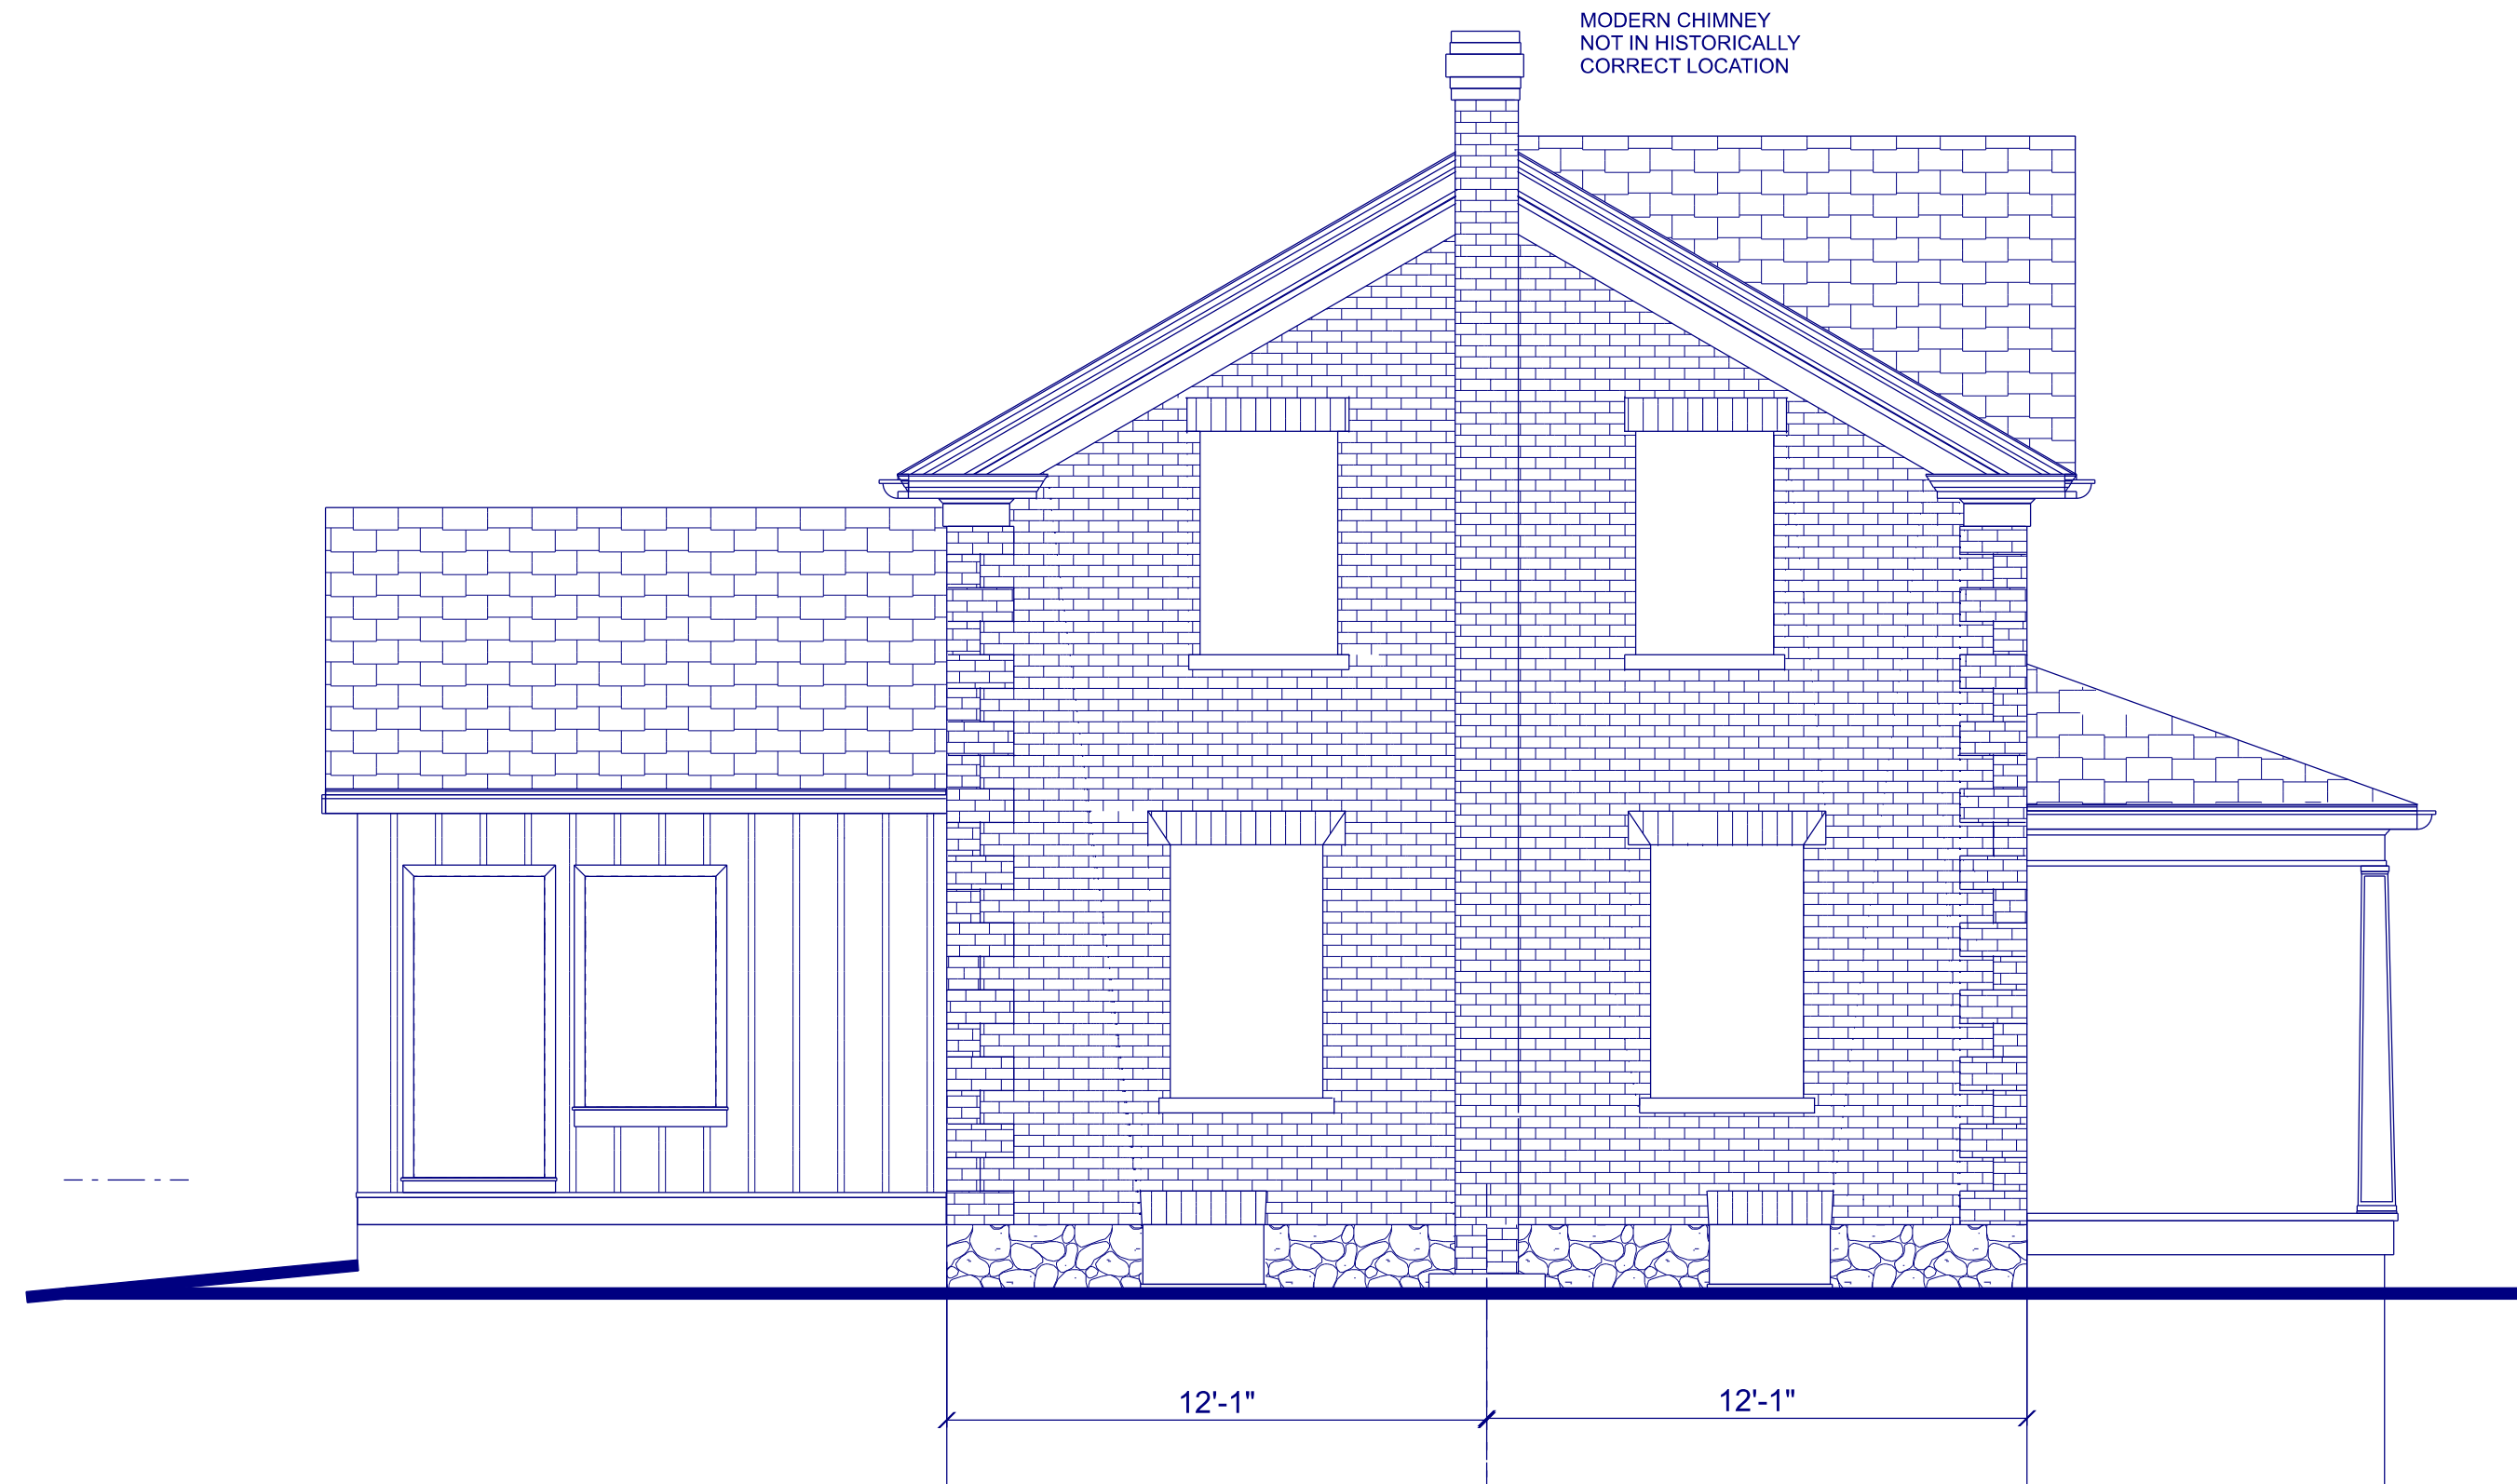
SOUTH FACADE AS FOUND

MODERN CHIMNEY NOT IN HISTORICALLY CORRECT LOCATION

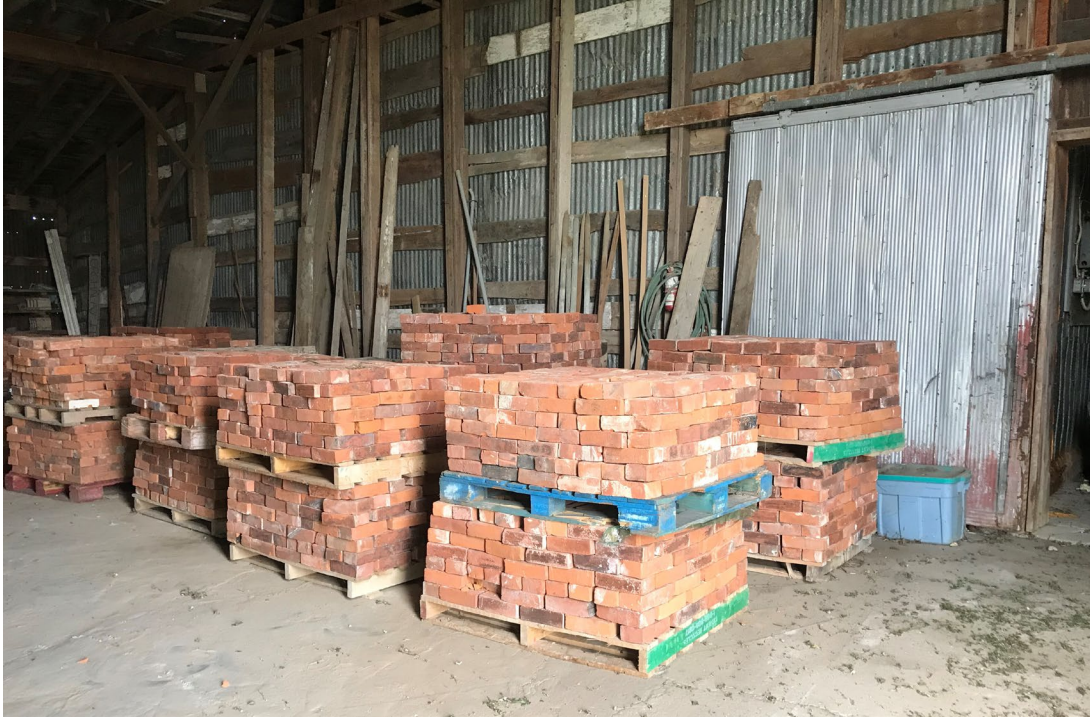
Figure 1: Salvaged bricks, August 15, 2022

- ▶ Original brick will not be altered and will be utilized in existing condition (stained and weathered)
 - ▶ Full bricks will not be cut, partial bricks for 'jackhearts' and other structural details were salvaged and retained and are stored in center of pallets

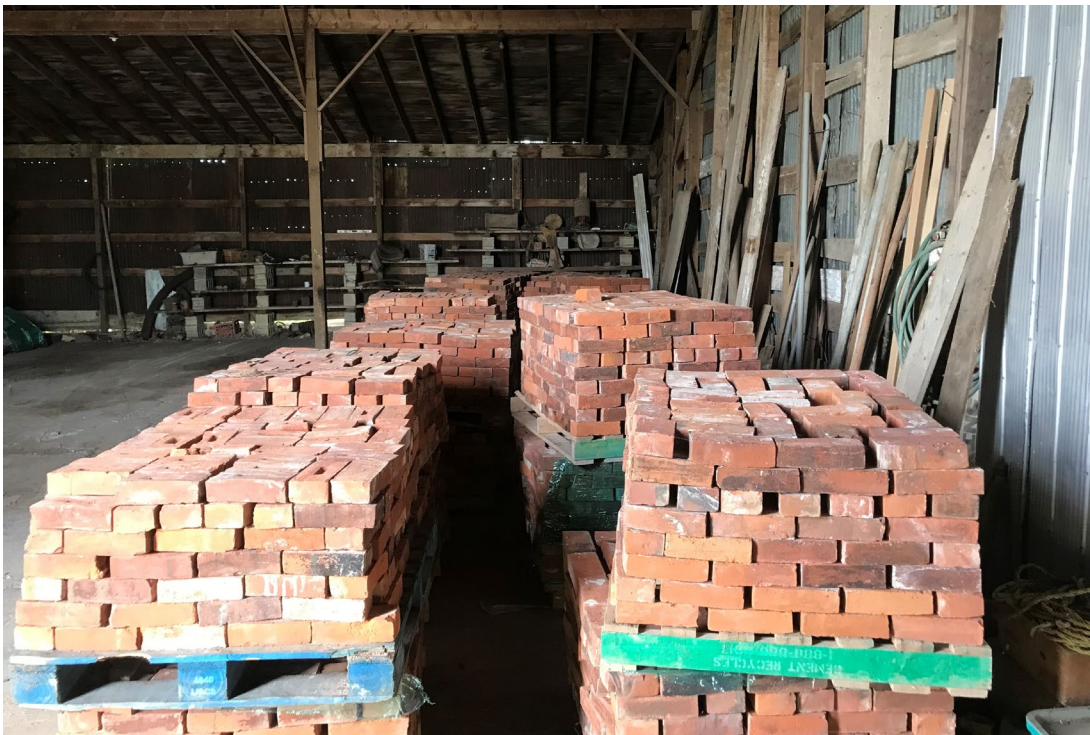
Figure 2: Salvaged bricks sorted by colour and stacked on pallets, August 15, 2022

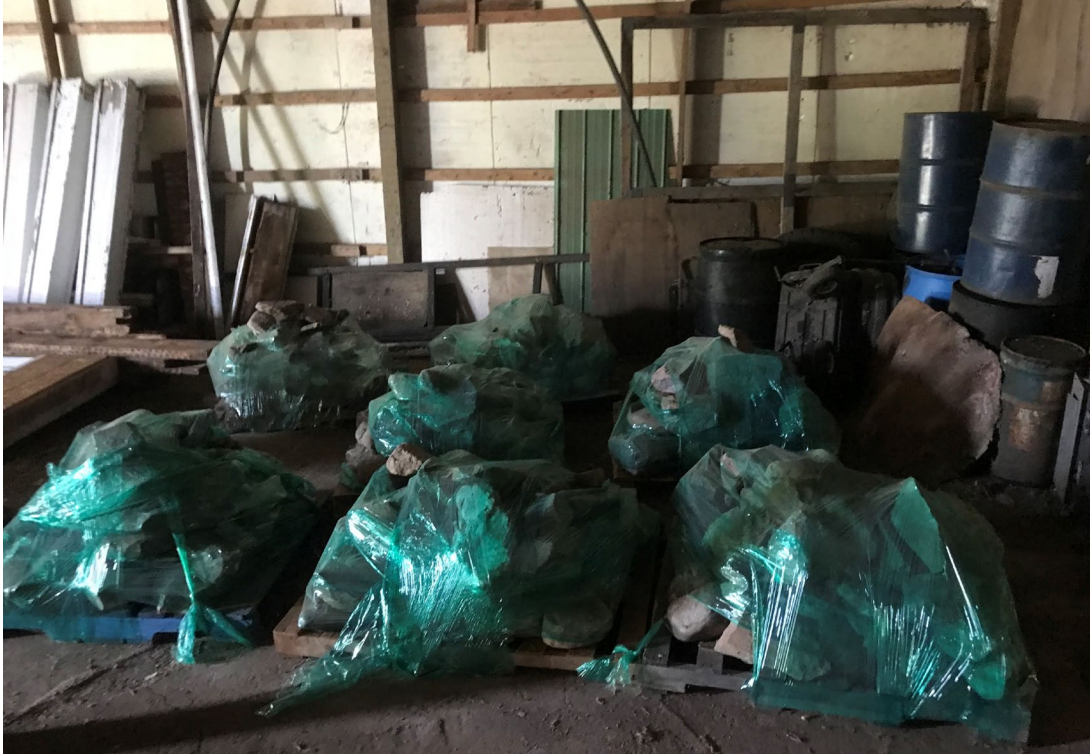
Figure 3: Salvaged foundation stone, August 15 2022

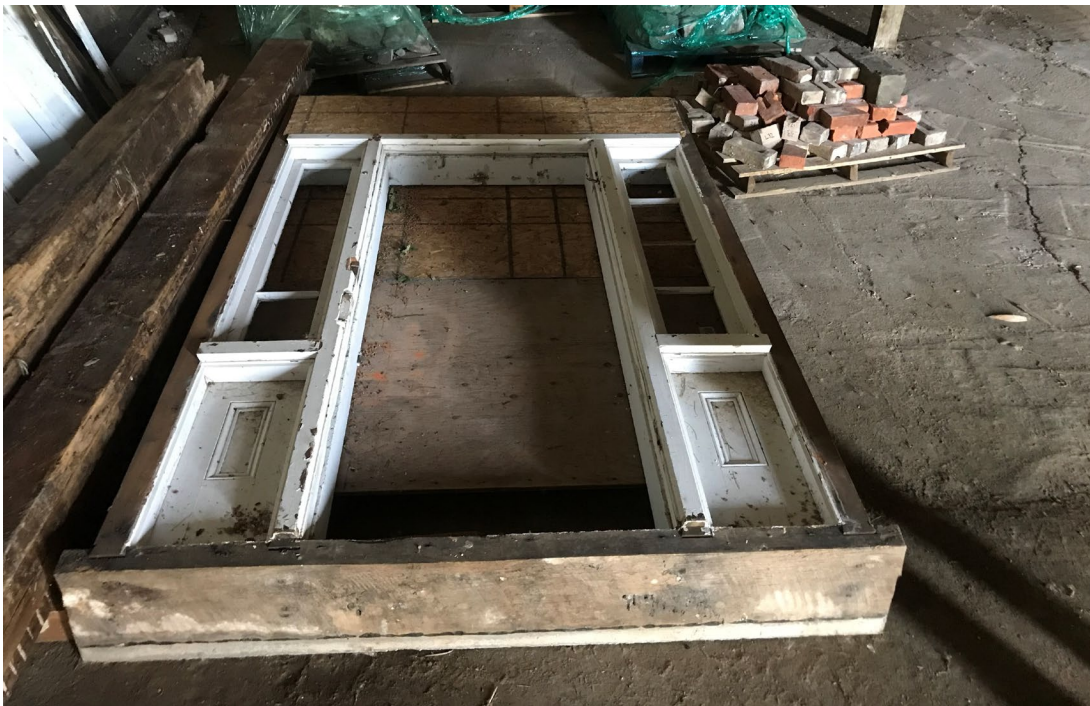
Figure 4: Front door, August 15, 2022

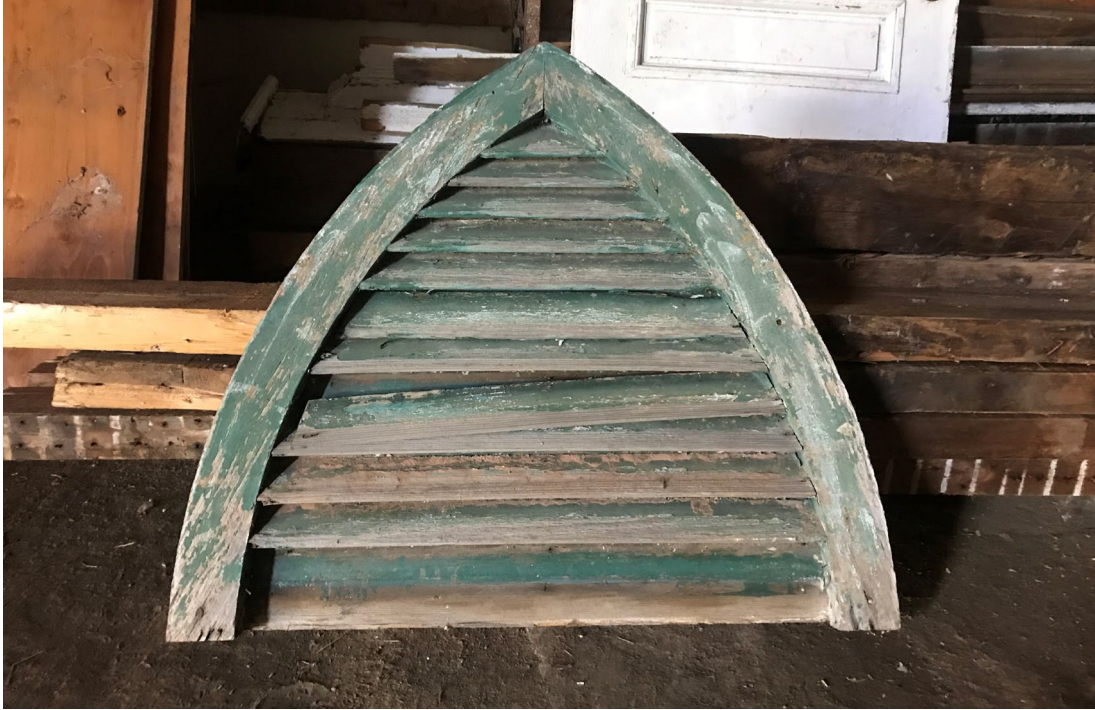
Figure 5: Center dormer louver, August 15, 2022

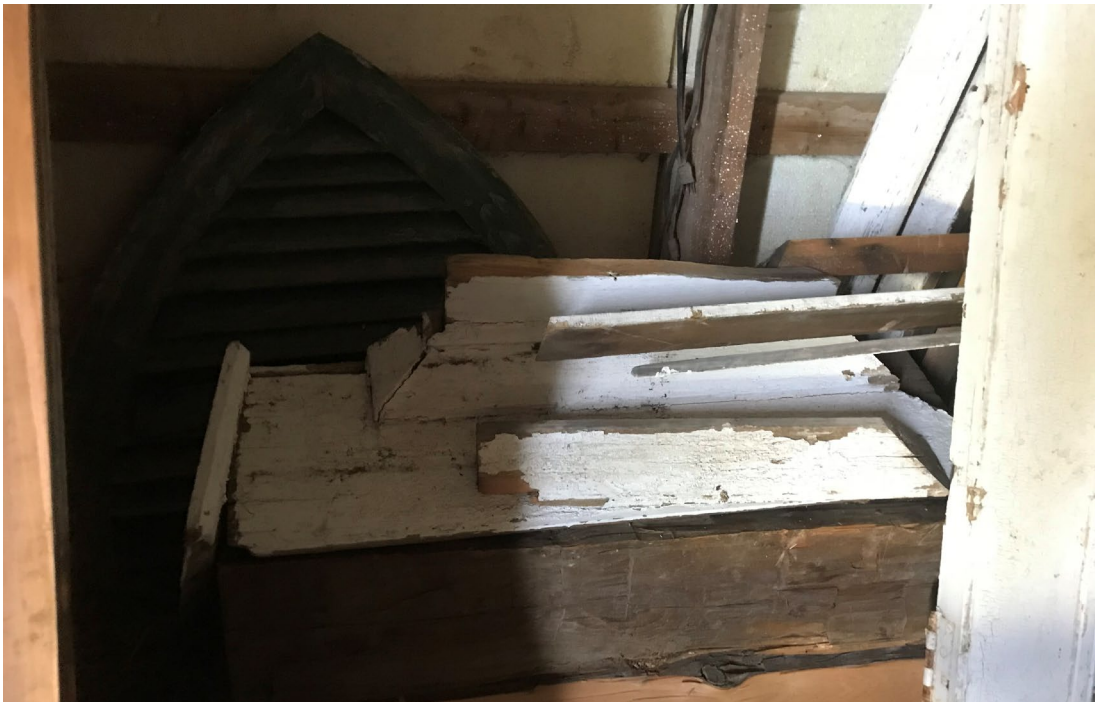
Figure 6: Sample of eave finishes for later duplication, August 15, 2022

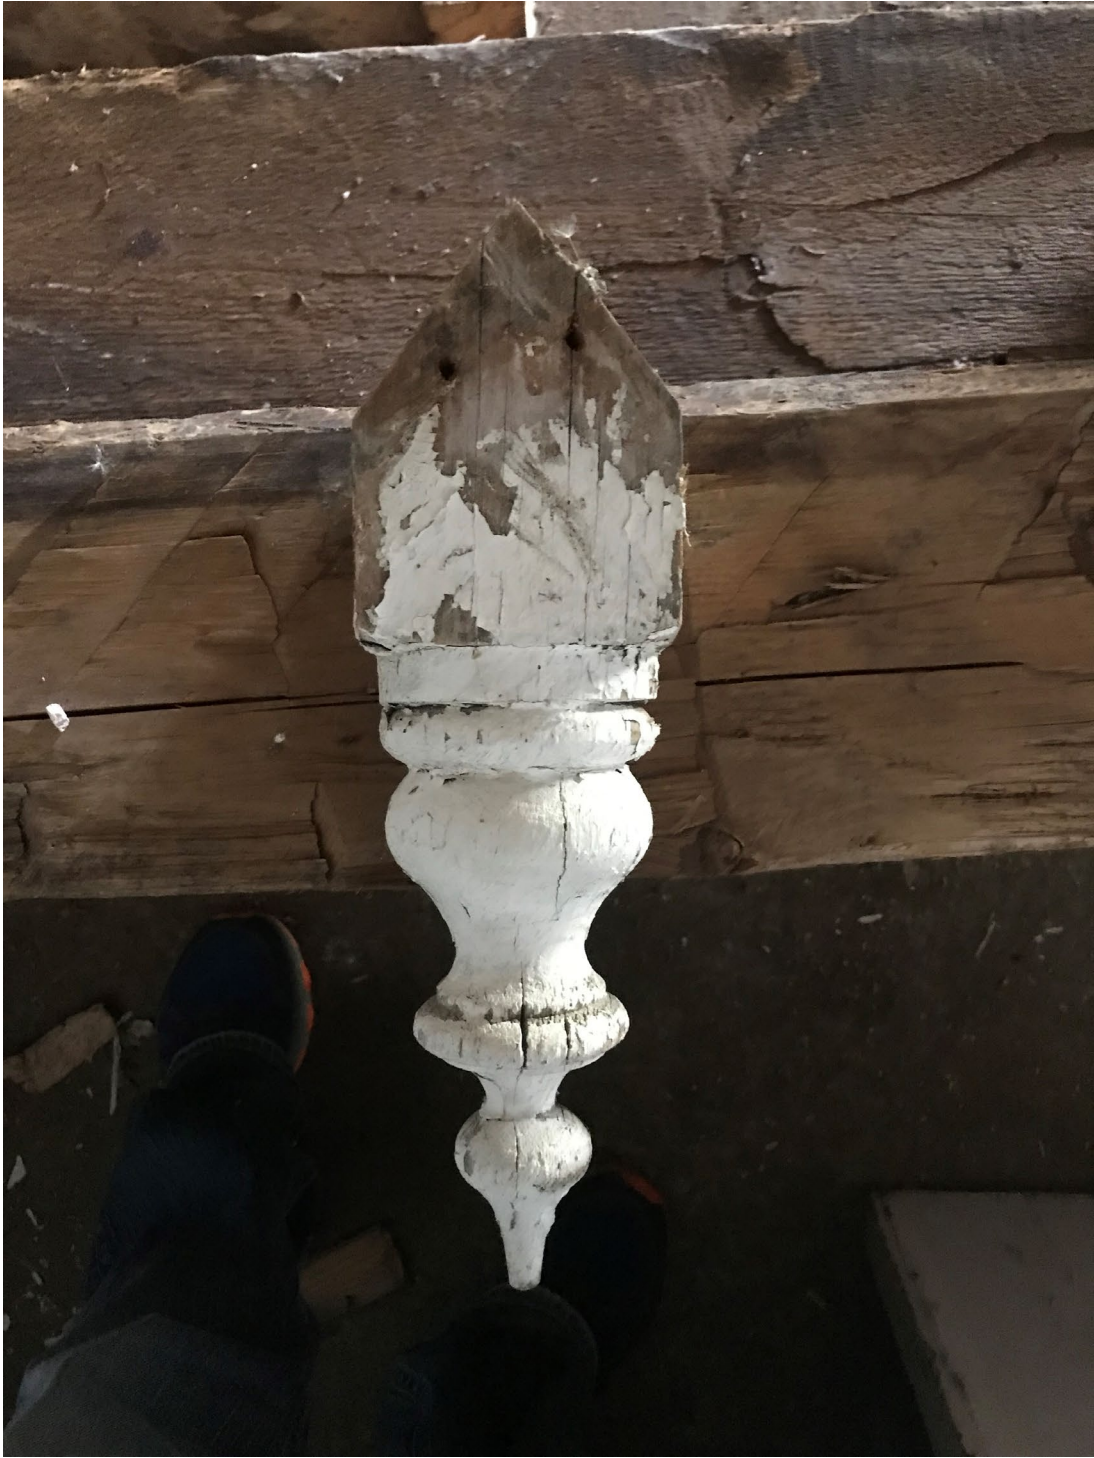
Figure 7: Drop pendent from center dormer, August 15, 2022
