Conservation Plan, Clark/McClure House, 10244 Mississauga Road, City of Brampton, Ontario

Project number: 2022-003

Report Date: Sept 2022

Proponents: Argo TFP Brampton II Limited

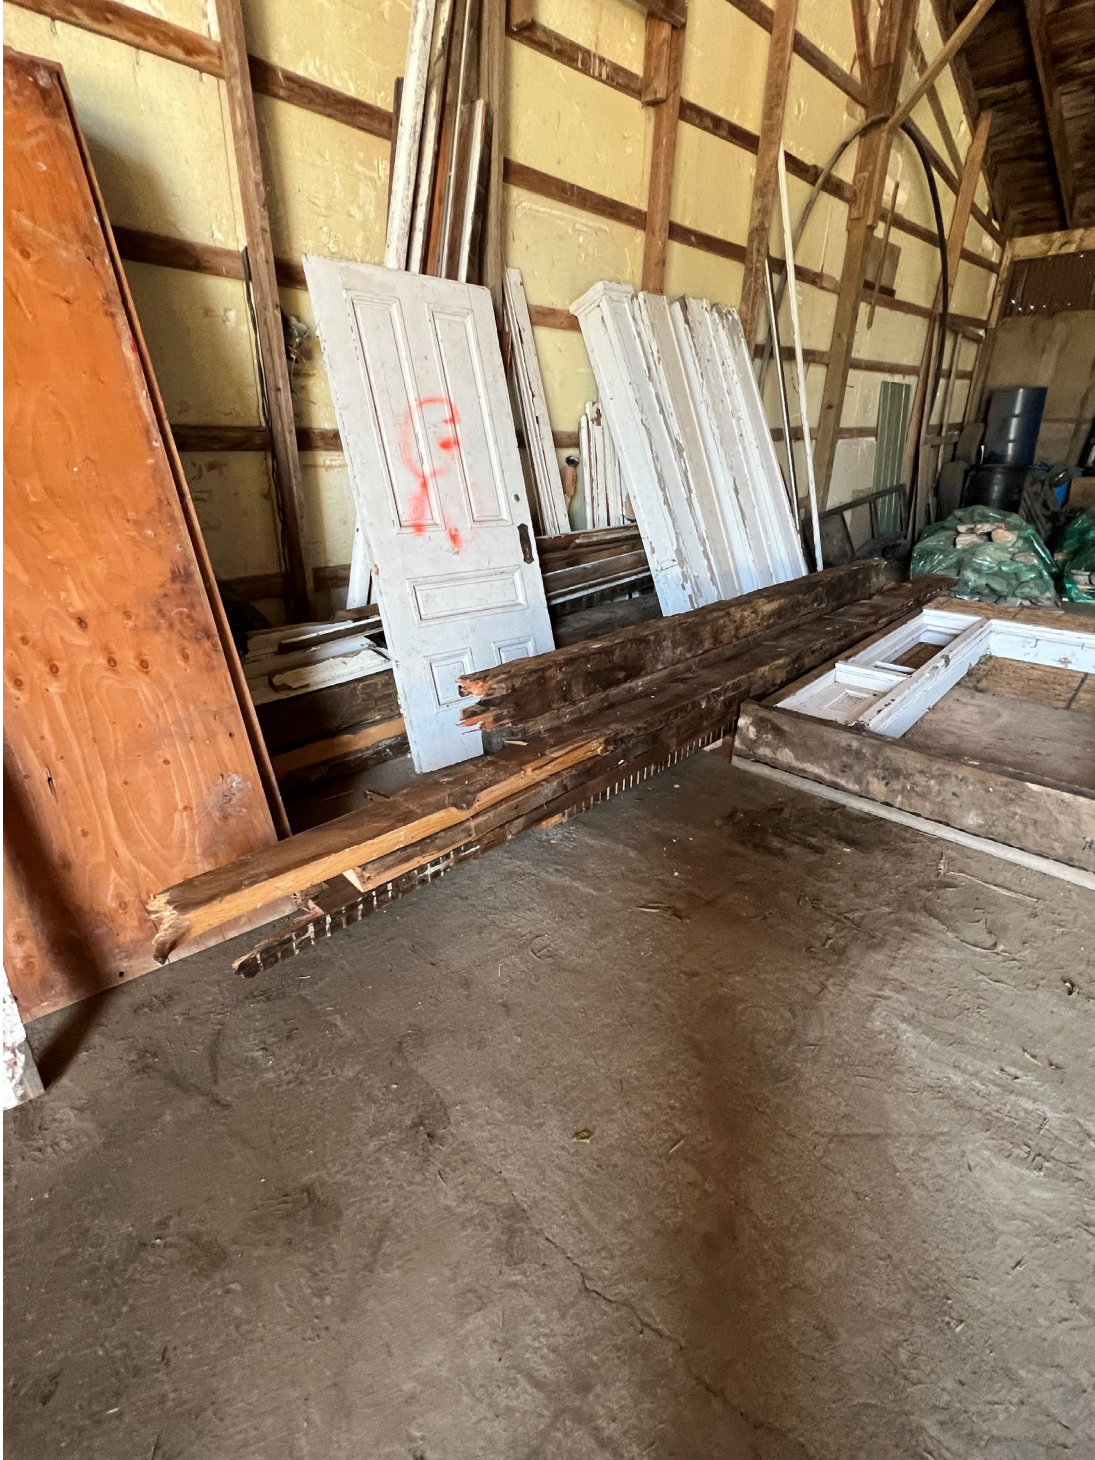
Figure 8: Salvaged components, August 15, 2022
