HERITAGE IMPACT ASSESSMENT

1 ISABELLA STREET
Brampton, ON

25 Aug 2022

MEGAN HOBSON CAHP
M.A. DIPL. HERITAGE CONSERVATION
Built Heritage Consultant
mhobson@bell.net

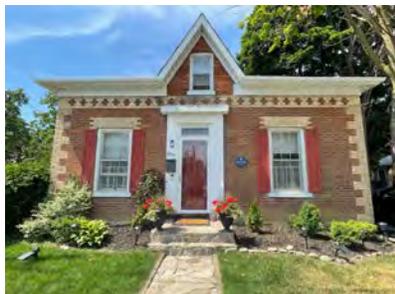
1 ISABELLA STREET – 1.5 storey brick dwelling

The exterior masonry is in good condition with some localized areas of deterioration typical of a building of this age. The dichromatic brickwork includes buff brick corner quoins, window lintels and a decorative band below the eaves. The original 6 over 6 wood window sash remains with modern metal storms on top. The soffits, sills and front door surround have been clad with aluminum, perhaps covering original wood components. The foundation is rubble stone construction with small windows above grade. There is an unfinished basement below the north half of the front portion and a crawlspace below the south half. The rear tail is believed to be the original summer kitchen. Originally constructed with a crawlspace, it has been underpinned with concrete to make a full basement below. The wide spacing of the circular sawn floor joists visible in the basement are consistent with a date of construction in the 1850s.

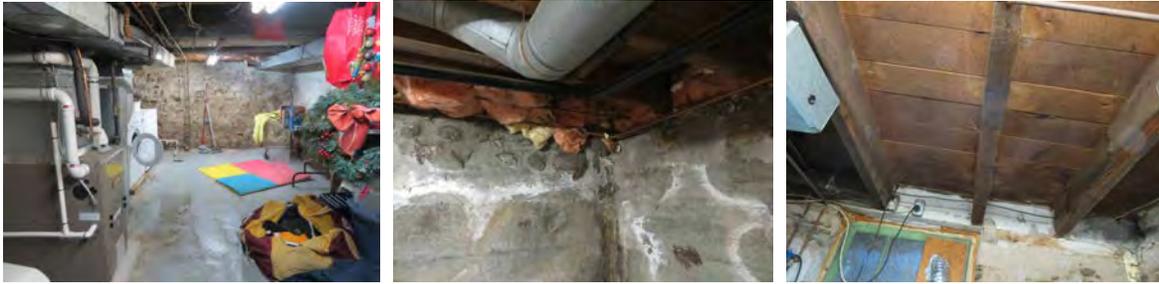
c. 1850s RUBBLE STONE FOUNDATION (left) c. 1920s or 1930s CONCRETE UNERPINNING (center) c.1850s floor framing (right)

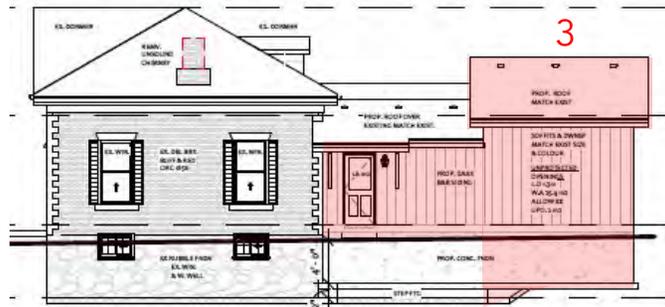
DRIVEWAY SIDE ELEVATION

1. The top of the brick chimney will be dismantled and the original portion at the base will be repaired and capped
2. The proposed rear addition will extend out slightly into the driveway
3. The roof of the proposed addition will be lower than the existing roof
4. A wood canopy will be introduced at the new side entrance on the driveway that matches the existing wood canopy on the rear elevation
5. The existing wood canopy on the rear elevation will be relocated to the David Street elevation above a window in the addition
6. The side door on the David Street elevation will be replaced with a new door with wood panels and glazing that is complimentary to the character of the heritage building
7. The cladding proposed for the addition is complimentary to the character of the heritage building and includes vertical wood siding on the walls and cedar shakes in the gable

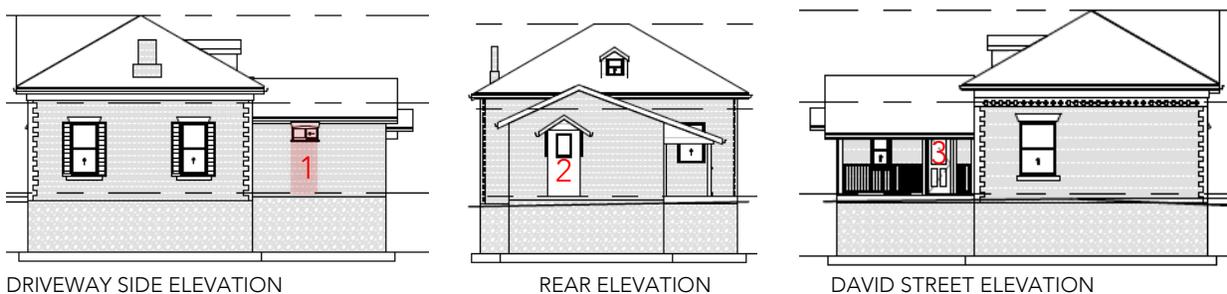
RECOMMENDED SALVAGE: brick removed to make two new openings should be salvaged so that it can be used to carry out repairs elsewhere: - 1. an existing window in the bathroom will be enlarged to create a doorway so a small amount of brick will be removed at this location - 2. an existing window in the kitchen that was originally a door will be reinstated so no brick will be removed at this location - 3. The side door probably dates from the c.1920/30s renovations and is not listed as a heritage attribute. If it is to be replaced it could be reused as an interior door, stored on site in a dry location, or removed by an architectural salvage company for reuse elsewhere

It is recommended that repairs and alterations to the masonry be carried out by an experienced heritage mason using an appropriate lime mortar and that bricks removed to make new openings through the existing masonry walls be salvaged so they can be used for repairs elsewhere.

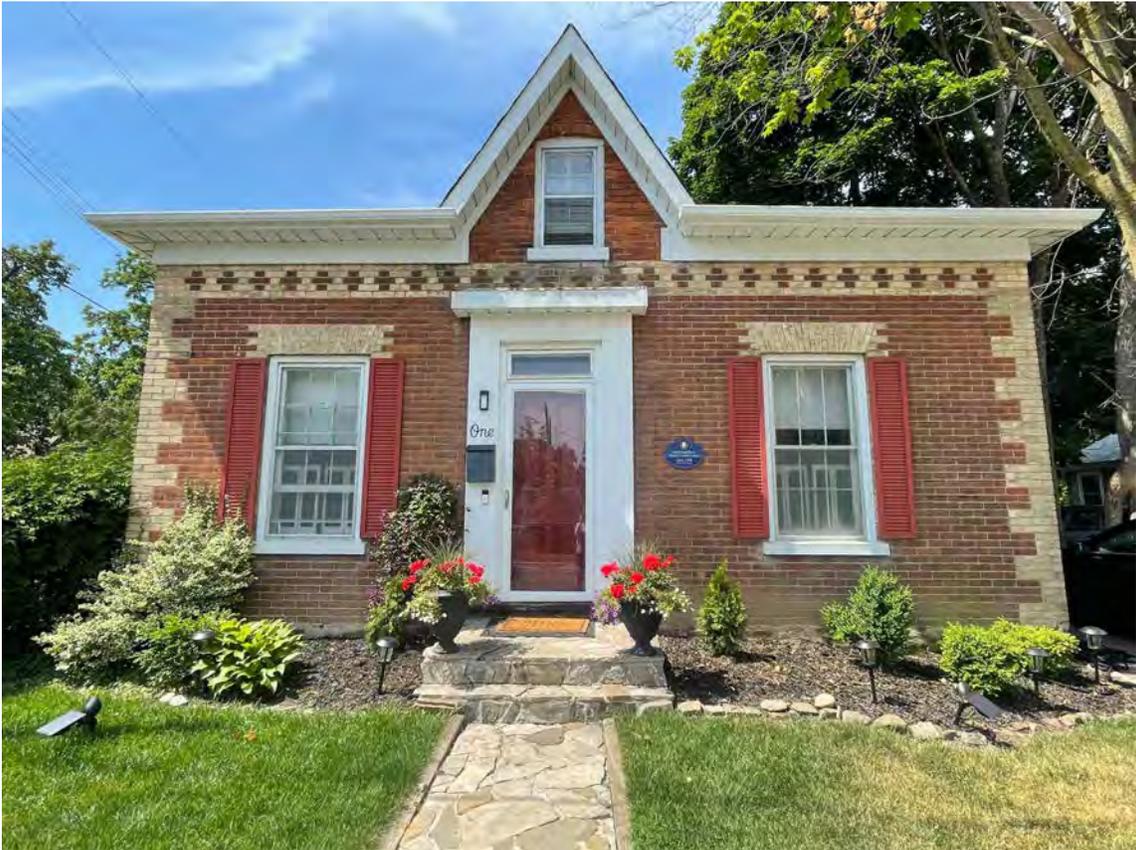
ISABELLA STREET ELEVATION – 3 bay, 1.5-storey 'Ontario Cottage' with a hip roof that was modified at the front for a gable – note the dichromatic brickwork that employs buff brick for corner quoins, frieze and window lintels. The windows are 6 over 6 wood sash.

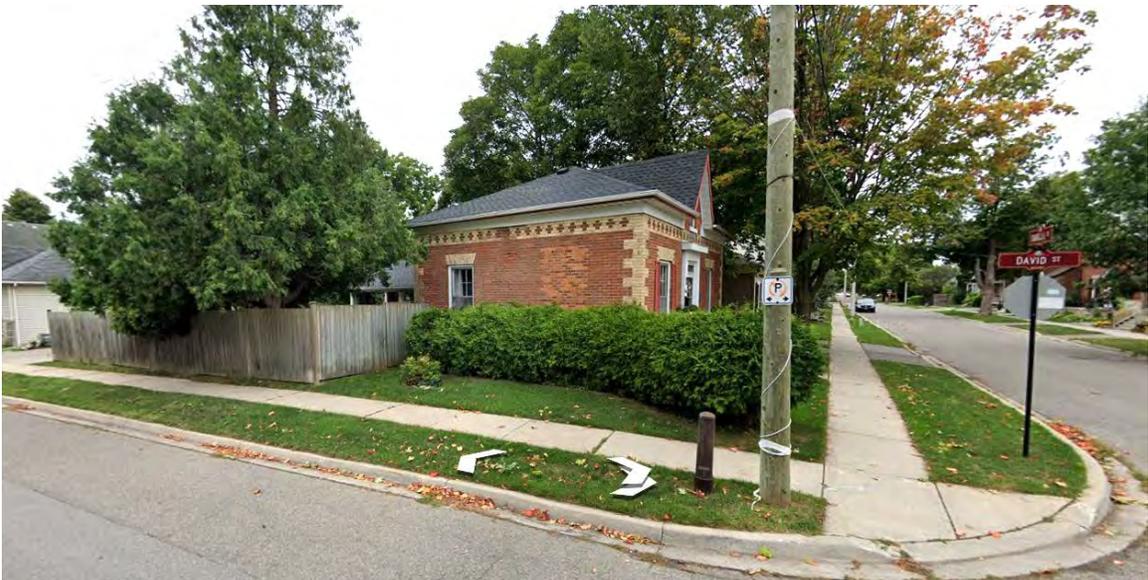
DAVID STREET ELEVATION – one of the windows on this elevation has been bricked in

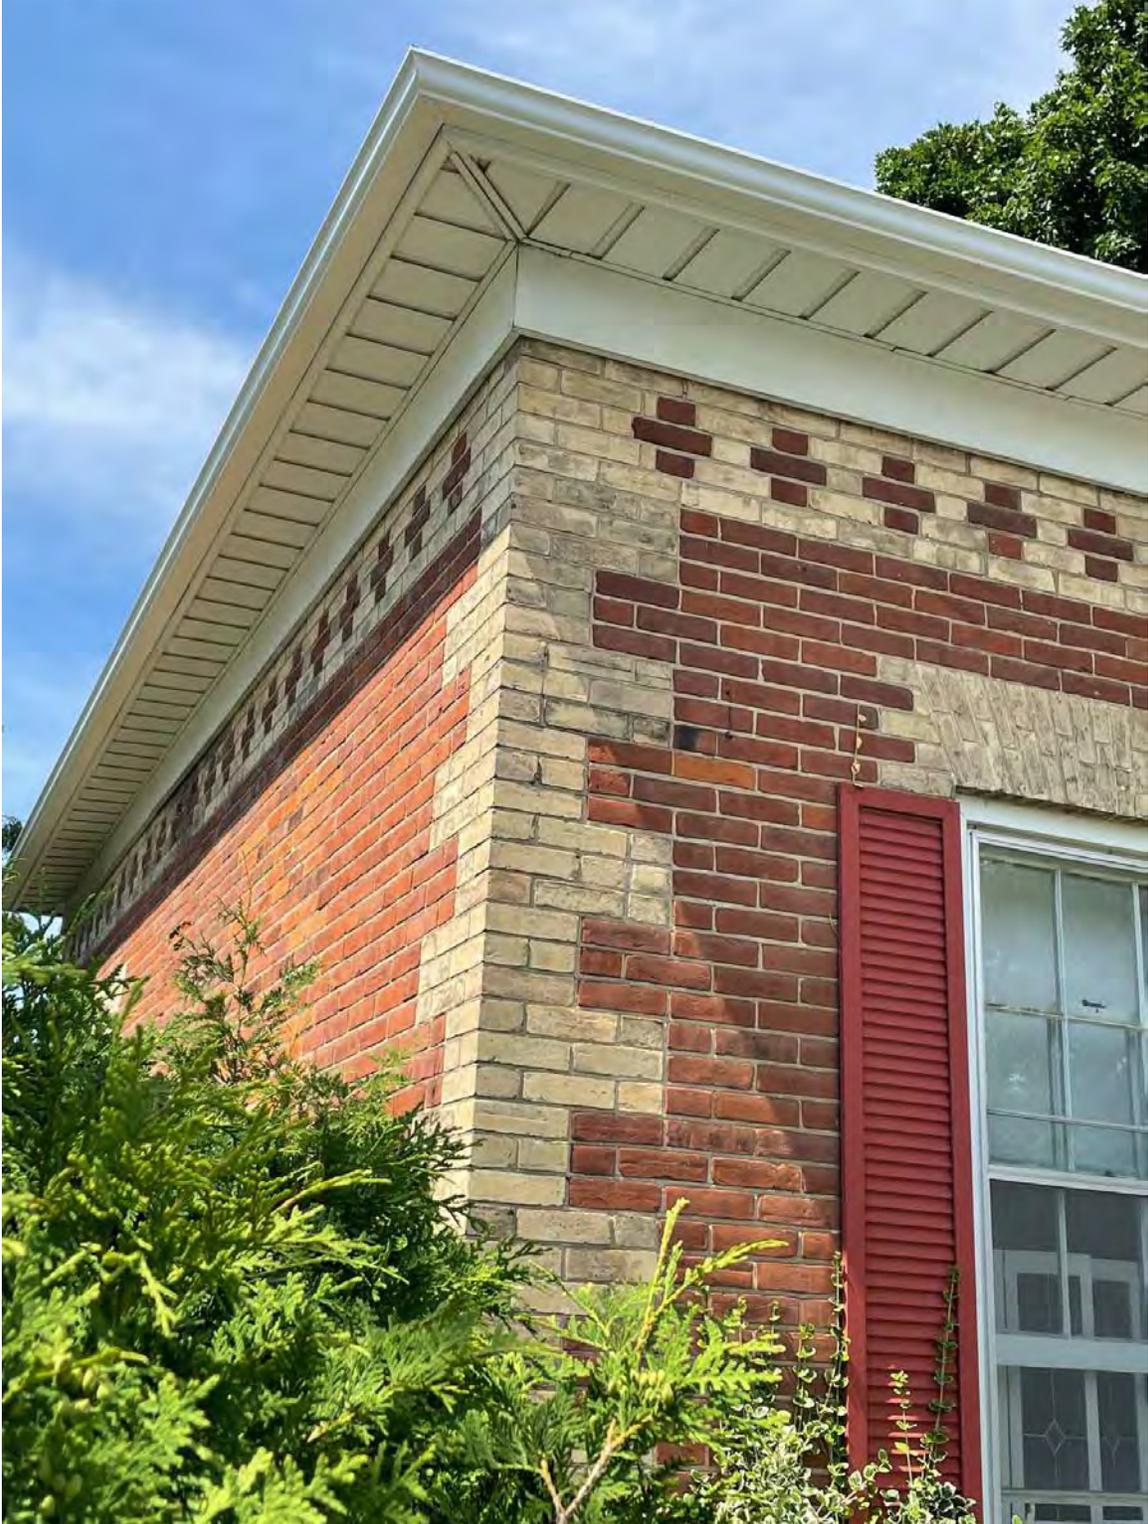
DI-CHROMATIC BRICK – red brick with buff brick quoins, window arches, and frieze – triple brick construction; a double layer of brick with headers and a third layer in running bond on top – the window arches are flat

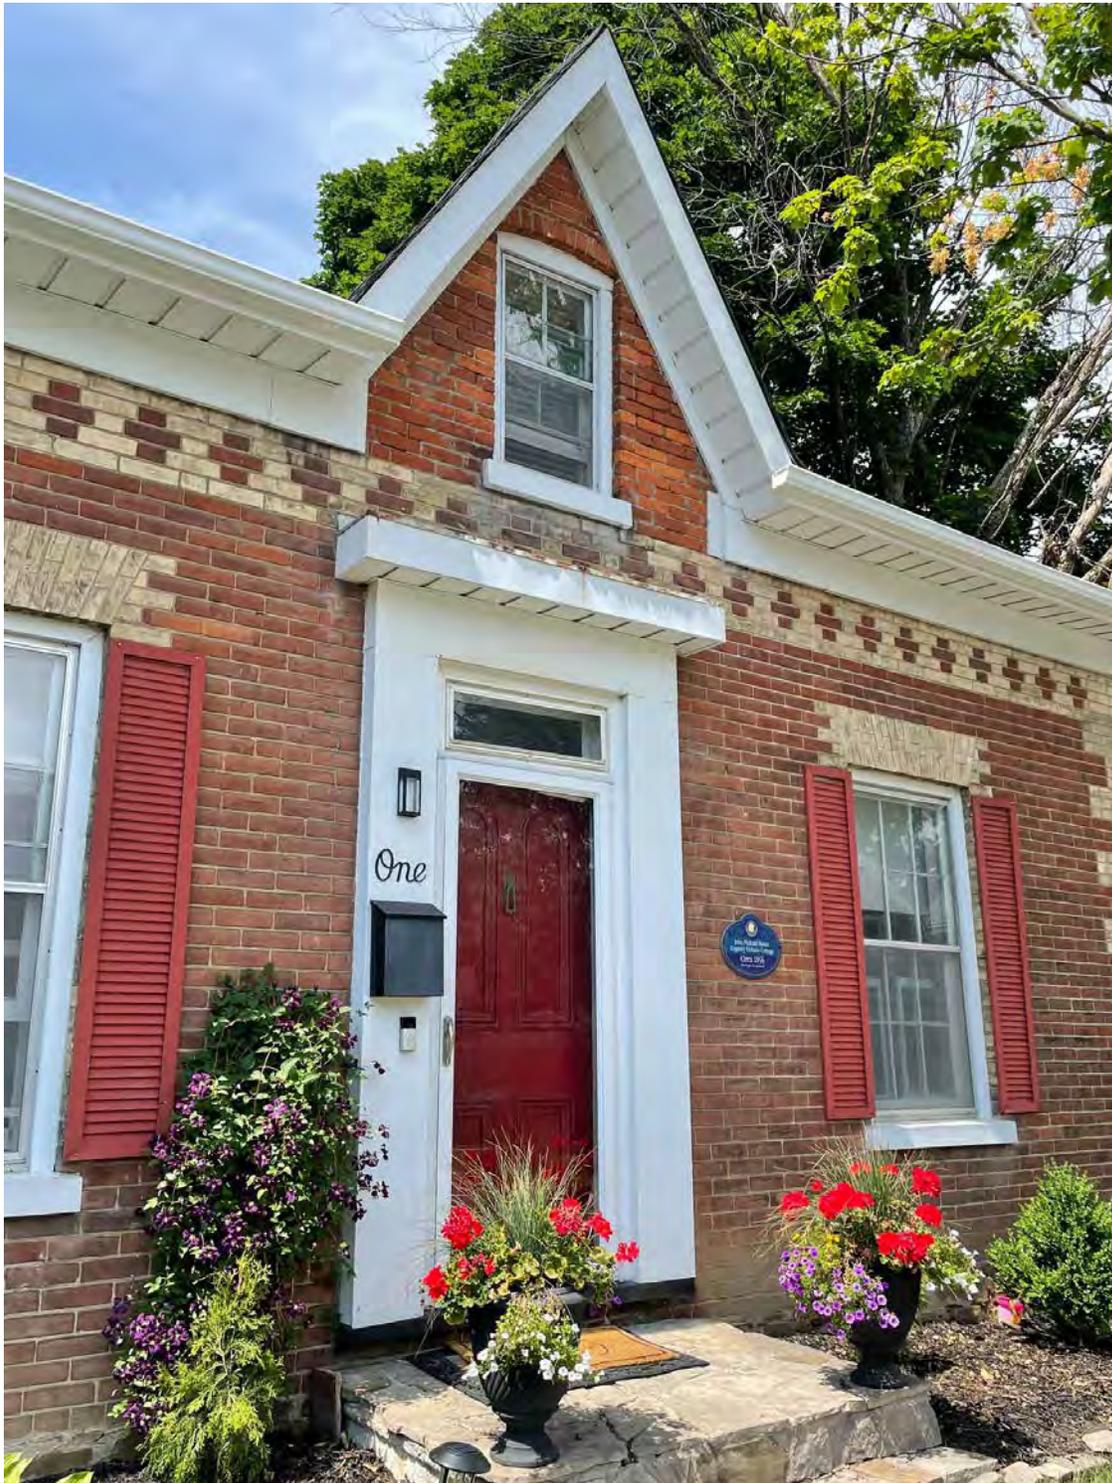
FRONT GABLE – the front gable appears to be a later alteration, possibly done in the late 19th or early 20th century – the door frame has been clad with aluminum, perhaps on top of original wood components – the soffits and fascia are aluminum, perhaps with original wood components beneath

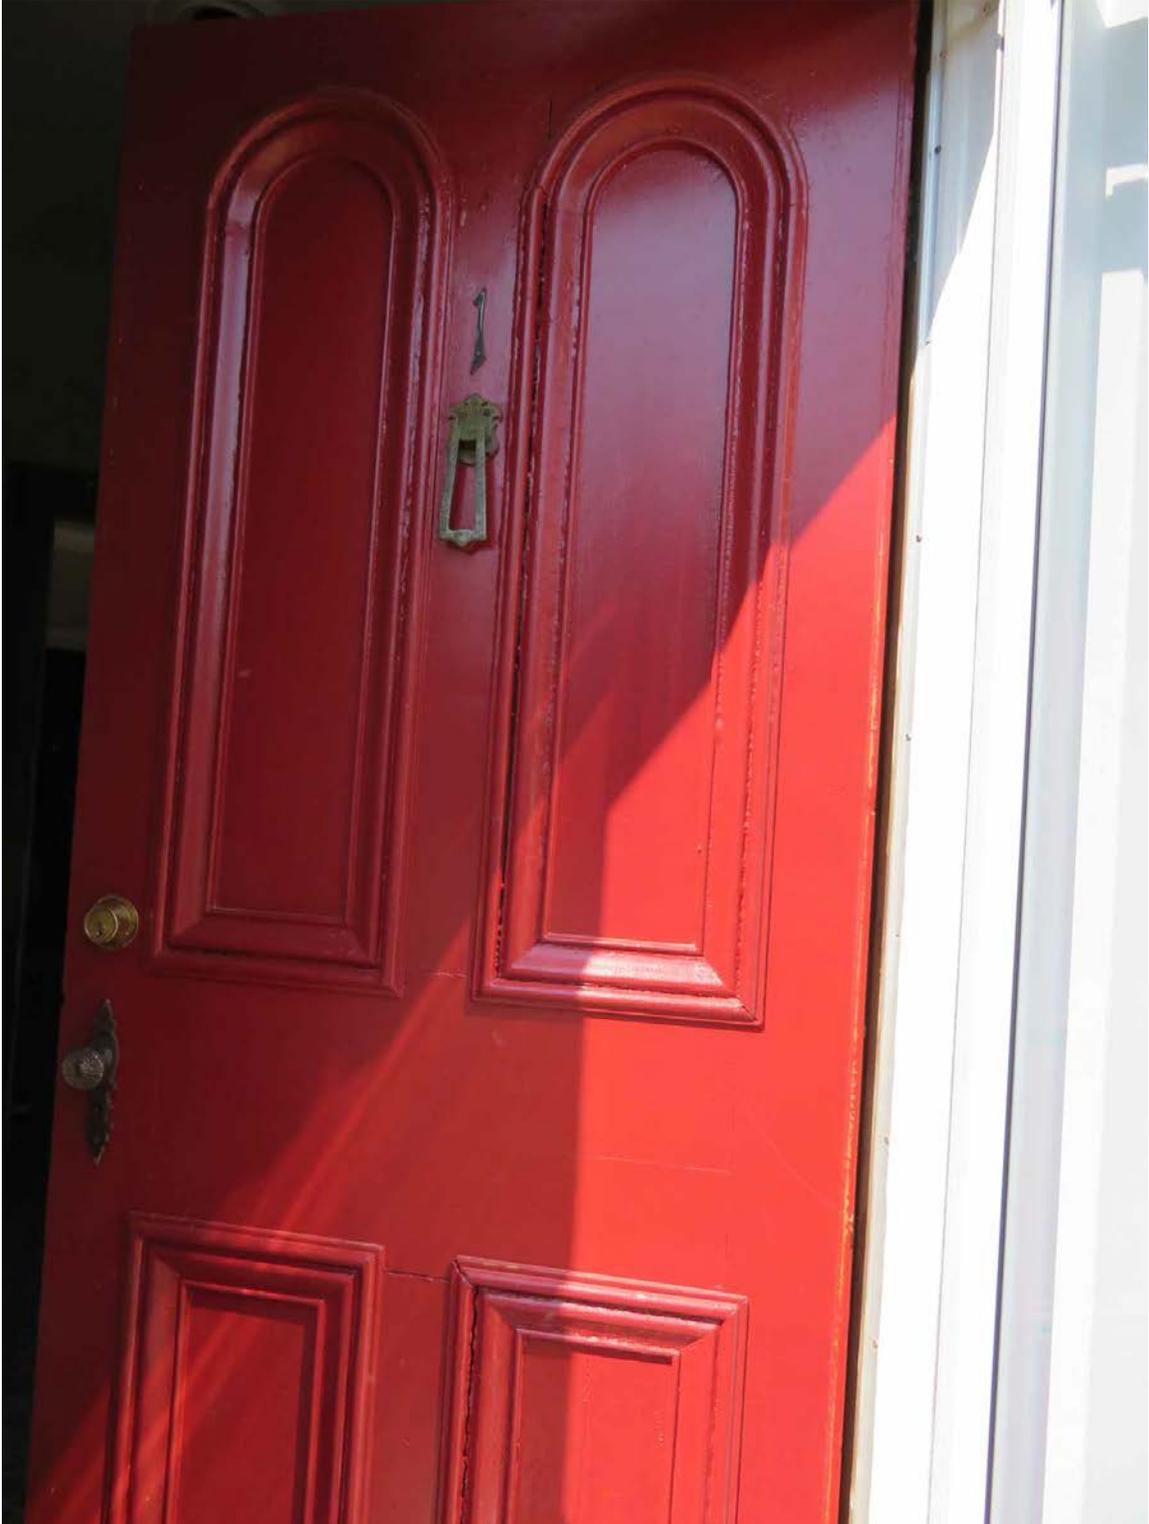
FRONT DOOR – four raised panels included two arched panels – a late Victorian door style, perhaps salvaged from another building

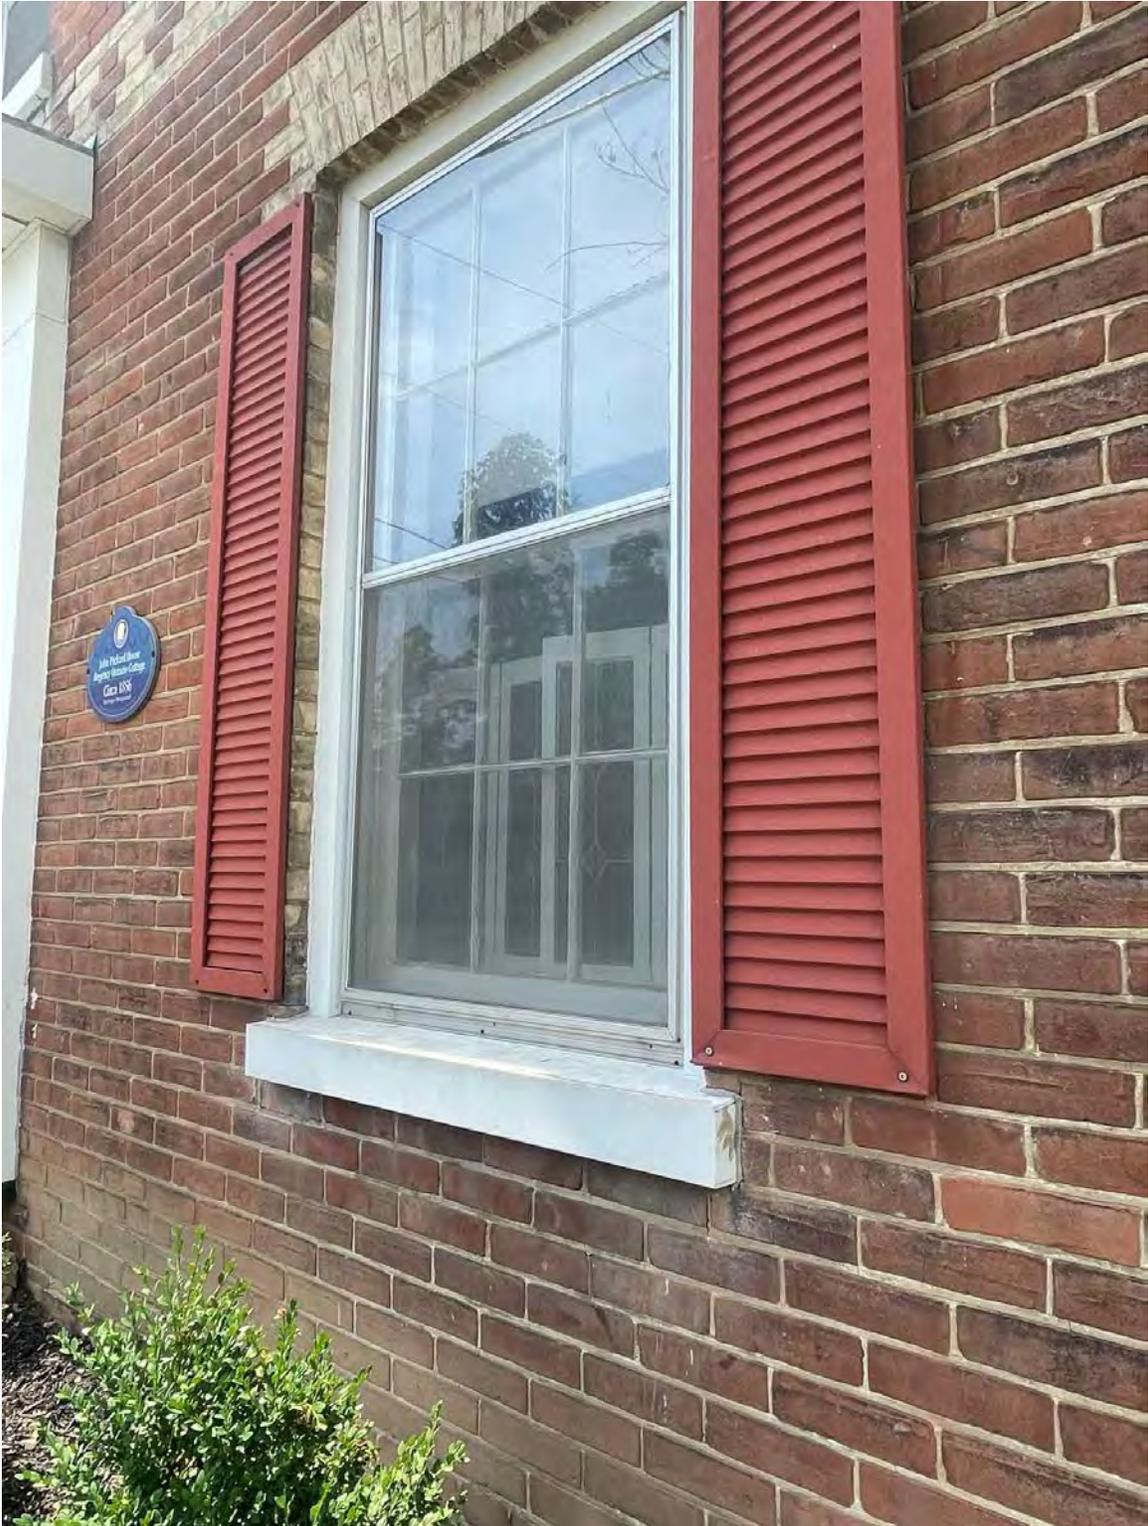
WINDOWS – wood sash windows with slender muntin bars are probably original – the sills have been covered with aluminum and may be wood beneath – the aluminum shutters are recent

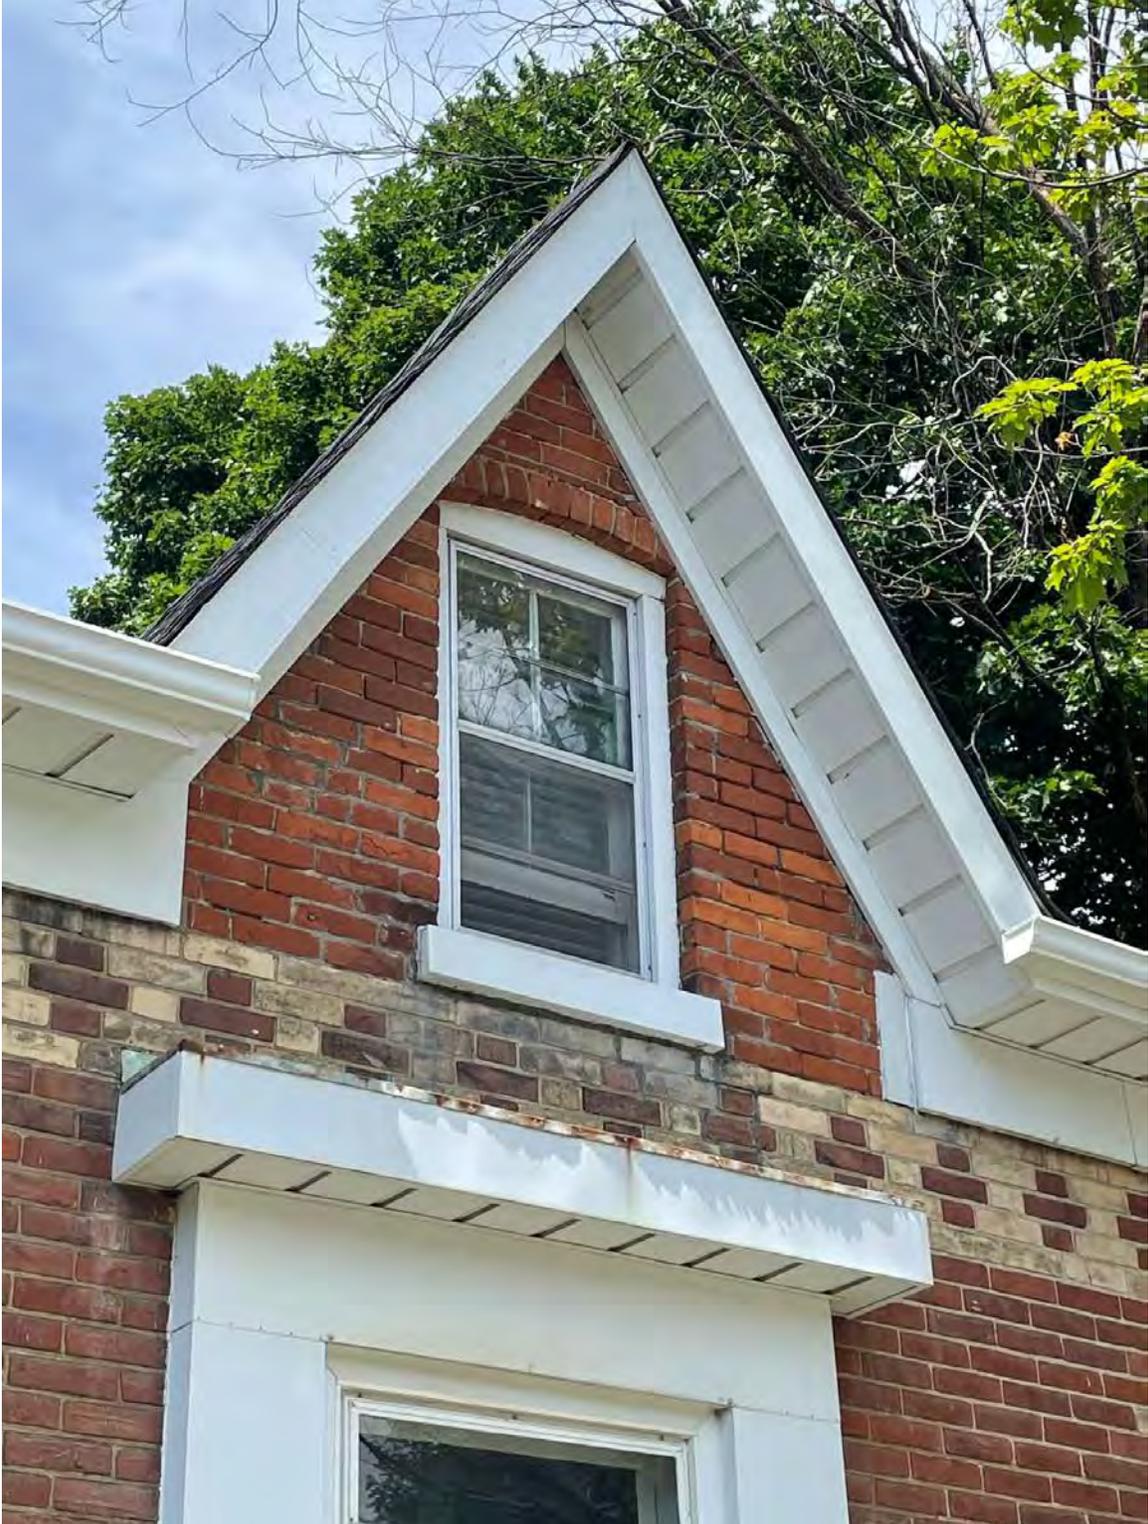
FRONT GABLE – the front gable is an early addition to give additional space on the 2nd floor – probably done in the late 19th or early 20th century – the window in the gable has a shallow segmental arch in red brick

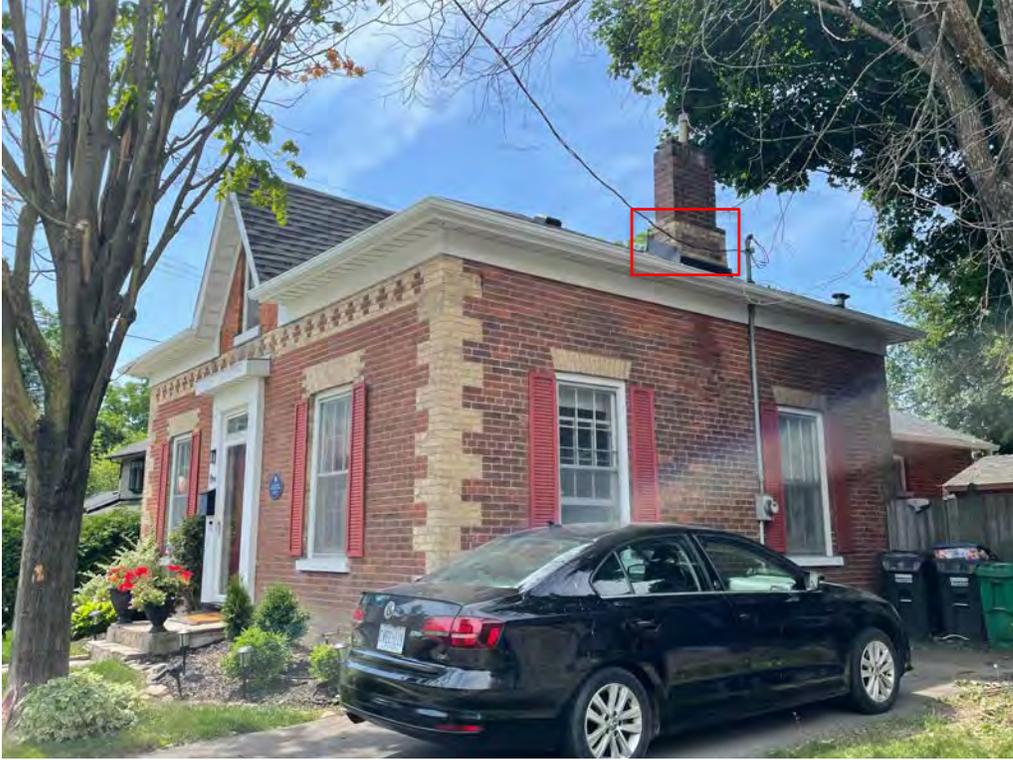
The upper part of the chimney is not historic and will be dismantled.

DRIVEWAY ELEVATION – 1.5-storey, 3 by 2 bay dwelling with a one storey tail at the back – the roofline of the addition is lower and the footprint is narrower – there is a chimney on this elevation

The original portion at the base will be preserved & a new cap will be installed.

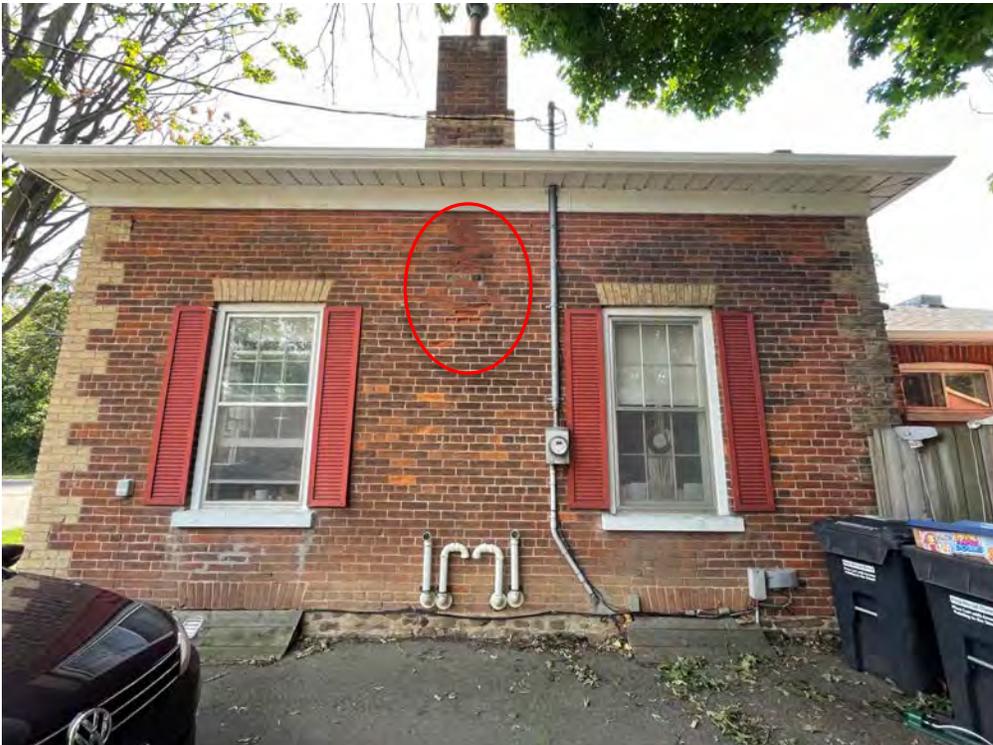
DRIVEWAY SIDE ELEVATION – note the wide overhang of the roof – note the spalling of the brick below the chimney – there is a basement below and two windows above grade on this elevation - note the rubble stone foundation

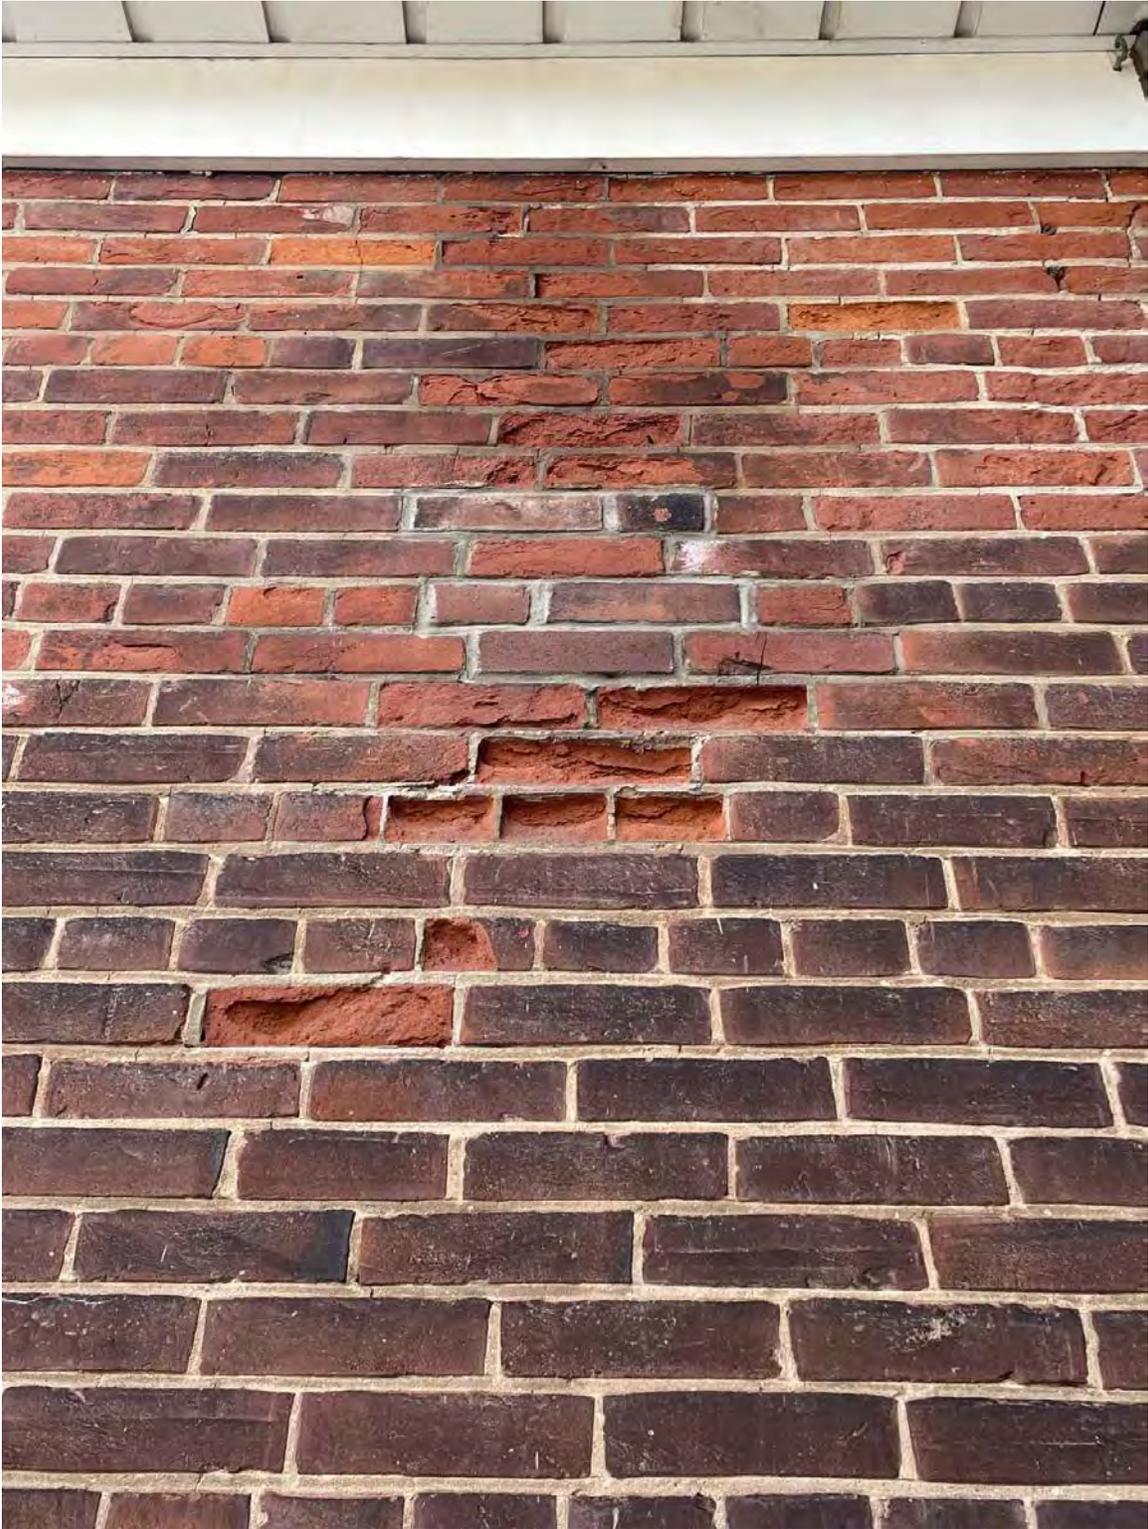
DRIVEWAY SIDE ELEVATION – detail of spalled brick noted above

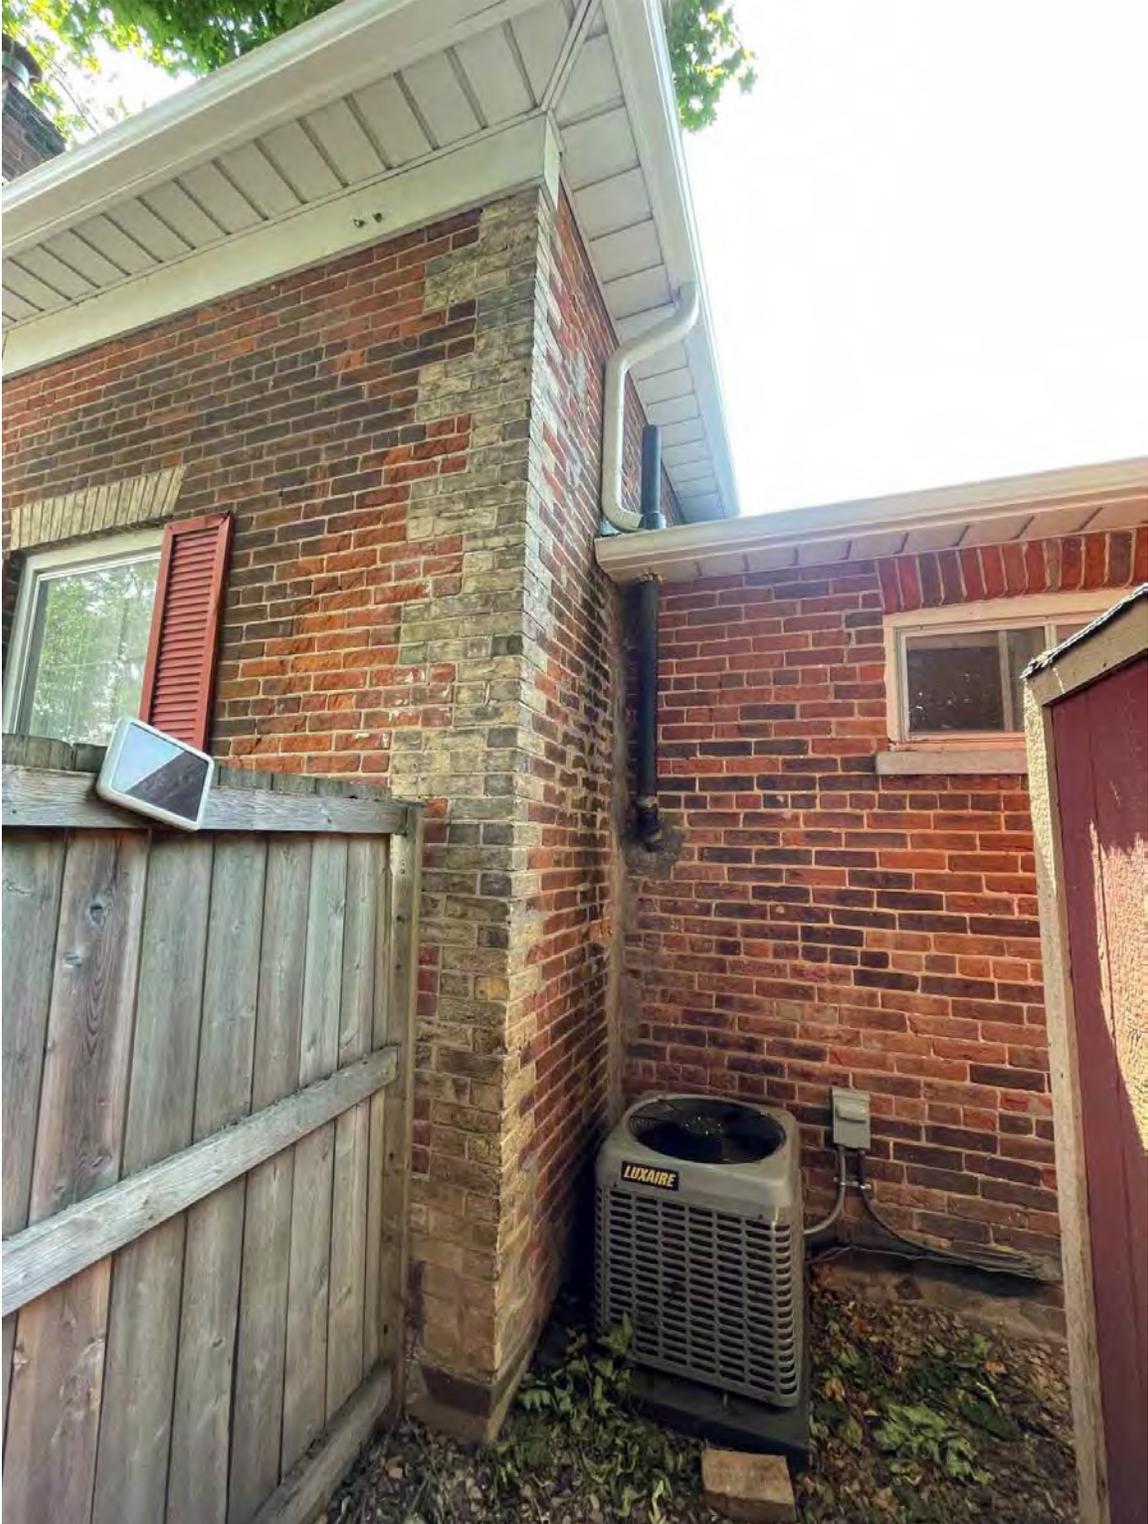
TRANSITION TO THE REAR SECTION – note the buff brick quoin detail – the addition is double-brick construction, note the different bond pattern of the addition that has a row of headers every 8th row – note the rubble stone foundation – the tail may be original or was an early addition built in the late 19th or early 20th century – the masonry openings have segmental brick arches

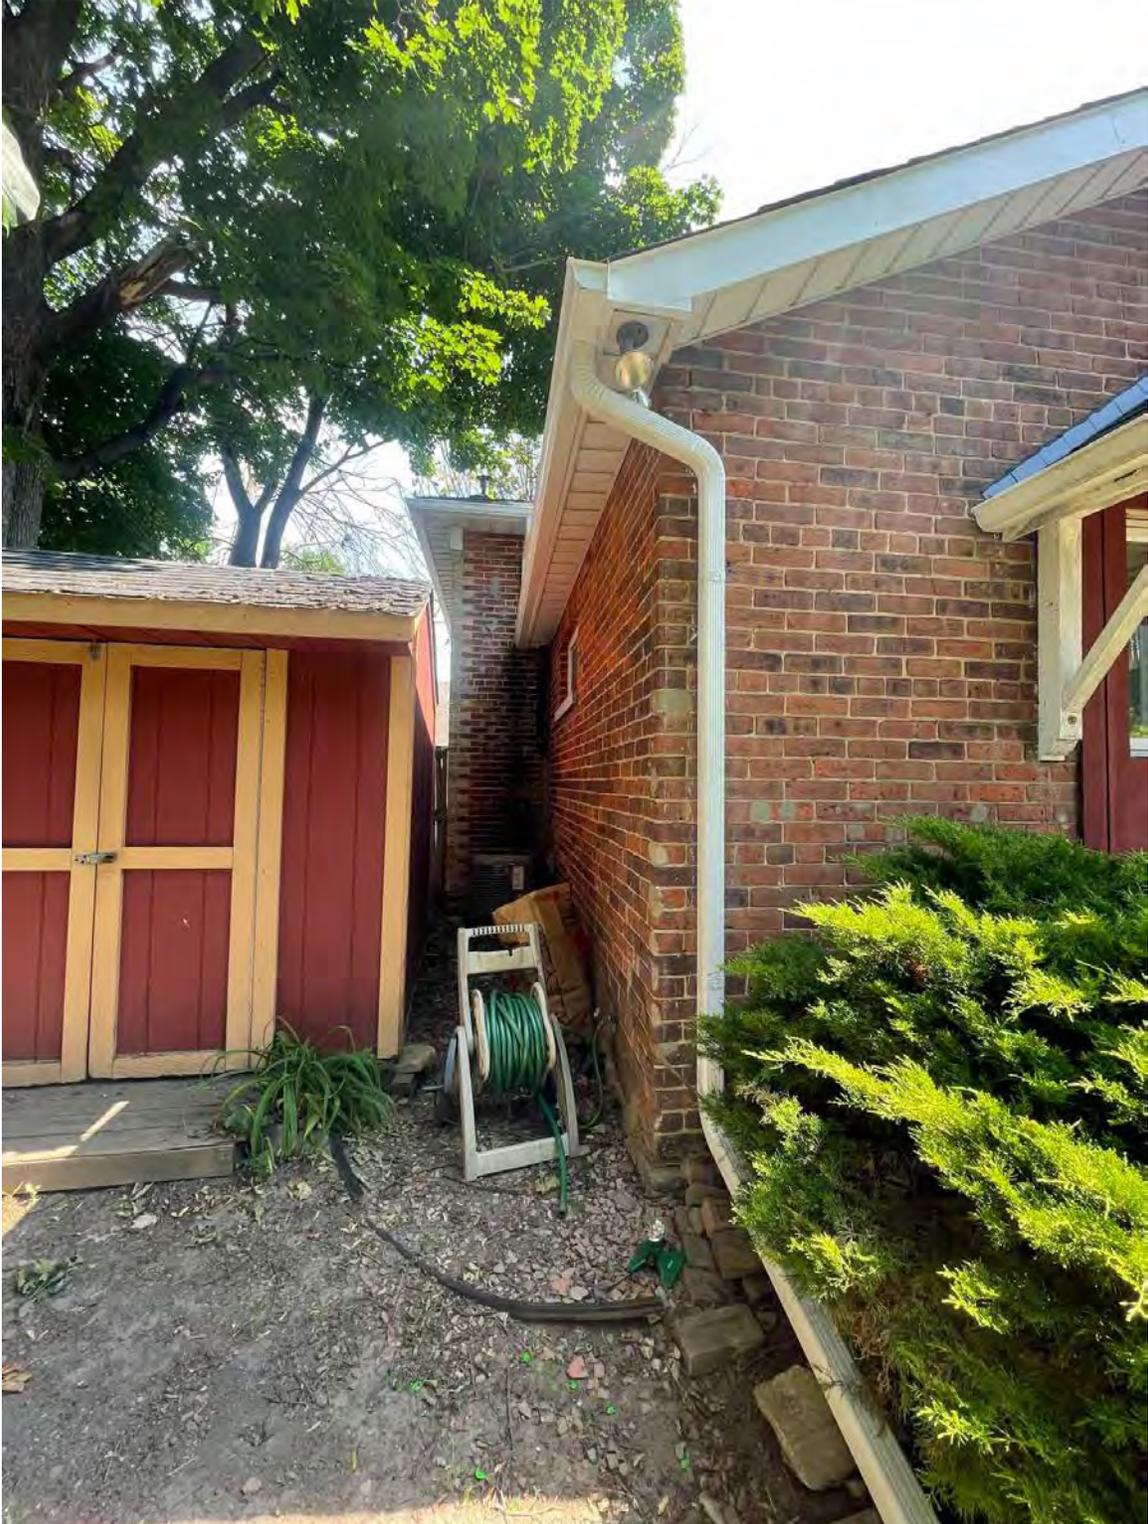
BACK CORNER ON THE DRIVEWAY SIDE – the addition is constructed of red brick without the buff brick detailing of the front – the shed is a modern frame structure

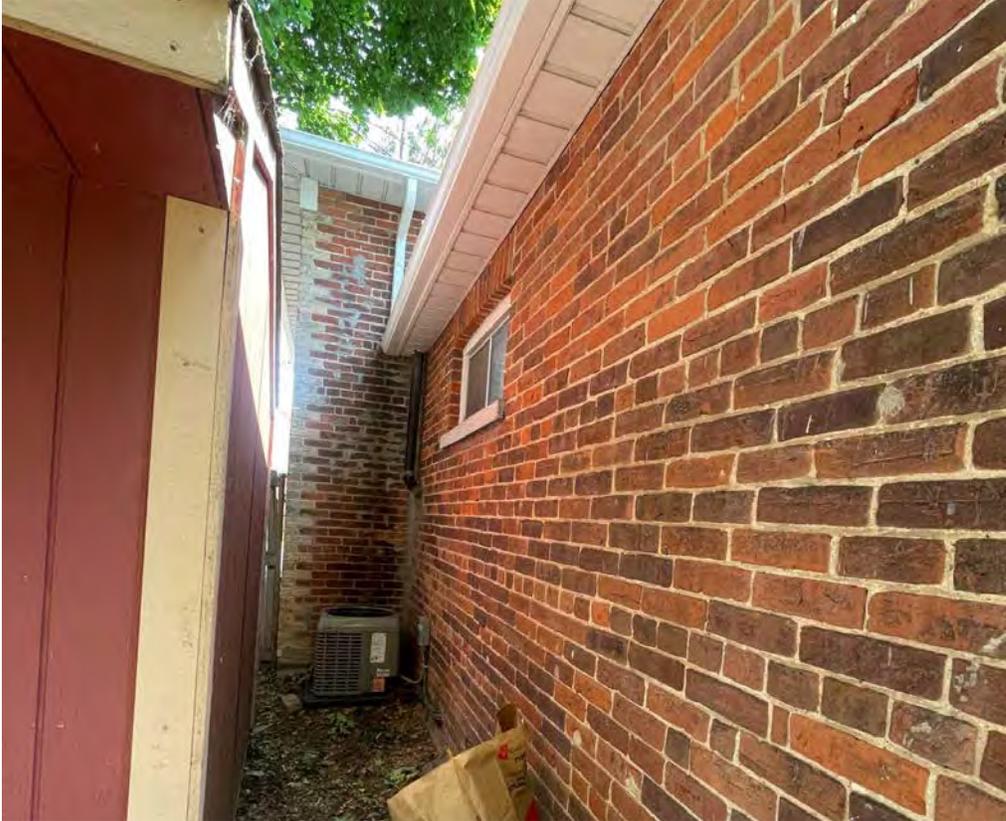
REAR SECTION – DRIVEWAY SIDE – there is one small window on this elevation

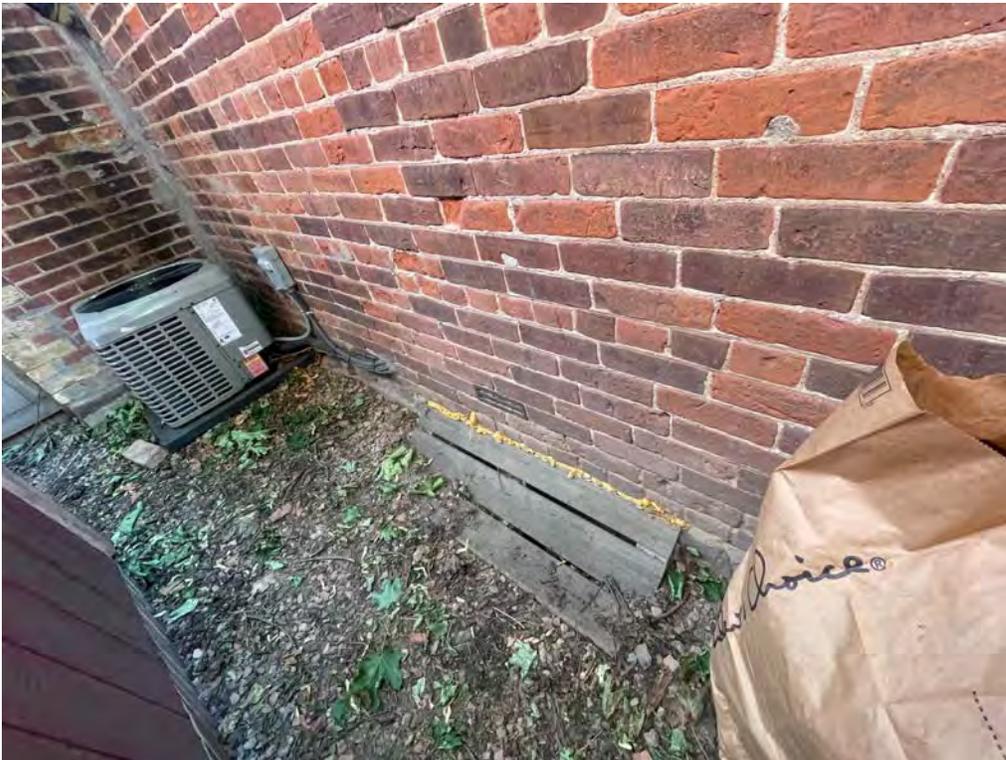
REAR SECTION – DRIVEWAY SIDE – there is one basement window on this elevation

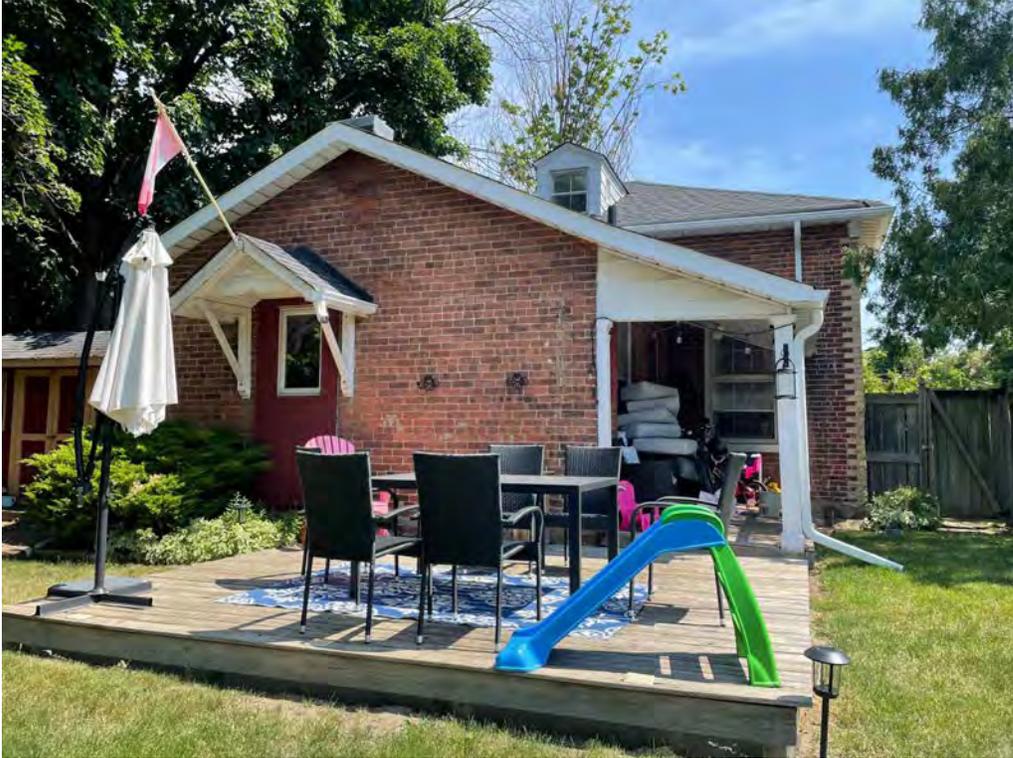
REAR ELEVATION – the rear tail section has a gable roof that extends over a porch on the David Street side – the roof of the porch overlaps a window on the rear elevation of the main portion of the house

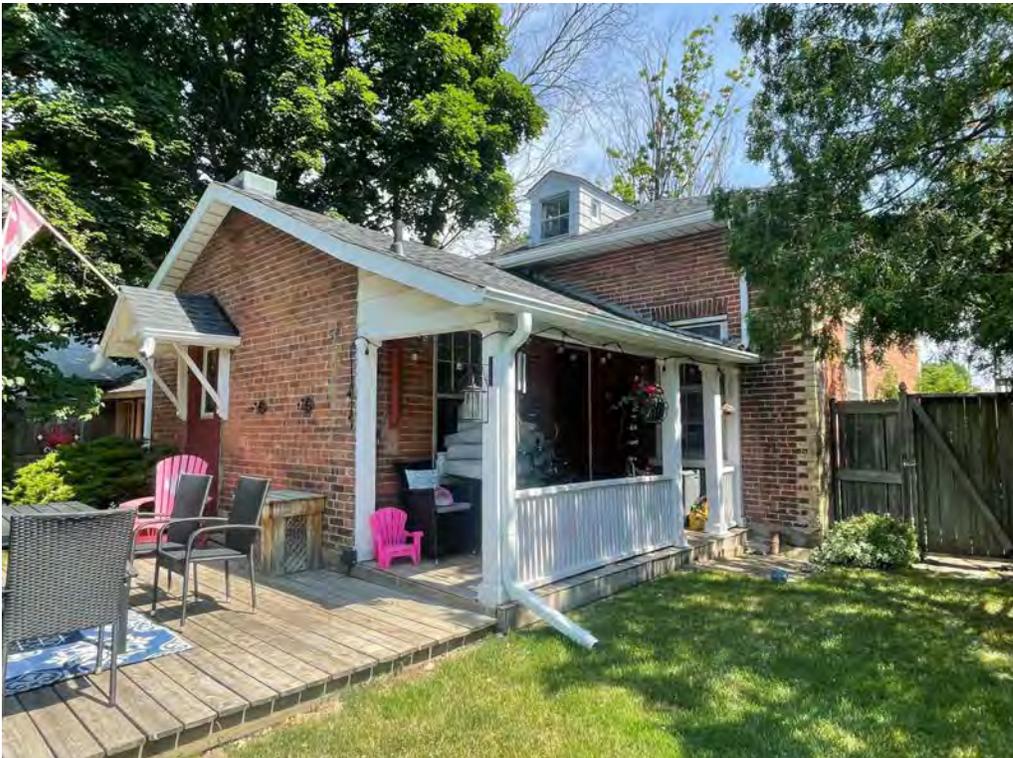
REAR ELEVATION – the 1917 Fire Insurance Plan shows a porch in this location but the wood posts and railings are probably more recent – there is a small dormer above that also seems to be a fairly recent alteration
